PETROHUNTER OPERATING  
COMPANY - 10200

LAKE #16-21

API # 05-103-10973

10/02/2015

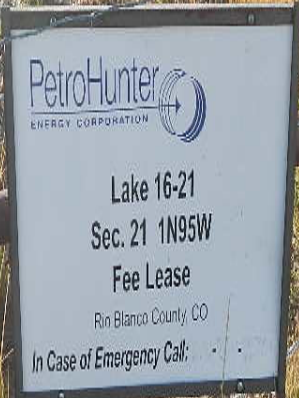
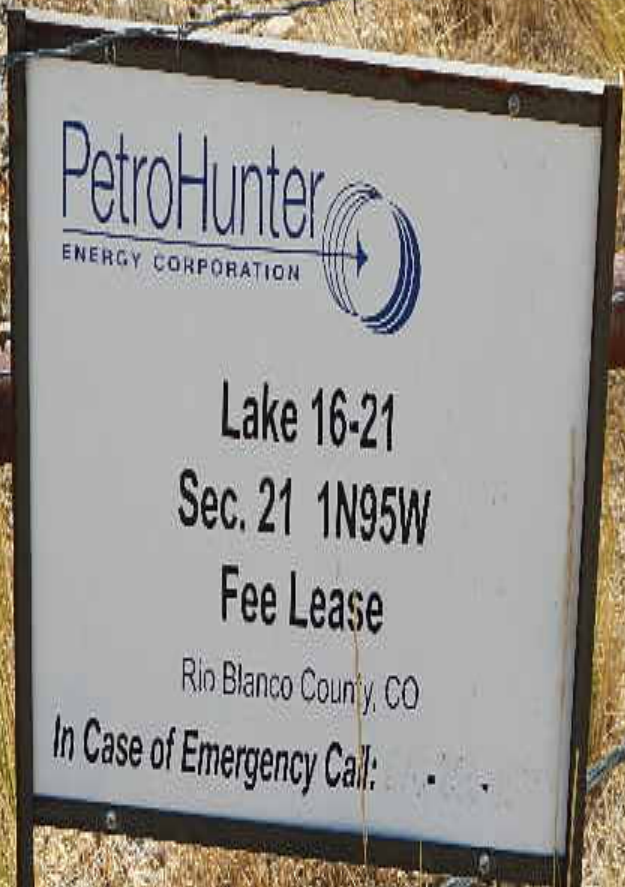
A1

Missing emergency contact number and  
nearest public access road

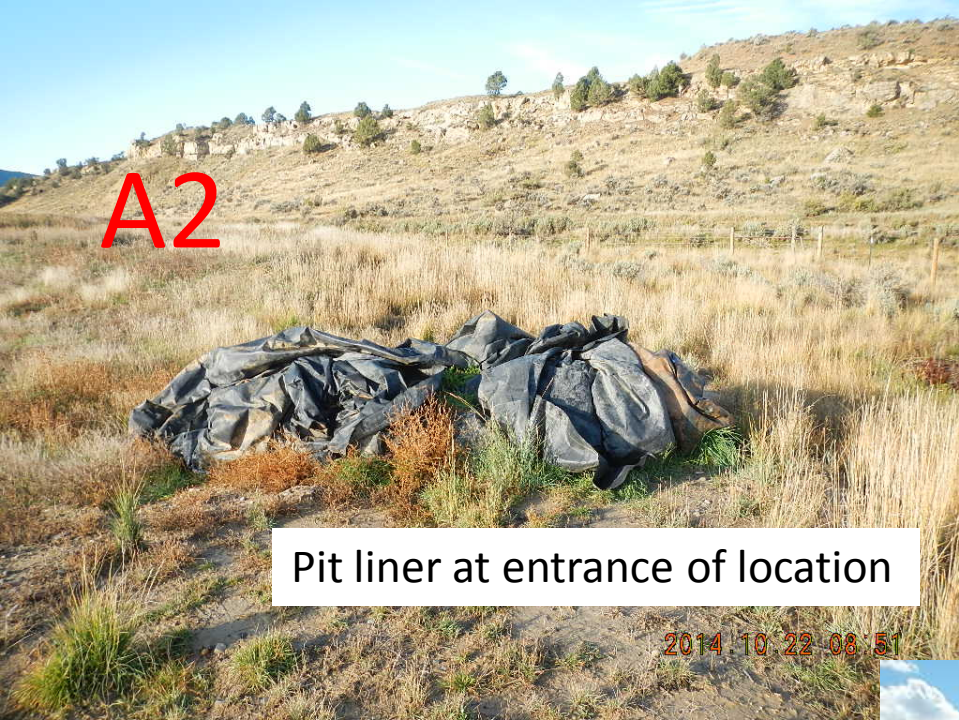
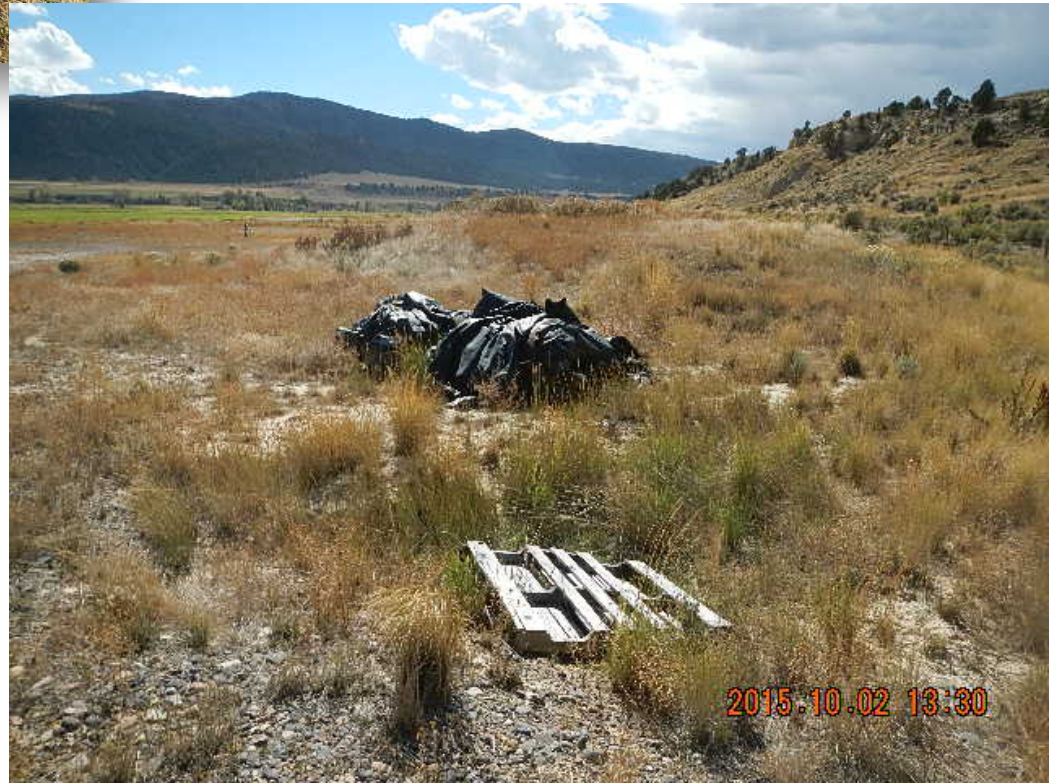
A2

Pit liner at entrance of location

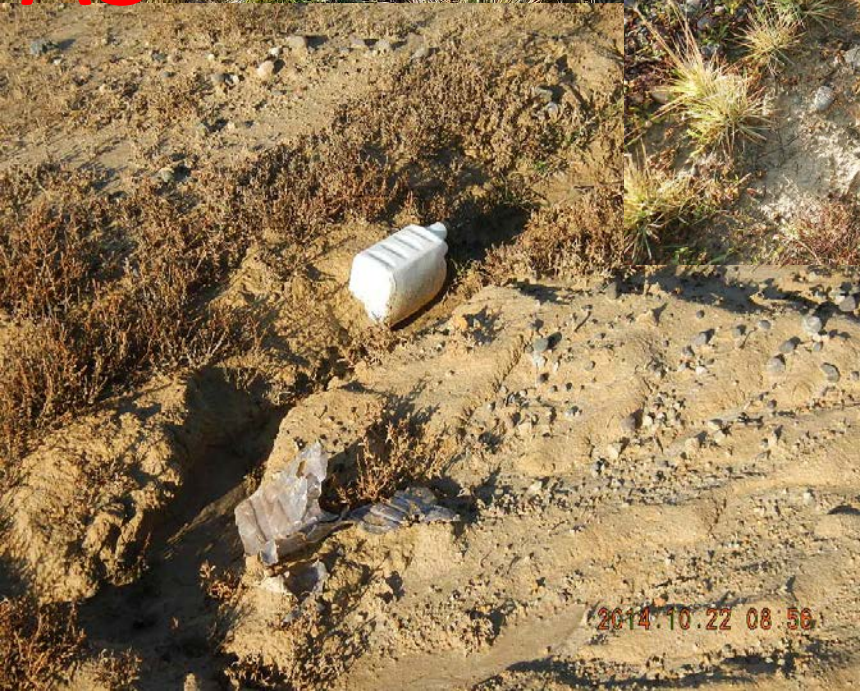
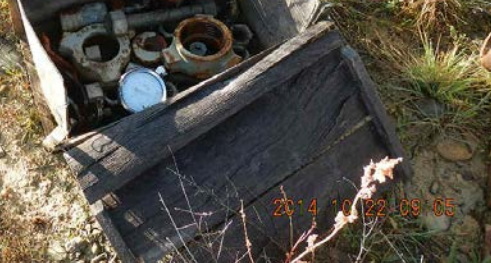
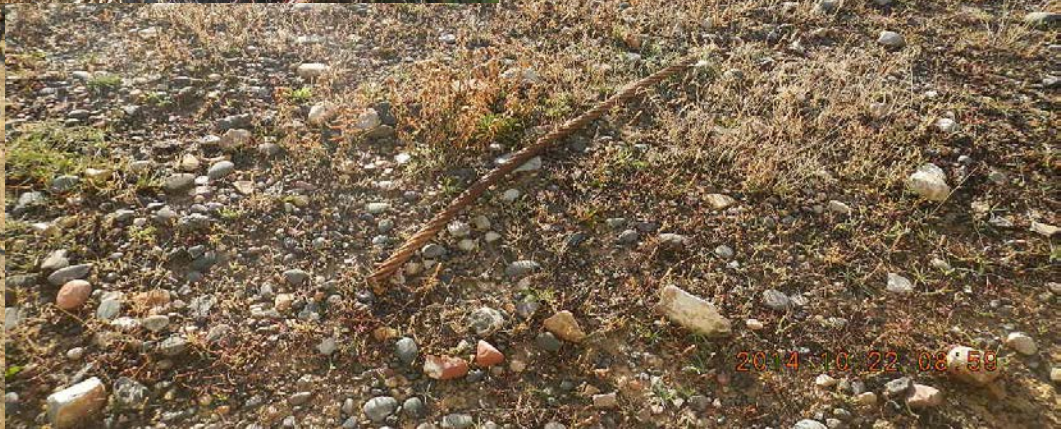
A3

Trash and unused equipment on location

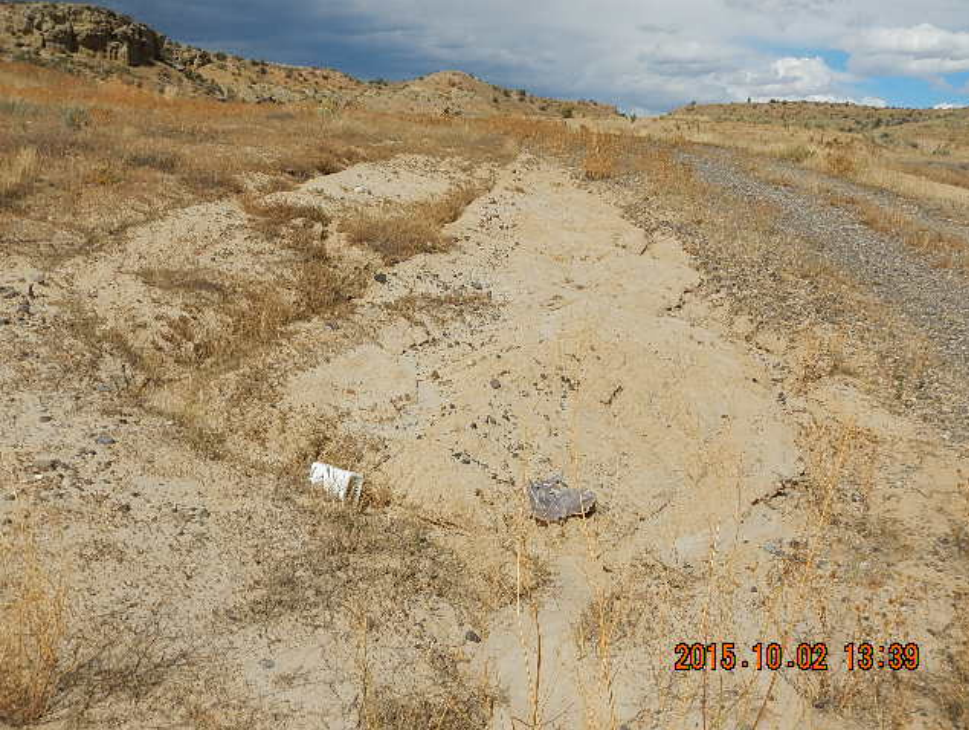
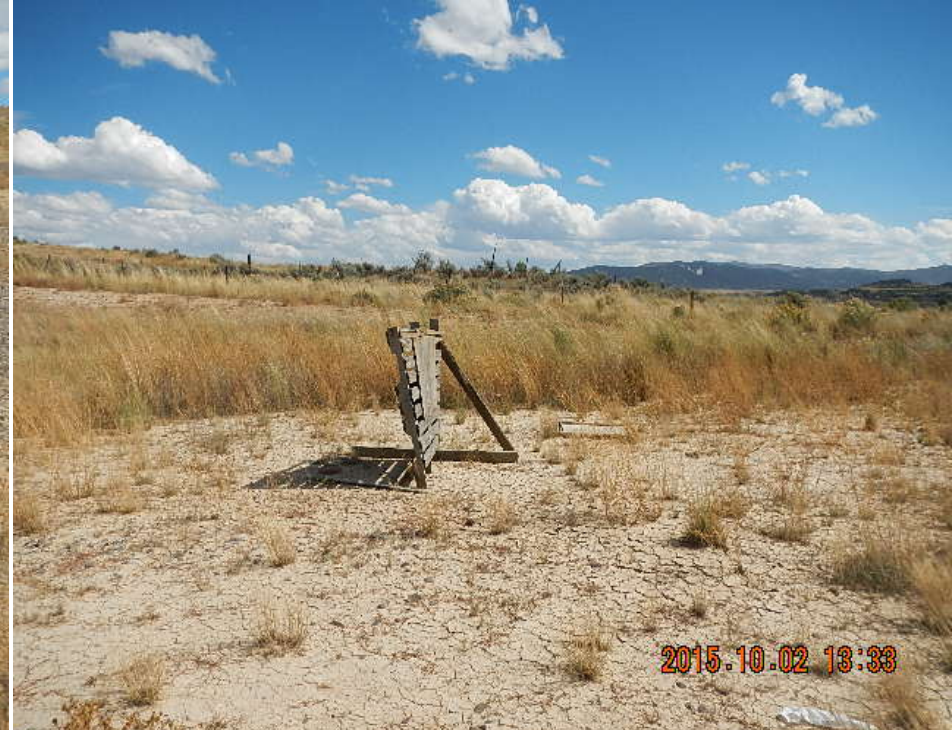
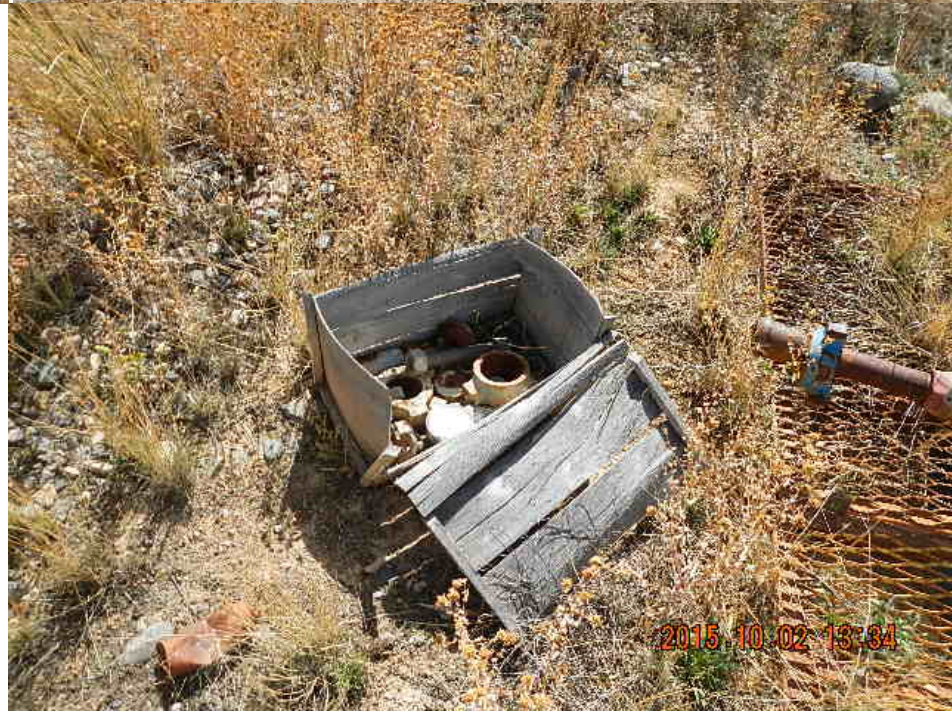
Trash/debris on follow up inspection

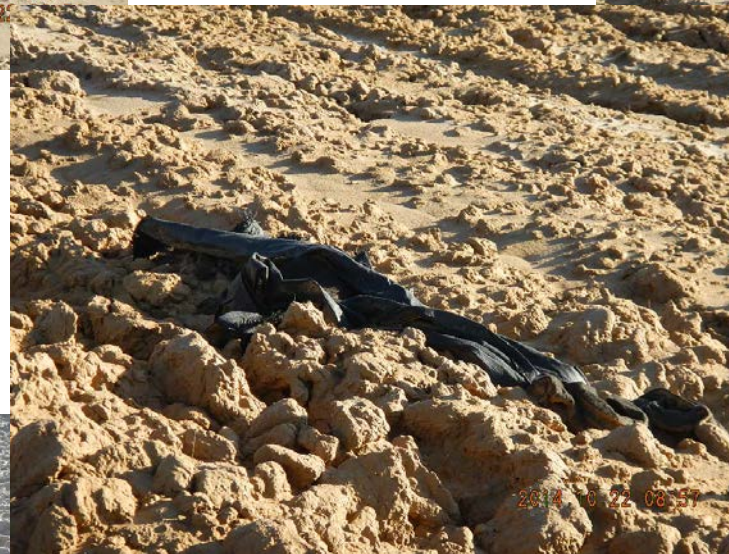
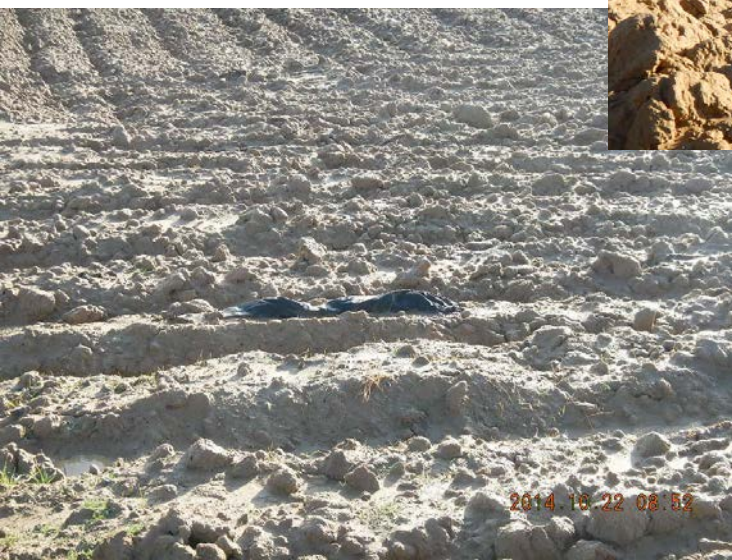
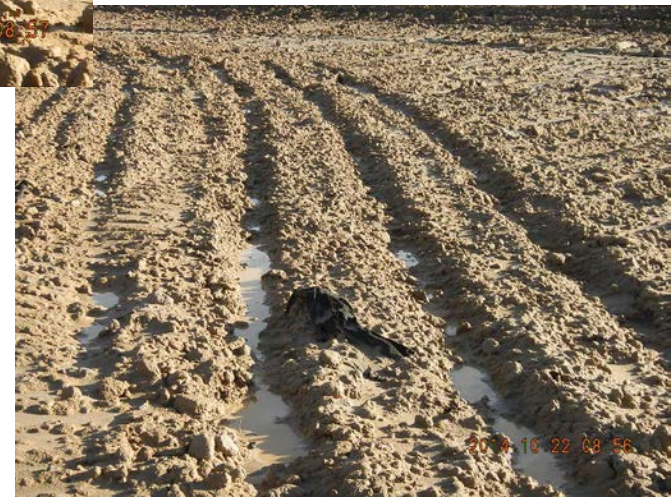
A4

Pit liner scattered through  
out recent pit reclaim

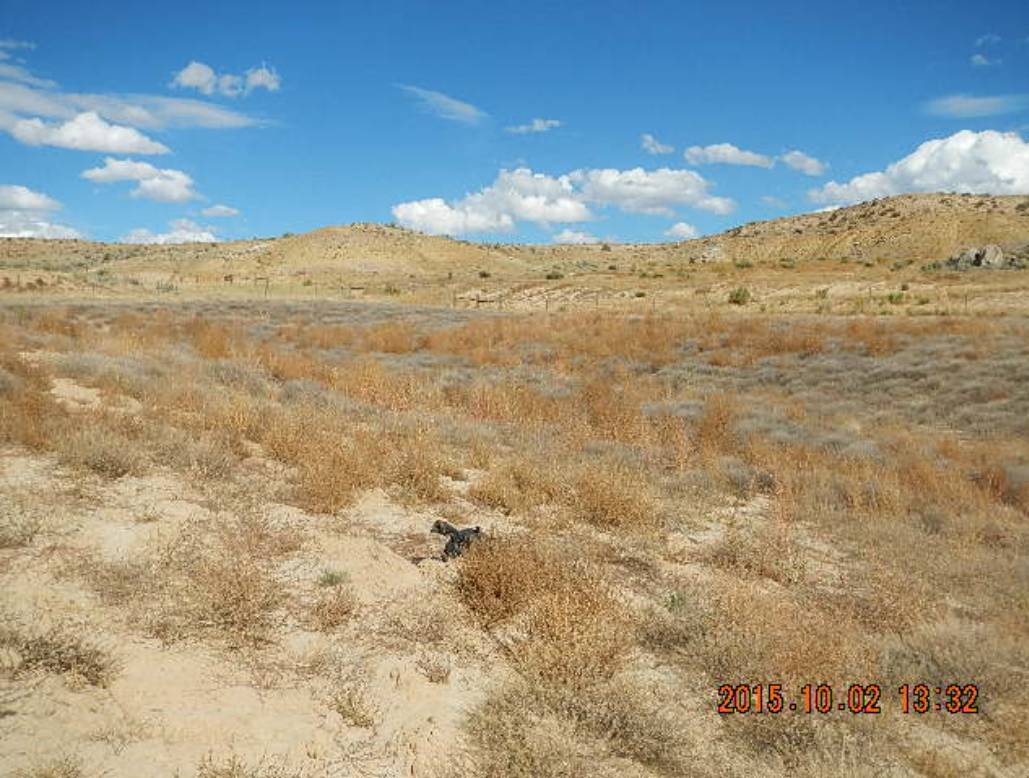
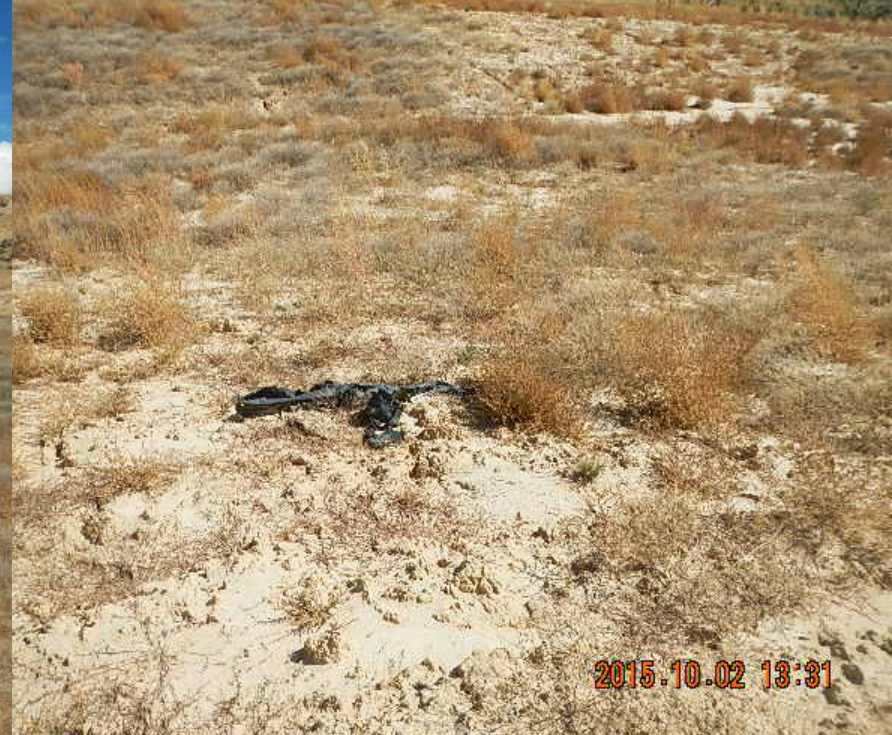
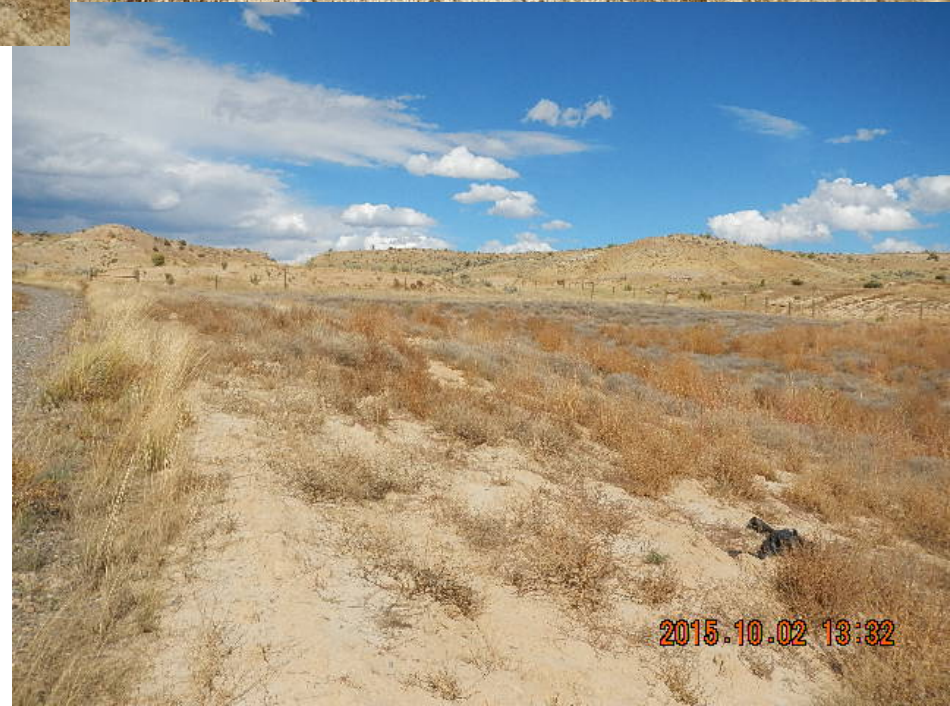
Follow up inspection – pit liner in pit reclaim

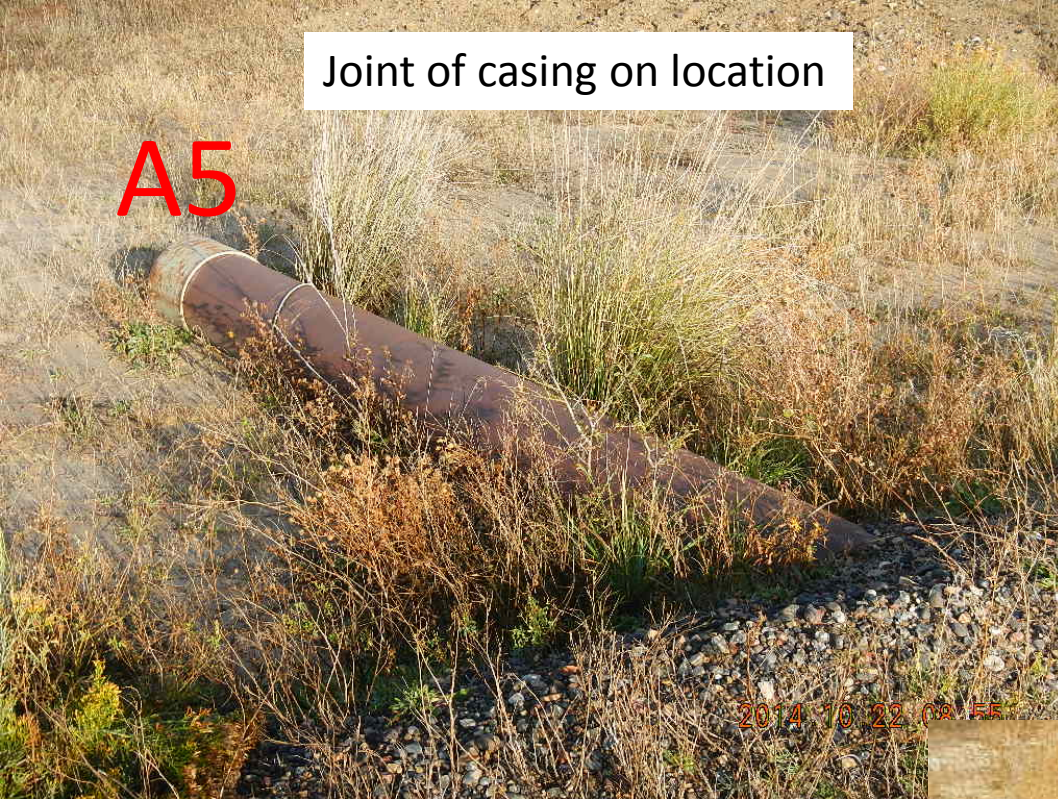
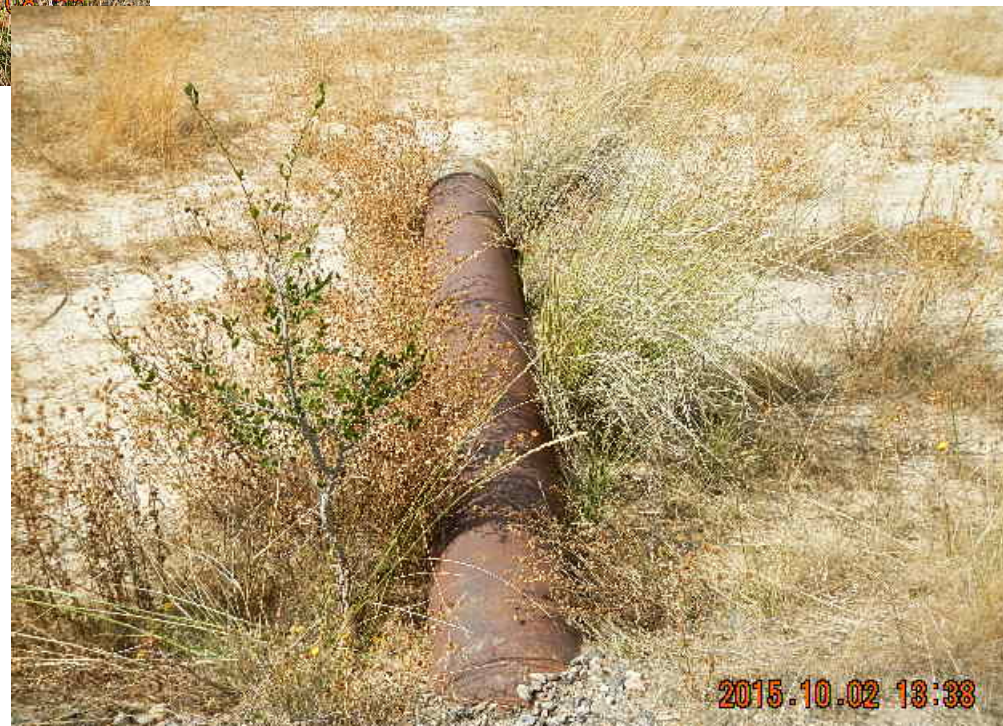
A5

Joint of casing on location

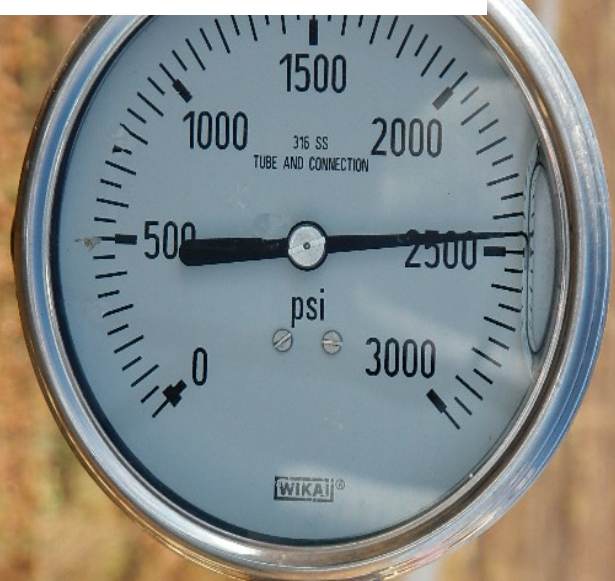
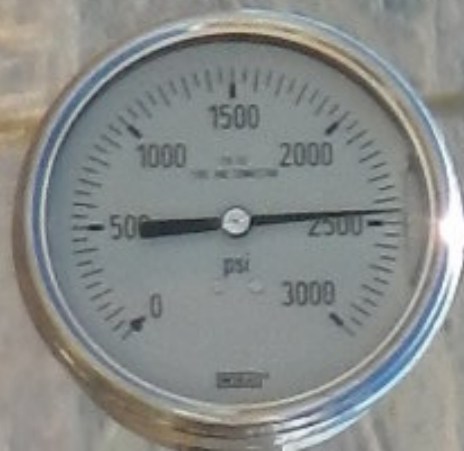
A7

Wellhead TA with 2450psi,  
missing wellhead sign
