Jones 1-11

Inspection# 673402480

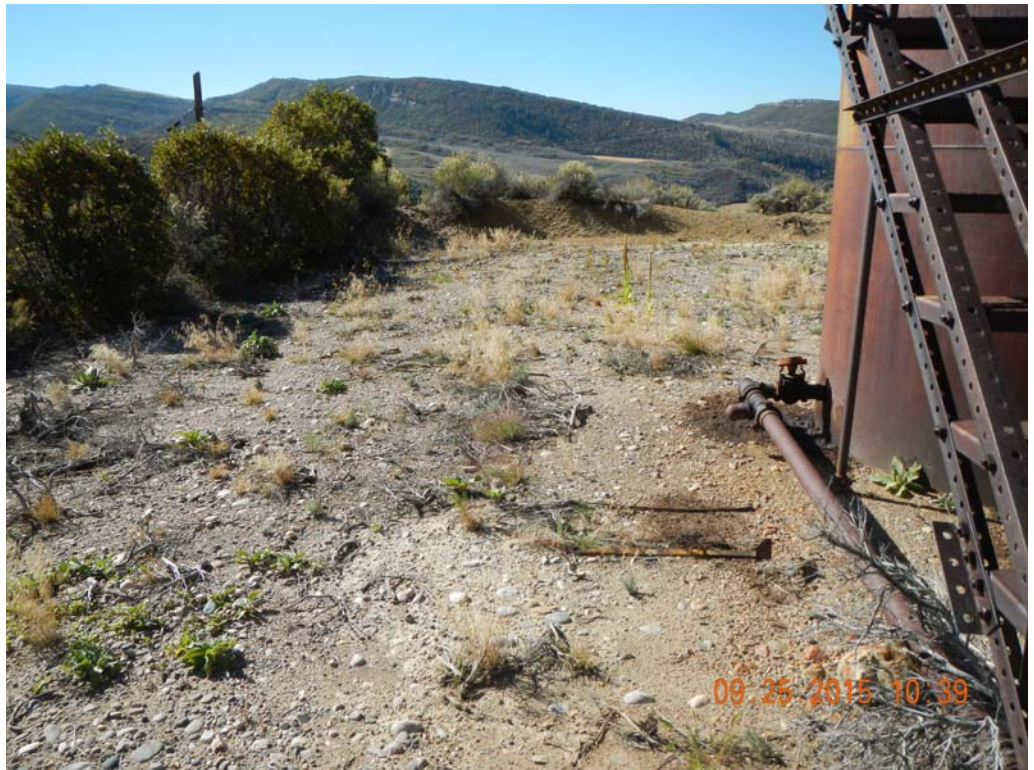
Vegetation growing on
berm. (2 of 4) stained soil
spots at tank base.

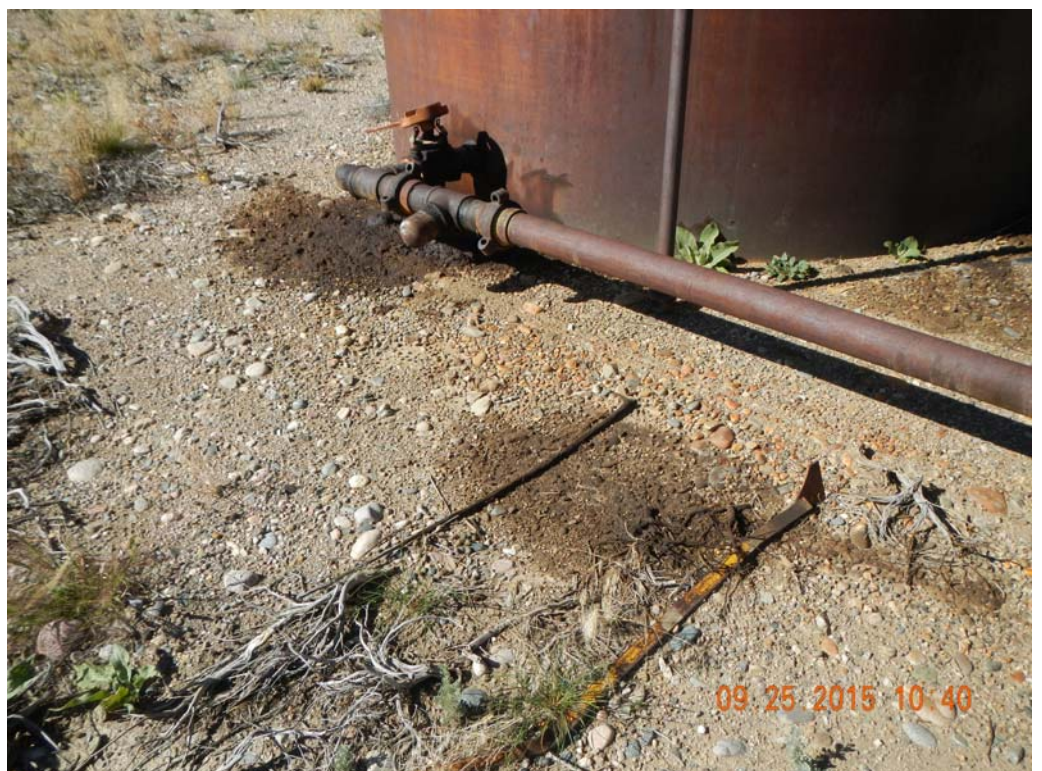
Close up of (2 of 4) stained
soil spots from previous
picture.

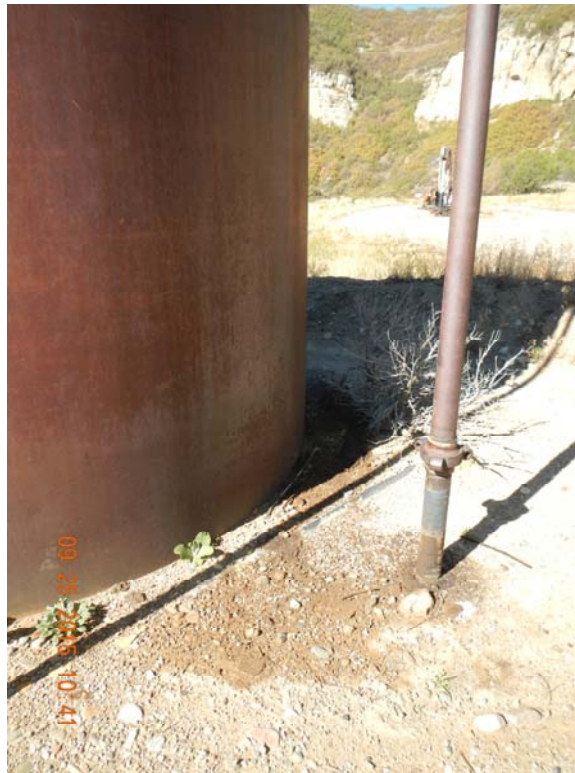
(3 of 4) Stained soil spot at tank base.

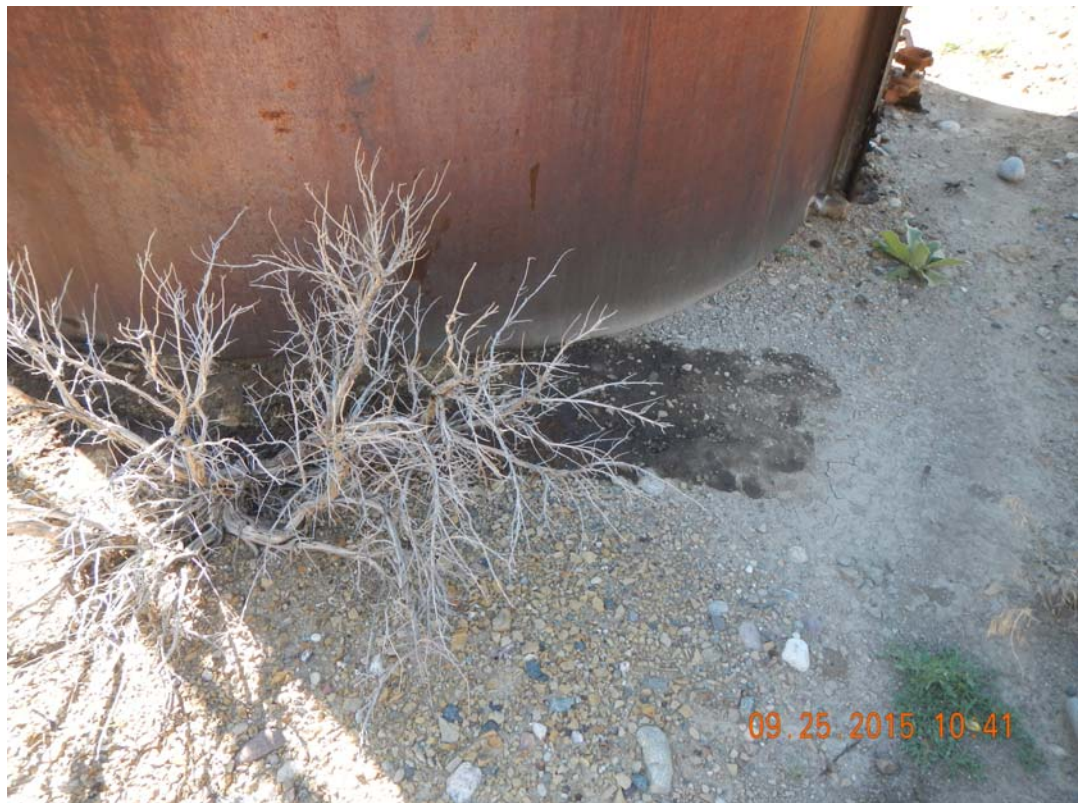
(4 of 4) stained soil spot at tank base.

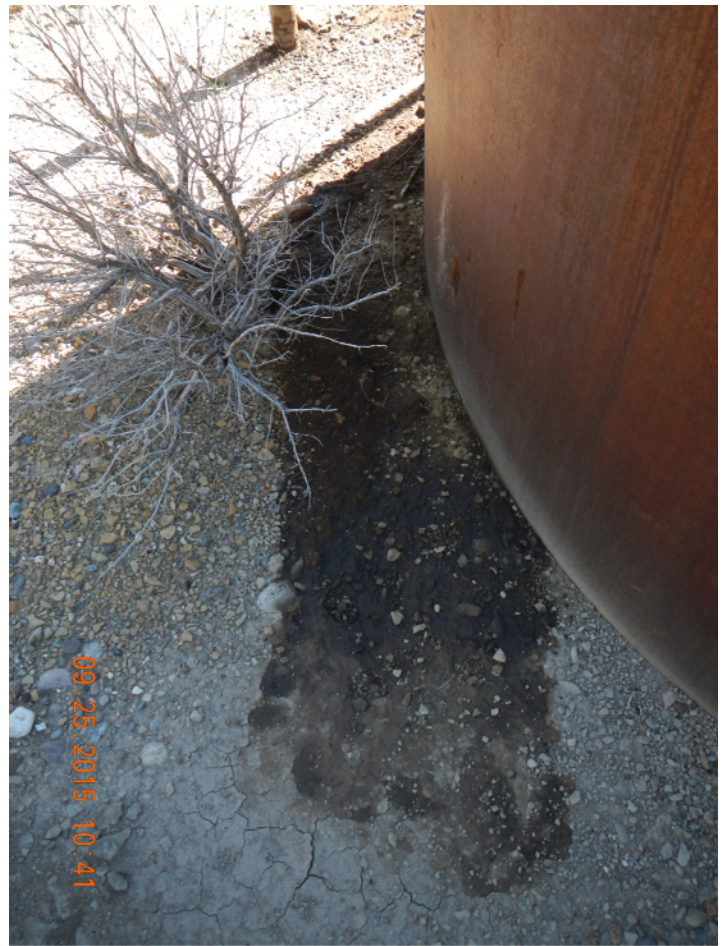
Close up of (4 of 4) stained soil spot at tank base.

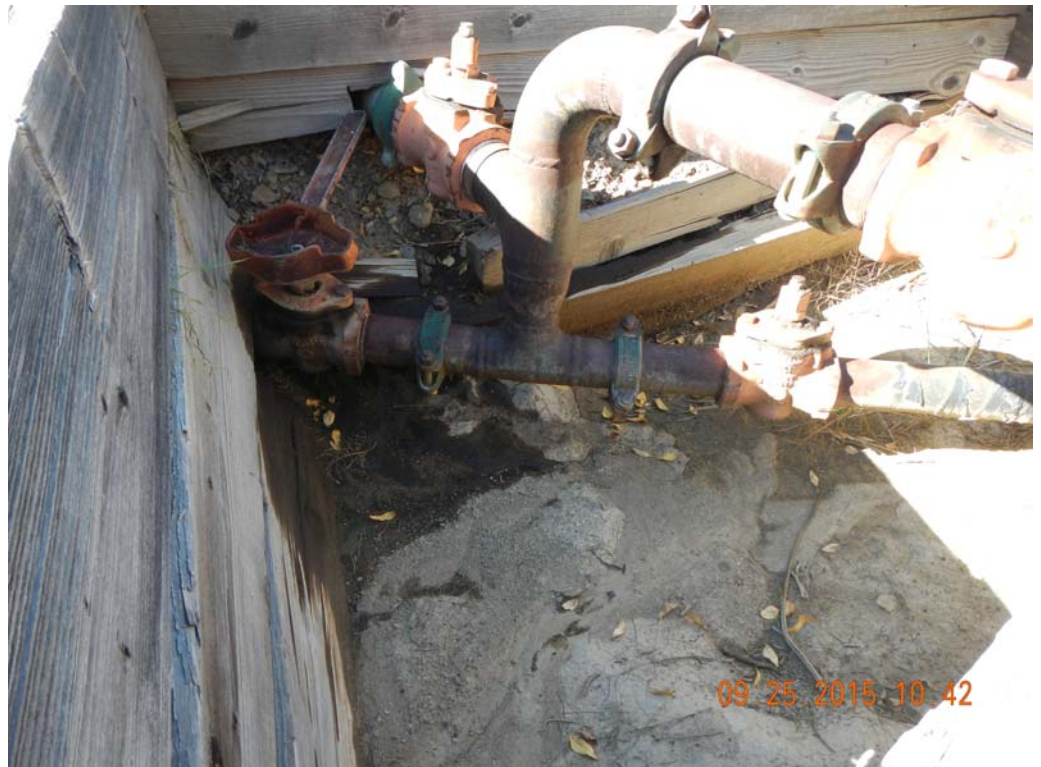
Stained soil at flowline.

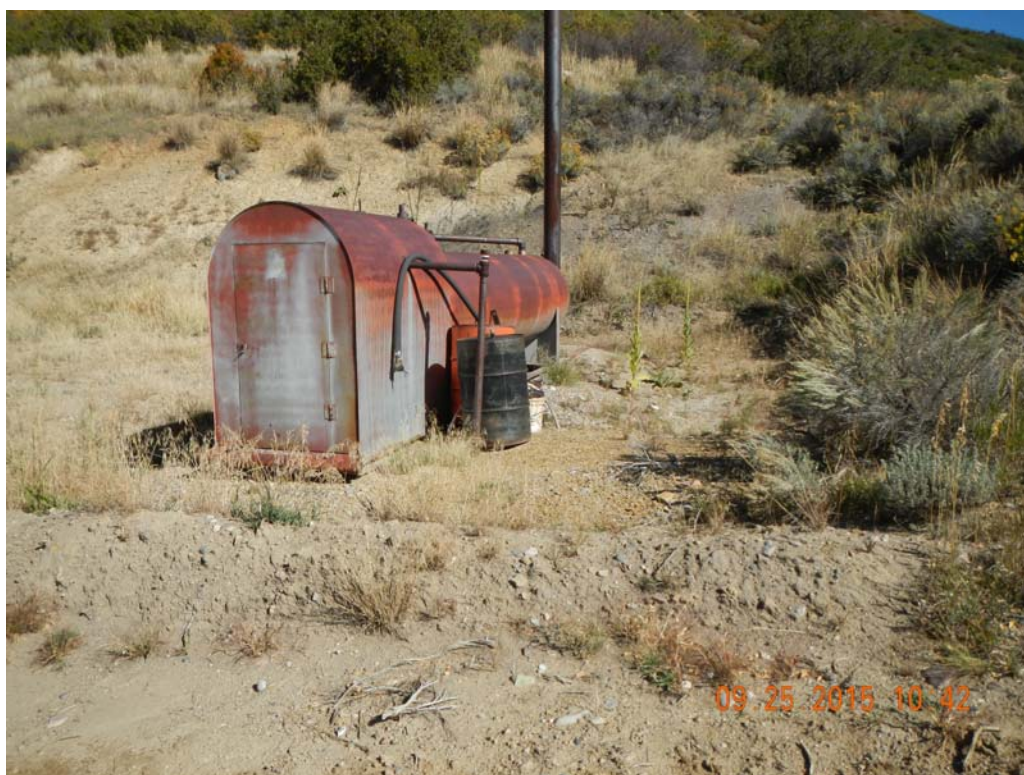
Vegetation growing in
separator berm.

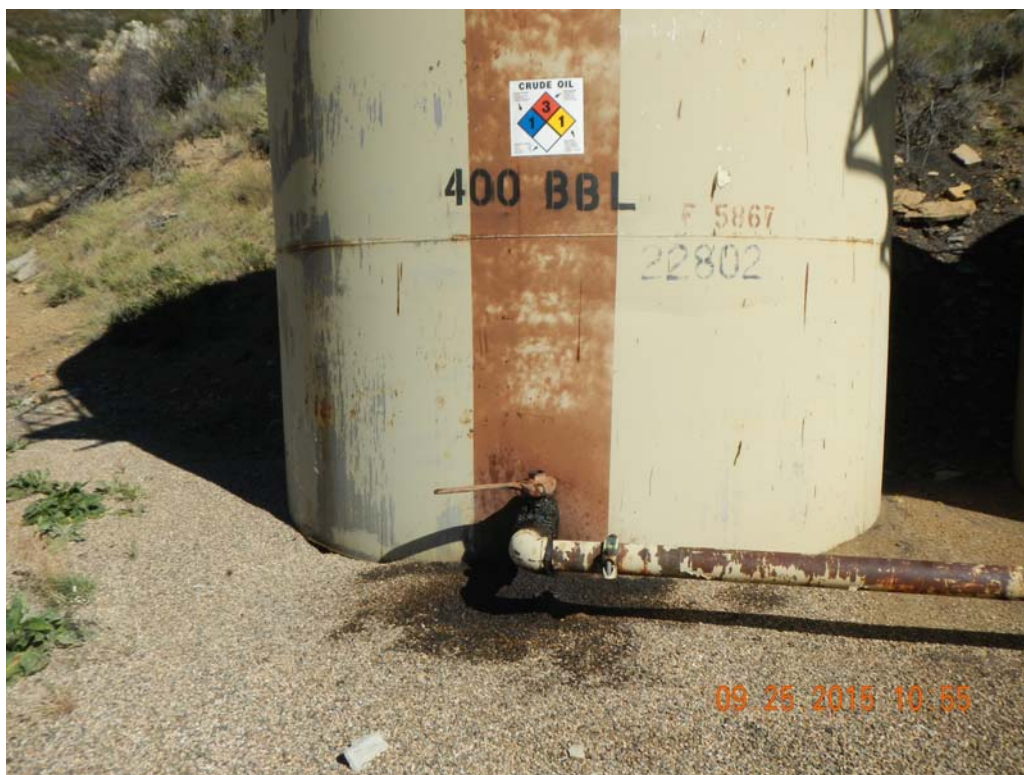
Stained soil at tank base.

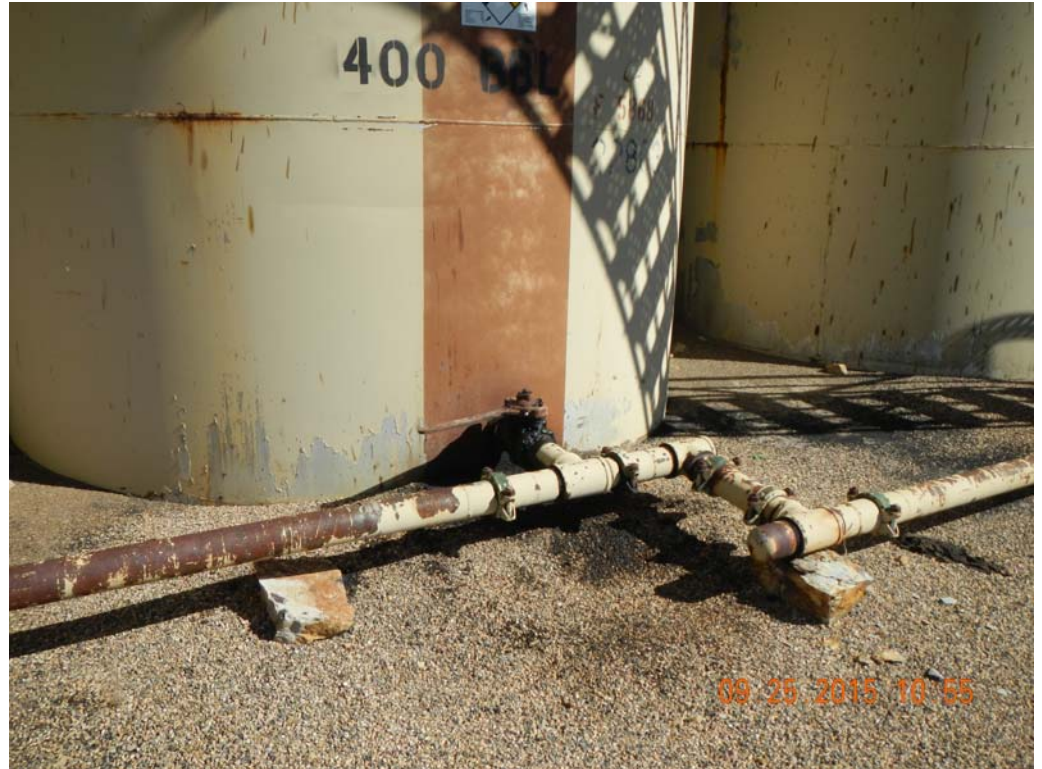
Stained soil at tank base.

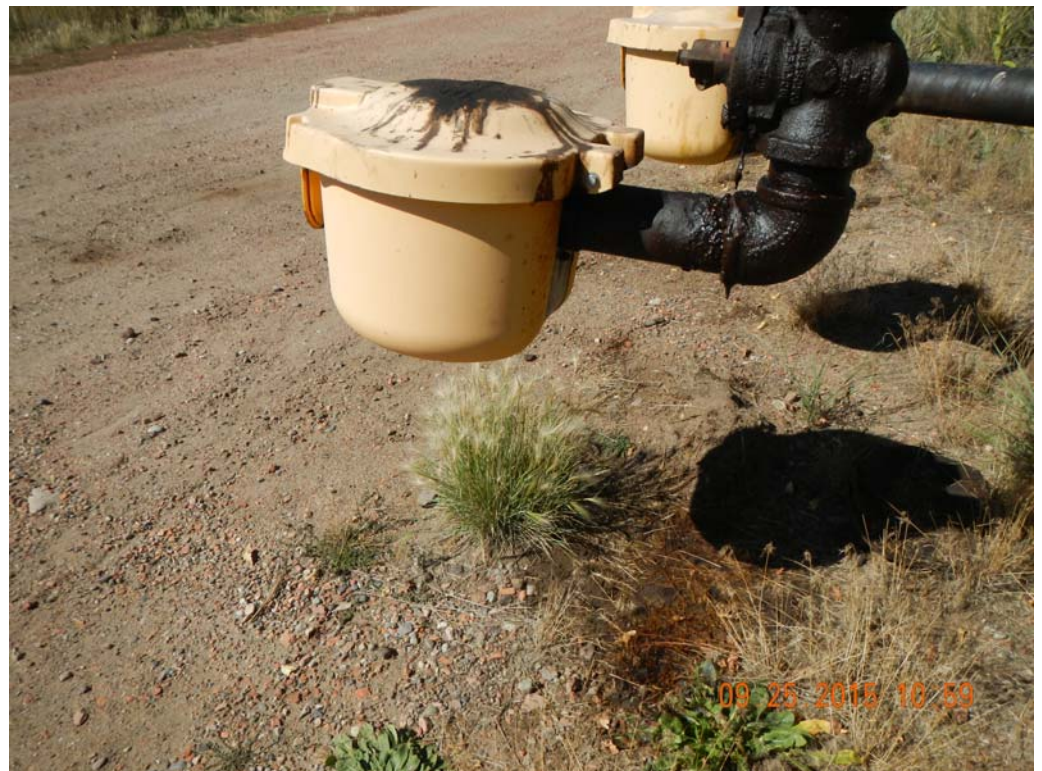
Slow drip leak at loadout.

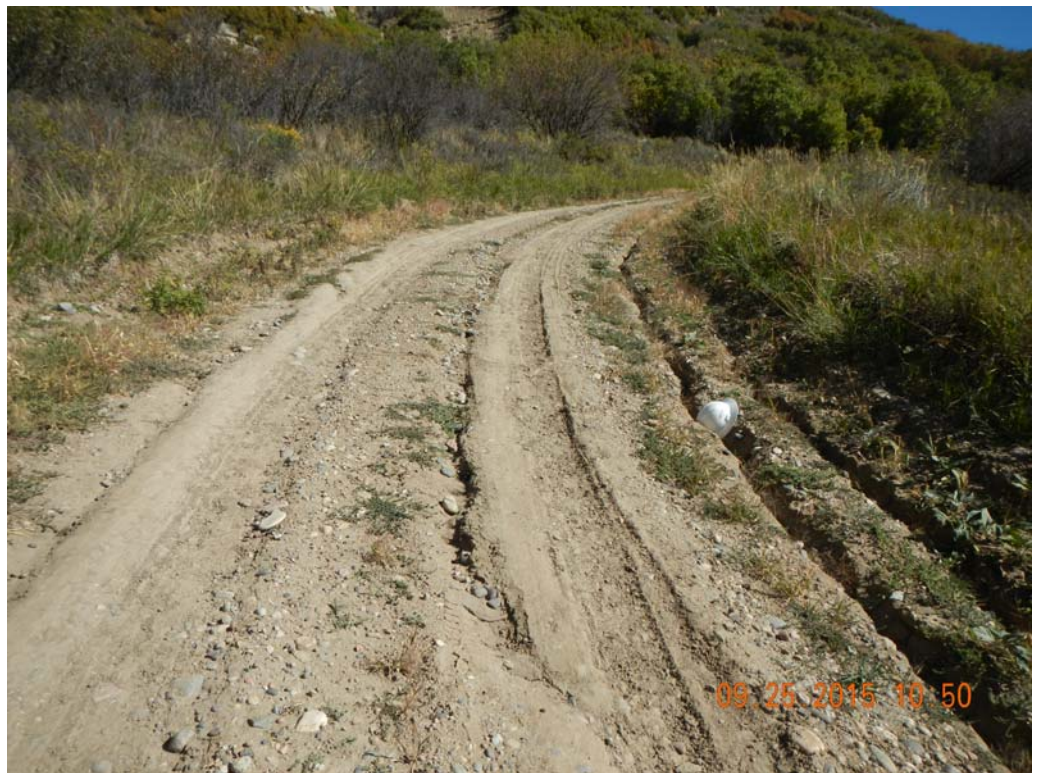
Ruts in access road.
Sediment migration.
Hard hat for scale.

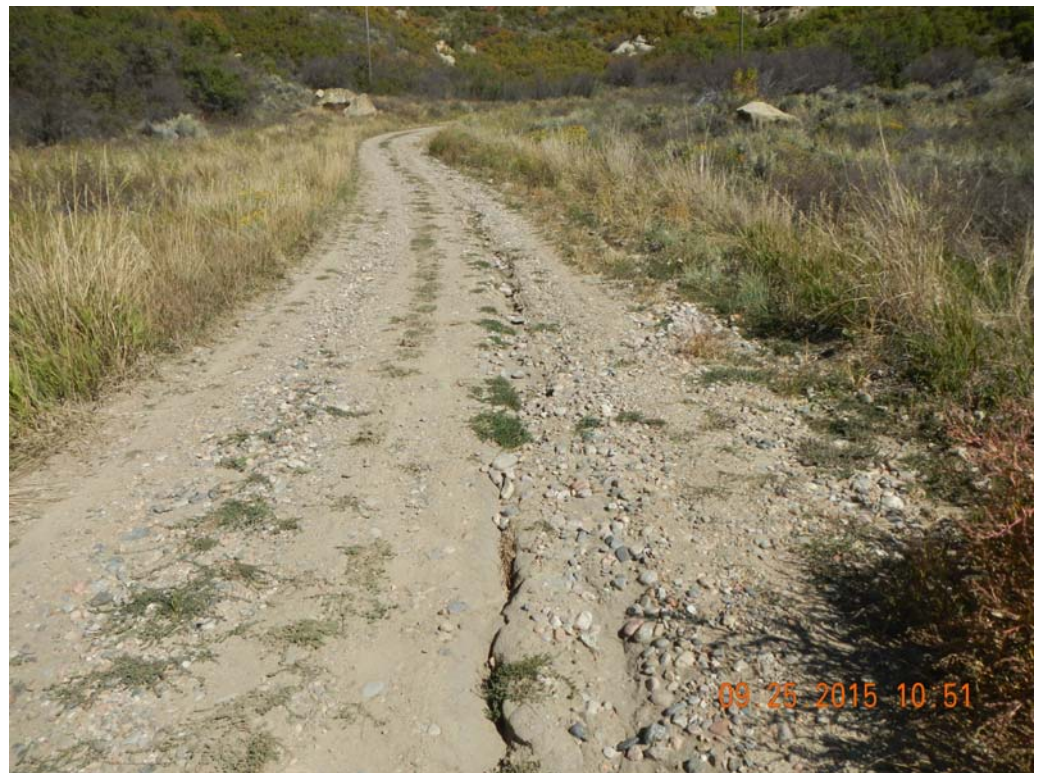
Sediment migration down
rills on access road.
