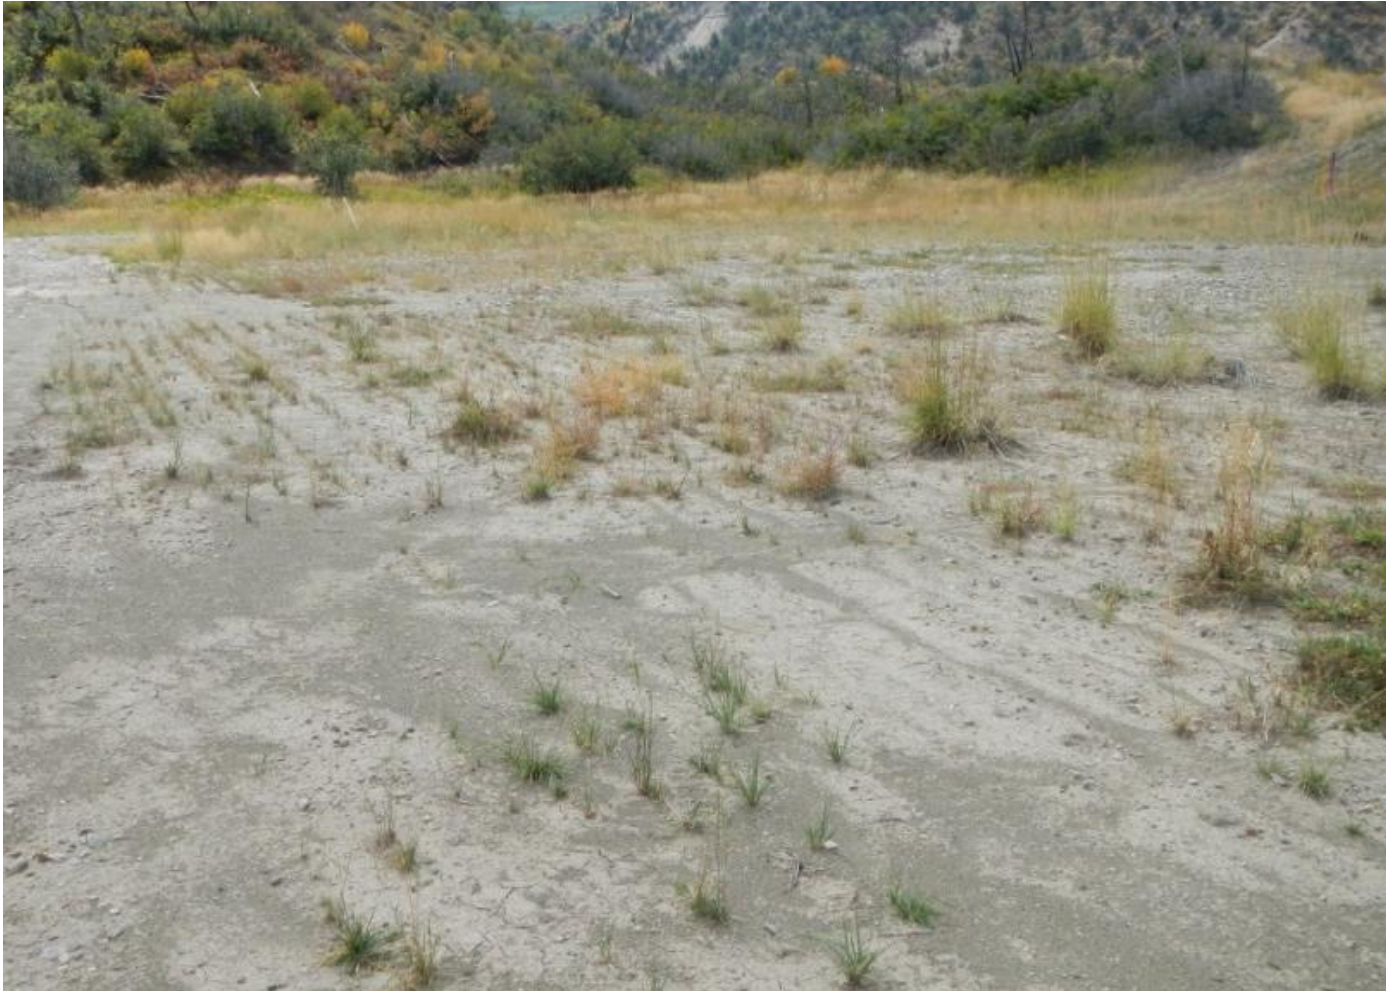
Photo 1. View of western portion of interim reclamation area that appears to be seeded in 2015, from northern edge facing southward.

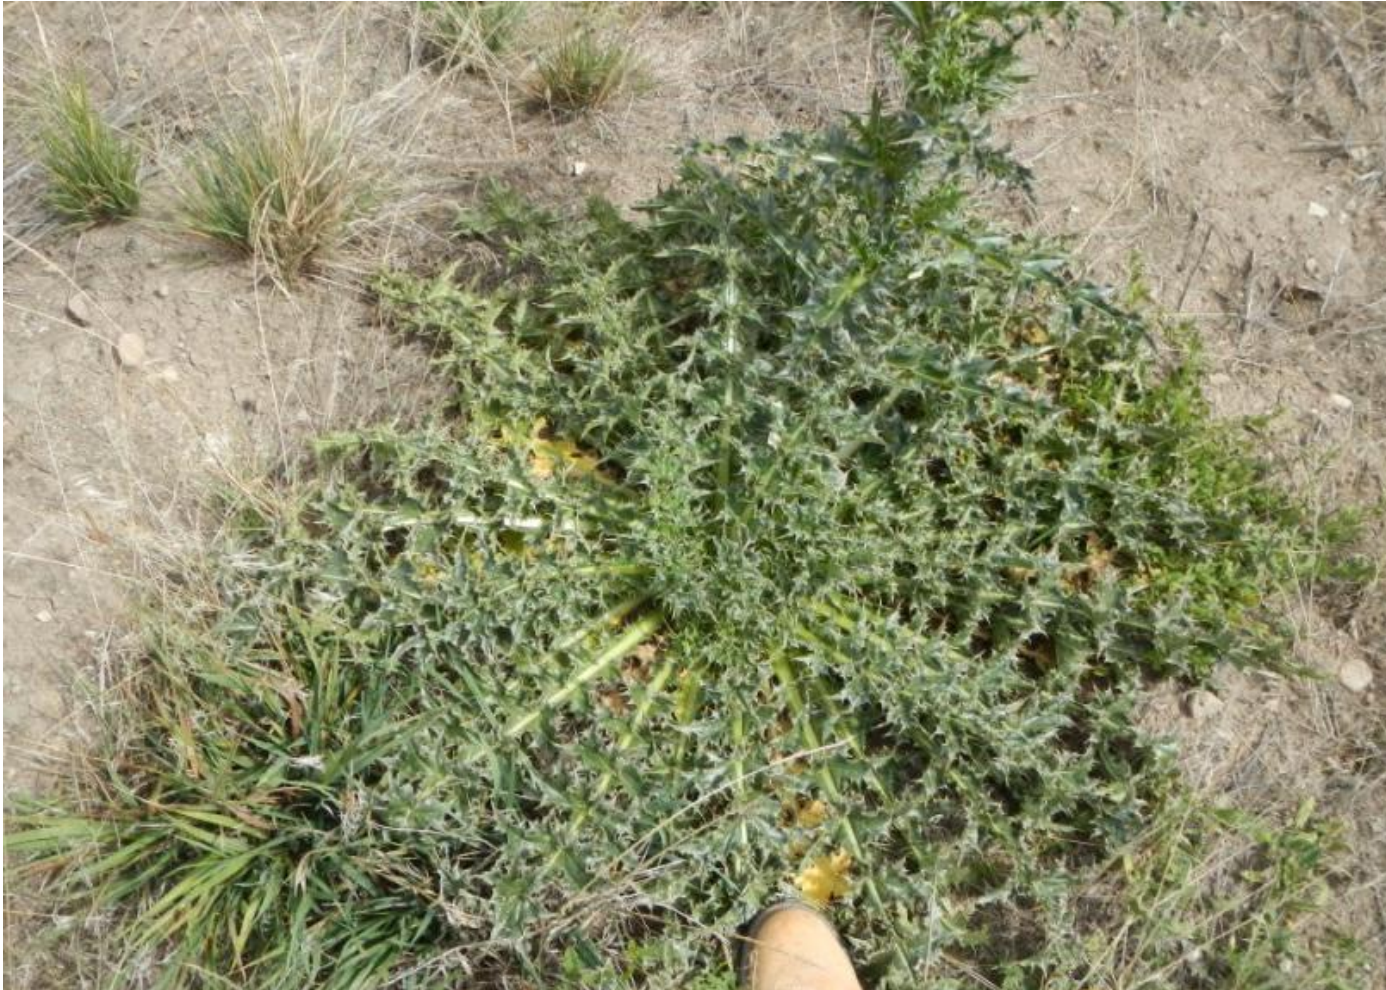
Photo 2. Birdseye view of large musk thistle (*Carduus nutans*) rosette within the eastern interim reclamation area.

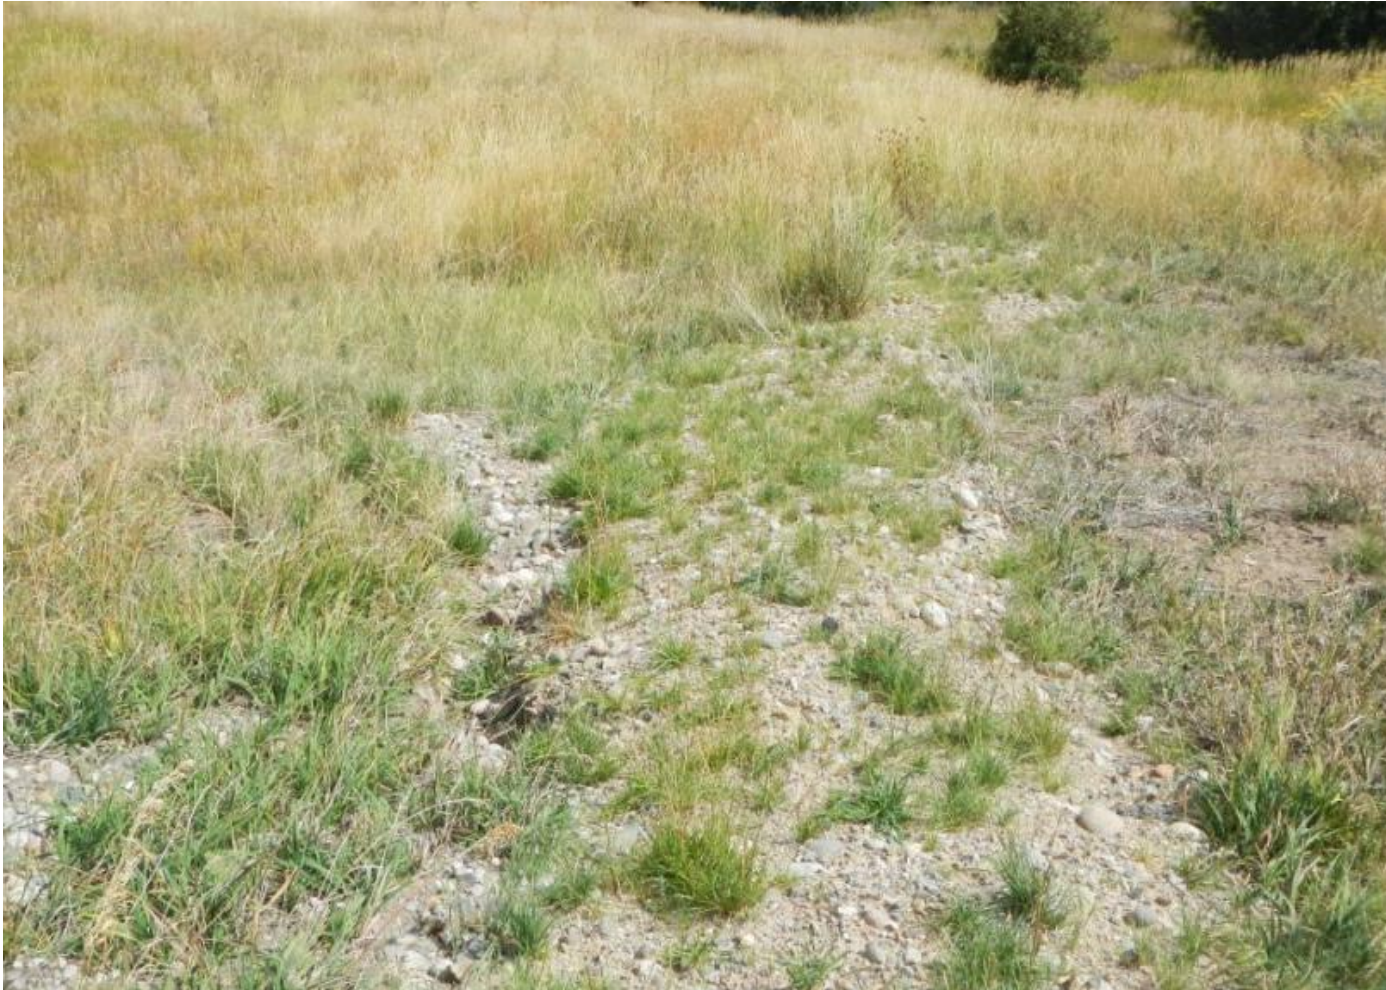
Photo 3. View of stormwater erosional channel that appears to have been filled and revegetated, facing downslope. Rilling is occurring on the sides of the channel as high energy water flows need BMPs to slow the water down.

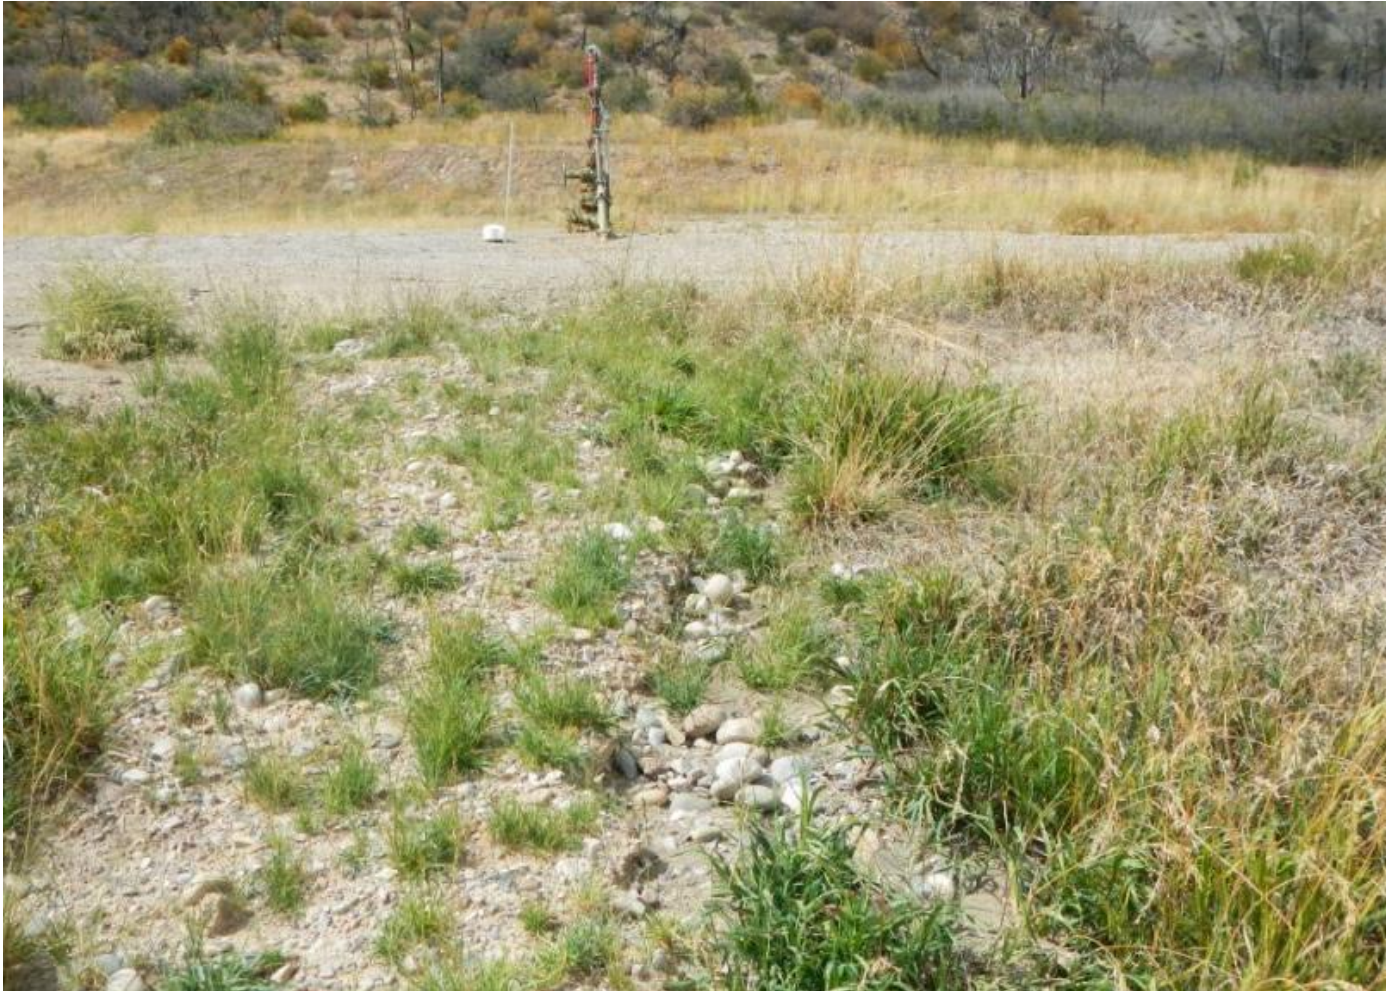
Photo 4. View of filled and revegetated erosional channel shown in Photo 3 facing upslope.

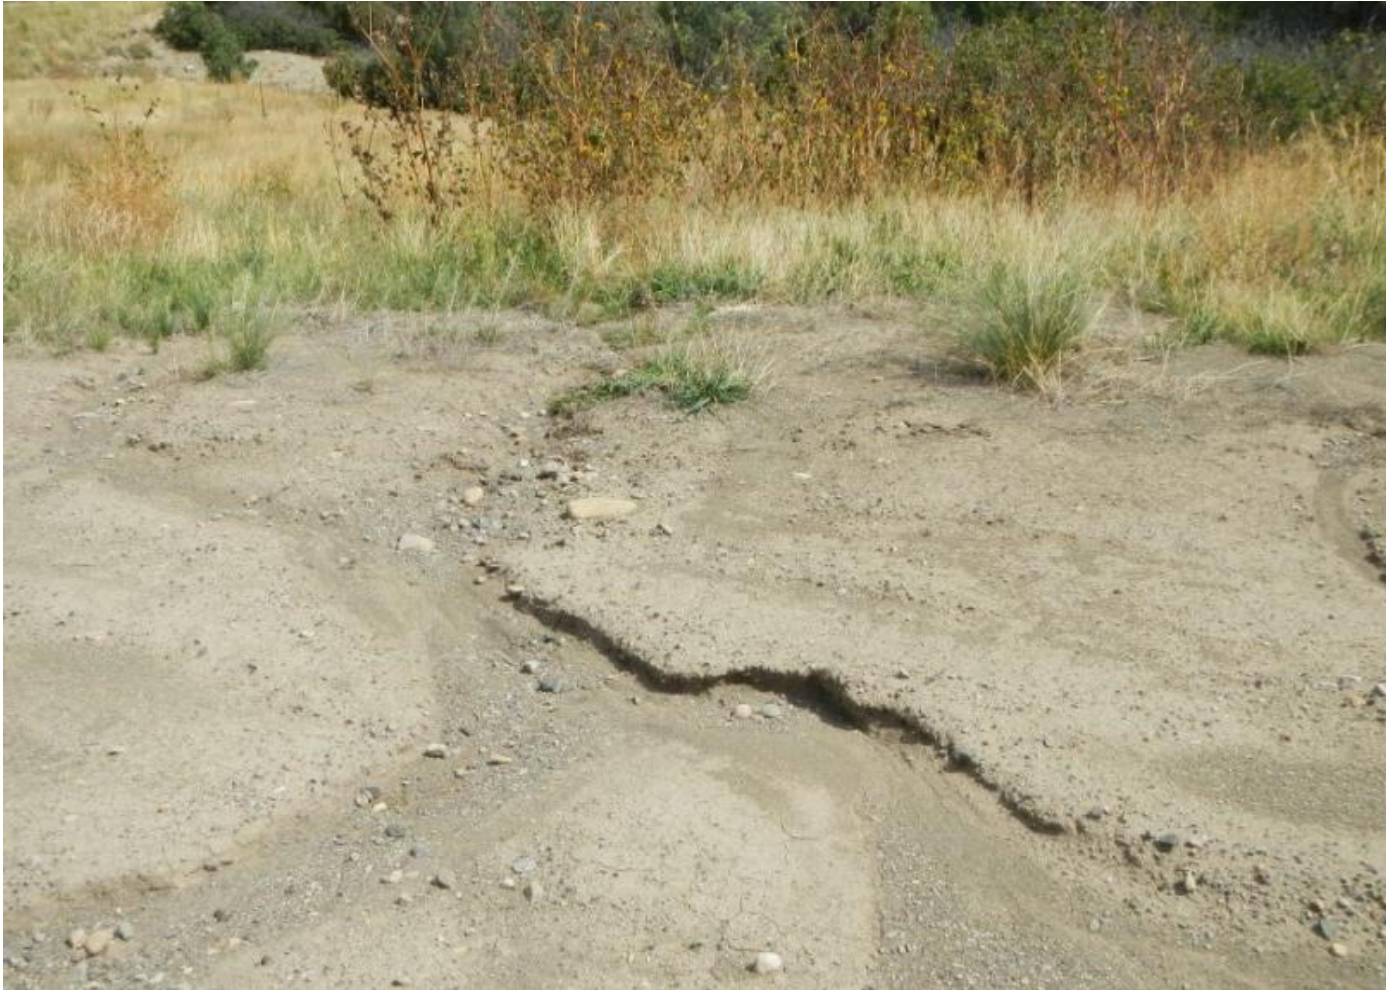
Photo 5. View of eastern edge of working area where concentrated stormwater flows exit the well pad.

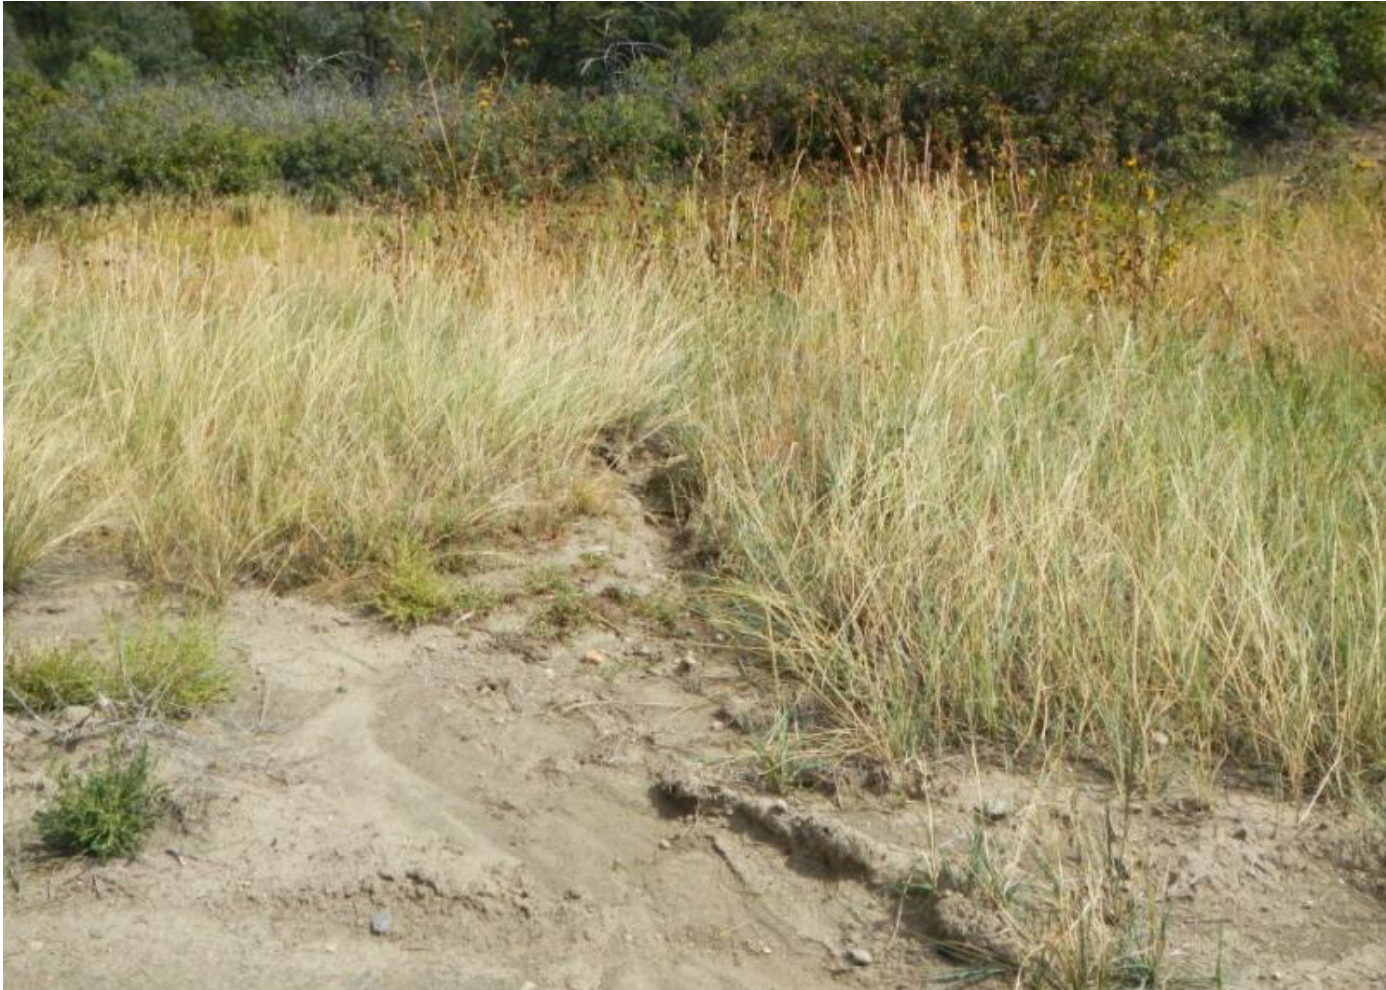
Photo 6. View of another area in the eastern edge of working area where concentrated stormwater flows exit the well pad.
