Elk Springs Unit 1

Inspection# 673402518

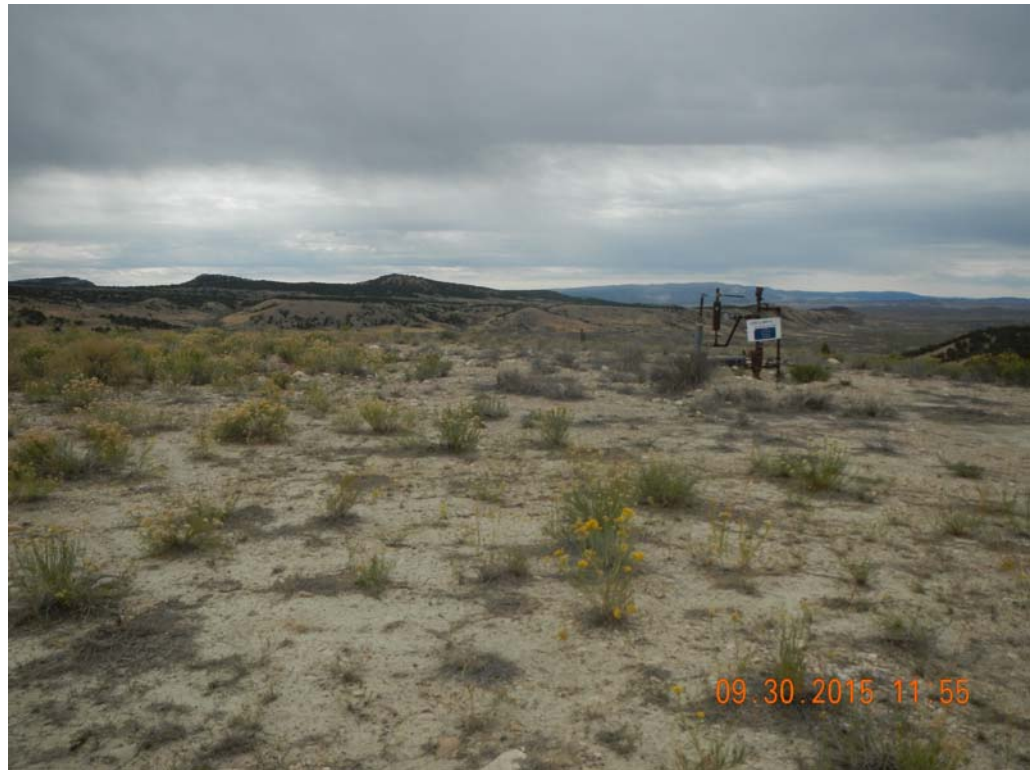
Inspection 673402518

Overgrown location.

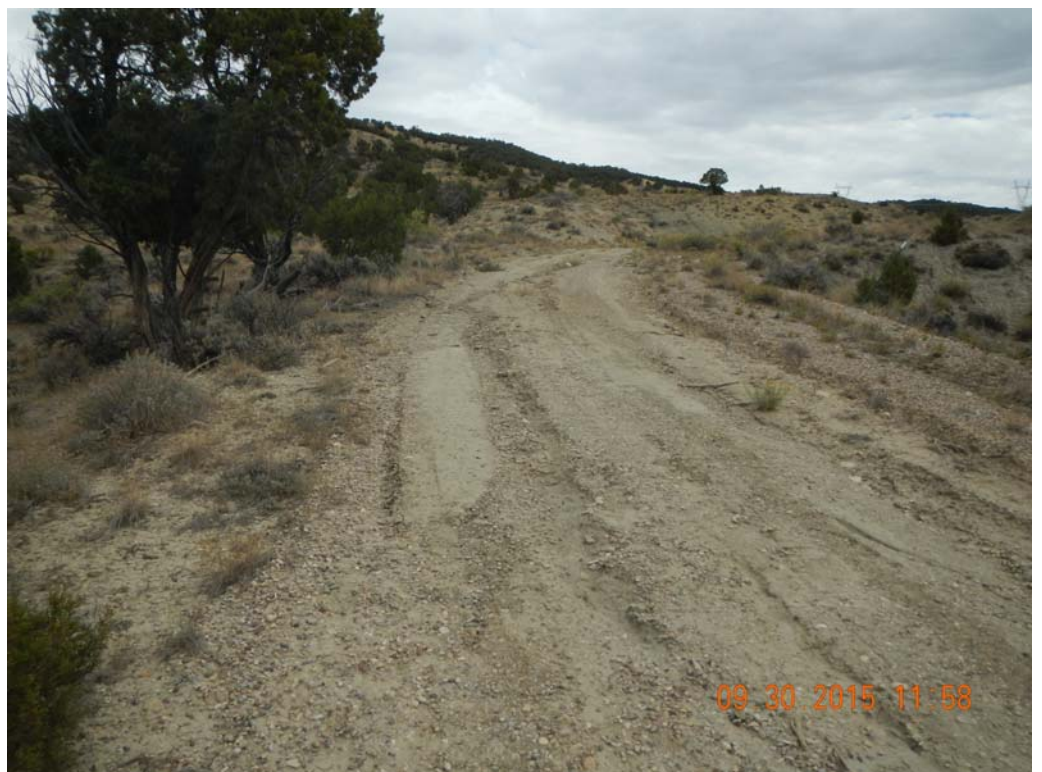
Inspection 673402518

Rills in access road. Appears to have been graded since previous inspection.

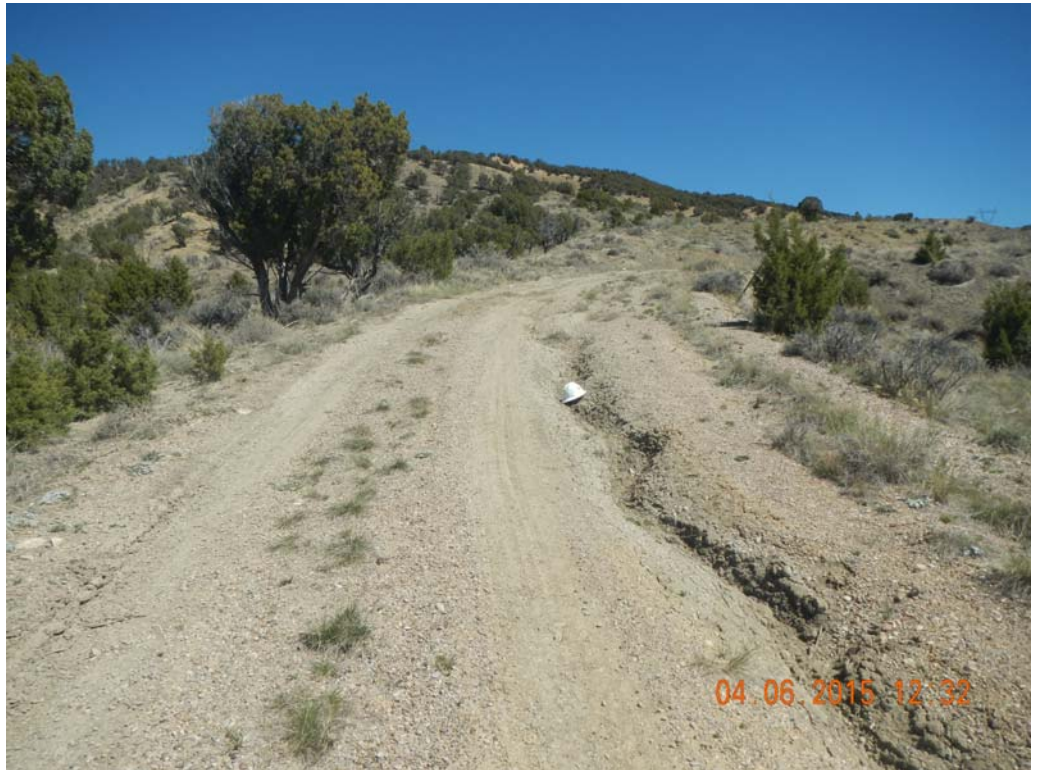
Inspection 673401982

Rill in access road.

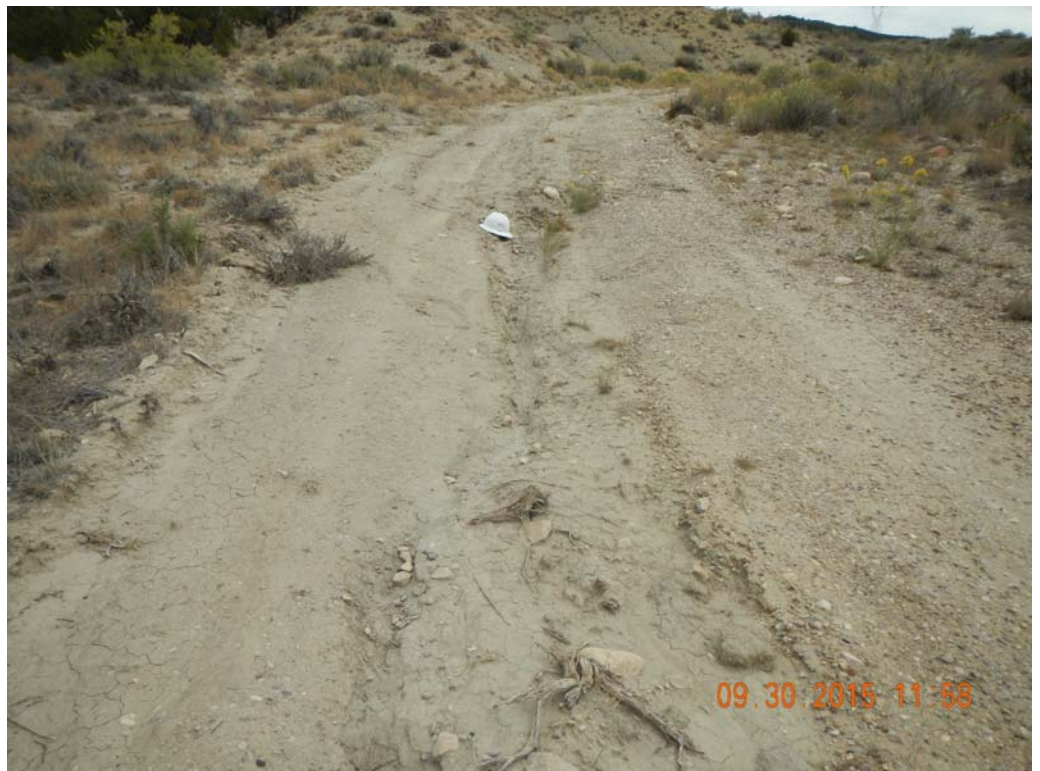
Inspection 673402518

Rills in road. Sediment migration apparent.

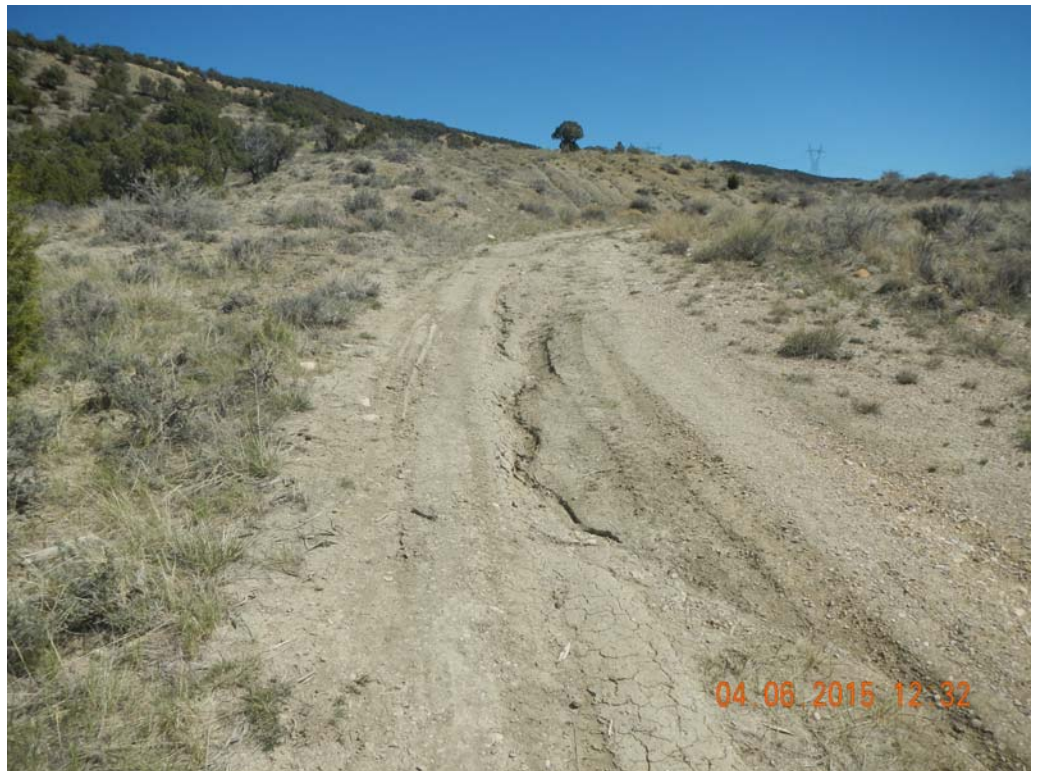
Inspection 673401982

Rills in road. Sediment migration apparent.
