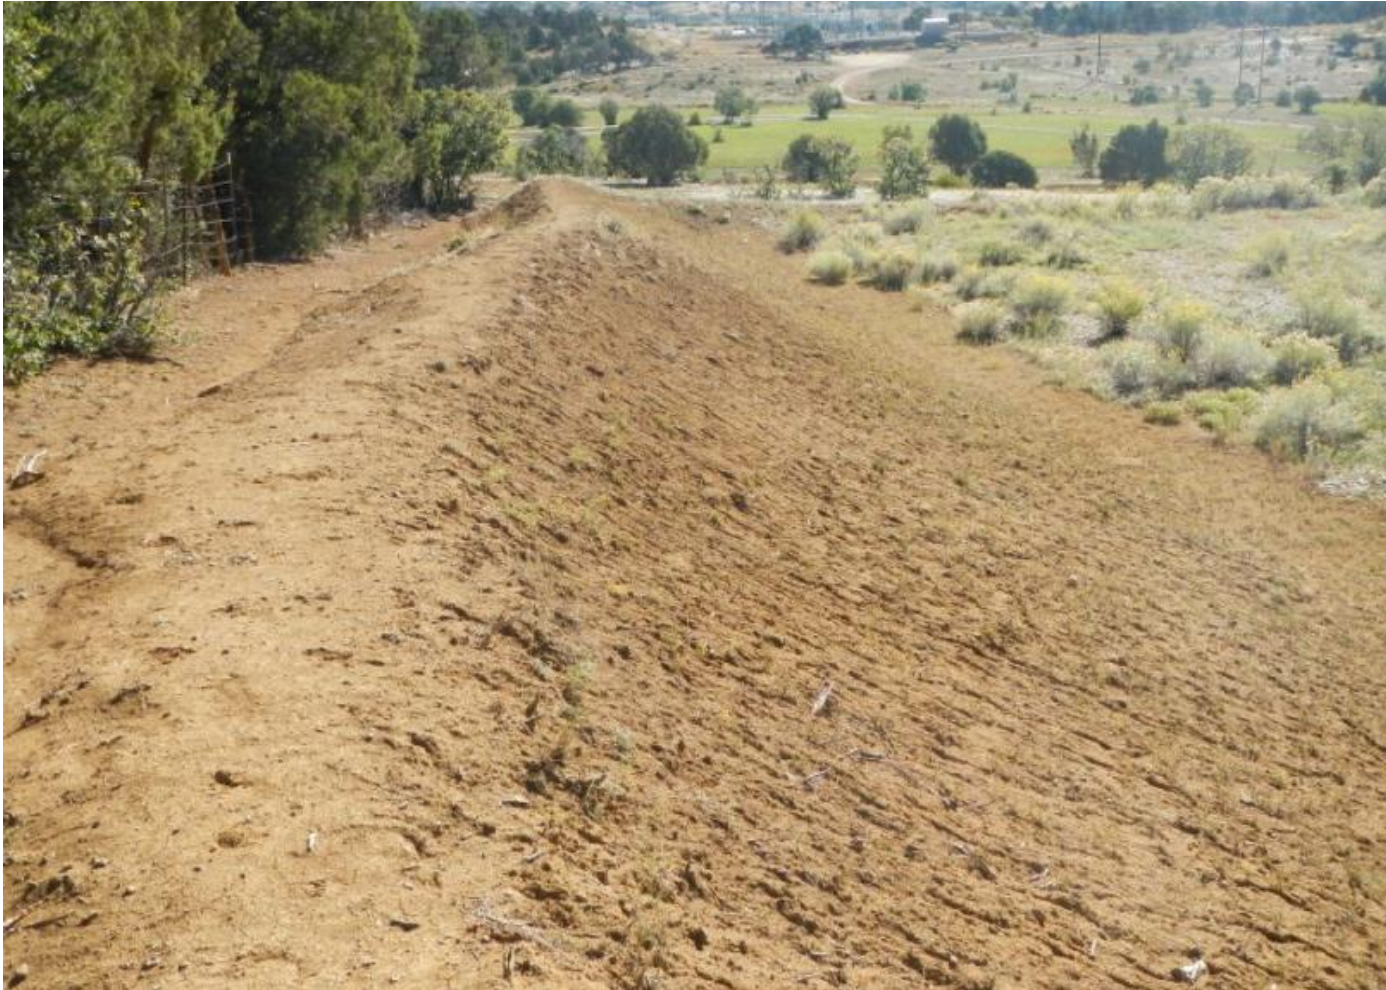
Photo 1. View of northern portion of project area from northwestern corner facing eastward. Rill erosion is occurring on the unvegetated cut slopes.

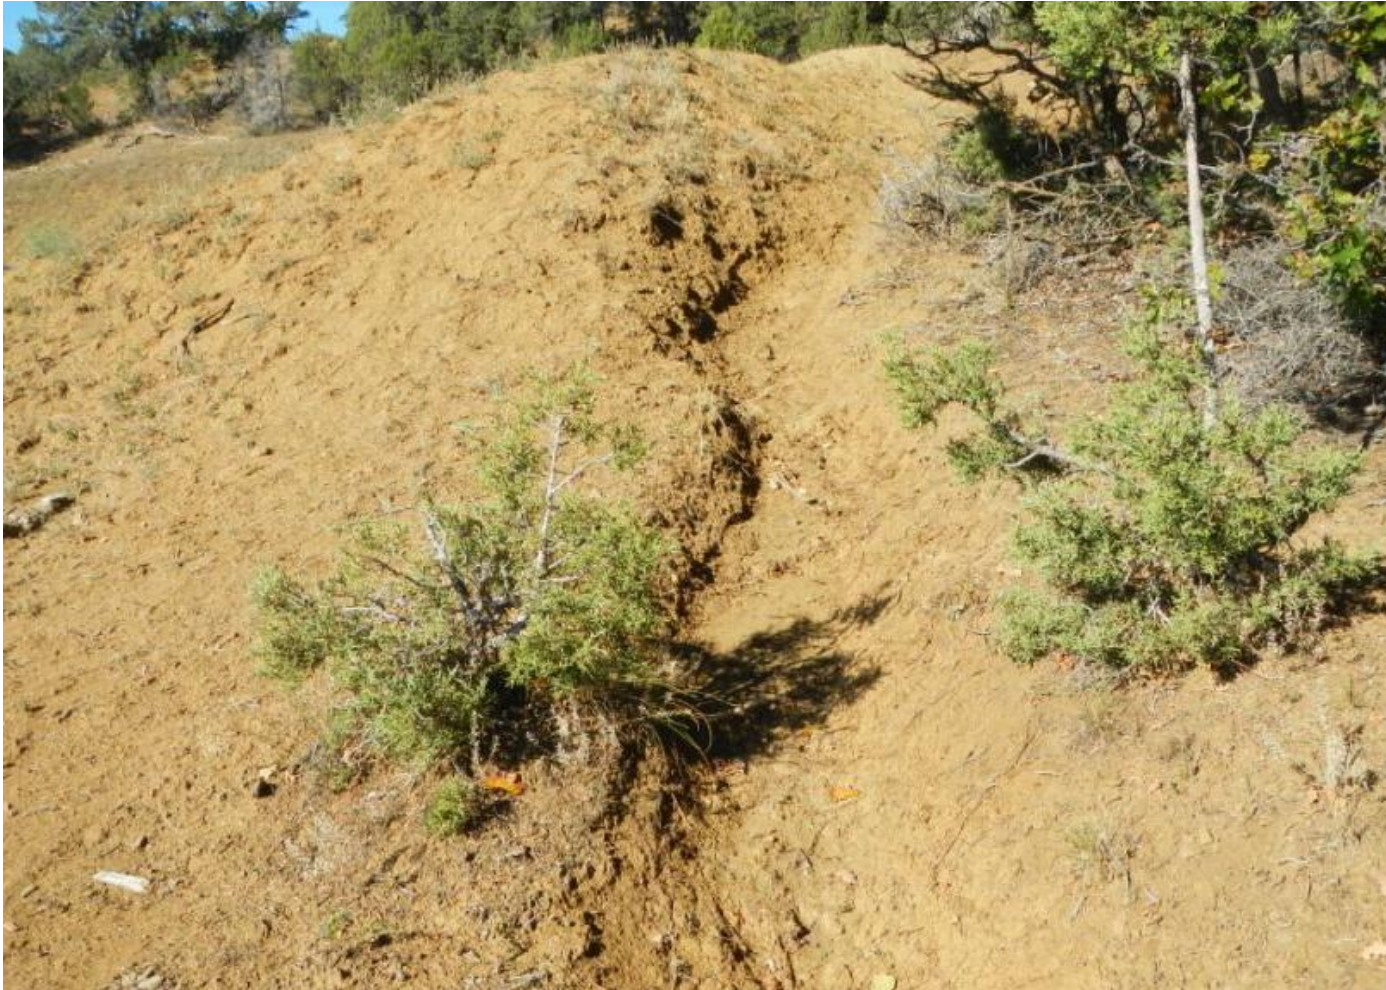
Photo 2. View of erosional channel in the northeastern corner of the project area. This channel is approximately 2.5 feet wide and 1 foot deep where it flows down slope toward the east.

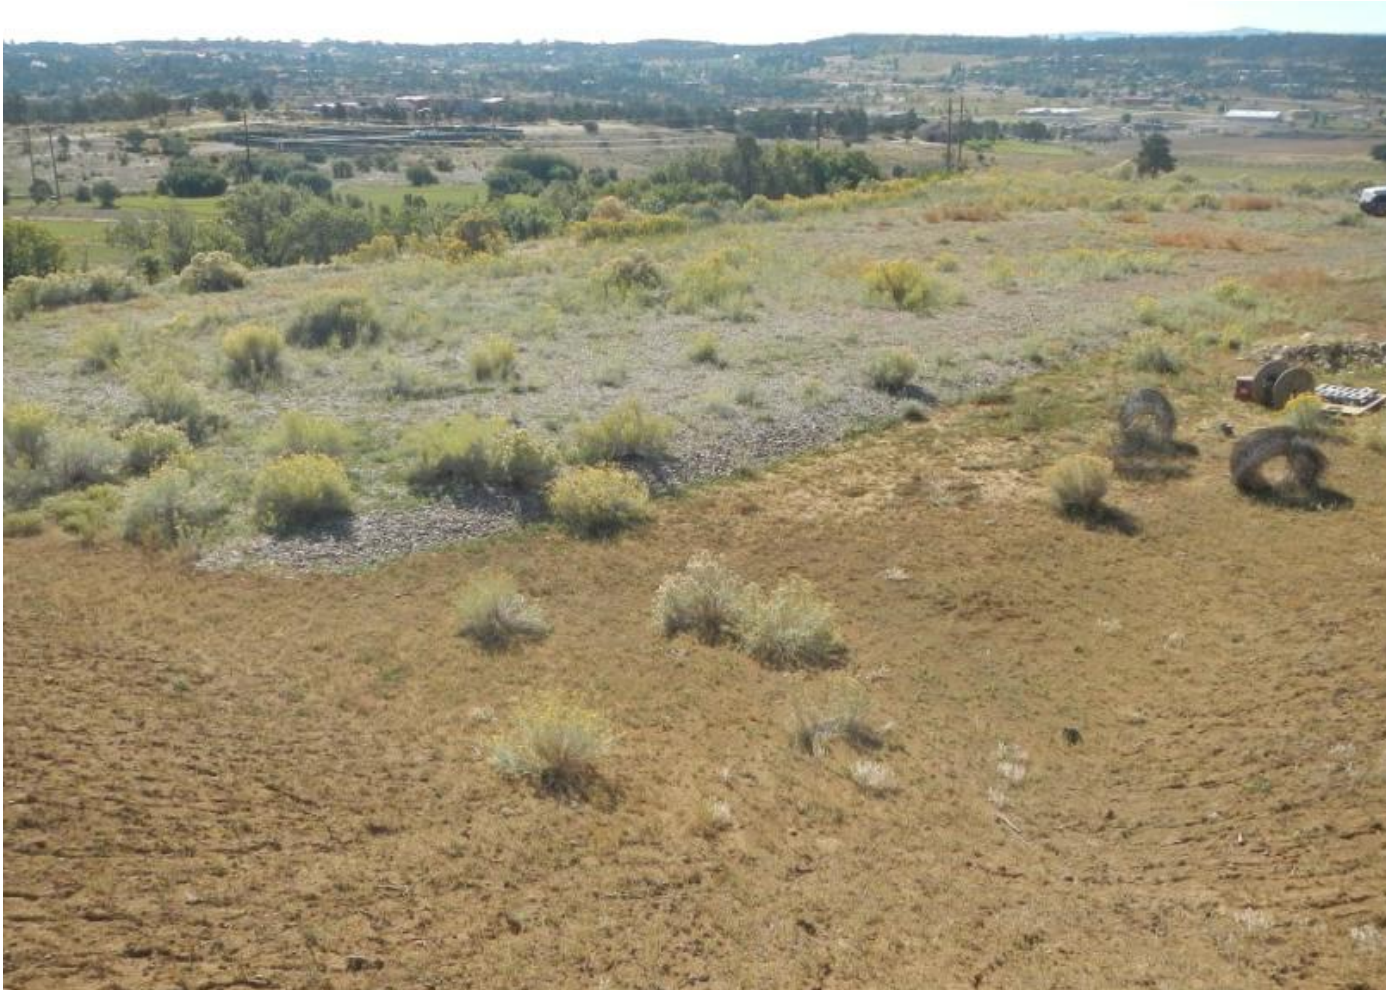
Photo 3. View from northwestern corner of project area facing center.

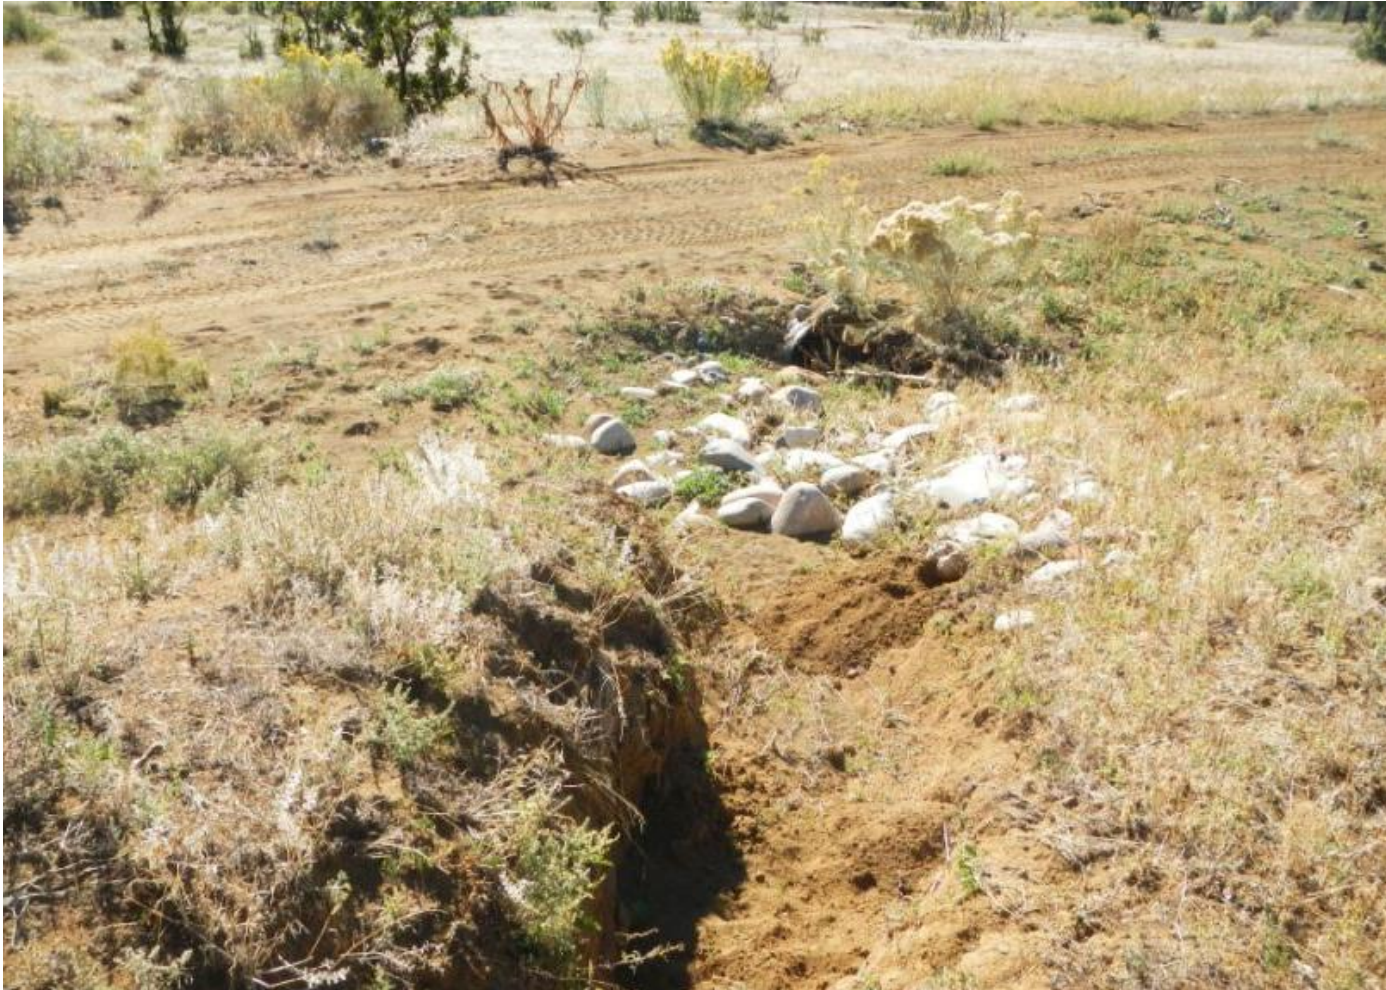
Photo 4. View of culvert along access road near the well pad entrance. Culvert is approximately 60 percent full of sediment and debris. It appears that stormwater flows frequently bypass the culvert and flow over the access road eroding the slope downstream (See photo 6).

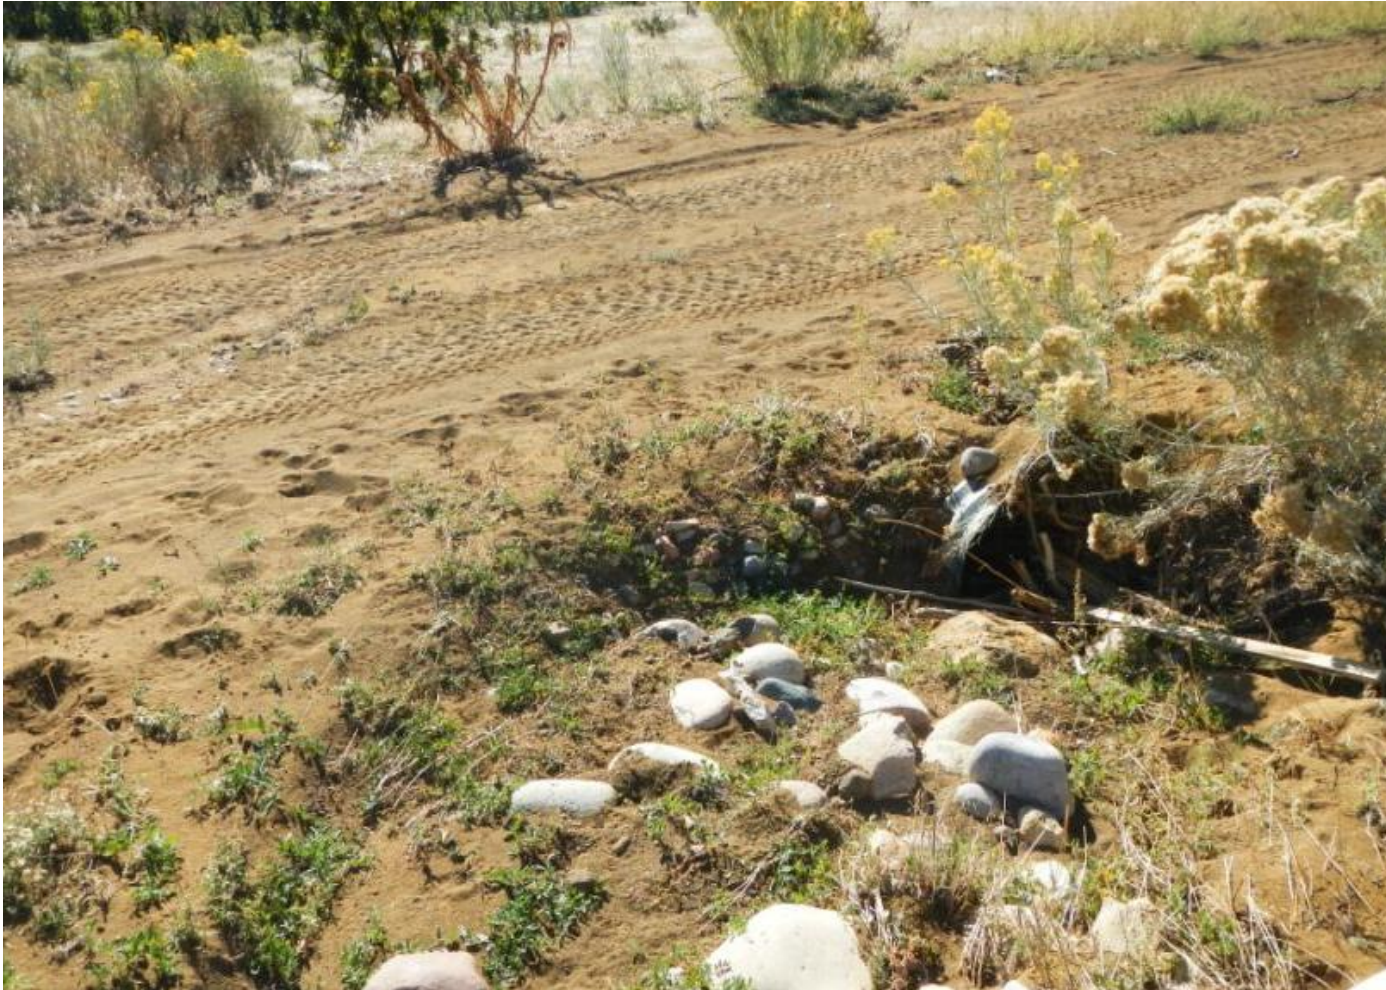
Photo 5. Closeup of culvert shown in Photo 4, showing that the culvert is large full of sediment and debris.

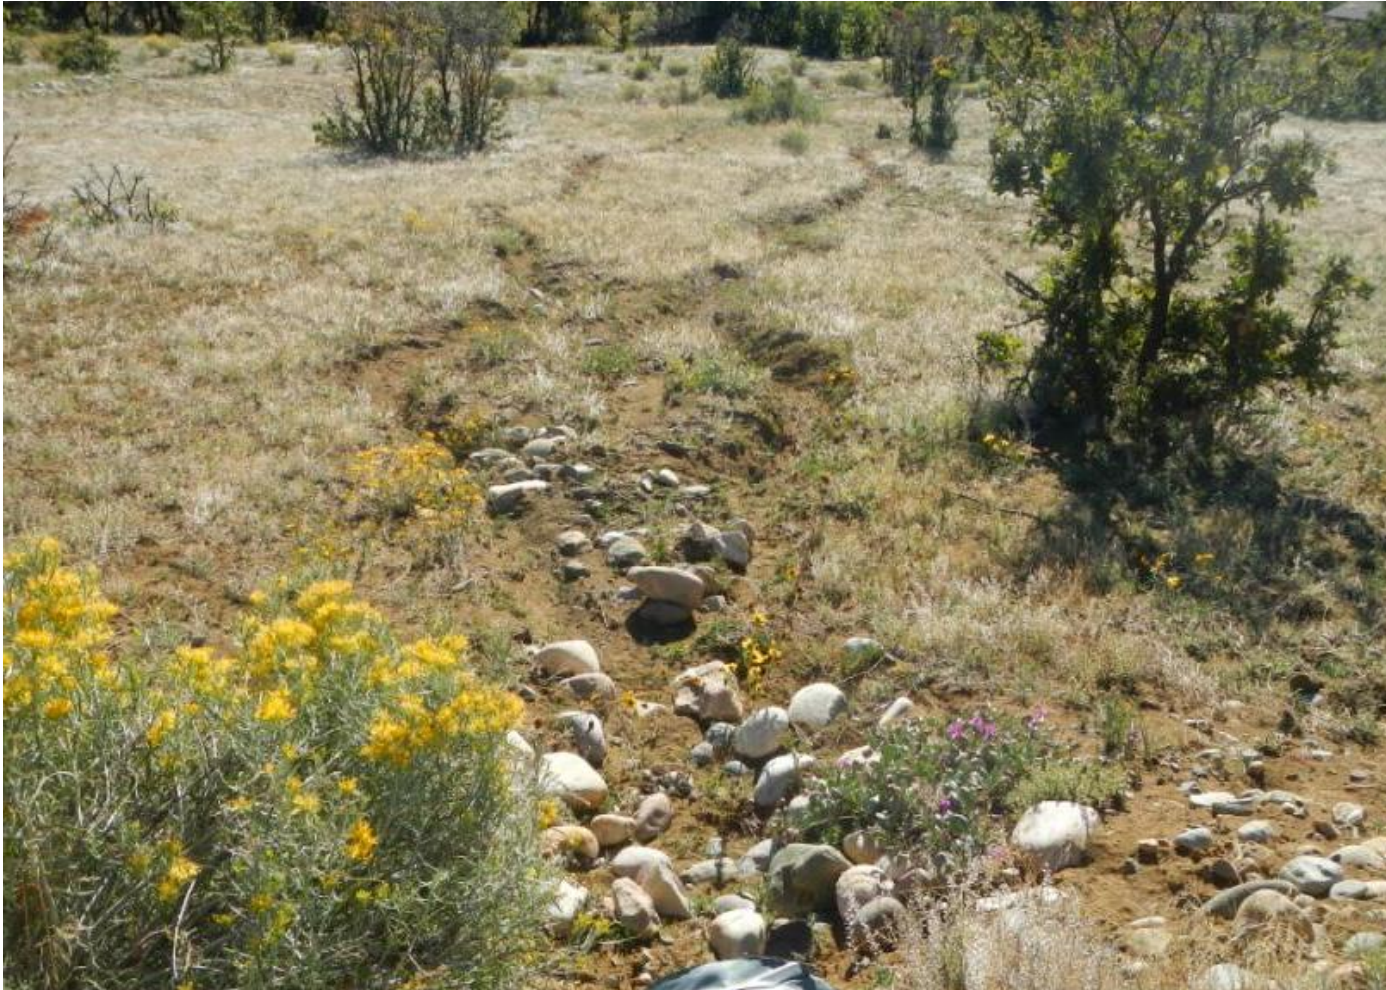
Photo 6. View of erosional channels approximately 2 feet wide and 2 feet deep are eroding into the hillside on the downstream side of the culvert shown in photos 4 and 5.

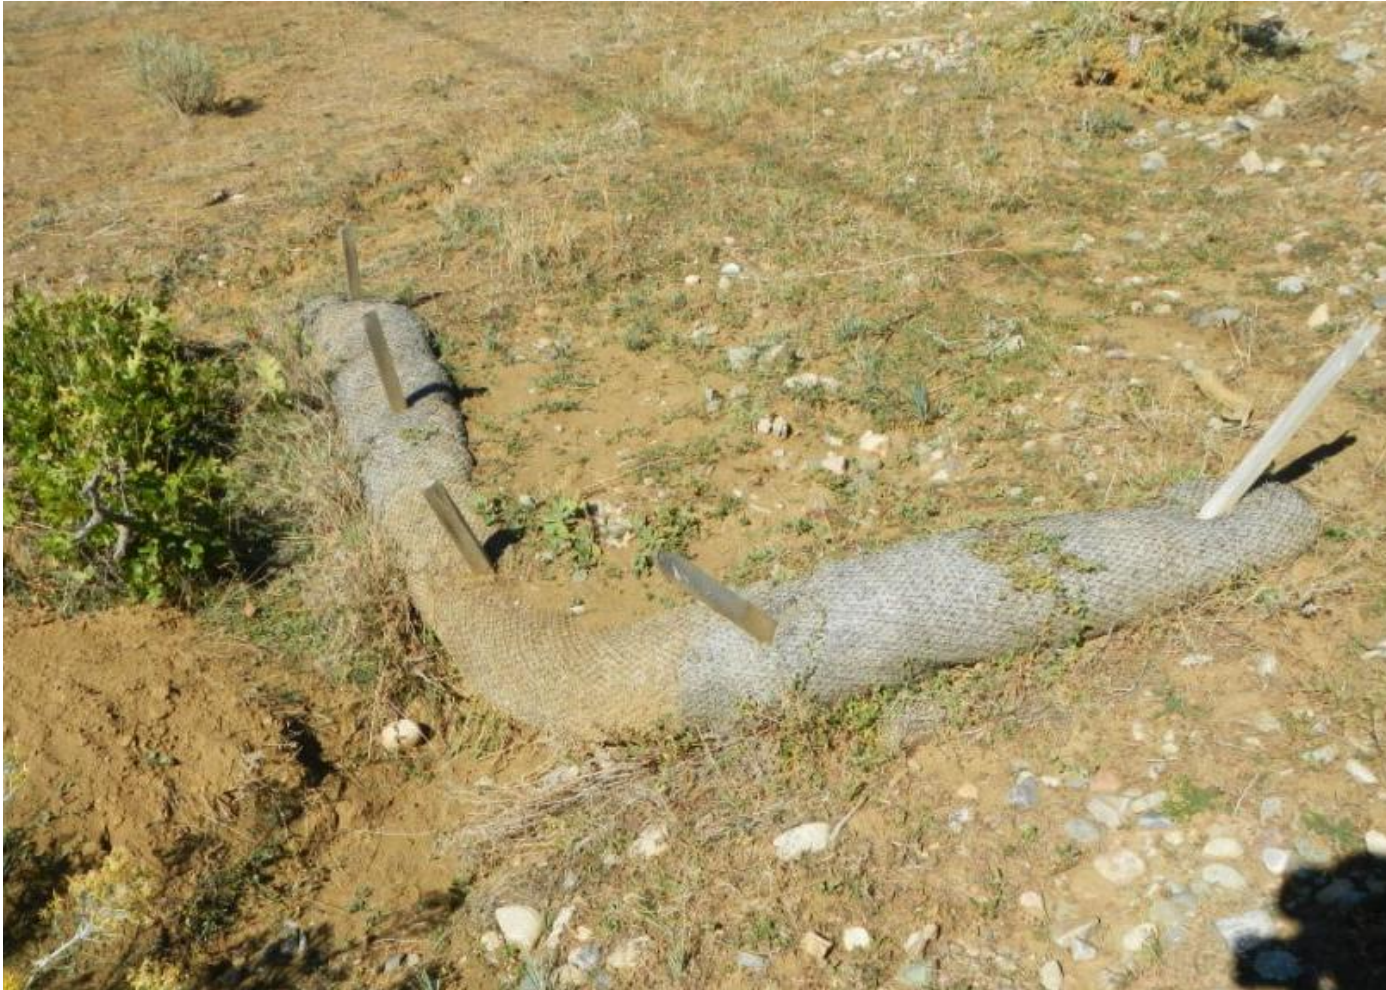
Photo 7. View of straw wattle on south side of the access road near the beginning of the access. Straw wattle is full of sediment, is eroding on the downstream side (on left) and stormwater flows appear to be bypassing the wattle and eroding around it (in background)
