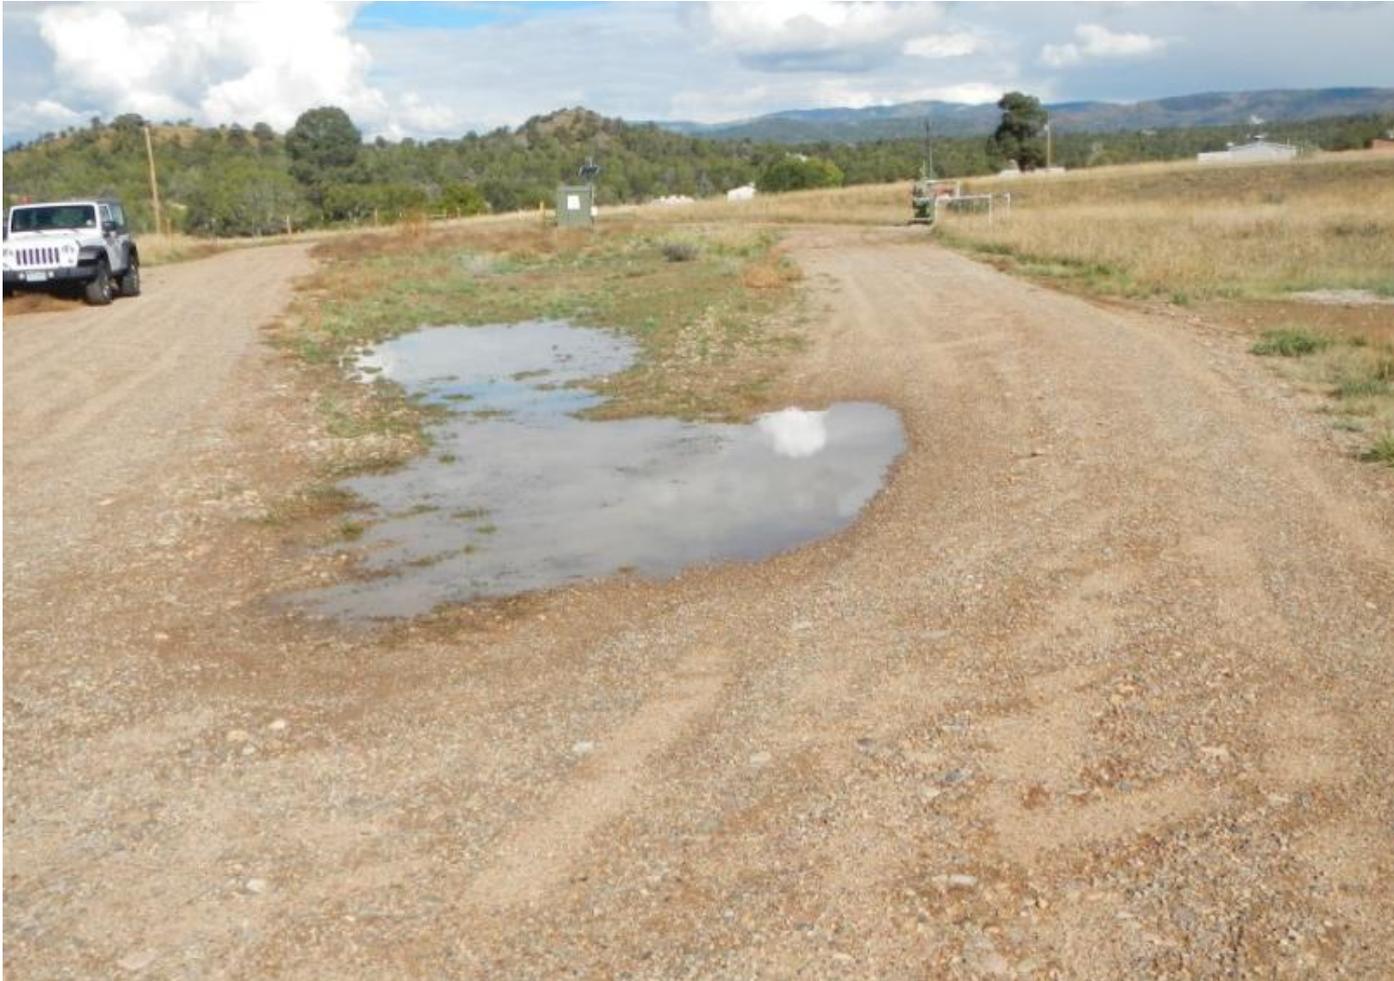
Photo 1. View of project area from well pad entrance facing northward. Pooled water does not appear to be causing rutting or vehicle diversion. Road is graveled. Also see photo 2.

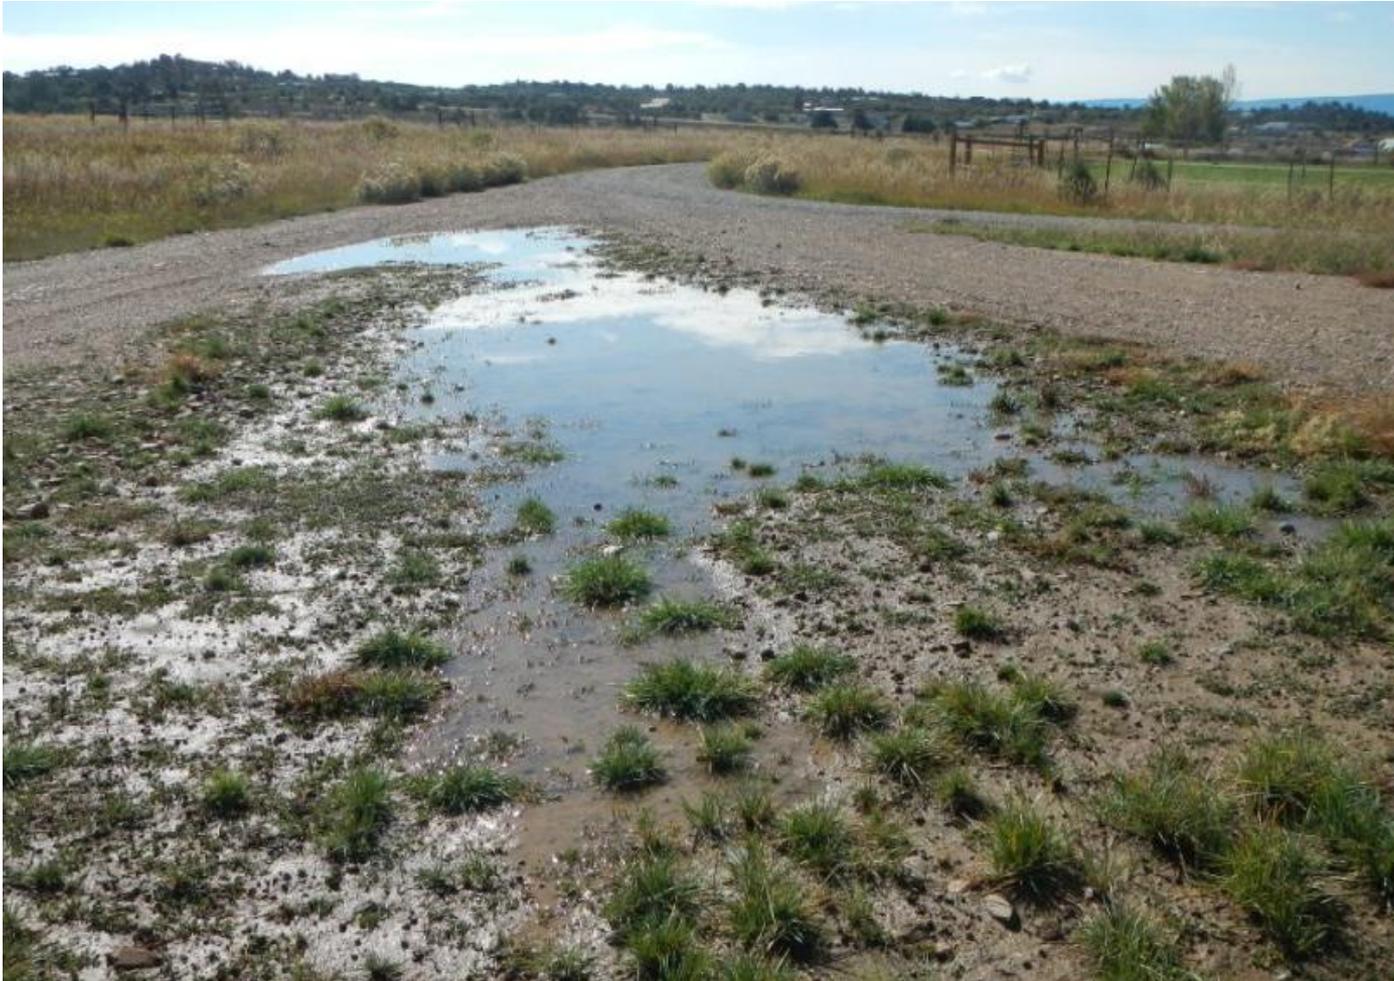
Photo 2. View of puddle in “teardrop” portion of project area. Landowner access is in background (on right and does not cross puddle area).

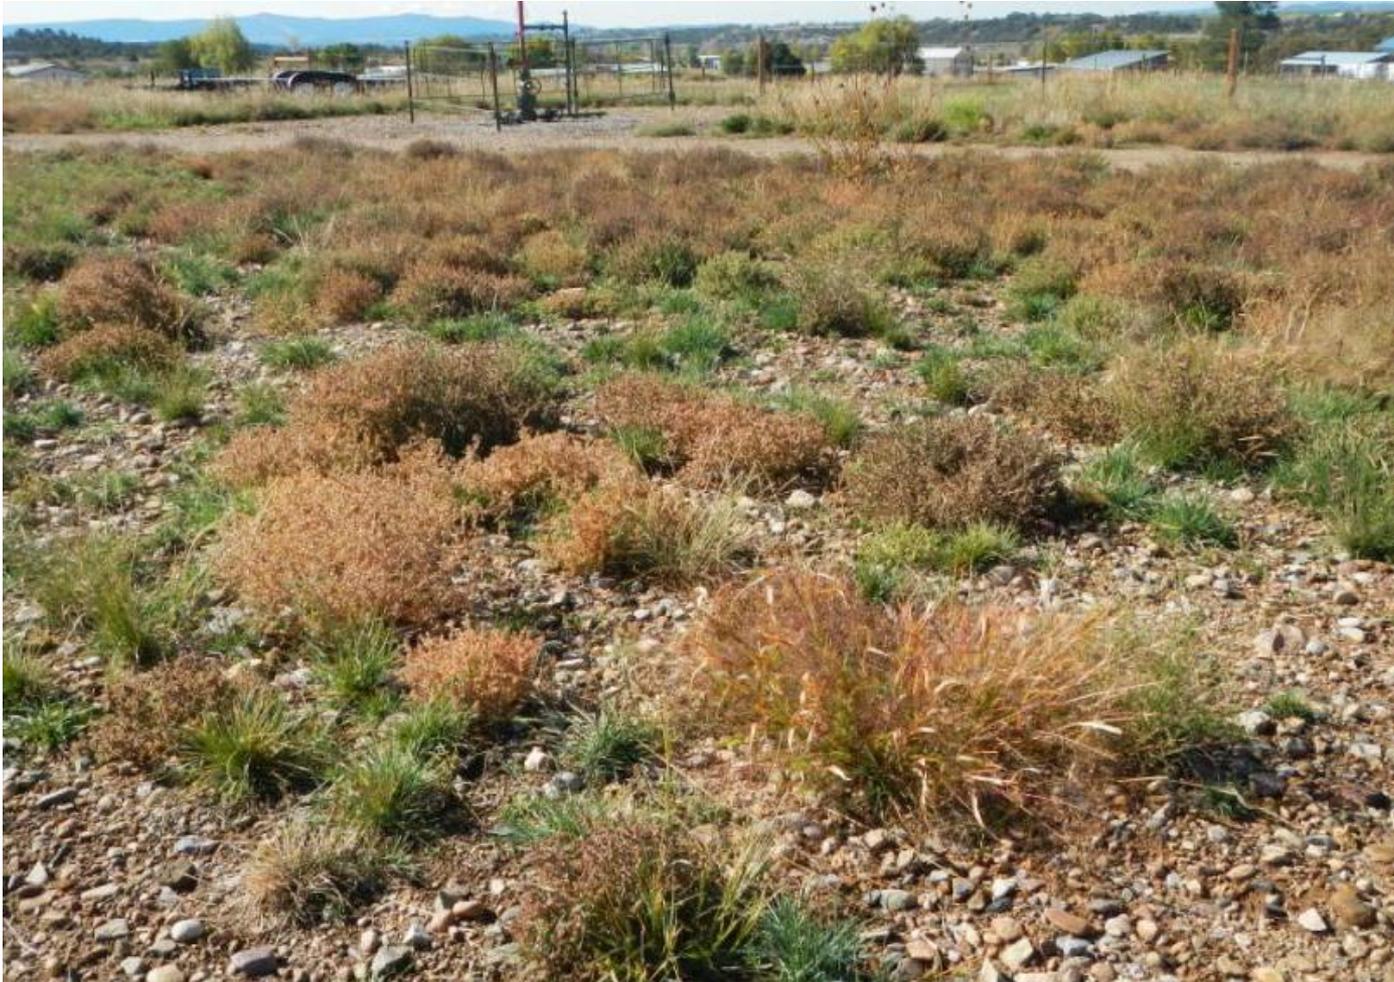
Photo 3. View of revegetation within teardrop area. Grasses such as blue grama (*Bouteloua gracilis*) and western wheatgrass (*Pascopyrum smithii*) are becoming established. Kochia (*Kochia scoparia*) and Russian thistle (*Salsola tragus*)-most less than 1 foot tall, are also present.

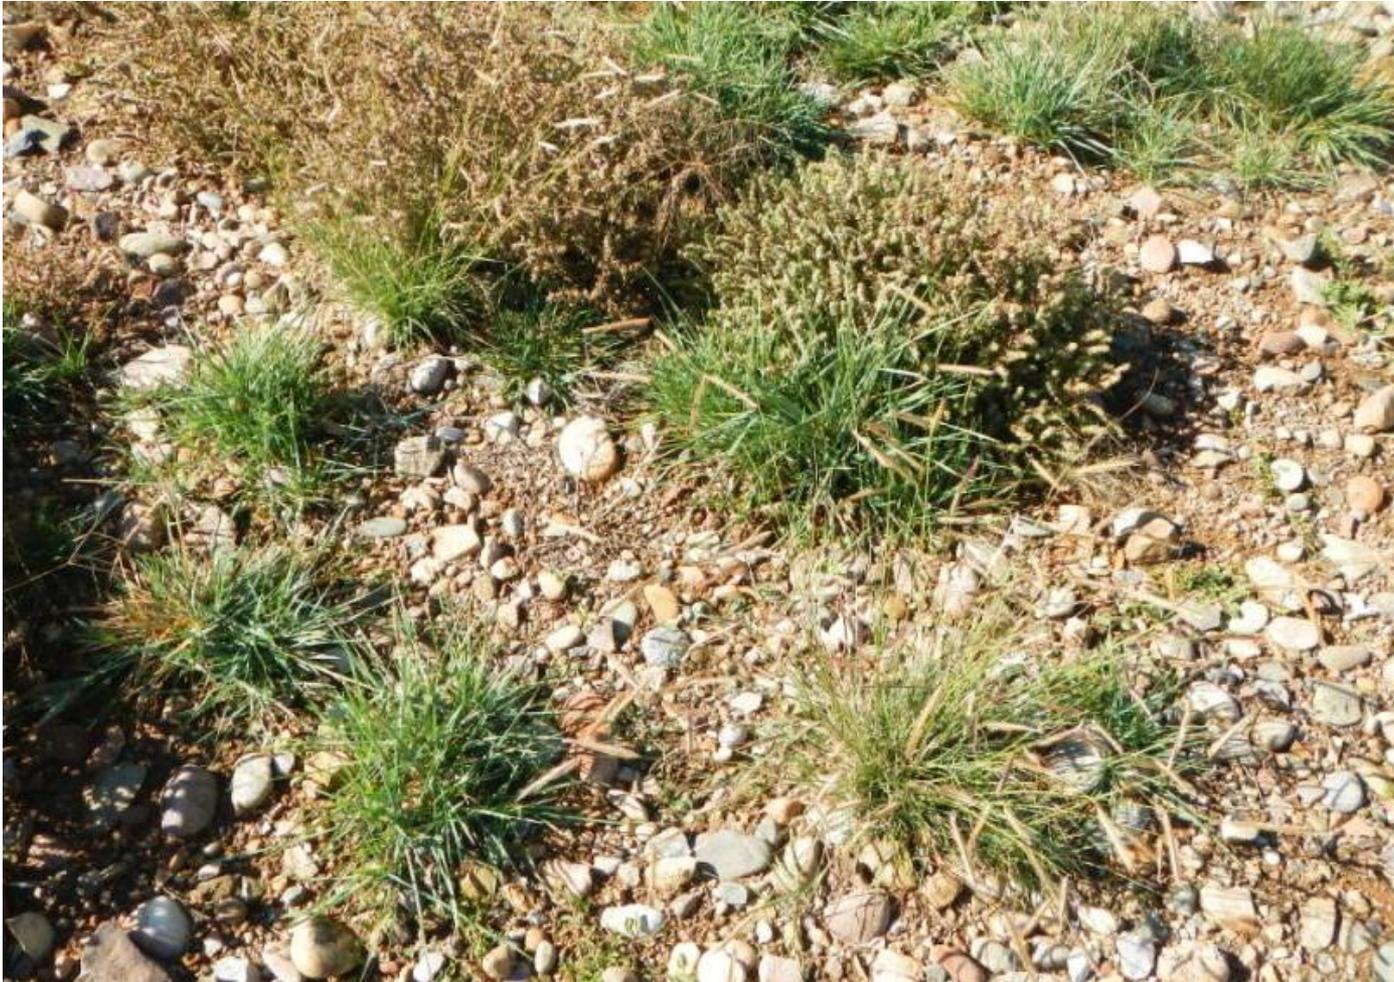
Photo 4. Typical birdseye view of revegetation within the teardrop area. Blue grama and Russian thistle are growing here.

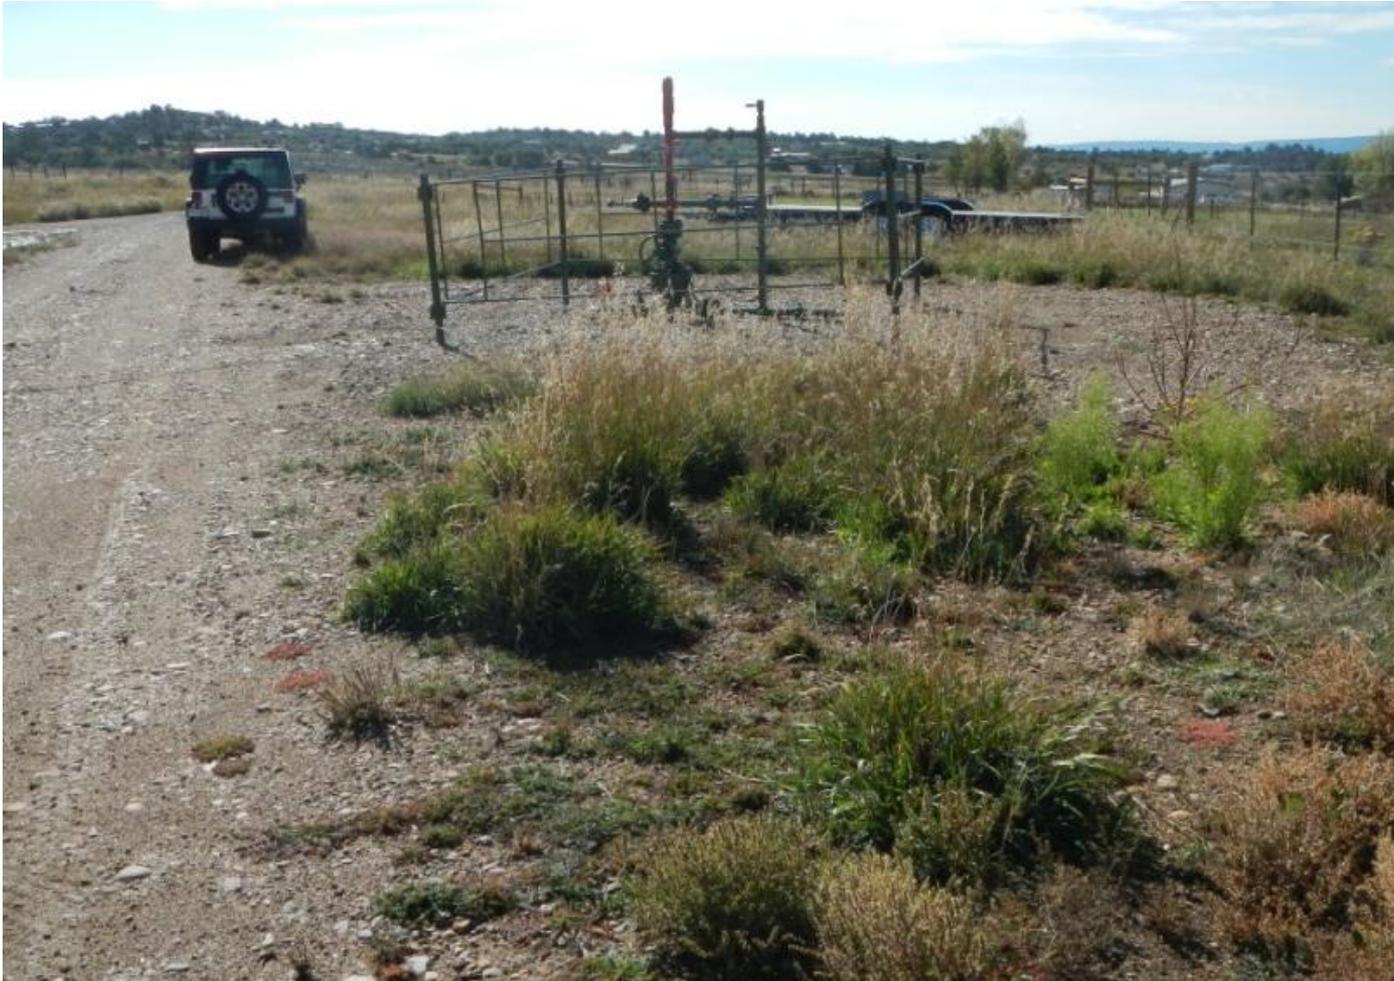
Photo 5. View of western portion of project area from northwest edge of working area facing southward. Revegetation appears to be progressing here.

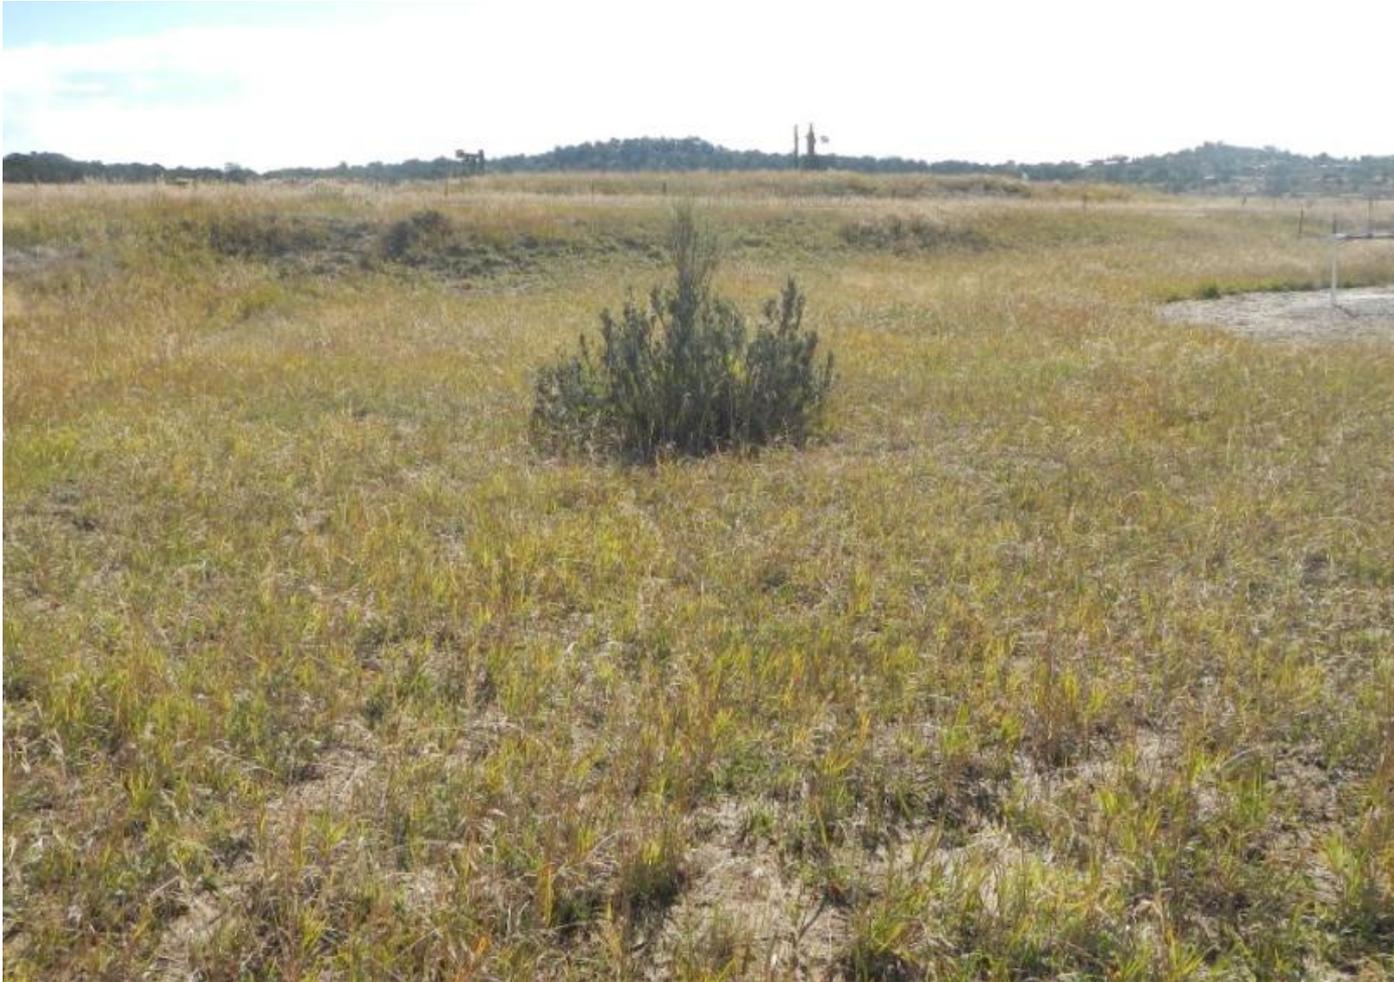
Photo 6. View of eastern portion of project area from northeastern corner facing southward. Smooth brome (*Bromus inermis*) and antelope bitterbrush (*Purshia tridentata*) are well established.

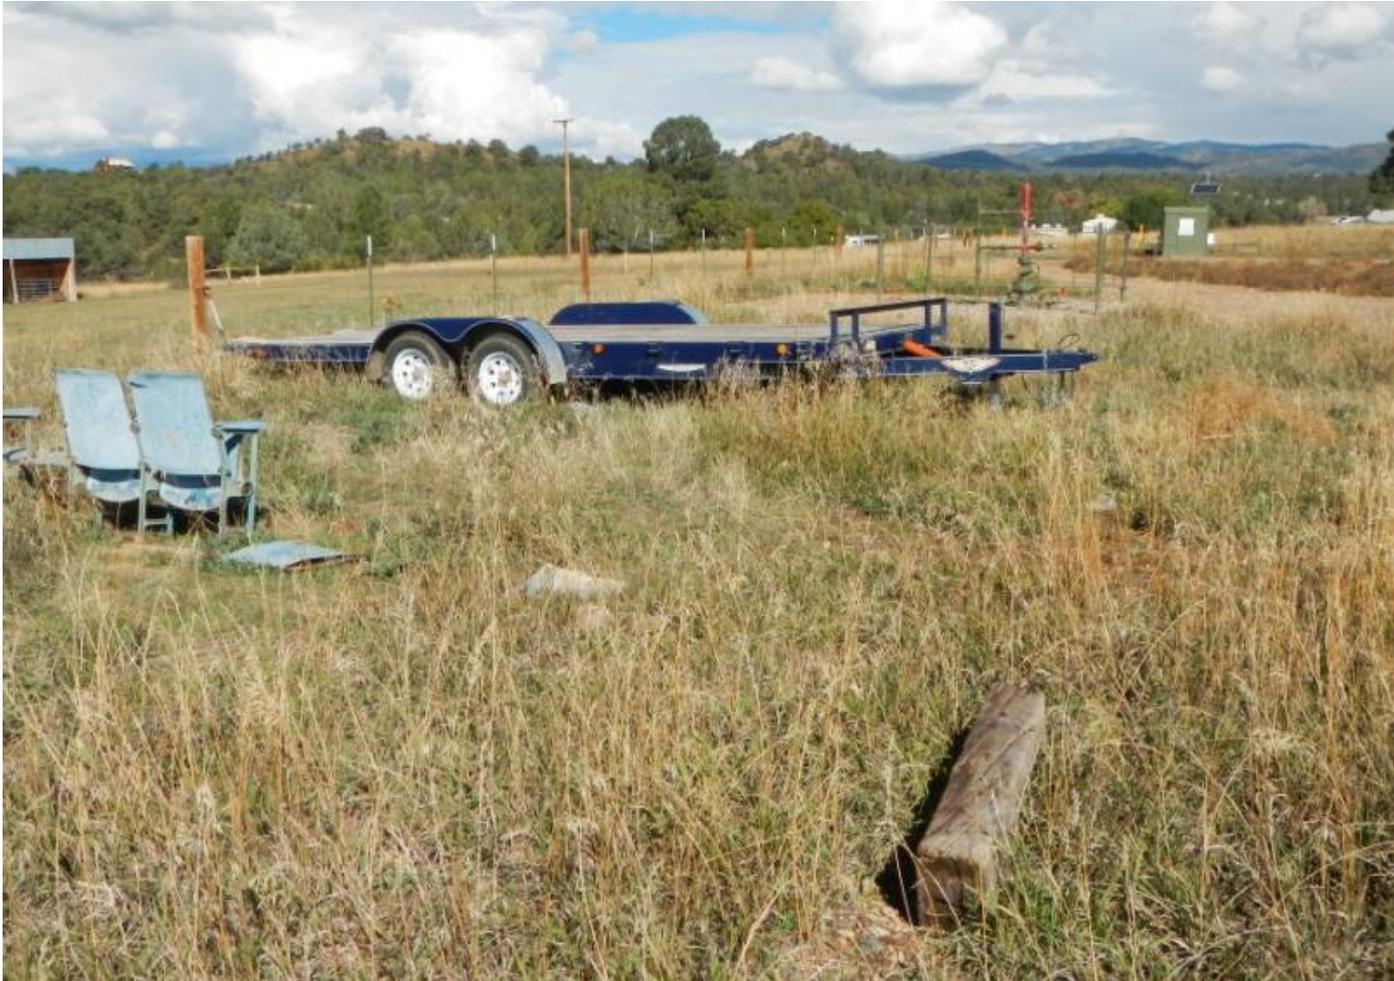
Photo 7. View of trailer and what appears to be other landowner debris being stored at southwestern portion of project area.
