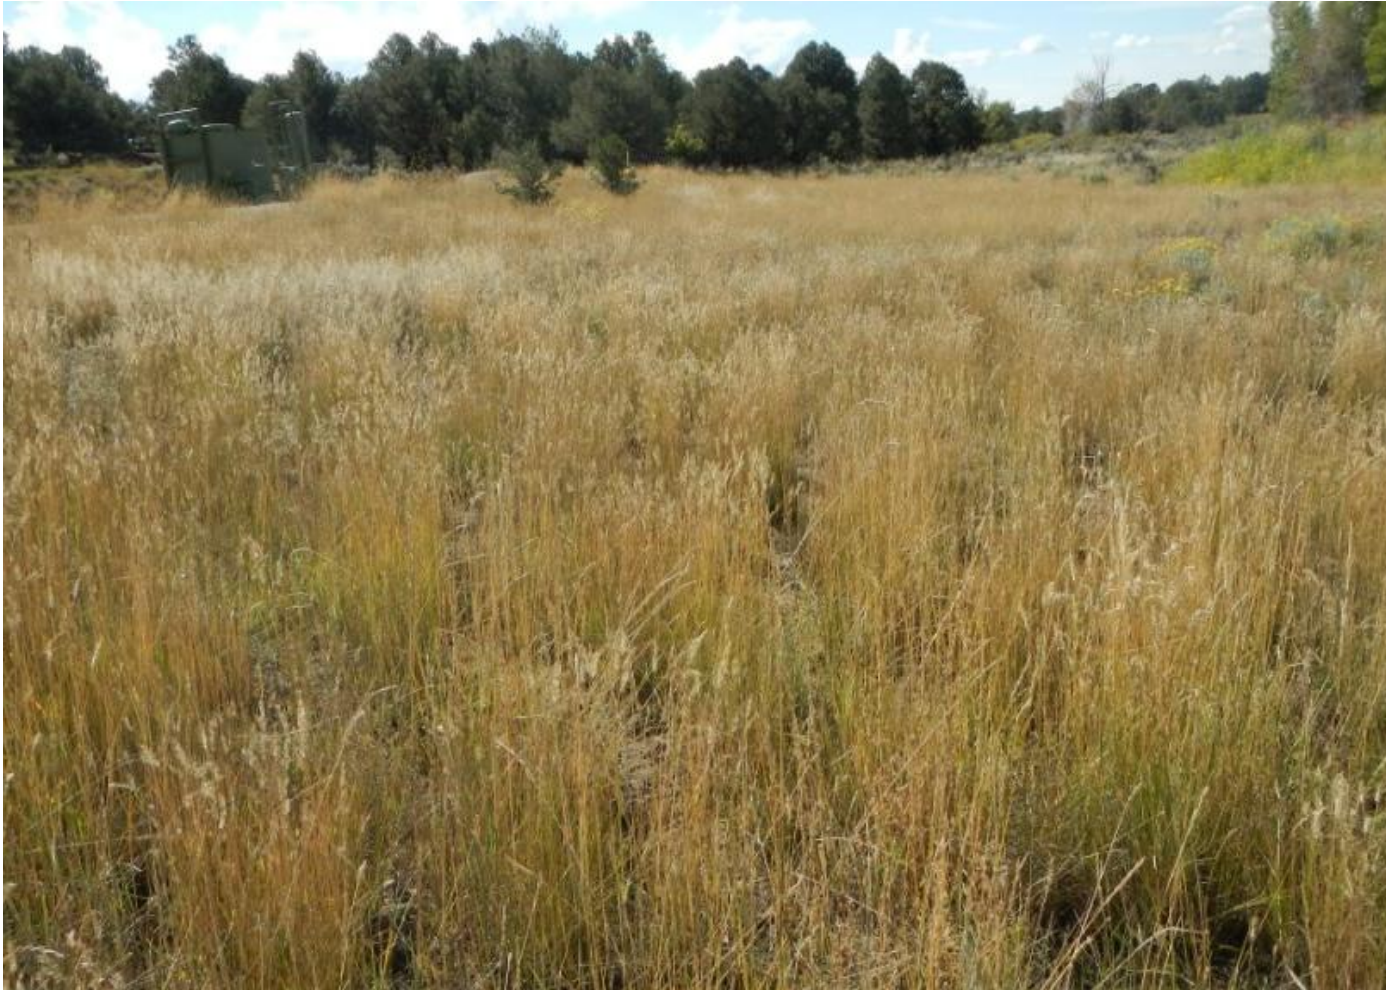
Photo 1. View of western portion of project area from northwestern corner facing southward. Revegetation is progressing in this area.

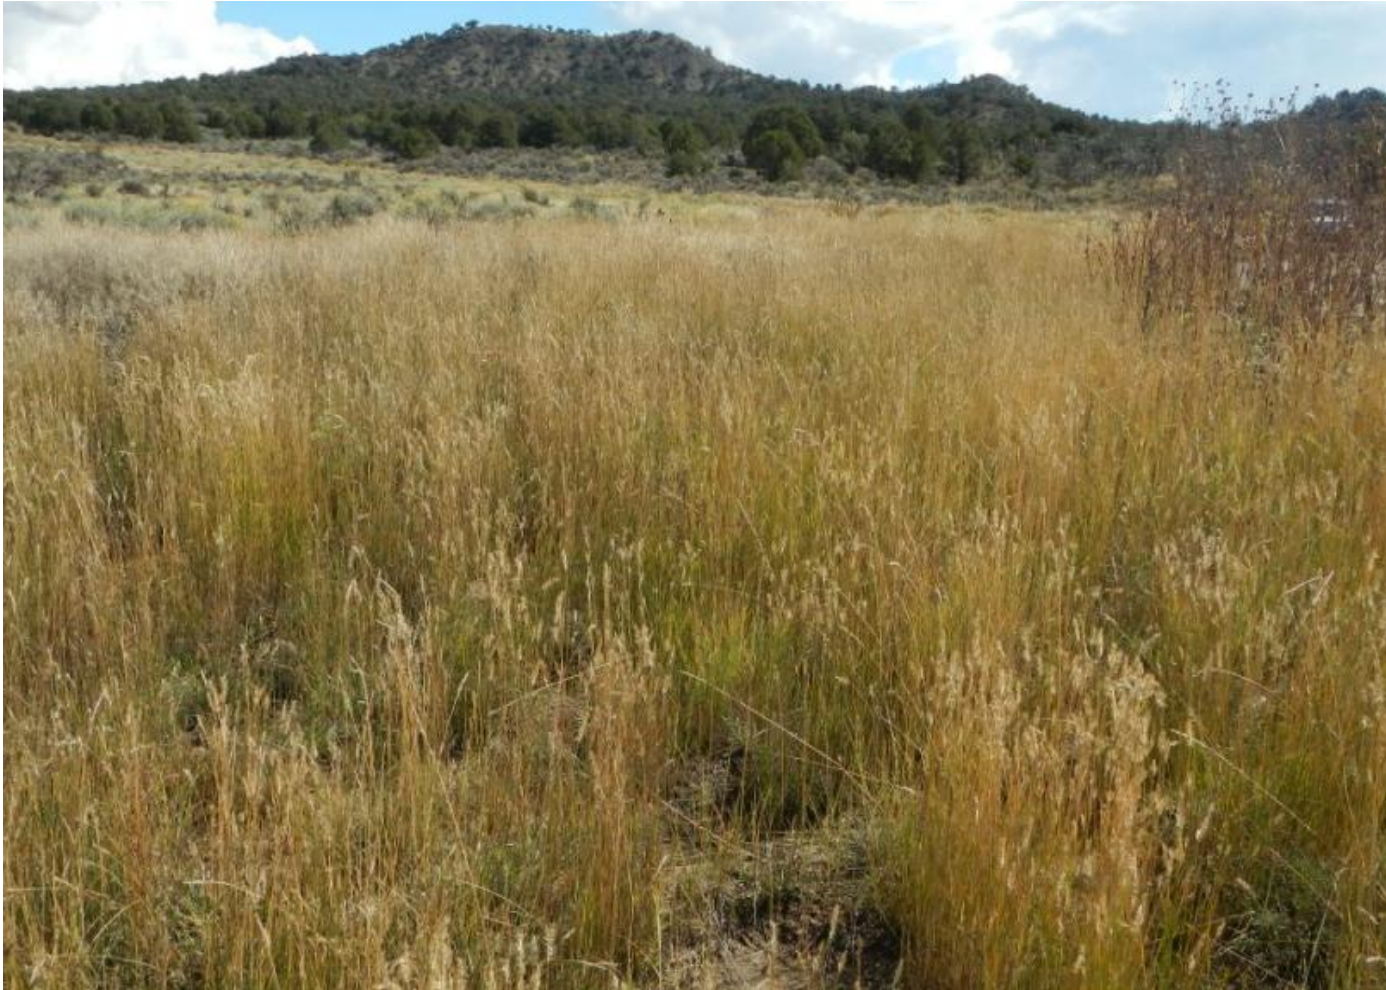
Photo 2. View of northern portion of project area from northwestern corner facing eastward.

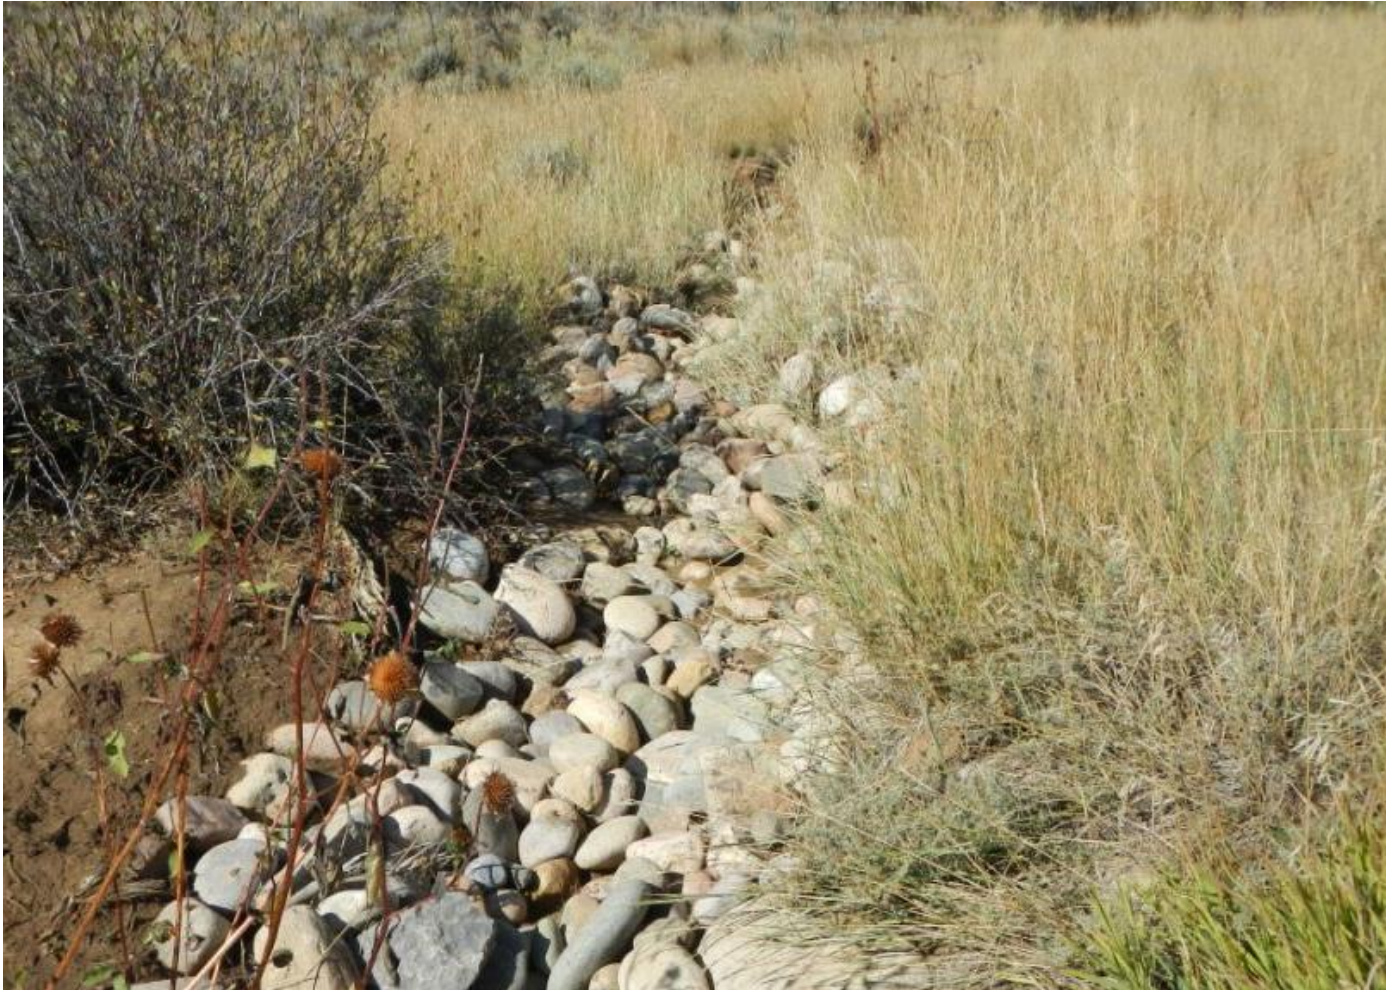
Photo 3. View of cobble BMP in southwestern corner of project area.

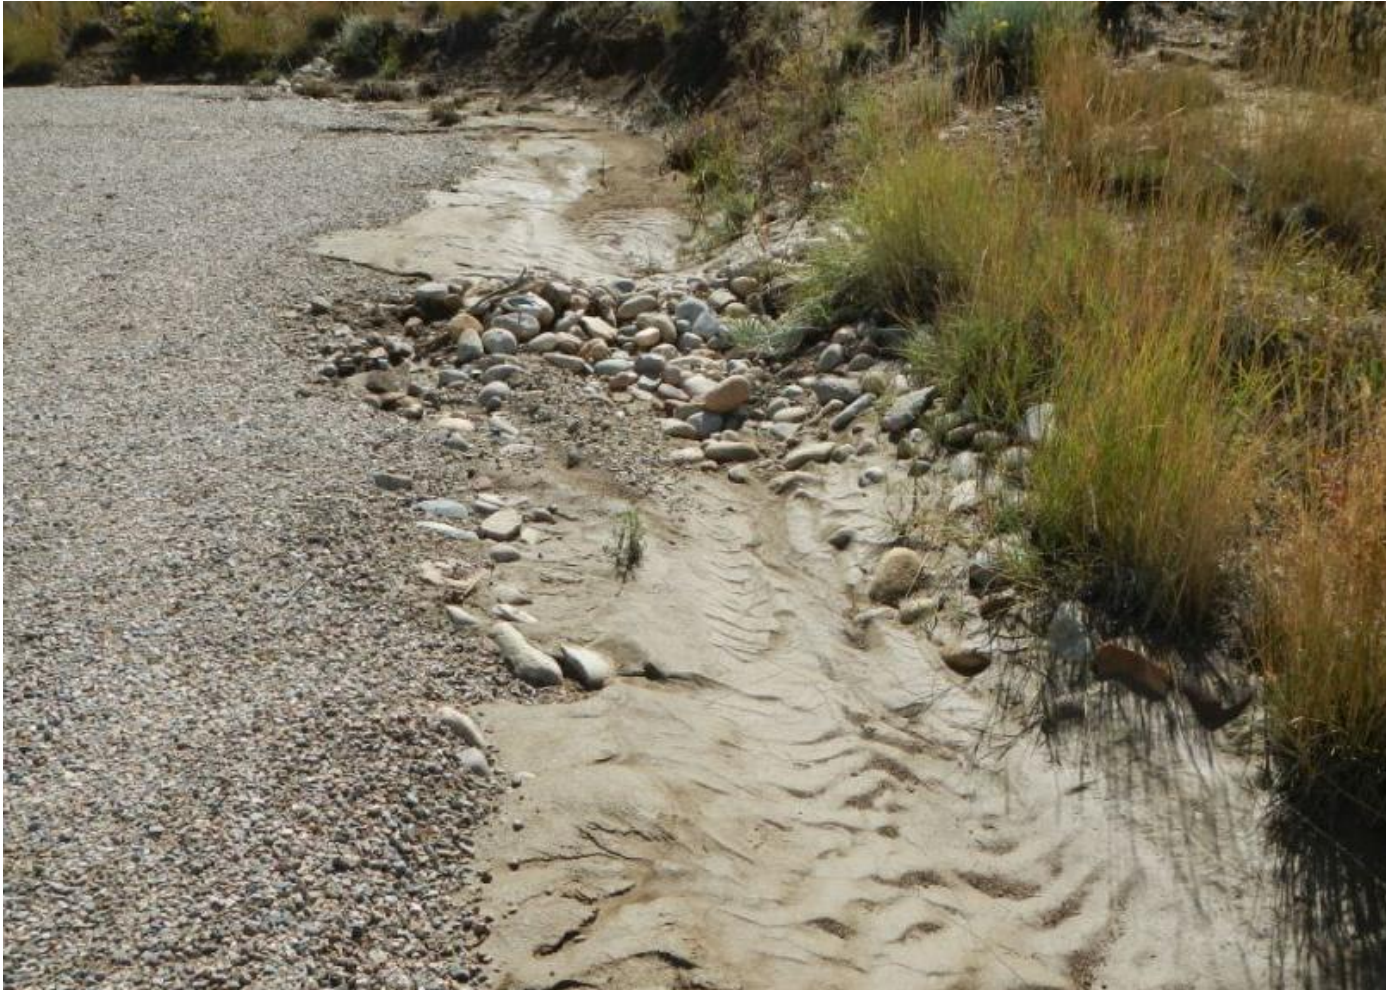
Photo 4. View of cobble BMPs and diversion filling with sediment along southern edge of working area.

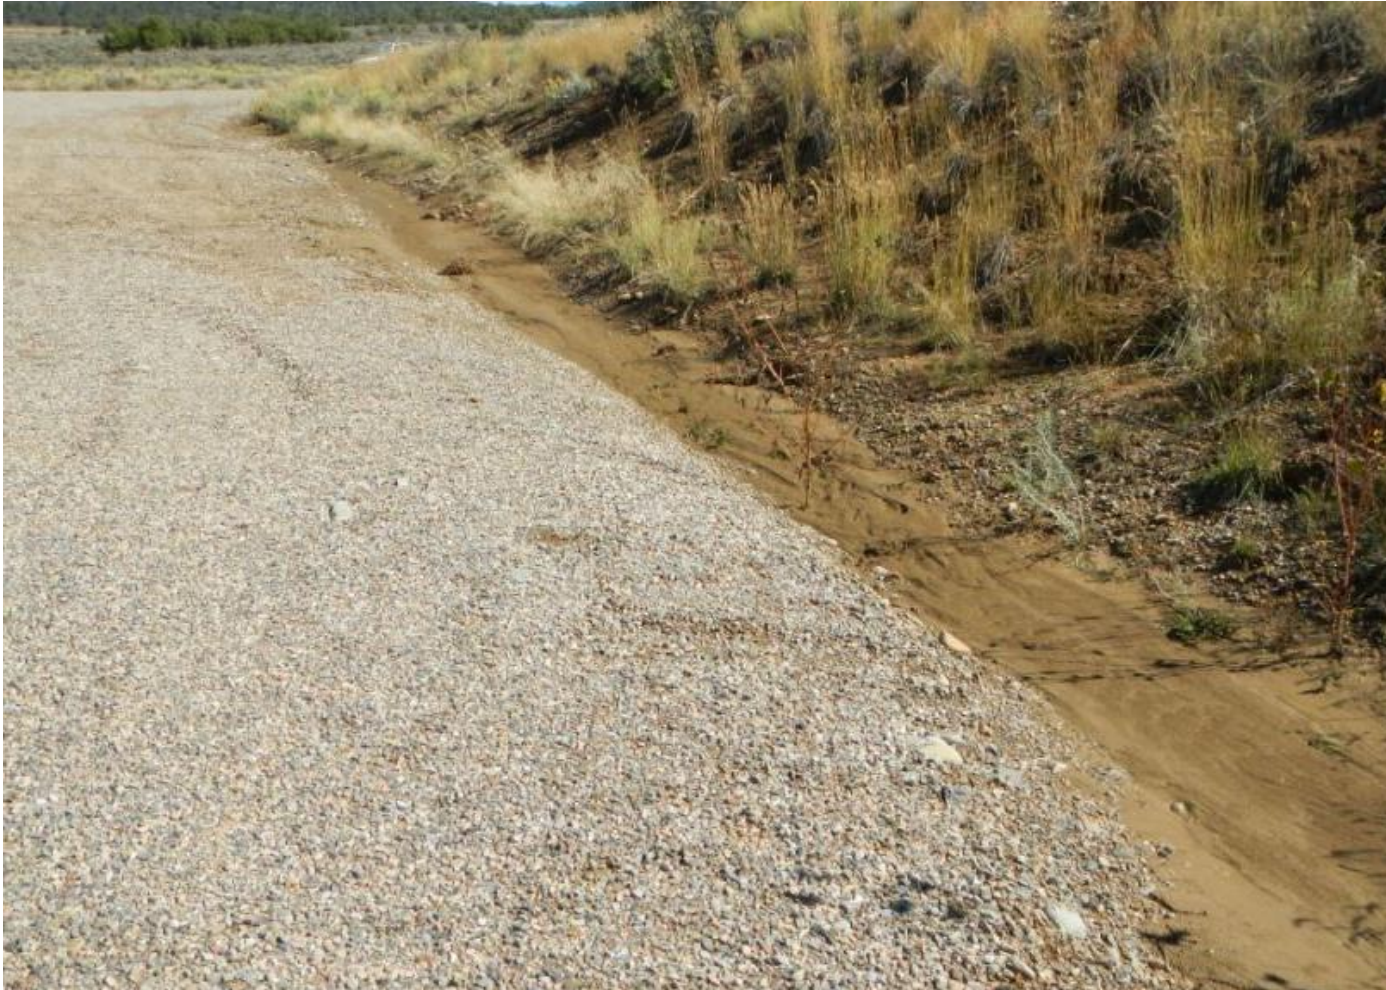
Photo 5. View of eastern edge of working area facing northward. Diversion is filling with sediment.
