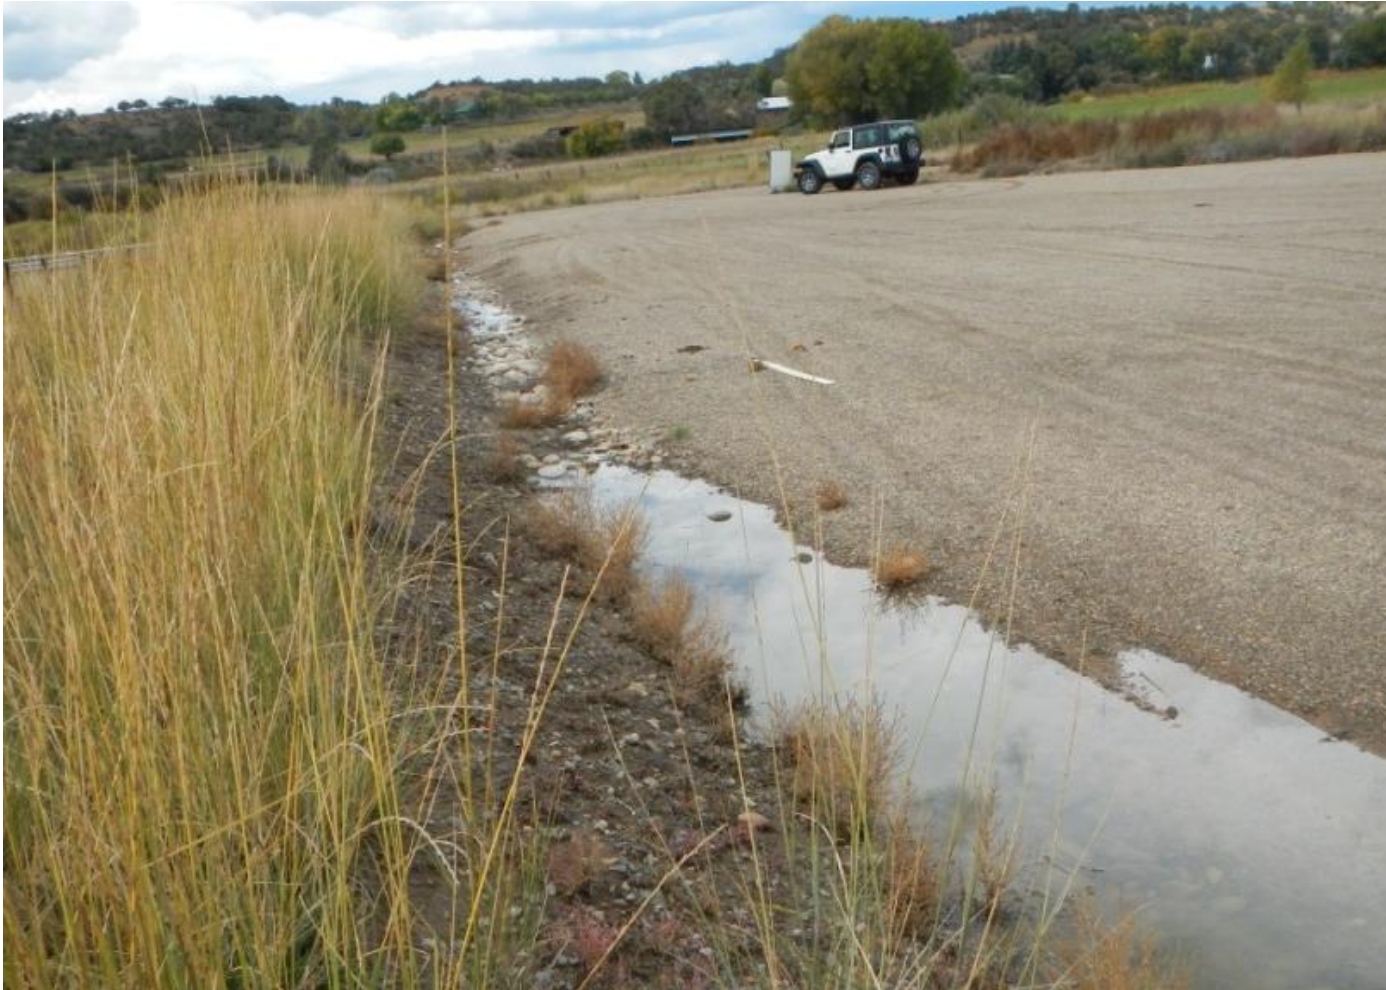
Photo 1. View of southern edge of working area and southern vegetated berm from mid-southern edge facing westward.

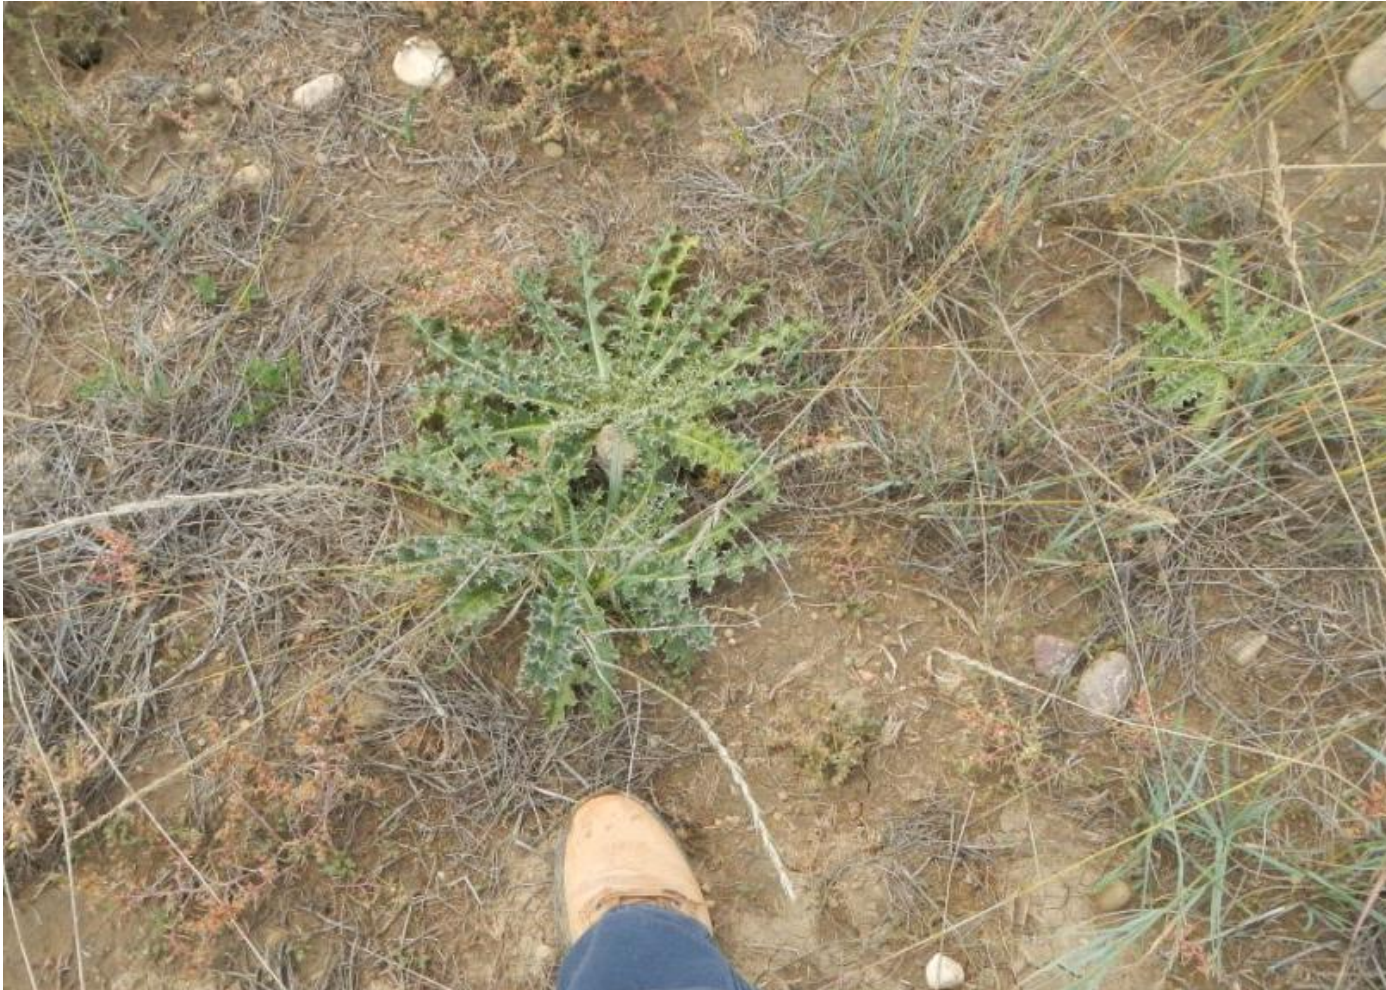
Photo 2. View of musk thistle (*Carduus nutans*) rosettes within the southern portion of the interim reclamation area.

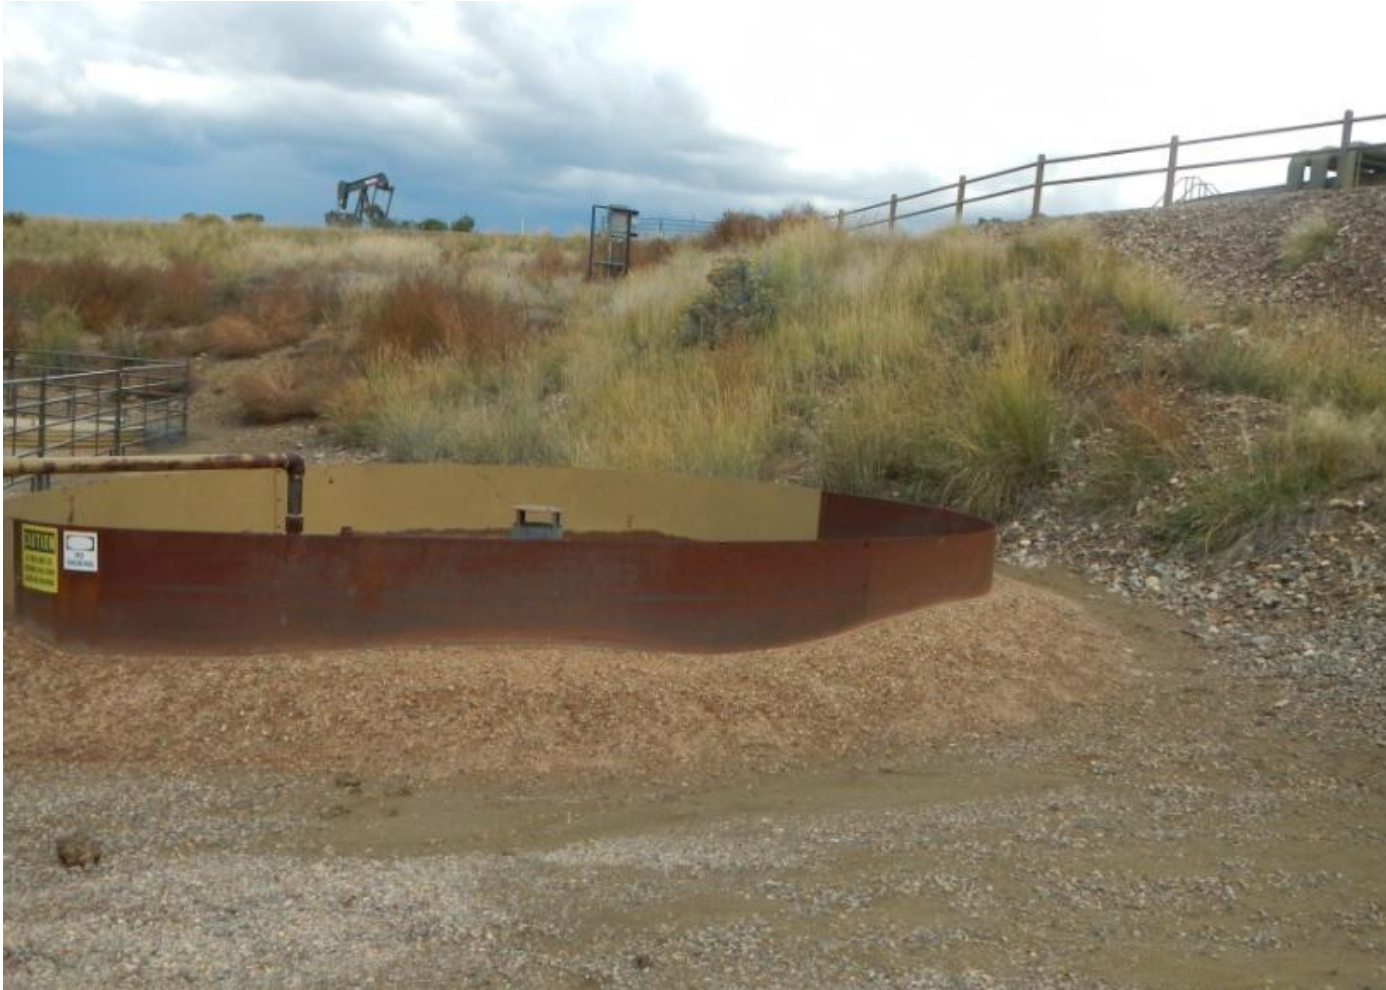
Photo 3. View of middle portion of project area from mid-southern edge facing northward. Revegetation is progressing on fill slope (on right).

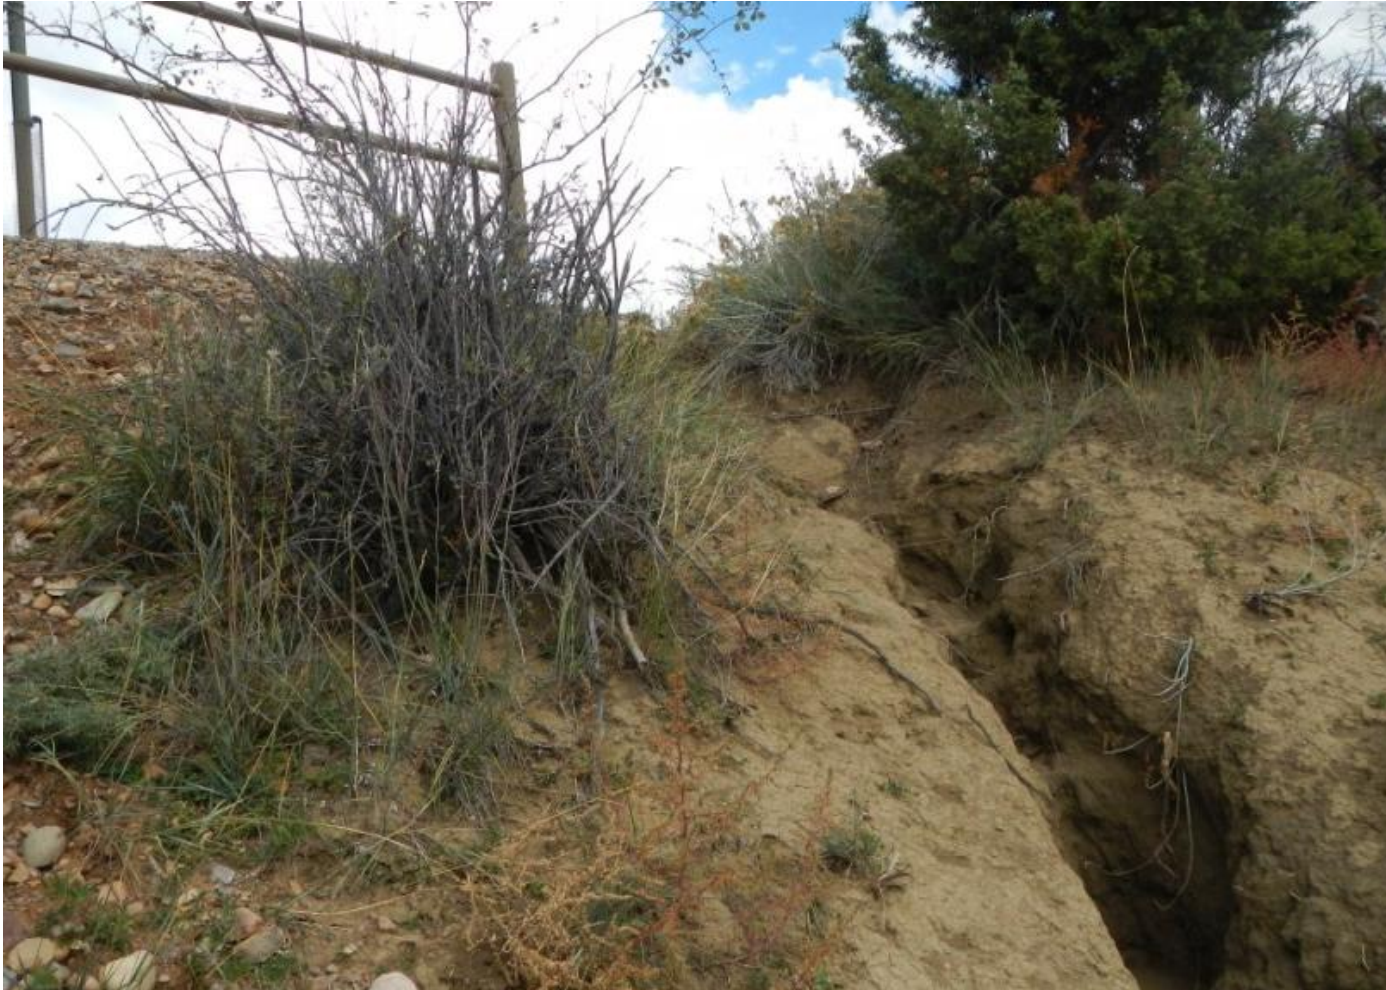
Photo 4. View of erosional channel eroding the southern edge of working area on the portion of the well pad that is west and elevated from the eastern portion (Facing upslope). This erosional channel is approximately 2 feet wide and up to 4 feet deep and eroding directly into the Florida River.

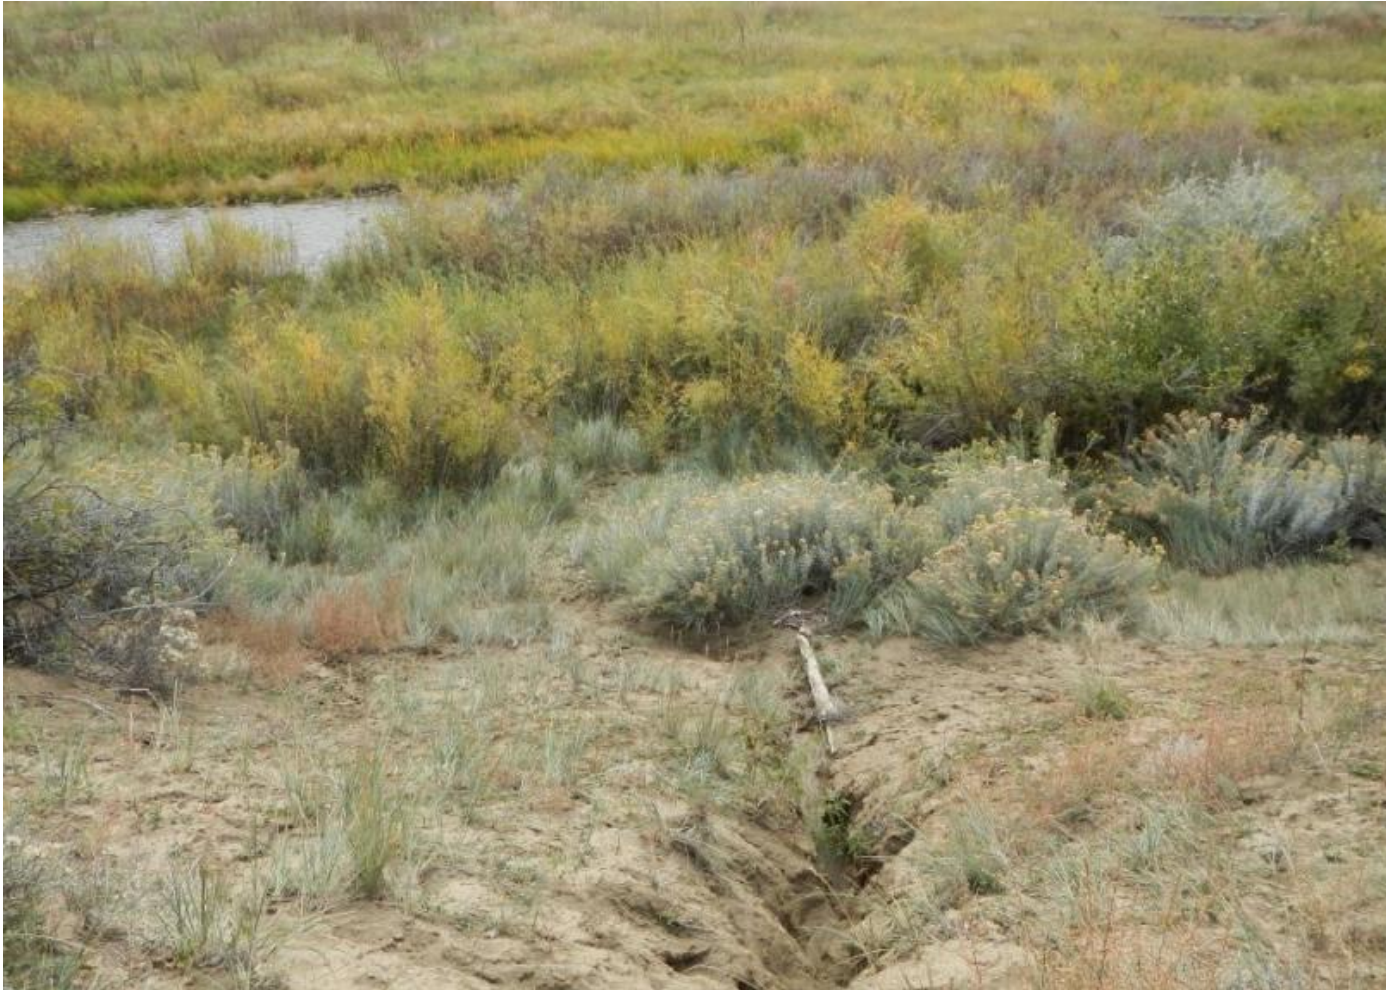
Photo 5. View of erosional channel shown in Photo 4, coming off of the southern edge of the well pad facing down-slope. Channel is eroding directly into the Florida River (in background).

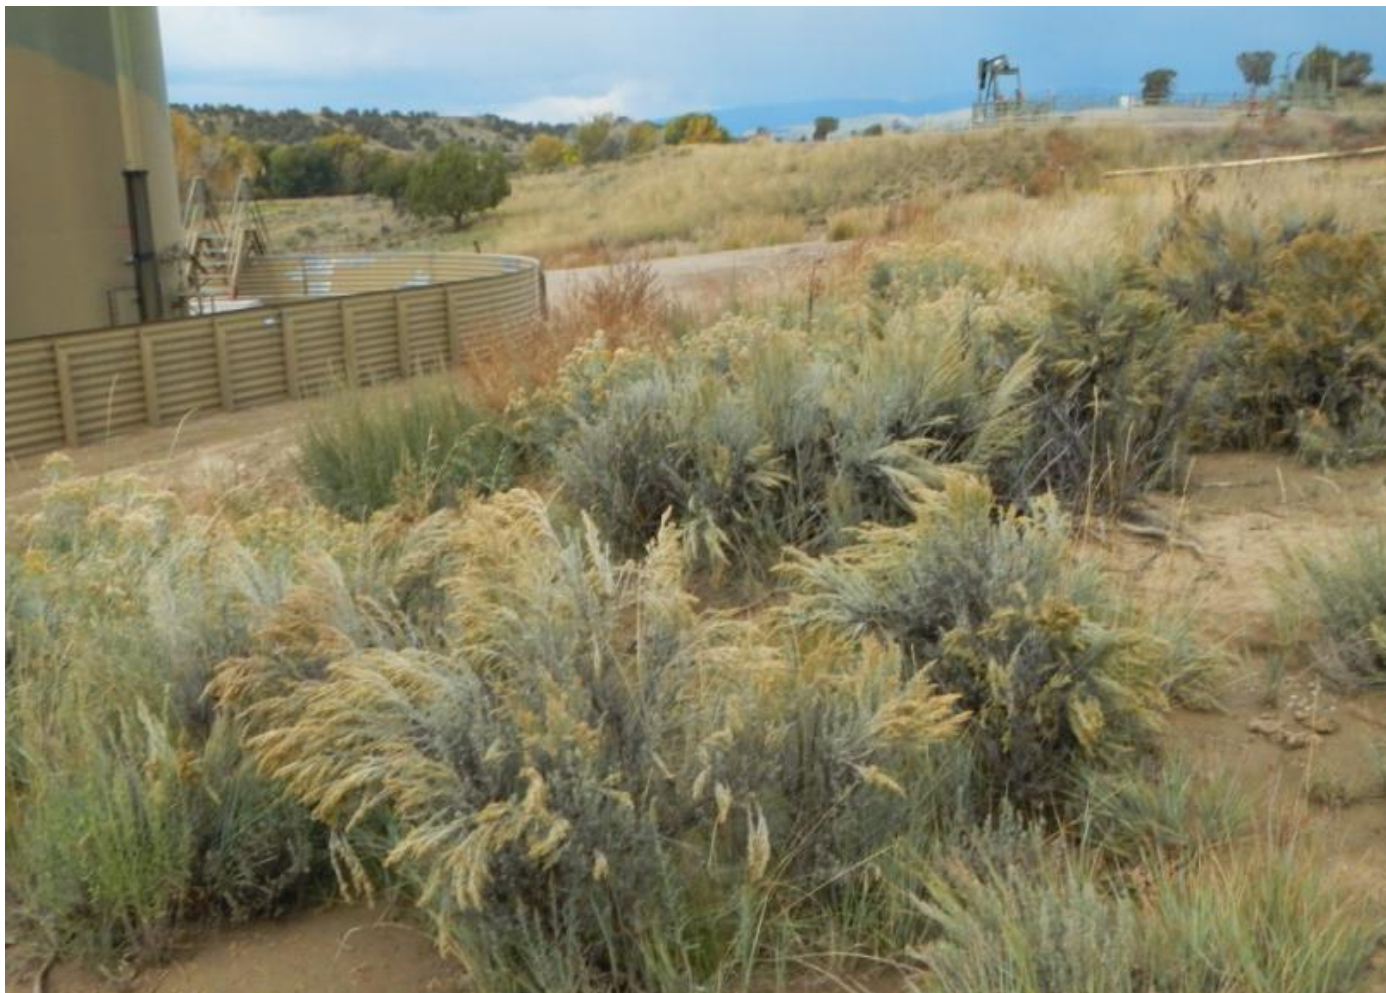
Photo 6. View of western portion of the project area from the southeastern edge facing northward. Native perennial vegetation such as big sagebrush (*Artemisia tridentata*) and Indian ricegrass (*Oryzopsis hymenoides*) are growing here.

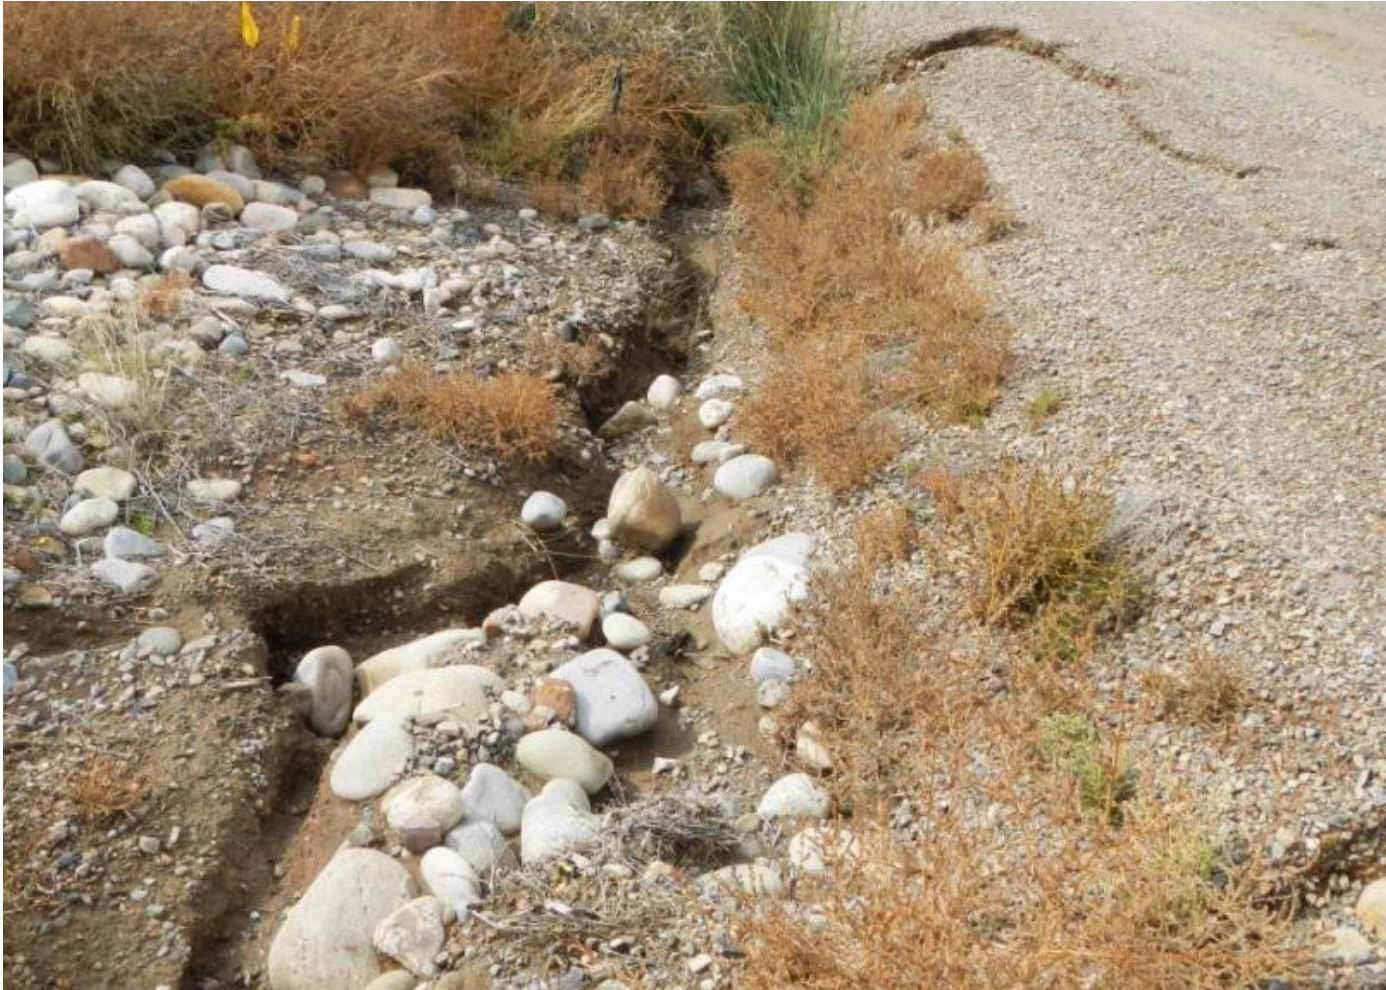
Photo 7. View of erosional channel forming along roadside and eroding road surface adjacent to the northern edge of the project area, facing downslope.

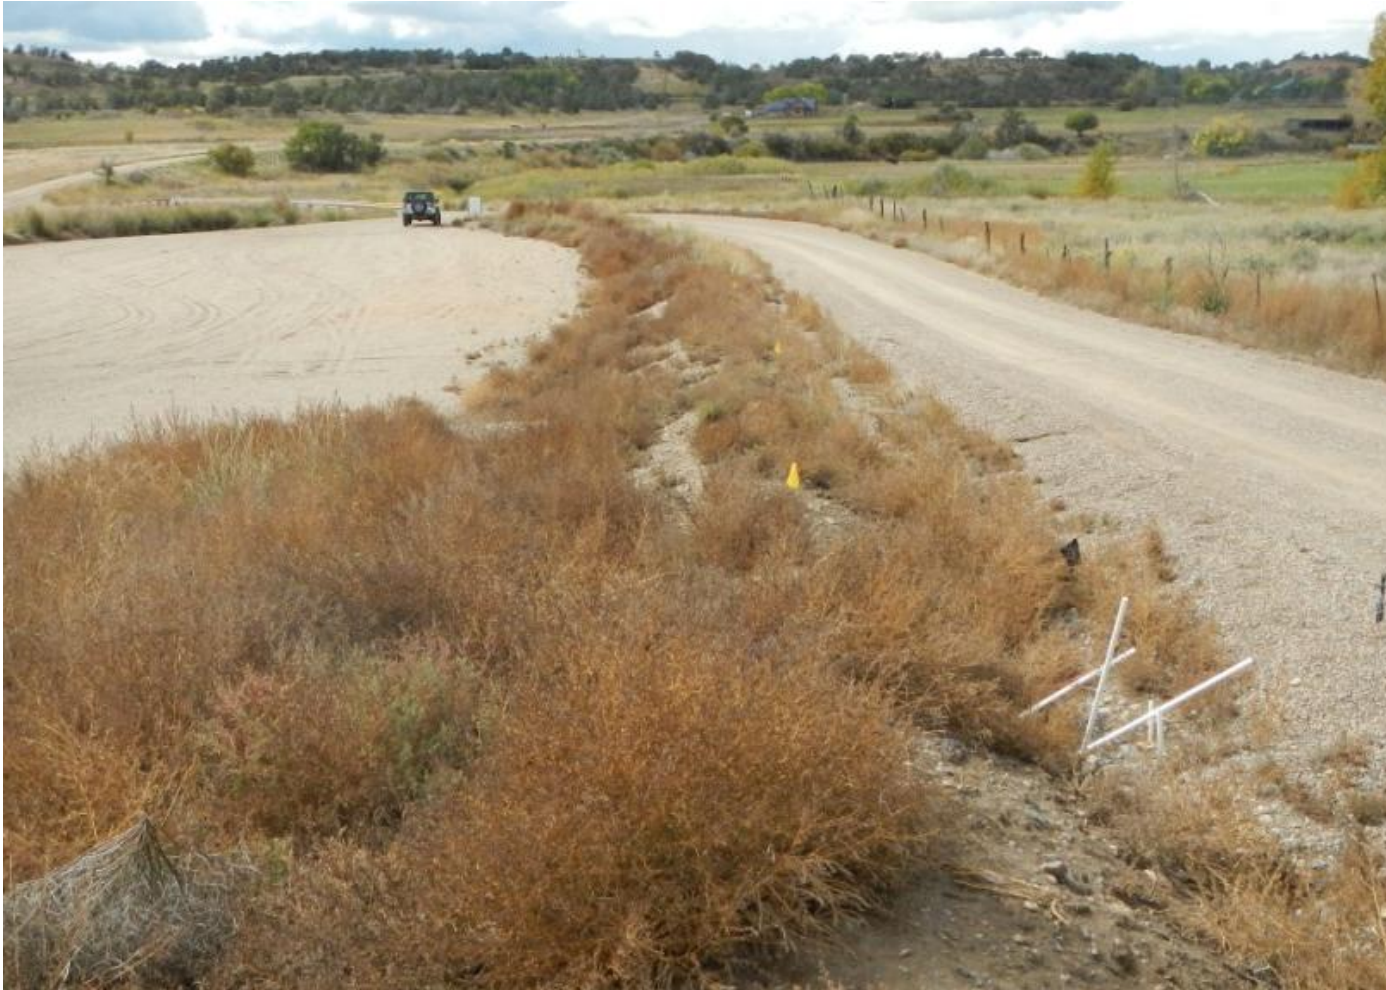
Photo 8. View of northern portion of project area from mid-northern edge facing westward. Revegetation along this berm is largely kochia (*Kochia scoparia*).

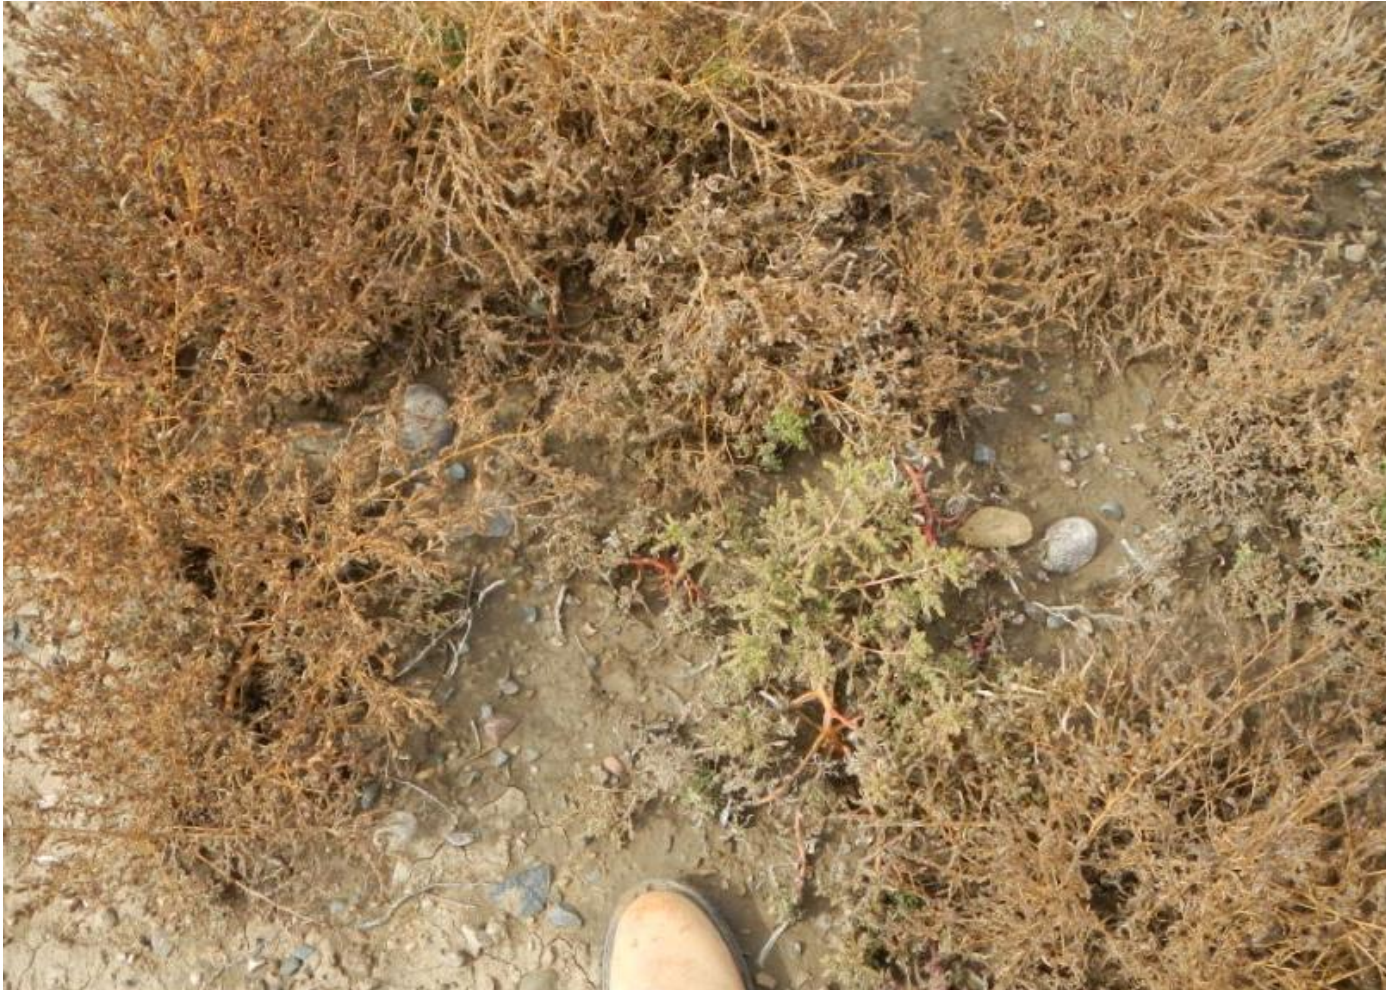
Photo 9. Typical birdseye view of poor revegetation along northern portion of the project area. It is unclear whether this berm was seeded as little or no desirable vegetation is present.

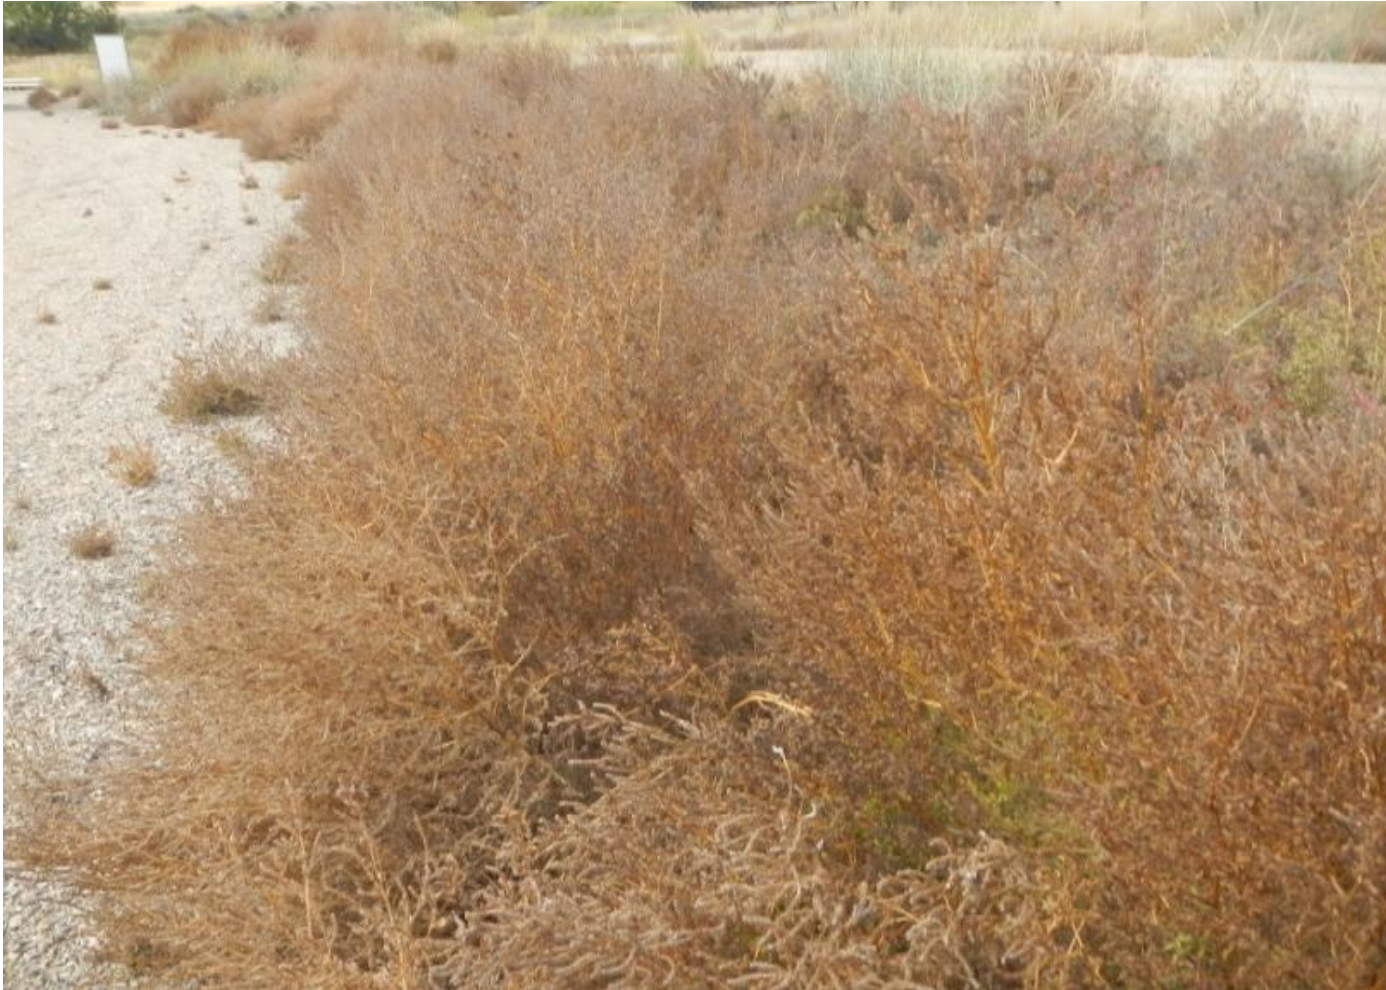
Photo 10. View of tall (approximately 3.5 feet) kochia plants growing in northwestern portion of the project area. These will soon break off and become debris.
