Photo 1. View of southern portion of project area from access road facing westward. Revegetation is progressing in this area.

Photo 2. View of eastern portion of project area from northeastern corner facing southward.

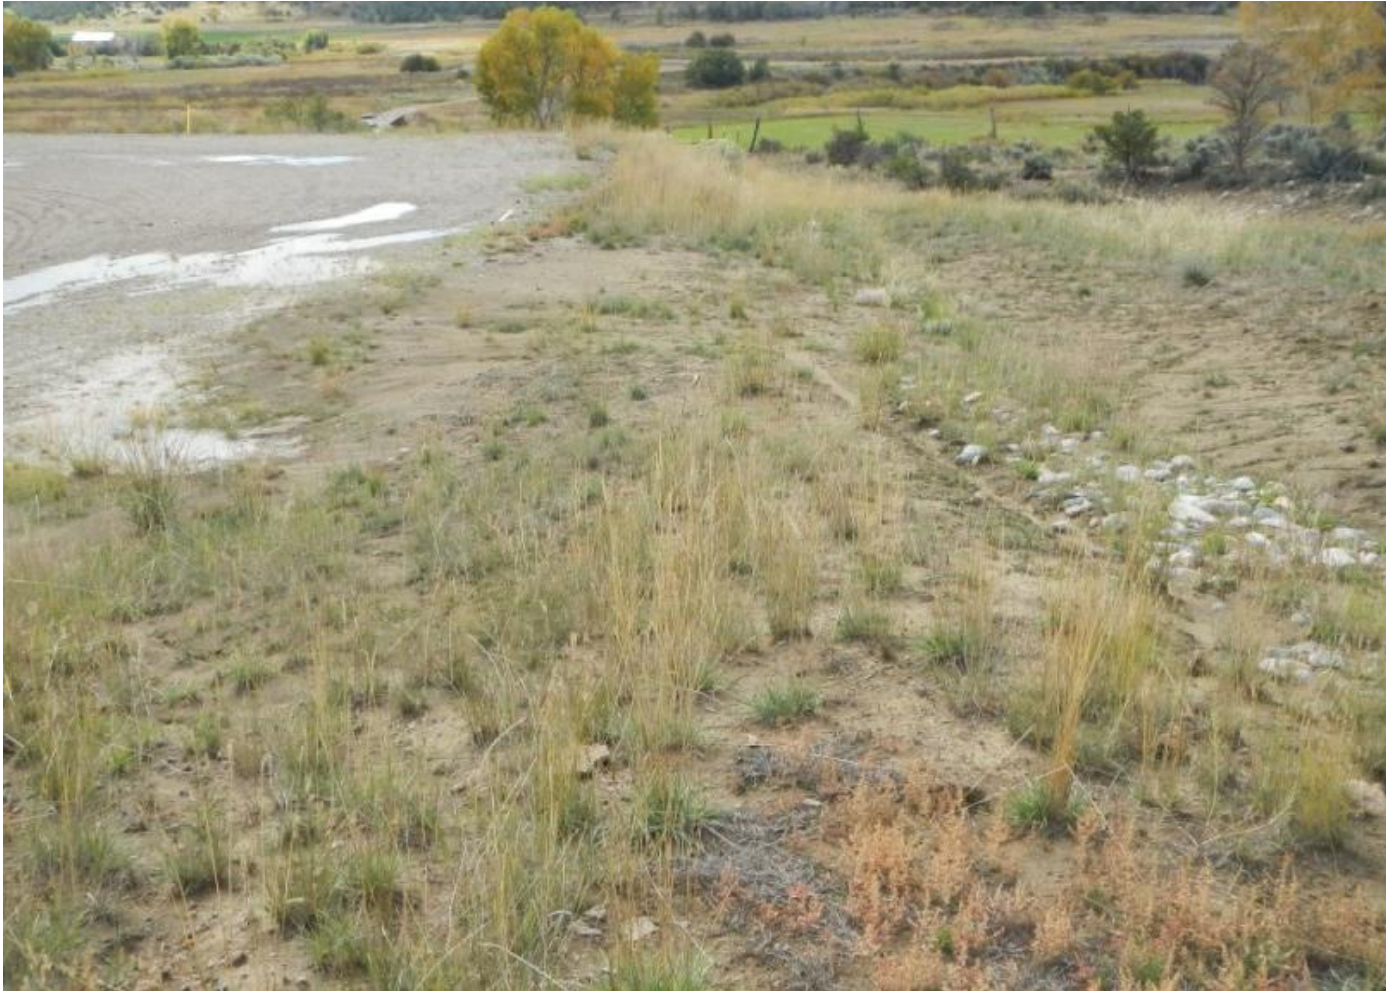
Photo 4. View of northern portion of project area from northeastern corner facing westward. Revegetation is progressing here and stormwater BMP appears to be in good condition. It appears that sediment is running off of the northern edge of the working area.

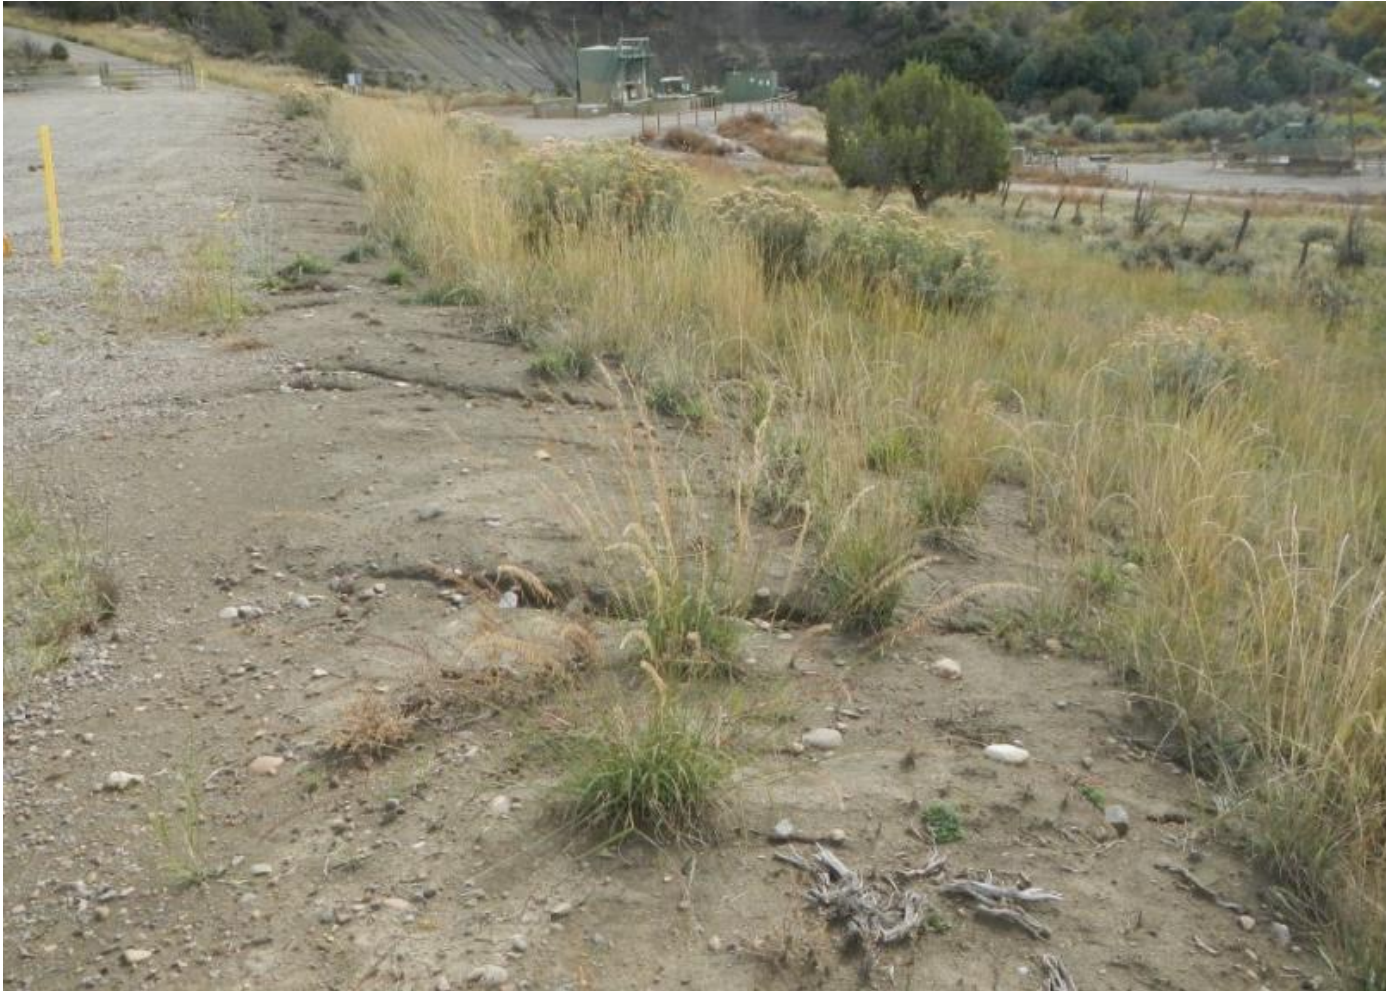
Photo 5. View of western edge of working area facing southward. Rill erosion is occurring all along this edge of the working area. See photos 6 and 7.
