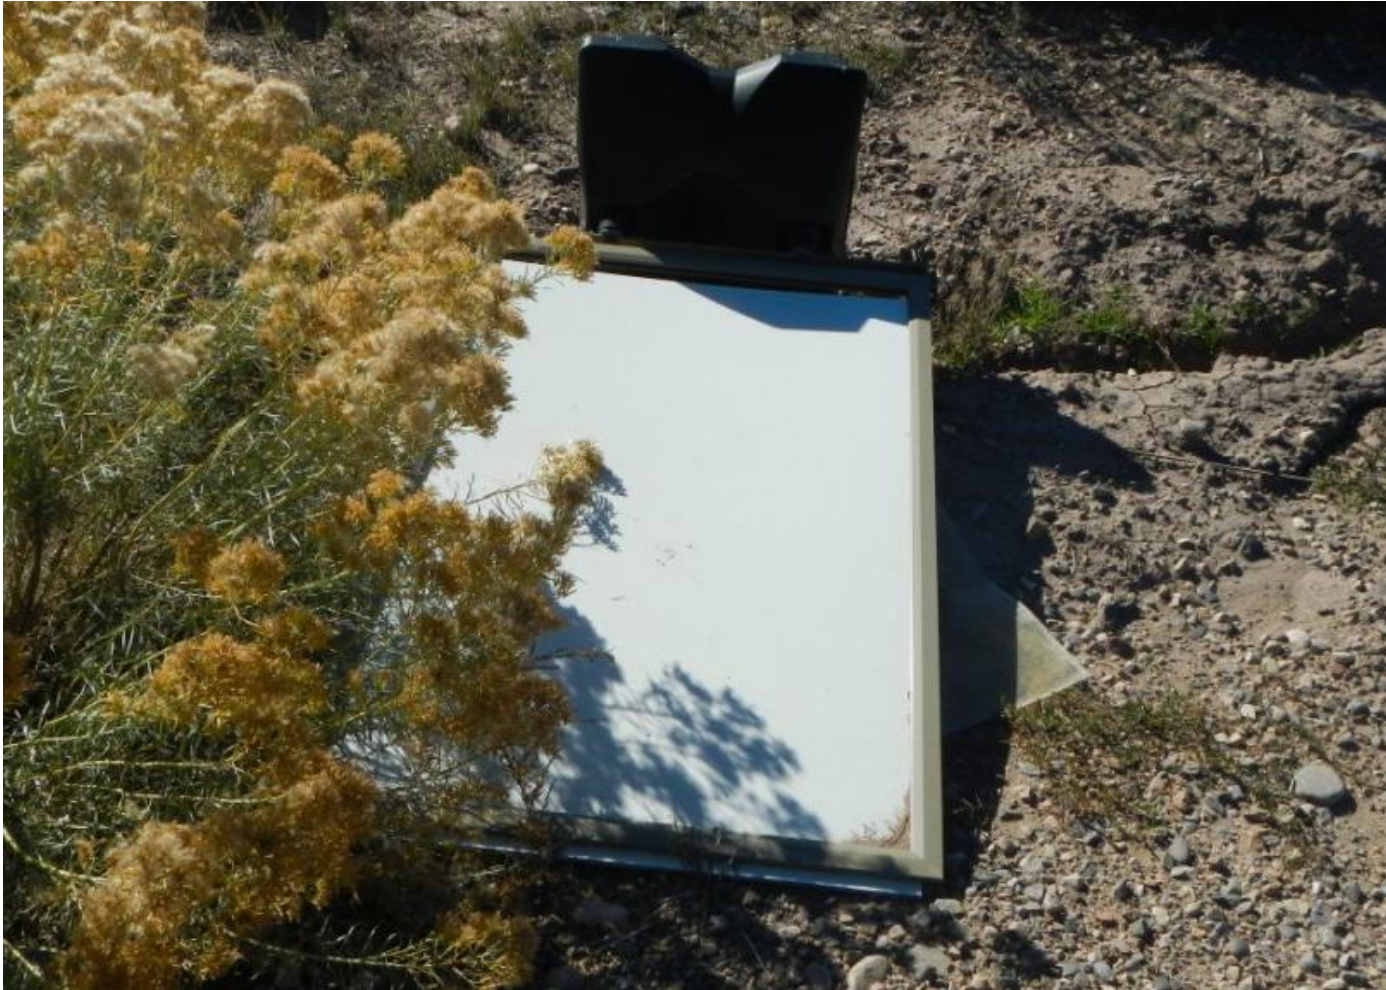
Photo 1. View of well sign at well pad entrance that is tipped over.

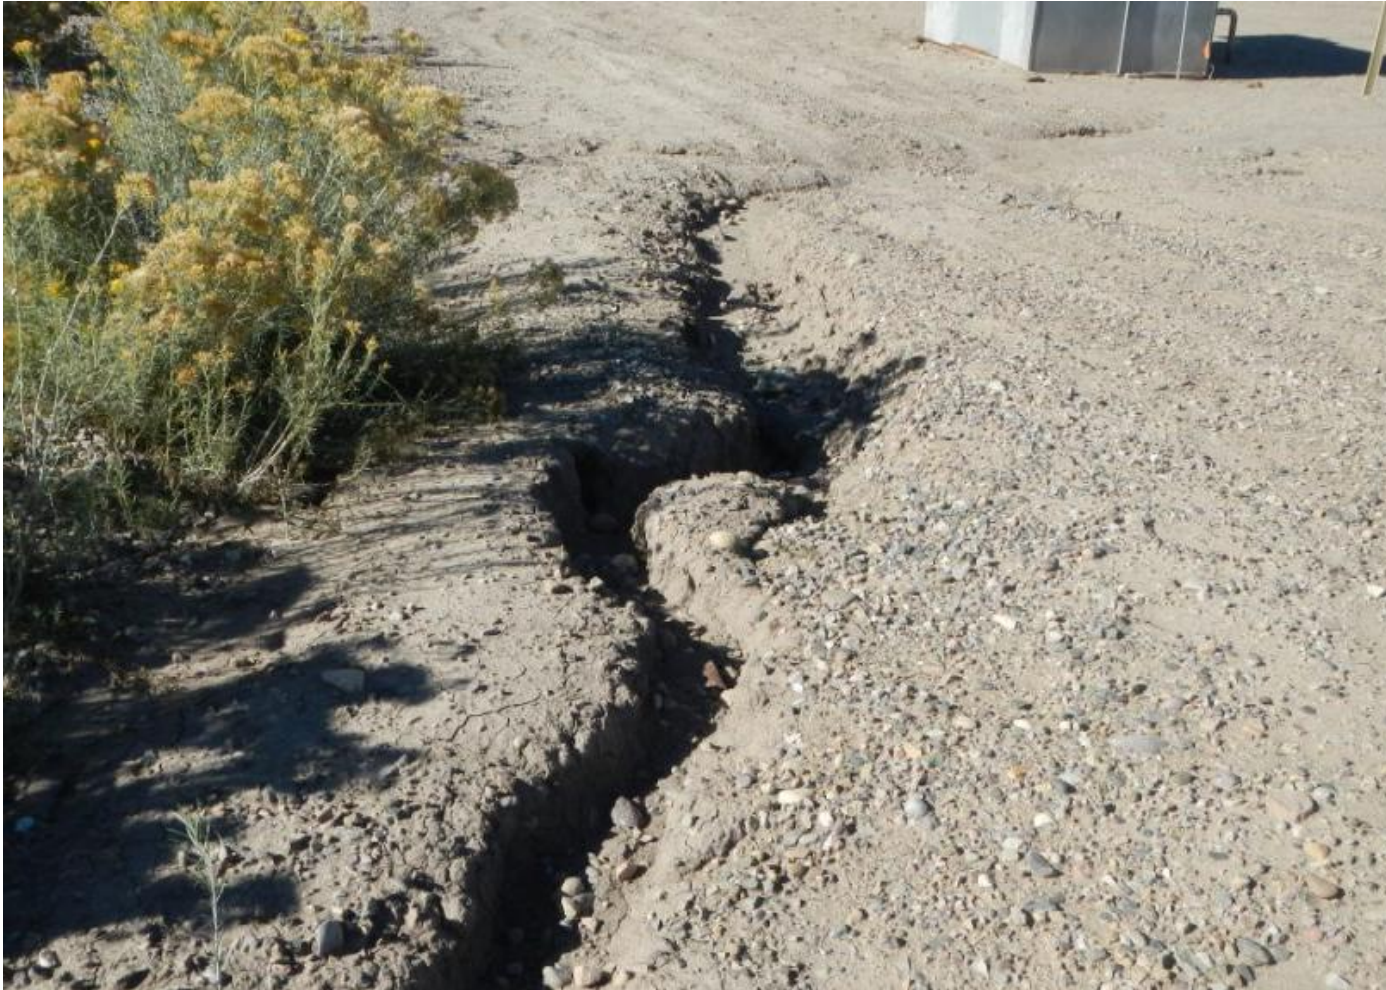
Photo 2. View of erosional channel at well pad entrance flowing across well pad toward the northern edge. Channel is approximately 1.5 feet wide and deep.

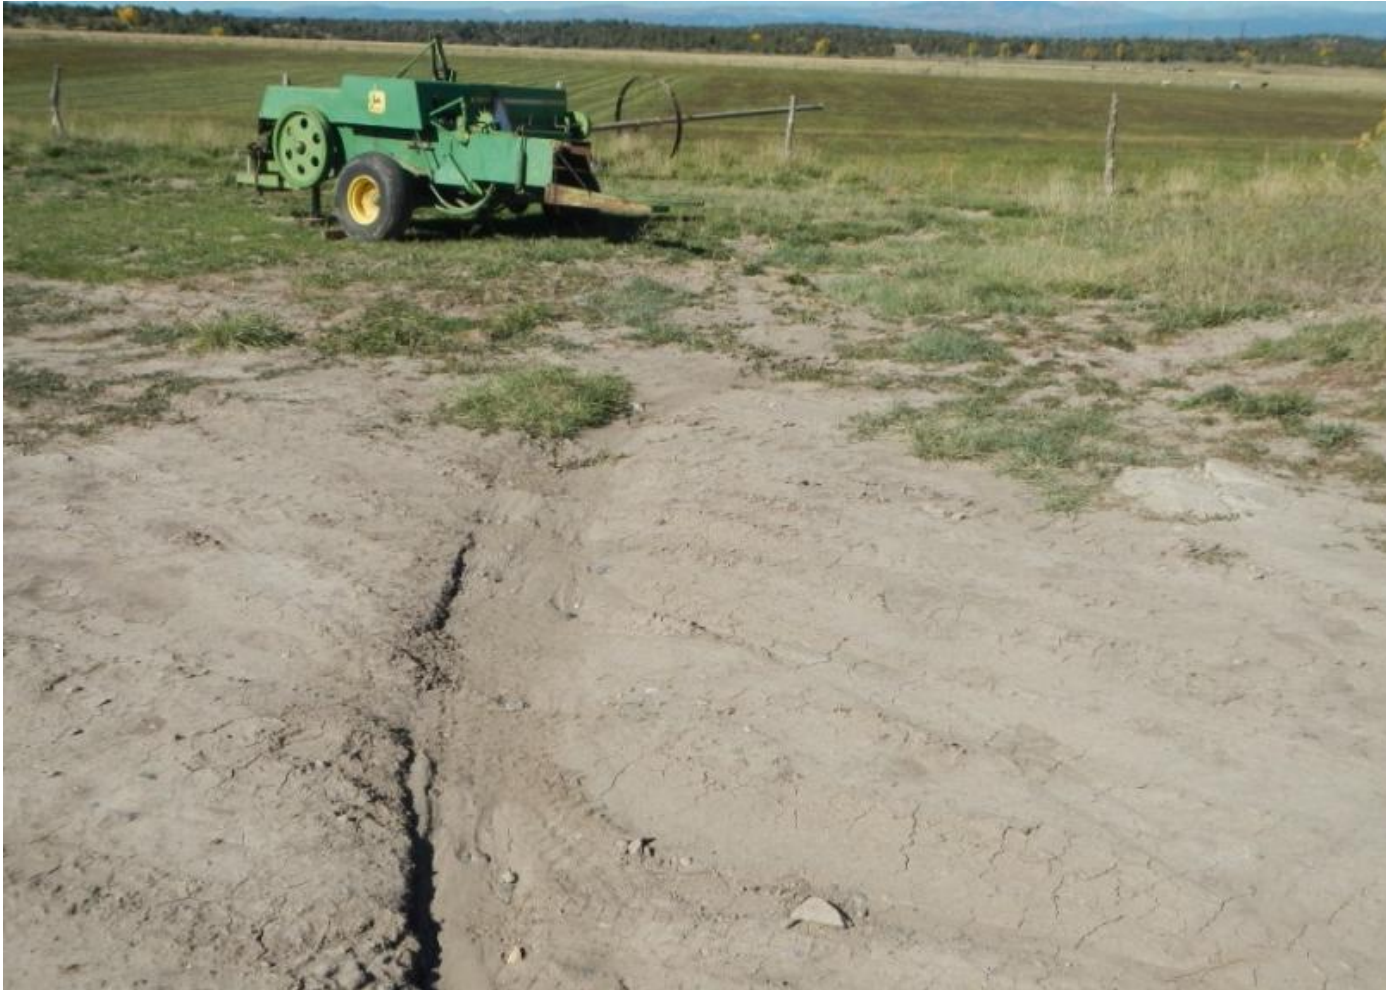
Photo 3. View of area where erosional channel in Photo 2, flows off of the northern edge of the working area.

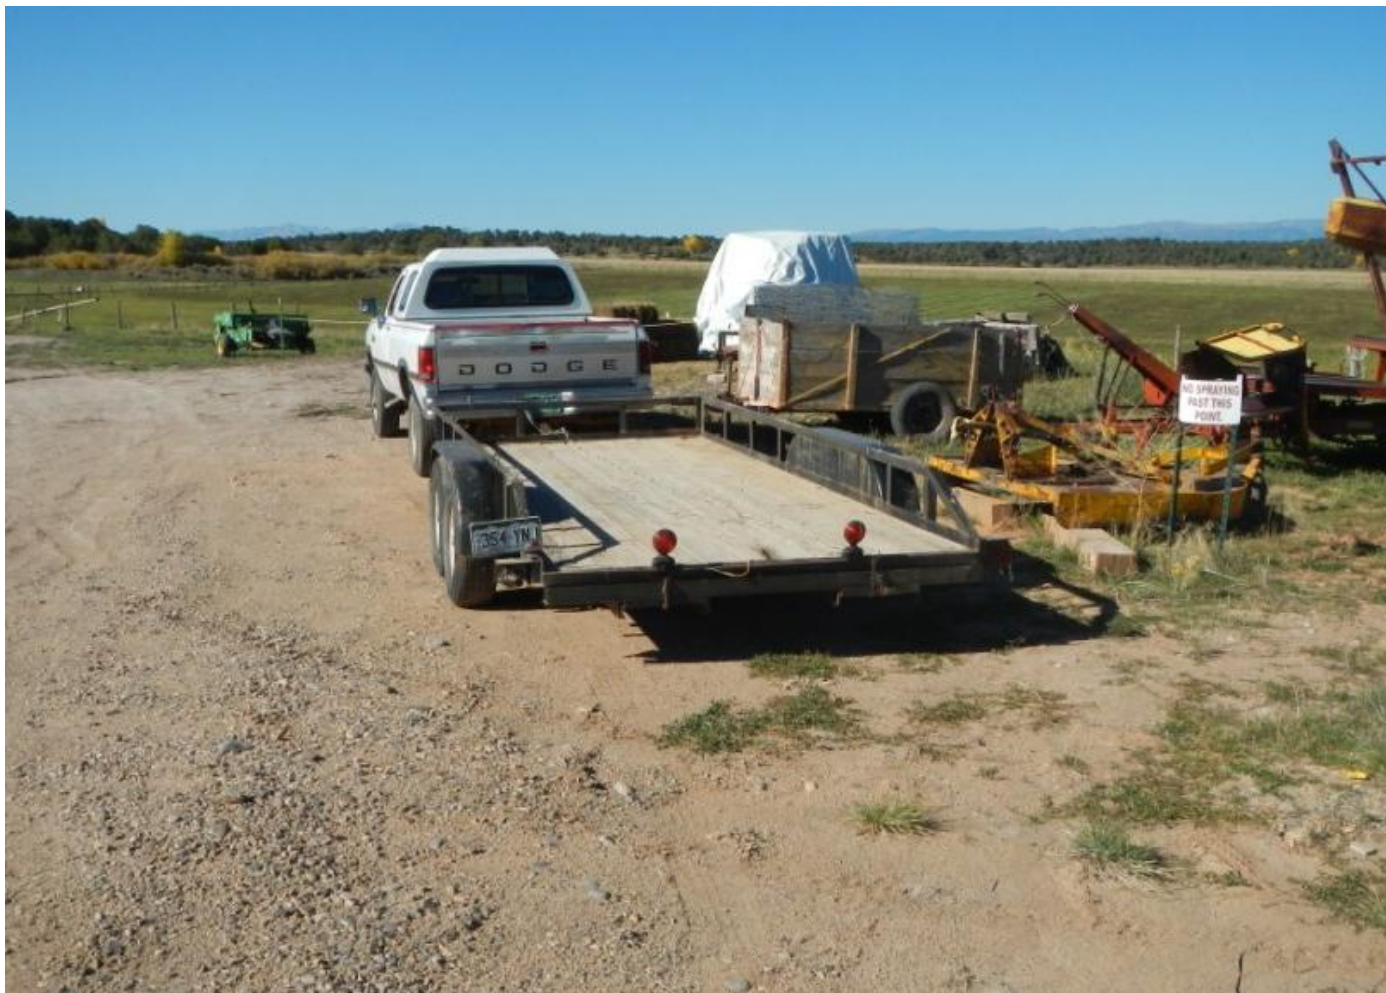
Photo 4. View of what appears to be surface owner equipment within northern portion of project area.

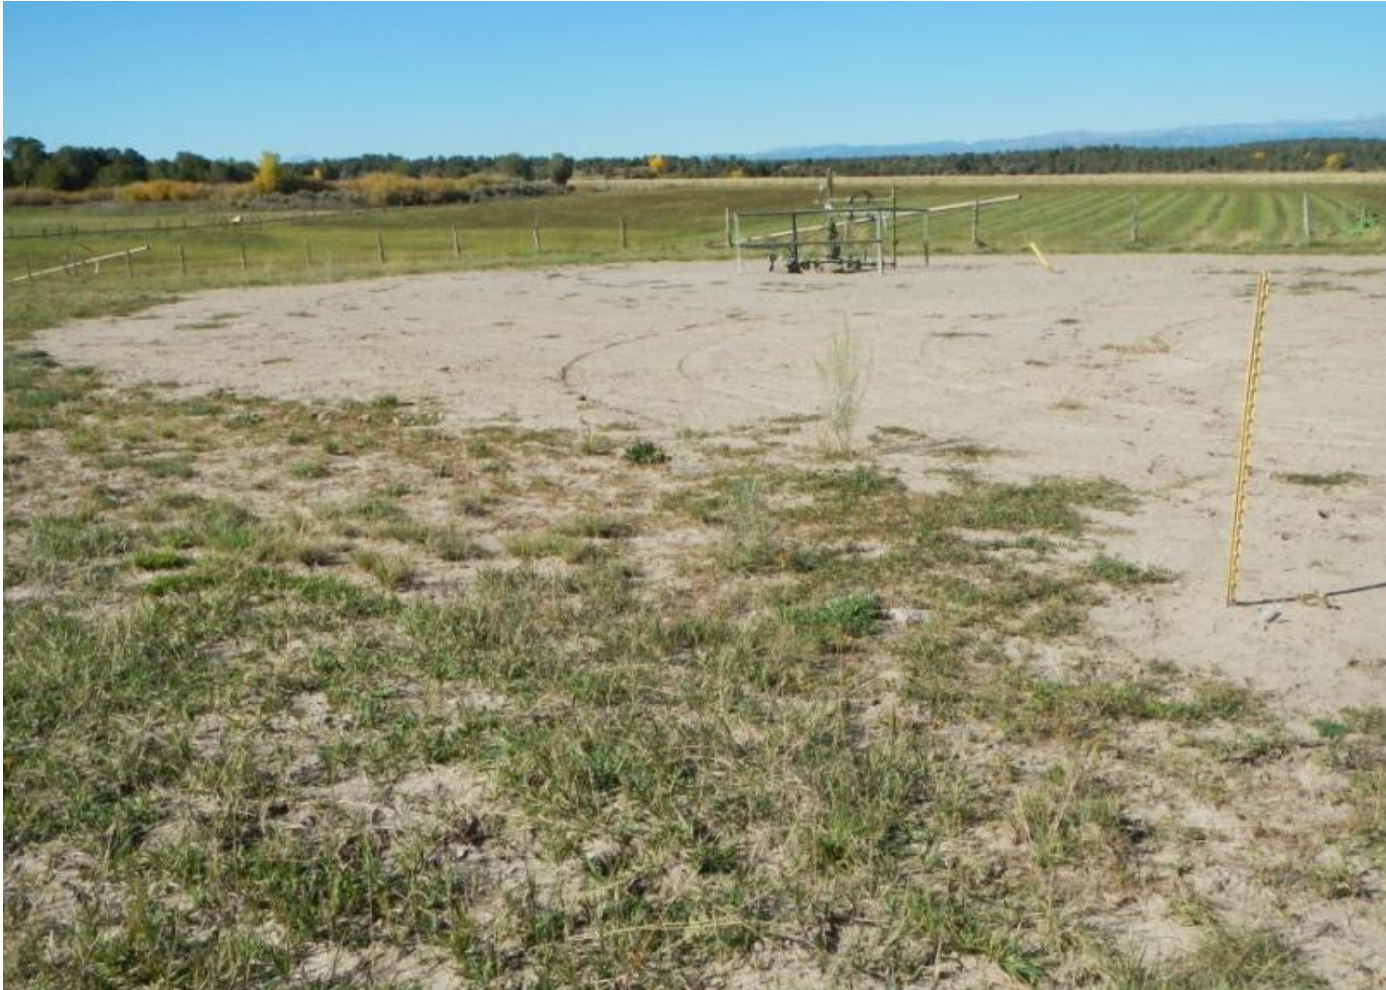
Photo 5. View of well pad from southern edge facing northward toward center.
