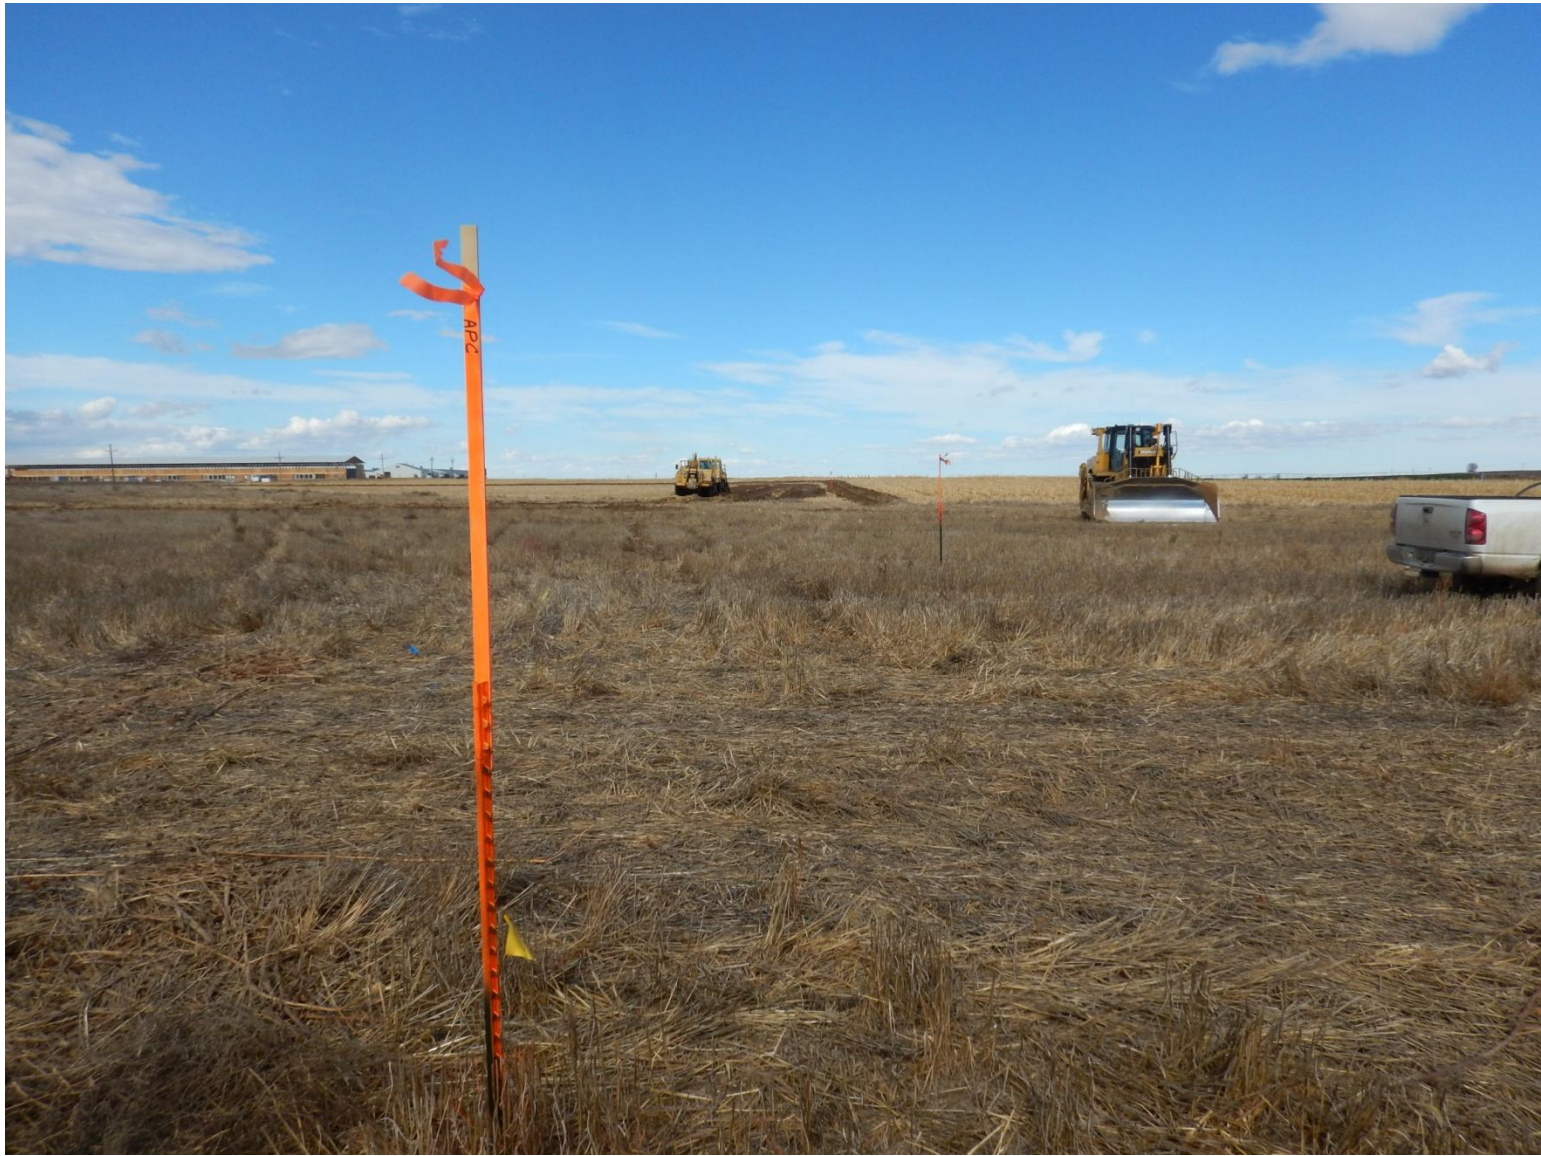
Photo 1: Photo taken from South side of location looking North.

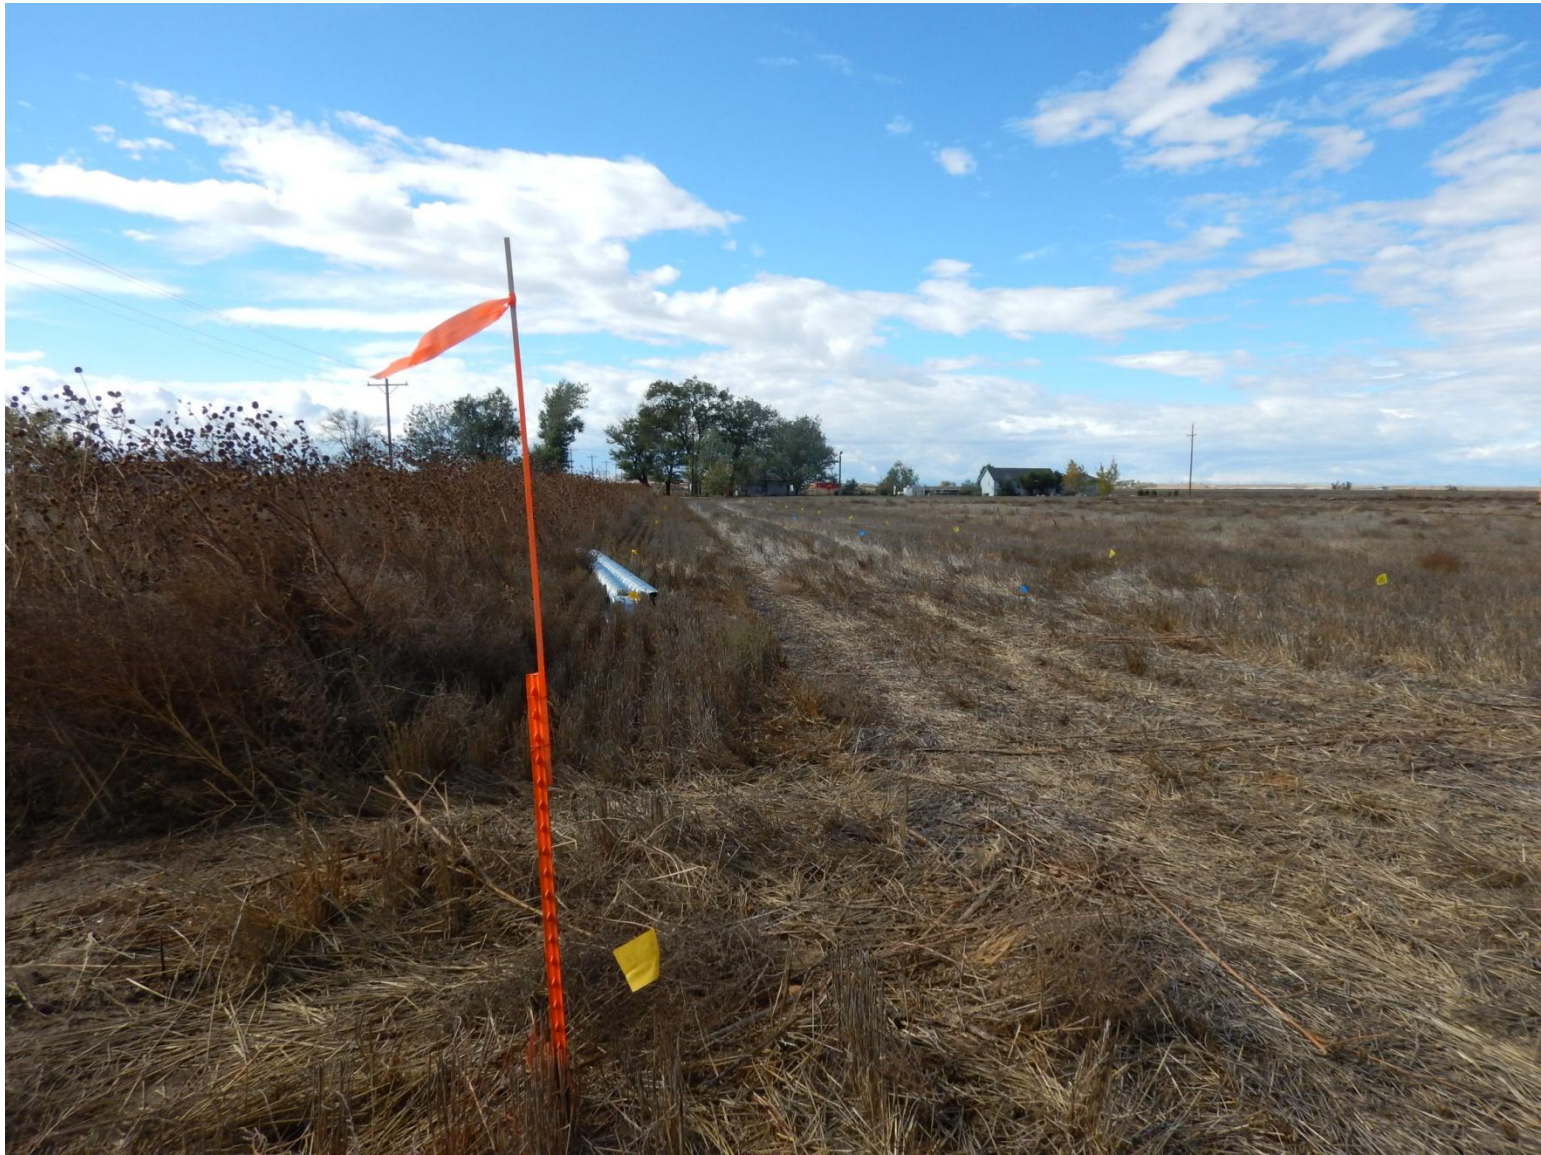
Photo 2: Photo taken from South side of location looking West.

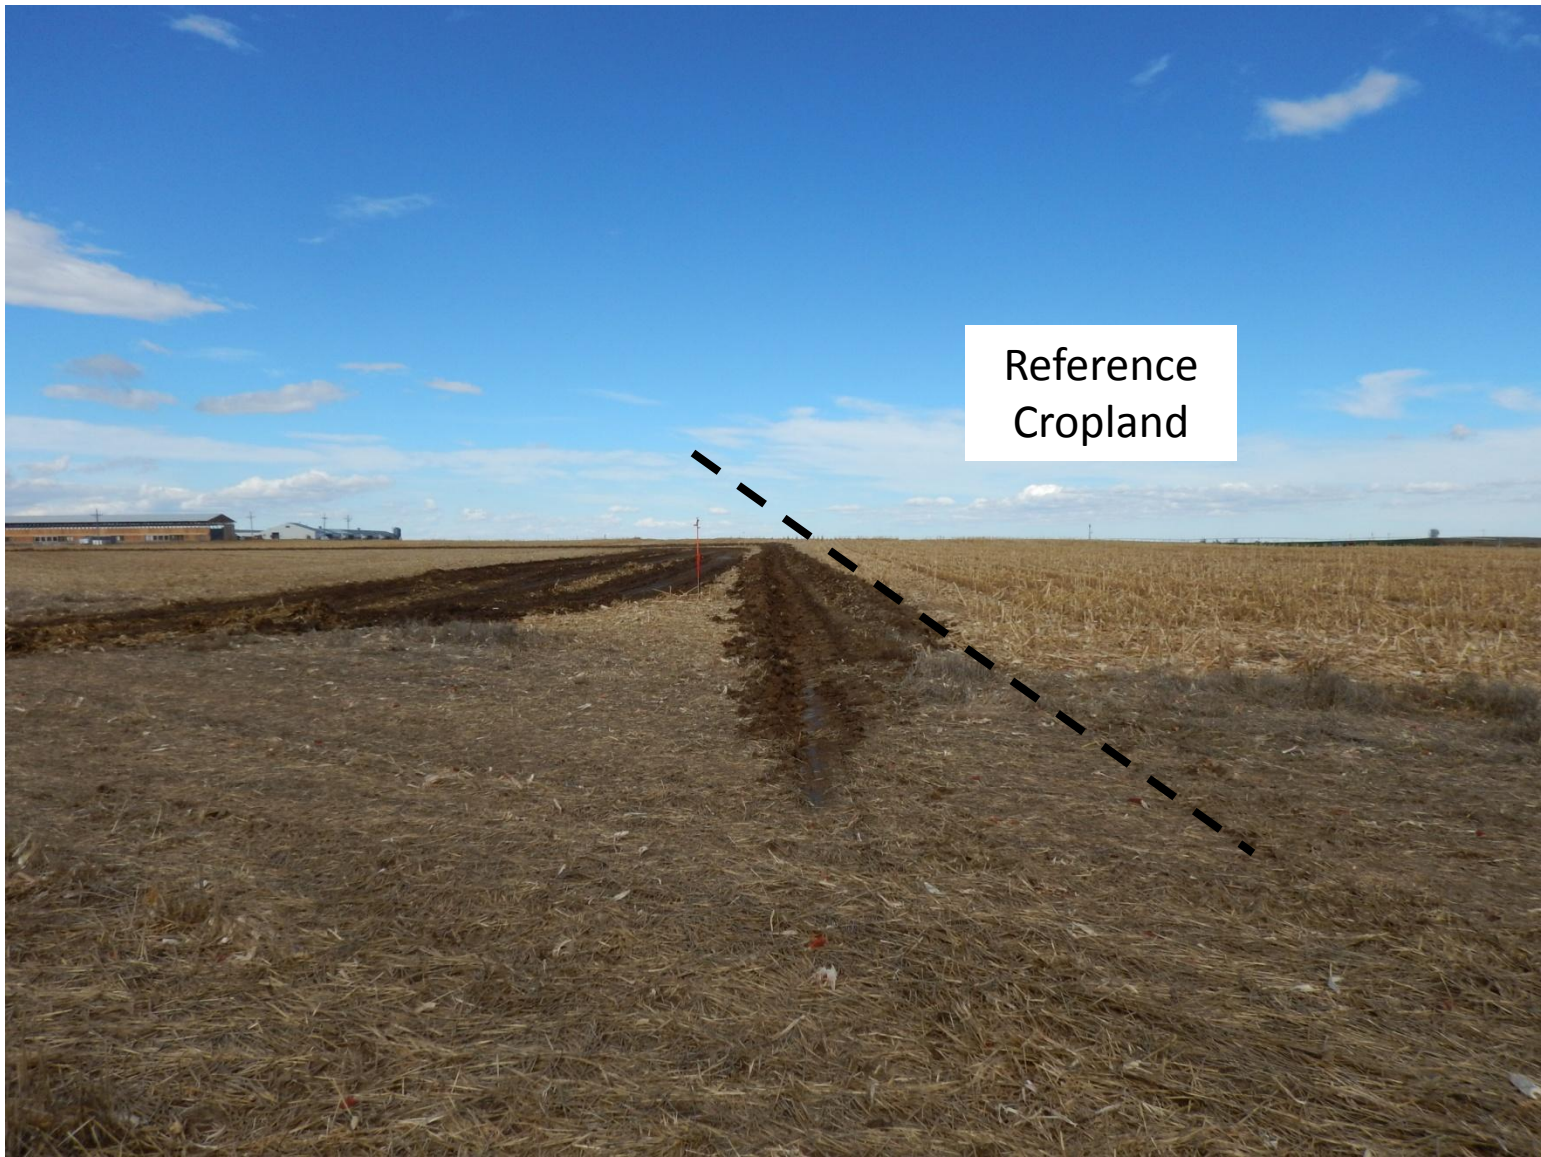
Photo 3: Photo taken from East side of location looking North. Stormwater control ditch center. Reference cropland on right of photo.

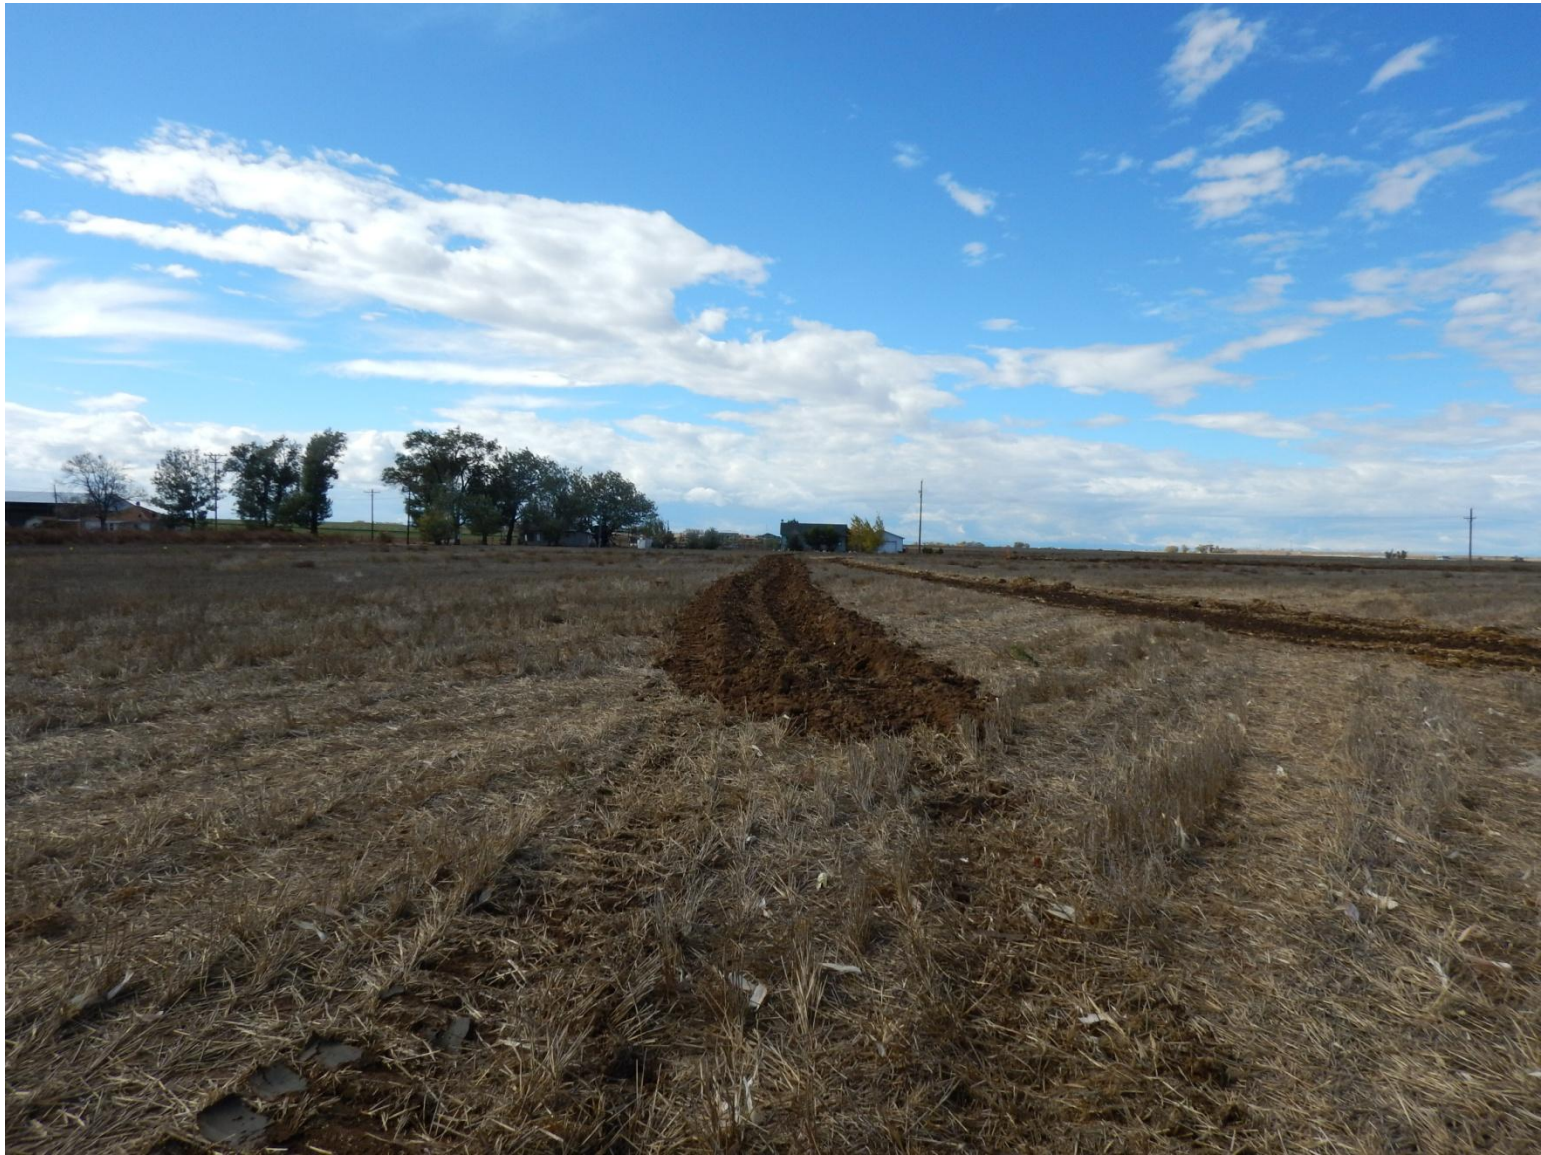
Photo 4: Photo taken from East side of location looking West. Stormwater control ditch center of photo.

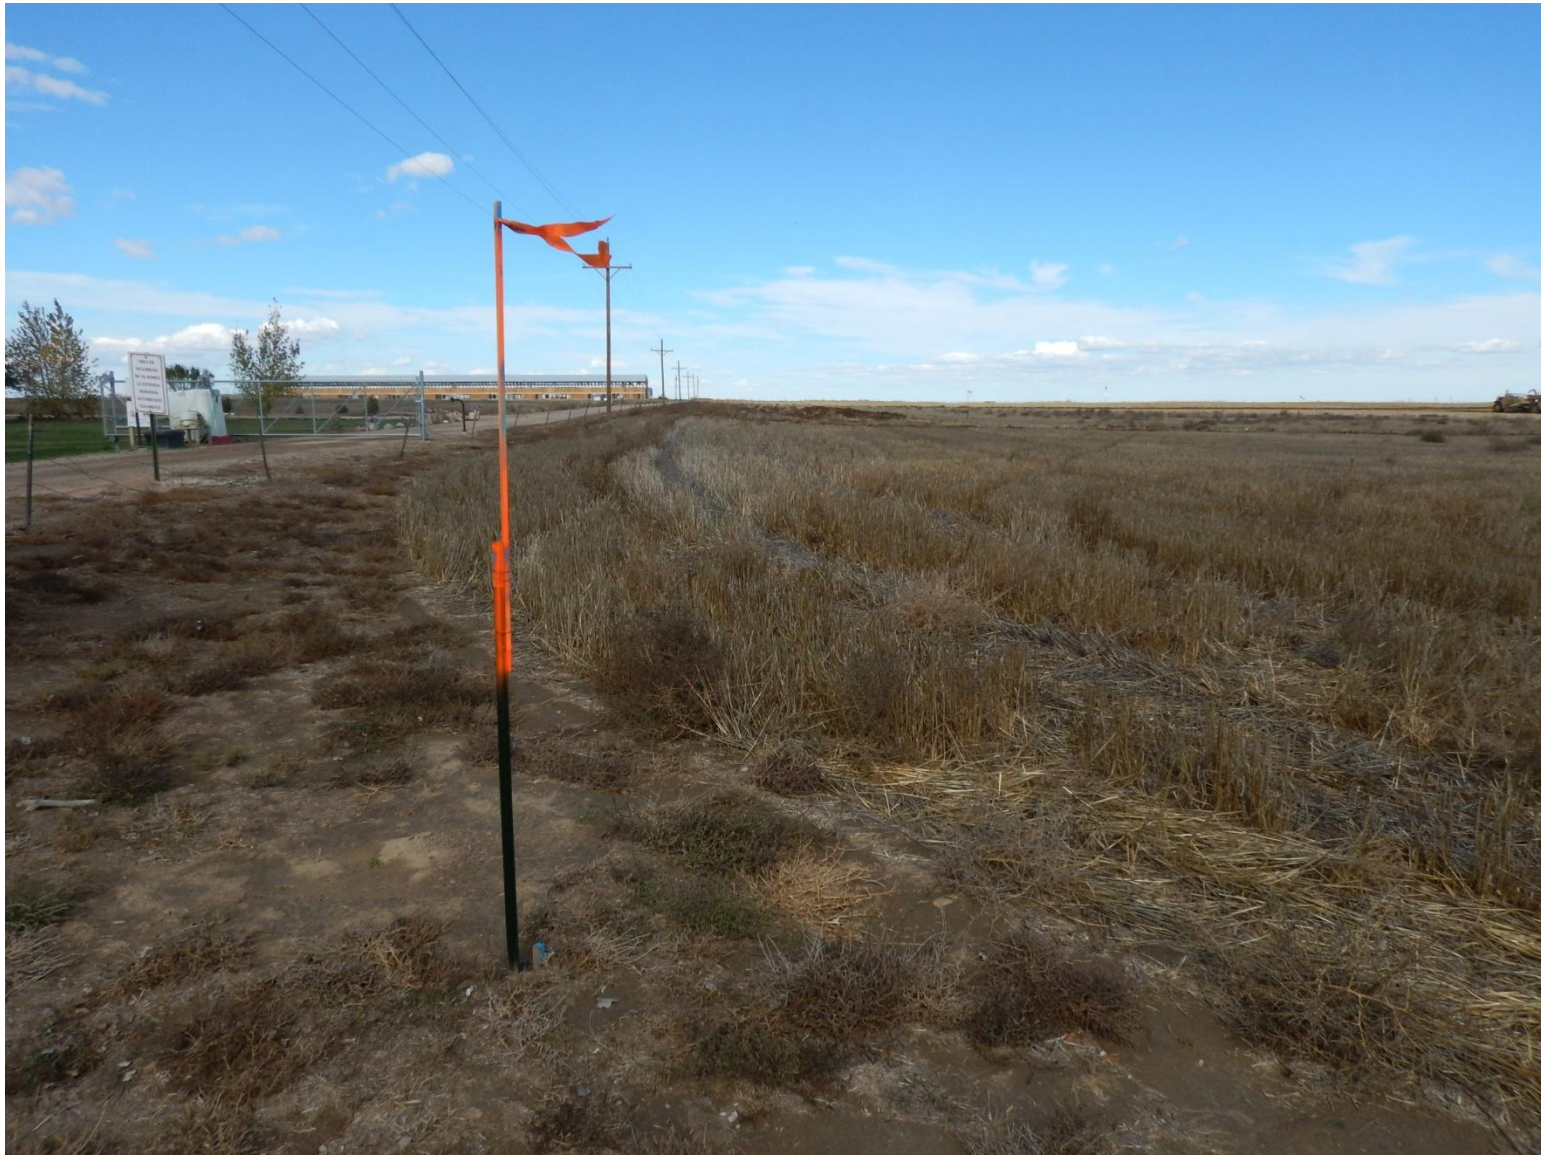
Photo 5: Photo taken from Southwest side of location looking North.

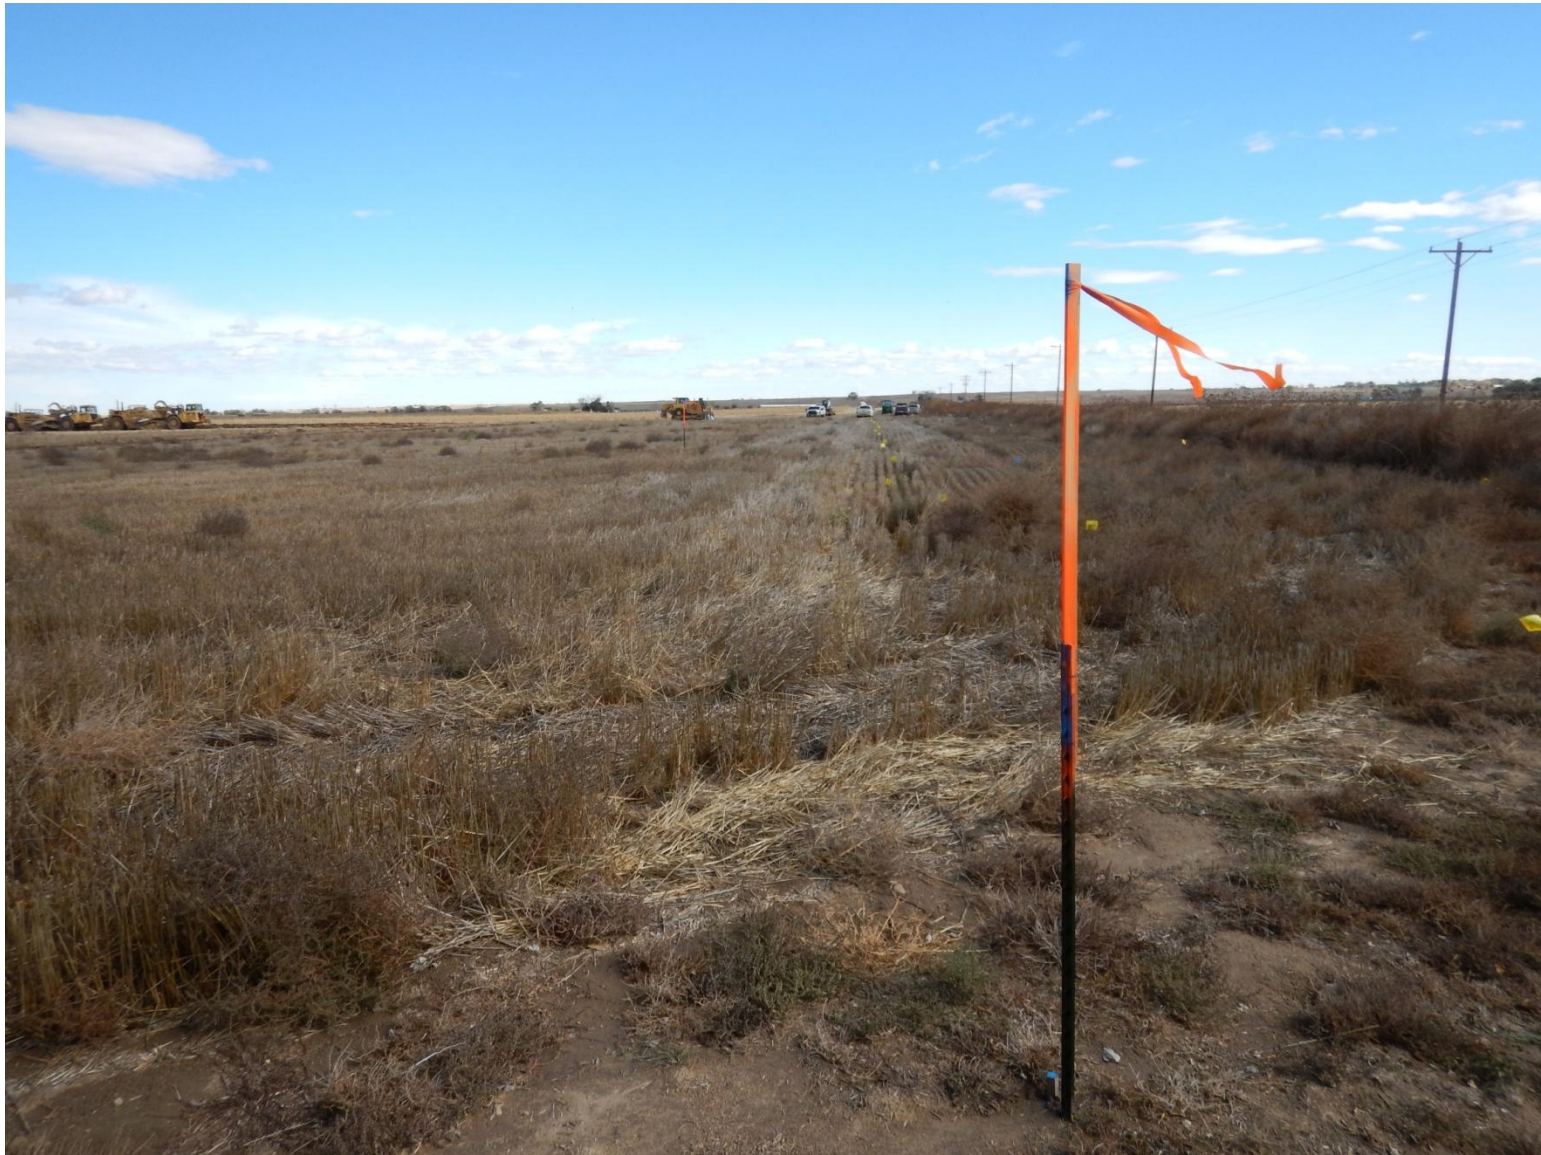
Photo 6: Photo taken from Southwest side of location looking East.

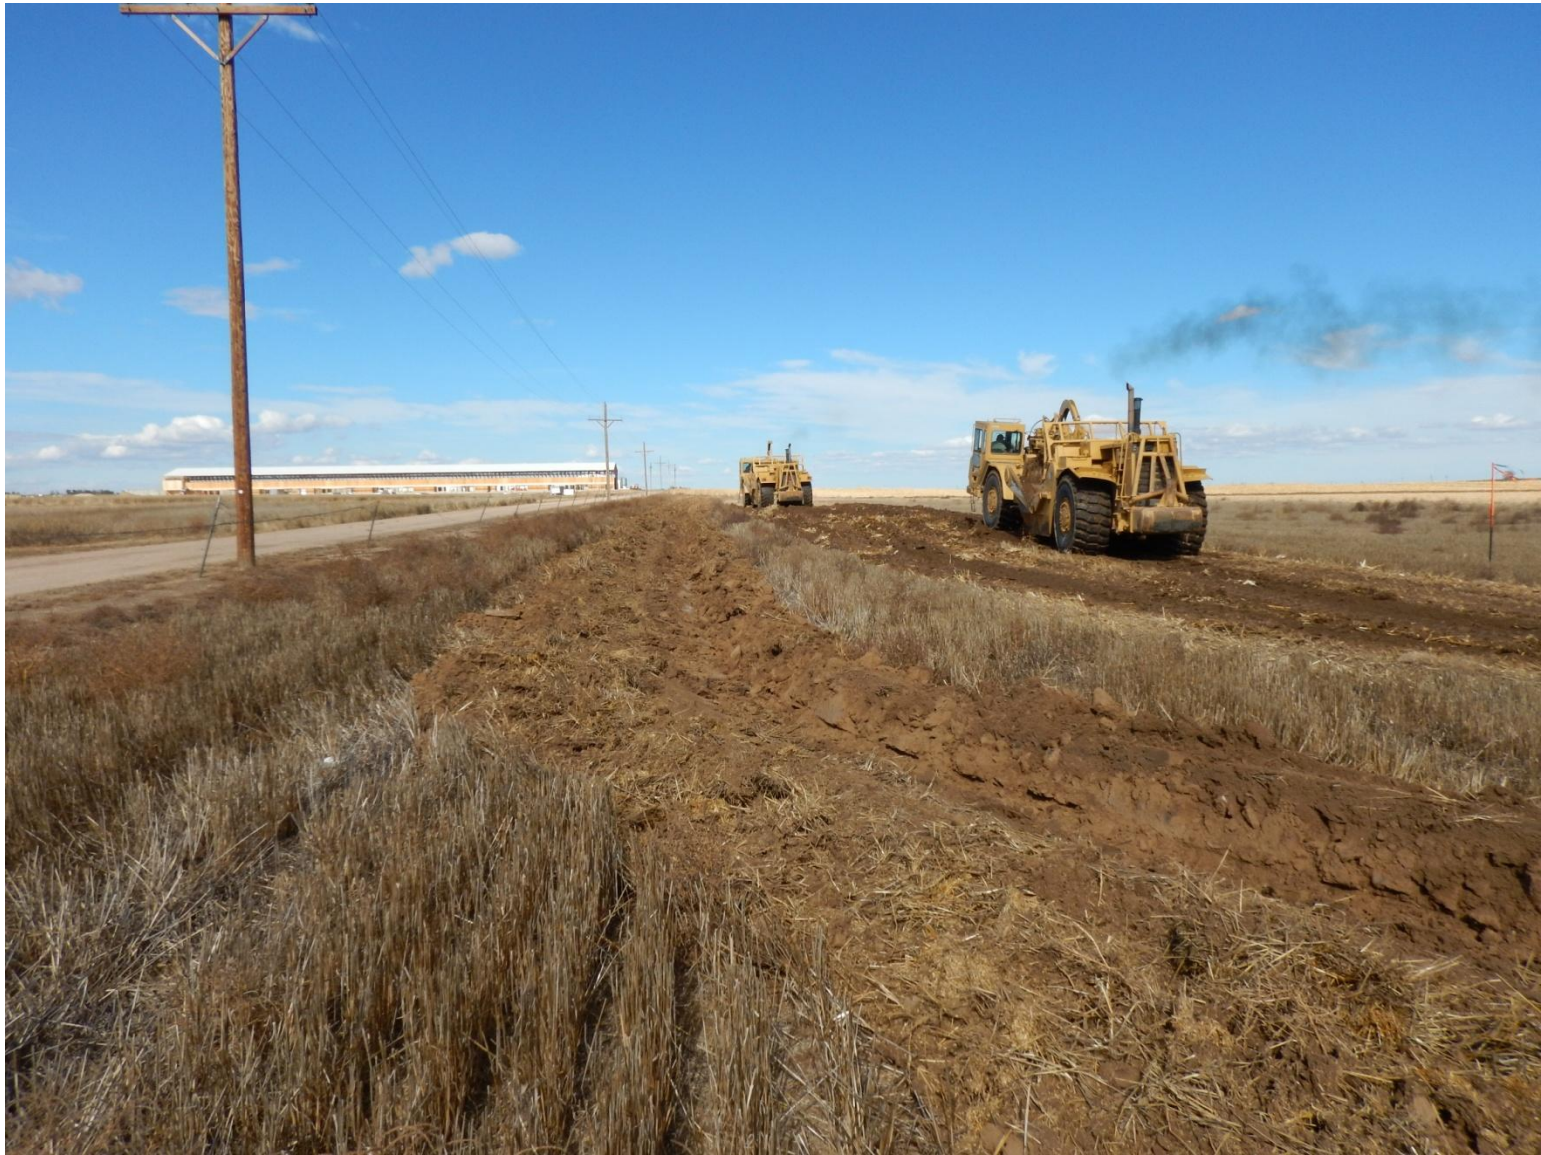
Photo 7: Photo taken from West side of location looking North. Note scrapers depositing topsoil. Stormwater control ditch center.

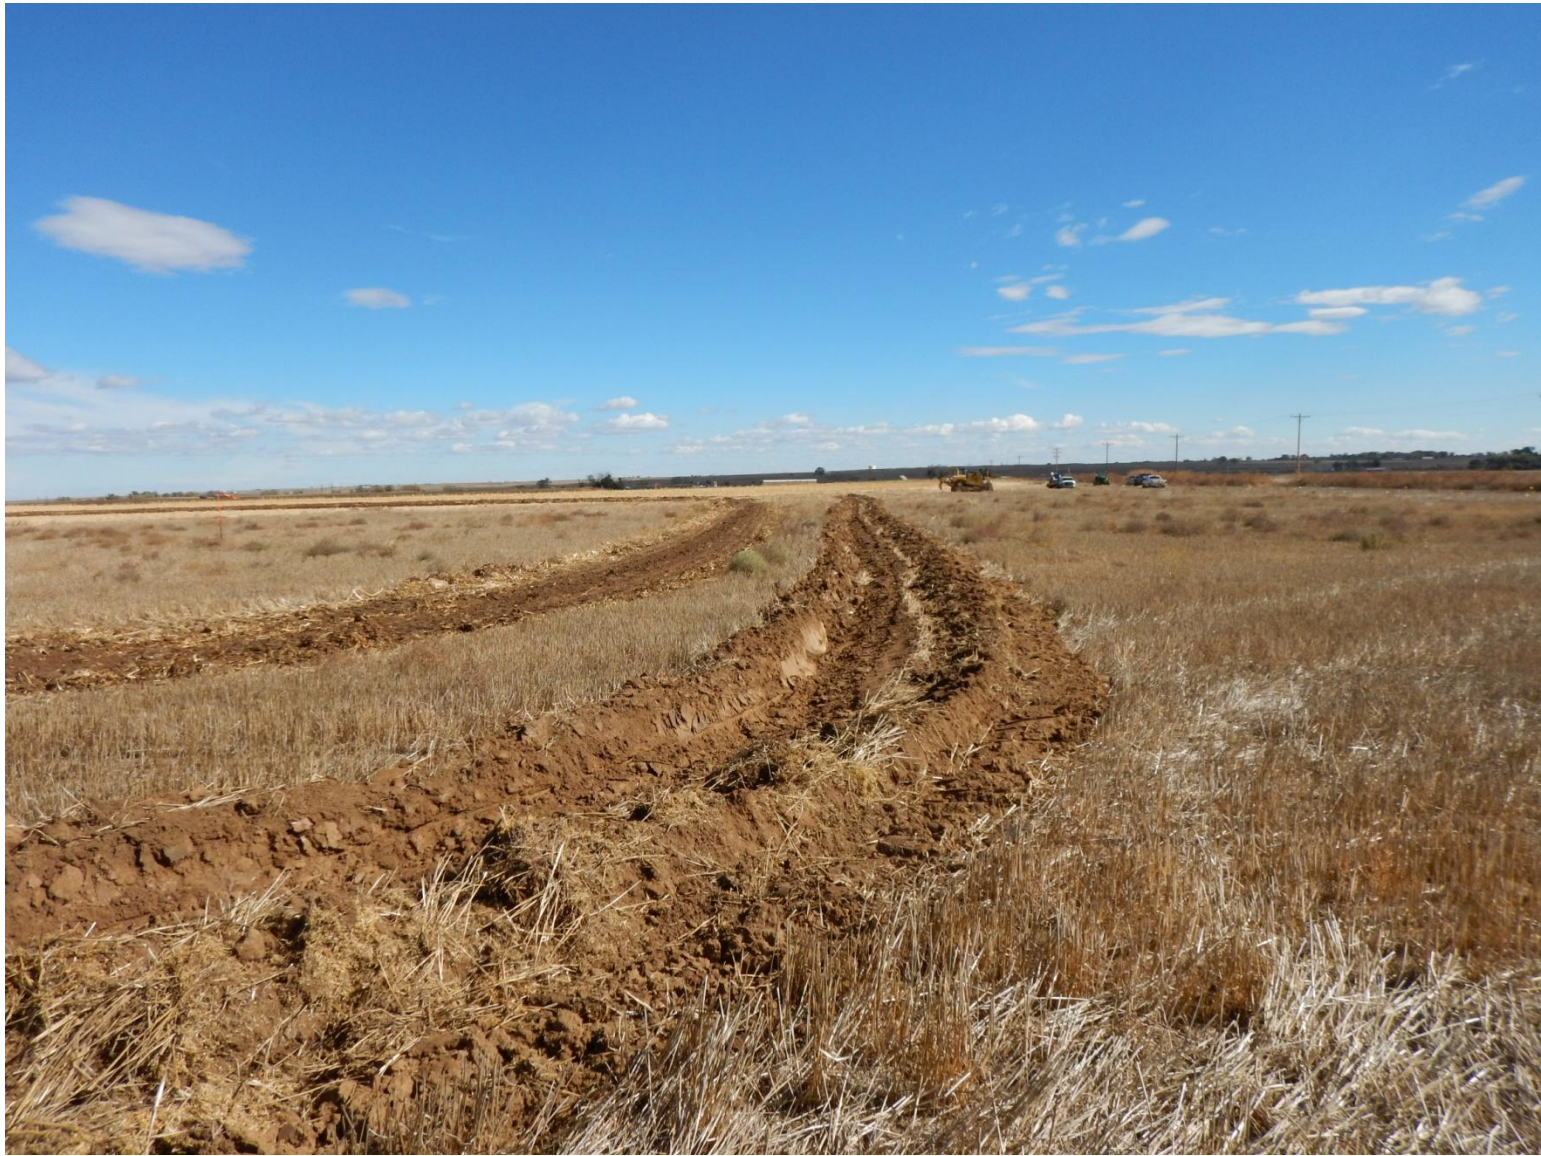
Photo 8: Photo taken from West side of location looking east.

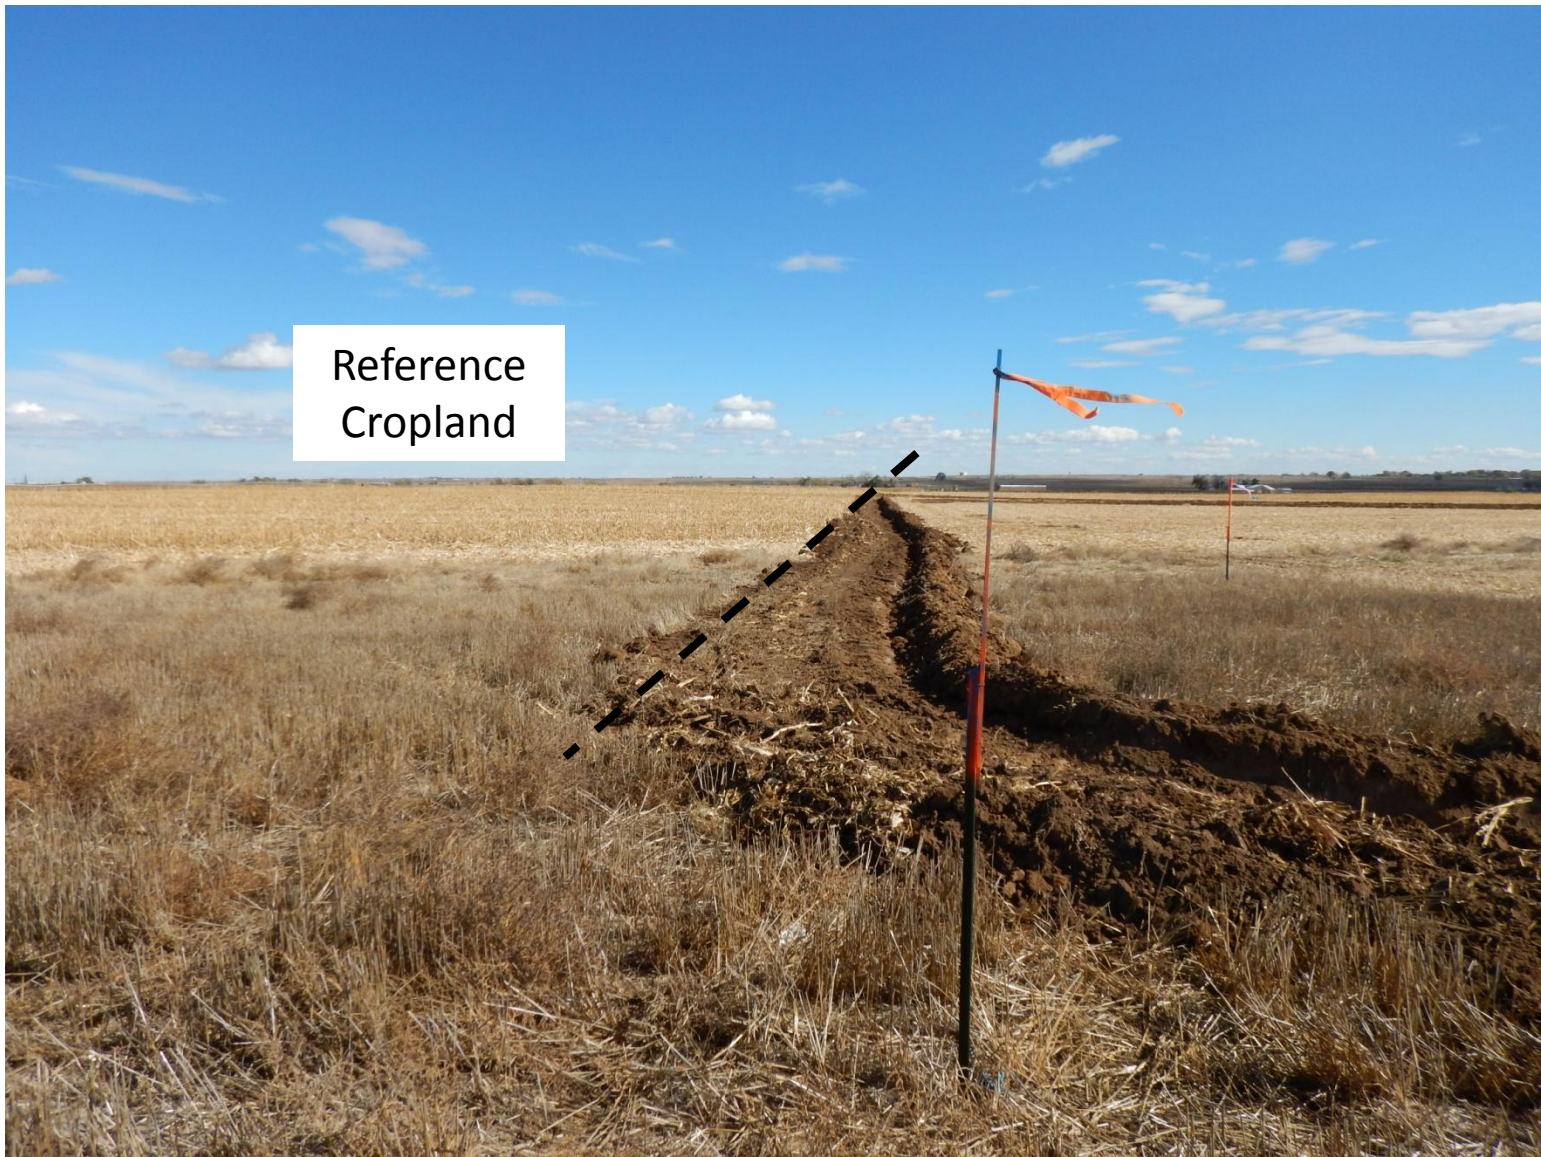
Photo 9: Photo taken from Northwest of location looking East. Stormwater control ditch center, reference cropland on left.

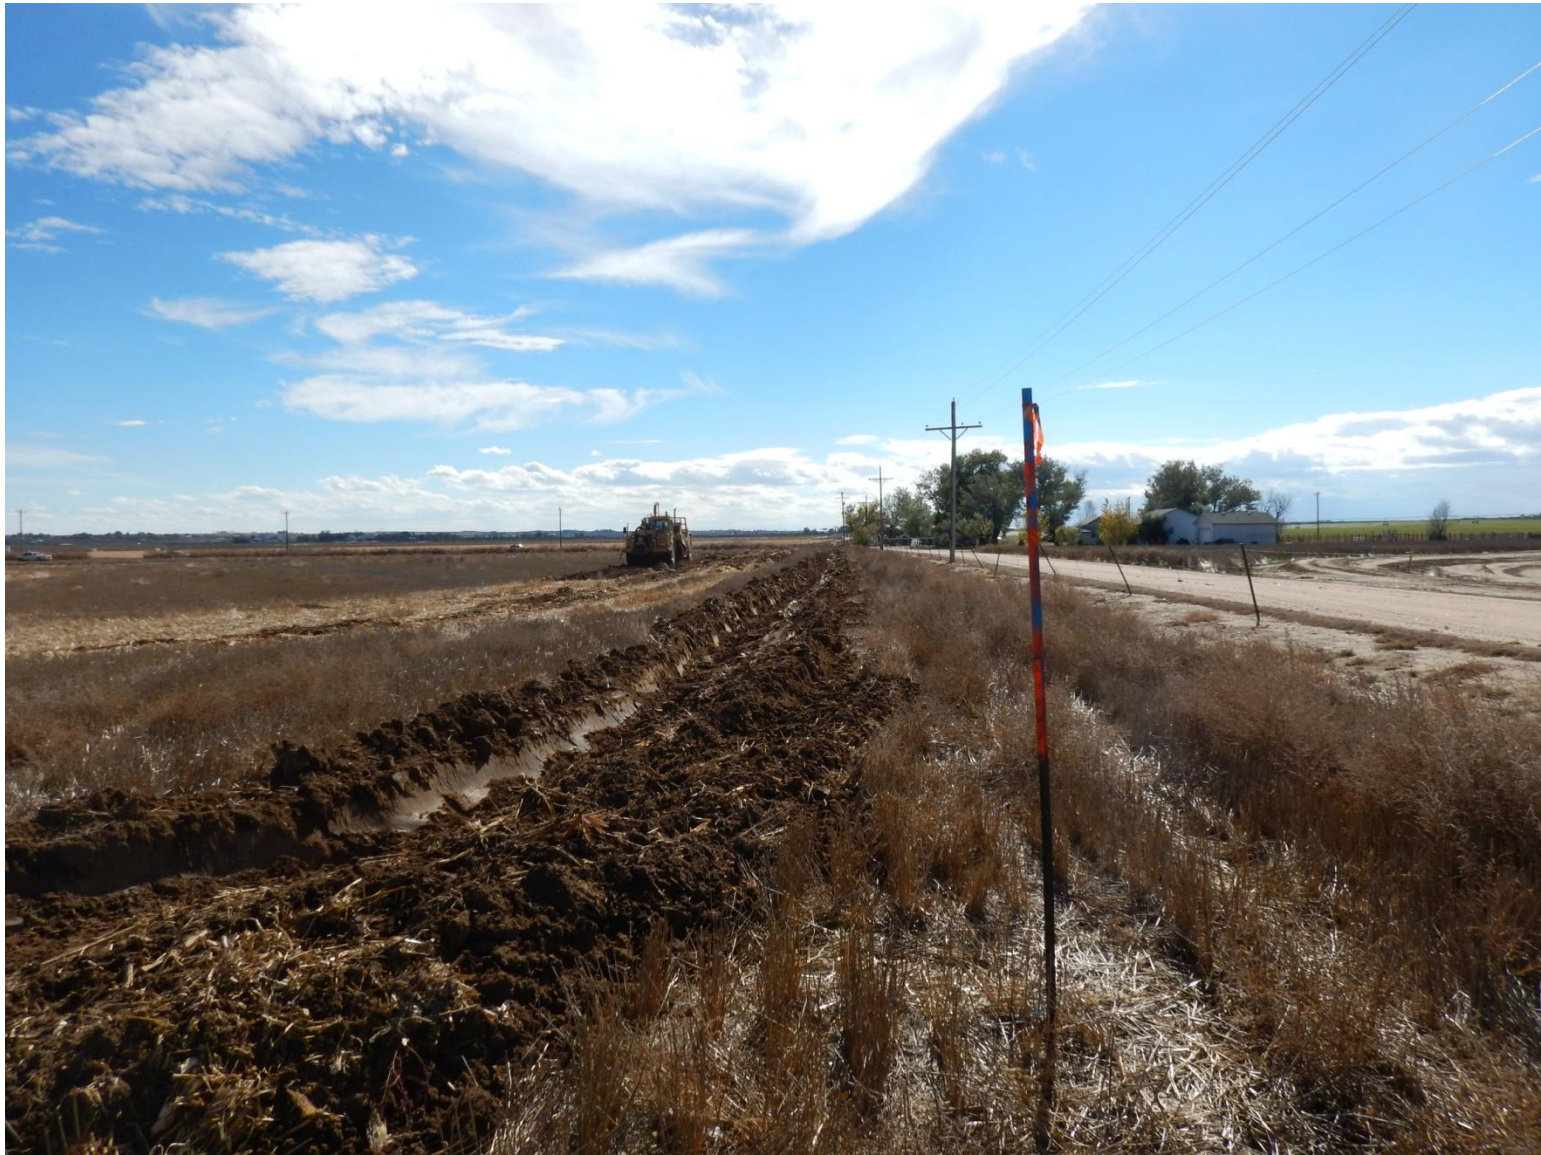
Photo 10: Photo taken from Northwest side of location looking South.

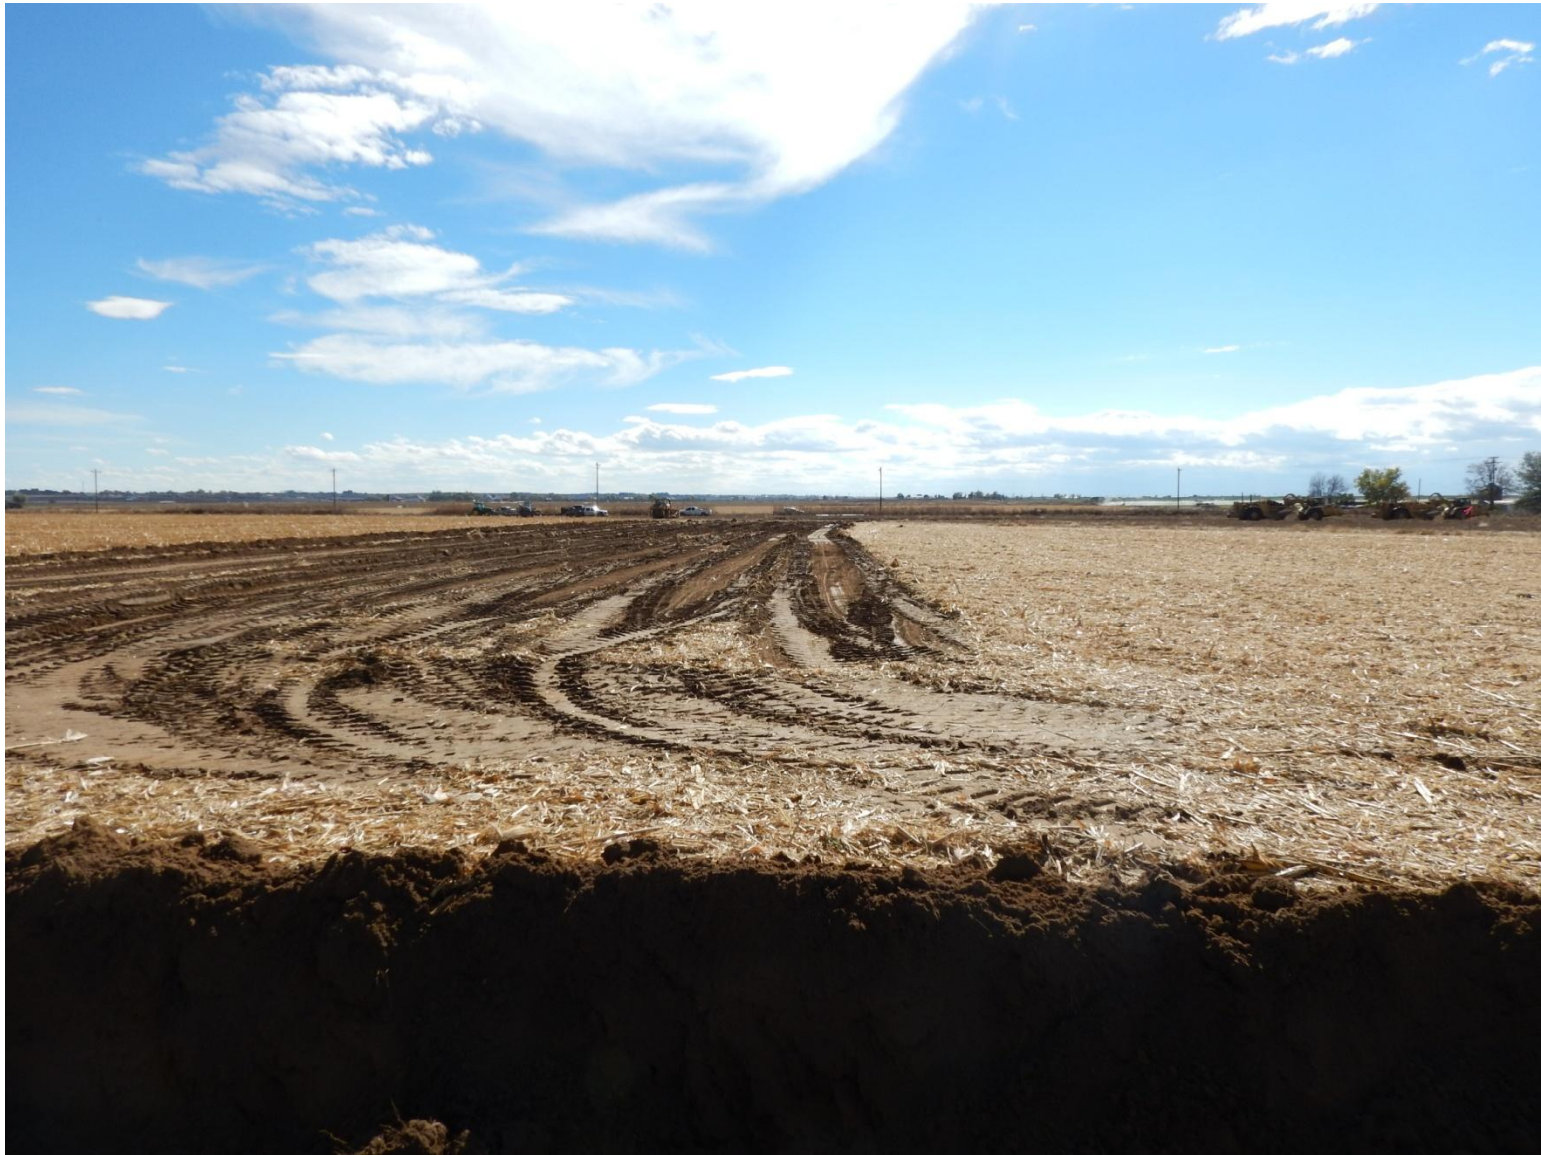
Photo 11: Photo taken from North side of location looking South. Topsoil removal in process.

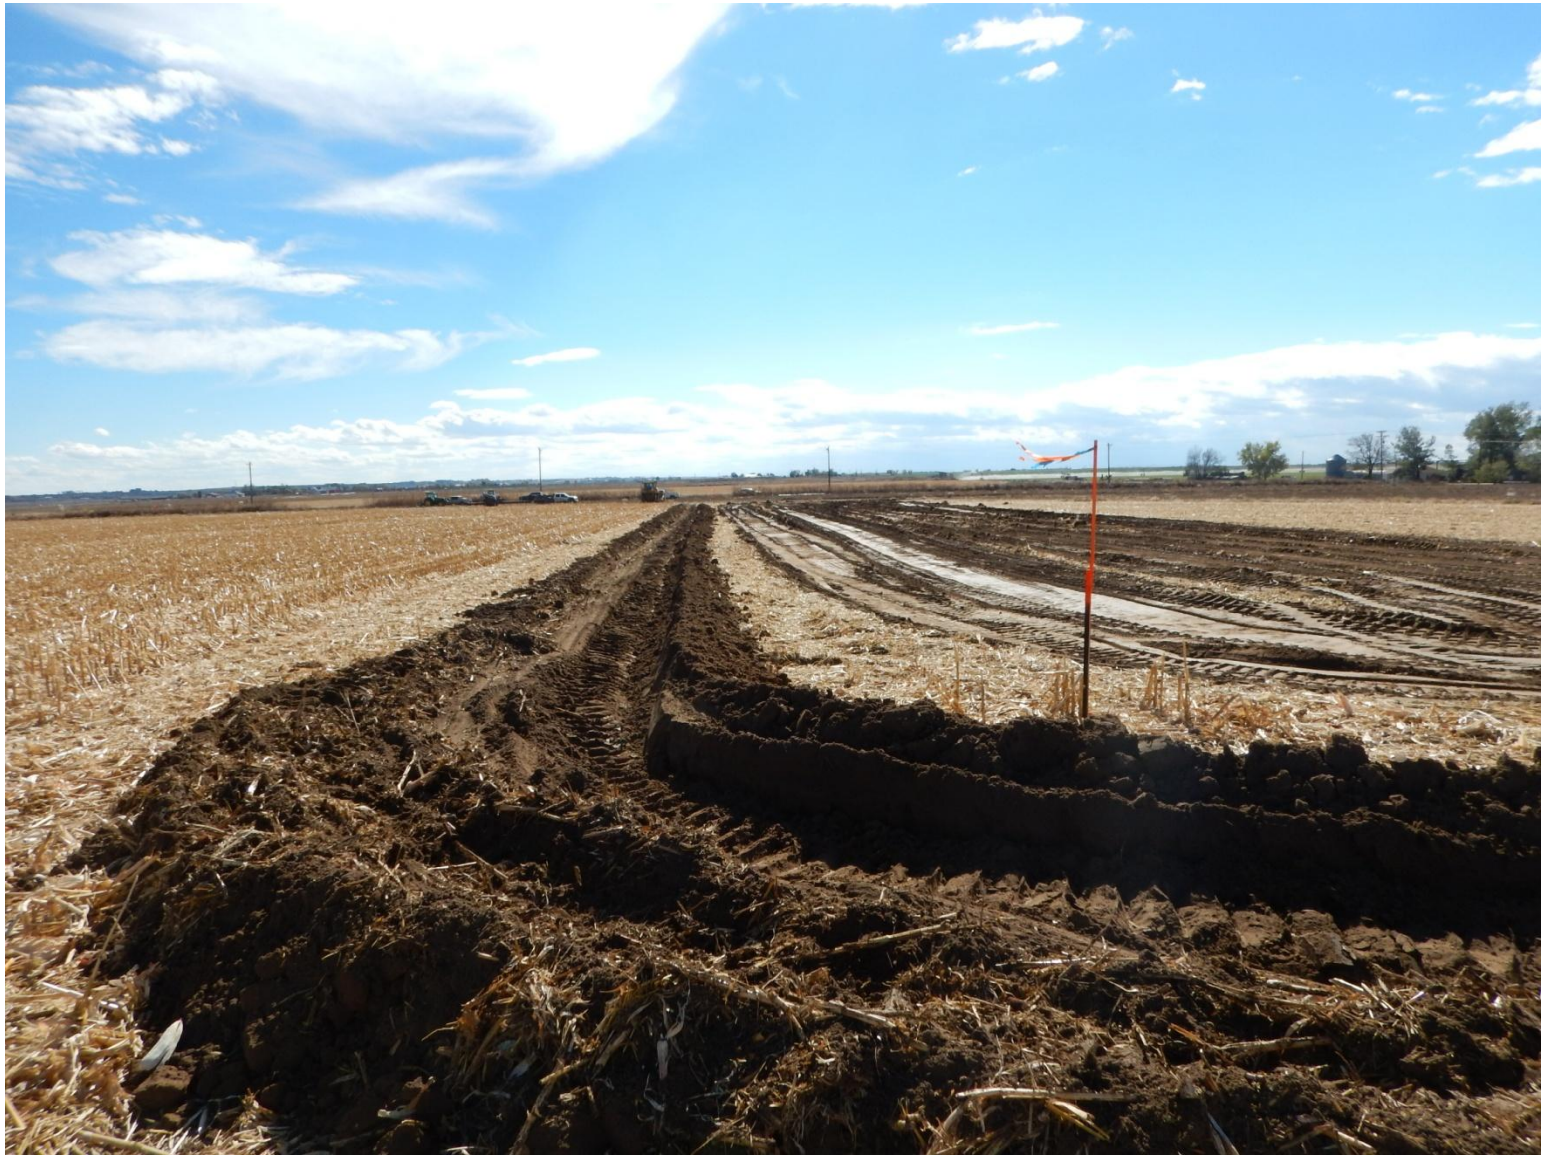
Photo 12: Photo taken from Northeast side of location looking South. Stormwater control ditch center.
