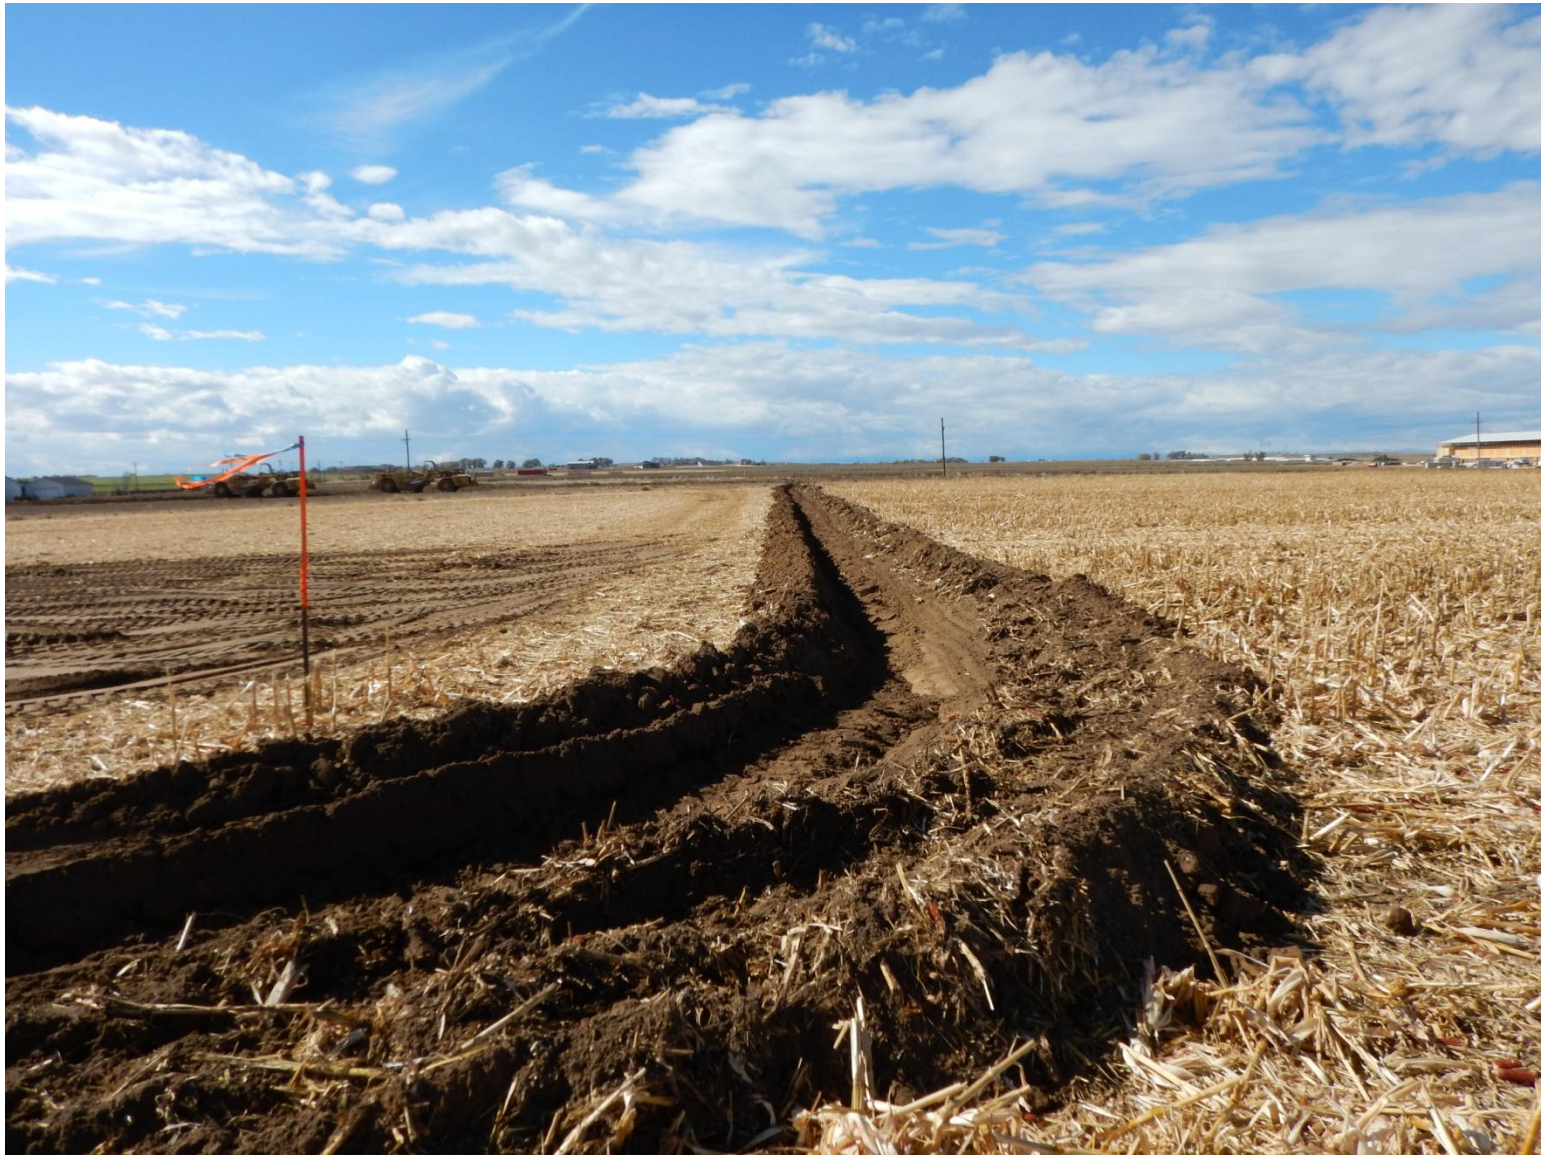
Photo 13: Photo taken from Northeast side of location looking West.
Stormwater control ditch center.

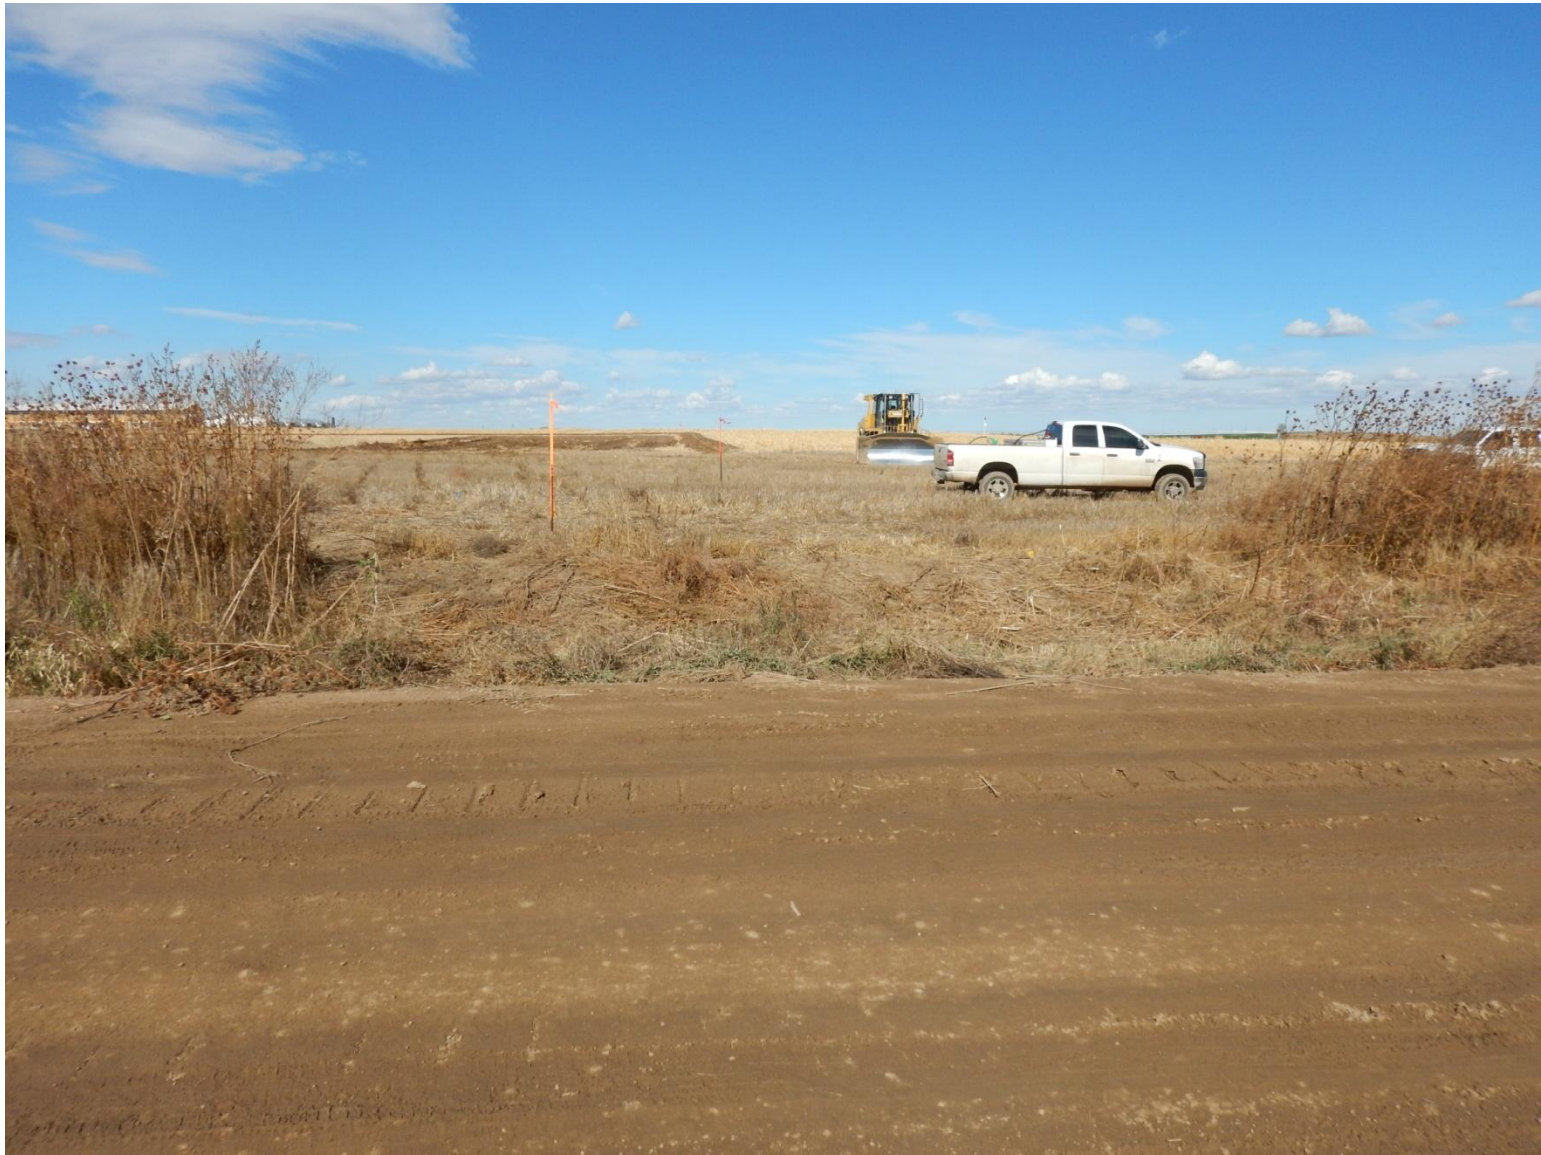
Photo 14: Photo taken from County Road 16 looking North to location. One of two sites vehicle/equipment have been using to access location.

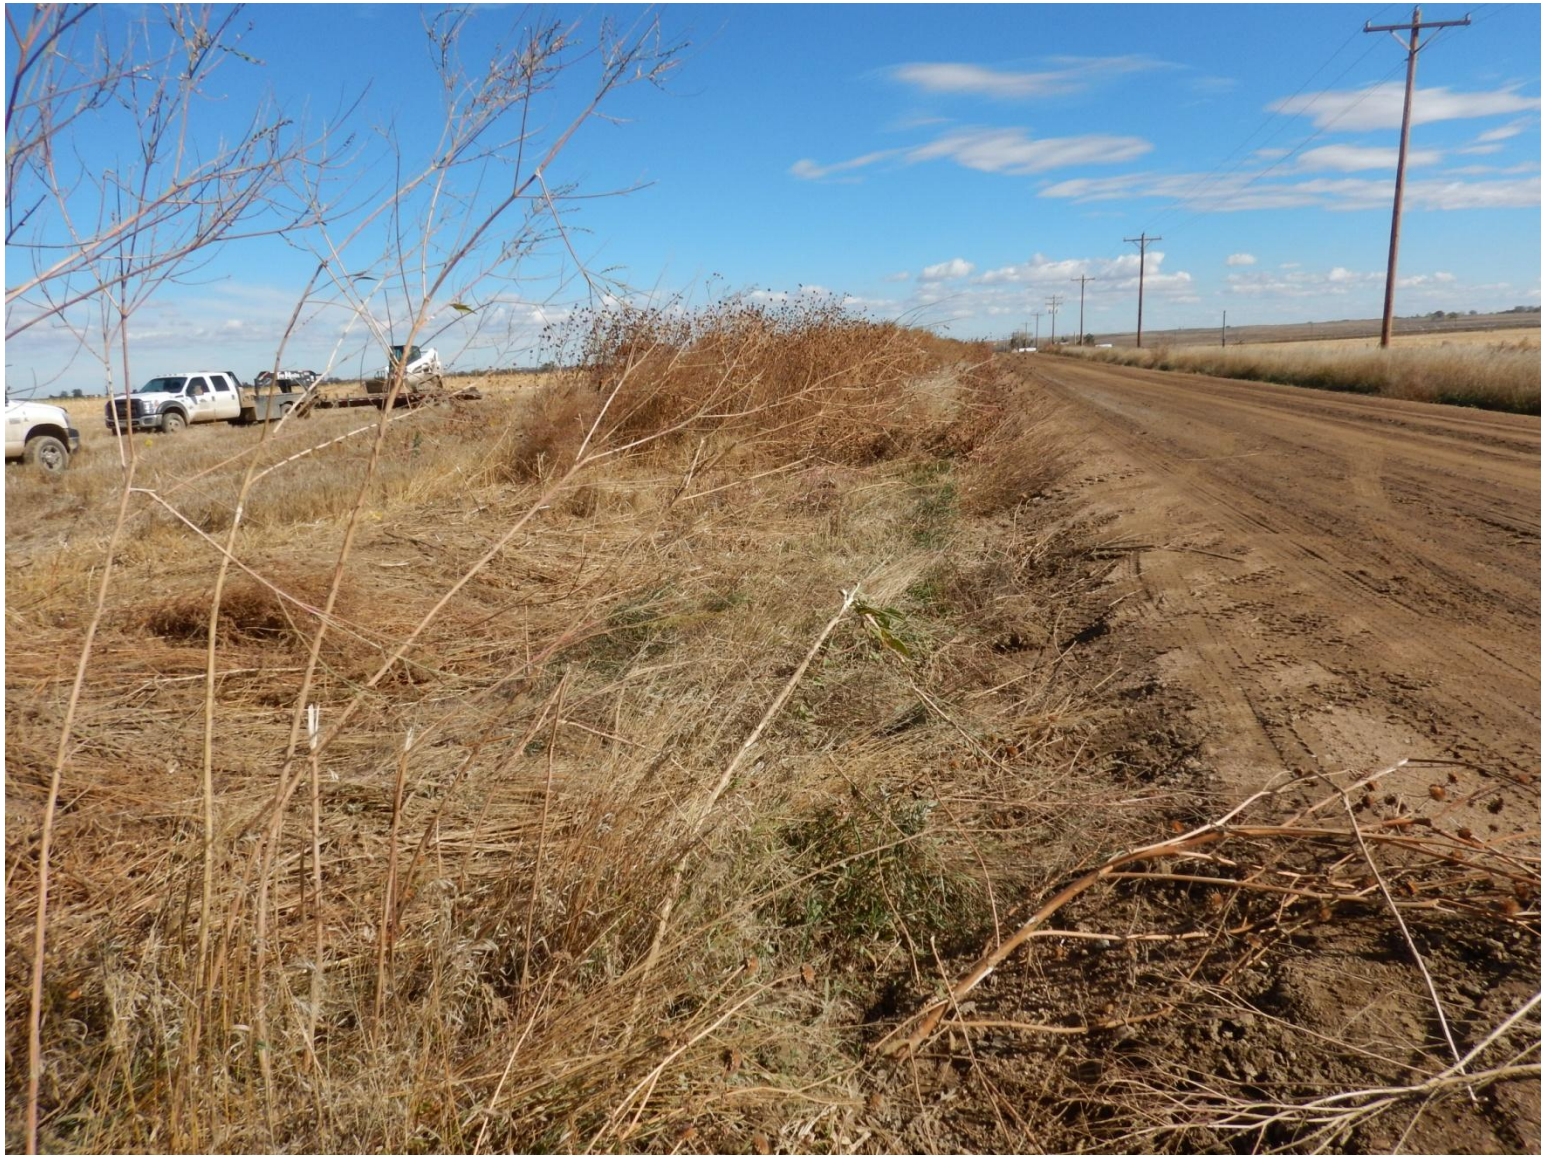
Photo 15: Photo taken from County Road 16 looking East. One of two sites vehicle/equipment have been using to access location.

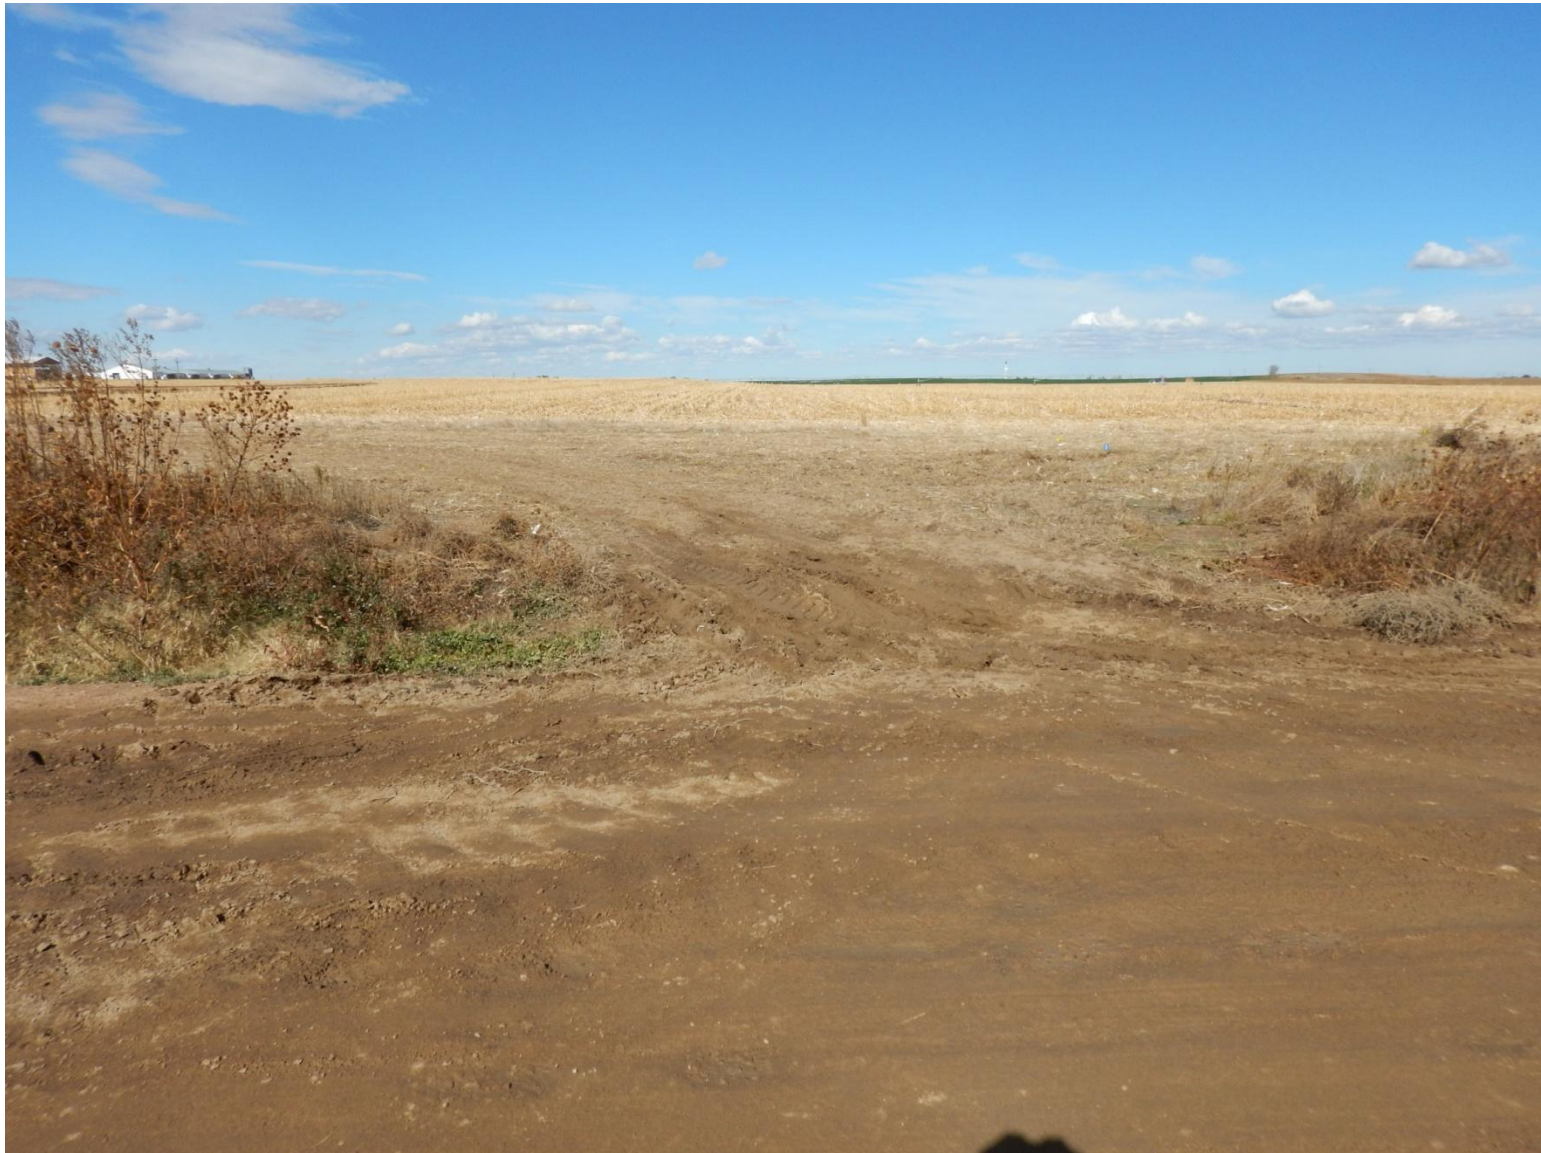
Photo 16: Photo taken from County Road 16 looking North at Eastern portion of location. Second of two sites vehicle/equipment have been using to access location.

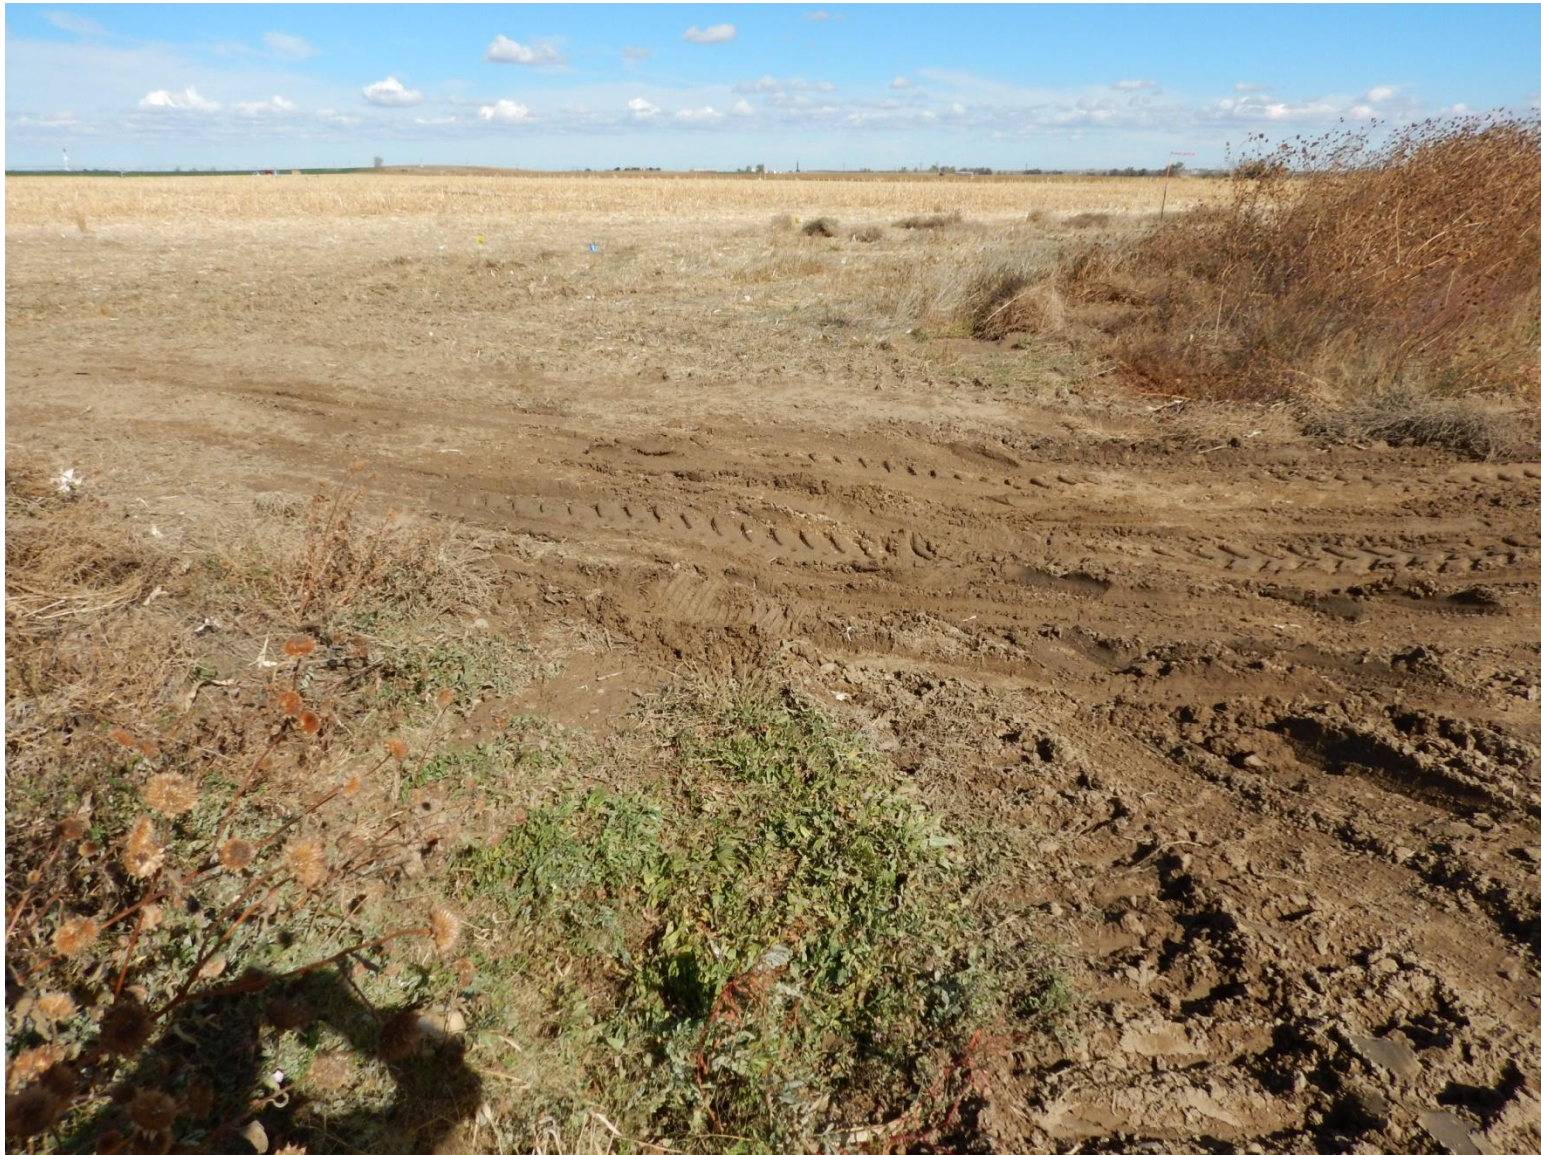
Photo 17: Photo taken from County Road 16 looking Northeast. Second of two sites vehicle/equipment have been using to access location..
