photo 1: Well sign, Pumpernickel 14-29

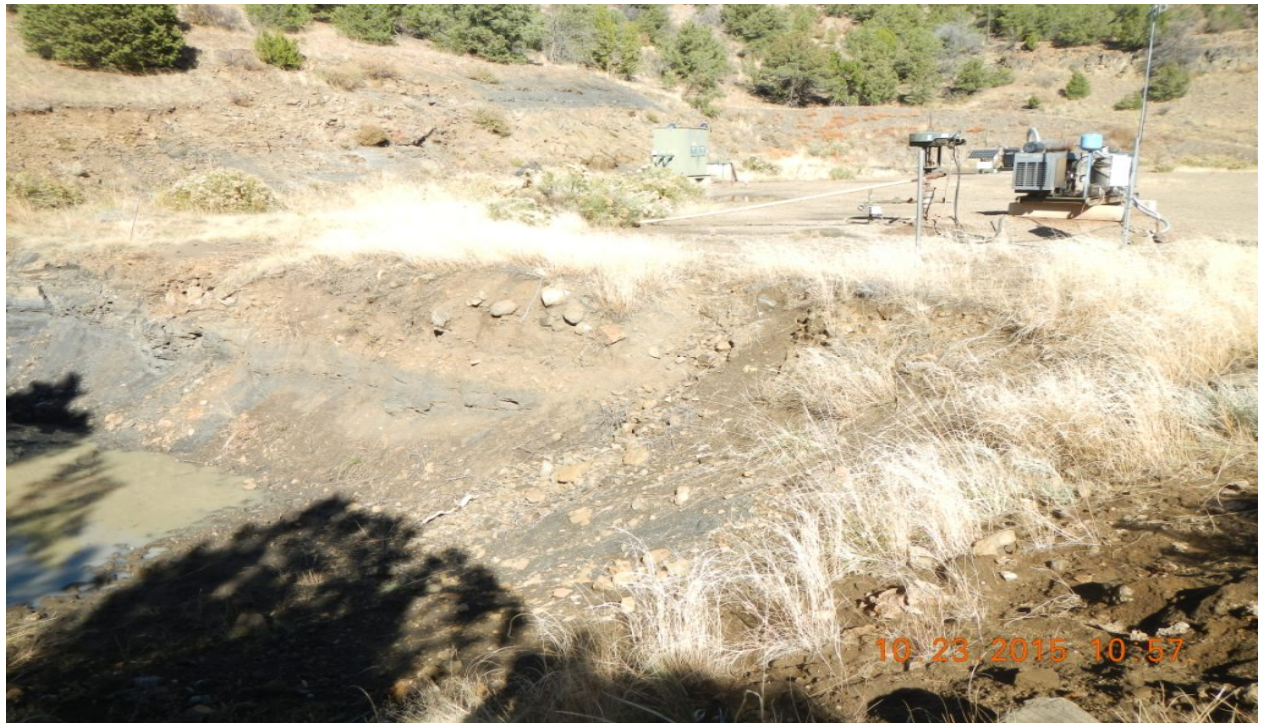
photo 2: Southwest corner facing northeast.

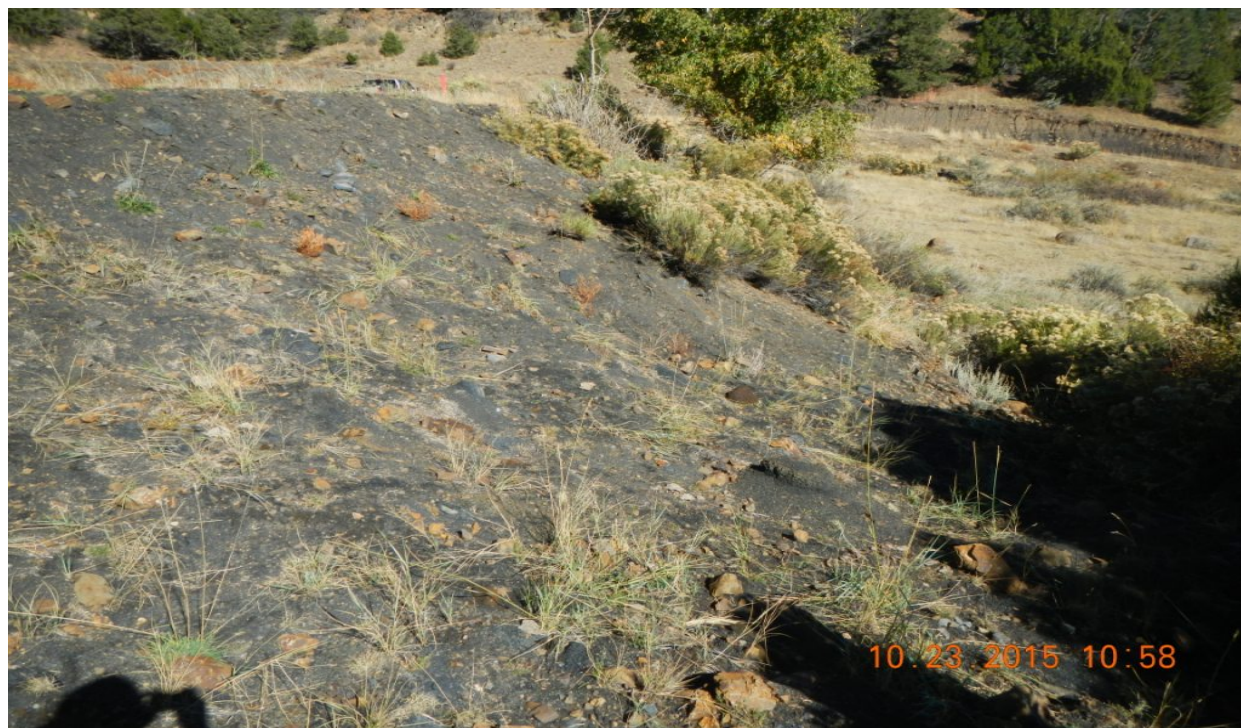
photo 3: Southwest side of pad has minimal vegetation cover.

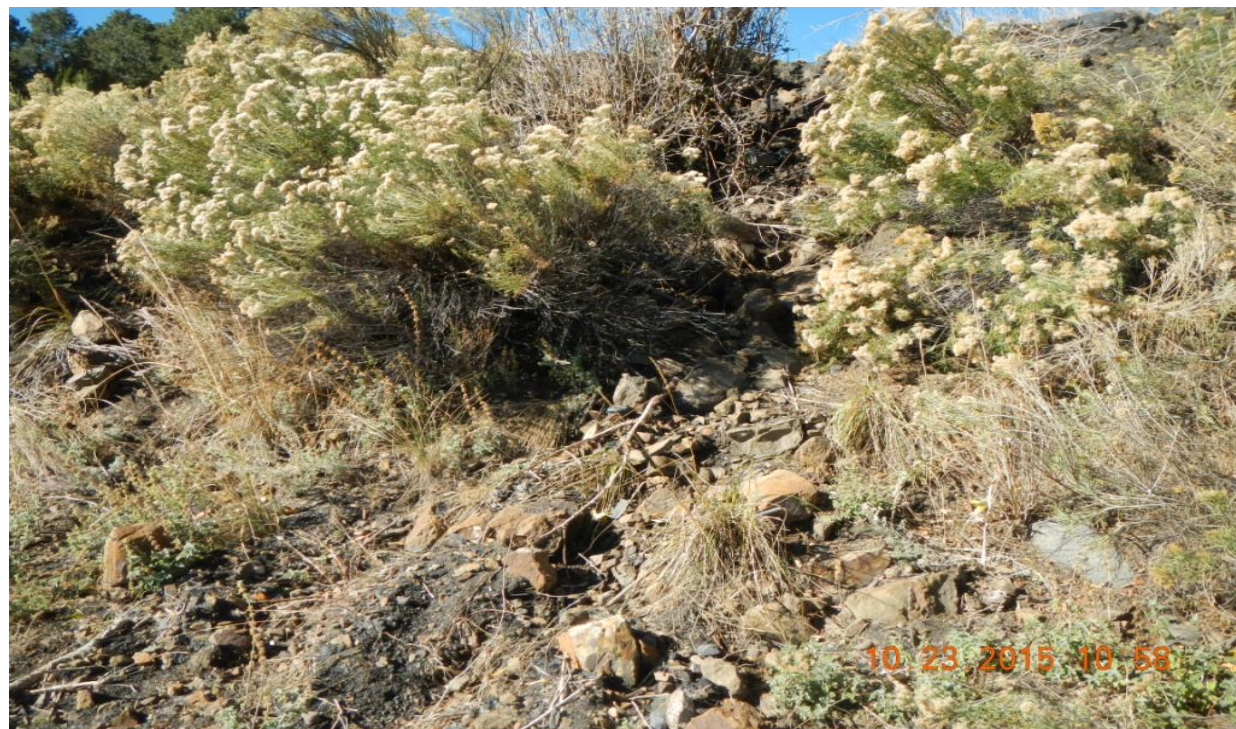
photo 4: An erosional channel has developed off the east side of the pad.

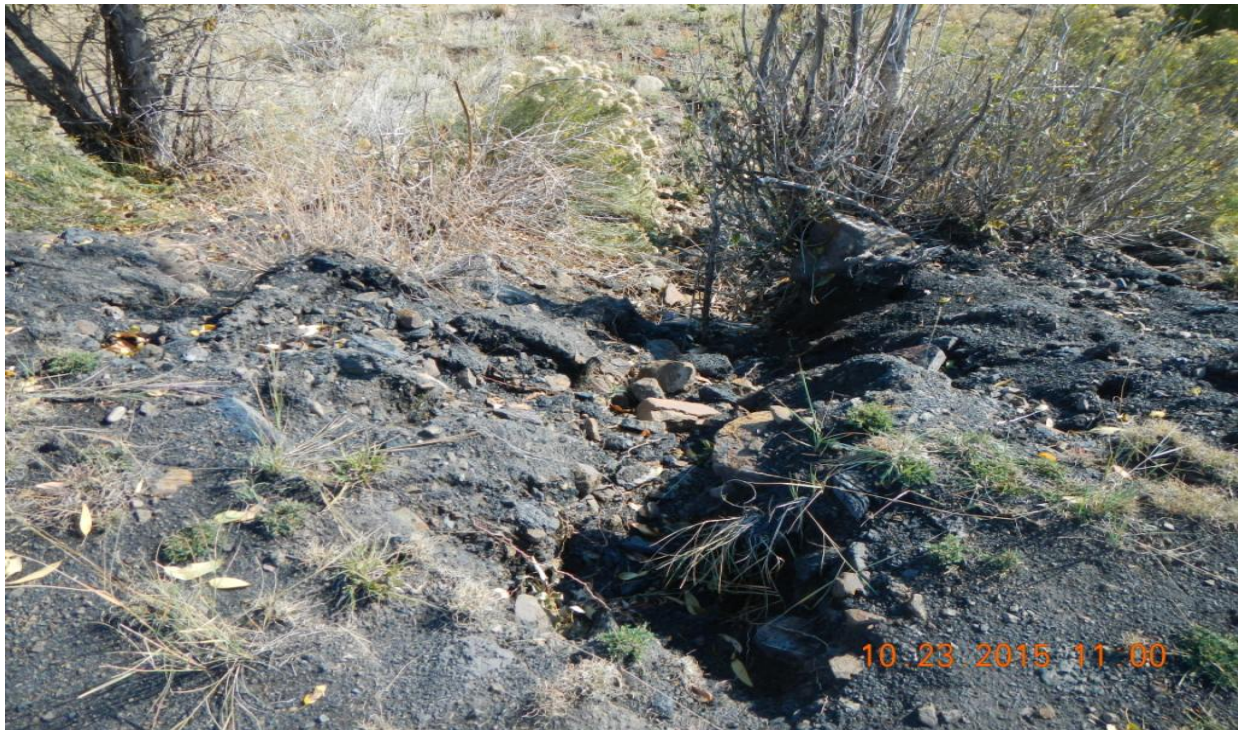
photo 5: Erosional channel has developed off the east side of the pad.

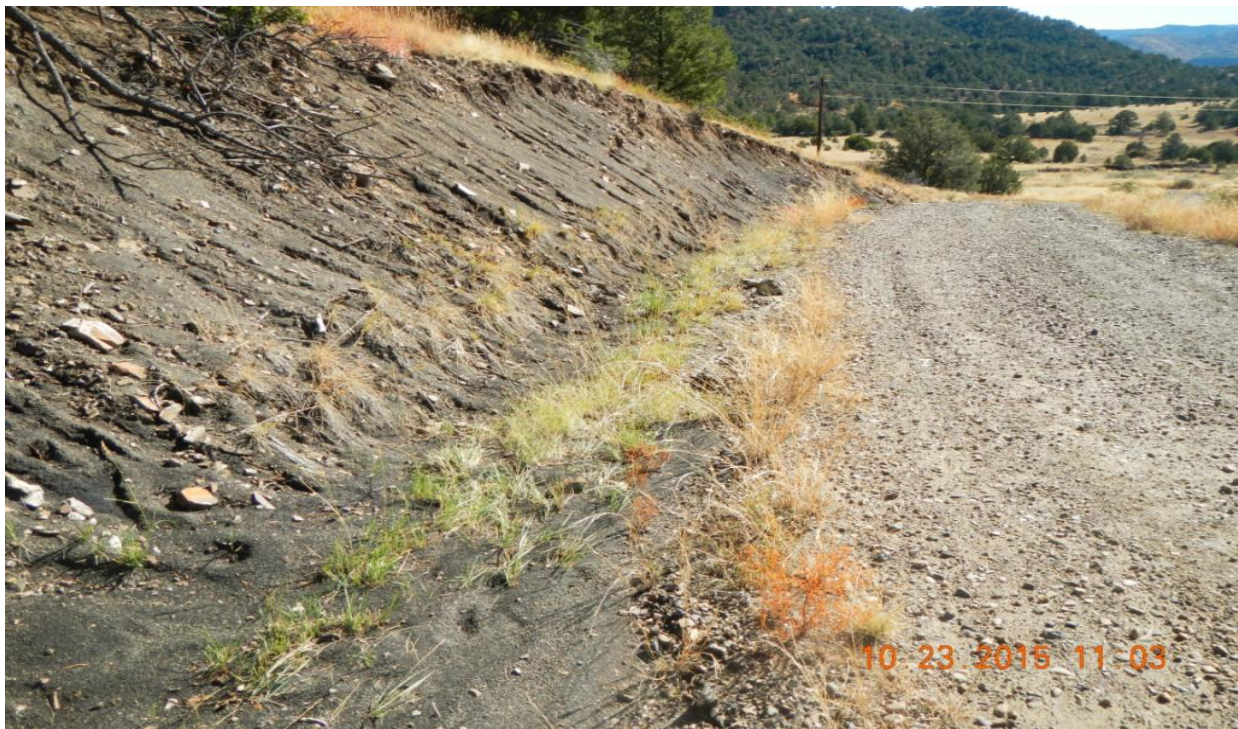
photo 6: Side of the access road is not well stabilized.
