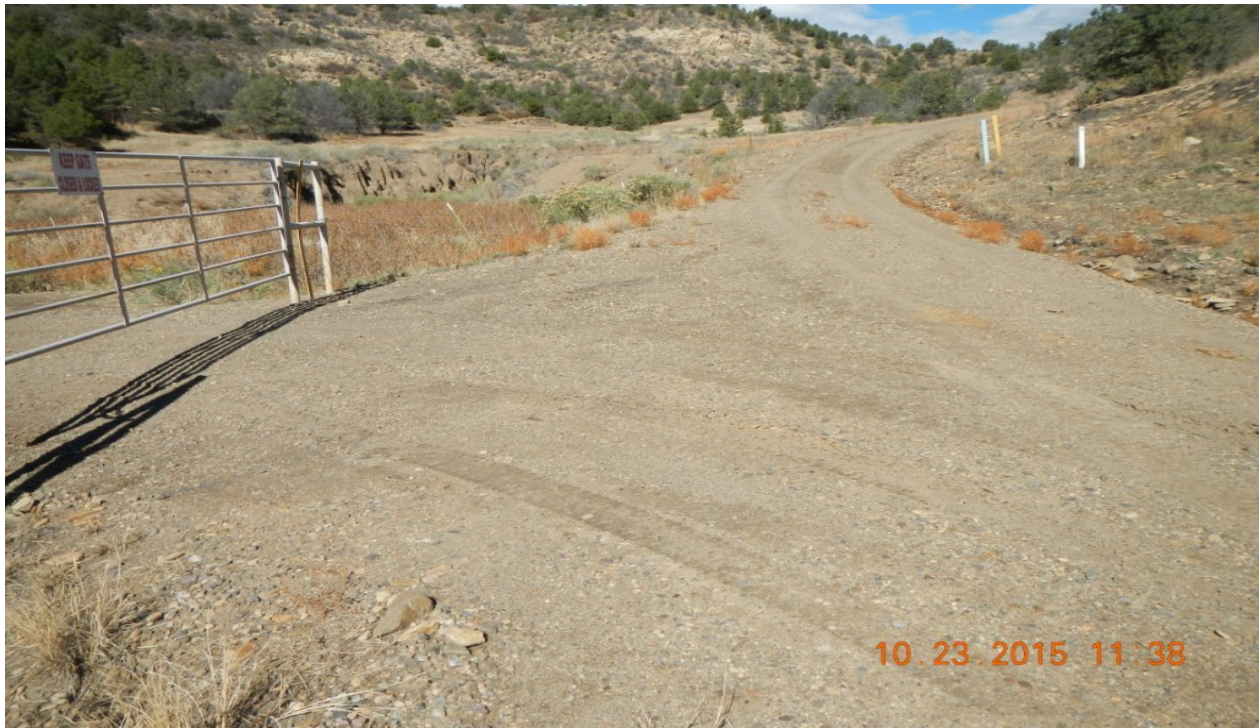
photo 1: Facing north towards the access road off of main road.

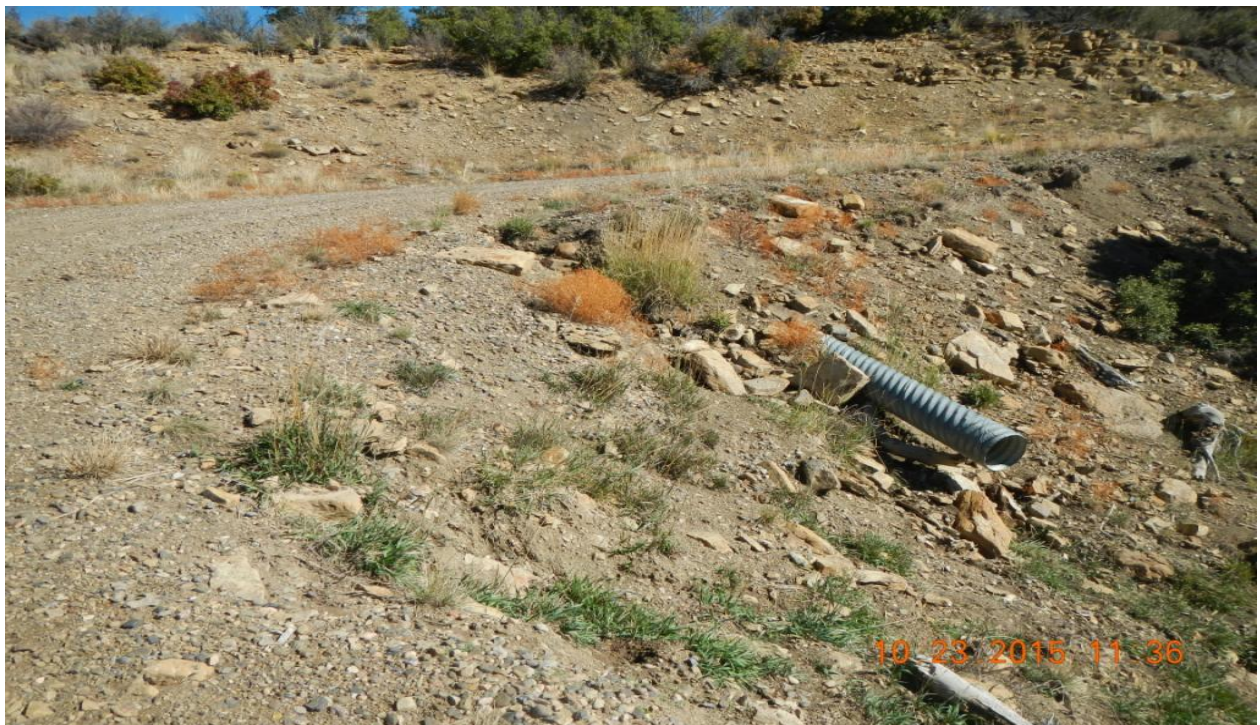
photo 2: Access road towards the location has not been reclaimed and culverts remain in place.

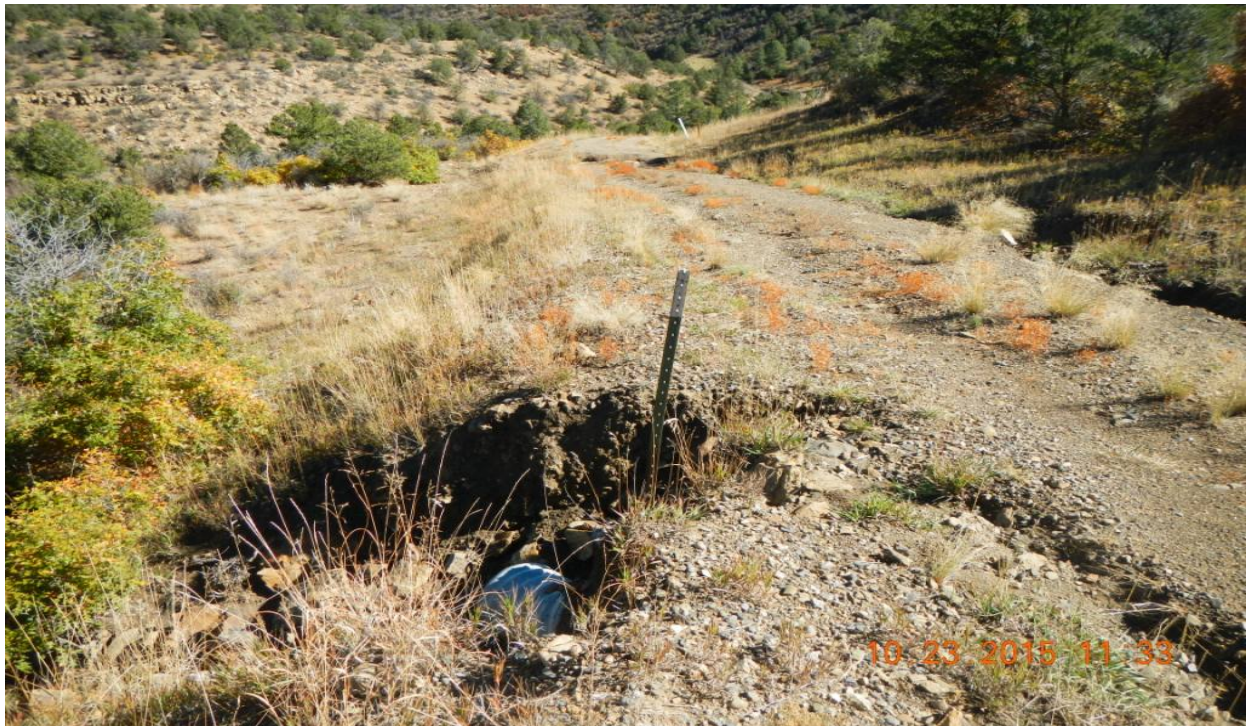
photo 3: Facing east along access road. Access road is eroding around the culvert.

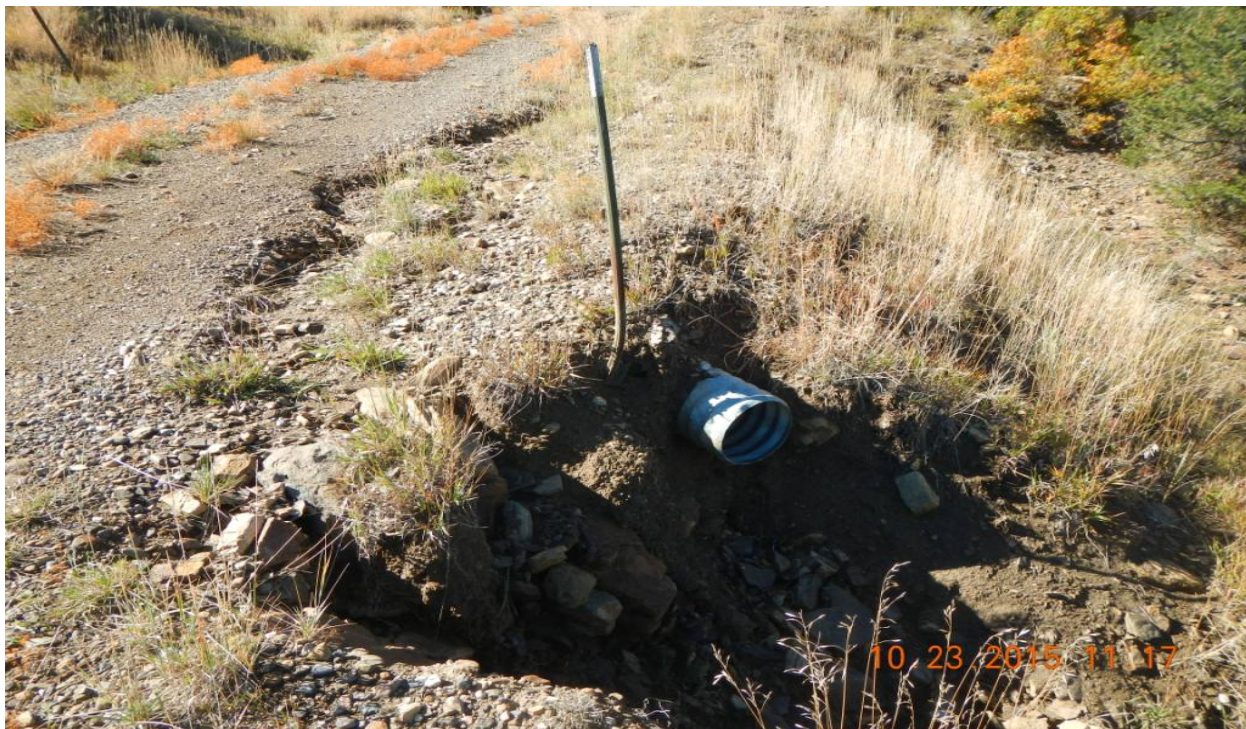
photo 4: Access road is eroding around the culvert.

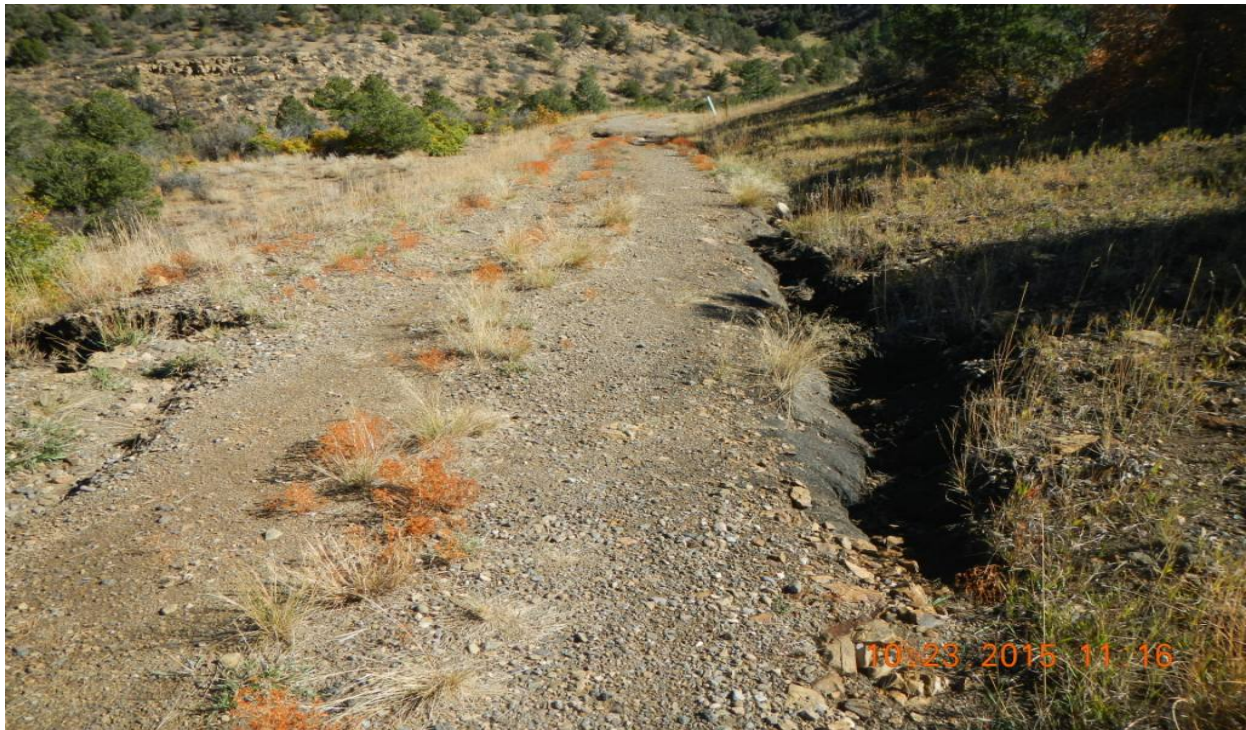
photo 5: Facing east along access road. Erosion is occurring on and along the side of the access road.

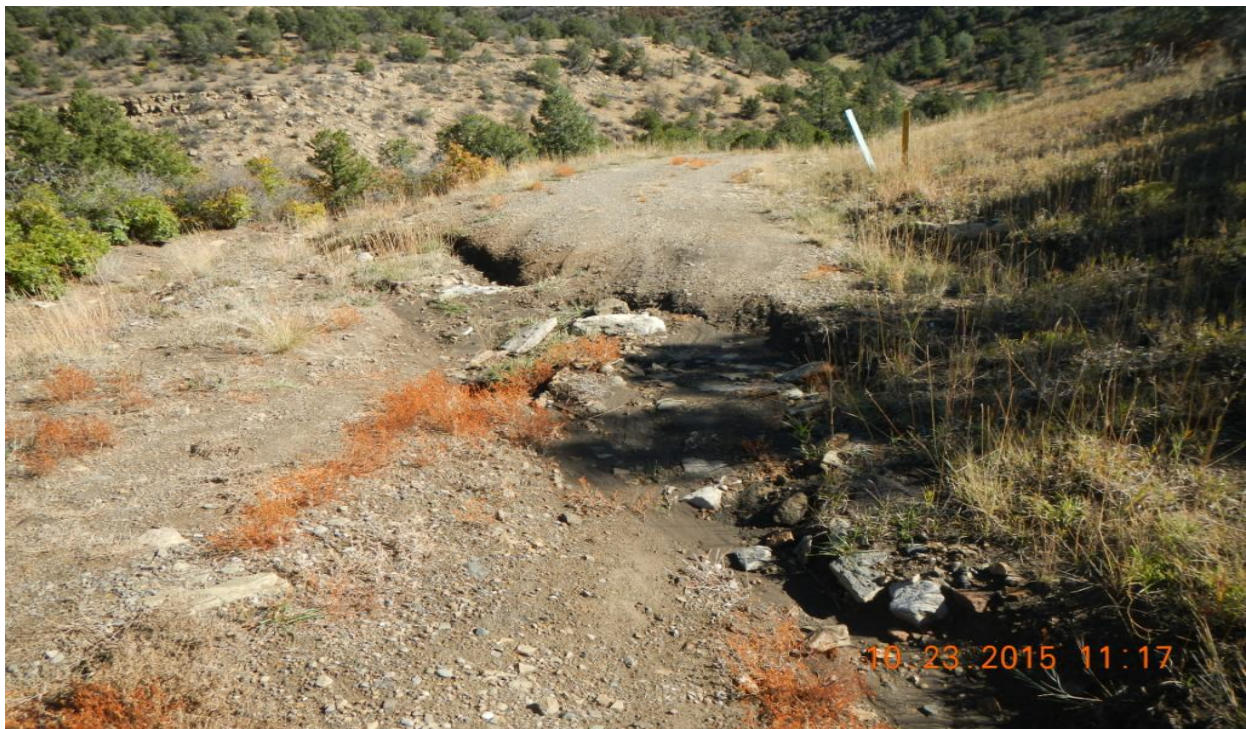
photo 6: Erosion is occurring across the road which is making the road inaccessible.

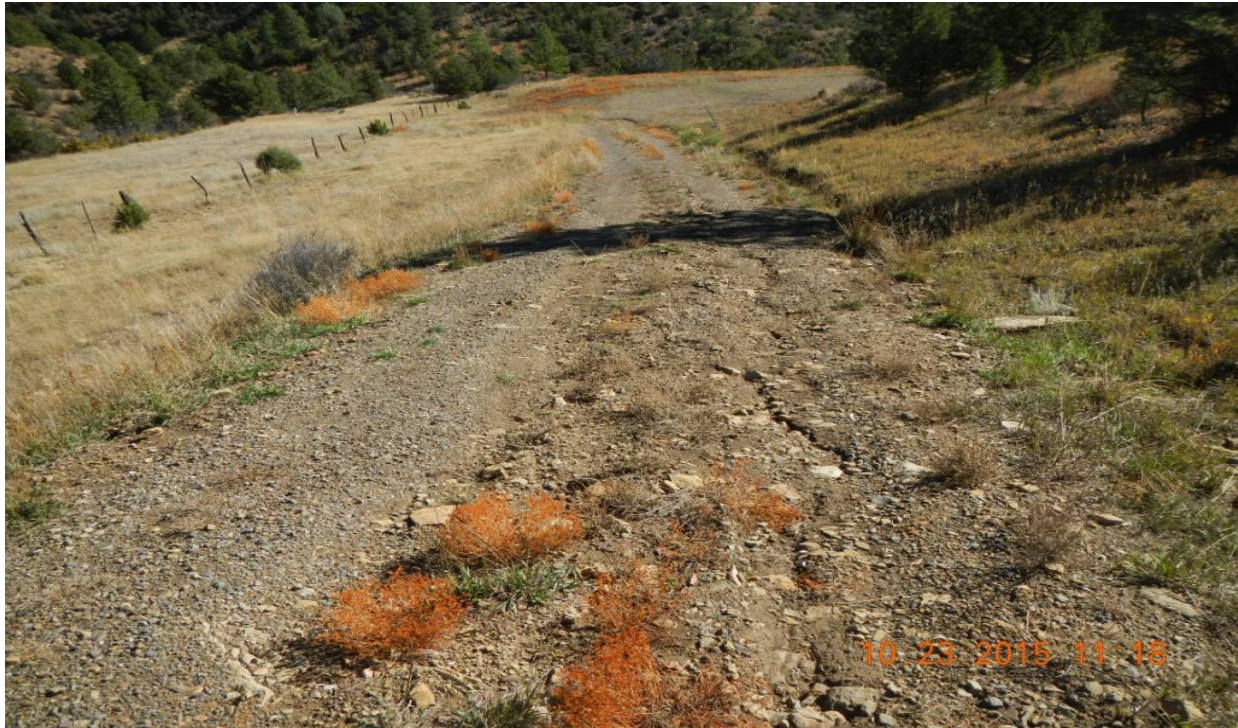
photo 7: Facing east towards the location.

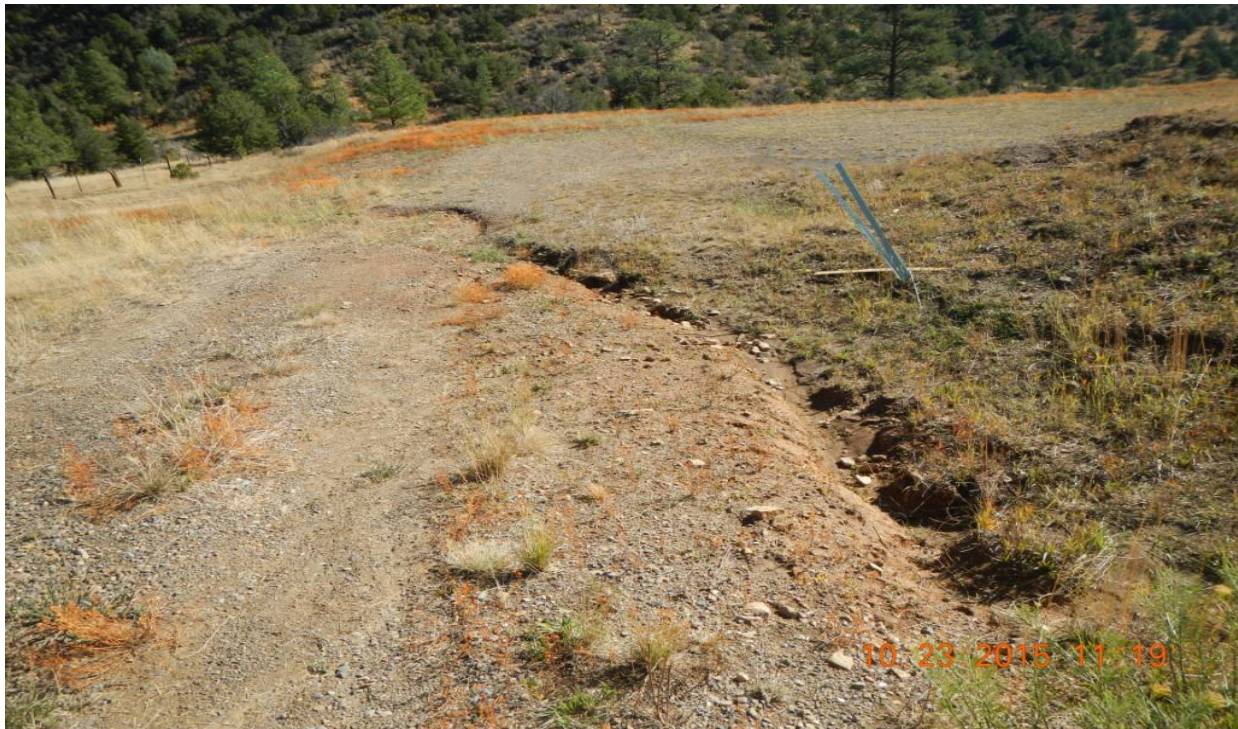
photo 8: Erosion occurring along the access road near the location.

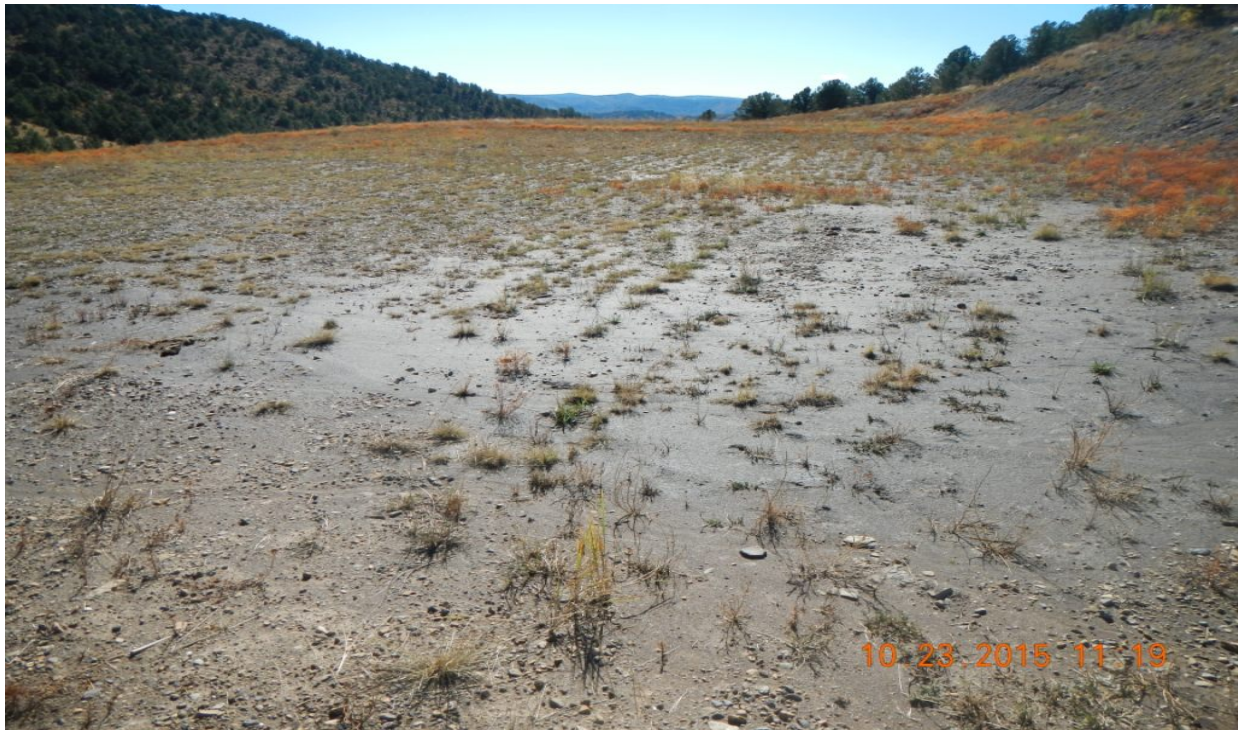
photo 9: North side of the location facing south.

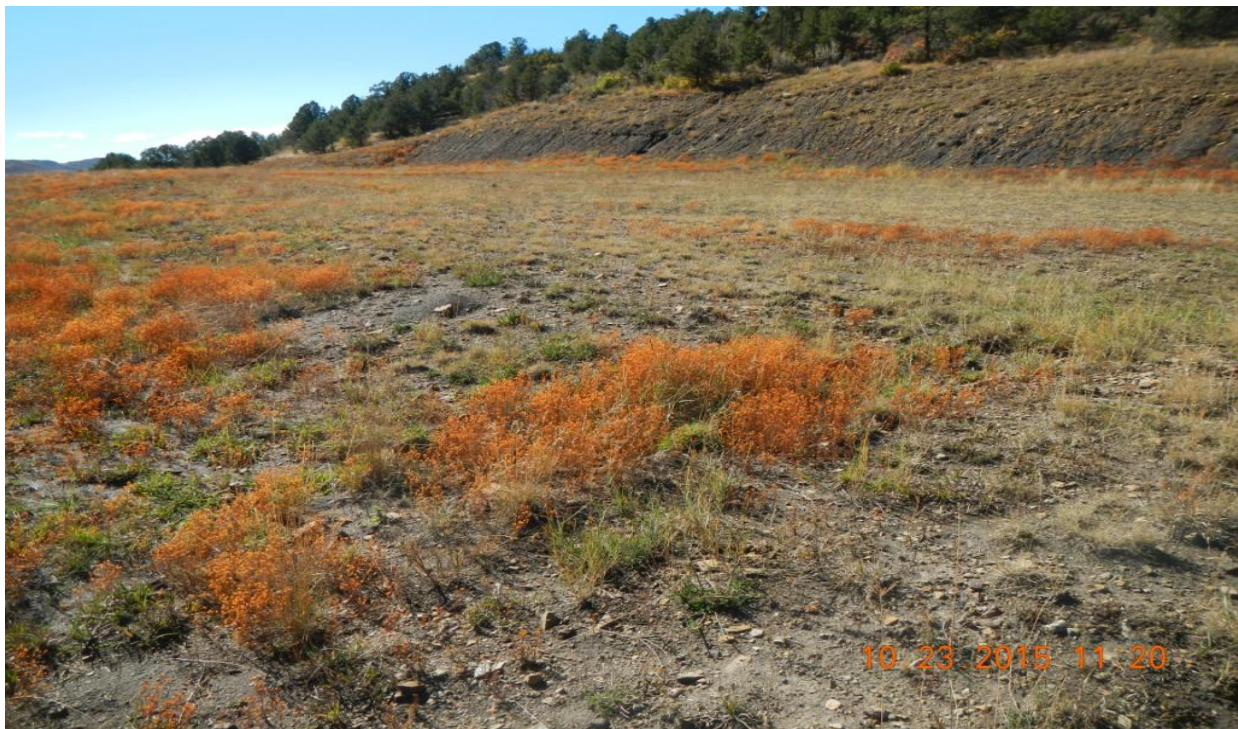
photo 10: Northeast corner of the location facing southwest.

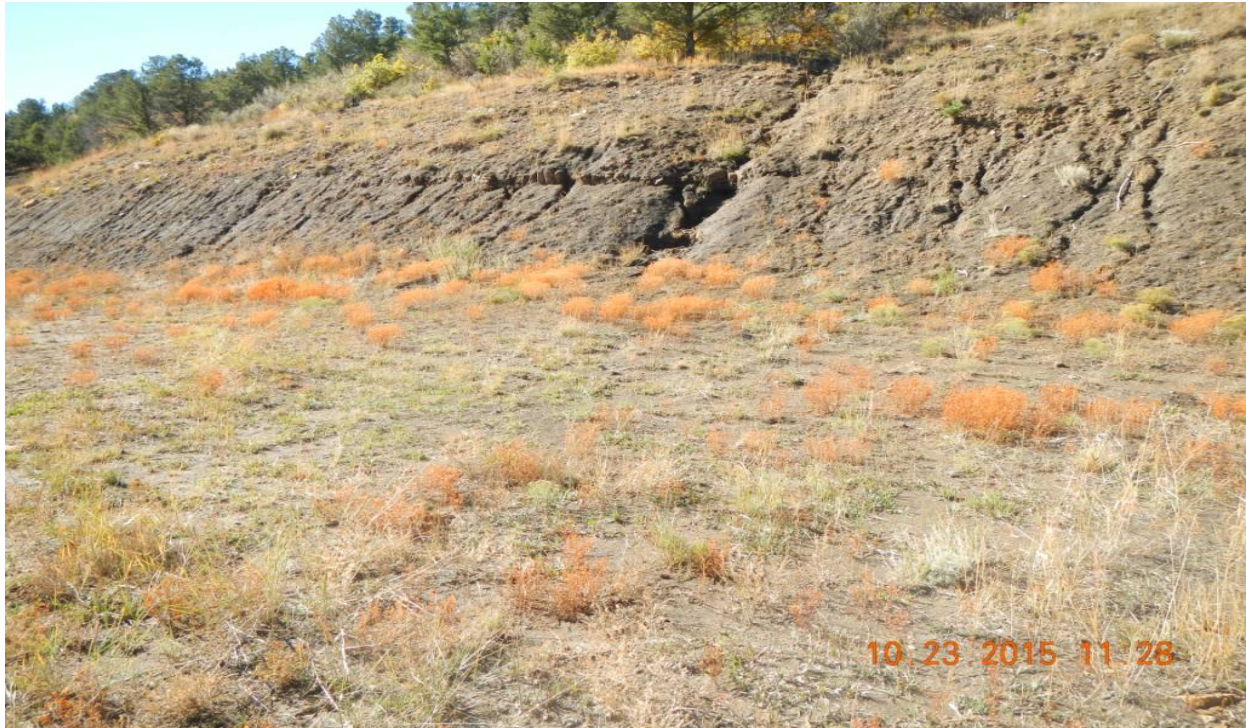
photo 11: Center of the location facing southwest. Erosion occurring along west side of the pad.

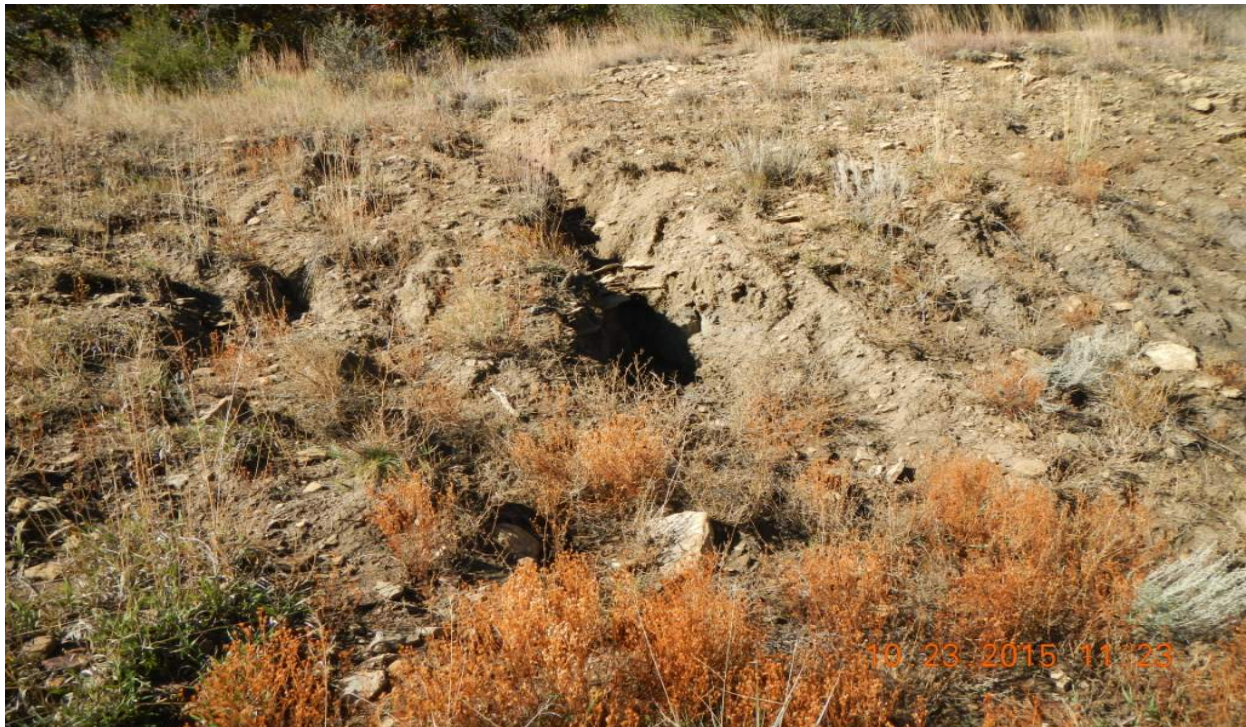
photo 12: Erosion channels at the southwest corner of the location.

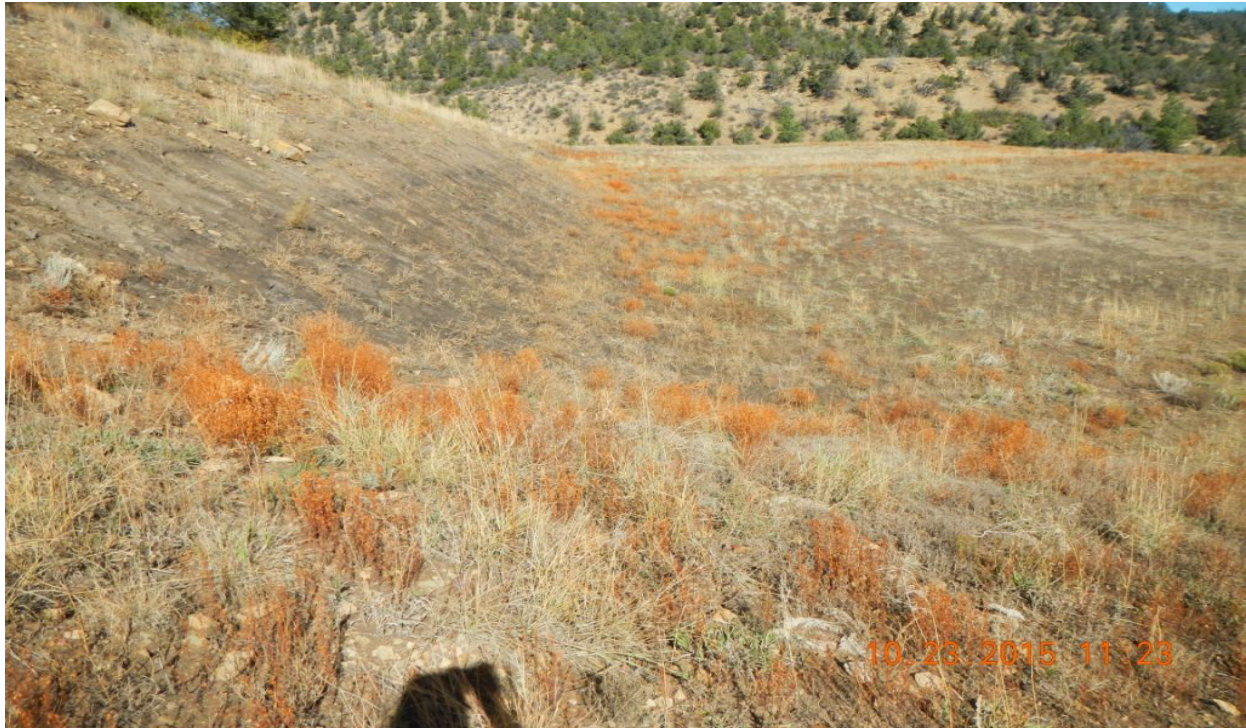
photo 13: Southwest corner of the location facing north.

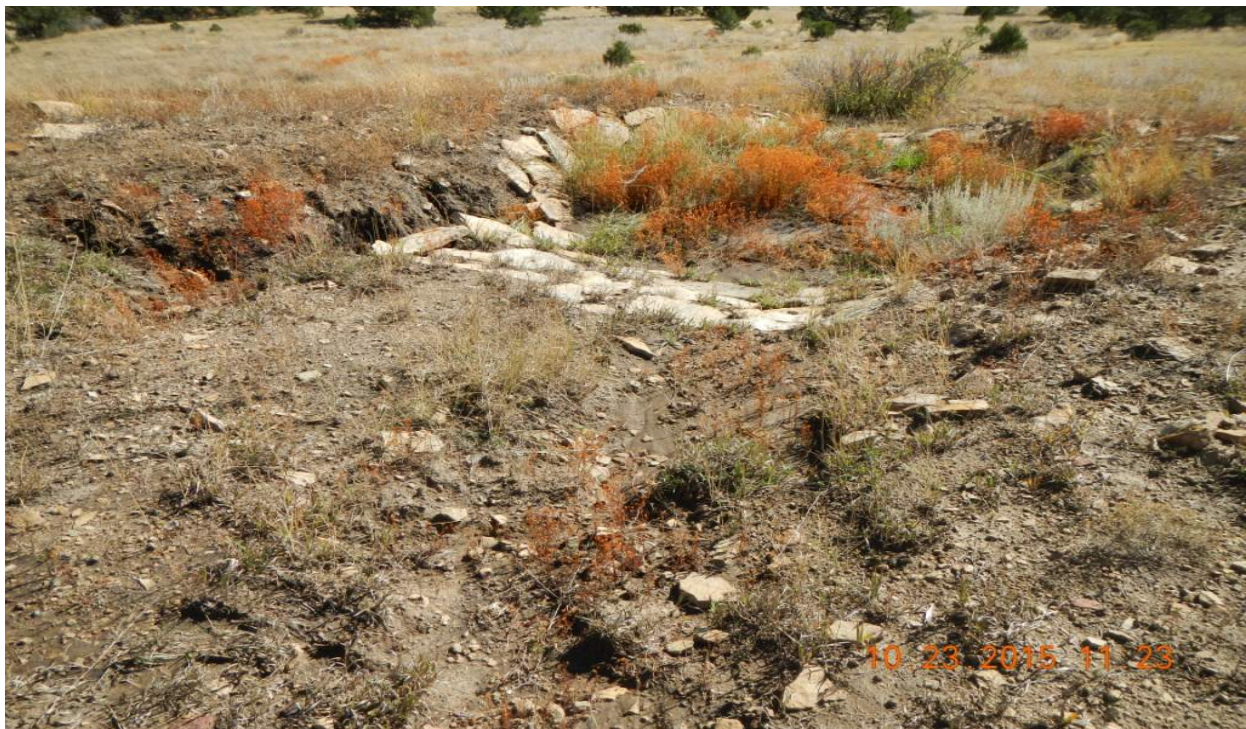
photo 14: Sediment trap the the southeast corner of location is filled with sediment.

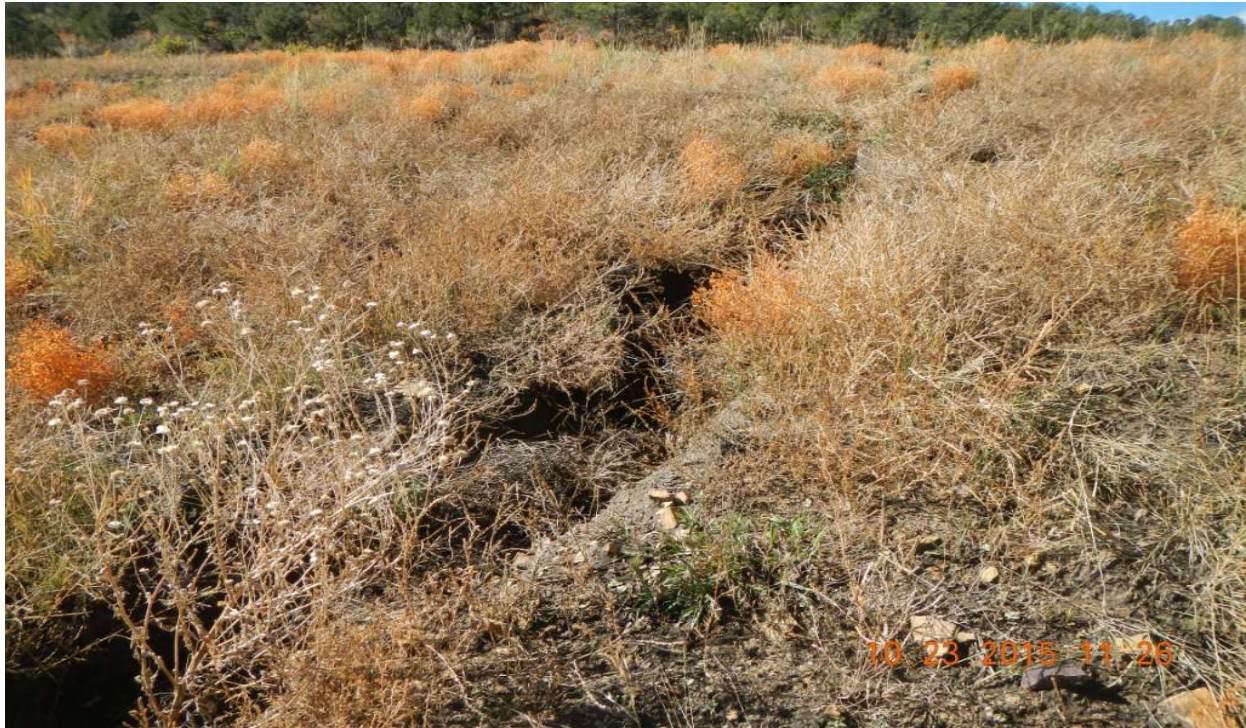
photo 15: East side of the pad. Erosion channel is transporting sediment off the location.

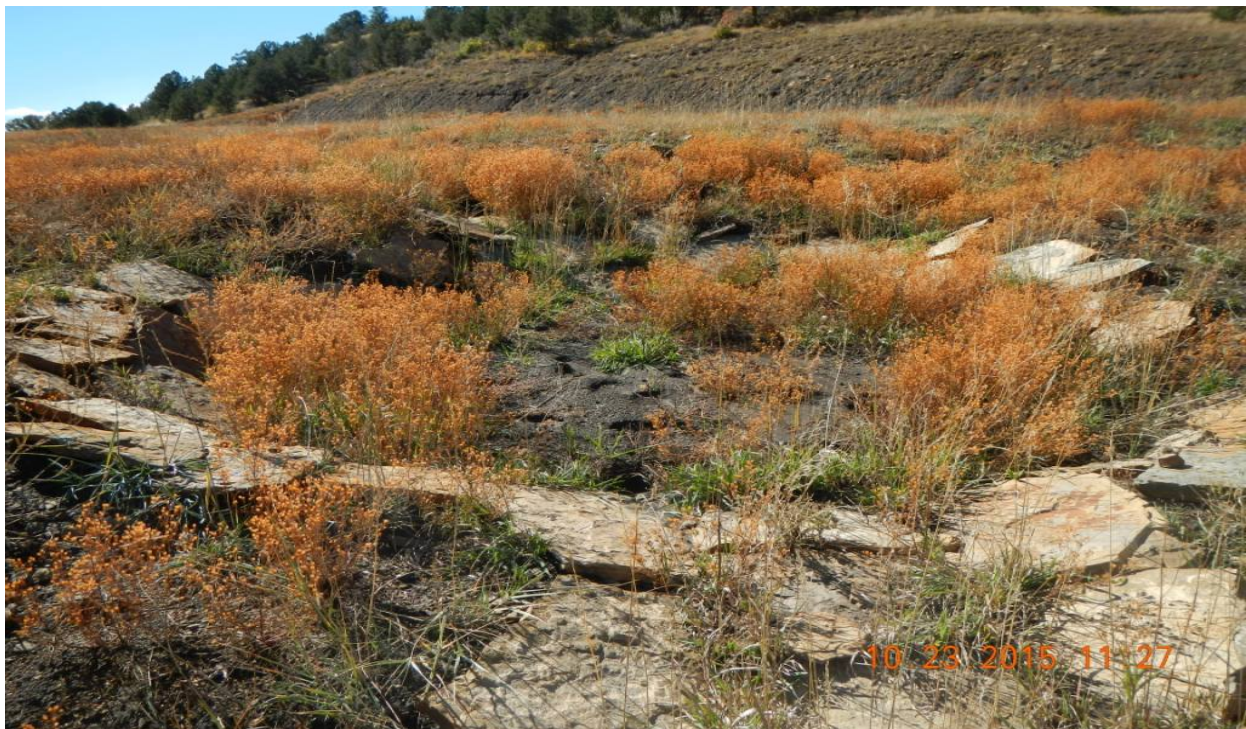
photo 16: Northeast corner of the location facing southwest. Sediment trap is filled with sediment.
