photo 1: Well sign, Drowsey Duck 43-30

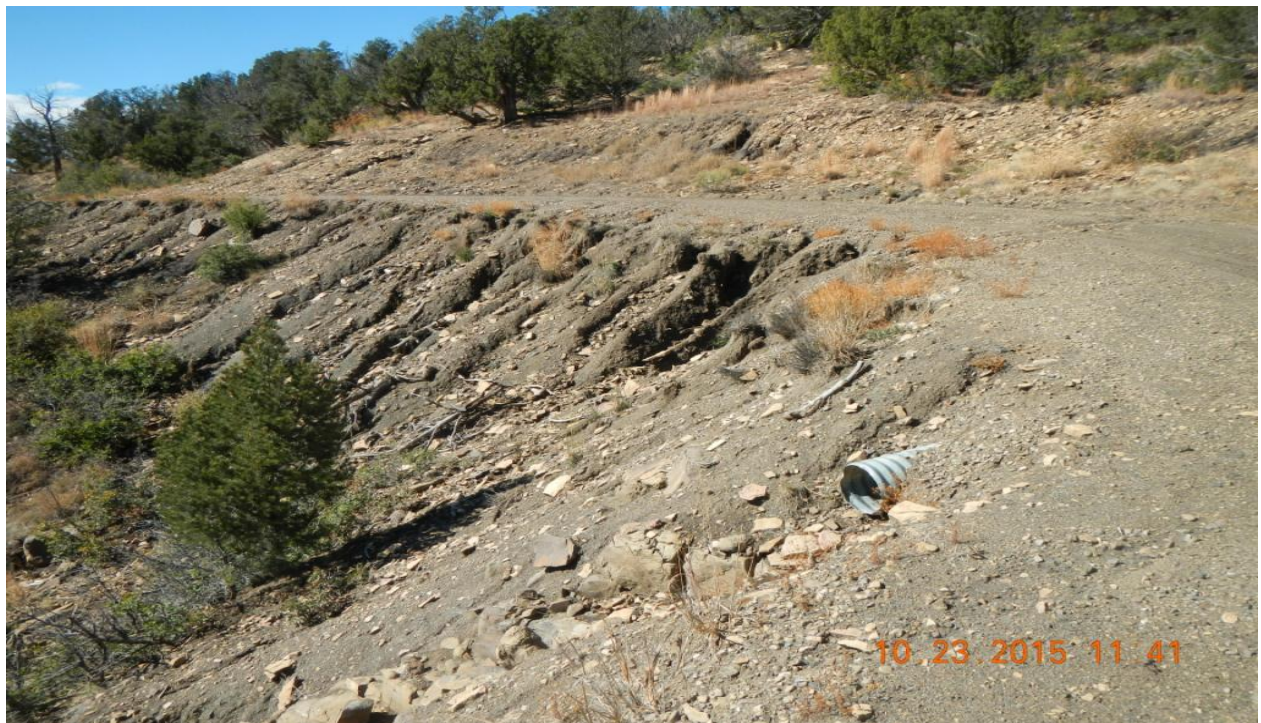
photo 2: Facing west. Erosion occurring along the access road near the location.

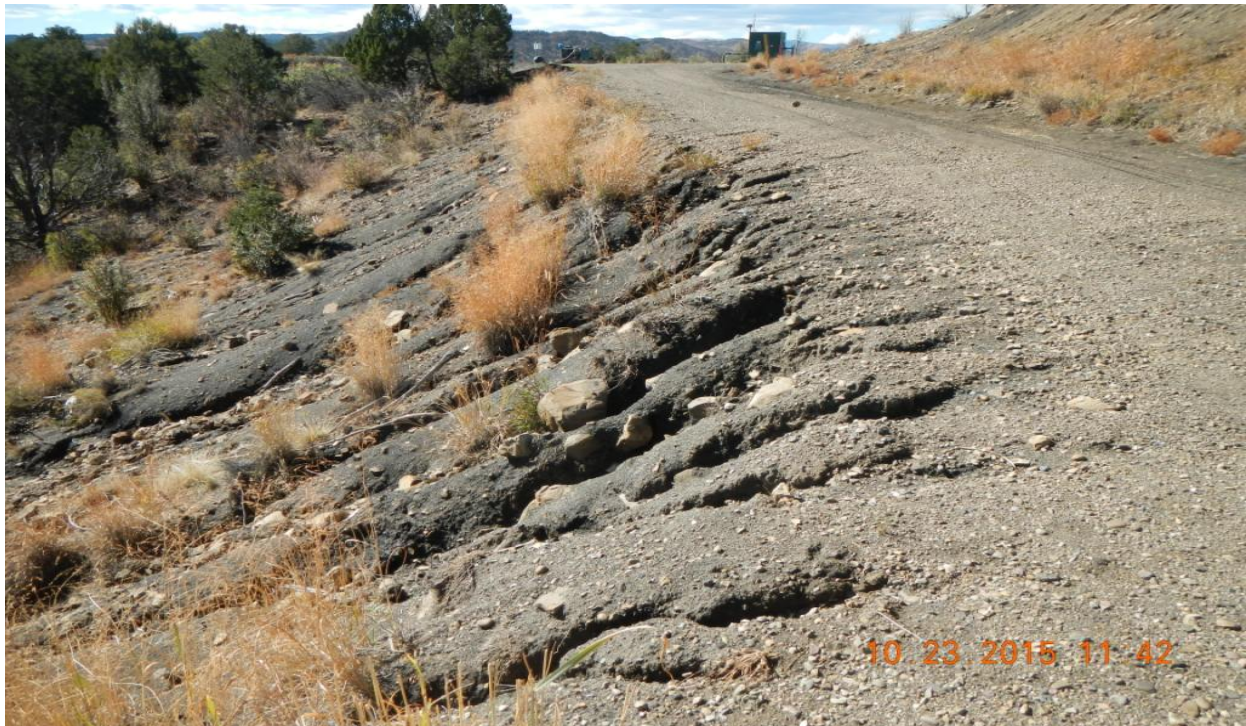
**photo 3:** Facing southwest. Erosion occurring along the access road near the location.

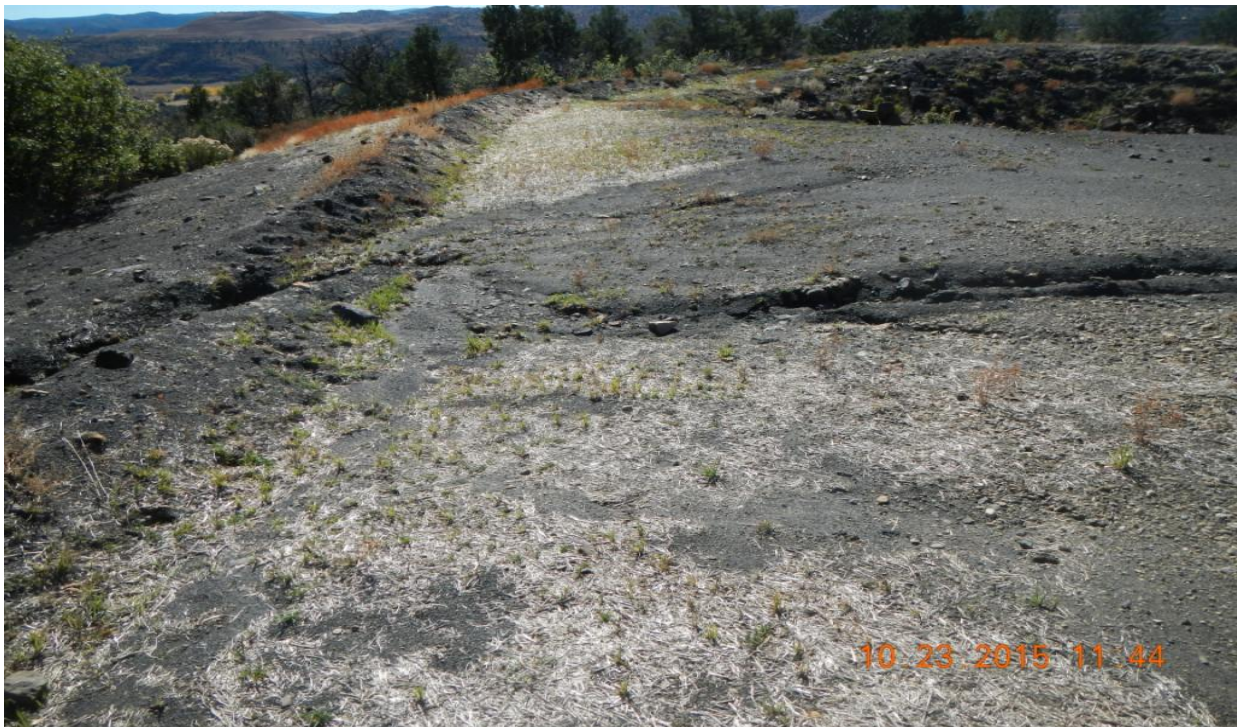
**photo 4:** East side of the location facing south. Erosion channel developing on the pad.

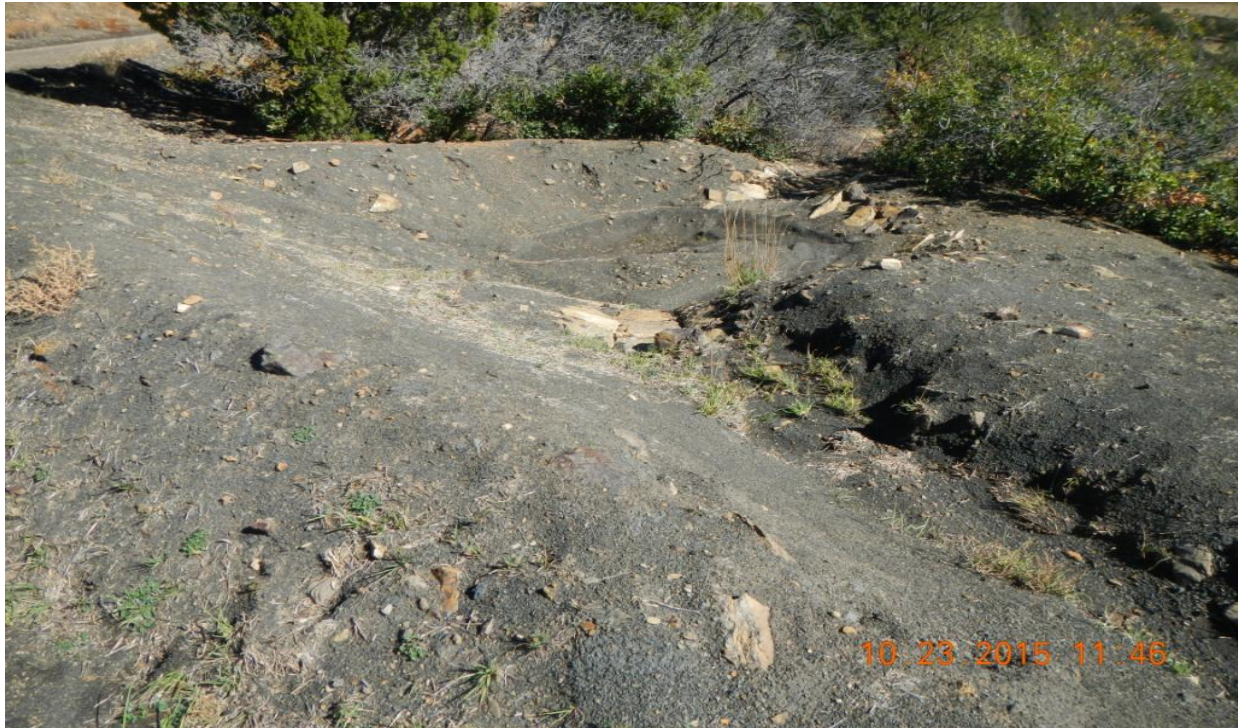
photo 5: Sediment trap at the northeast corner of location is filling up with sediment.
