Wilson Ranch
12N-27HZ

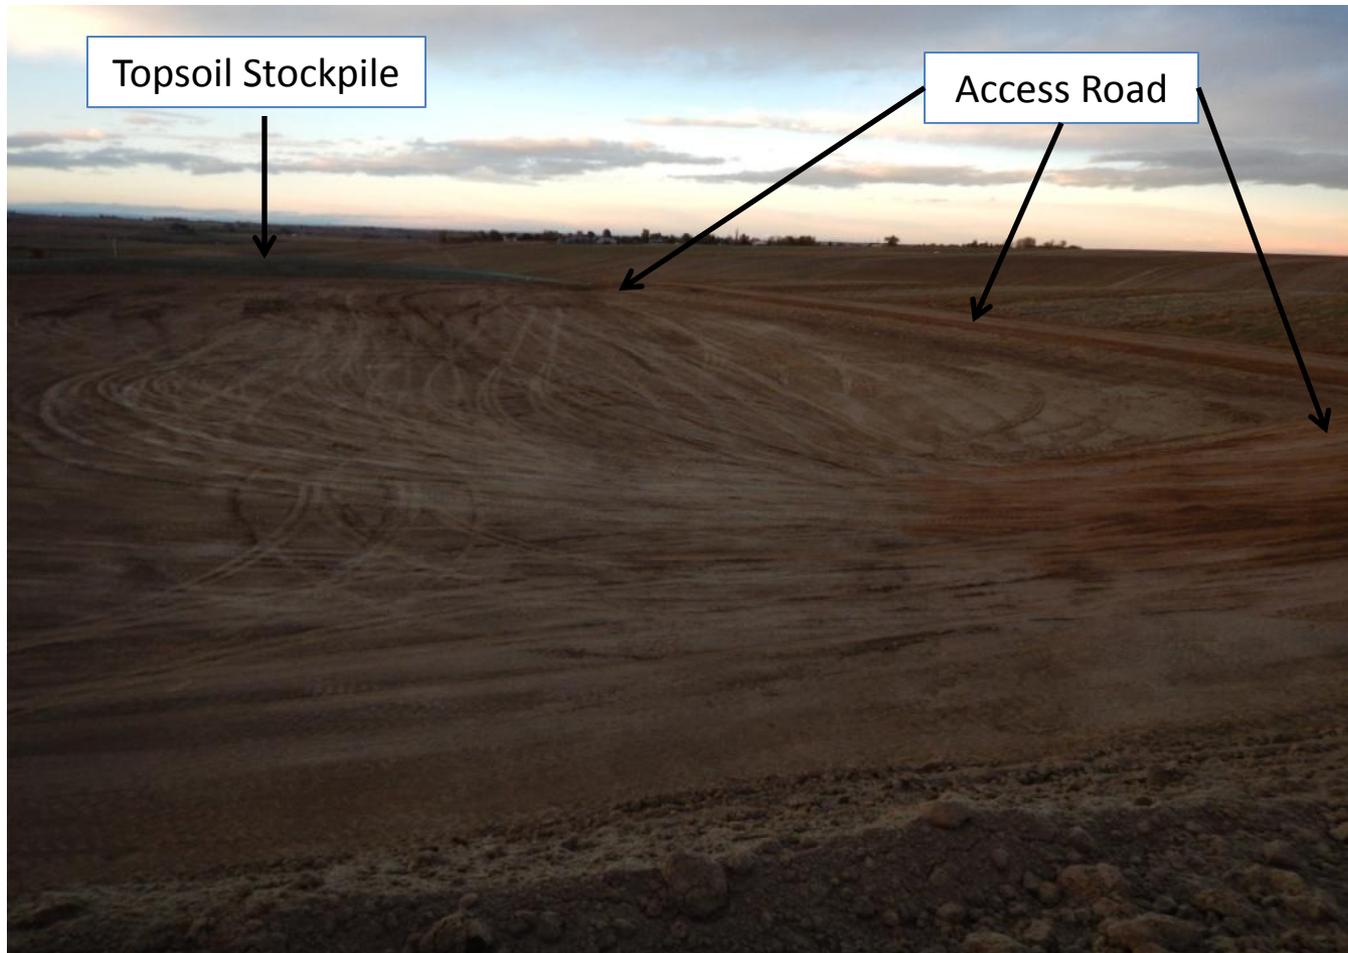
Photo 1. Photo taken from southern location of facility pad, facing Northeast.

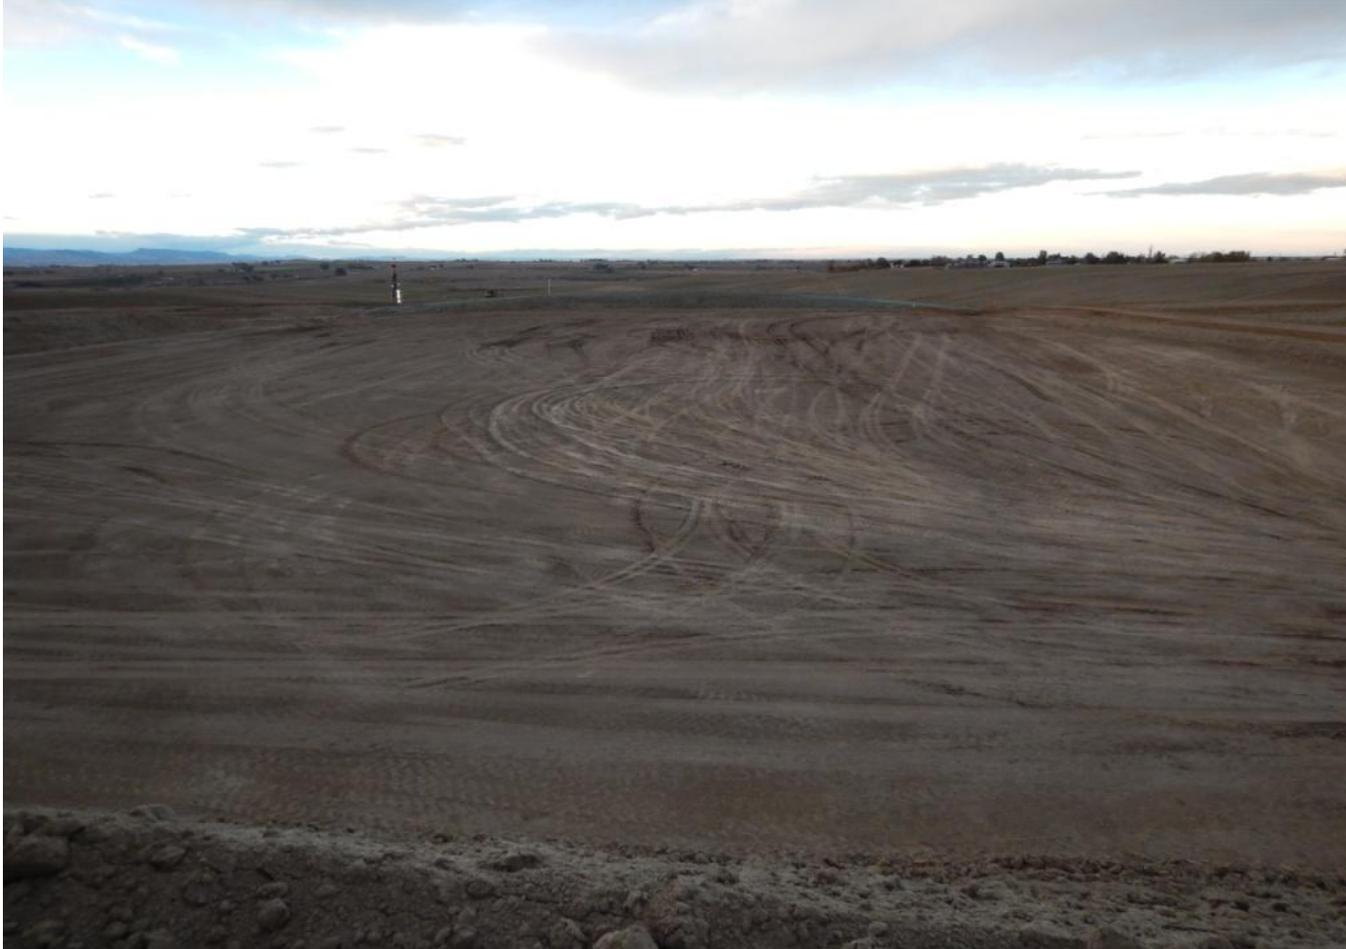
Photo 2. Photo taken from southern location of facility pad, facing North towards topsoil stockpile.

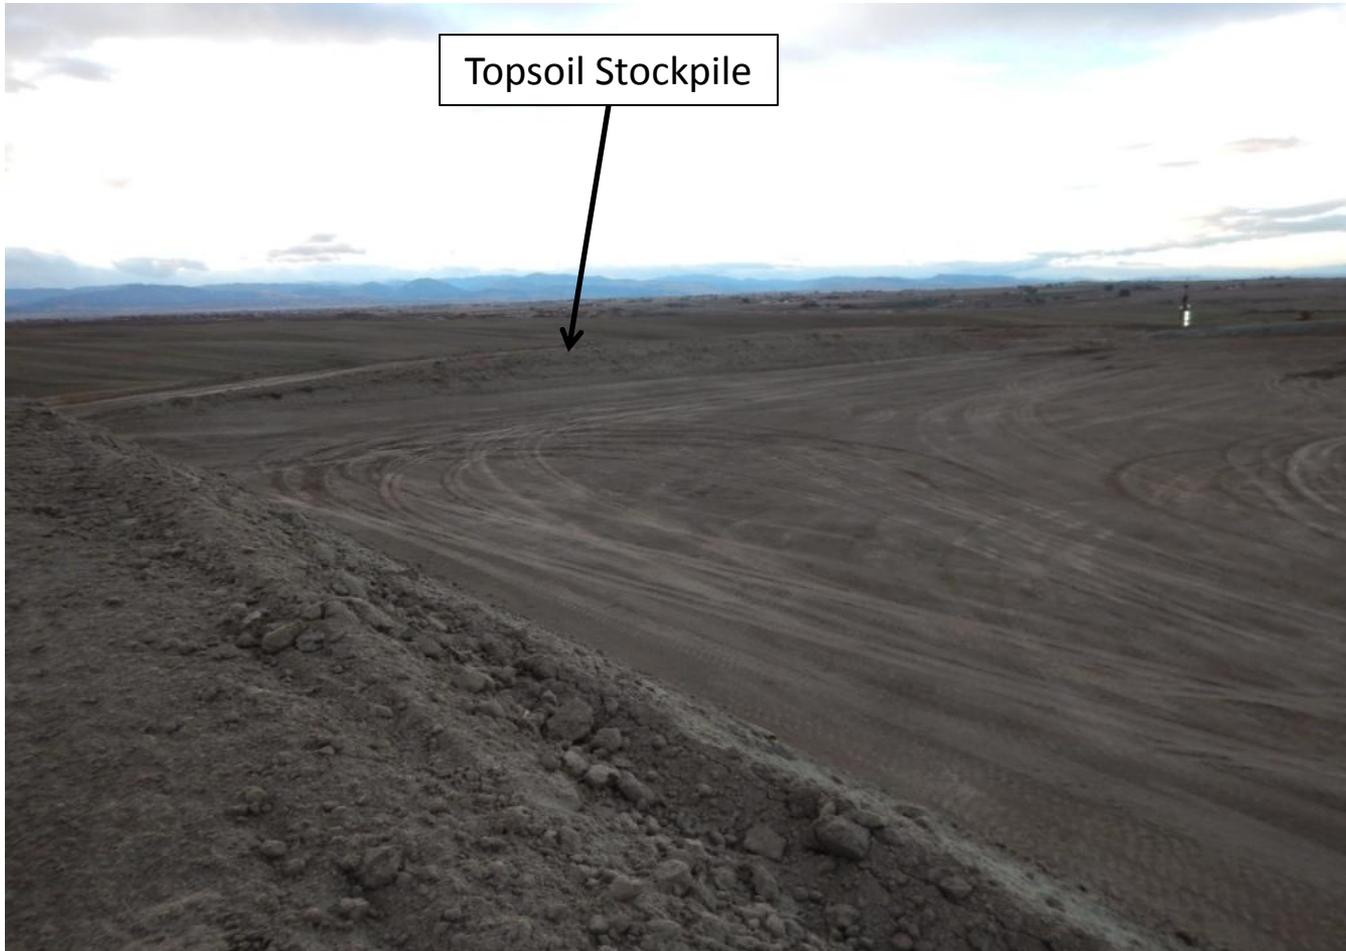
Photo 3. Photo taken from southern location of facility pad, facing Northwest.

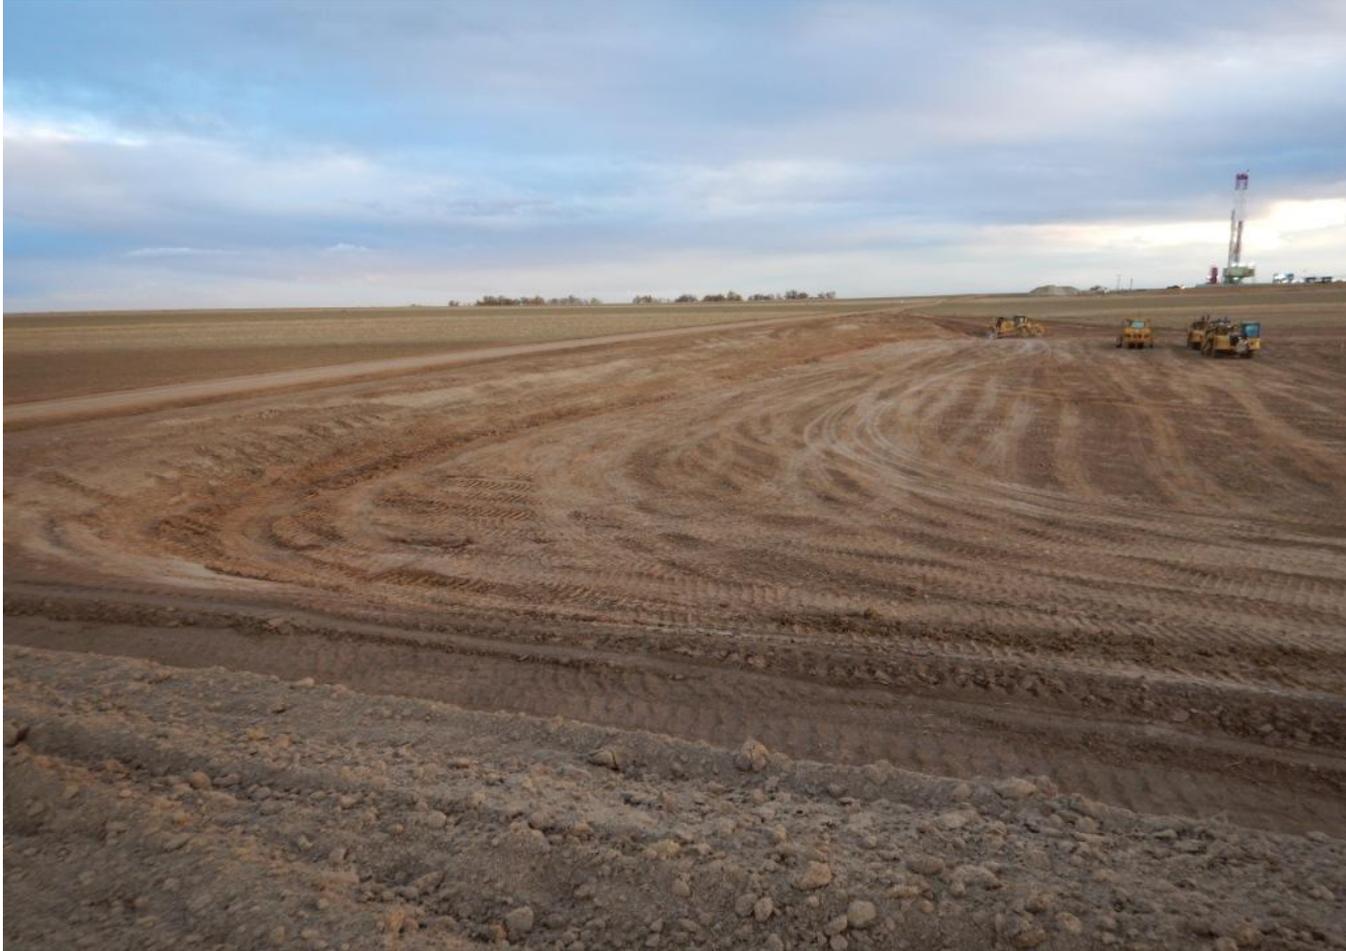
Photo 4. Photo taken from northern location of well pad, facing Southeast.

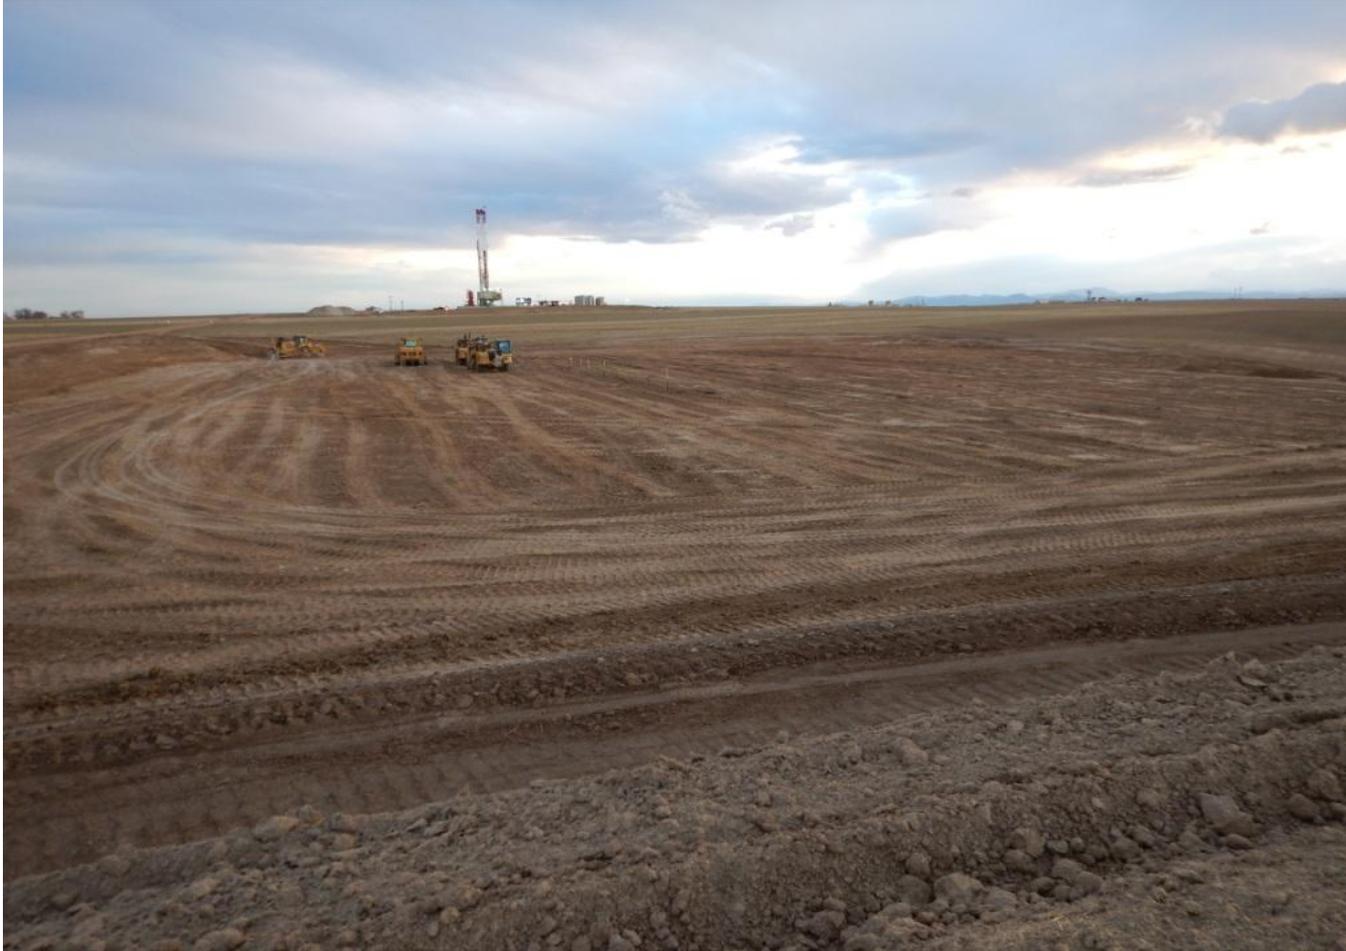
Photo 5. Photo taken from northern location of well pad, facing South.

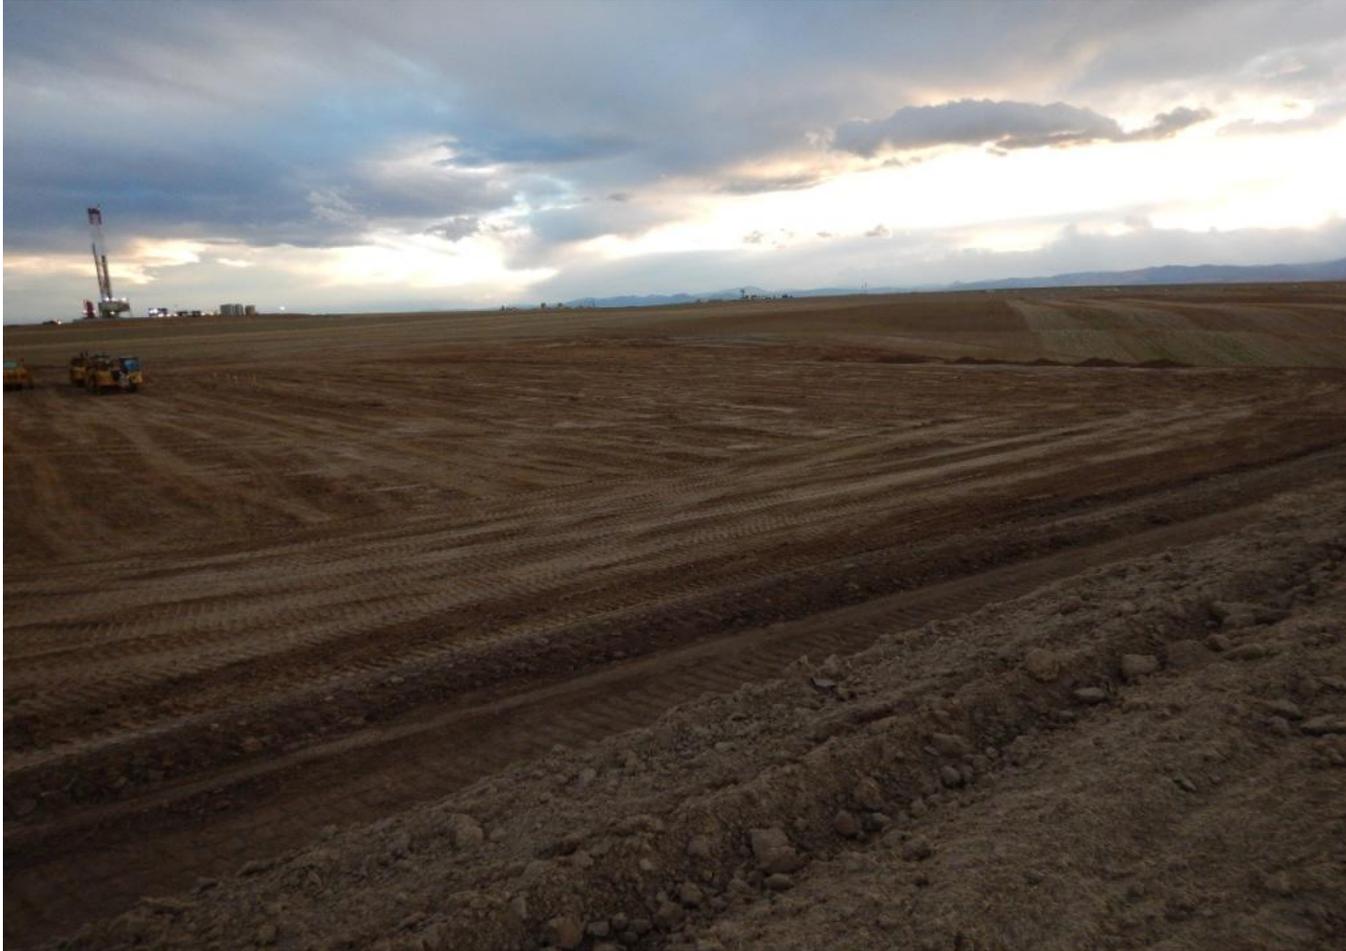
Photo 6. Photo taken from northern location of well pad, facing Southwest.

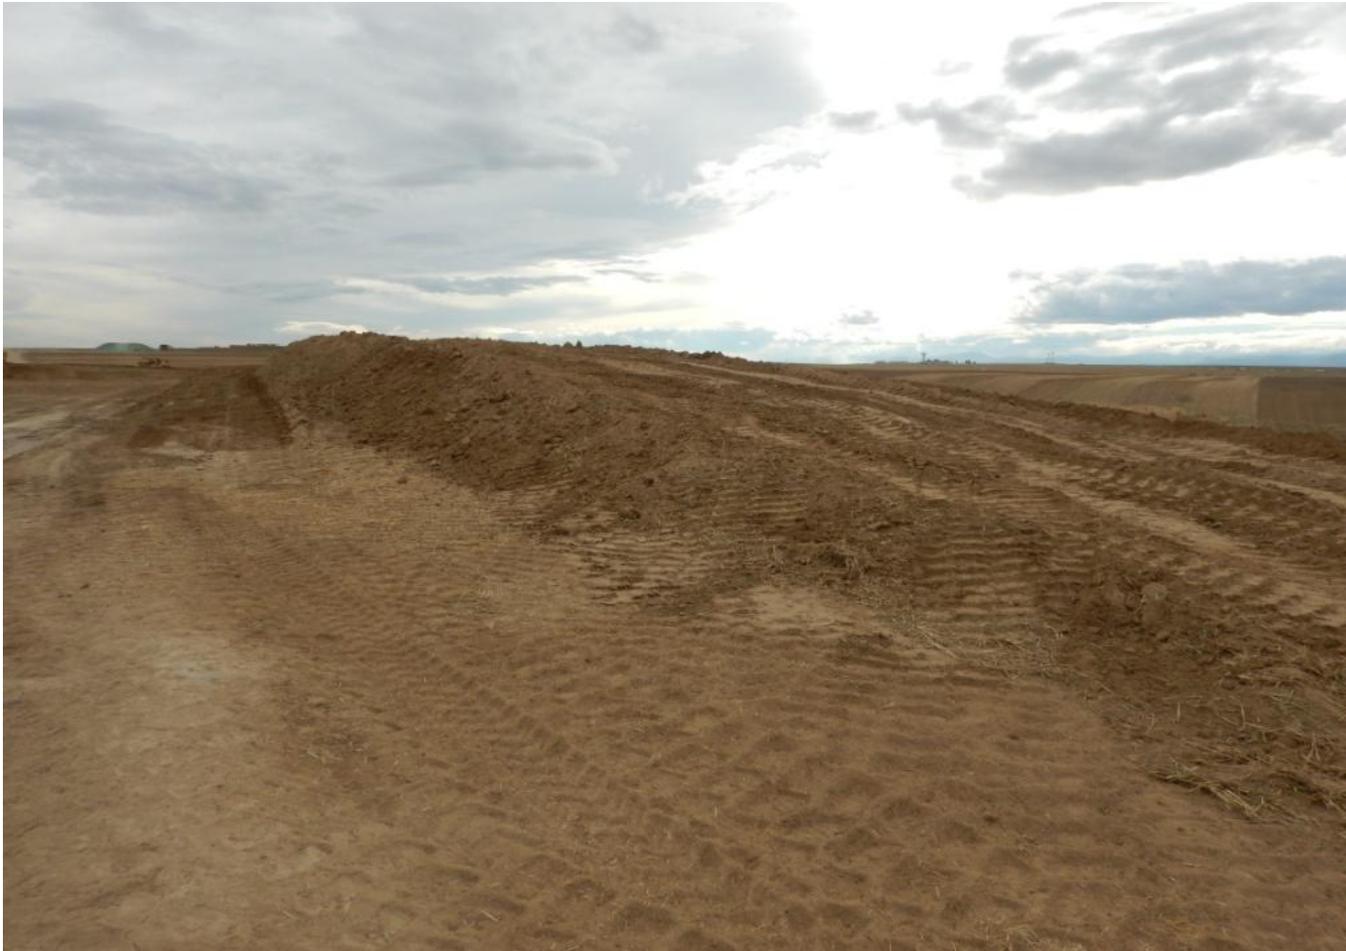
Photo 7. Photo taken of topsoil stockpile from western location of facility pad, facing South.

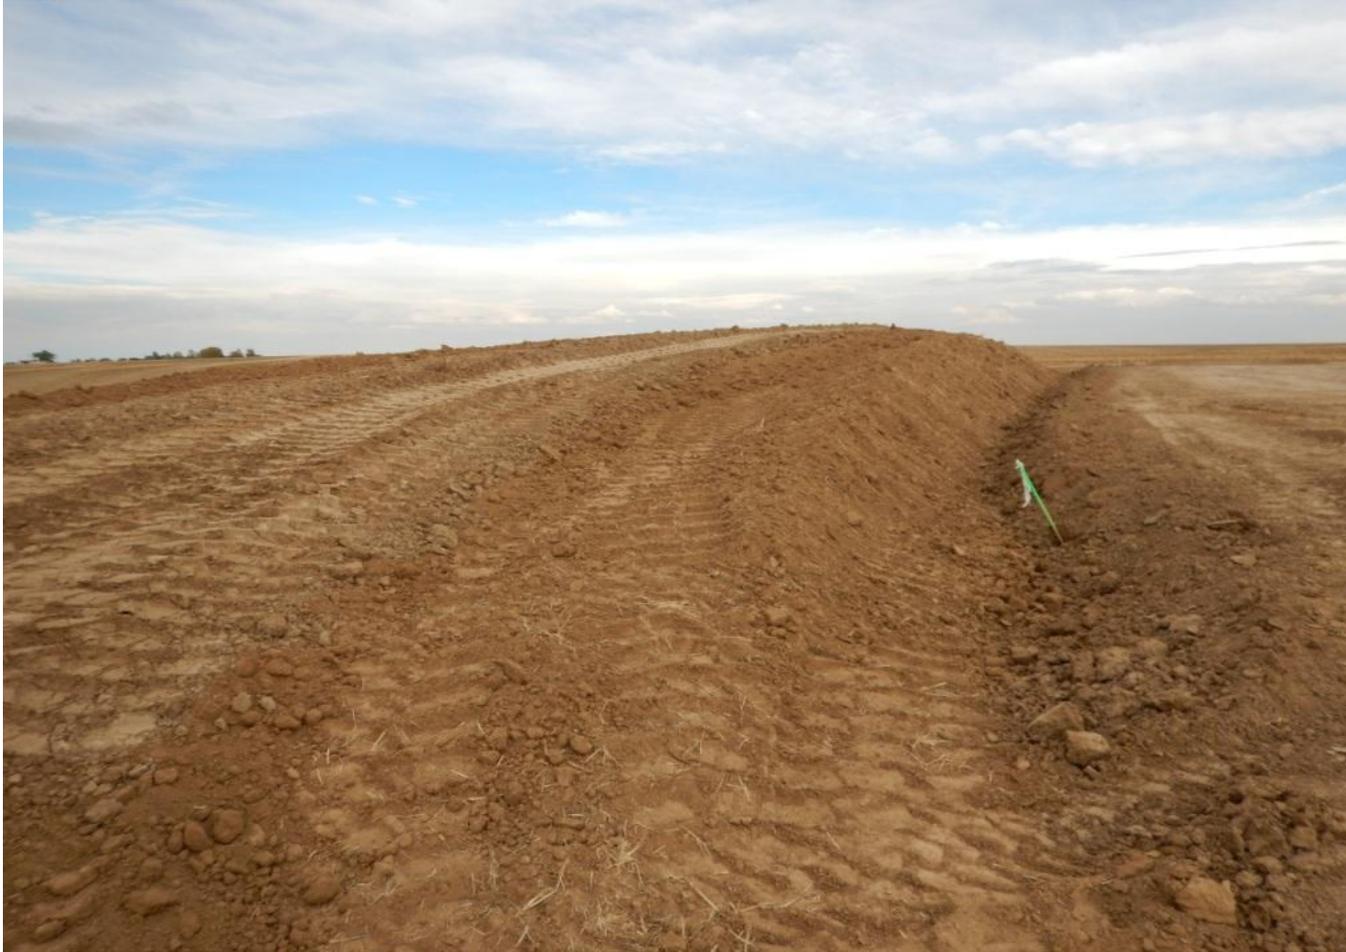
Photo 8. Photo taken of topsoil stockpile from northern location of facility pad, facing East.

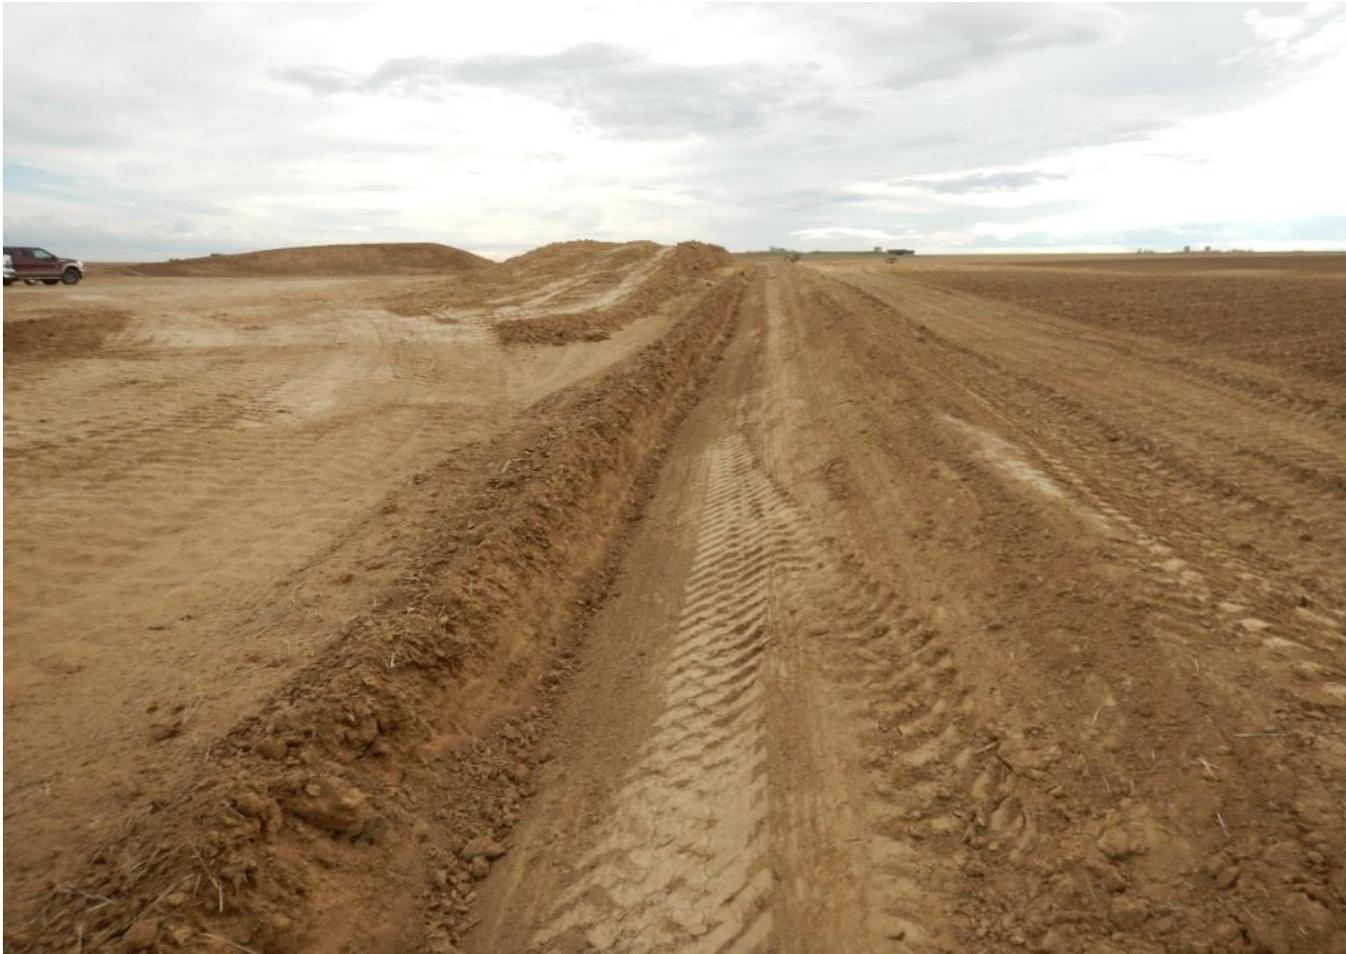
Photo 9. Photo taken from western edge of facility pad, facing south. Stormwater control ditch located in center of photo.

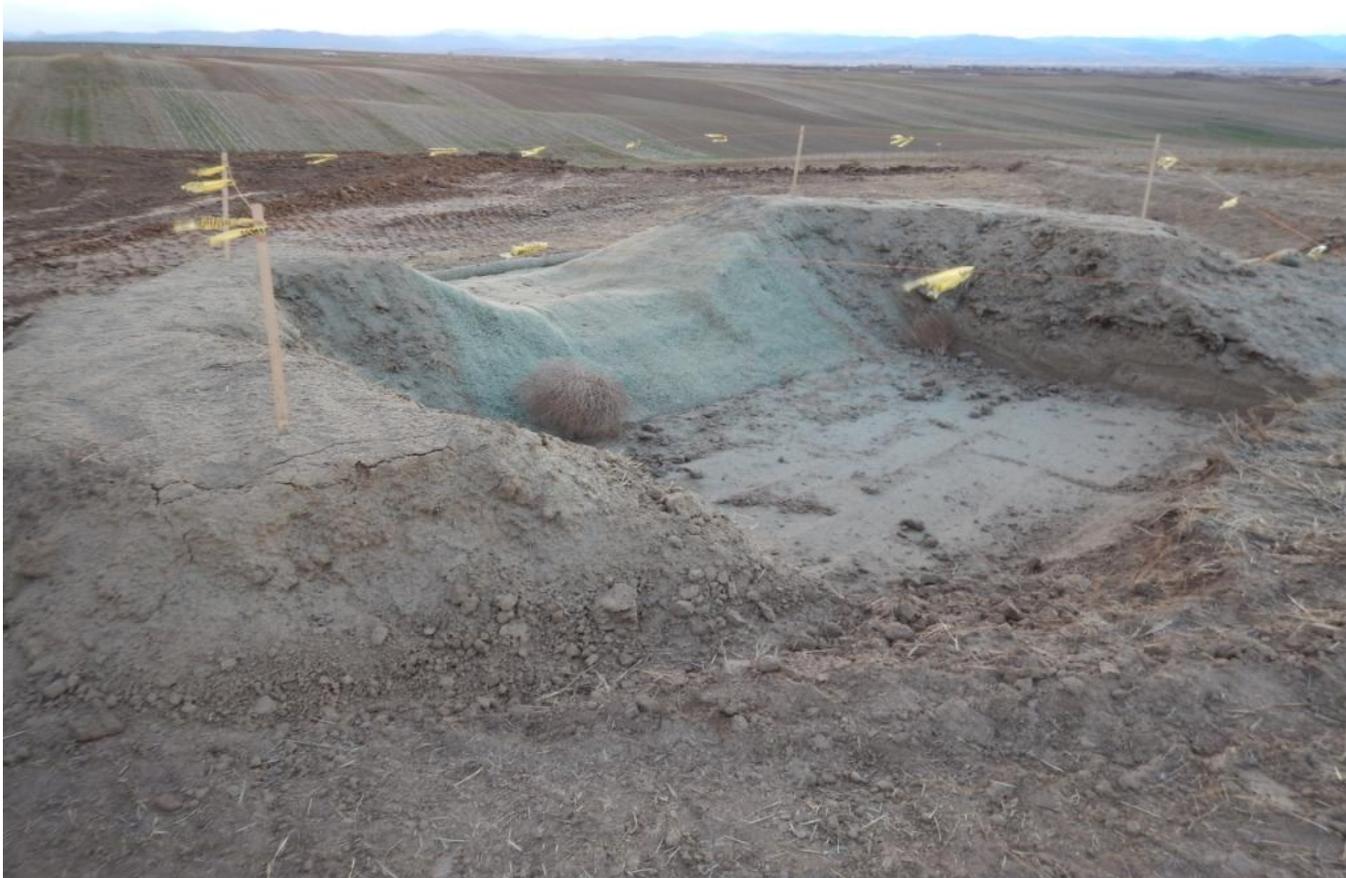
Photo 10. Photo taken from southwest location of facility pad, facing West. Stormwater sediment catch located in center of photo.

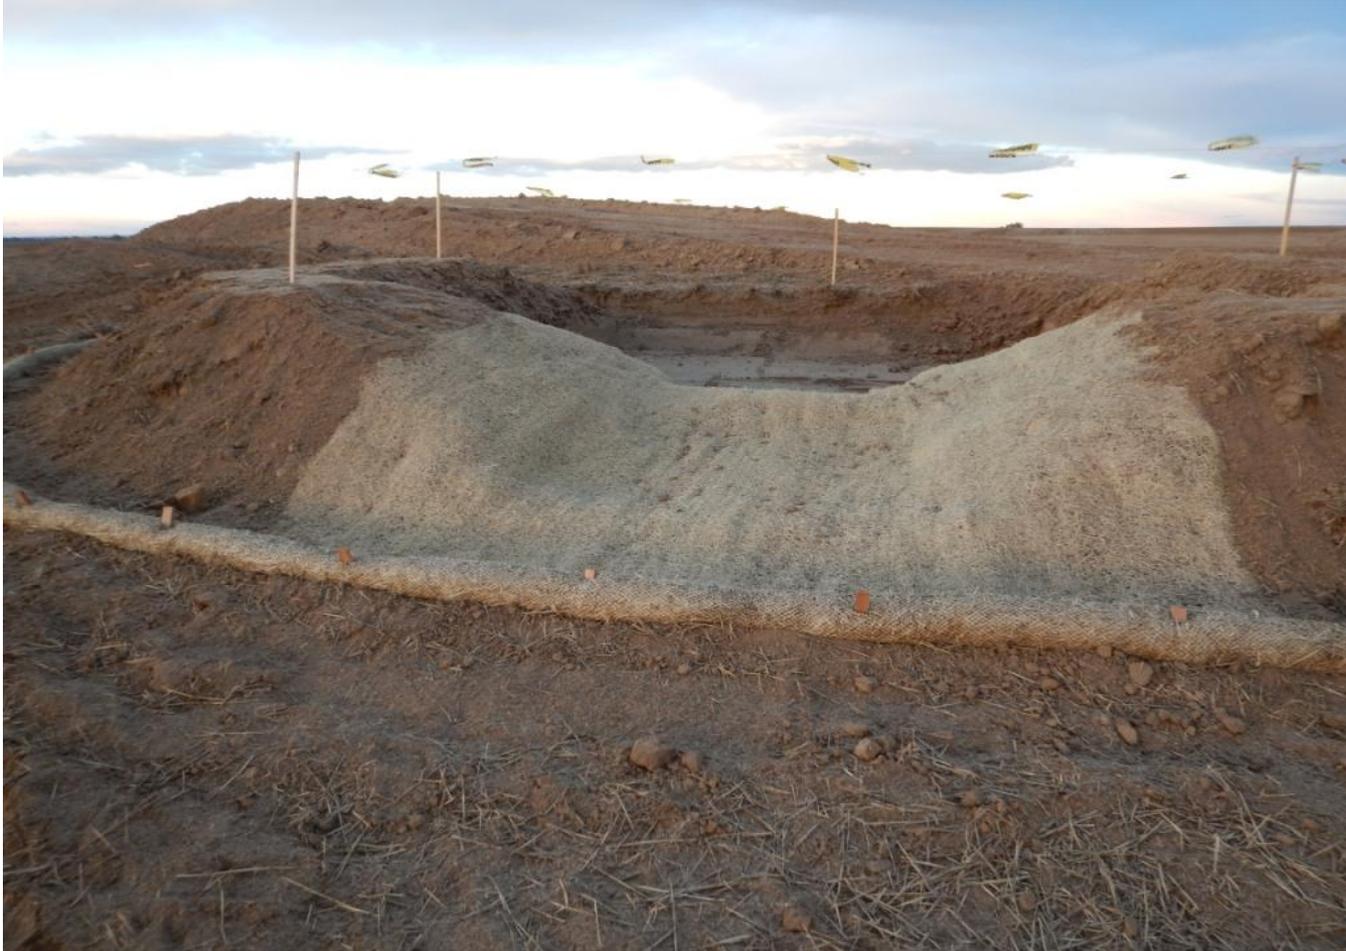
Photo 11. Photo taken from southwest location of facility pad, facing Northeast. Stormwater sediment catch located in center of photo.

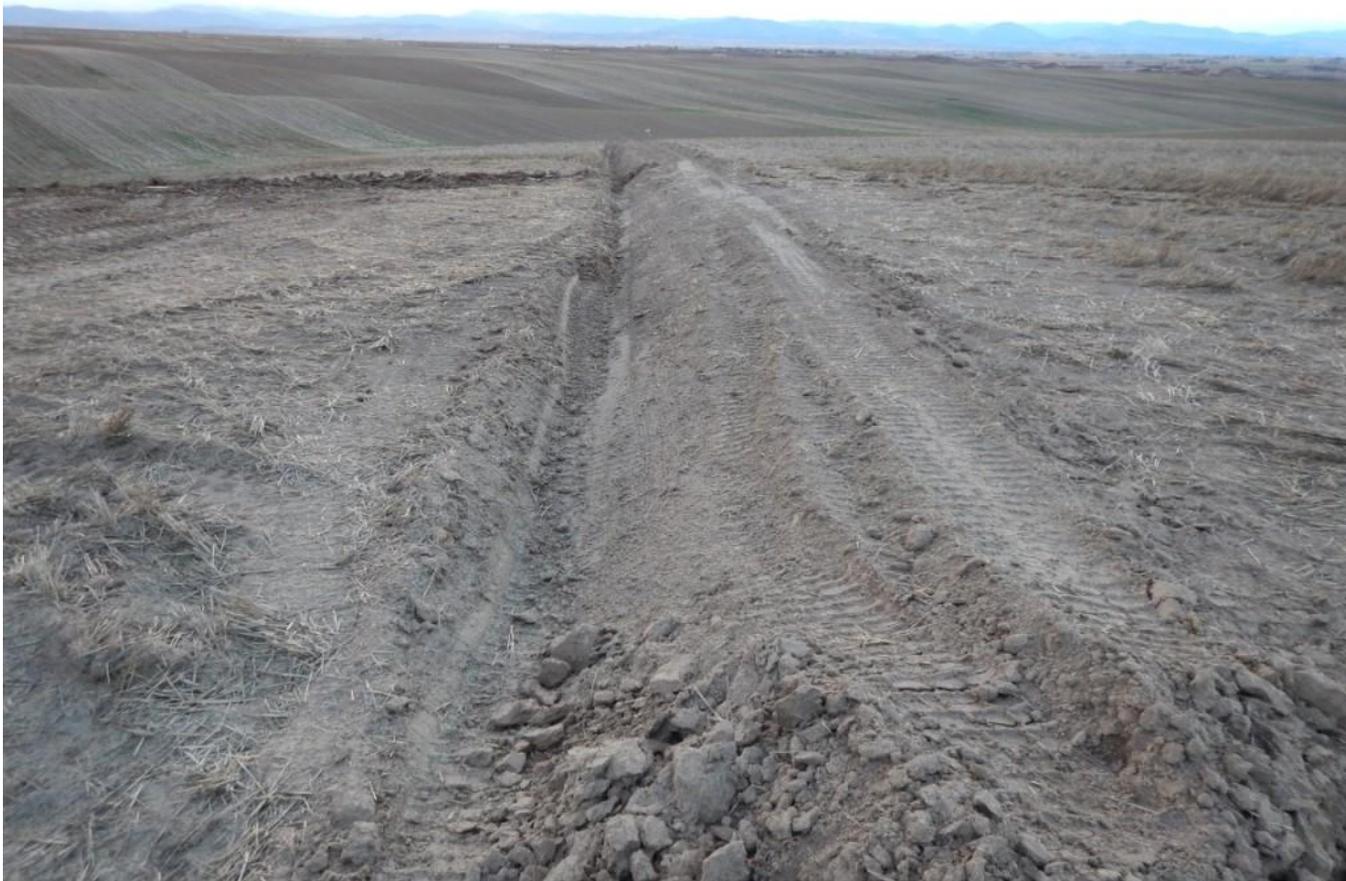
Photo 12. Photo taken from southwest location of facility pad, facing West. Stormwater control ditch located in center of photo heading West from sediment catch.

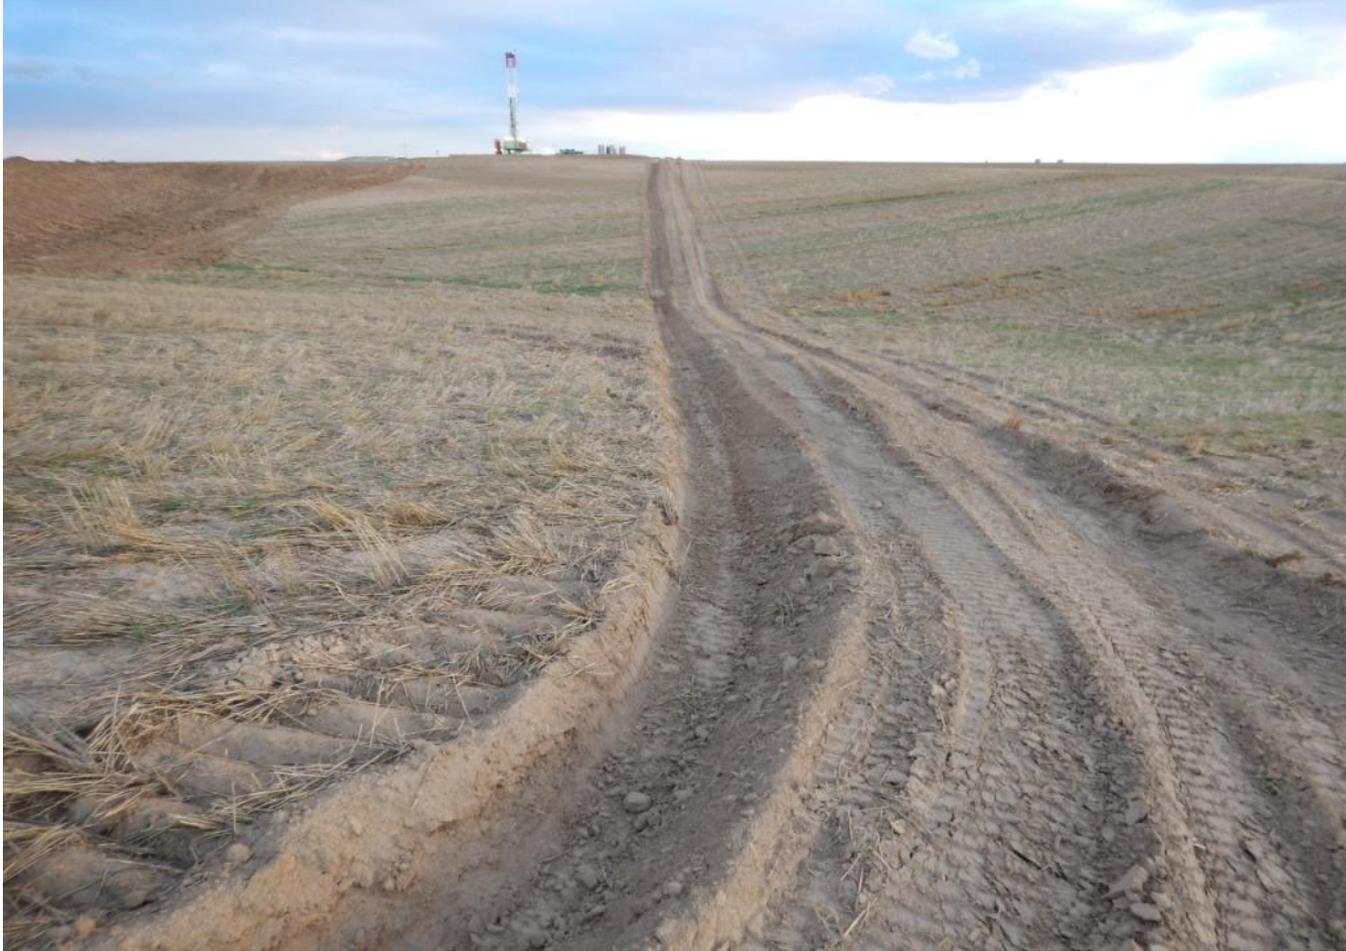
Photo 13. Photo taken from western location of facility pad and well pad, facing South. Stormwater control ditch located in center of photo.

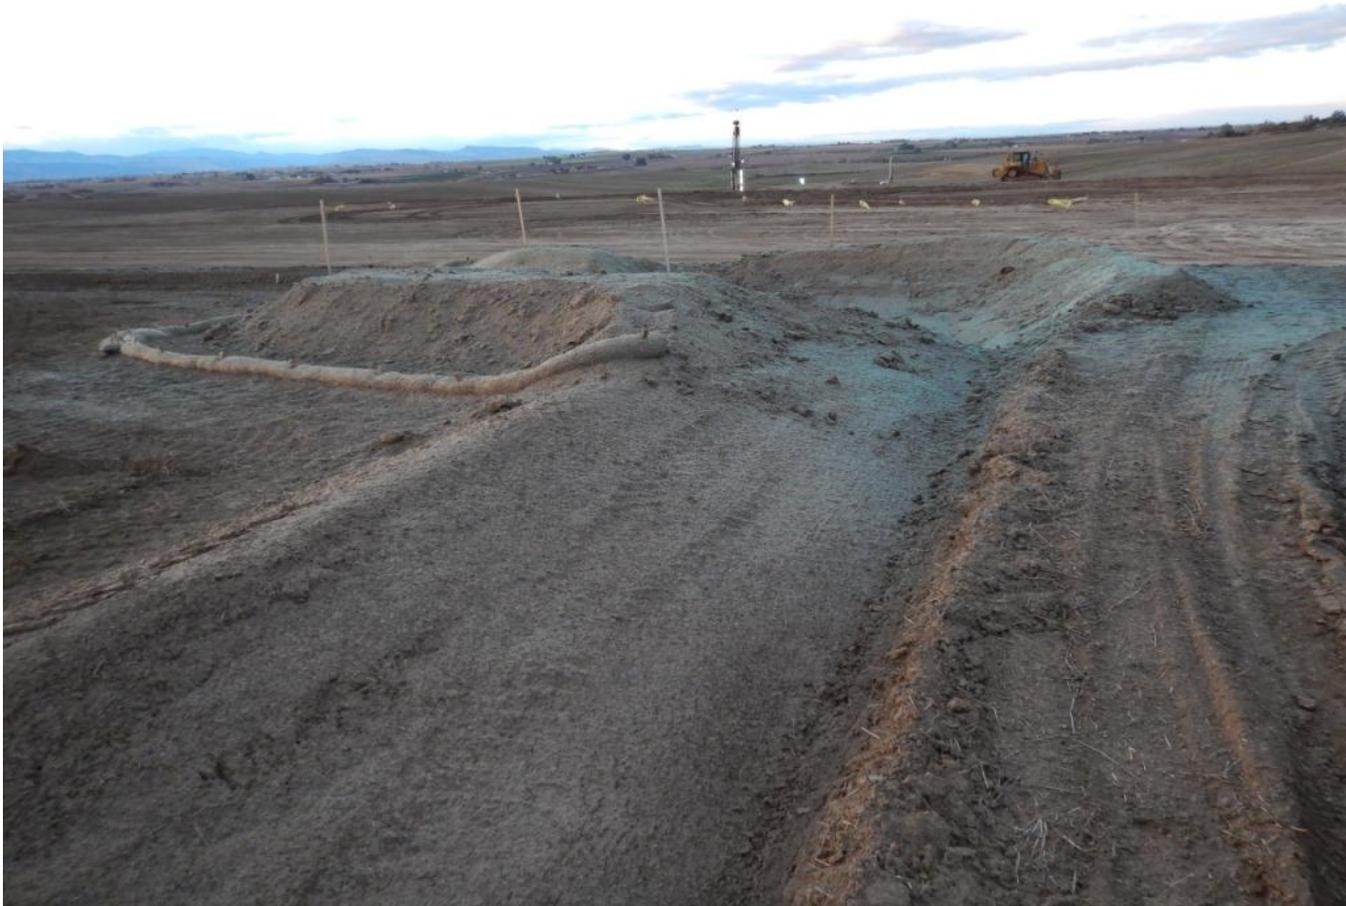
Photo 14. Photo taken from northwest location of facility pad, facing North. Stormwater sediment catch located in center of photo.

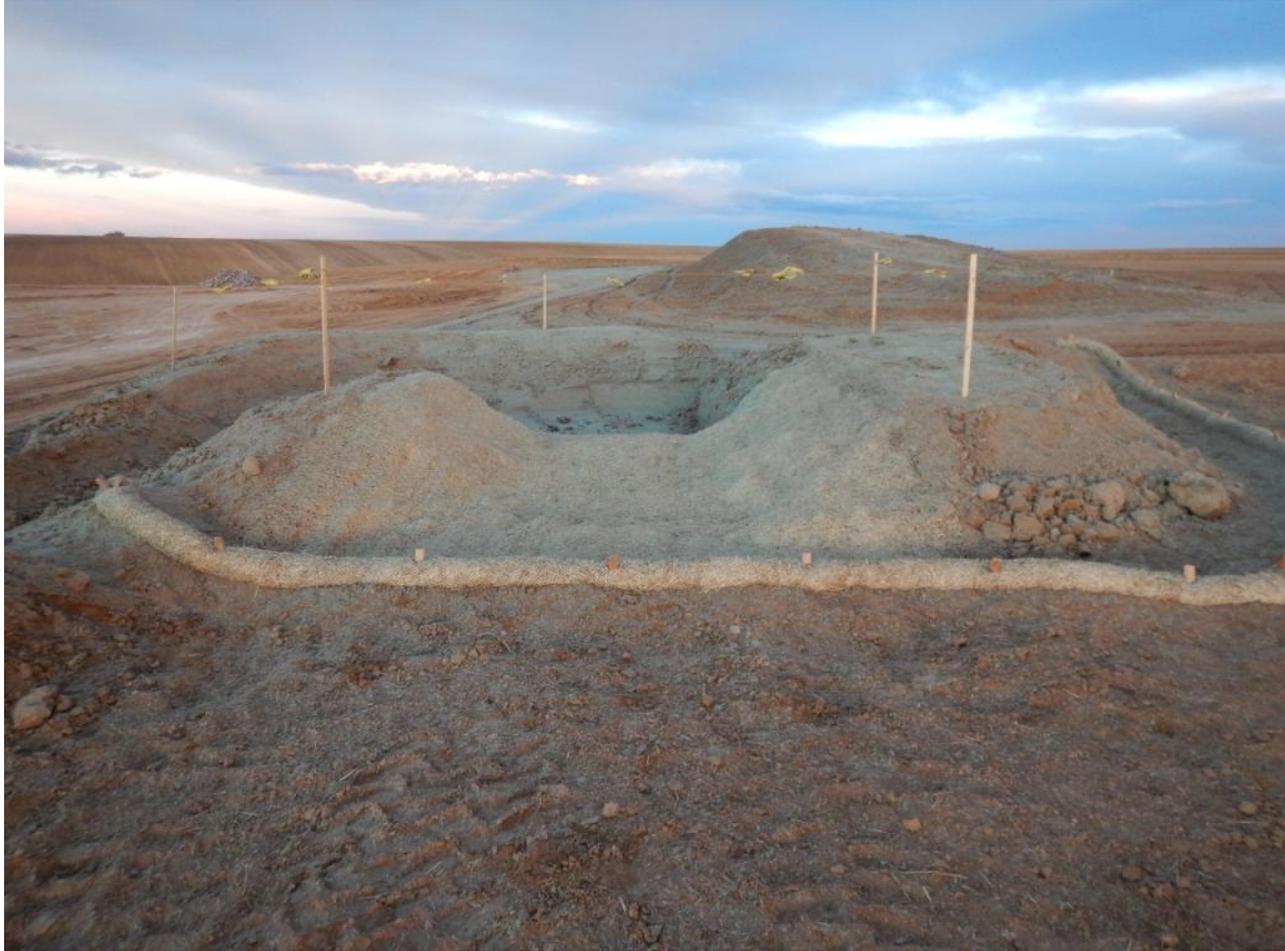
Photo 15. Photo taken from northwest location of facility pad, facing East towards north topsoil stockpile. Stormwater sediment catch located in center of photo.

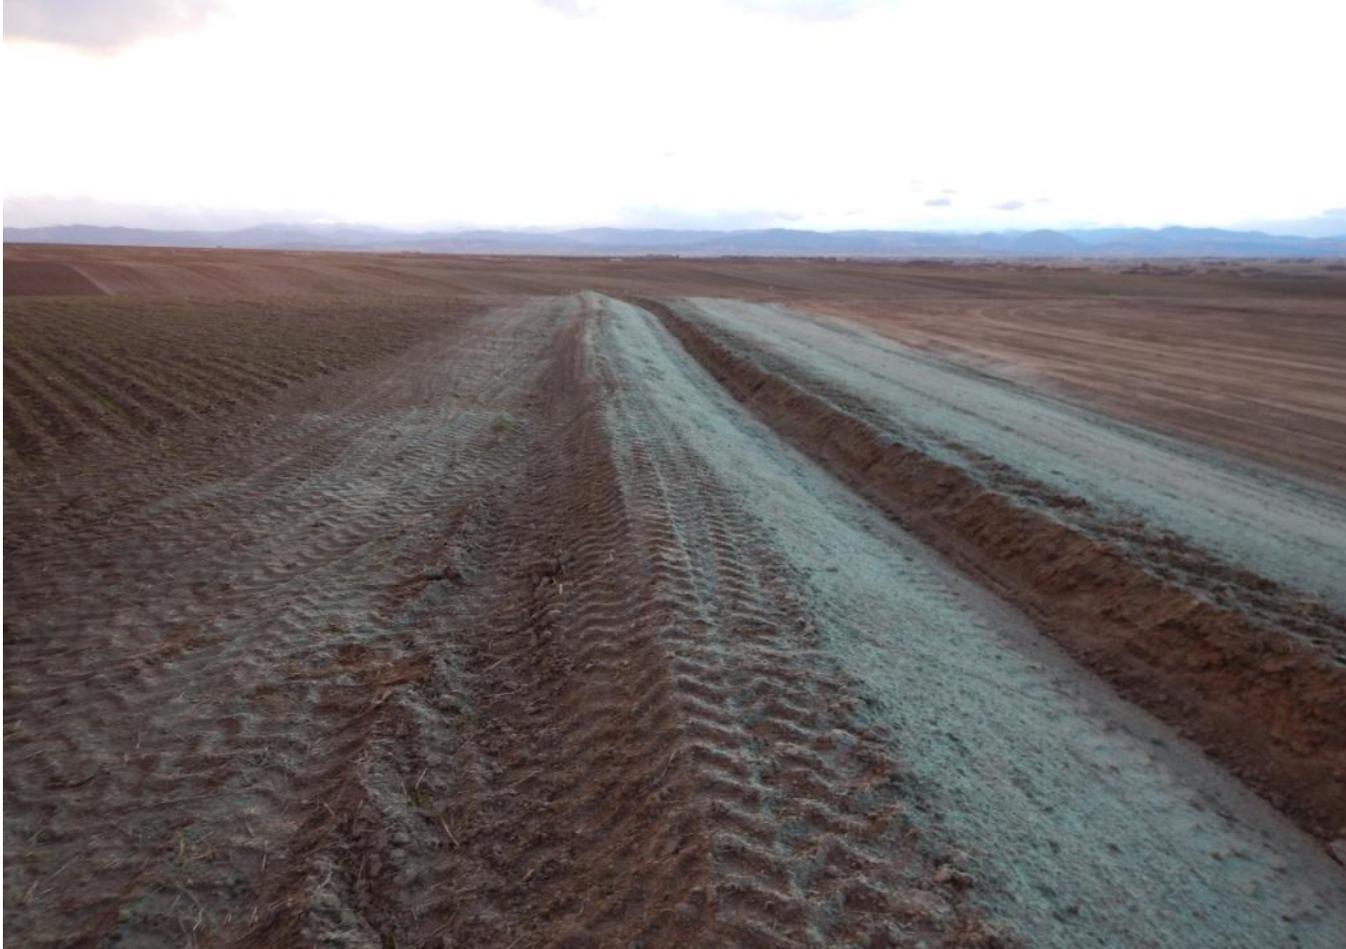
Photo 16. Photo taken from northwest location of facility pad, facing West. Stormwater control ditch located in center of photo.

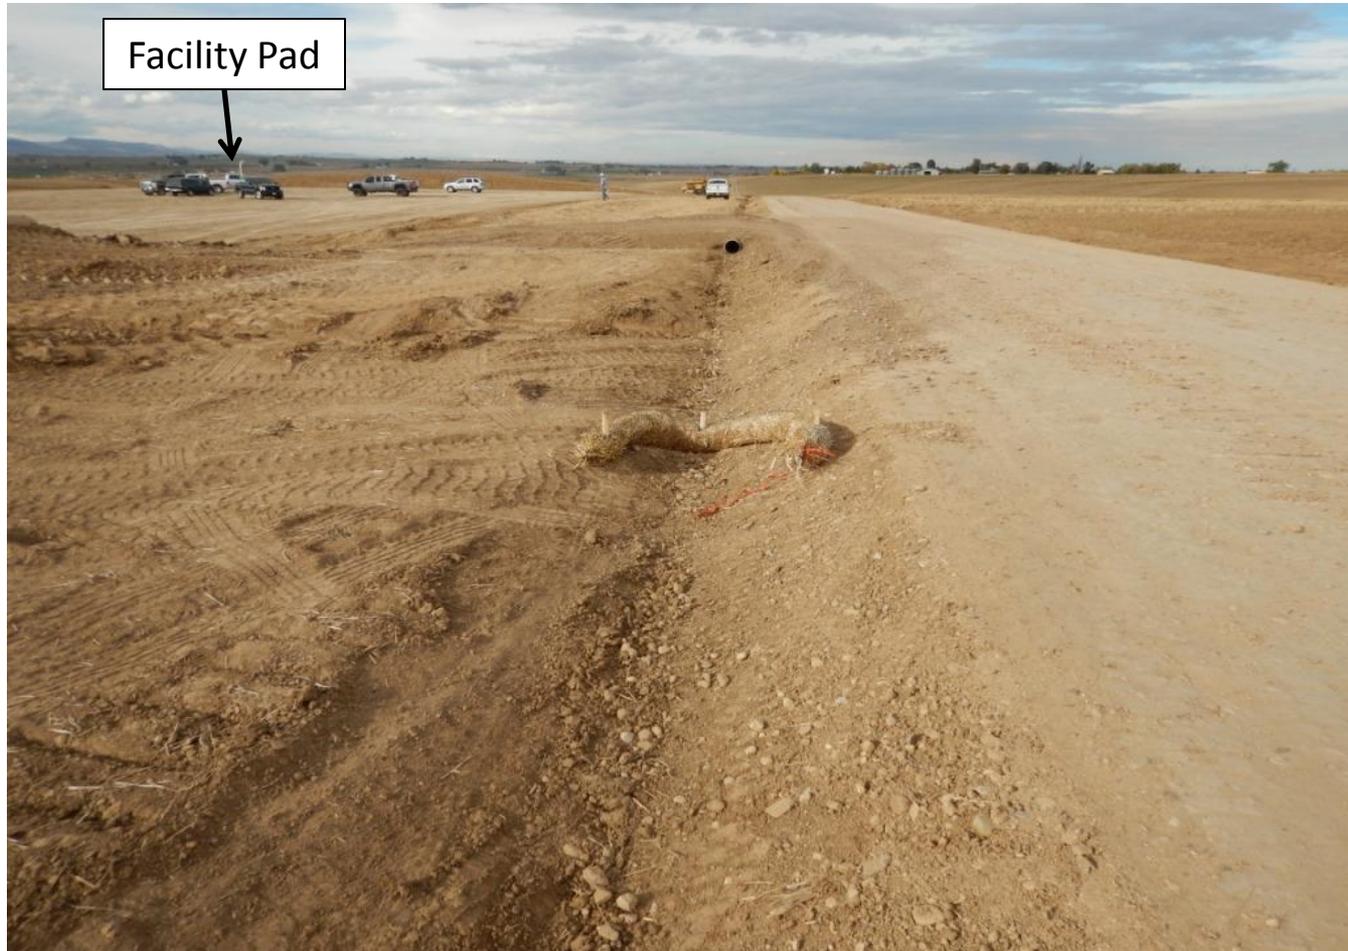
Photo 17. Photo taken from eastern edge of facility pad and well pad, facing North. Stormwater control ditch, culvert, and straw wattle in center of photo for access road.
