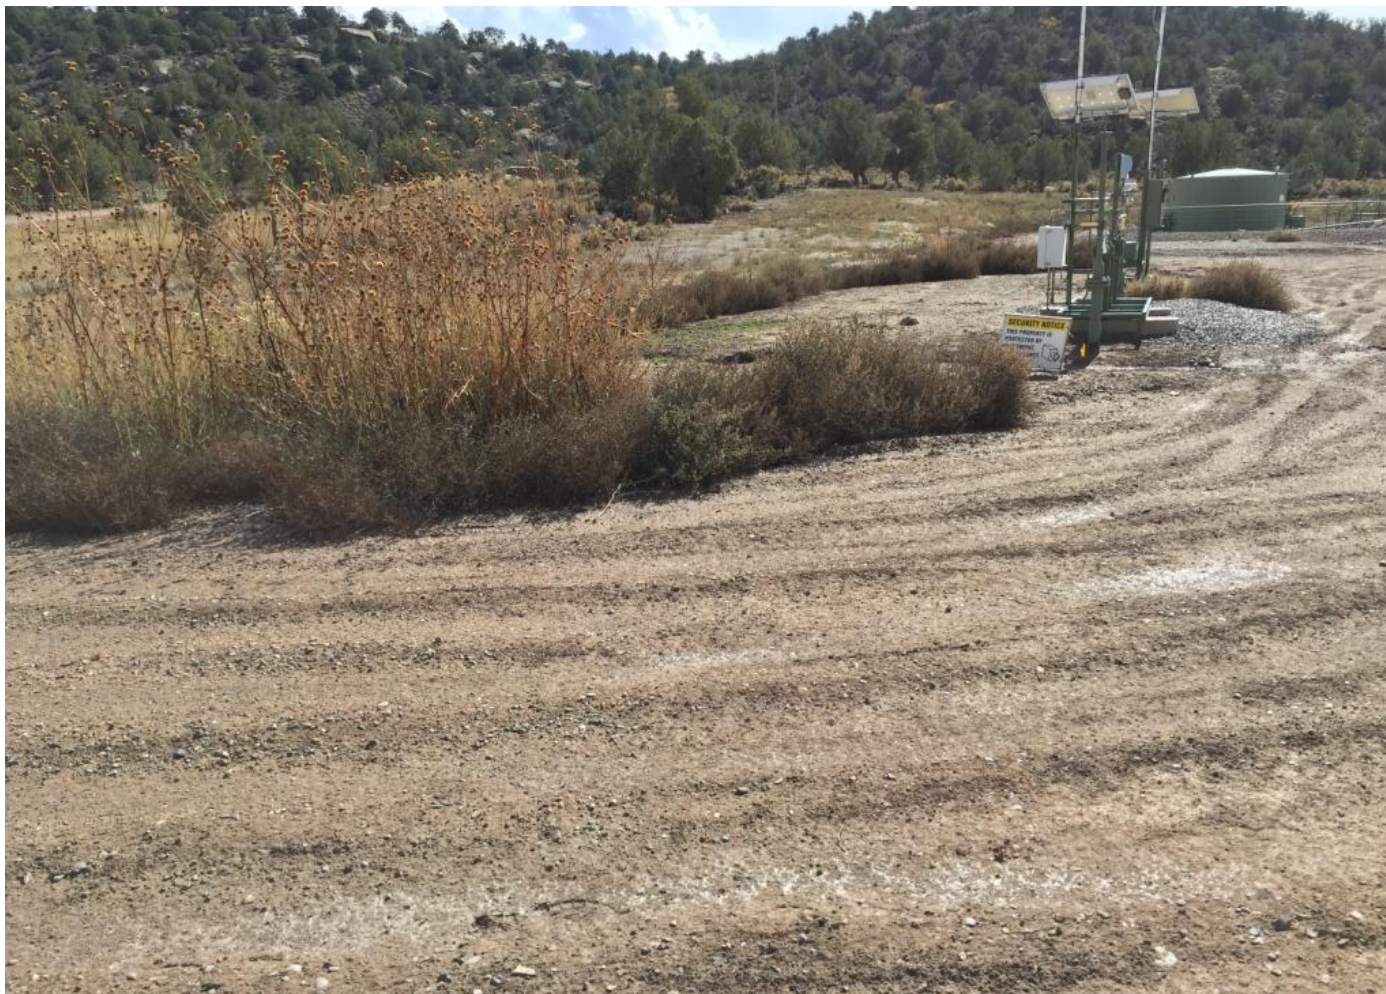
Photo 1. View of eastern portion of project area from well pad entrance (northeast) facing southward. Russian thistle (*Salsola tragus*) plants are growing along the edges of the working area and facilities areas and needs to be removed.

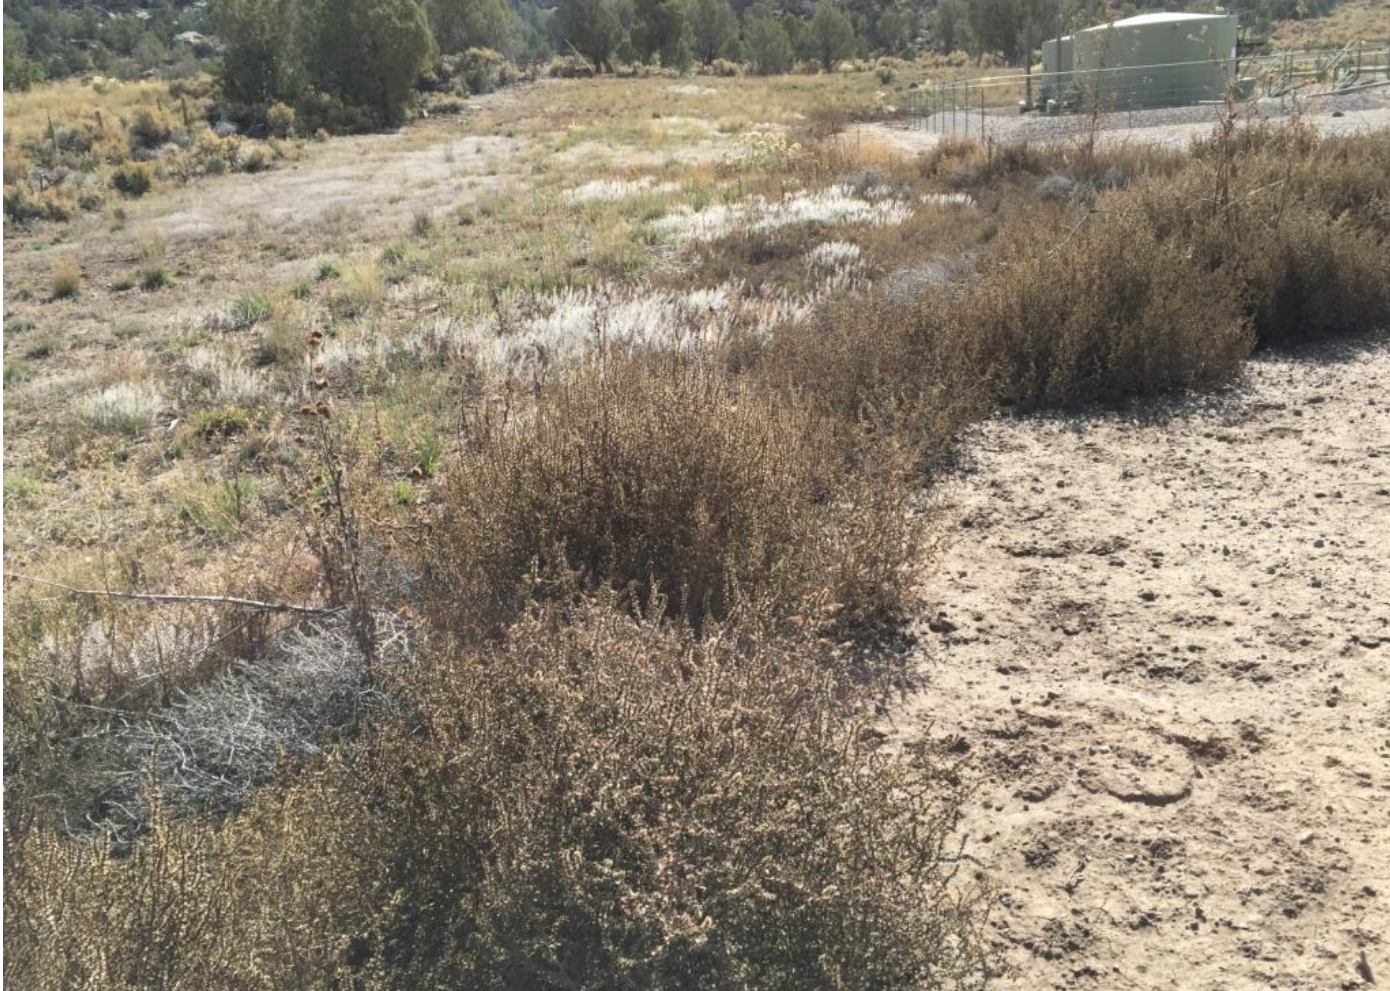
Photo 2. View of Russian thistle plants growing along the eastern edge of the project area (brown spiny vegetation on right side of photo).

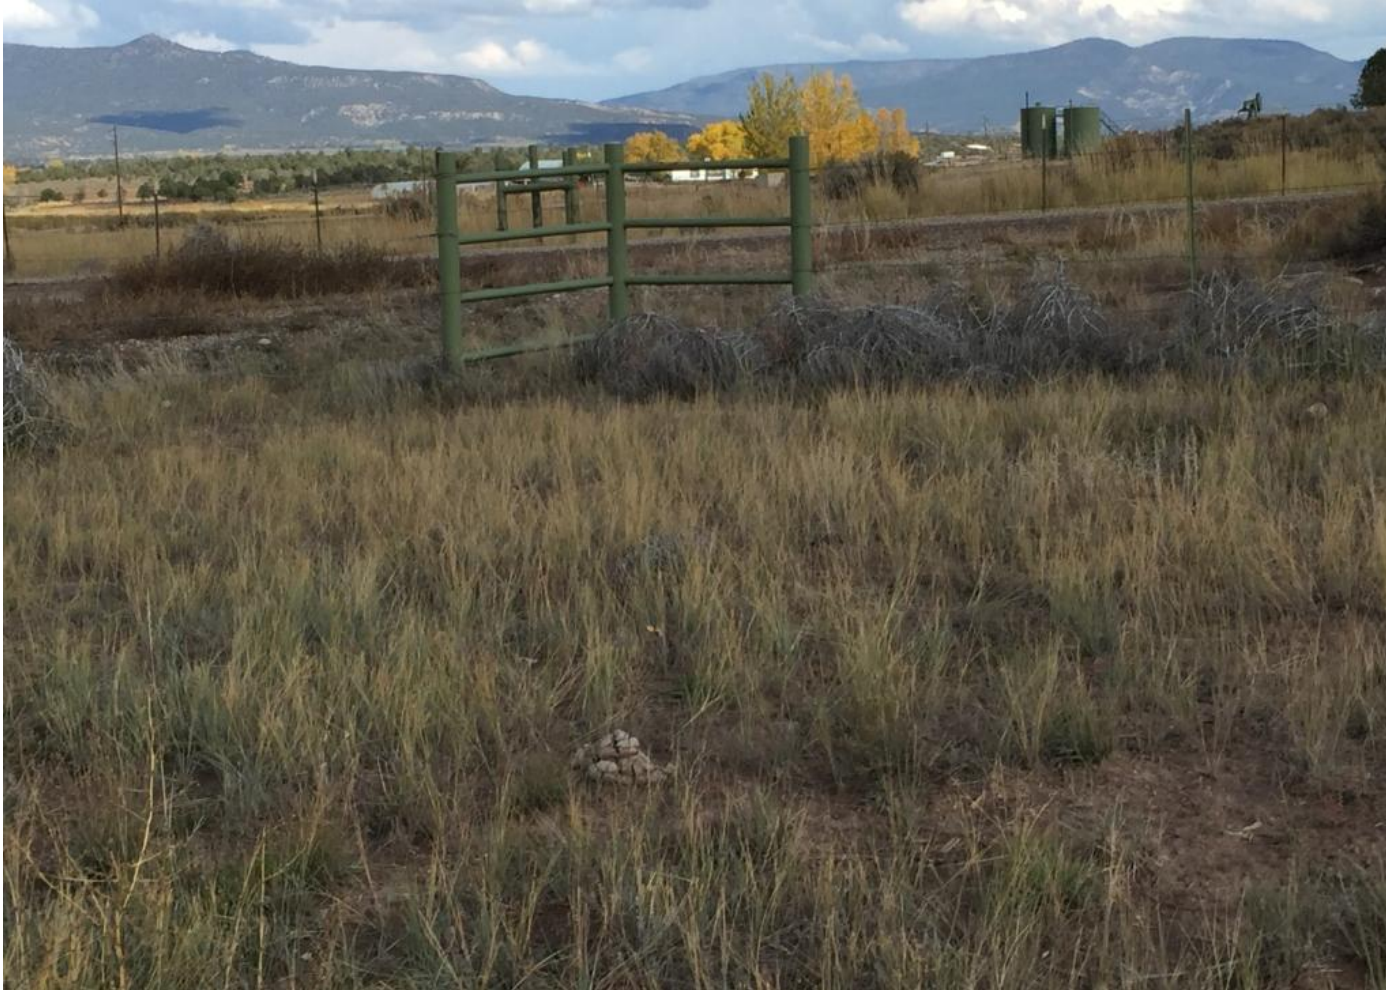
Photo 3. View of Russian thistle debris (in background) that appears to have blown off of the project area caught along the fenceline, just east of the project area.

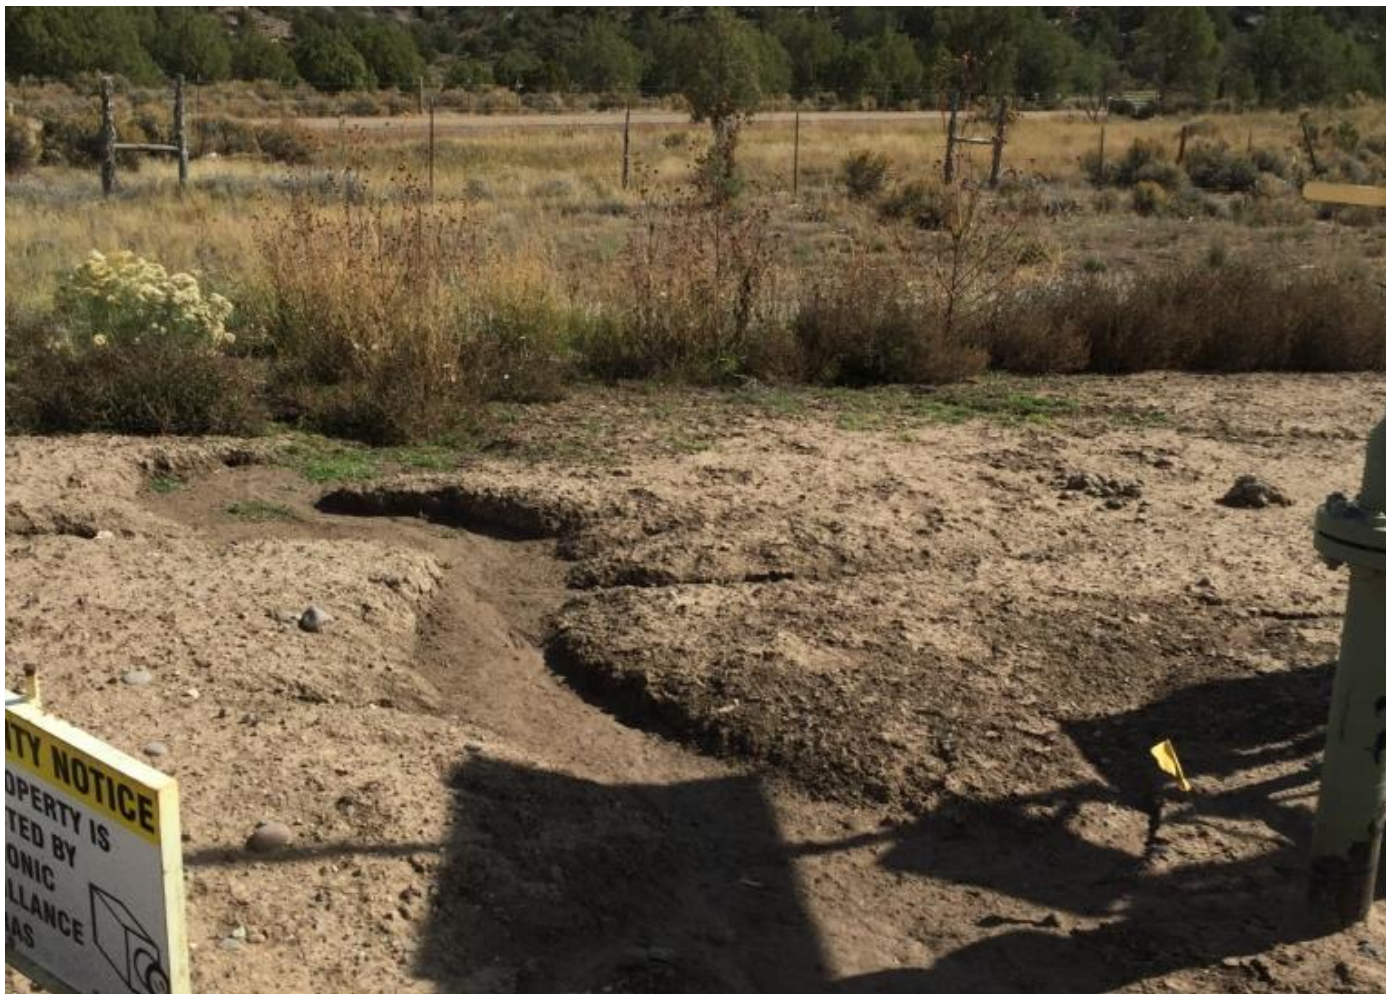
Photo 3. View of erosional channel (approximately 2 feet wide and 6 inches deep) forming within the northeastern portion of the project area.

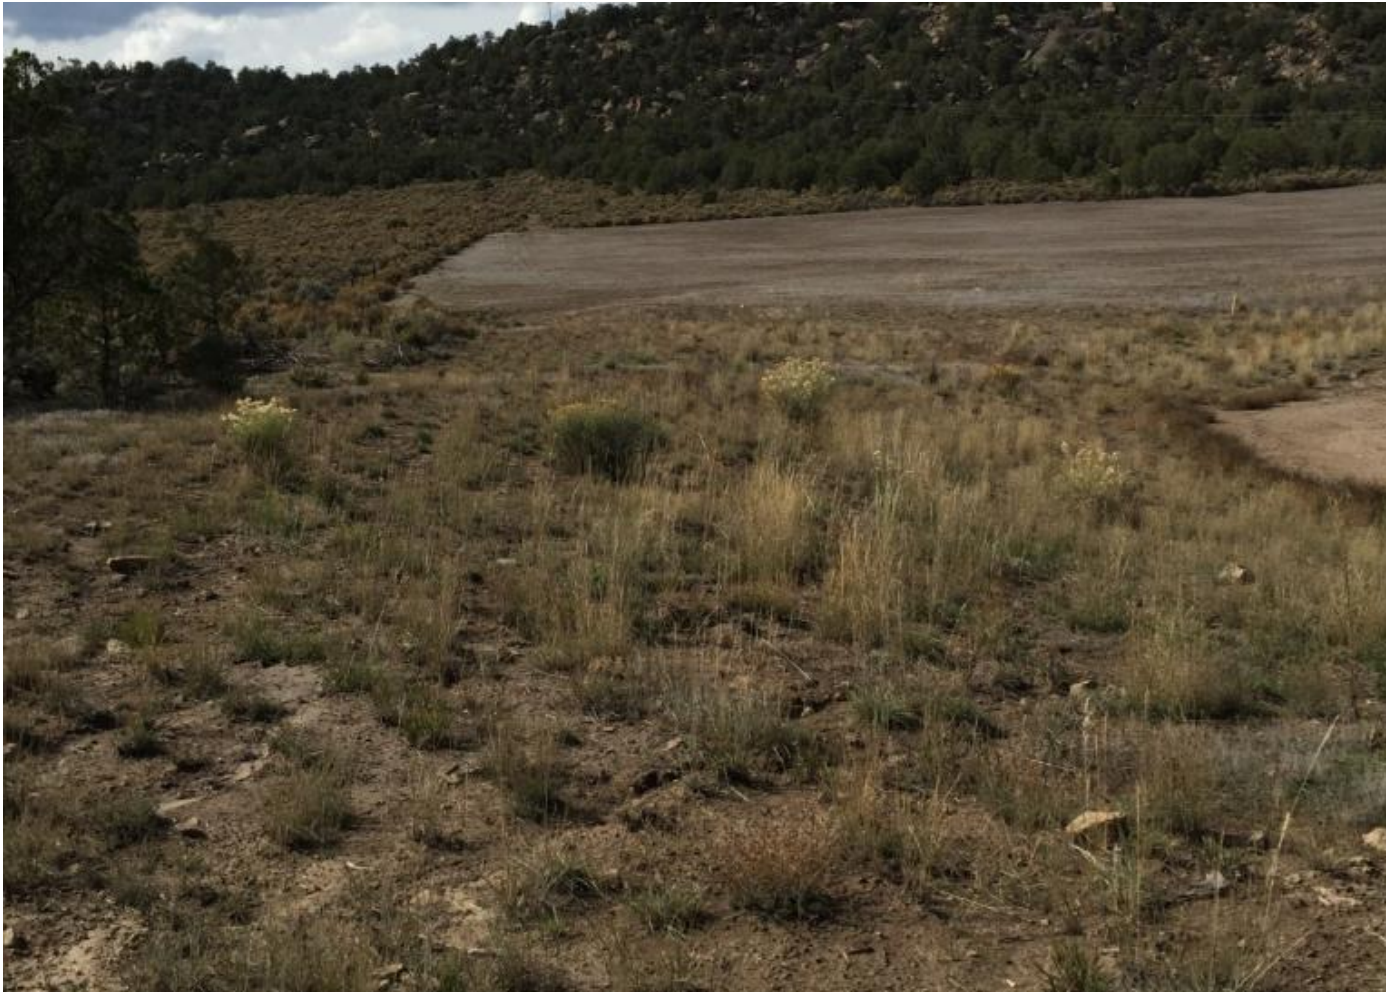
Photo 4. View of southern portion of the project area from the southeastern portion of the project area facing westward. Revegetation is comprised of both desirable and undesirable species such as crested wheatgrass (*Agropyron cristatum*), western wheatgrass (*Pascopyrum smithii*), and alyssum (*Allysum simplex*).

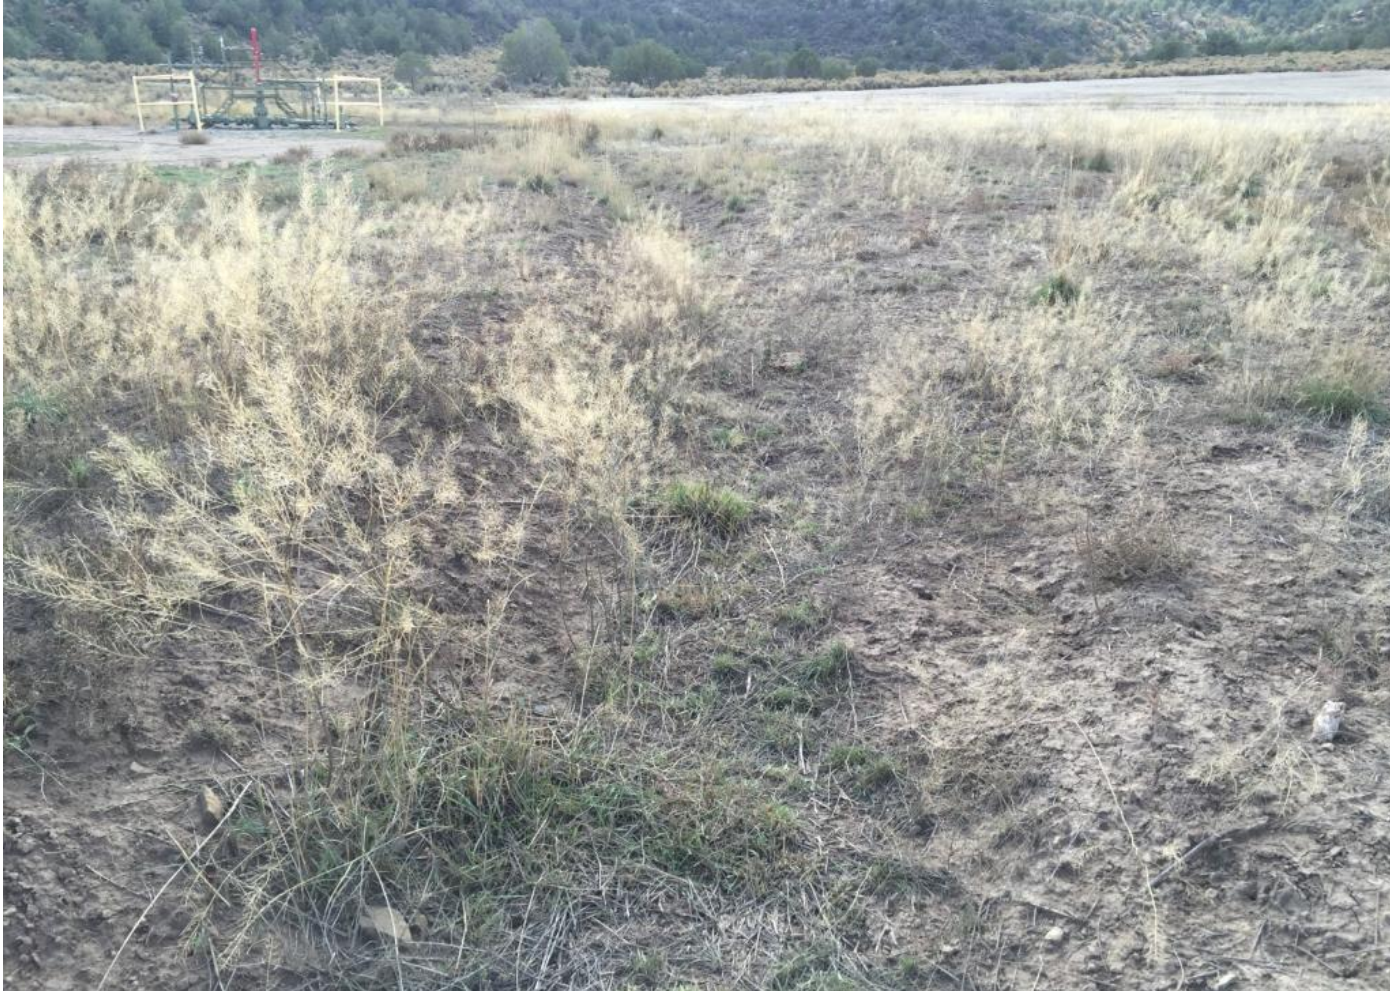
Photo 5. View of western portion of the project area from the northwestern corner facing southward.
