## Silverback 36-A

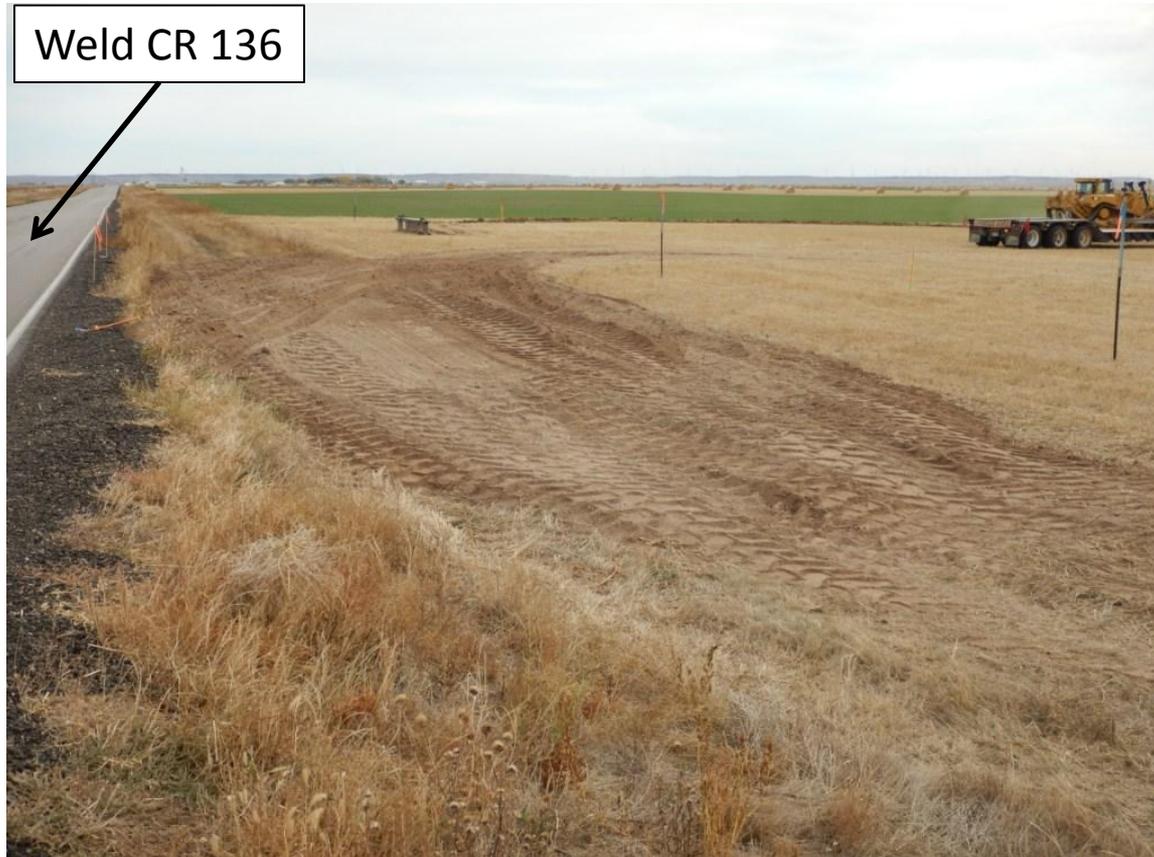
**Photo 1.** Photo taken from northern access road with no stormwater BMP's, facing East on 10/20/2015.

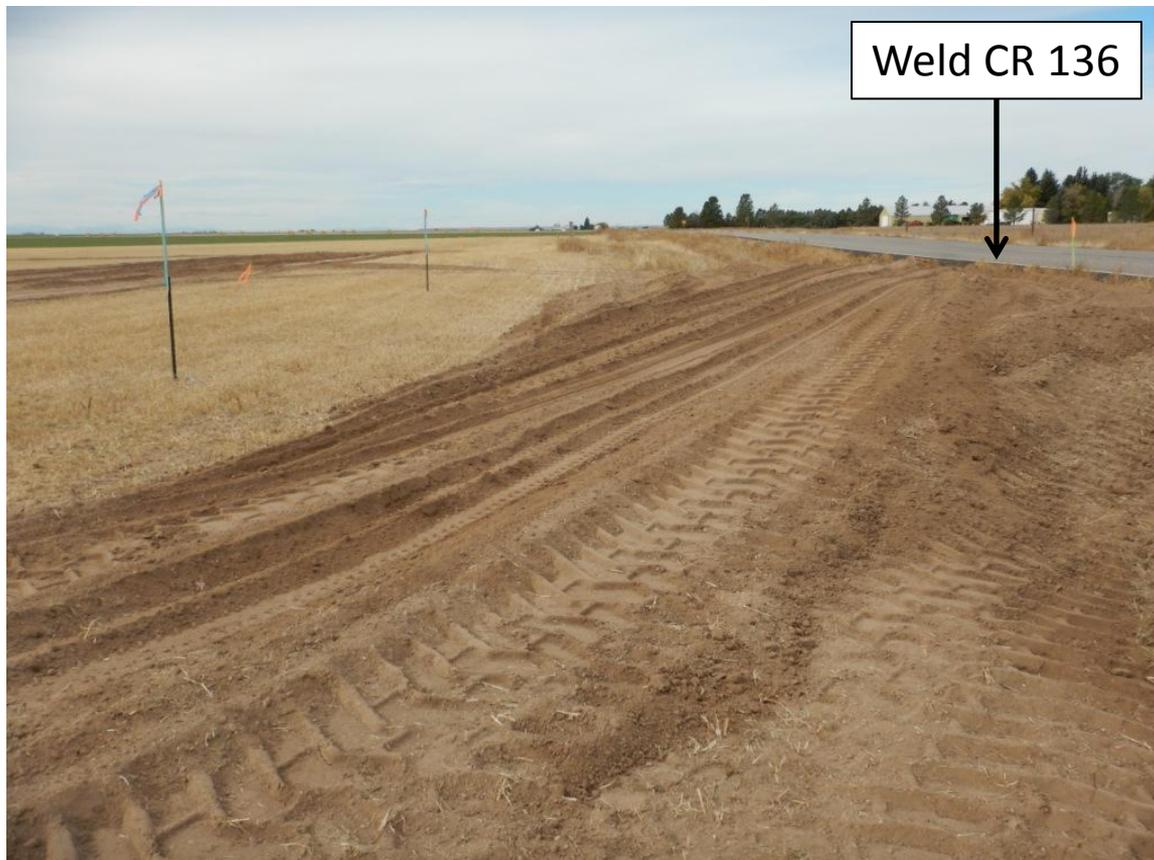
**Photo 2.** Photo taken from northern location, facing West on 10/20/2015. No stormwater control BMPs.

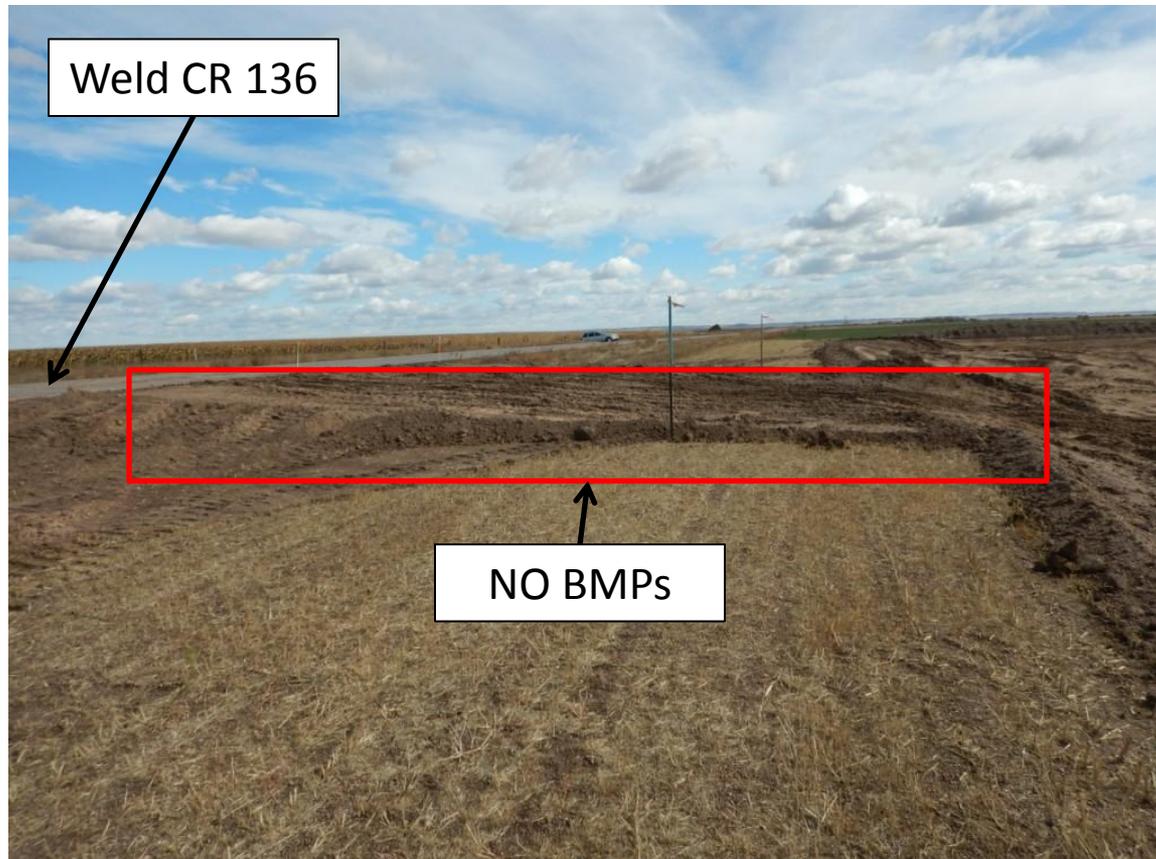
**Photo 3.** Photo taken from northern access road with no stormwater BMP's, facing East on 10/23/2015. Corrective action was not met.

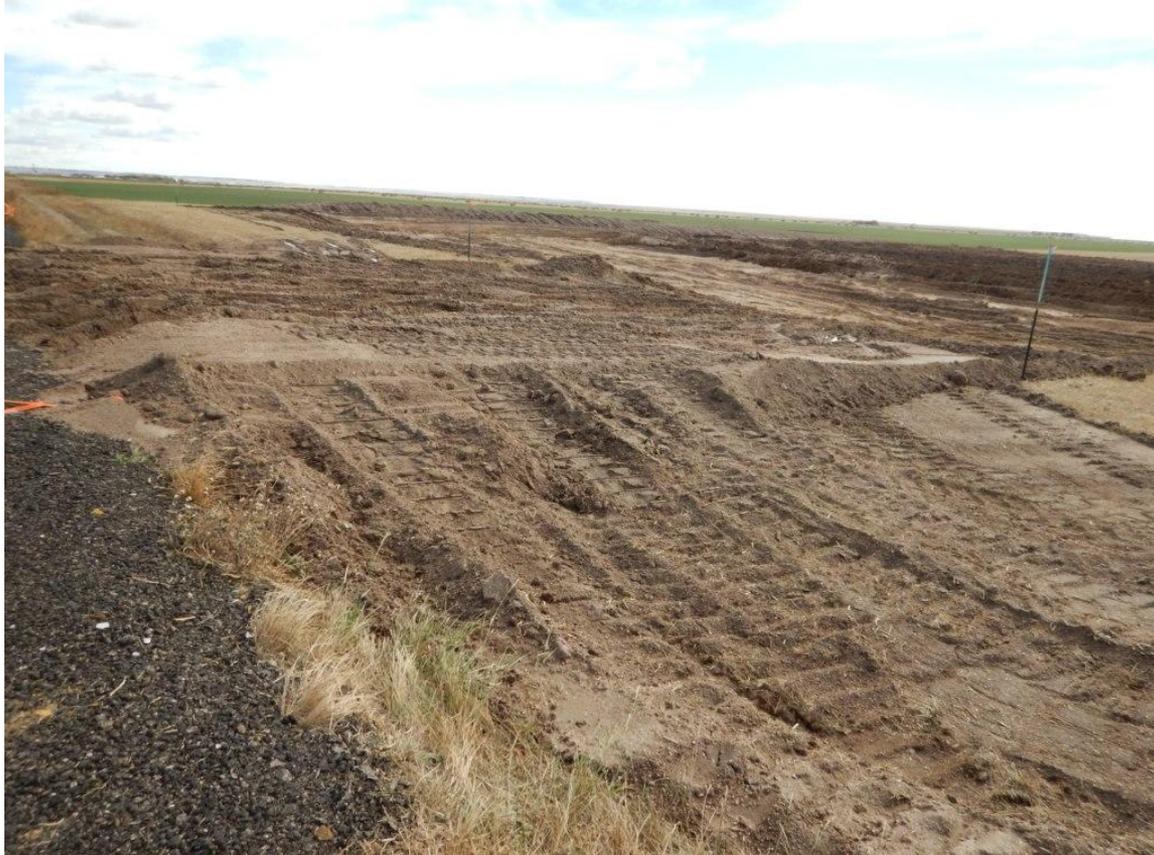
**Photo 4.** Close-up photo taken from northern access road with no stormwater BMP's, facing East on 10/23/2015. Also, the County road bar ditch disturbance is exceeding the permitted area. This will be forwarded onto OGLA for further review.

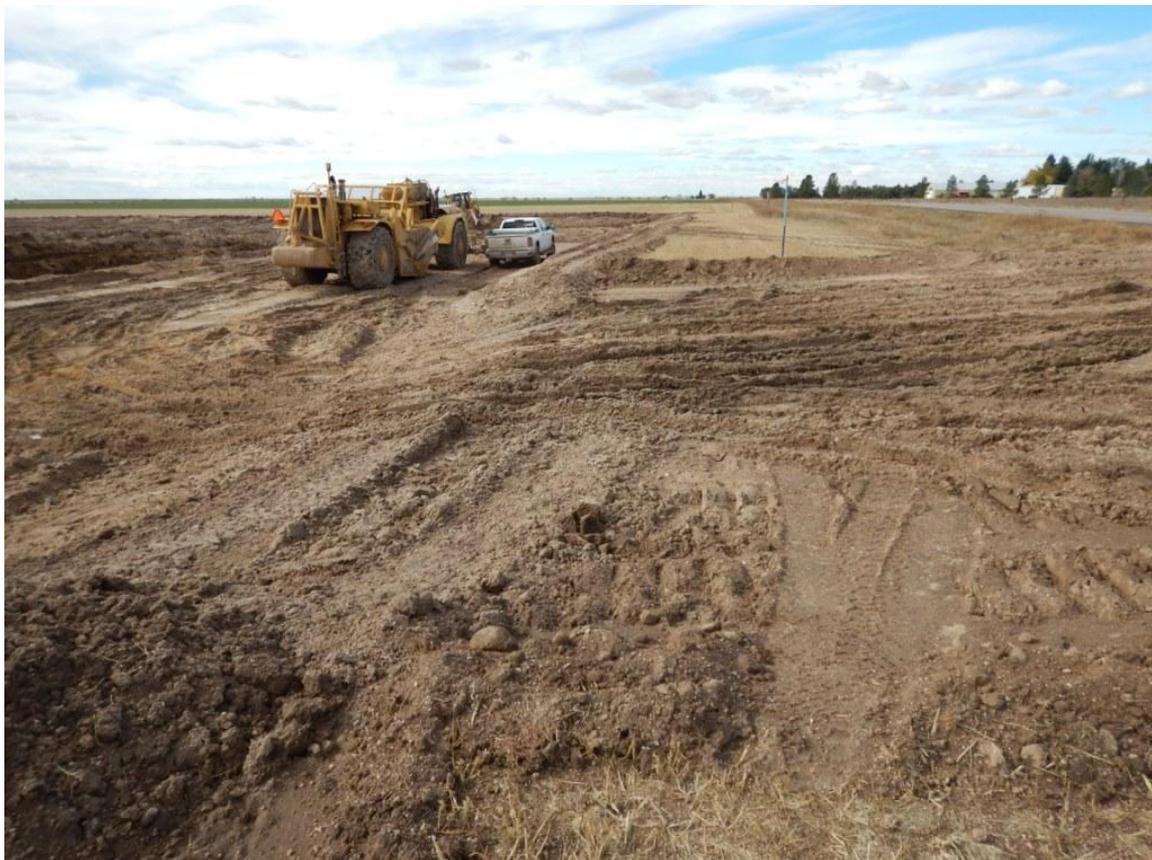
**Photo 5.** Close-up photo taken from northern location, facing West on 10/23/2015. No stormwater control BMPs. Corrective action was not met.

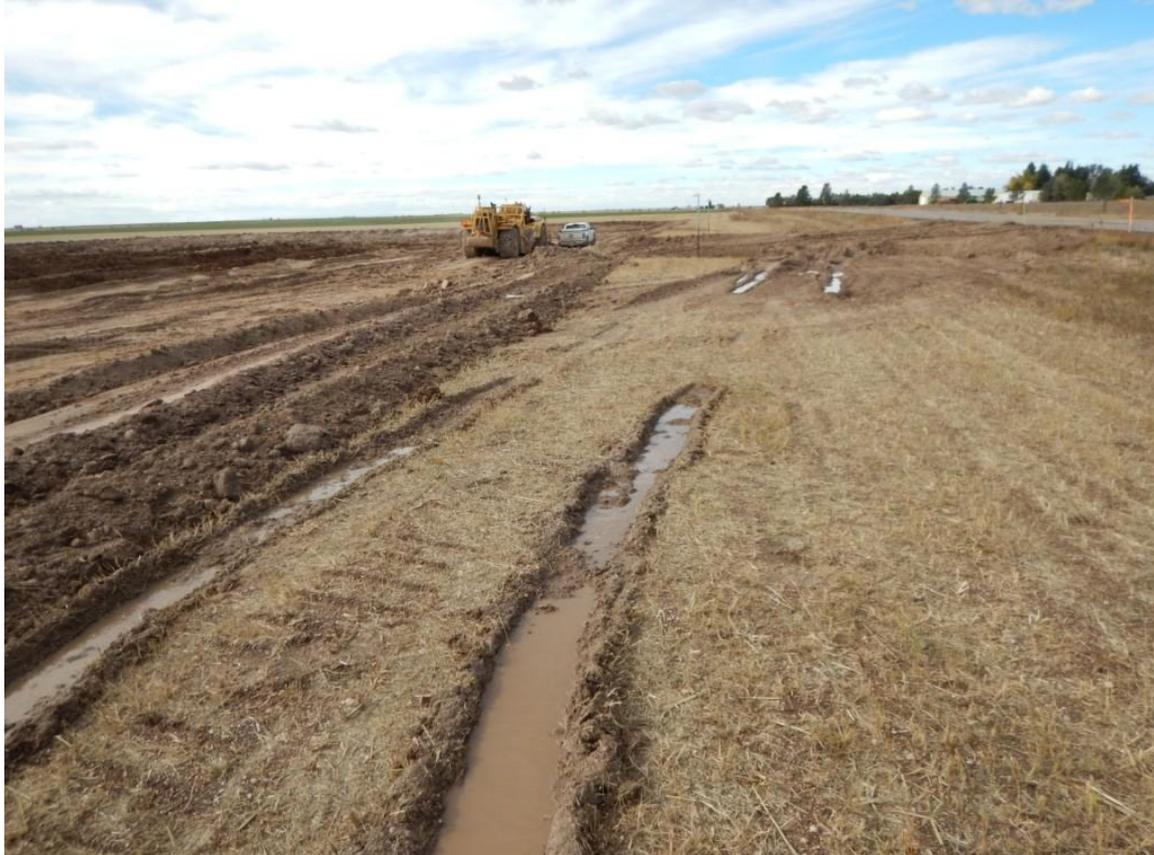
**Photo 6.** Photo taken from northern location, facing West on 10/23/2015. No stormwater control BMPs. Corrective action was not met.

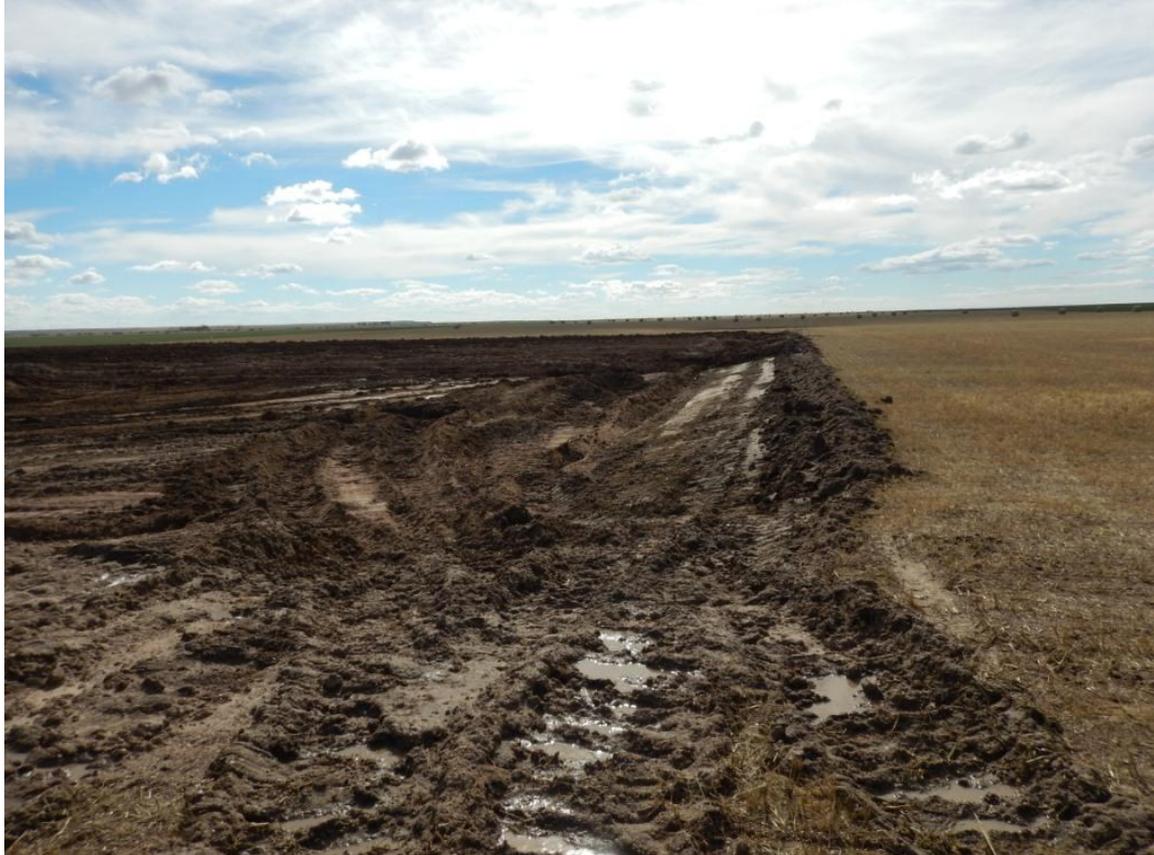
**Photo 7.** Photo taken from west location, facing South on 10/23/2015. No stormwater control BMPs. Corrective action was not met.

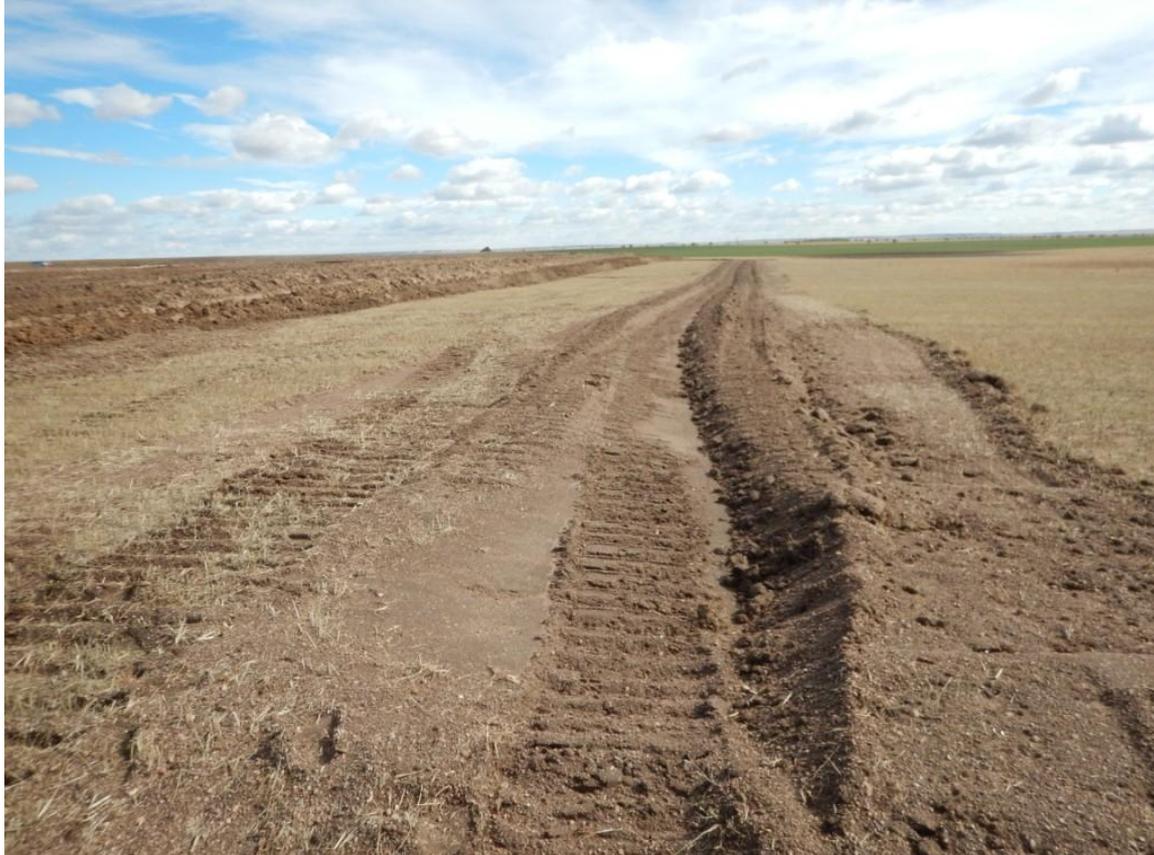
**Photo 8.** Photo taken from southern location, facing East on 10/23/2015. Stormwater control ditch about 30 feet south of disturbed location.

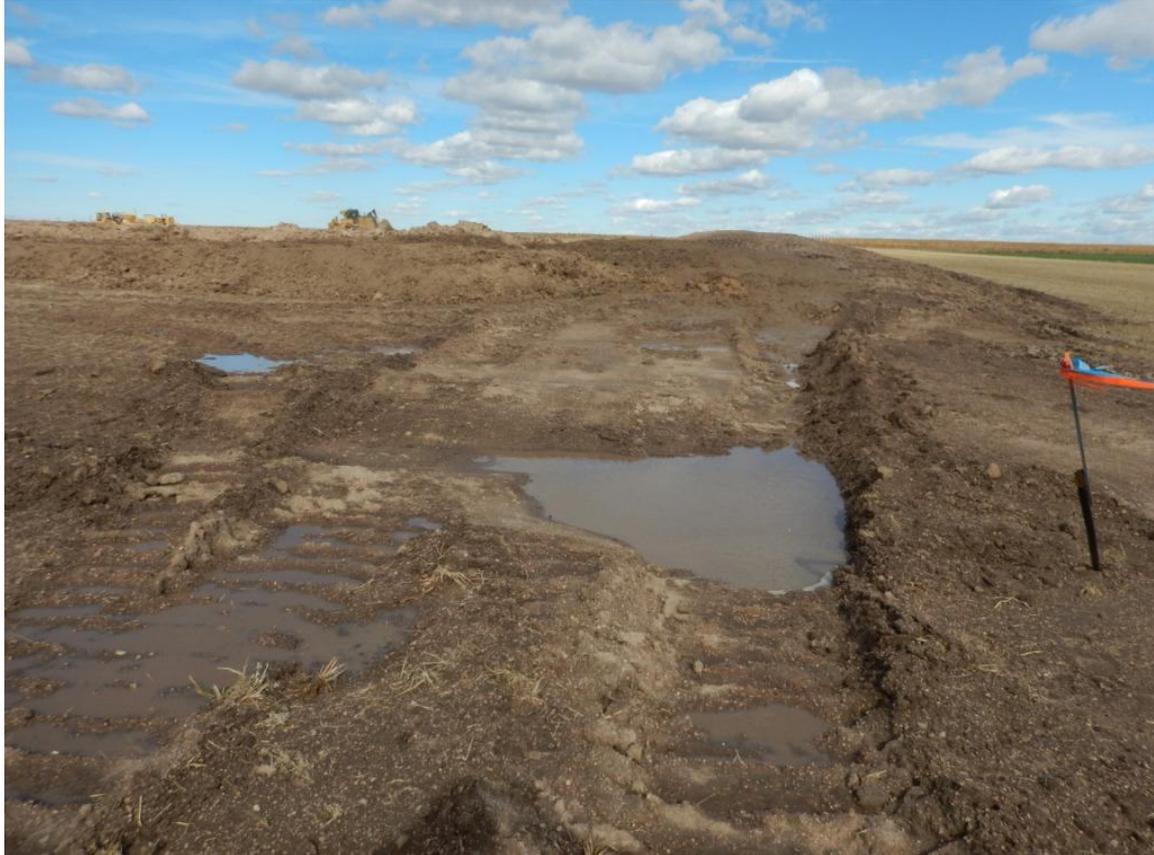
**Photo 9.** Photo taken from Southeast corner of location, facing North towards topsoil stockpile on 10/23/2015. No stormwater controls. Also, pooling water in center of photo. Corrective action was not met.

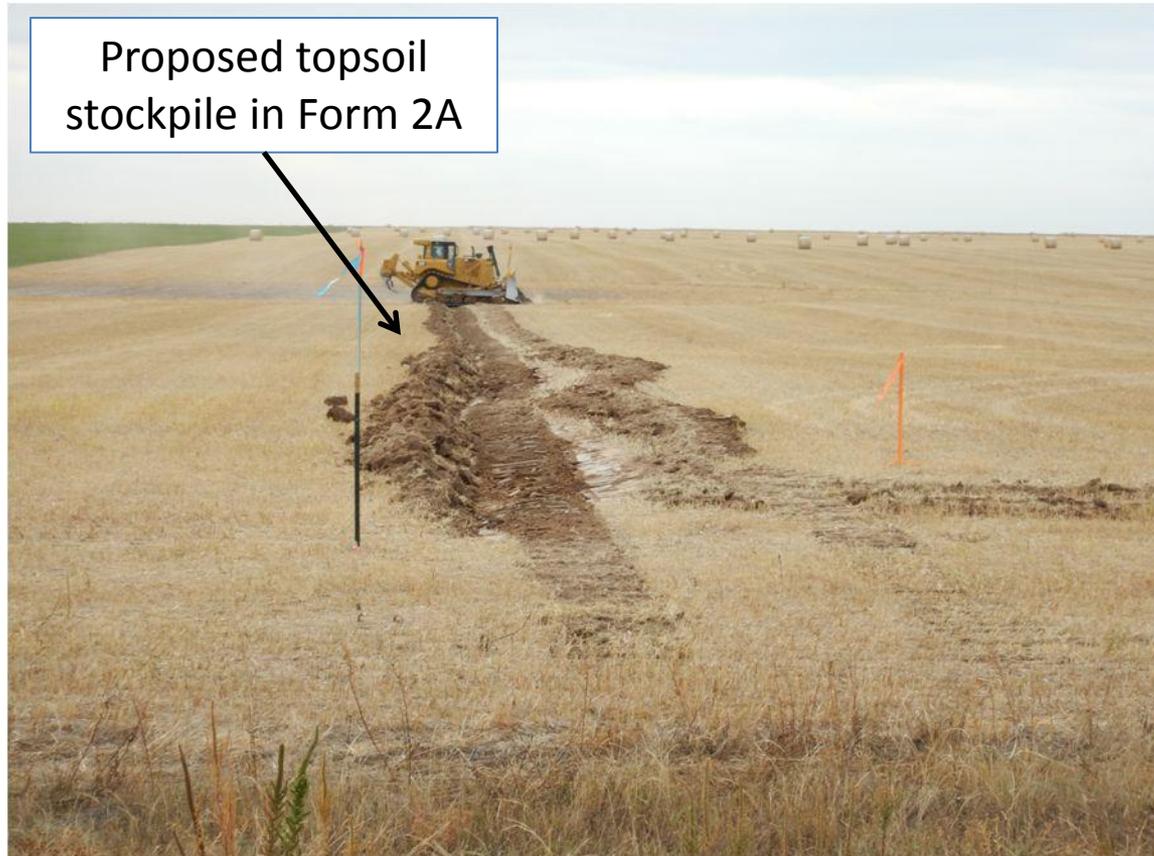
**Photo 10.** Photo taken from northeast location of the east stormwater control ditch, facing South on 10/20/2015. Dozer operator installed ditched after discussing lack of BMPs on 10/20/2015.

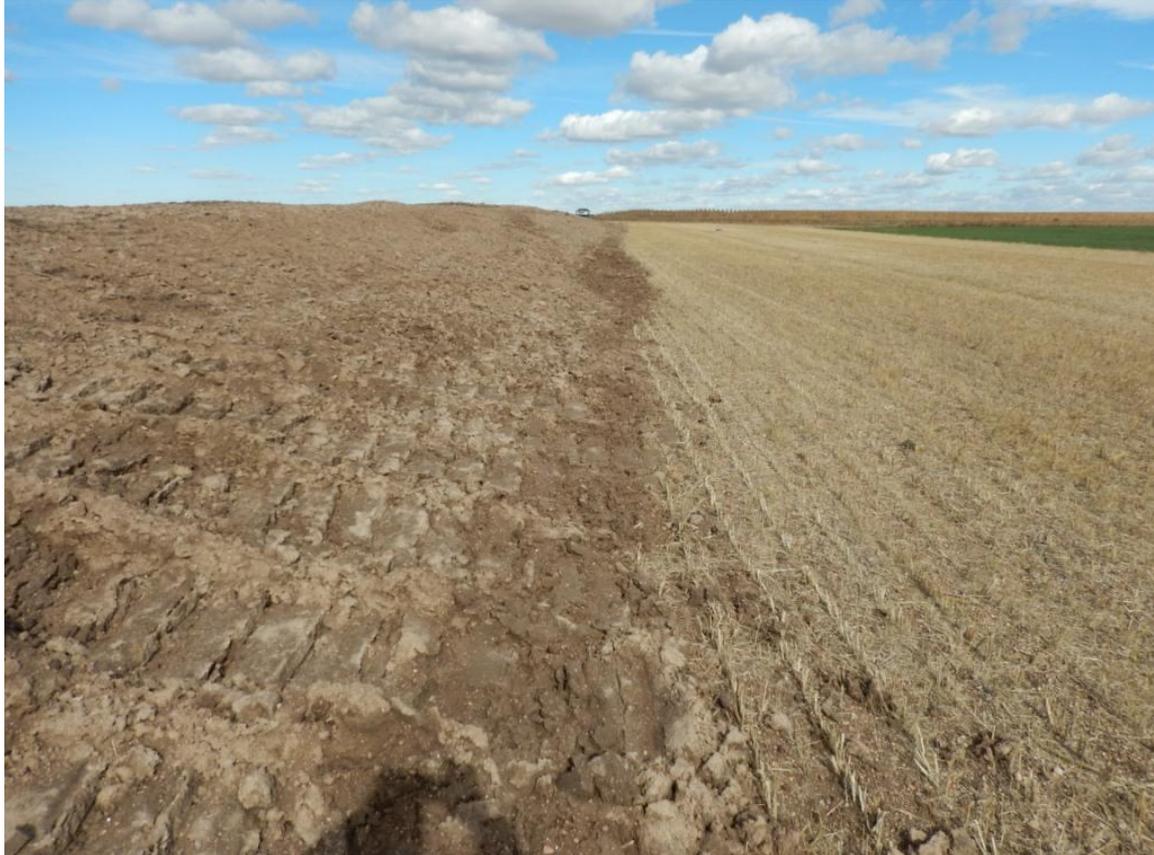
**Photo 11.** Photo taken from east location, facing North on 10/23/2015. Topsoil stockpile was placed on top of east stormwater control ditch (refer to Photo 10). Need to reconstruct stormwater control ditch and stormwater controls need to be in place for the topsoil stockpile.
