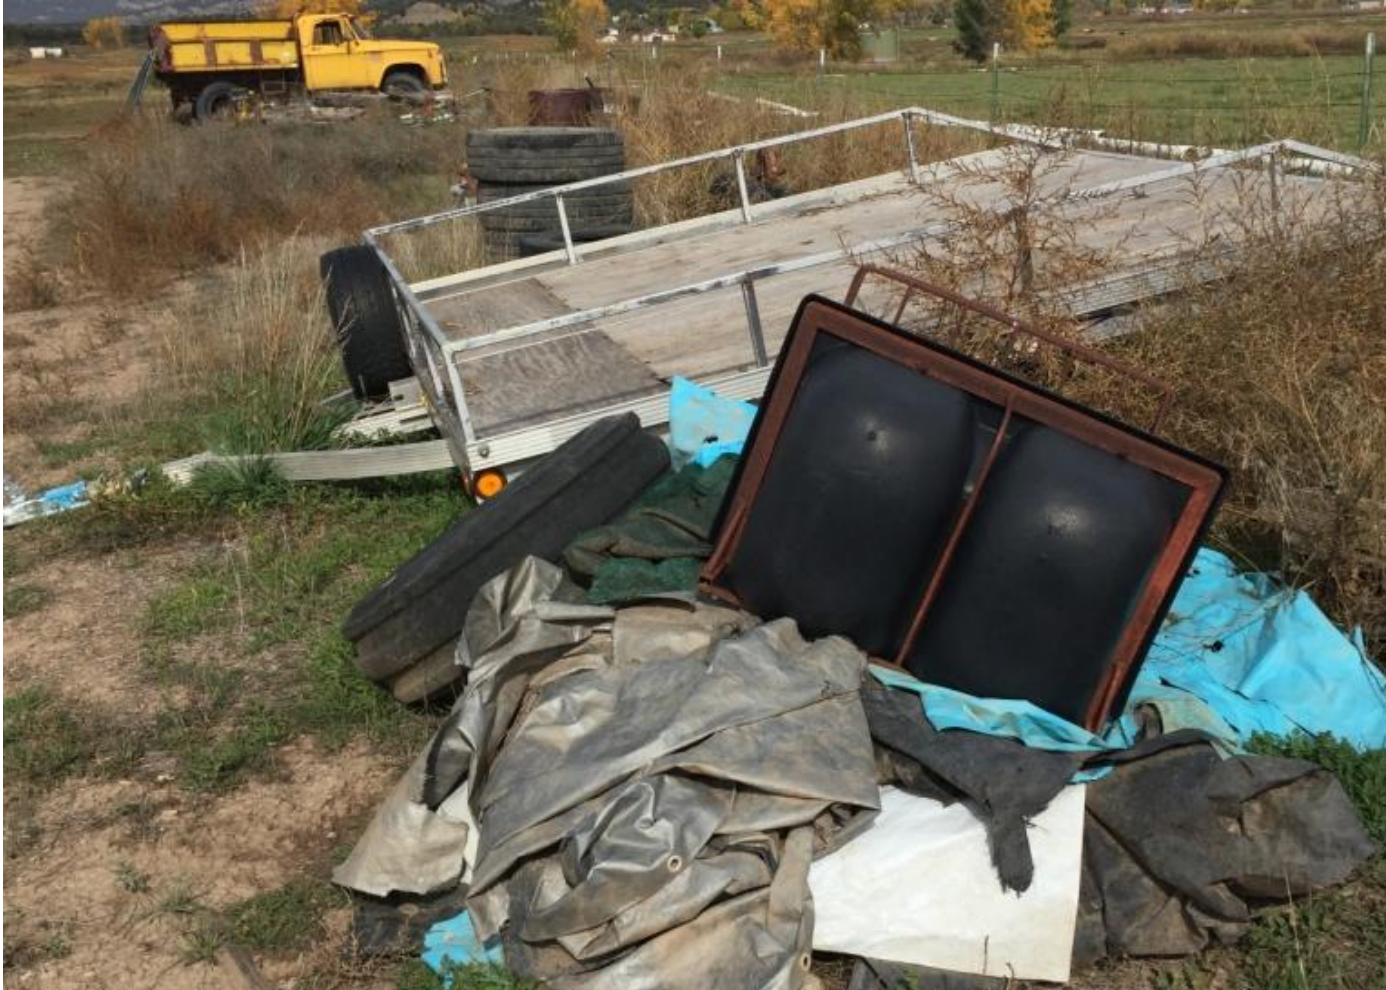
Photo 1. View of eastern portion of project area from southeastern corner facing northward. A significant quantity of junk and debris is being stored here.

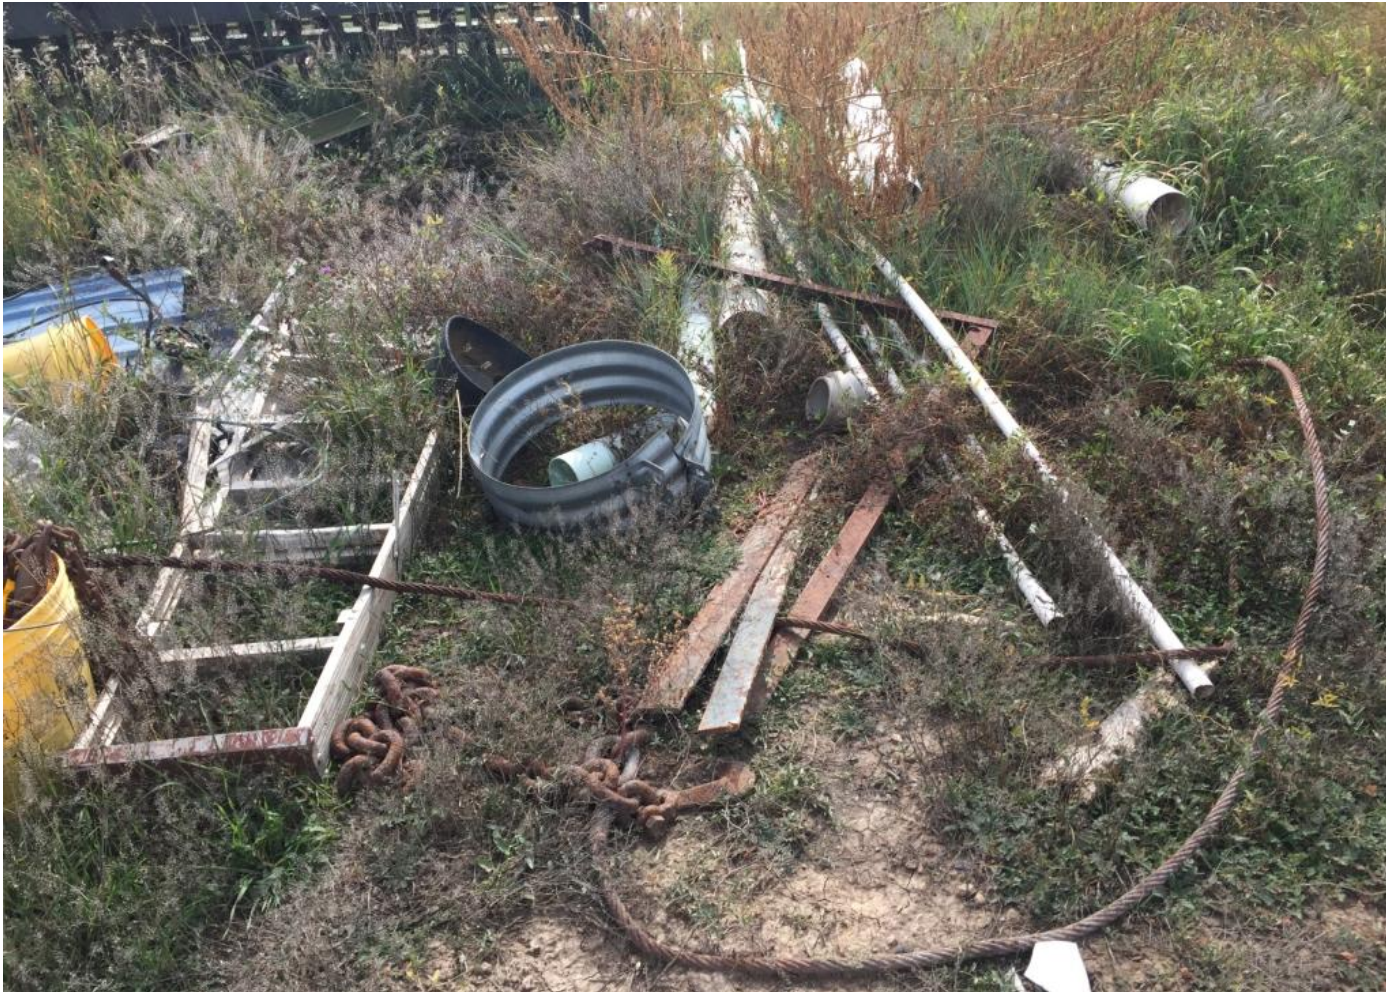
Photo 2. View of junk and debris in southern portion of the project area. Some appears like it could be oil and gas related, as evidenced by metal pipes, and steel anchor cable.

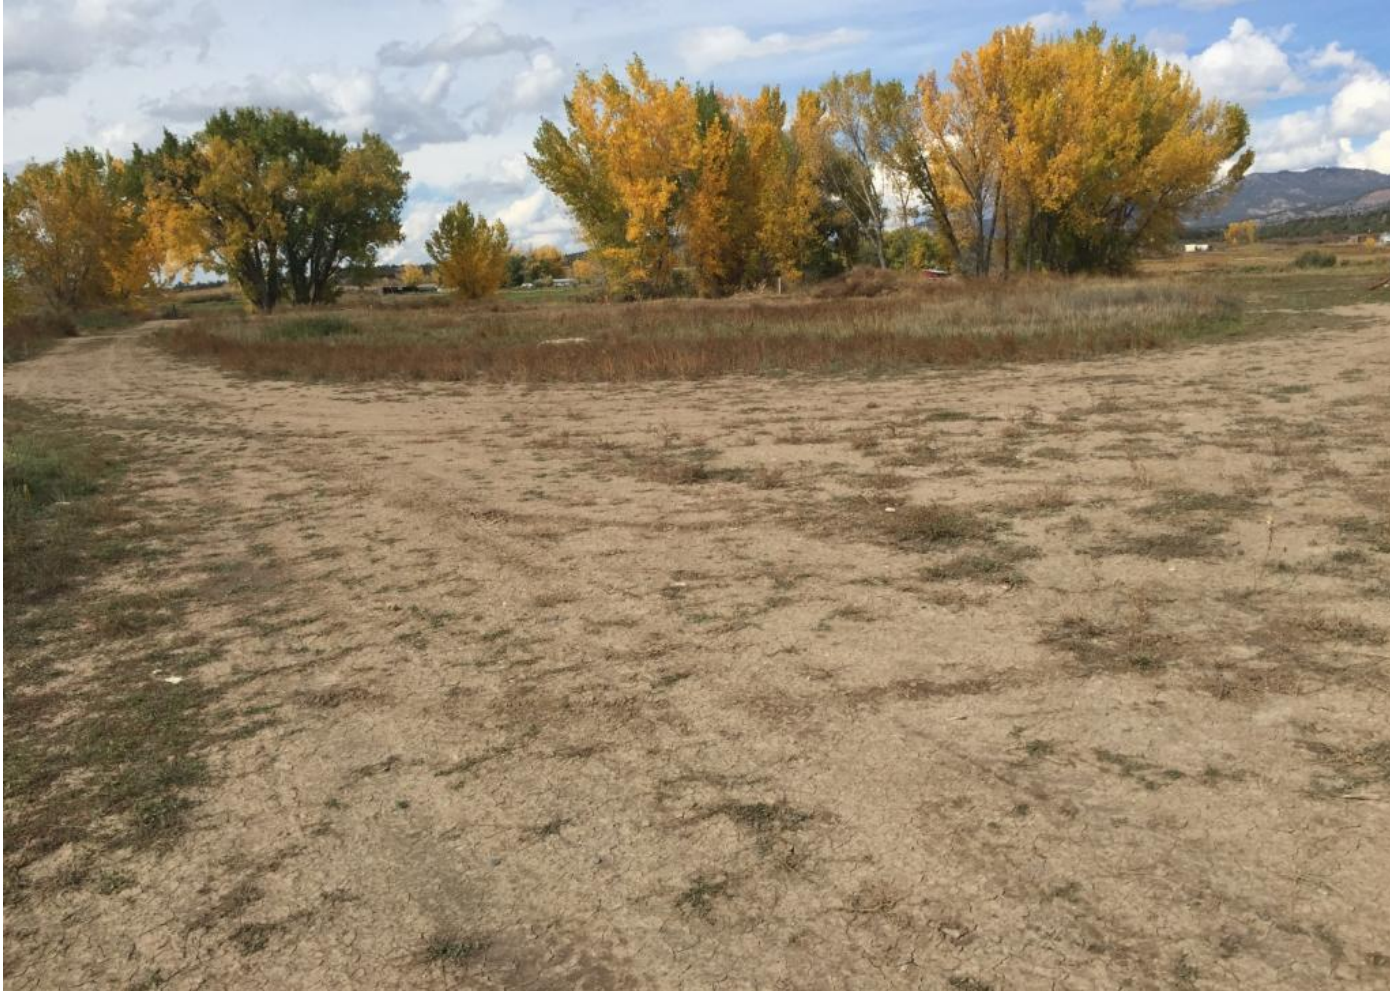
Photo 3. View of project area from southeastern corner facing center. A road is present around the perimeter of the location.

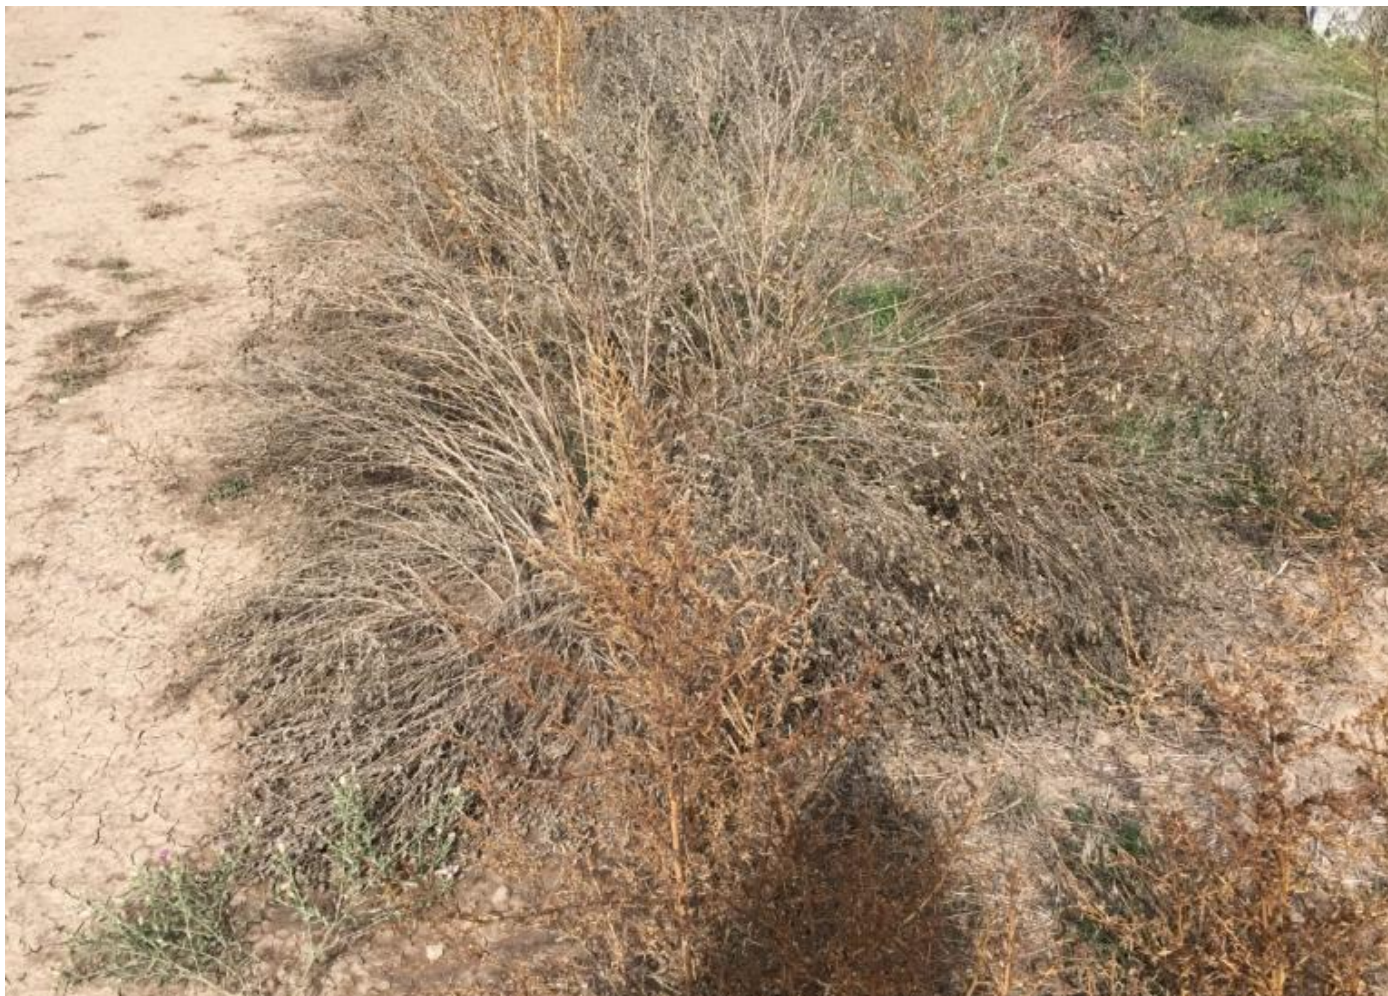
Photo 4. View of Russian knapweed (*Acroptilon repens*) and kochia (*Kochia scoparia*) plants within the southern portion of the project area.

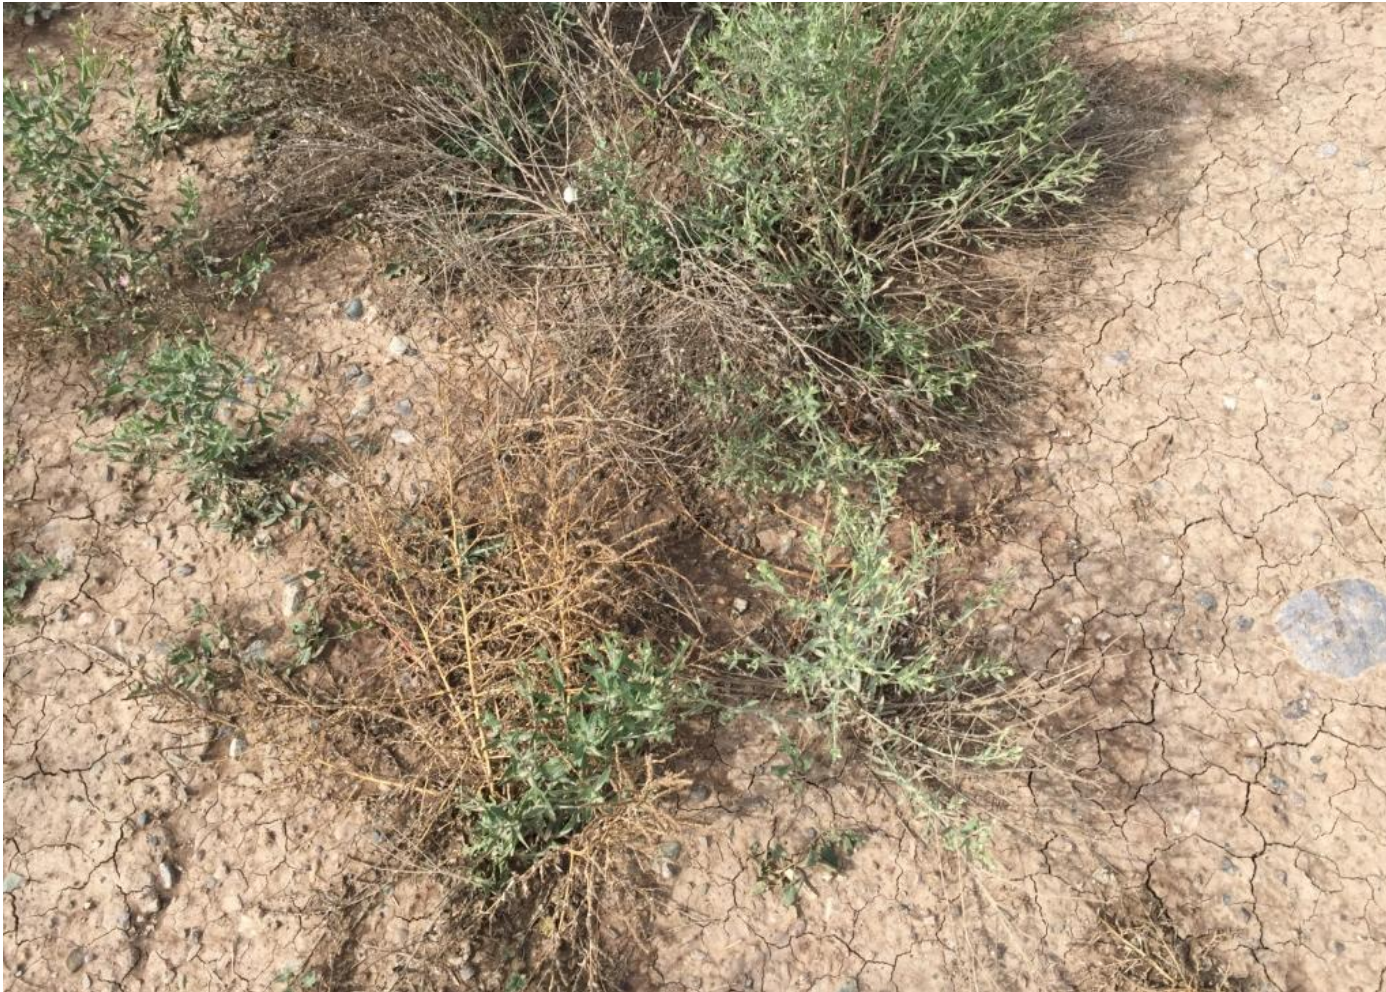
Photo 5. View of actively growing Russian knapweed plants growing within the project area.

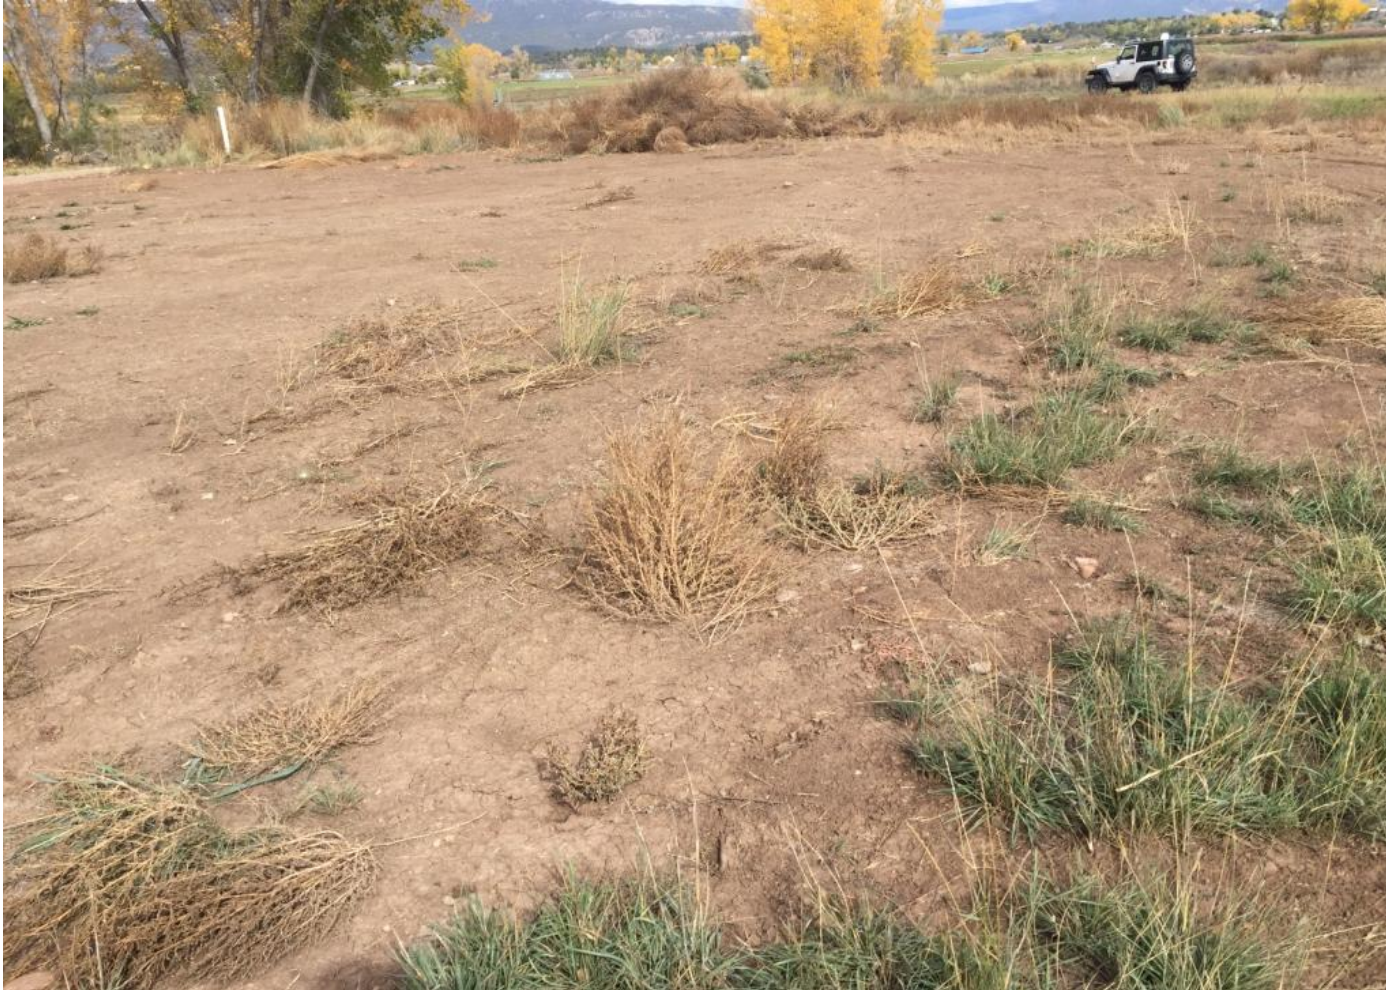
Photo 6. View of area where vegetation was recently scraped within central portion of project area. Area is approximately 50 feet wide and 50 feet long.

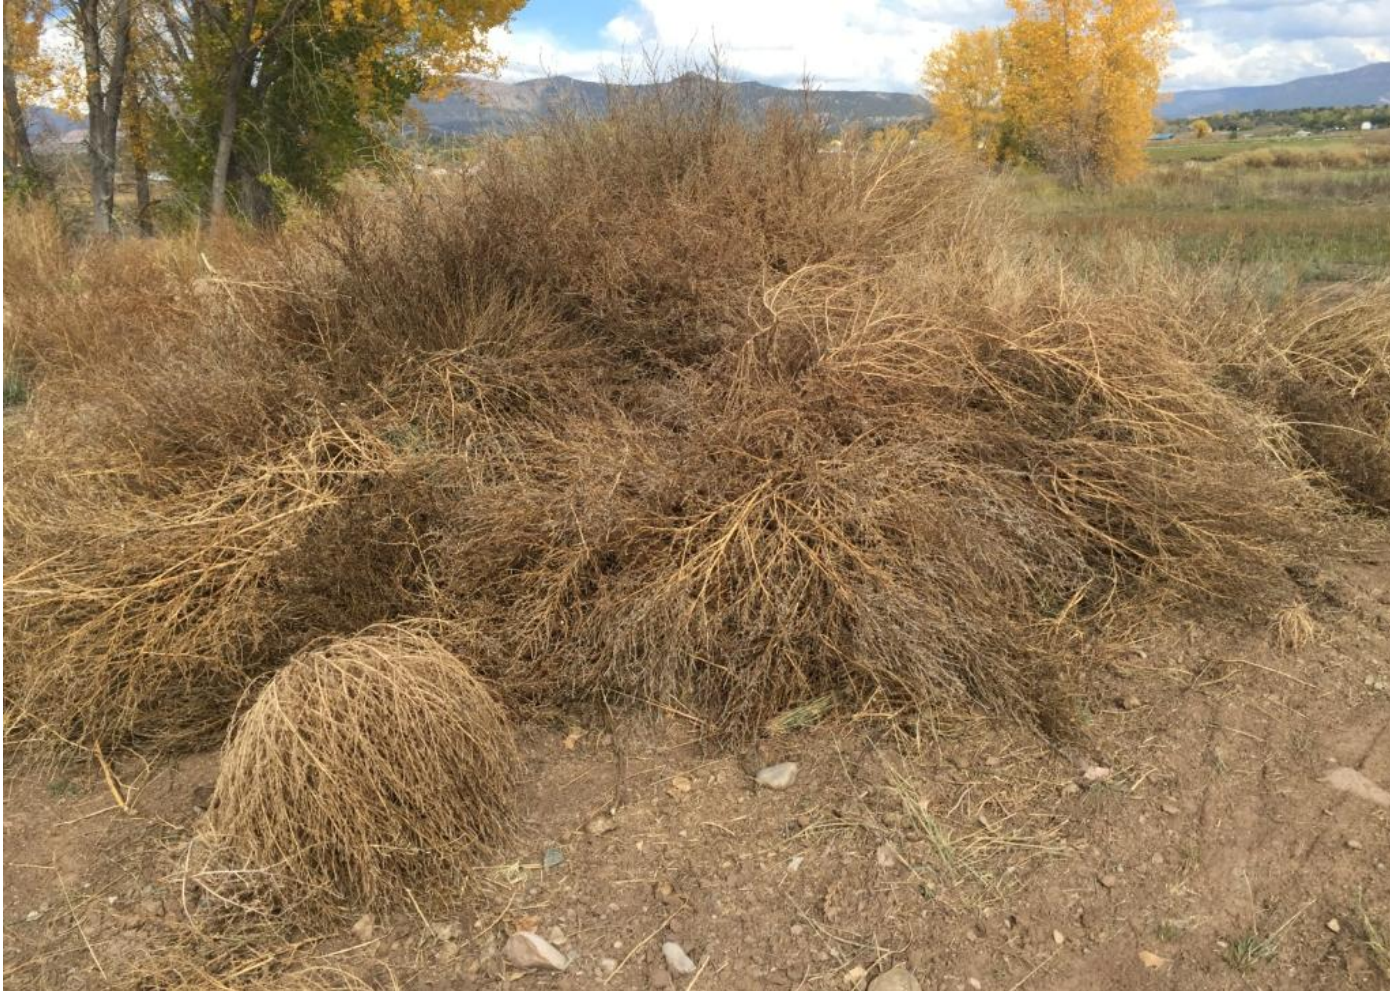
Photo 7. View of pile of kochia debris that is approximately 6 feet tall and 10 feet wide, within central portion of the project area.

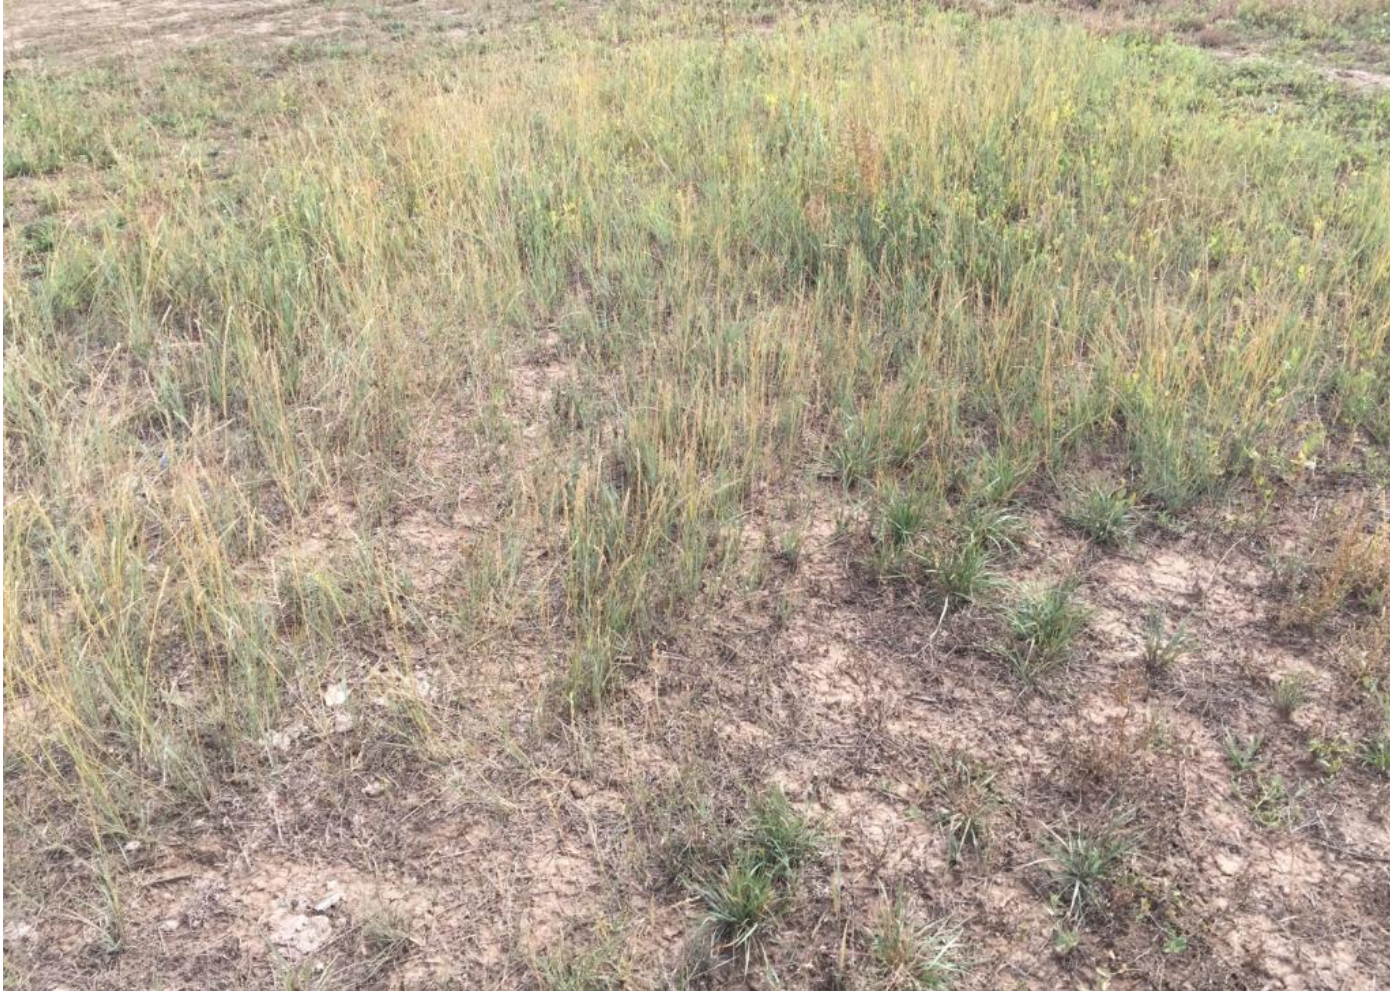
Photo 8. View of eastern portion of working area where it appears revegetation is progressing, with western wheatgrass (*Pascopyrum smithii*), crested wheatgrass (*Agropyron cristatum*), and yellow sweetclover (*Melilotus officinalis*).
