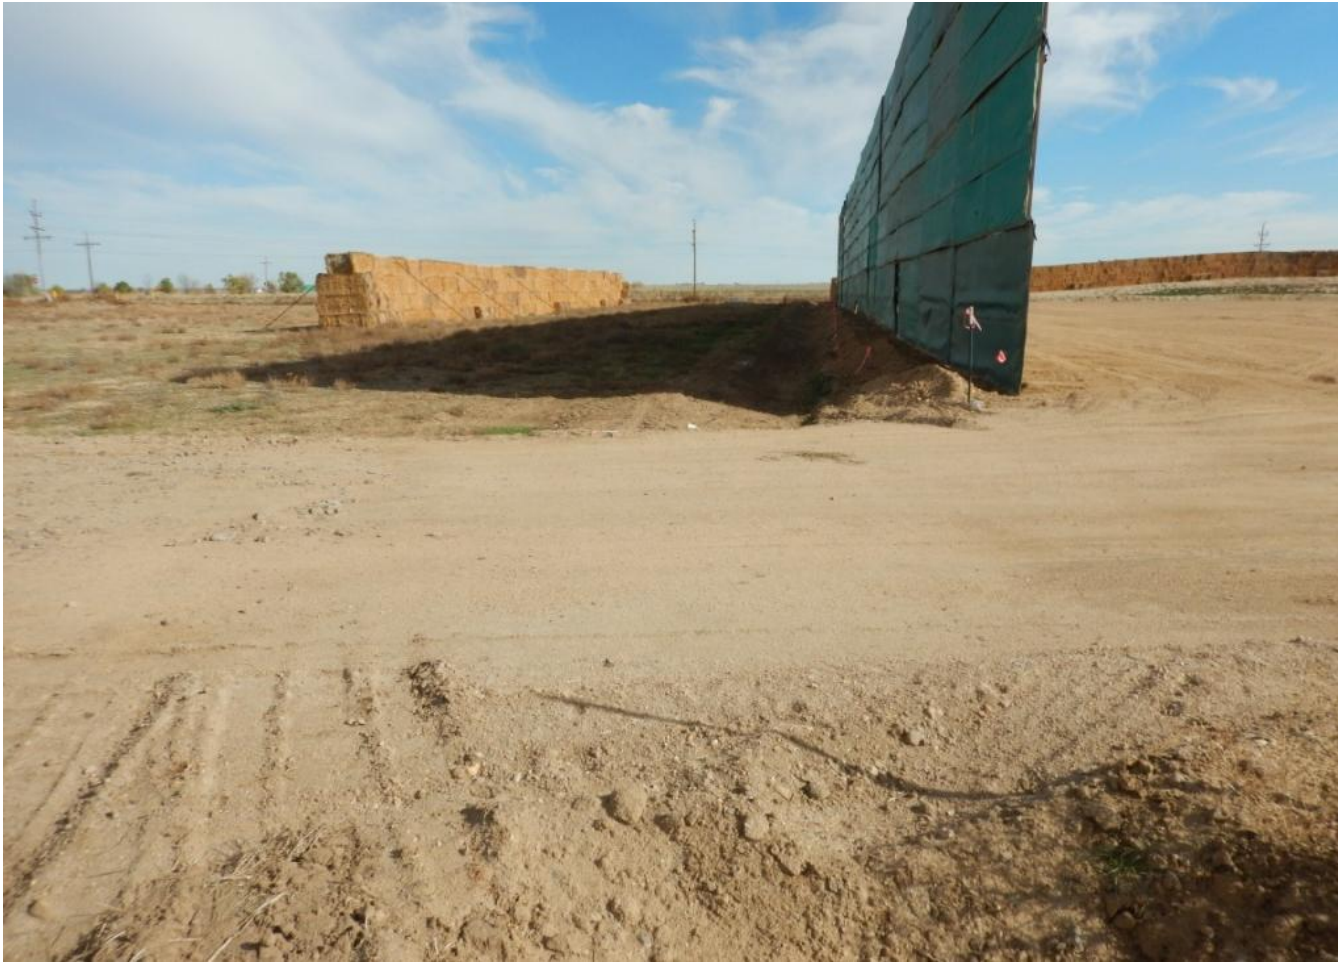
Photo 1. Photo taken from north entrance, facing East.

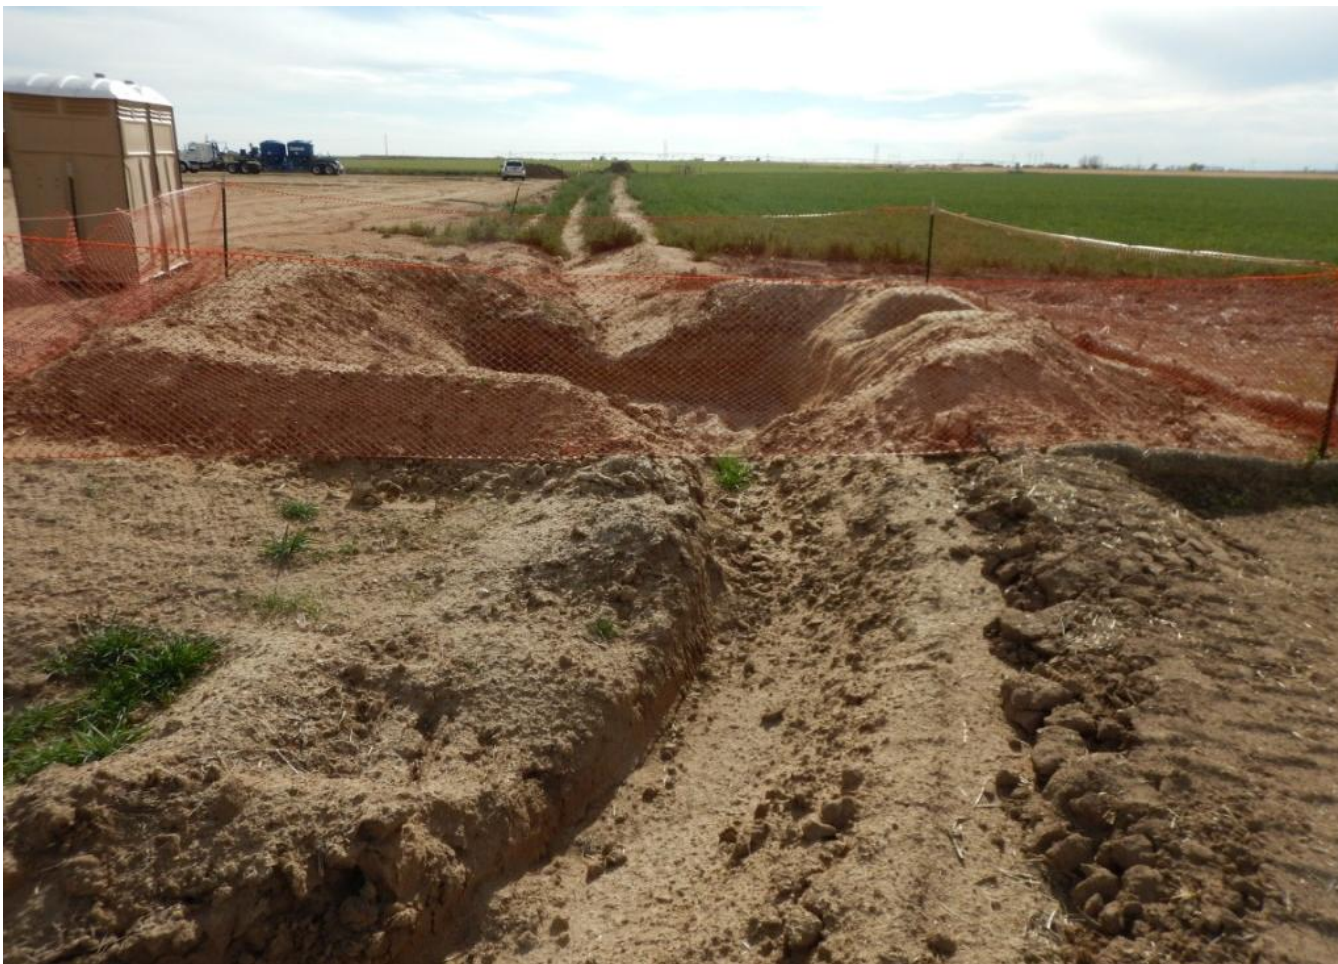
Photo 2. Photo taken from north entrance, facing South.

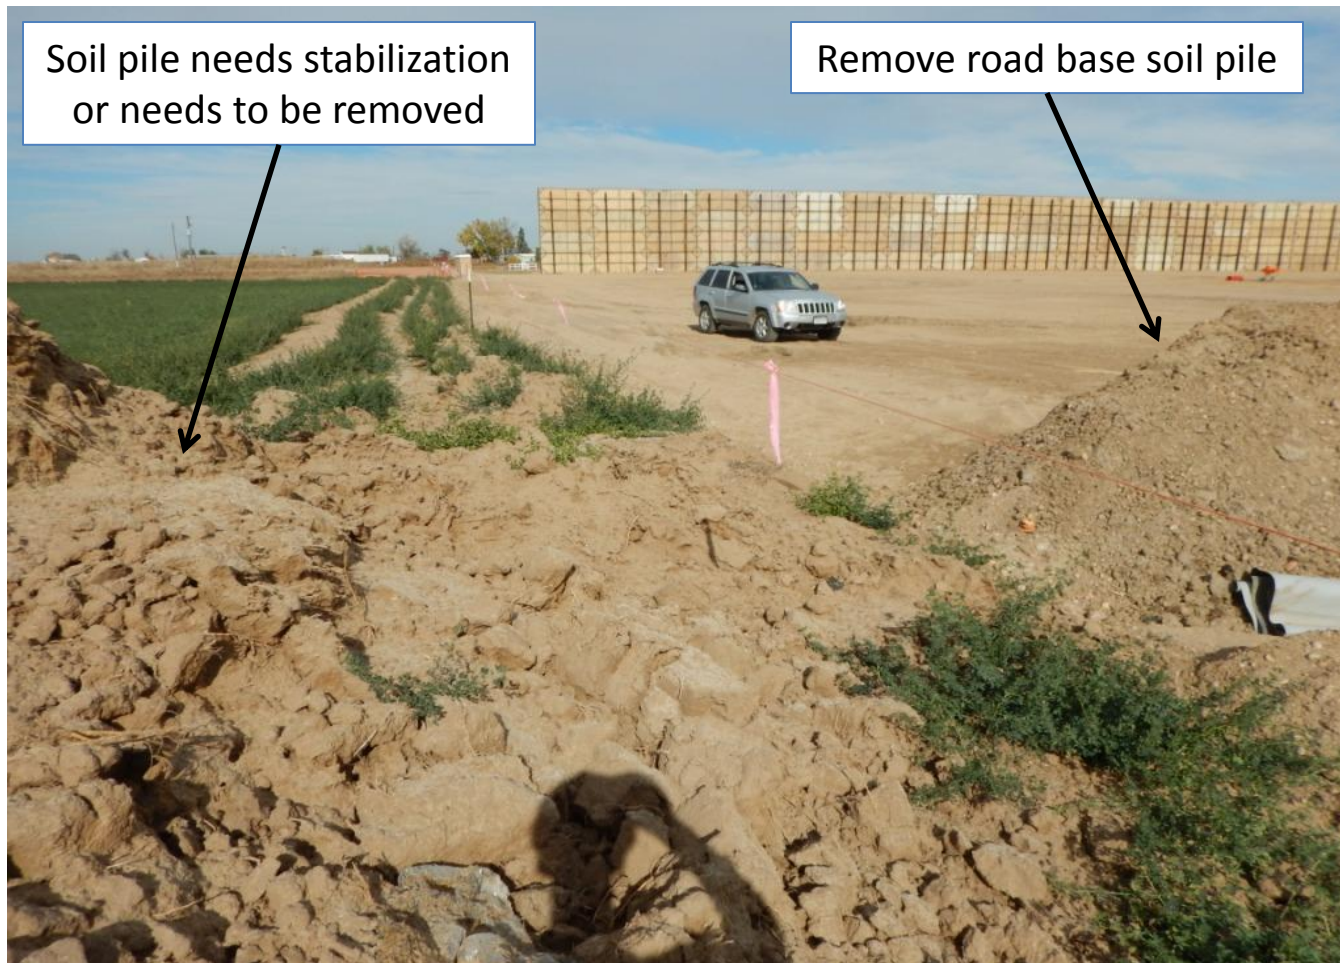
Photo 3. Photo taken from southwest location, facing North. Need to stabilize soil pile from sediment erosion or needs to be removed, and remove road base soil pile.

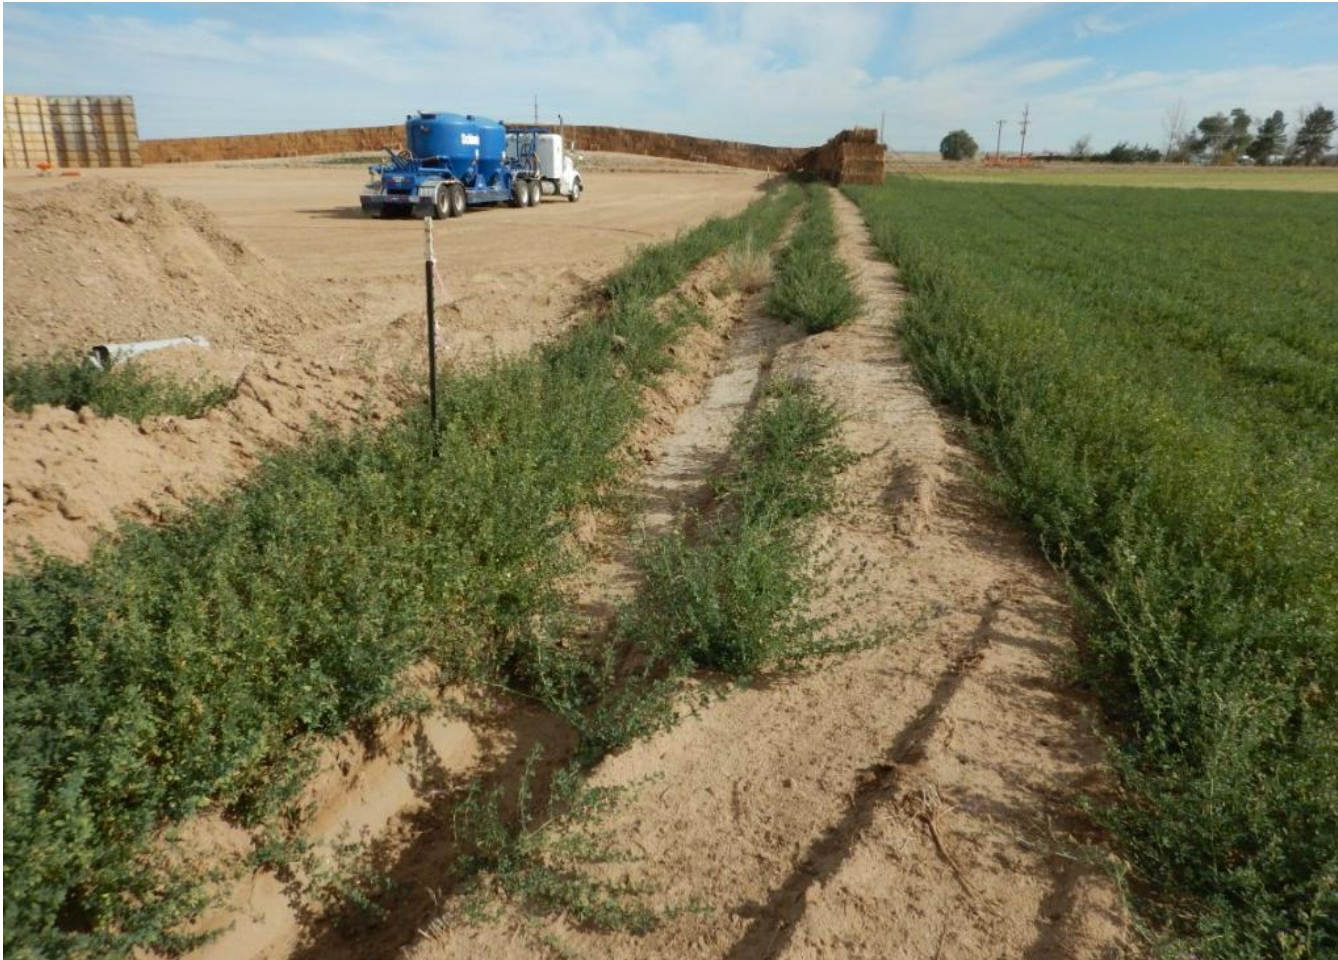
Photo 4. Photo taken from southwest location, facing East.

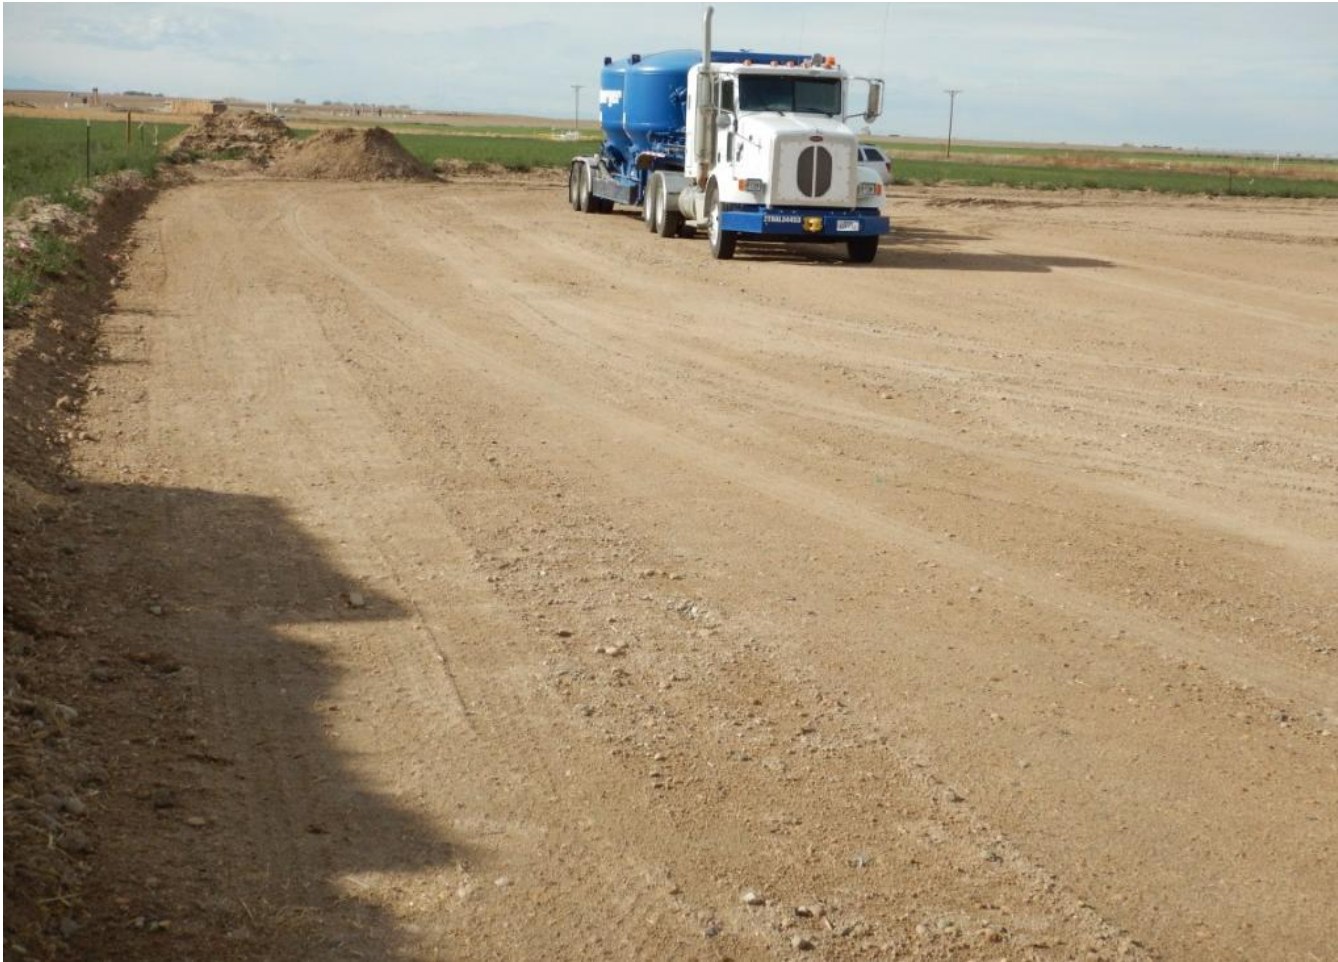
Photo 5. Photo taken from southern location, facing West. When interim reclamation starts, this area shall be reclaimed and minimized where production or facilities are no longer necessary.

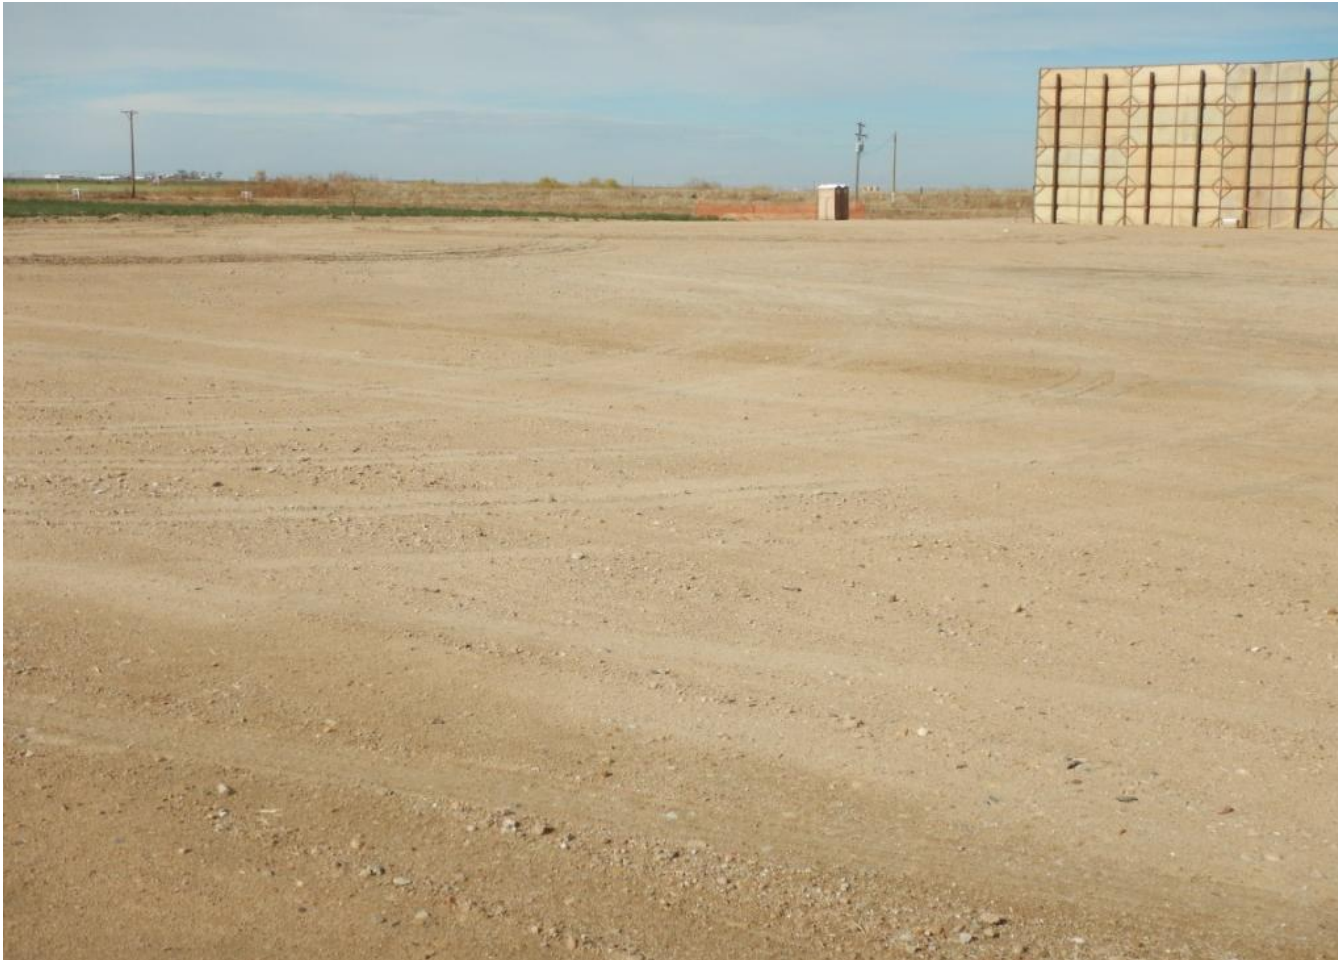
Photo 6. Photo taken from southern location, facing Northwest. When interim reclamation starts, this area shall be reclaimed and minimized where production or facilities are no longer necessary.

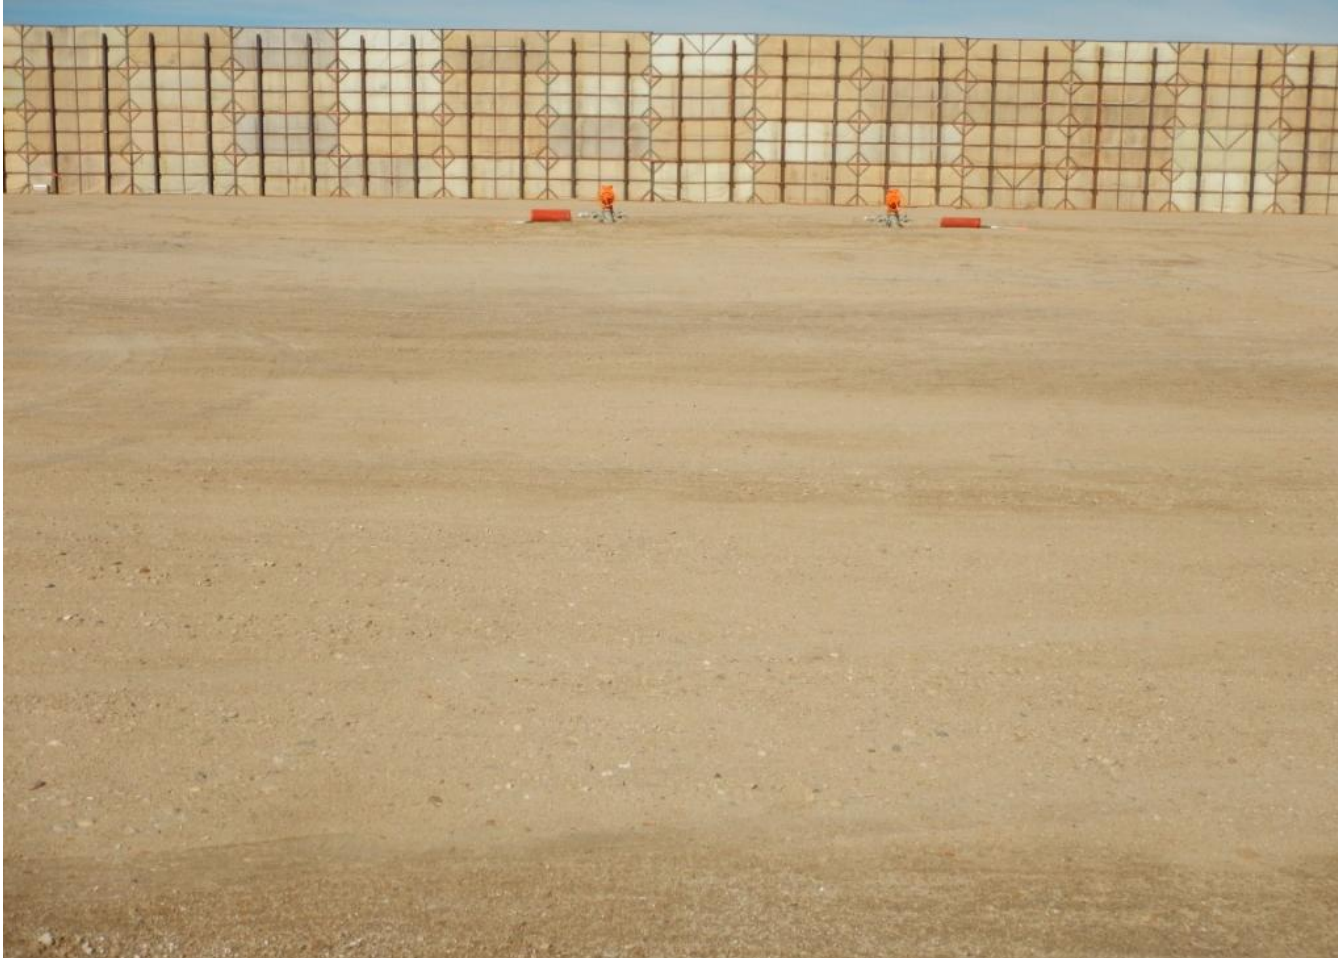
Photo 7. Photo taken from southern location, facing North. When interim reclamation starts, this area shall be reclaimed and minimized where production or facilities are no longer necessary.

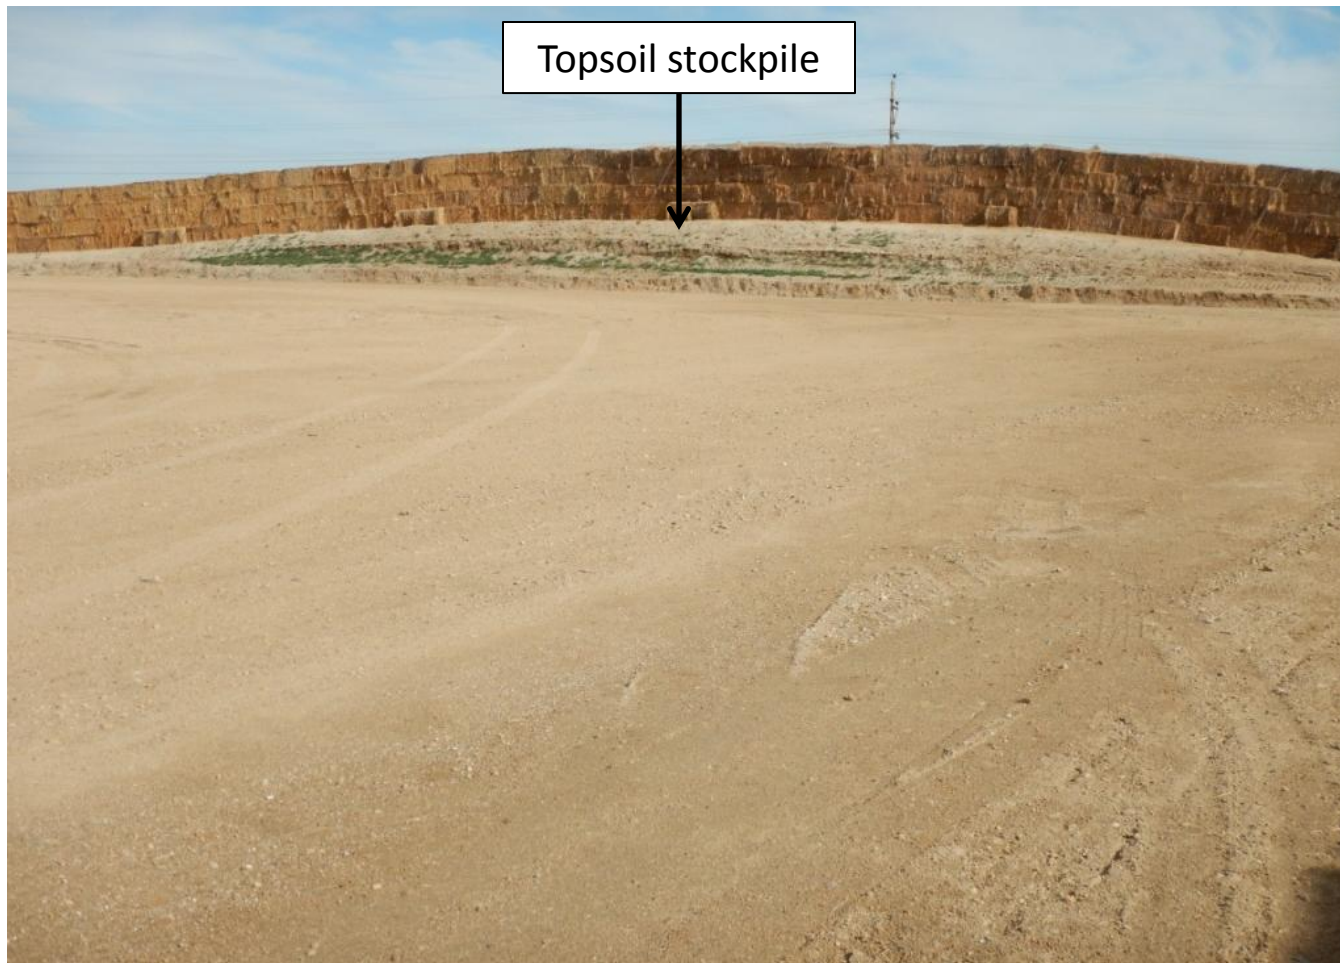
Photo 8. Photo taken from southern location, facing Northeast. When interim reclamation starts, this area shall be reclaimed and minimized where production or facilities are no longer necessary.

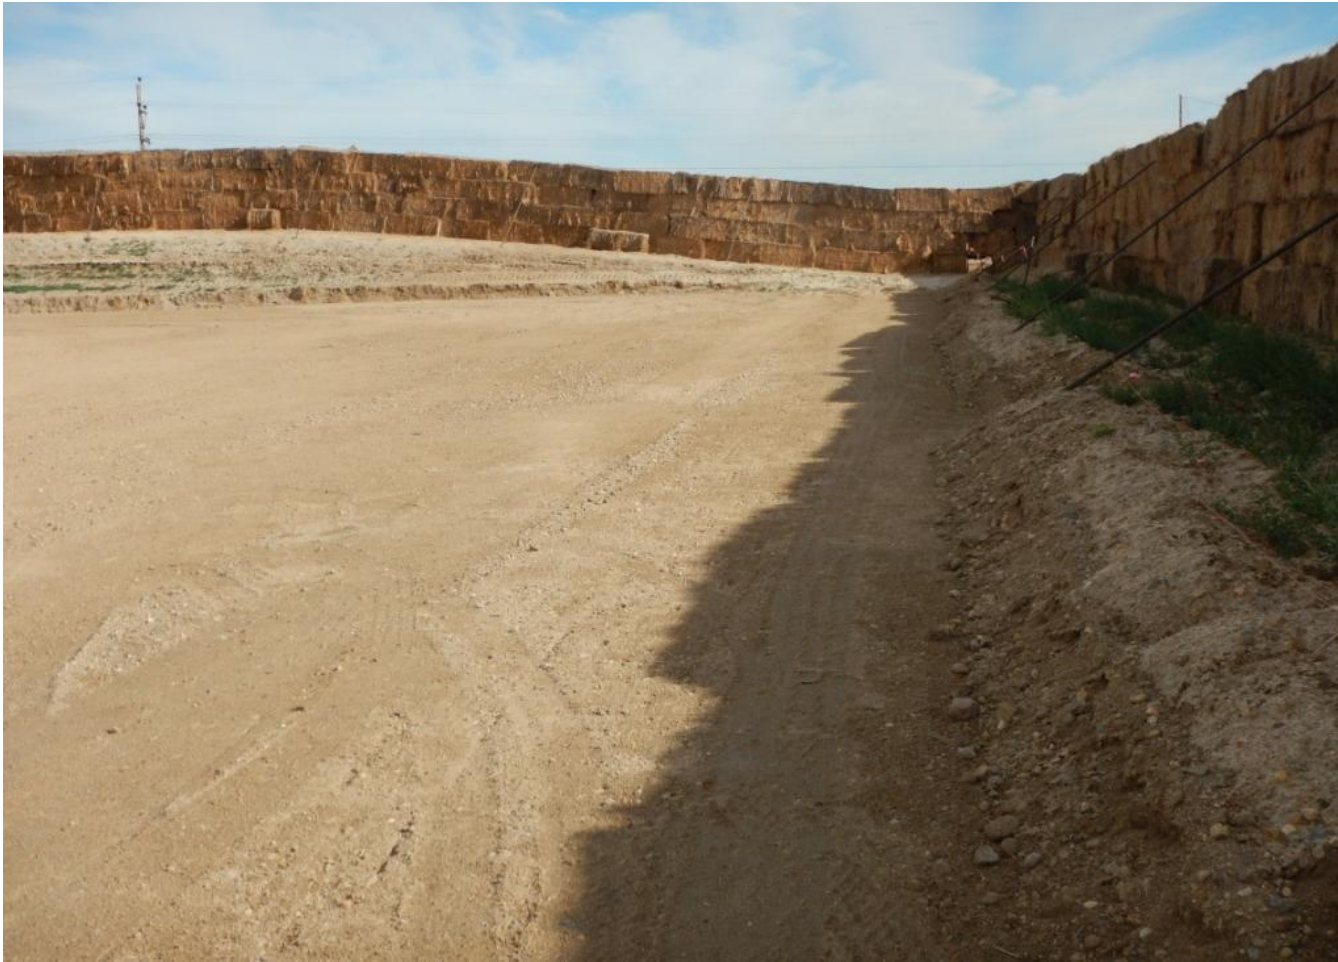
Photo 9. Photo taken from southern location, facing East. When interim reclamation starts, this area shall be reclaimed and minimized where production or facilities are no longer necessary.

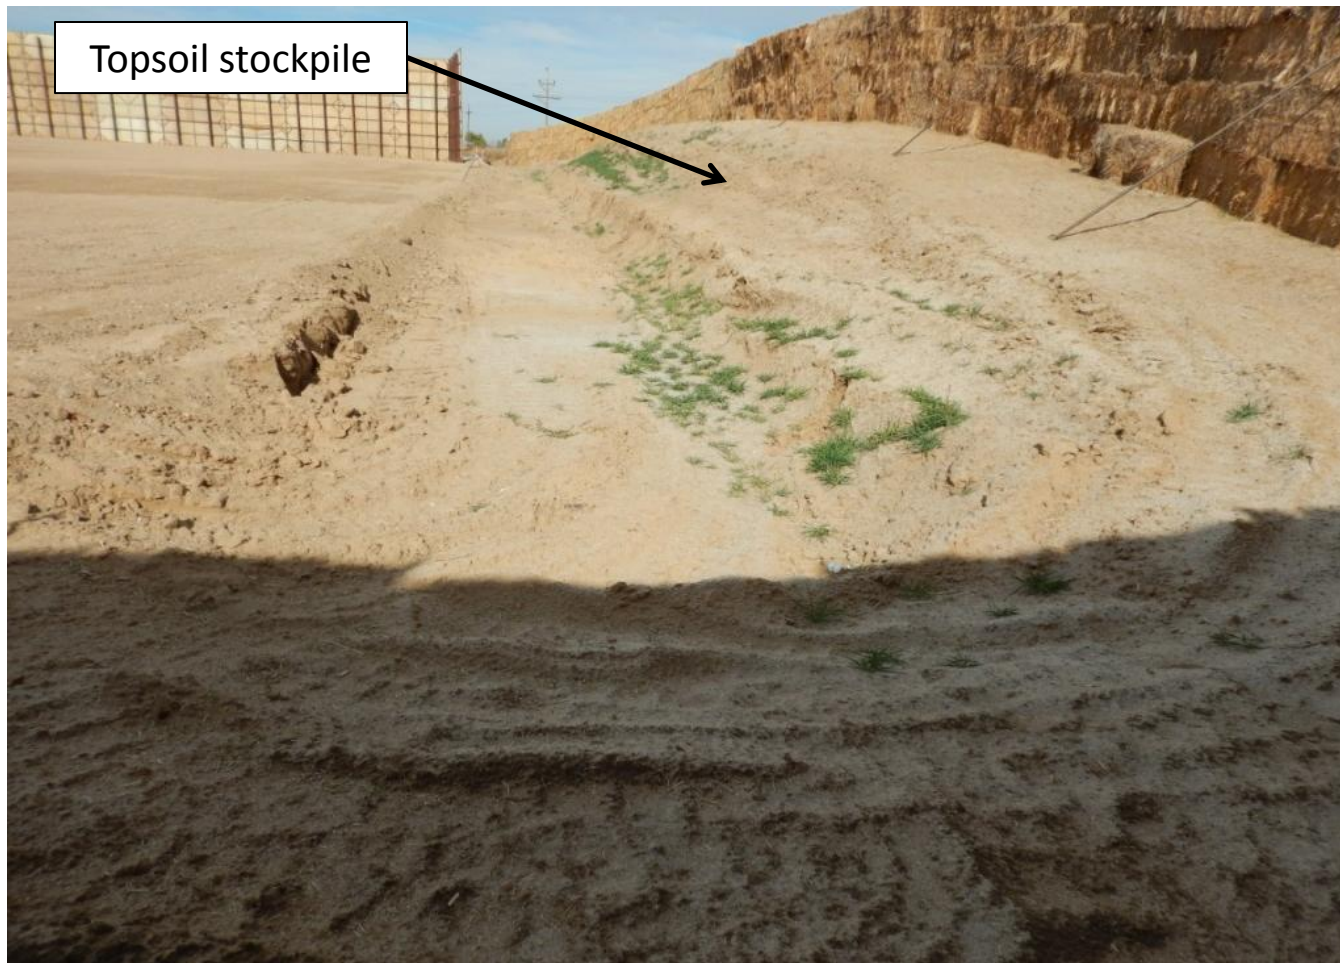
Photo 10. Photo taken from southeast location, facing North. Perennial vegetation is required for topsoil stabilization.

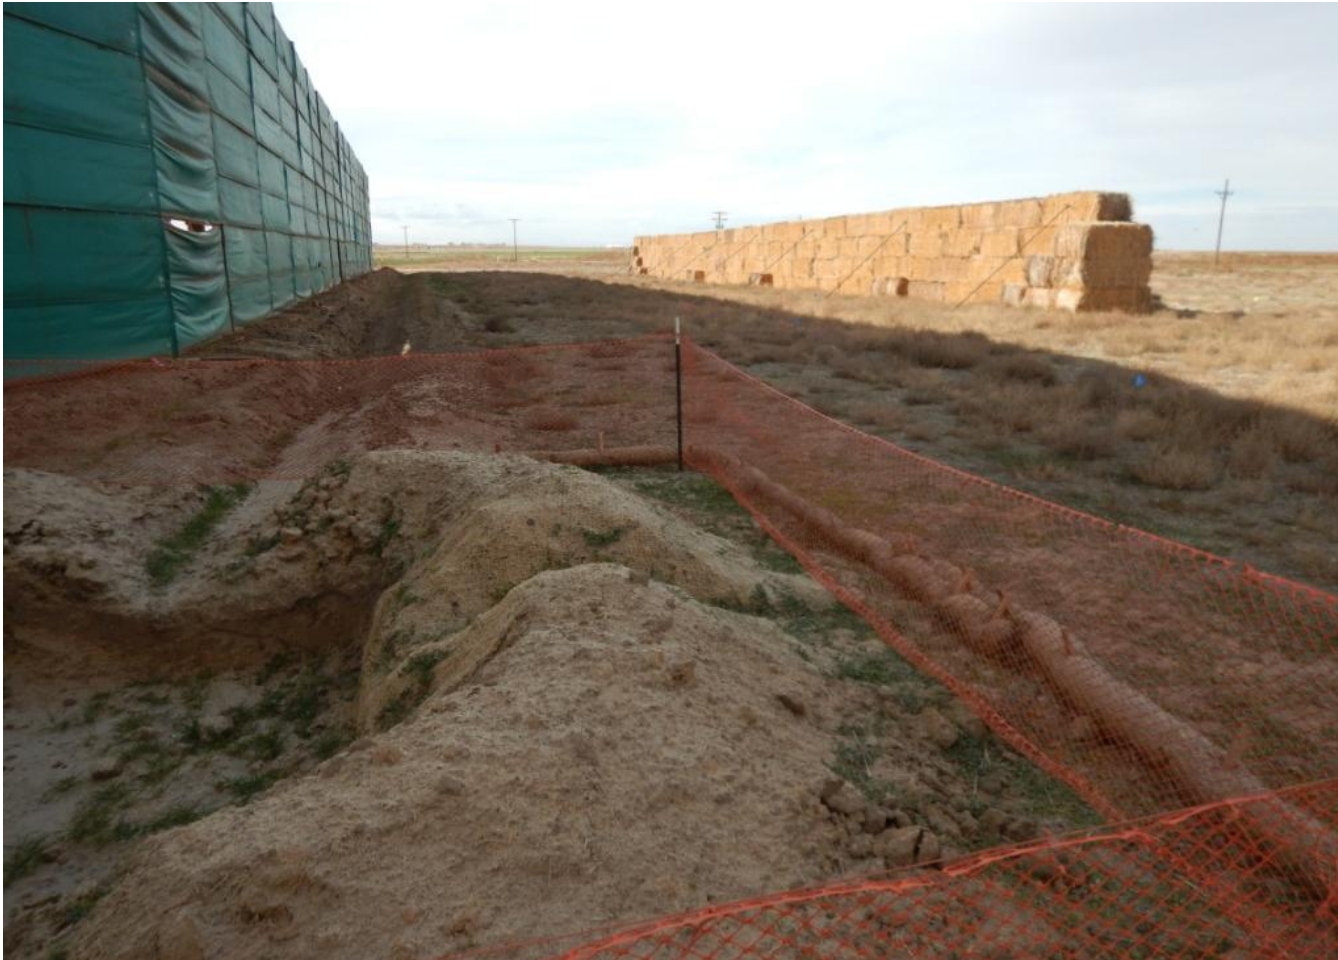
Photo 11. Photo taken from northeast location, facing West. Kochia (*Kochia sp.*) located throughout the northern location is debris and will break off, encroach upon adjacent lands and needs to be removed. Weed maintenance is needed.

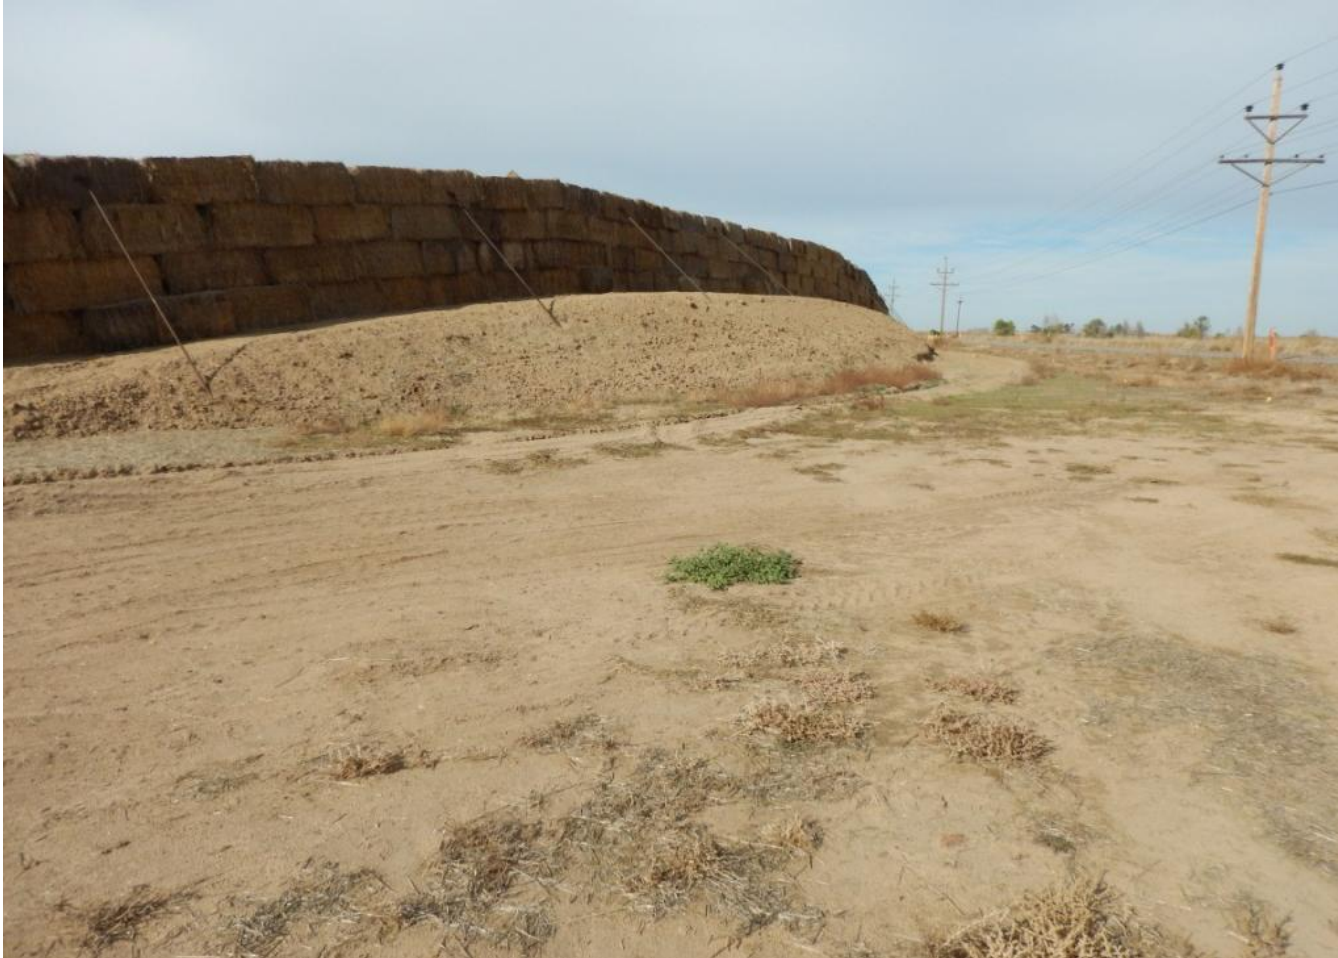
Photo 12. Photo taken from outermost southeast location, facing North. When interim reclamation starts, this area shall be reclaimed and minimized where production or facilities are no longer necessary.

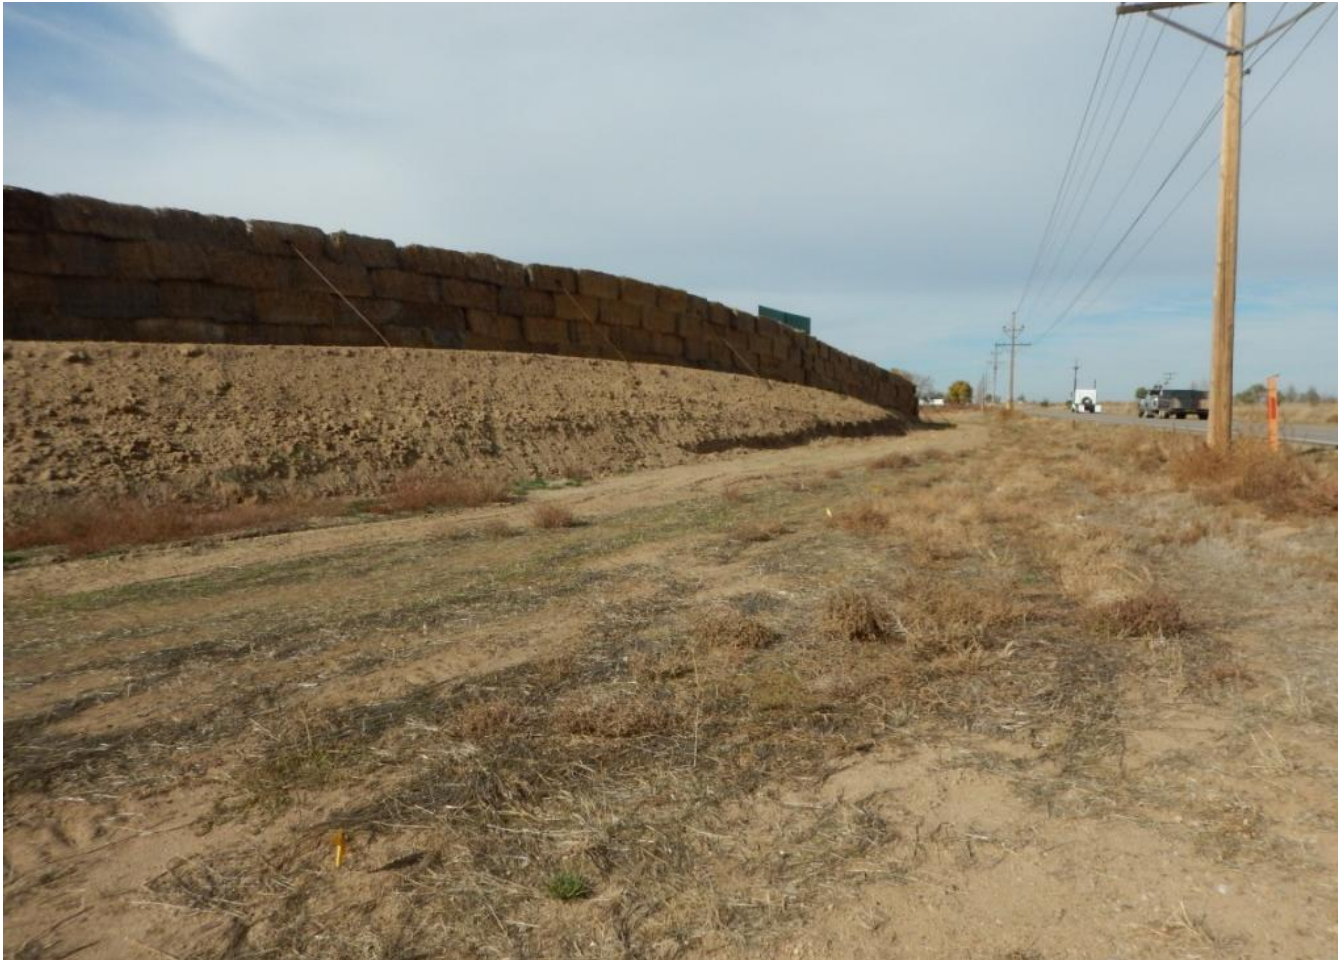
Photo 13. Photo taken from outermost east location, facing North. When interim reclamation starts, this area shall be reclaimed and minimized where production or facilities are no longer necessary. Weed maintenance is needed.

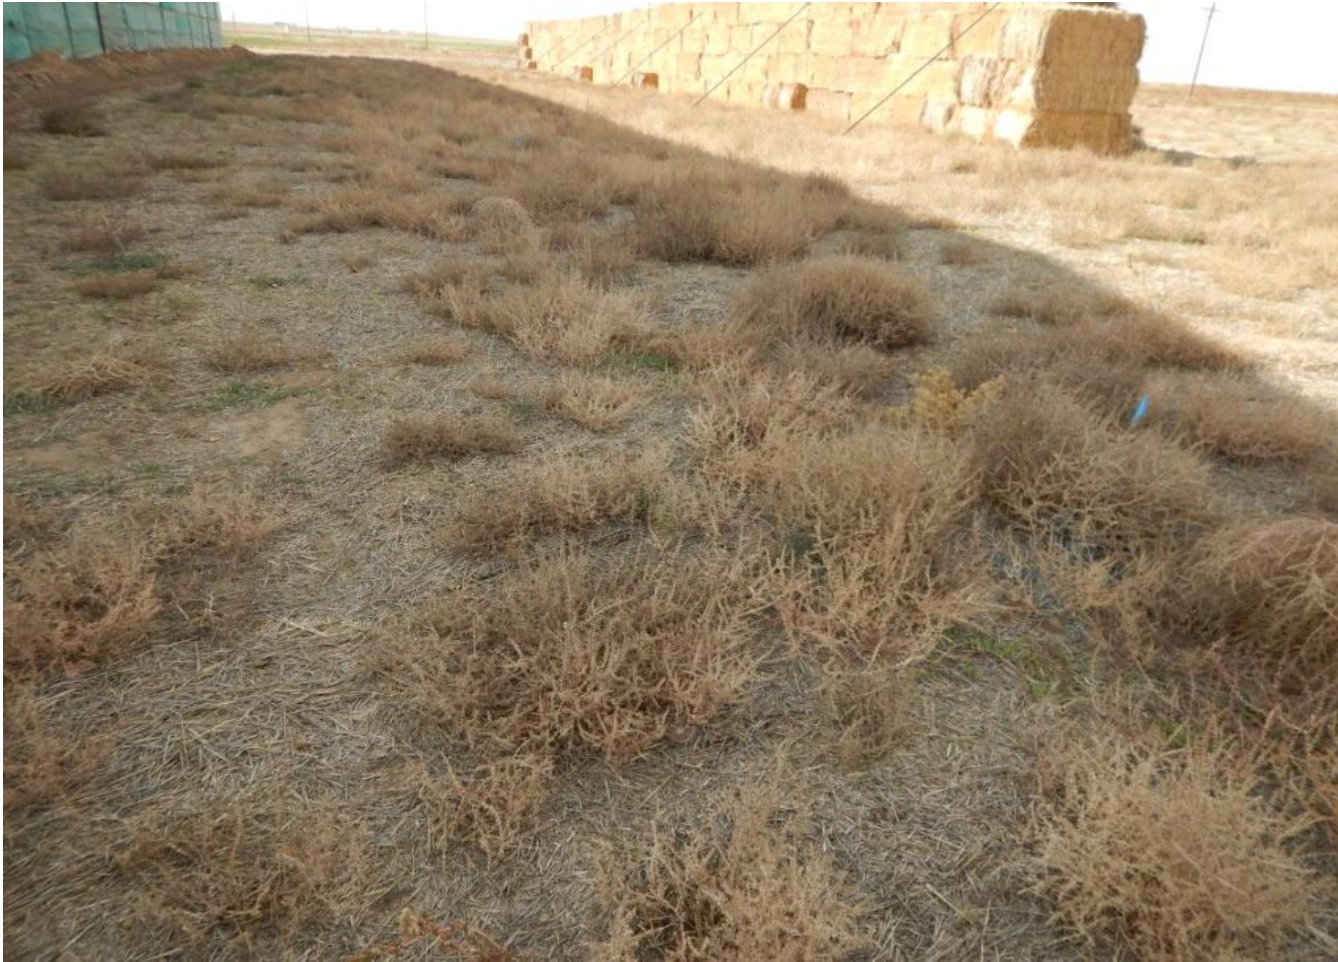
Photo 14. Photo taken from northeastern location, facing West. Kochia (*Kochia sp.*) located throughout northern location is debris and will break off, encroach upon adjacent lands and needs to be removed.

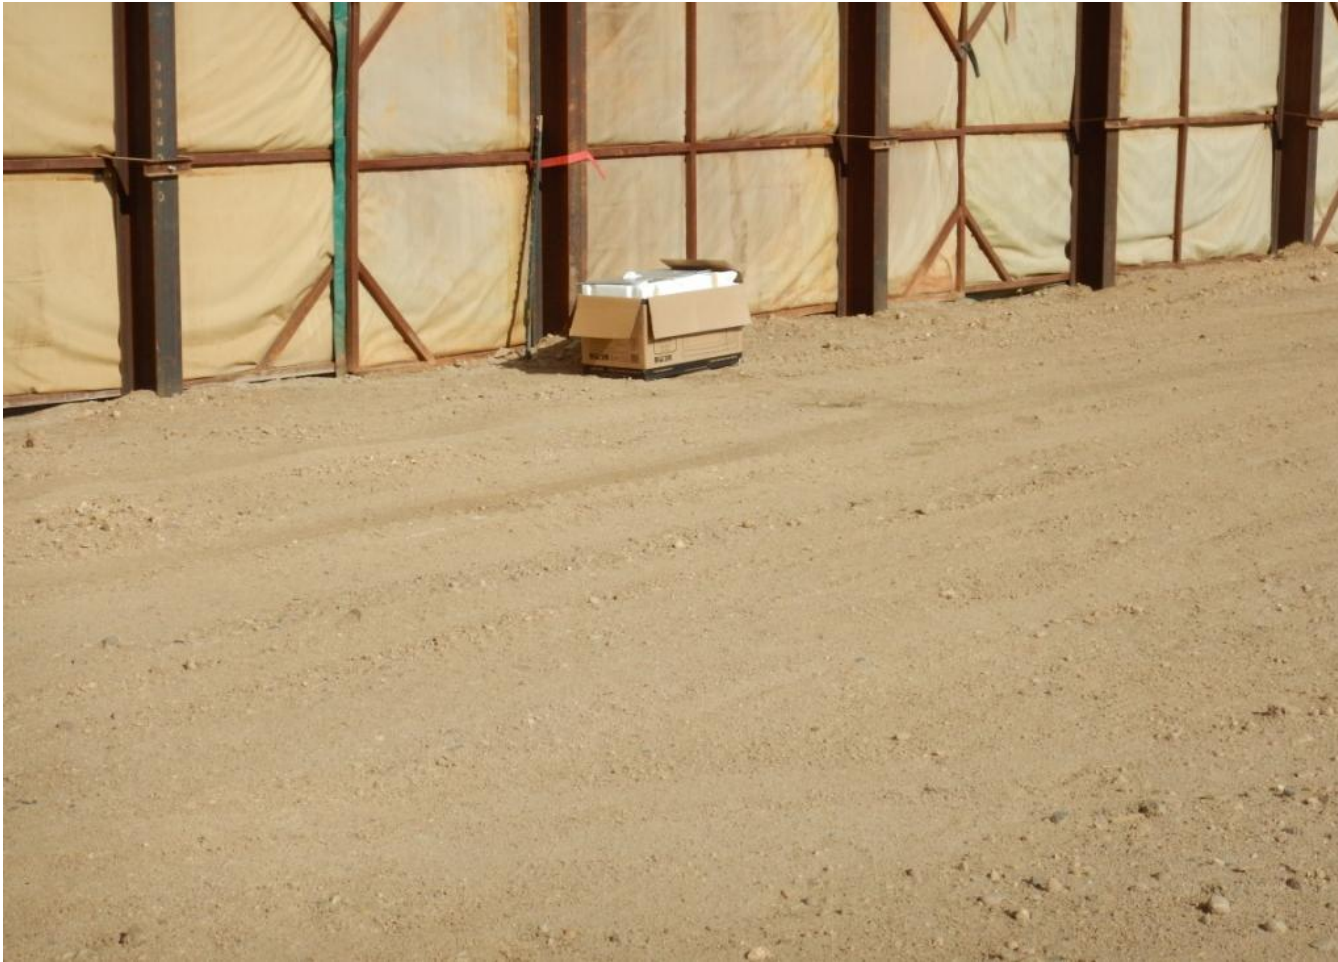
Photo 15. Photo taken from northern location, facing West. Unused or unneeded equipment needs to be removed.

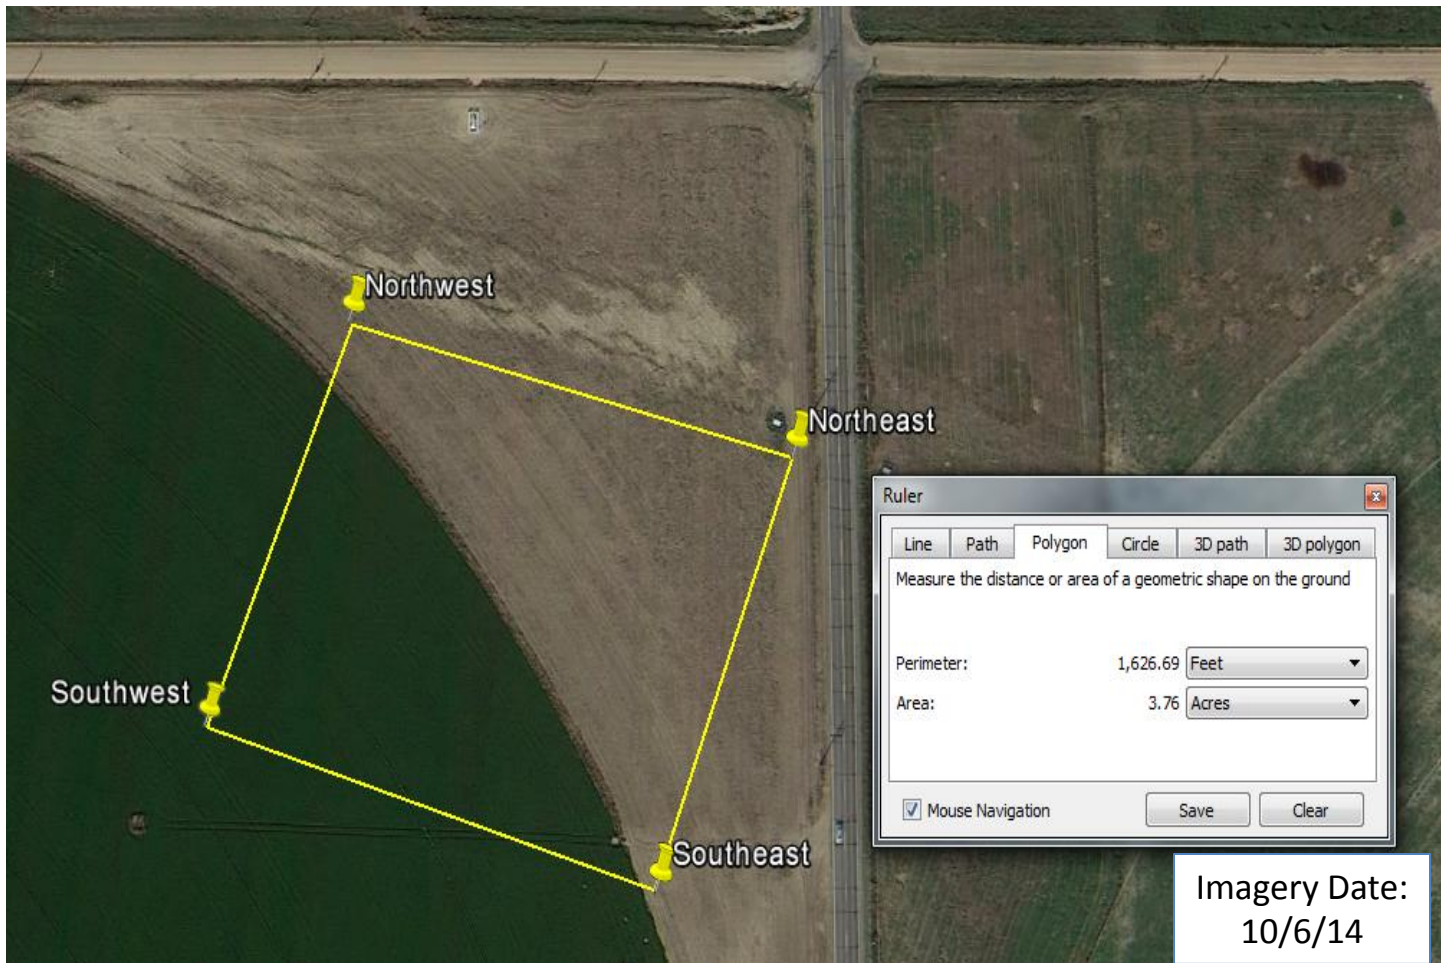
Photo 16. The perimeter, in yellow, illustrates the disturbance boundary as of 10/29/15. Total disturbance equals 3.76 acres.
