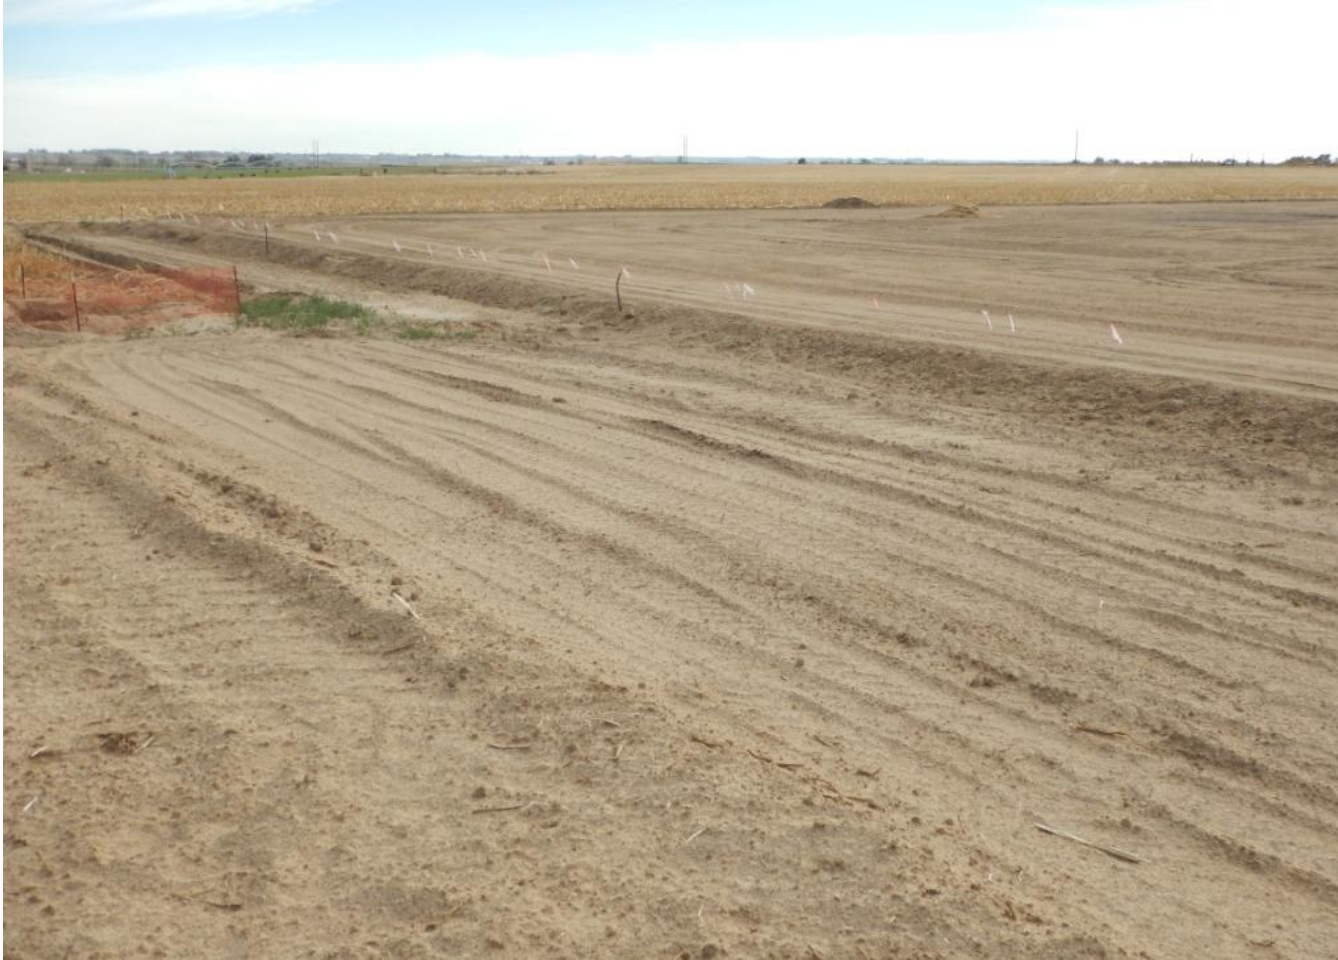
Photo 1. Photo taken from northeast location, facing South. When interim reclamation starts, this area shall be reclaimed and minimized where production or facilities are no longer necessary.

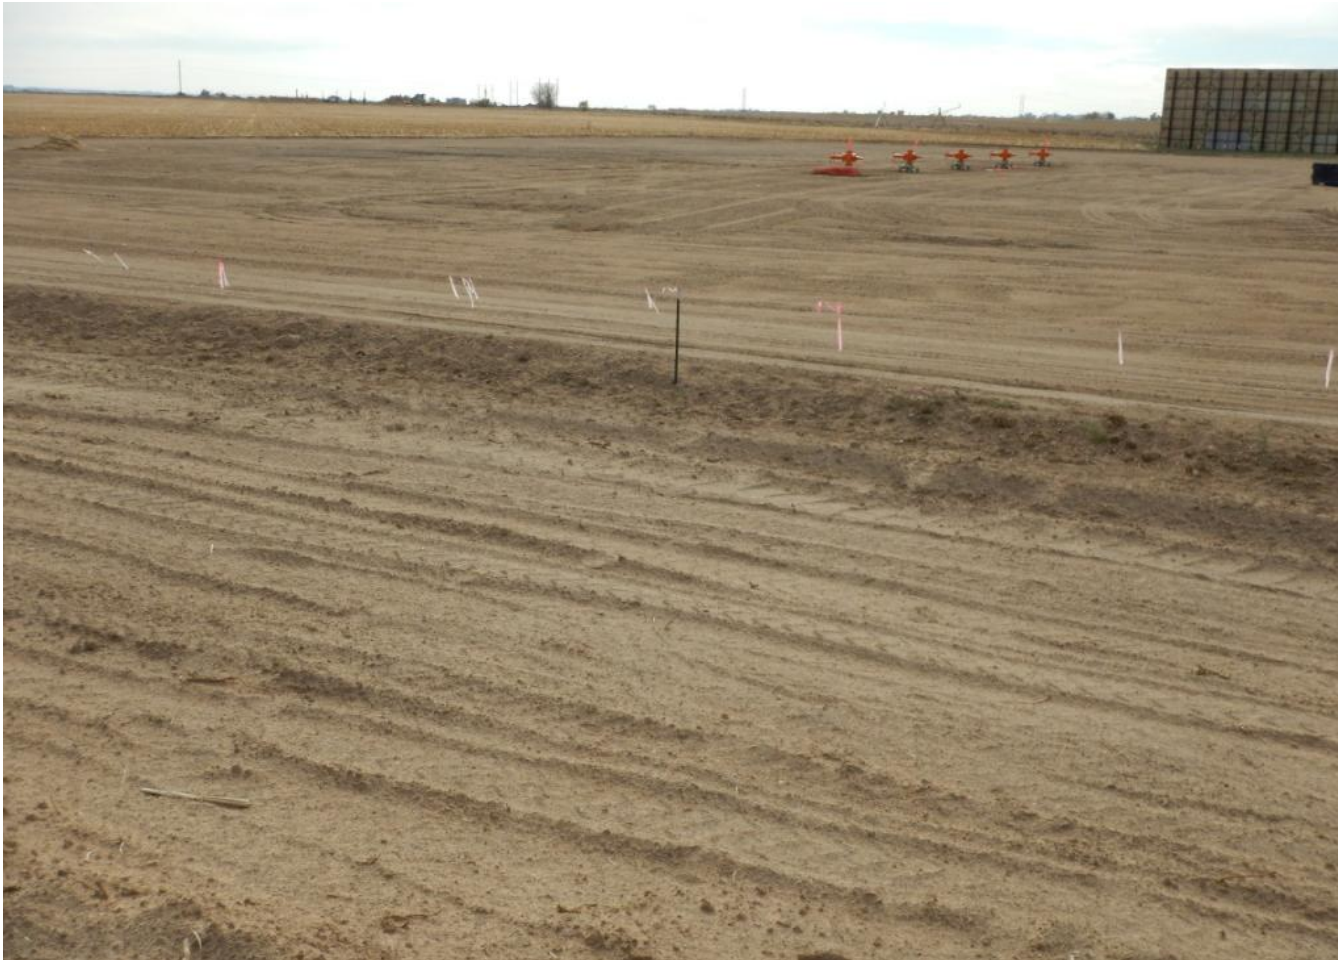
Photo 2. Photo taken from northeast location, facing Southwest. When interim reclamation starts, this area shall be reclaimed and minimized where production or facilities are no longer necessary.

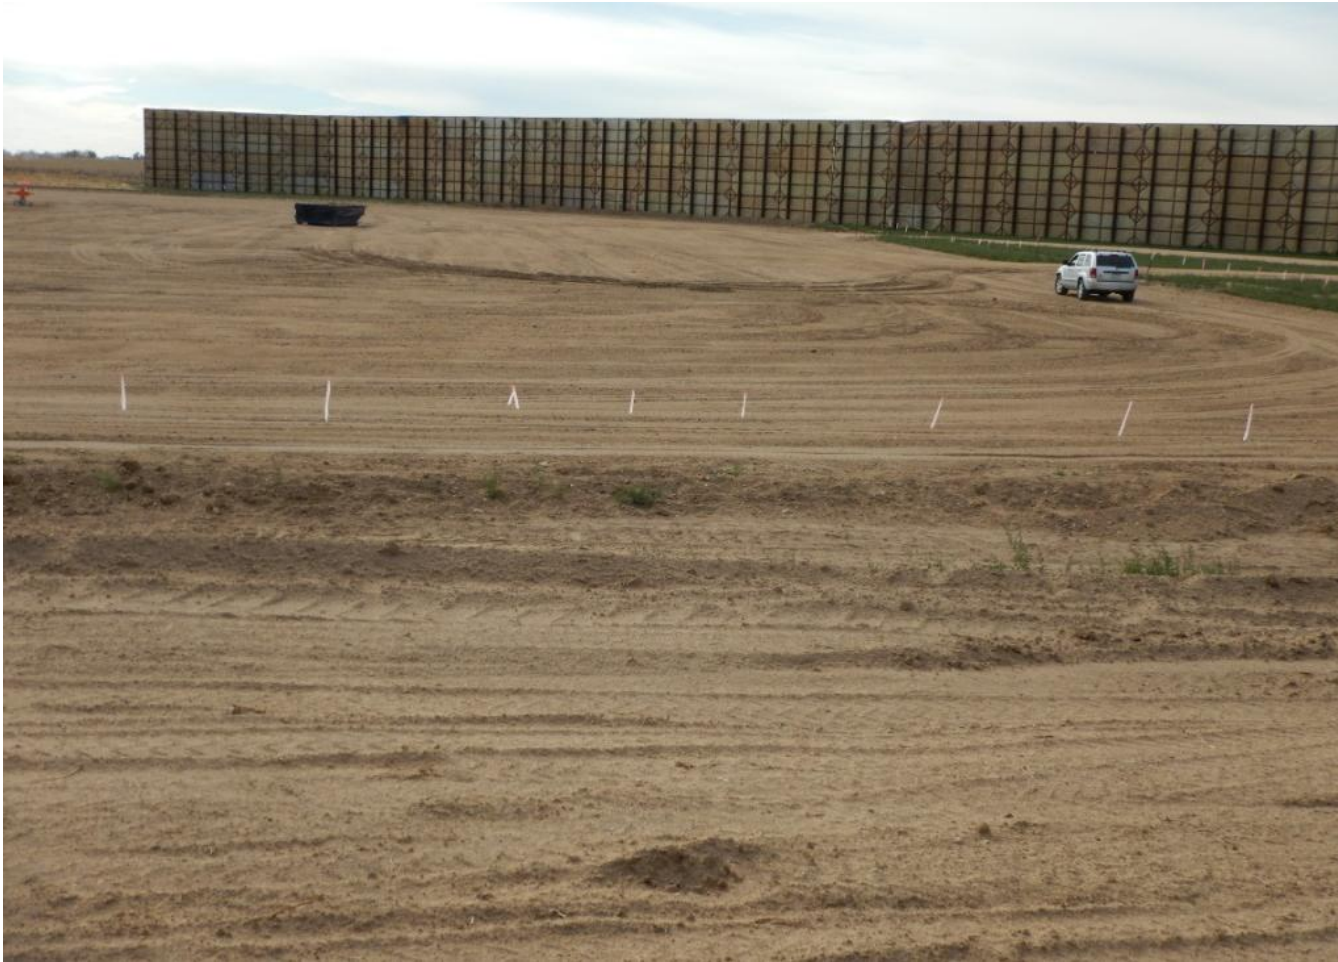
Photo 3. Photo taken from northeast location, facing Southwest. When interim reclamation starts, this area shall be reclaimed and minimized where production or facilities are no longer necessary.

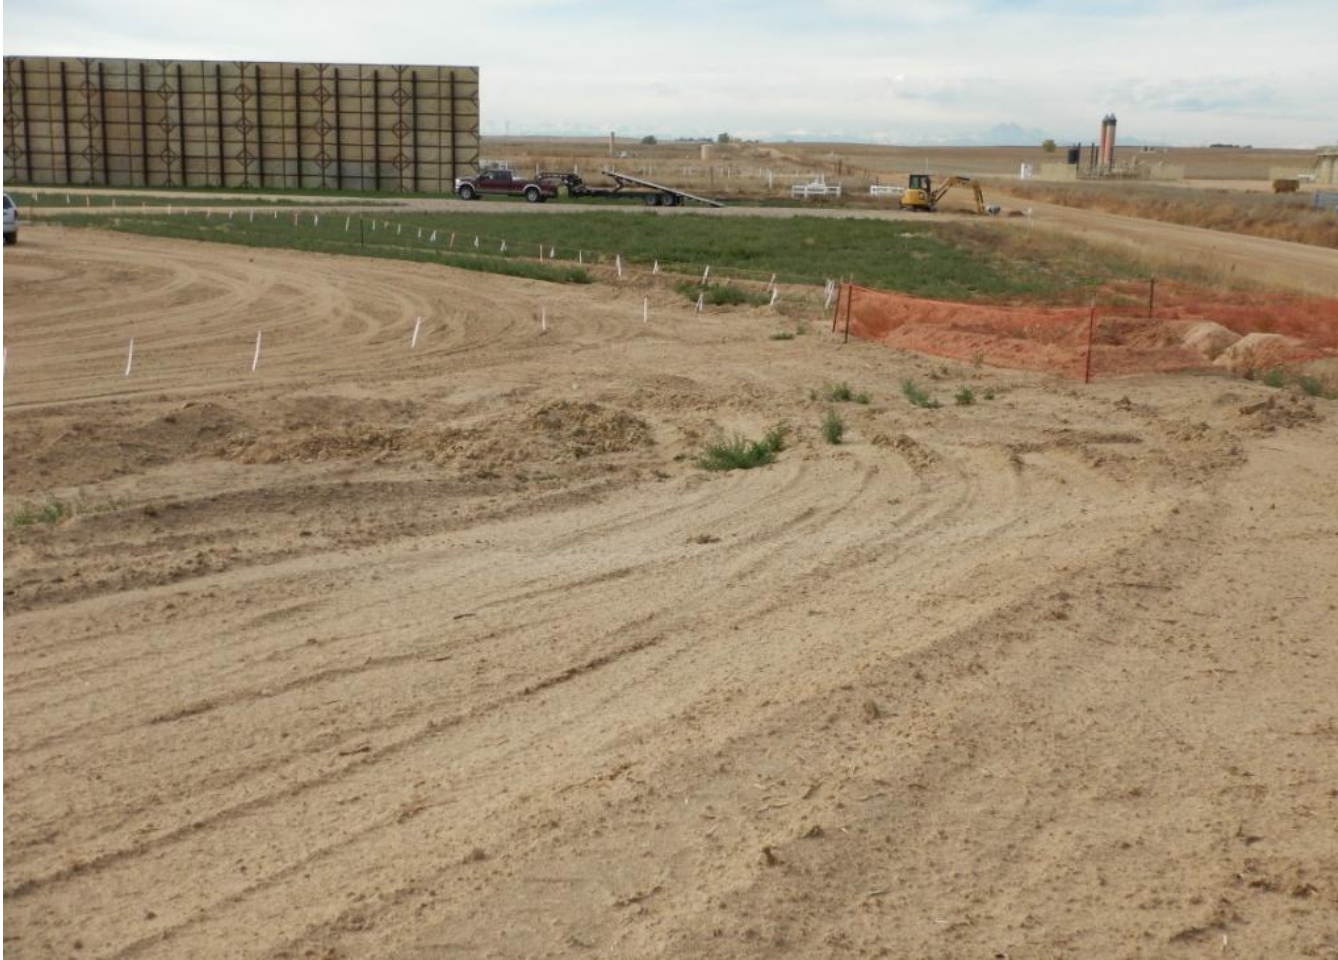
Photo 4. Photo taken from northeast location, facing West. When interim reclamation starts, this area shall be reclaimed and minimized where production or facilities are no longer necessary.

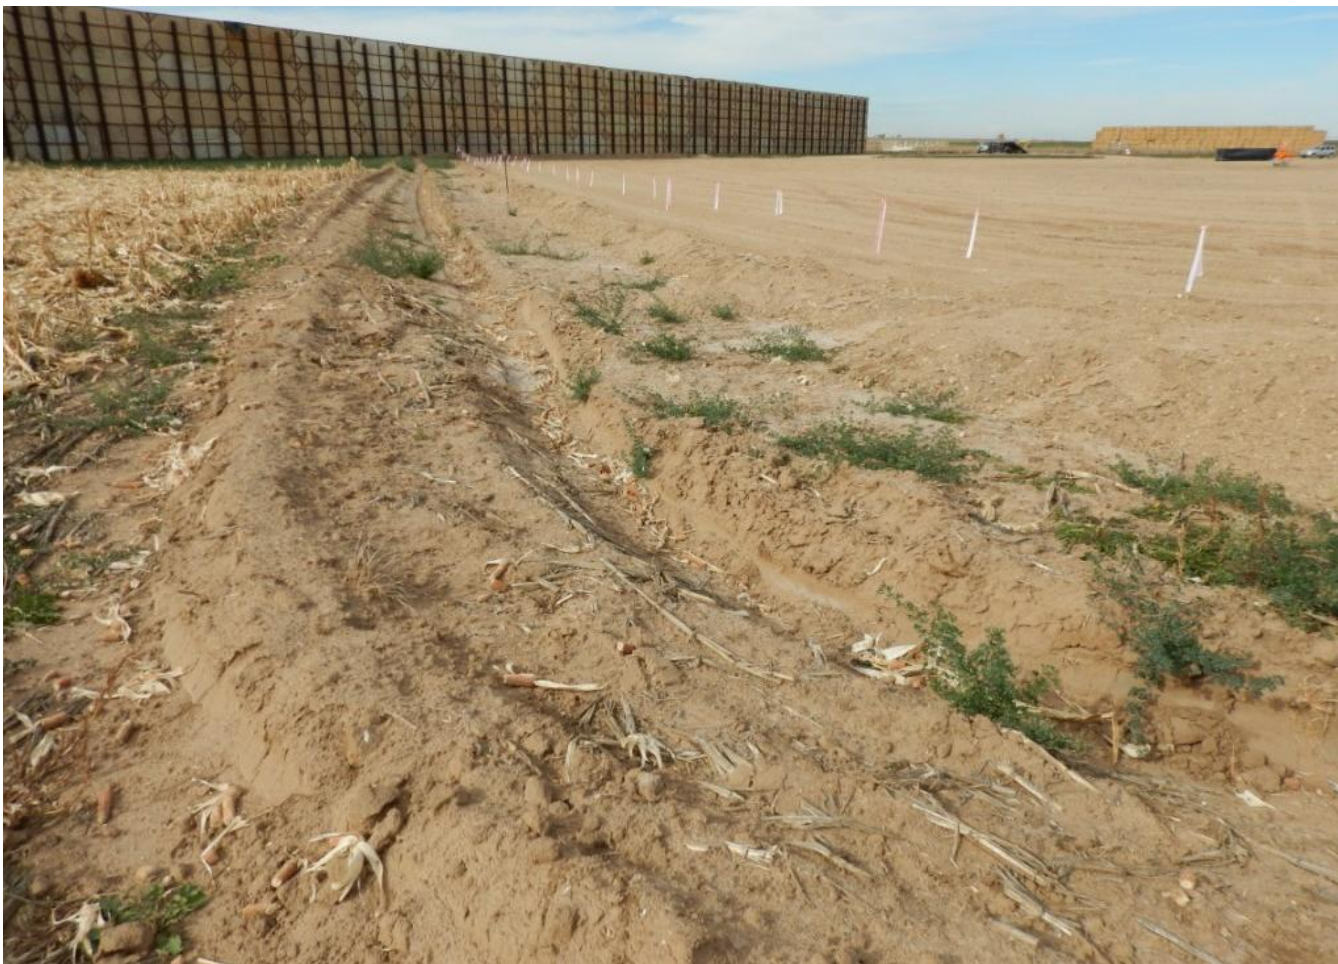
Photo 8. Photo taken from south location, facing North. When interim reclamation starts, this area shall be reclaimed and minimized where production or facilities are no longer necessary.

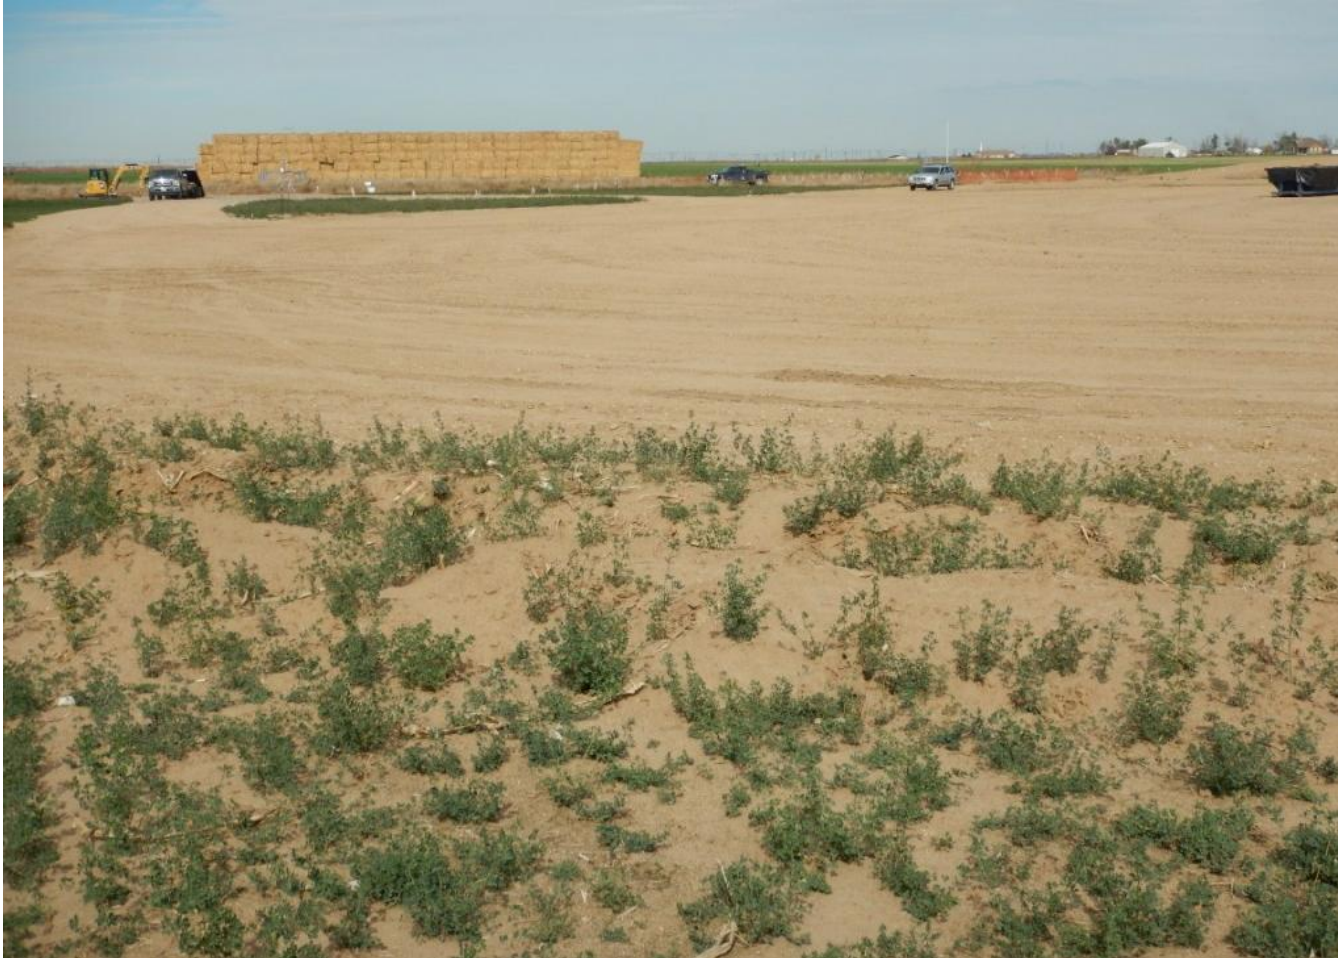
Photo 9. Photo taken from west location, facing North. When interim reclamation starts, this area shall be reclaimed and minimized where production or facilities are no longer necessary.

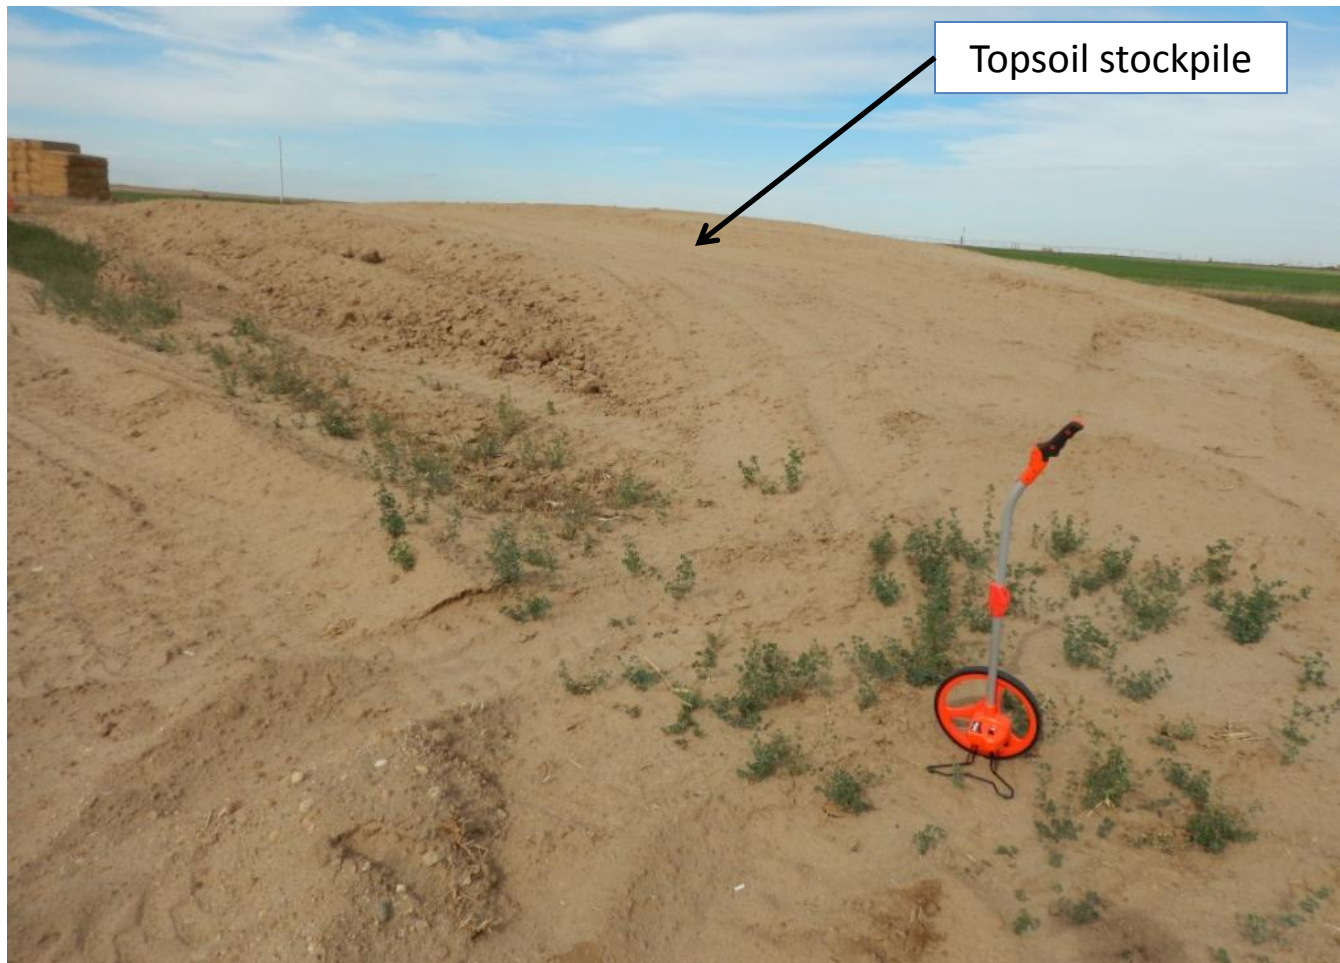
Photo 10. Photo taken from east location, facing North. Perennial vegetation is required for topsoil stabilization.

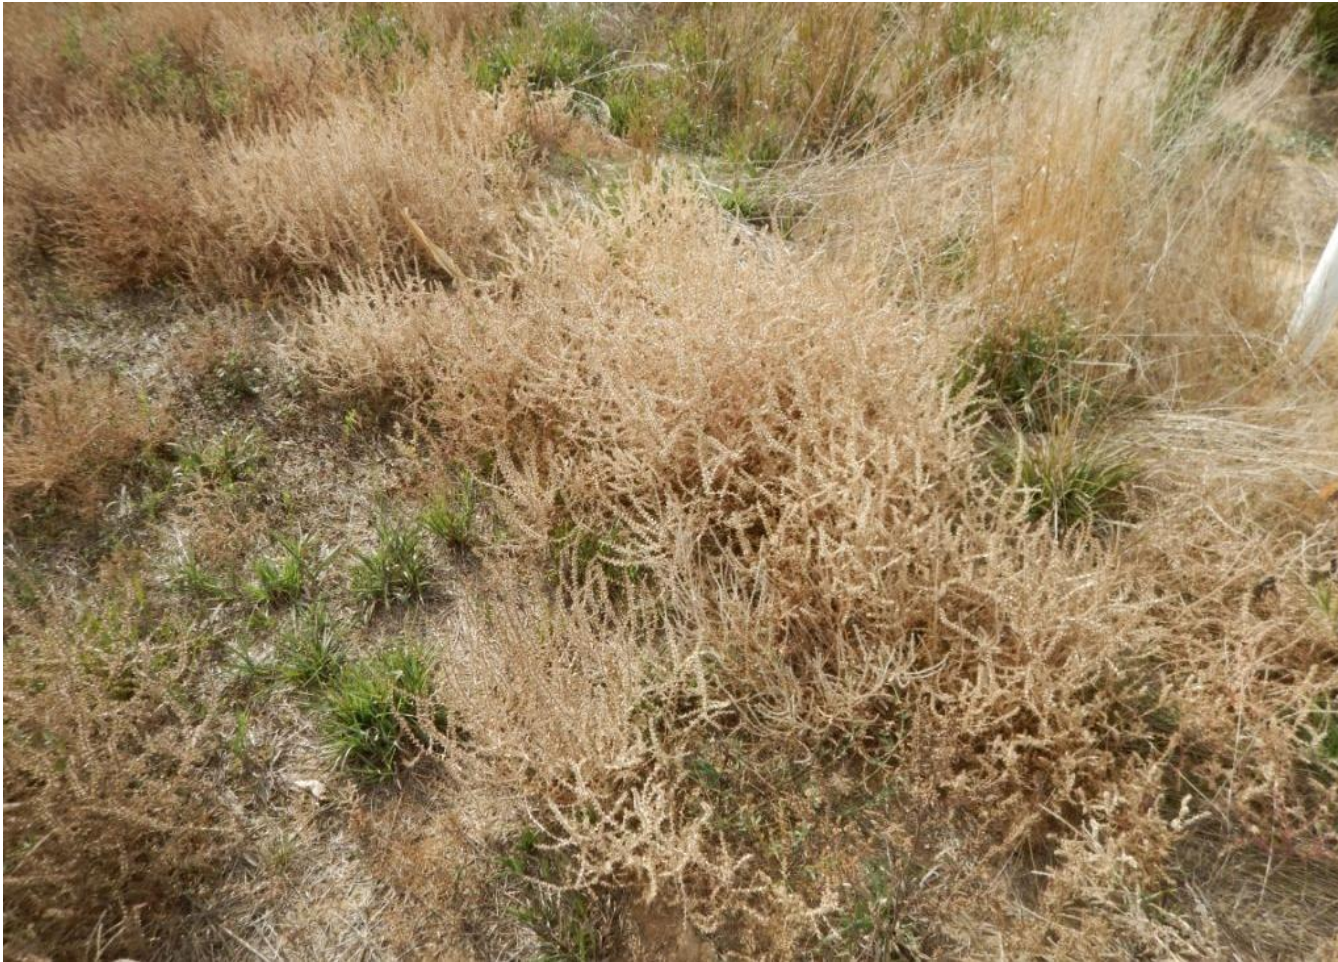
Photo 11. Kochia (*Kochia sp.*) located throughout northern location is debris and will break off, encroach upon adjacent lands and needs to be removed.

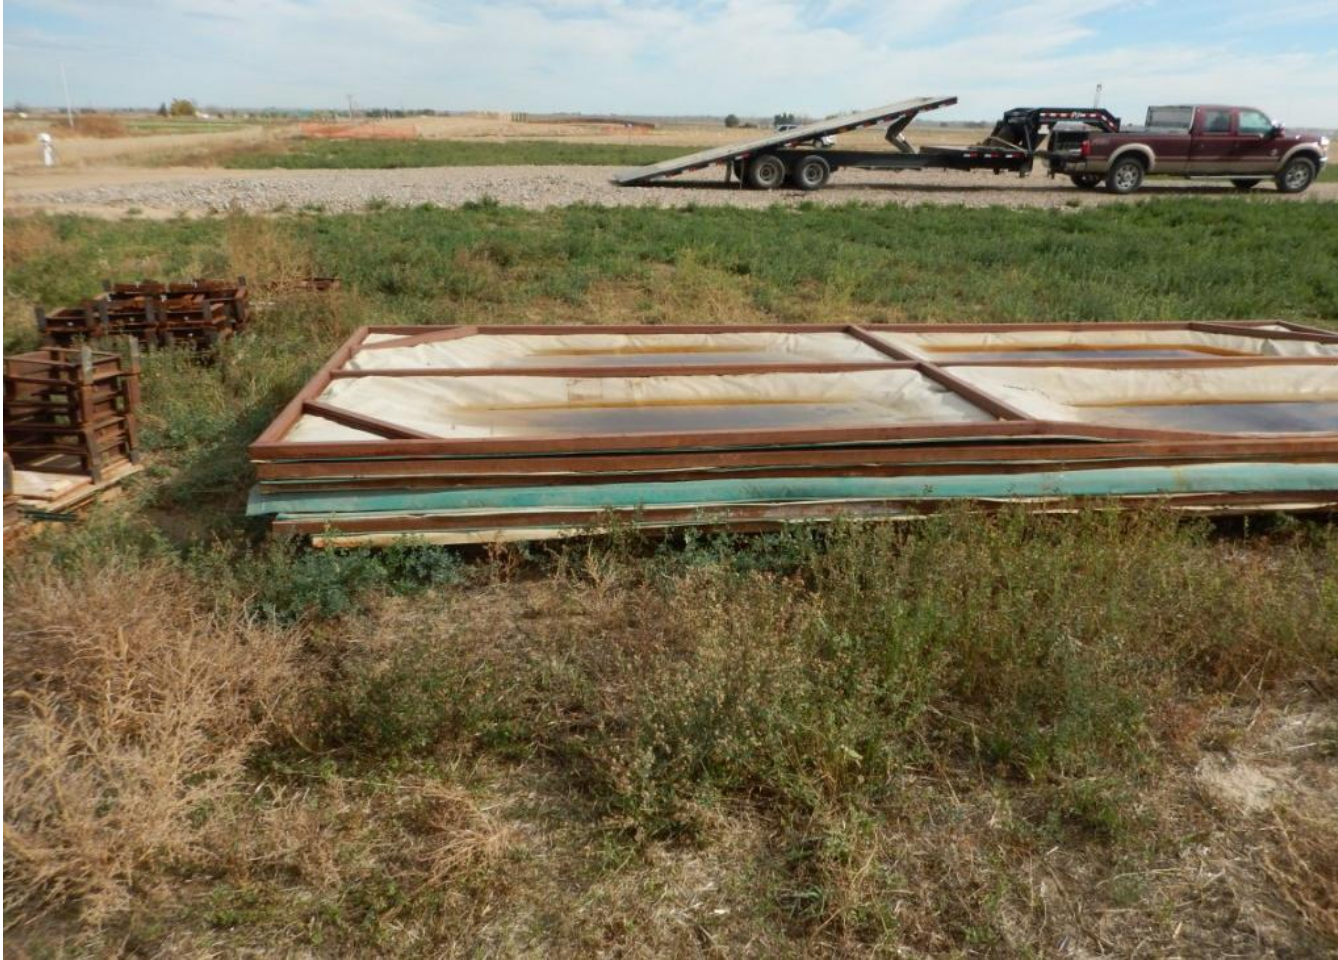
Photo 12. Photo taken from the northwest location, facing East. Unused or unneeded equipment needs to be removed.

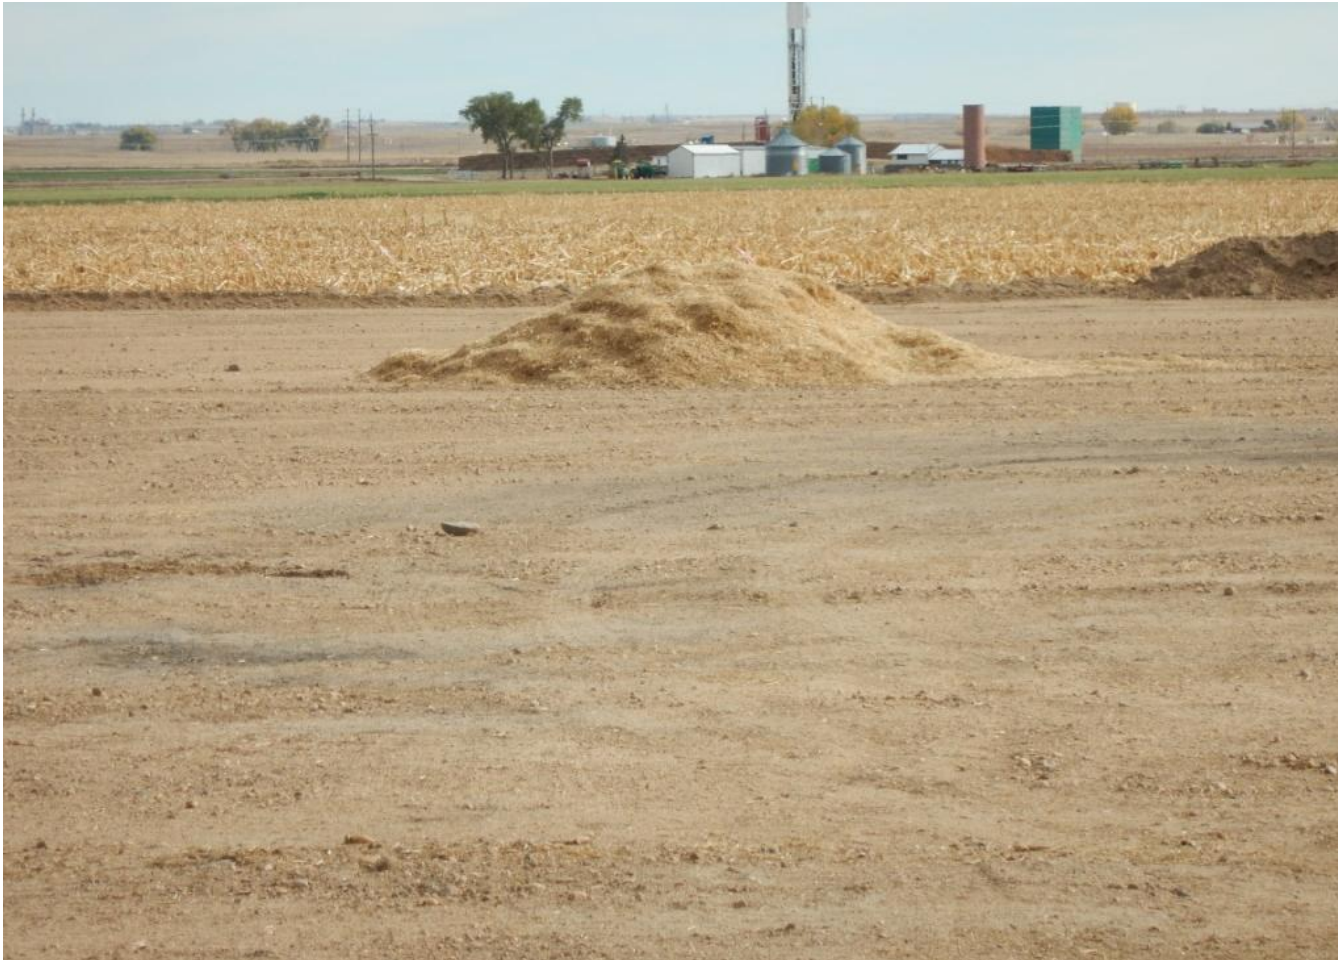
Photo 13. Photo taken from the central location, facing East. Need to remove all debris from location.

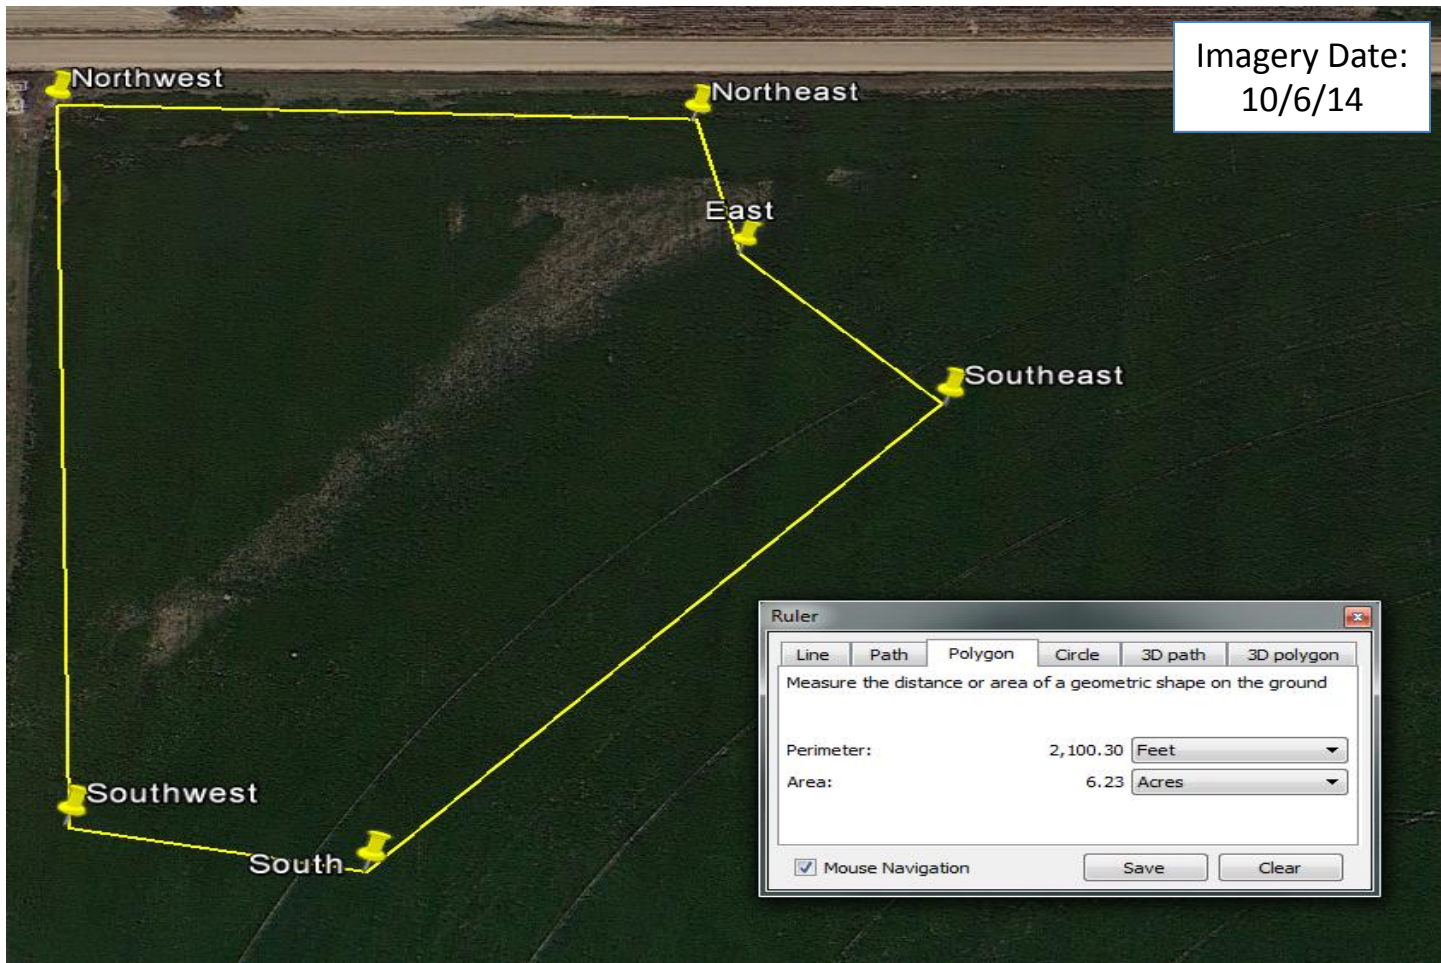
Photo 14. The perimeter, in yellow, illustrates the disturbance boundary as of 10/29/15. Total disturbance equals 6.23 acres.
