**Photo 2:** Photo of PR well Murphy # 11-5, API # 005-07112

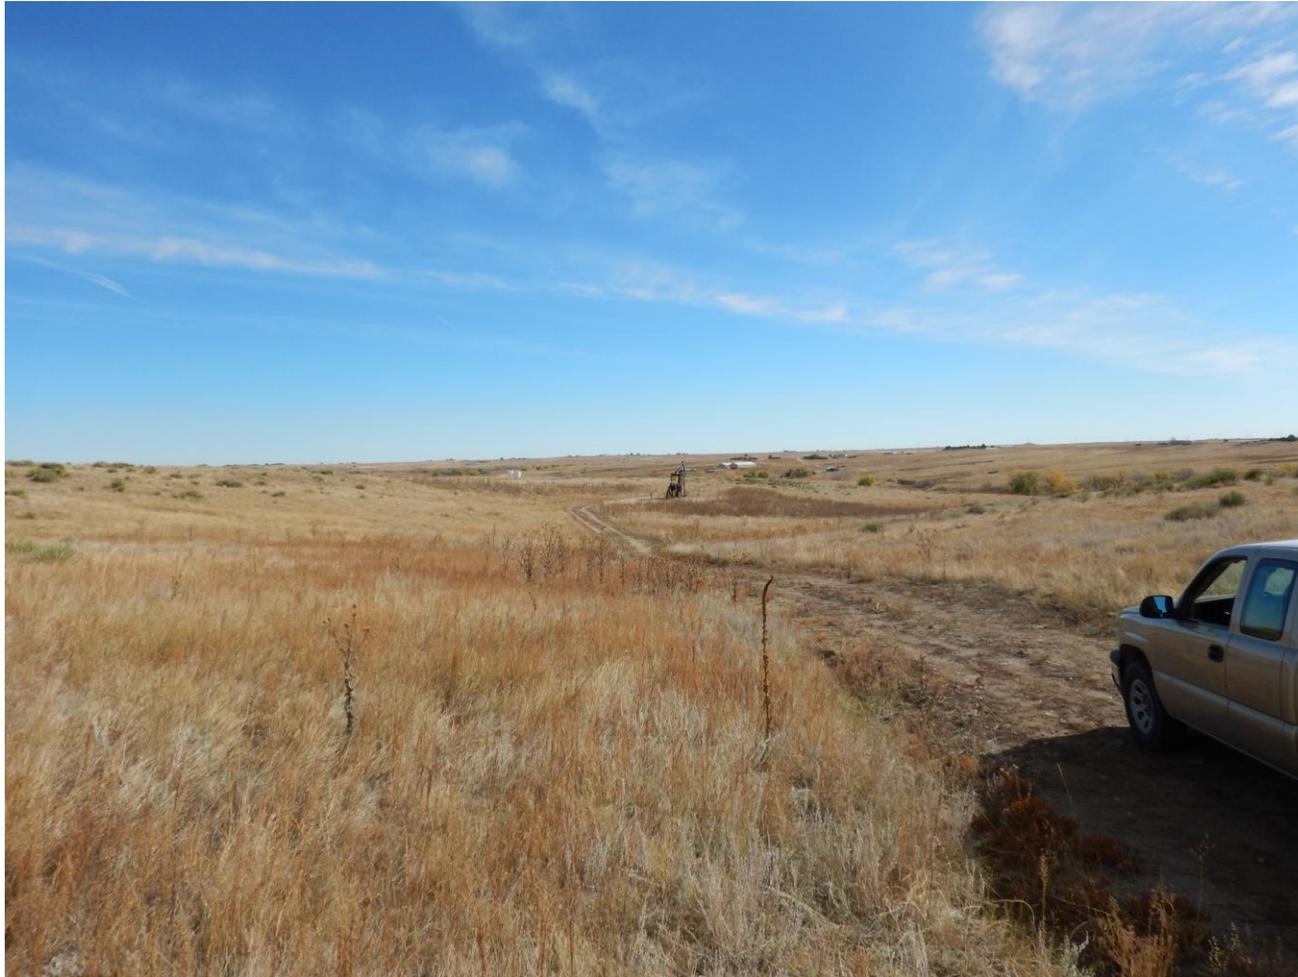
**Photo 1:** Photo taken from access road west of location, facing east. Storm water erosion evident on road. Darker vegetation to right of well is Scotch thistle (please see photos 3 and 4).

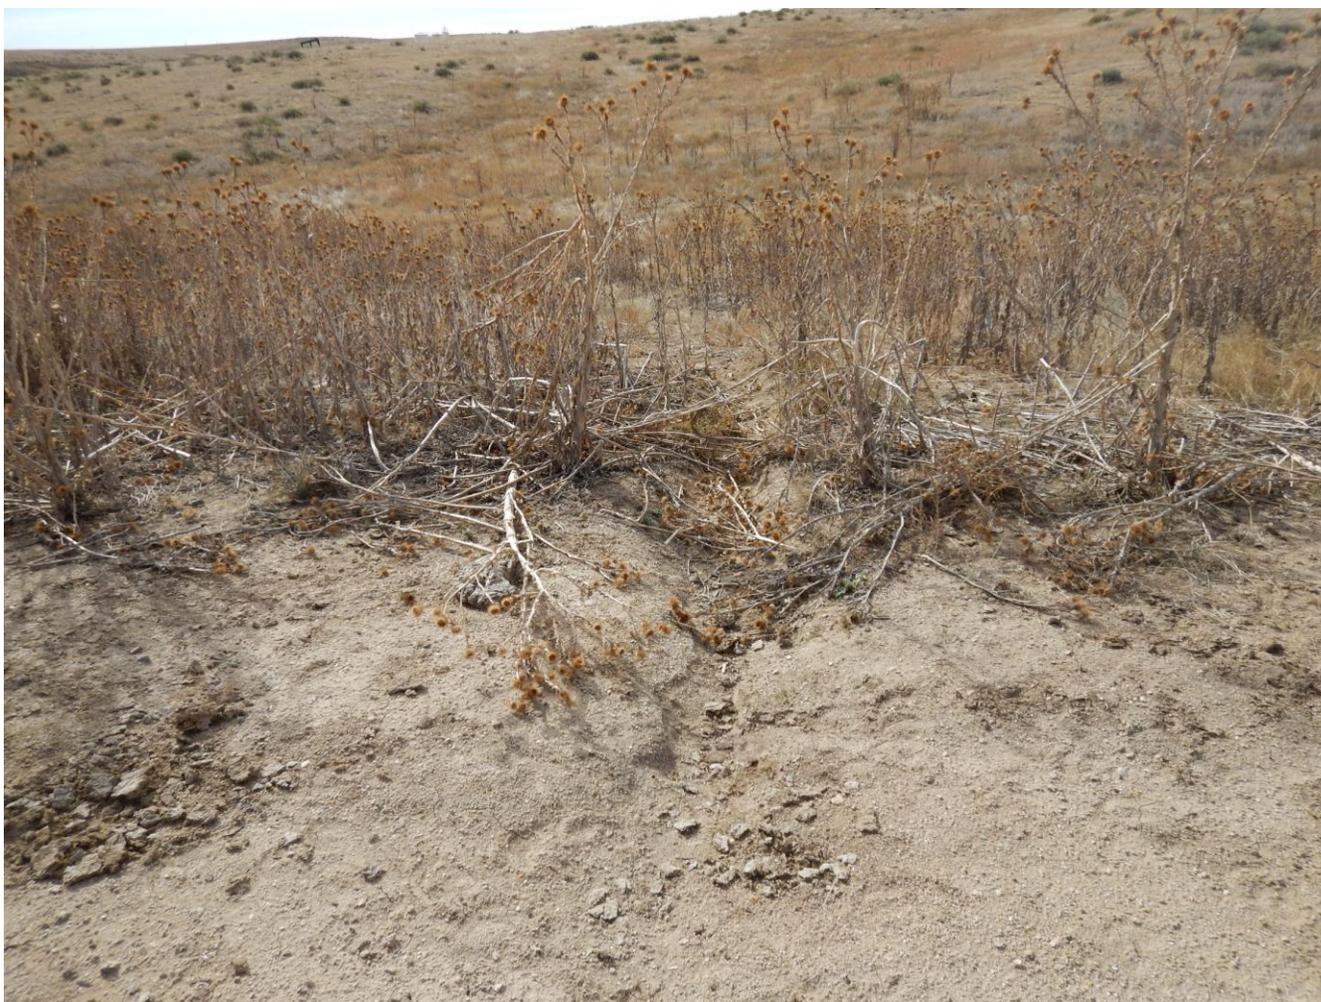
**Photo 3:** Photo from South end of well location, facing south. Note the abundance of Scotch thistle on site, these are noxious weeds and must be managed. Note the development of rill erosion on slope.

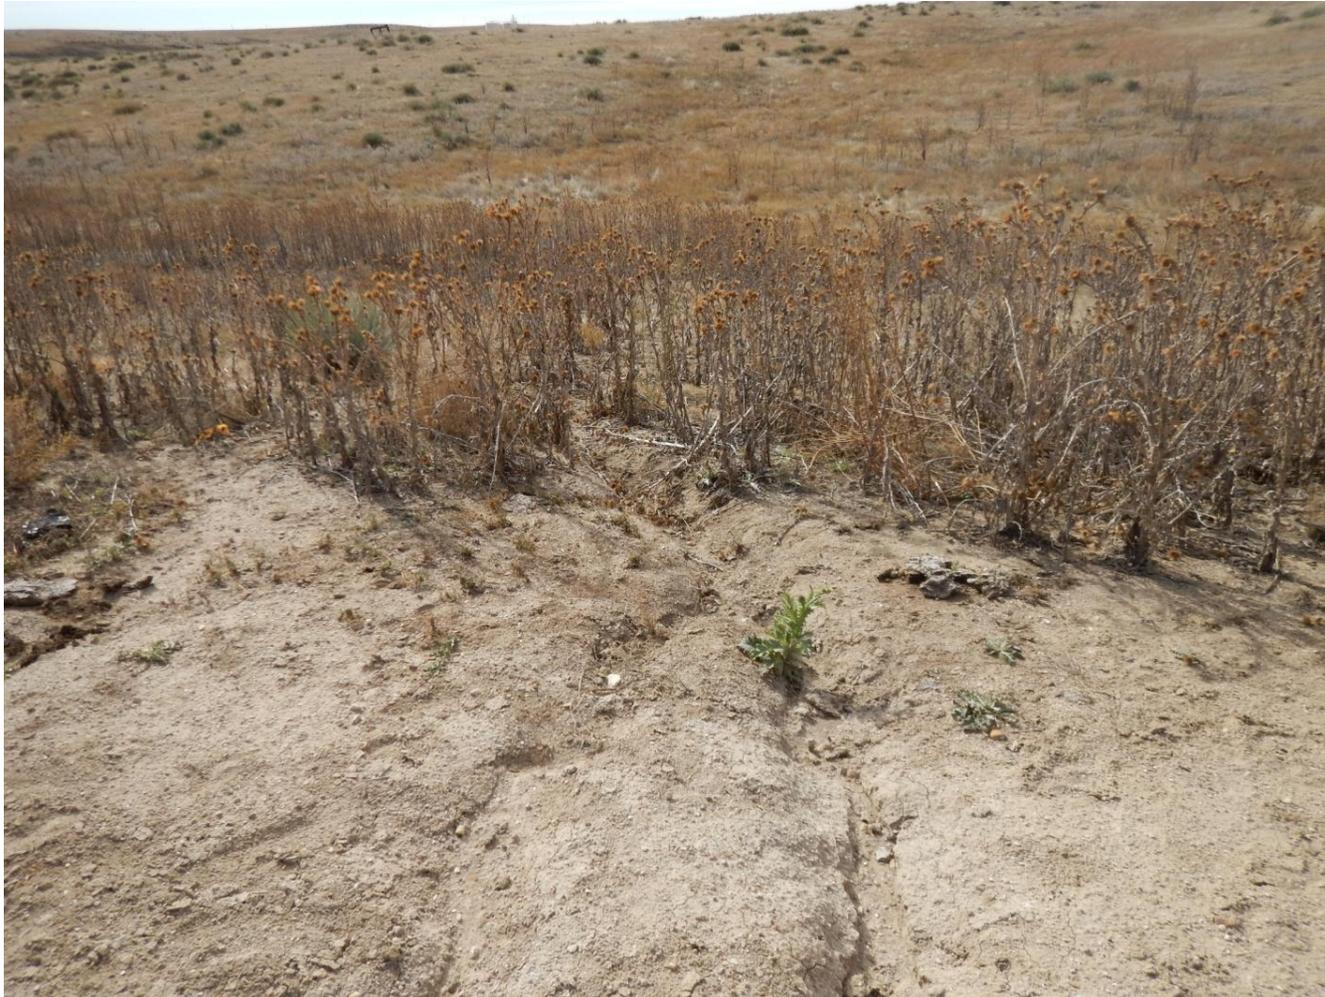
**Photo 4:** Photo from South end of location, facing South. Note the abundance of Scotch thistle on site, these are noxious weeds and must be managed. Note the development of rill erosion on slope.

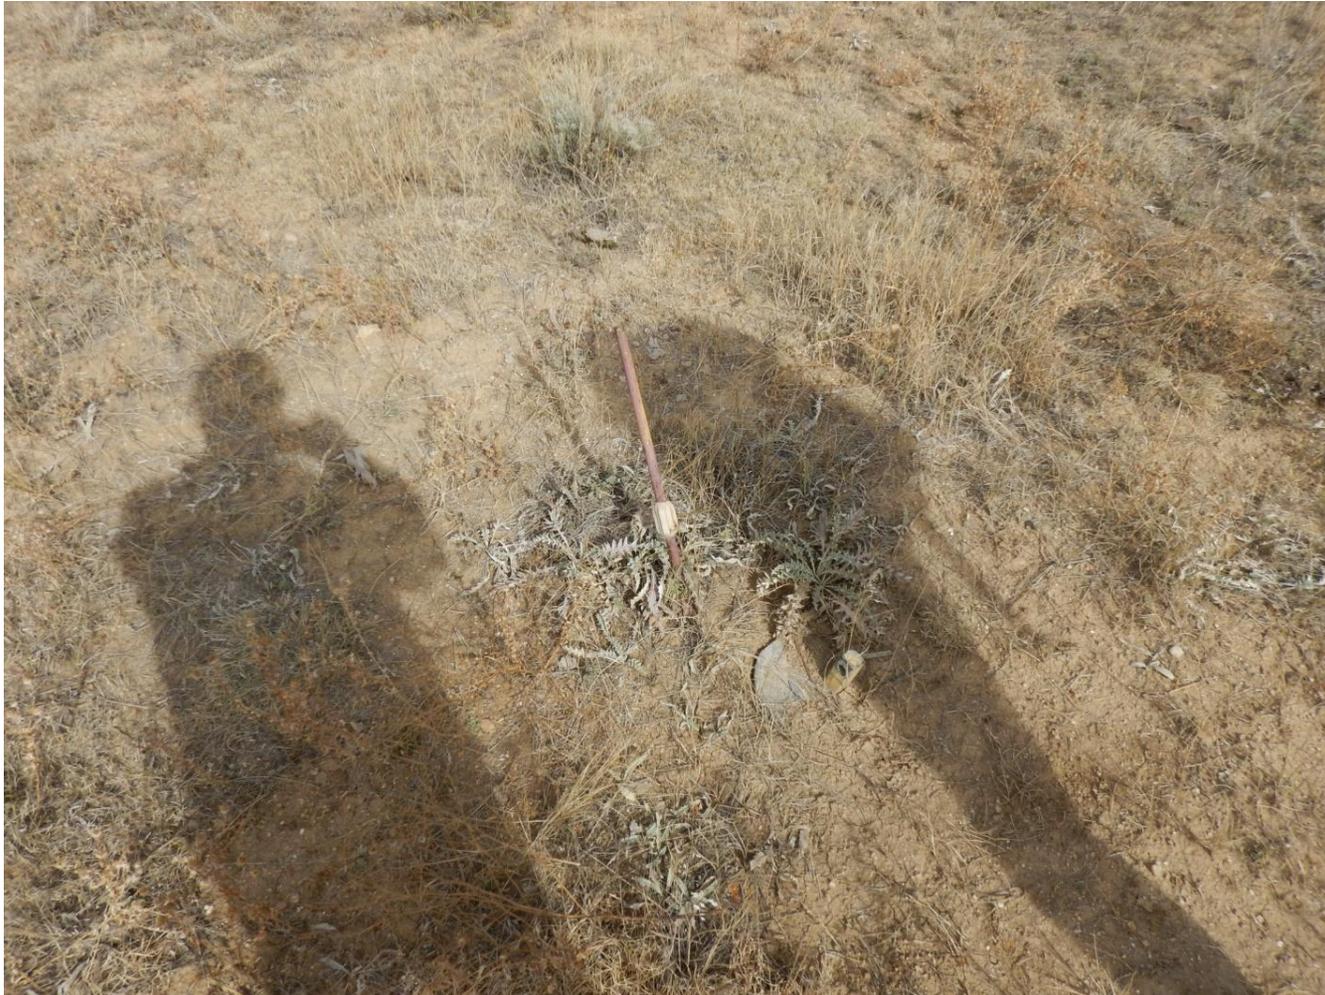
**Photo 5:** Photo of Guy line anchor. Guy line anchors need to be clearly marked/identified.

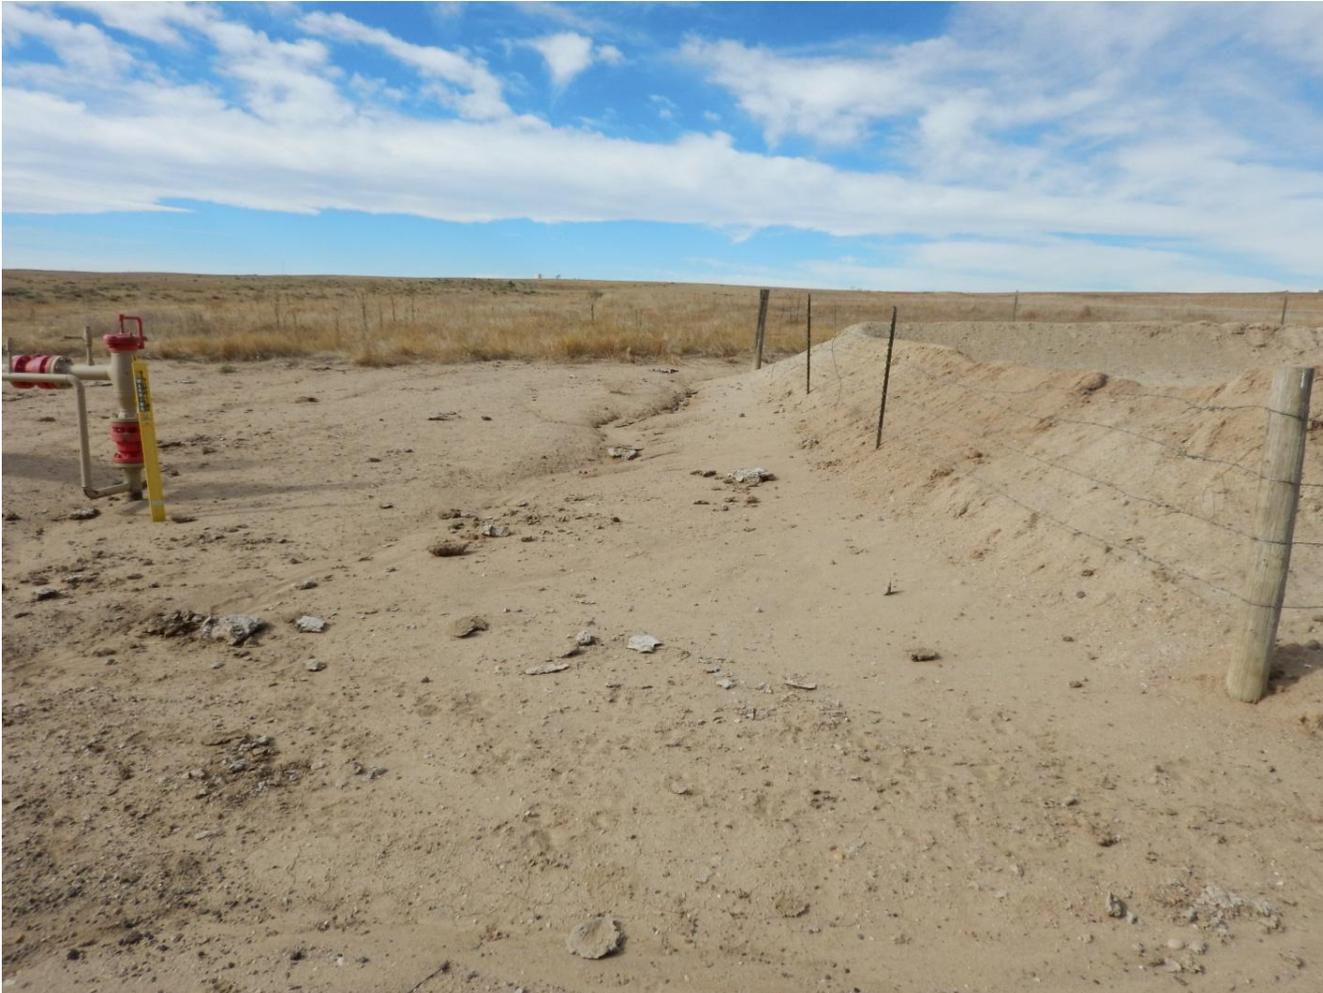
**Photo 7:** Photo taken from battery location facing west. Note the rill erosion developing on site.

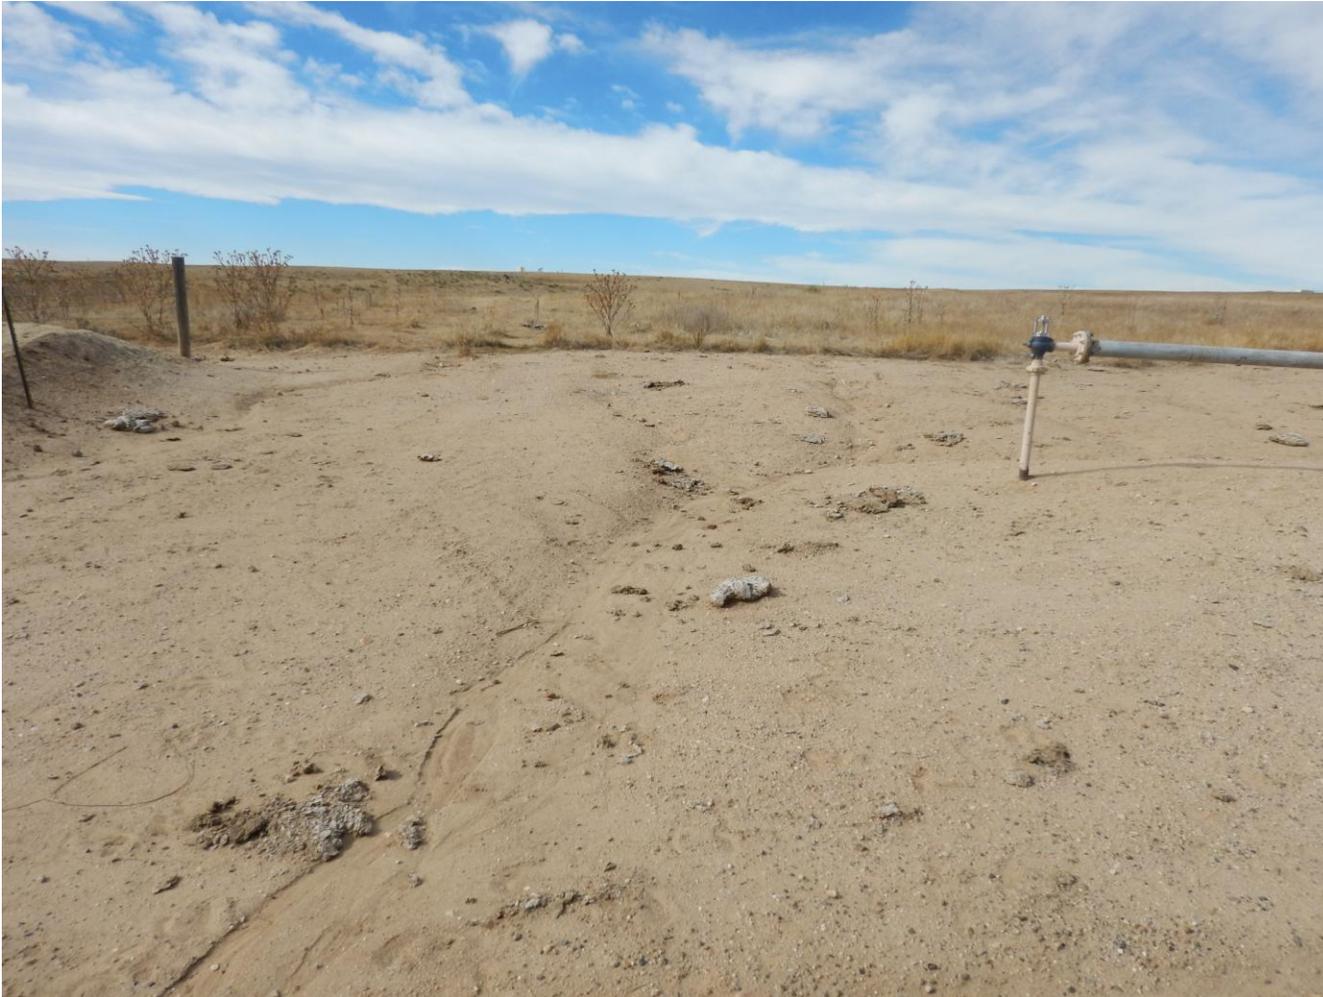
**Photo 8:** Photo taken from battery location facing west. Note the rill erosion developing on site.

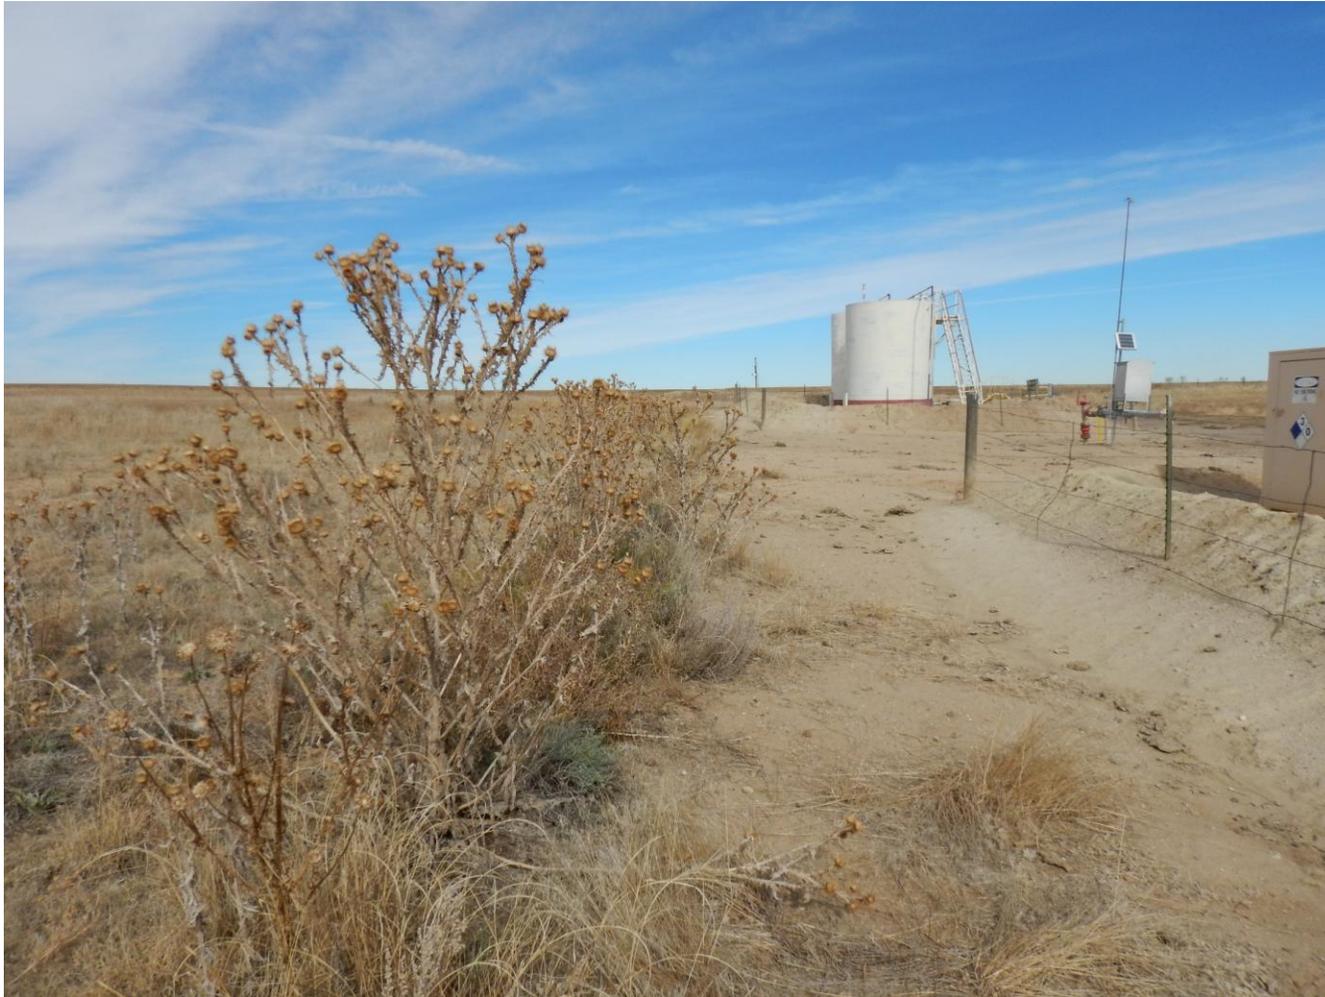
**Photo 9:** Photo taken from Southwest side of battery location, facing North. Note the Scotch thistle; this is a noxious weed and must be managed.
