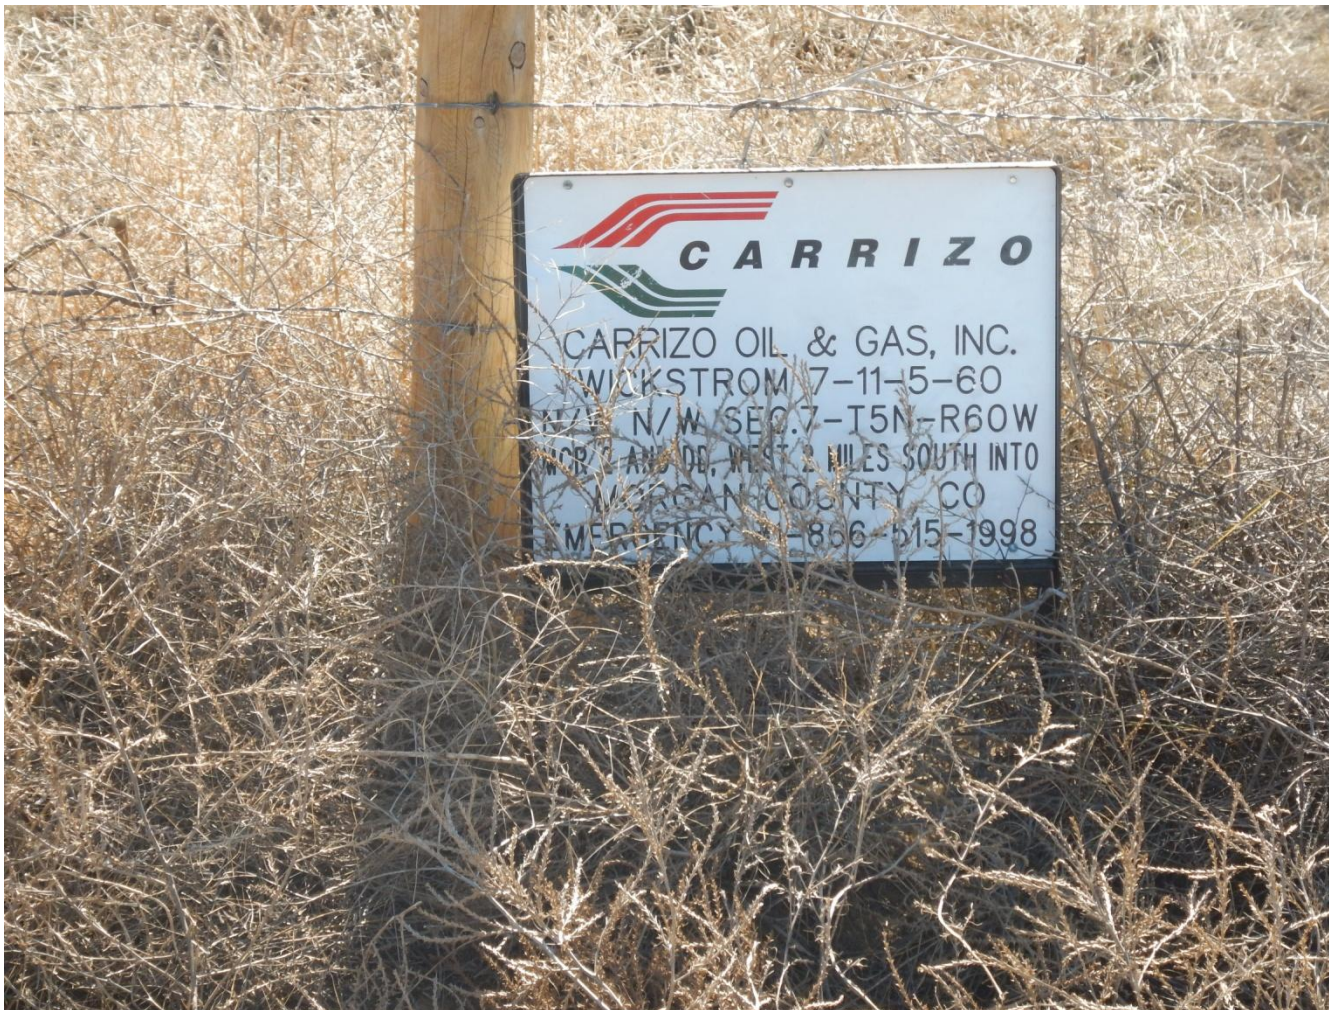
Photo 1: Photo of entrance sign on North side of location. Not the vegetative debris along fence line.

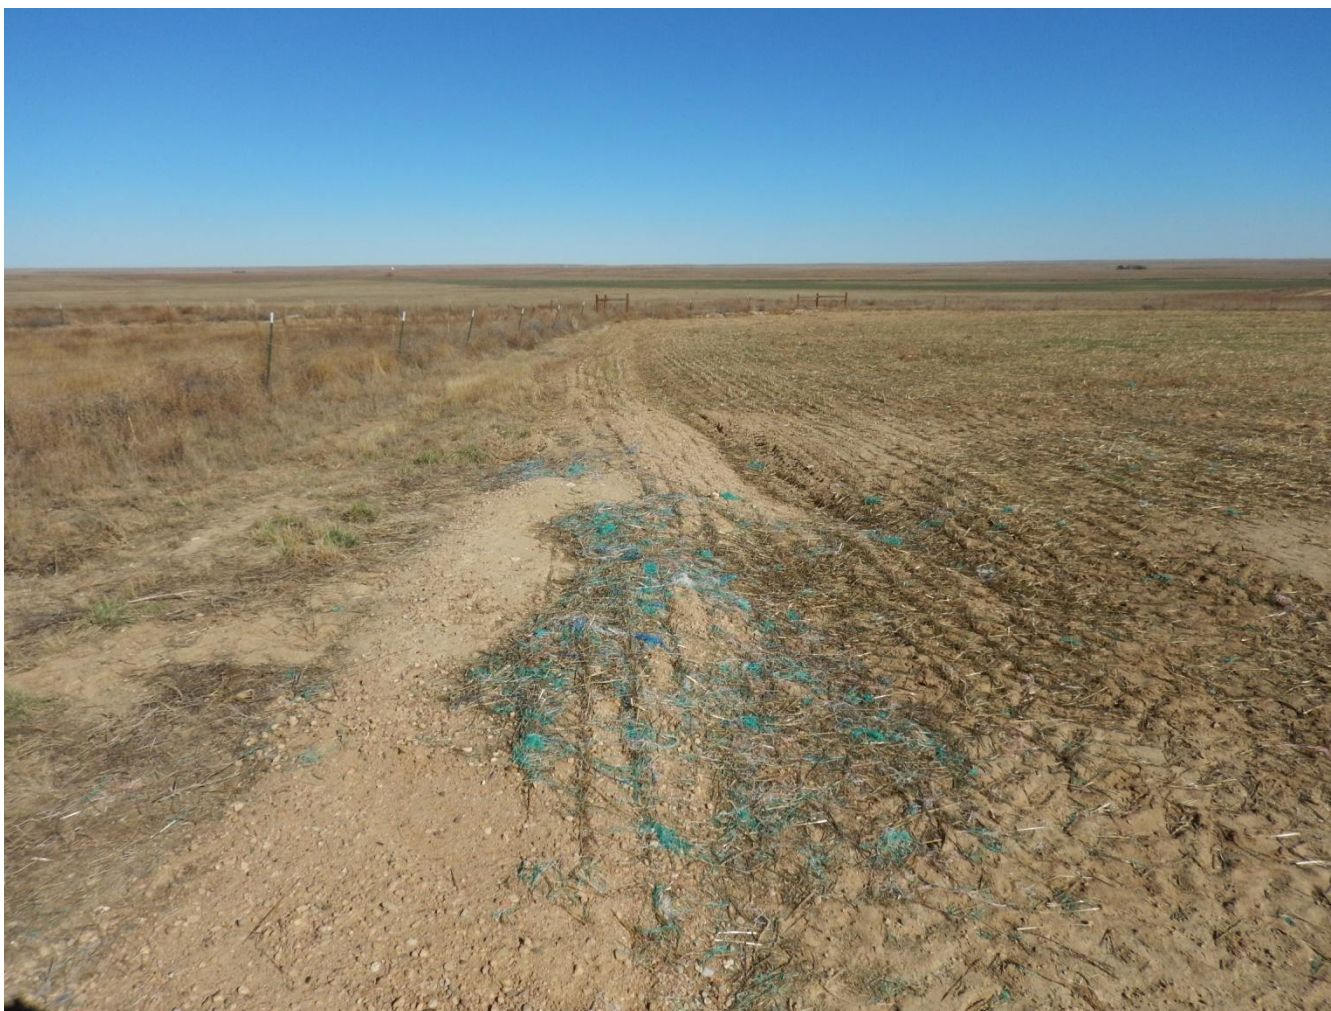
Photo 2: Photo taken from North side of location looking east. Note the trash debris in center of photo.

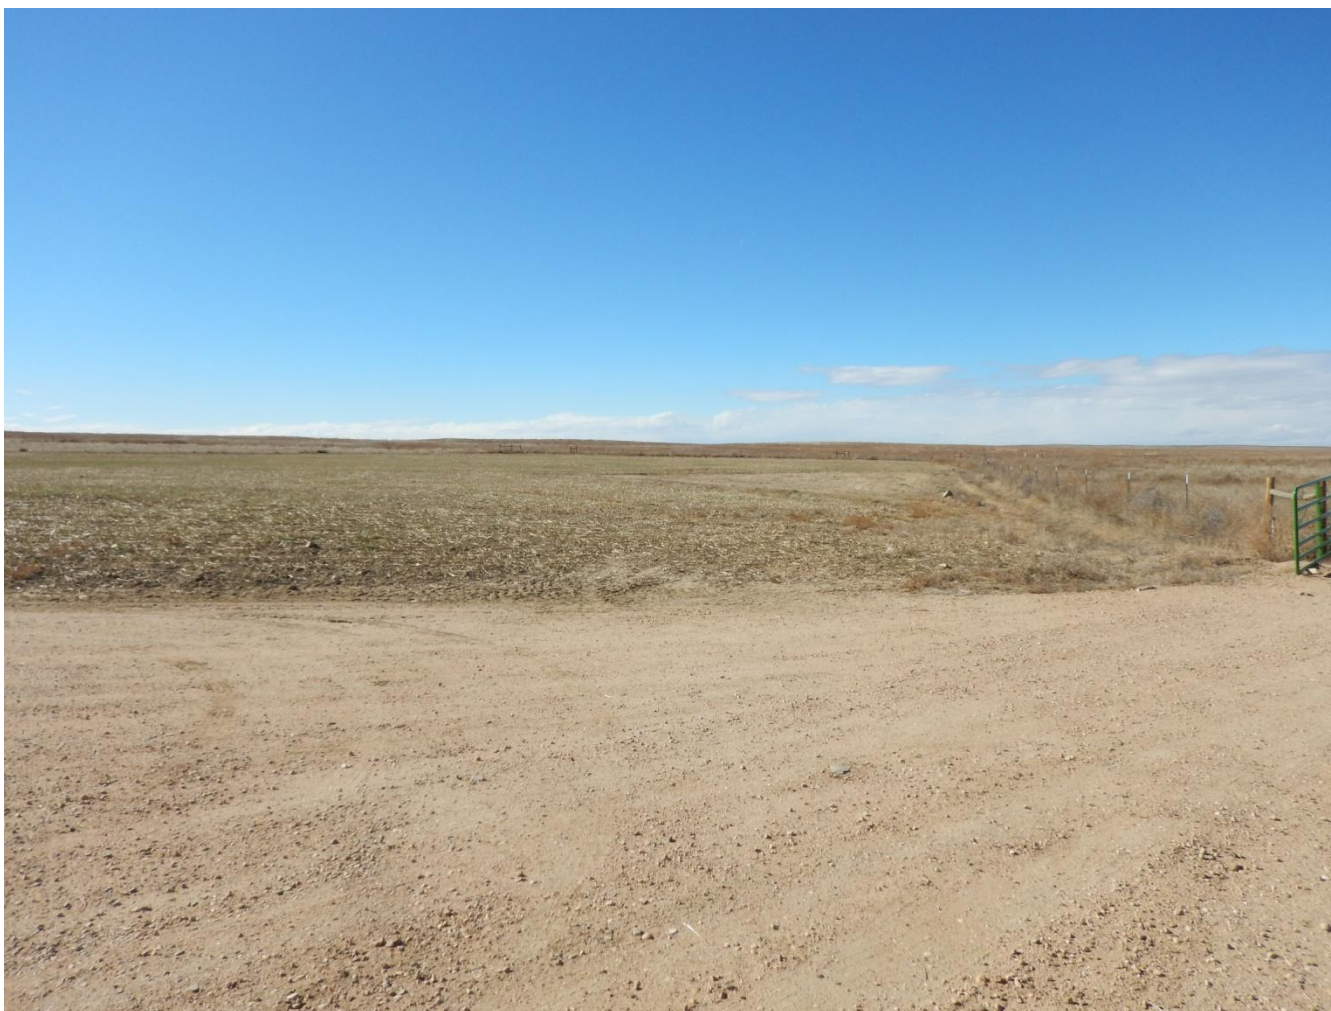
Photo 3: Photo taken from North side of location looking west. Interim reclamation in progress.

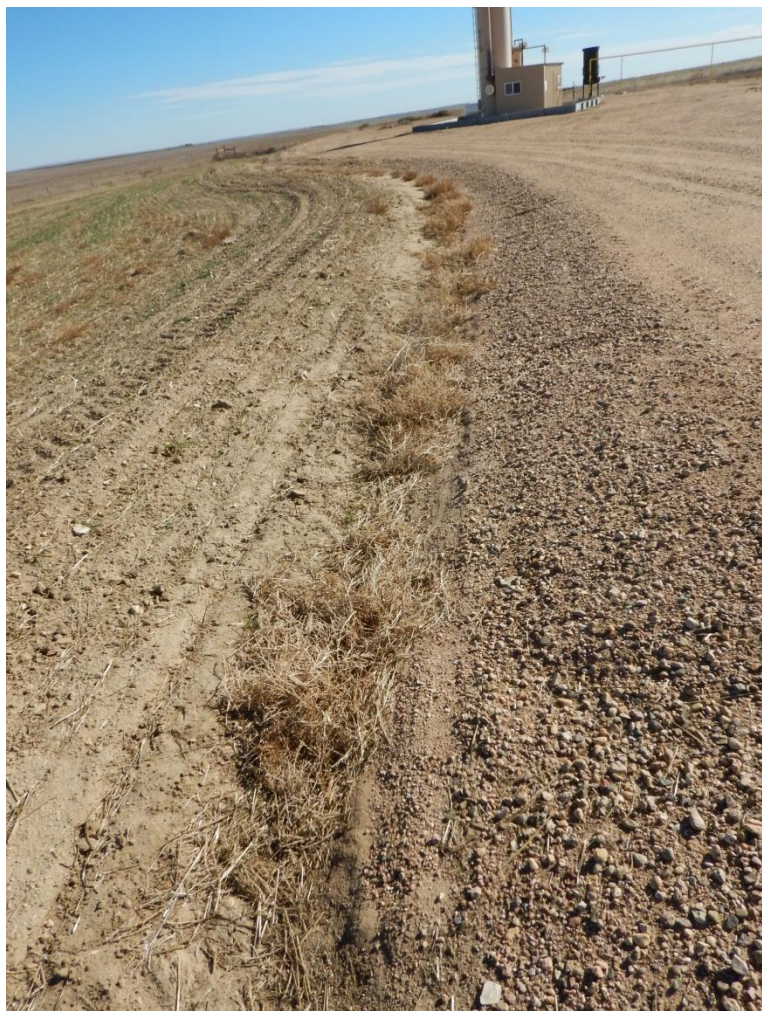
Photo 4: Photo taken from North side of location looking south. Photo of Kochia and Russian thistle weeds along center of storm water control ditch.

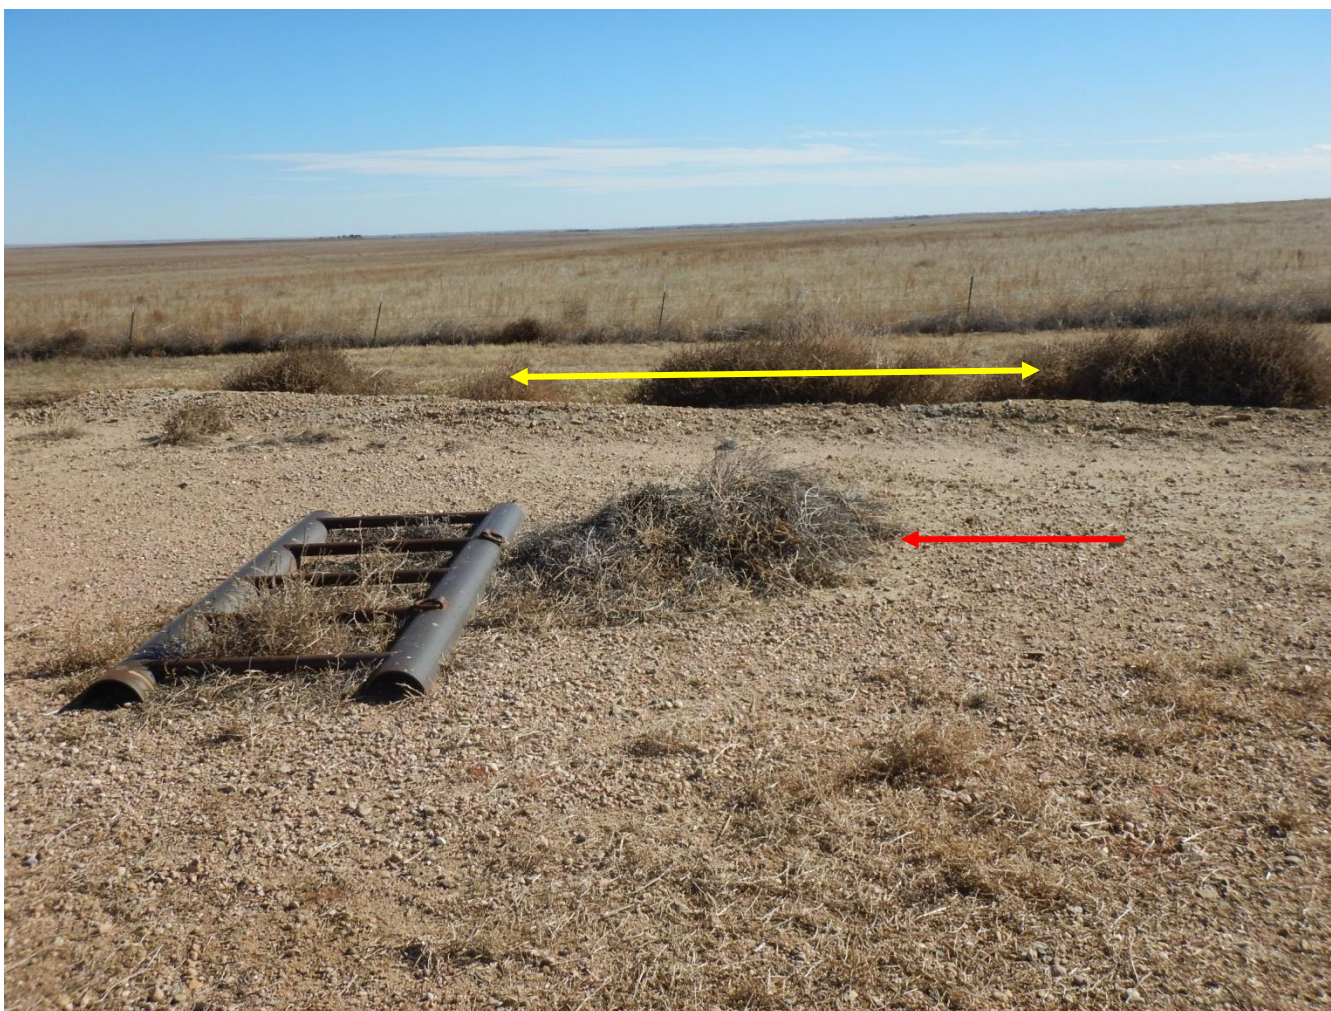
Photo 5: Photo taken on South end of location facing south. Note the vegetative debris center of photo (arrow in red), and Russian thistle/Kochia weeds towards top of photo (arrow in yellow).

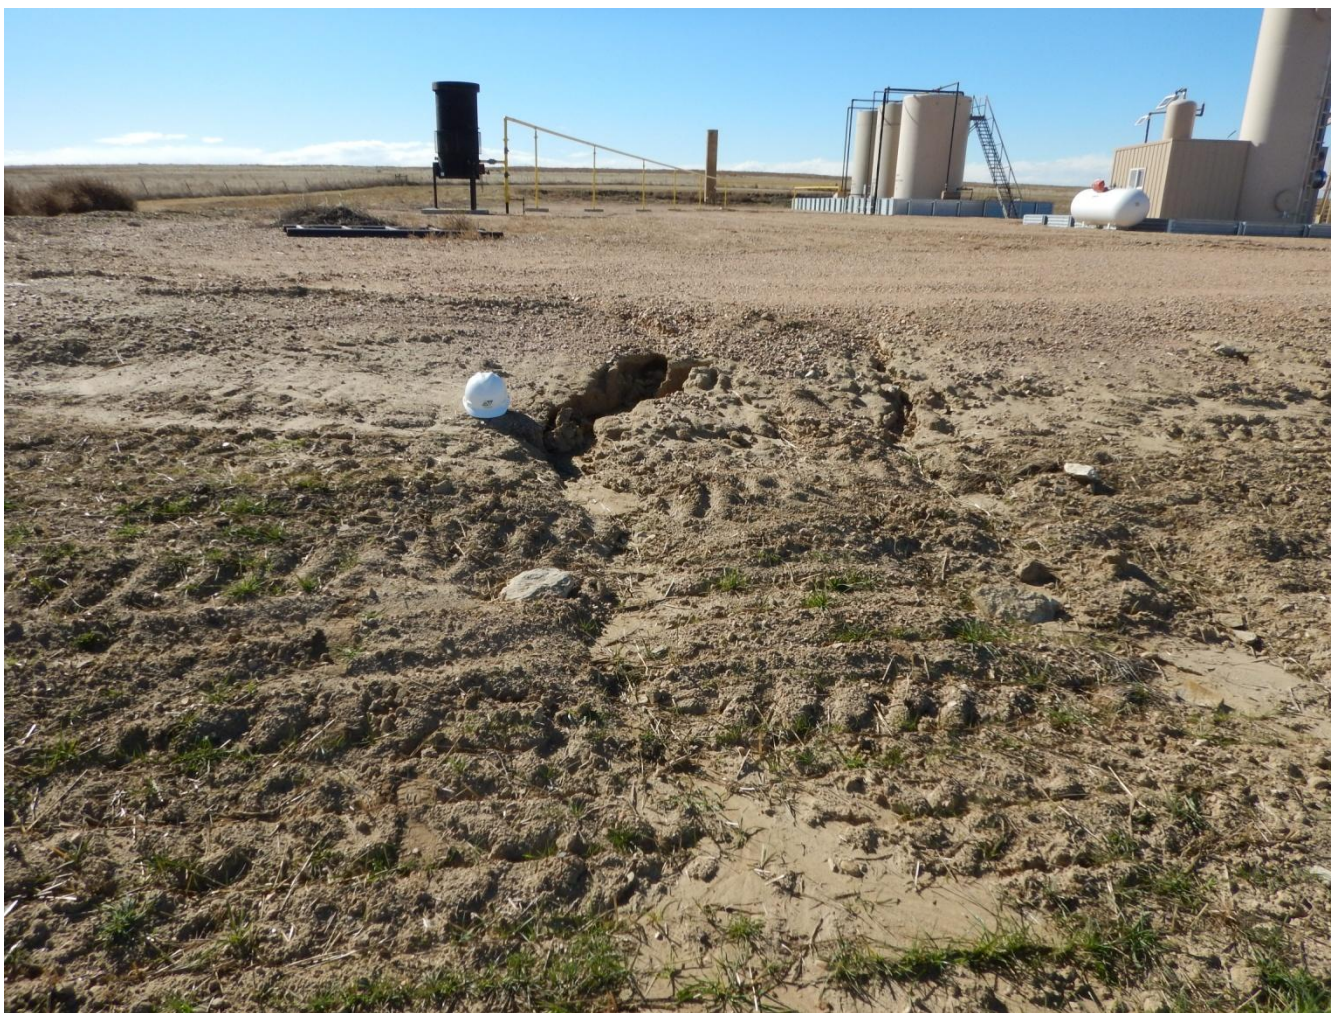
Photo 6: Photo from Southeast portion of location. Photo of rill erosion on slope.

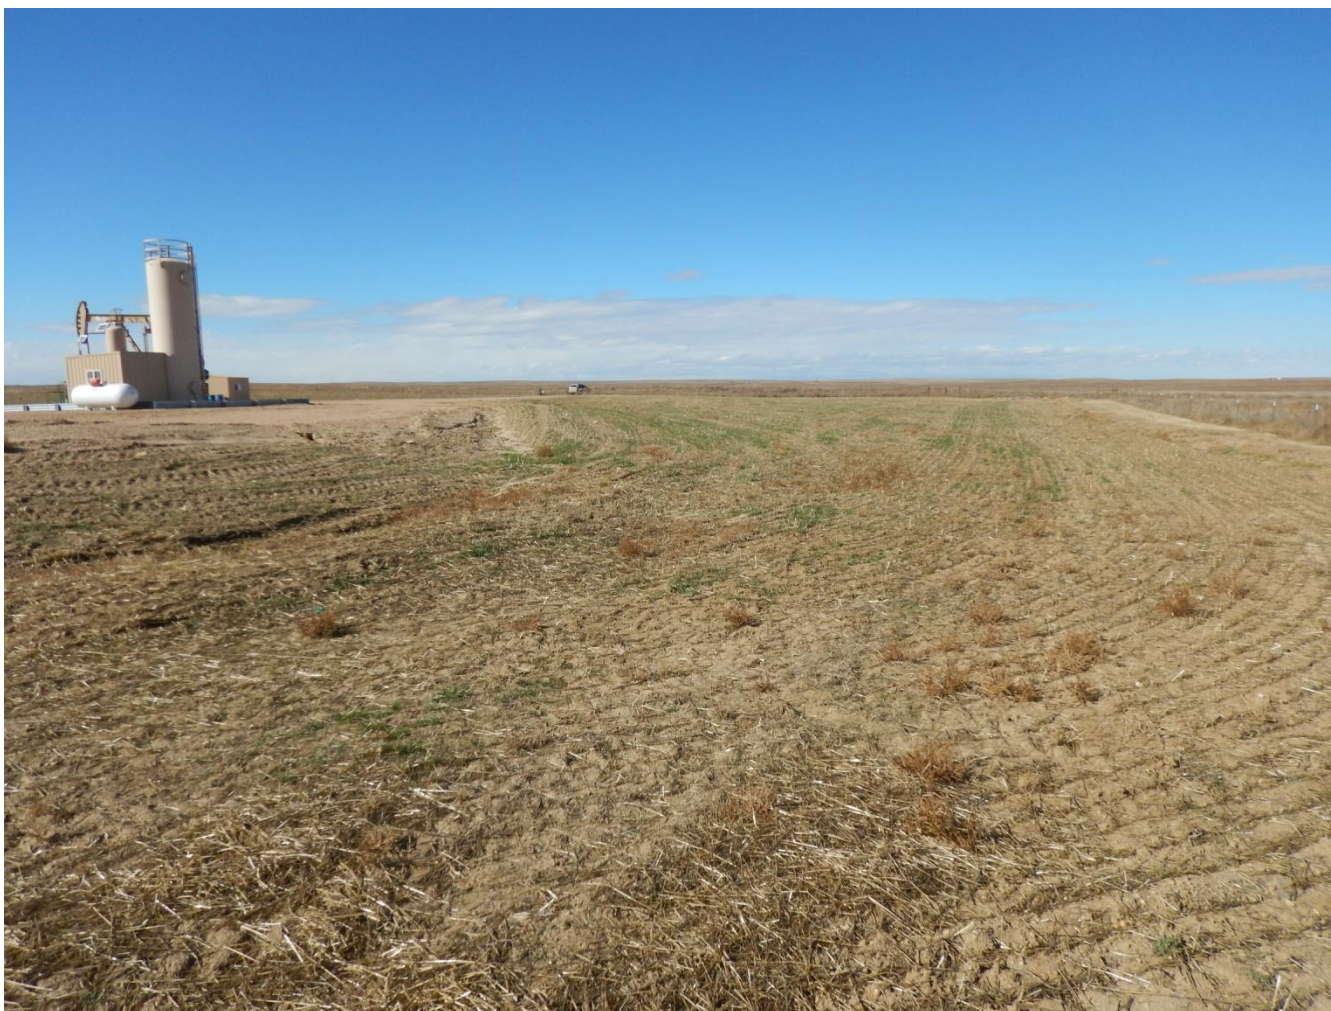
Photo 7: Photo taken from Southeast side of location facing north. Interim reclamation in progress.

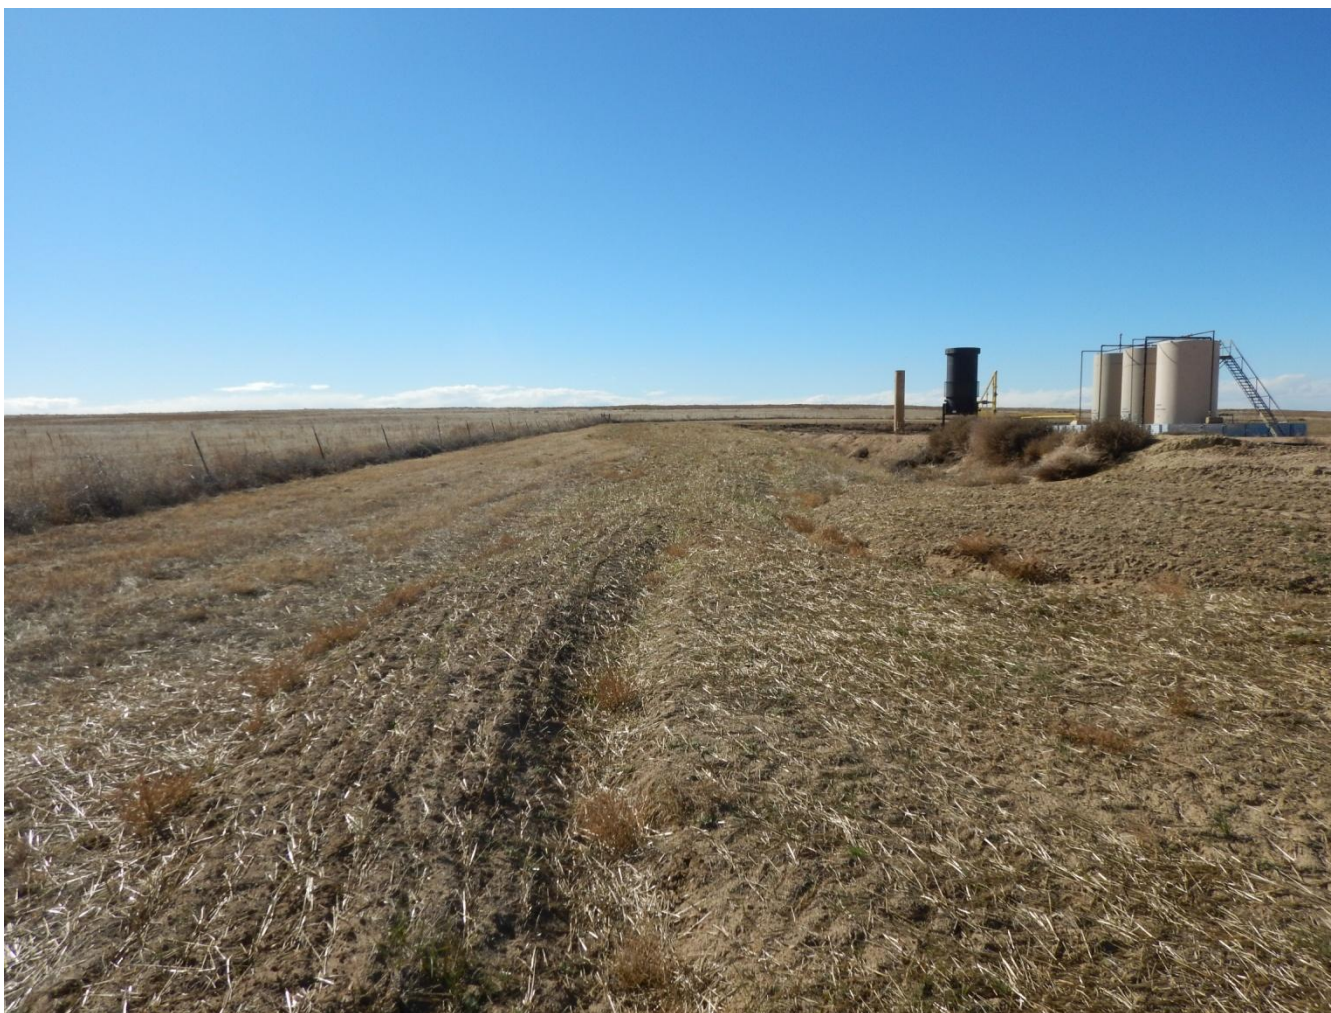
Photo 8: Photo taken from Southeast of location facing west. Interim reclamation in progress.

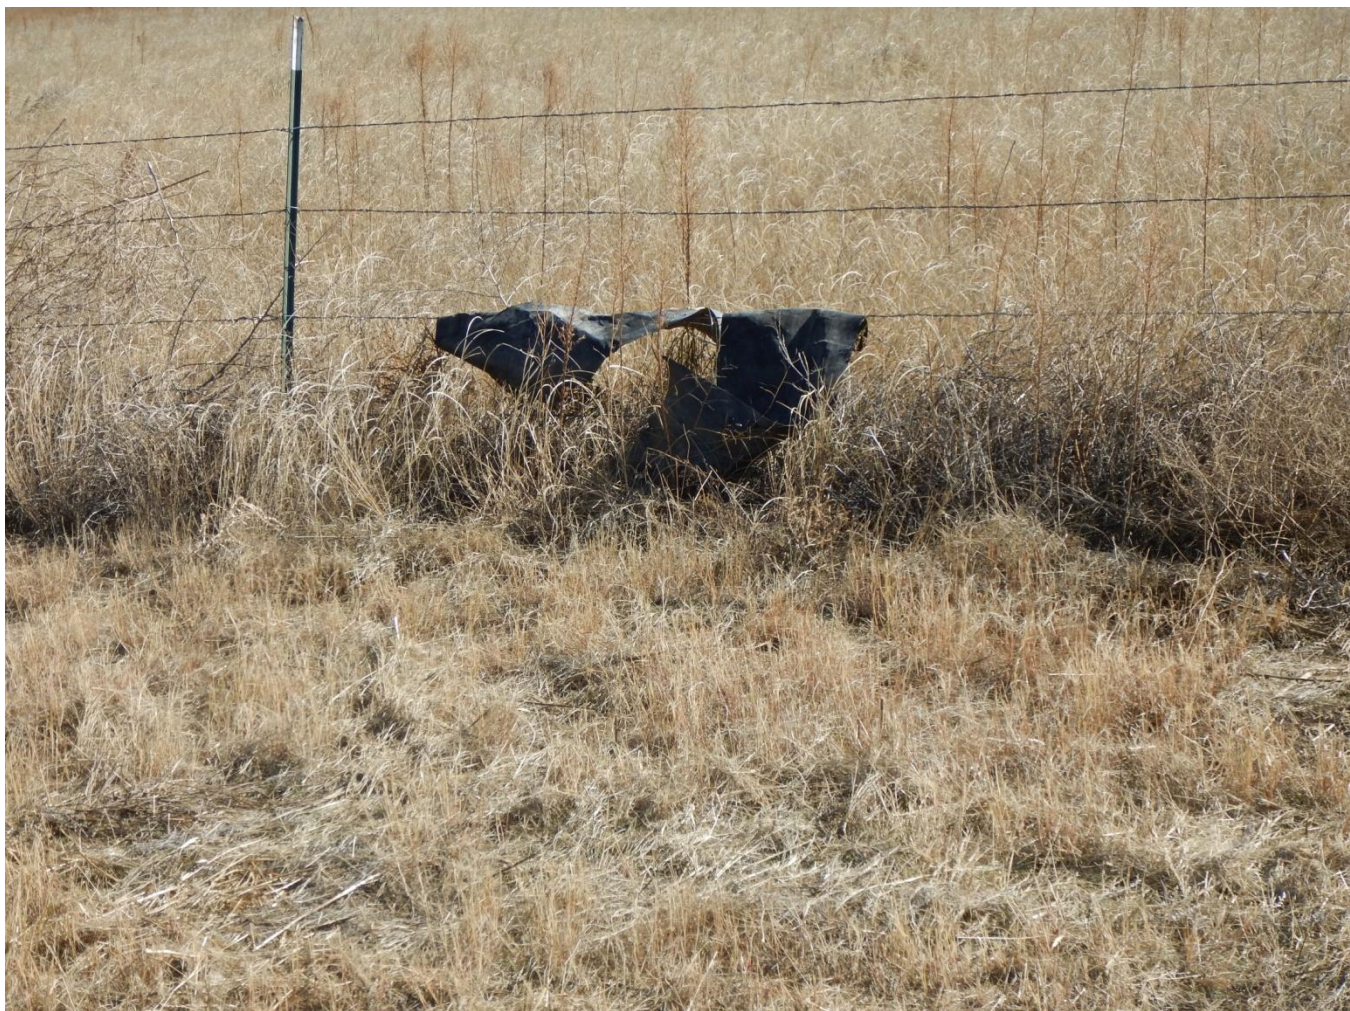
Photo 9: Photo taken from South side of location. Trash and weed debris in fence line.

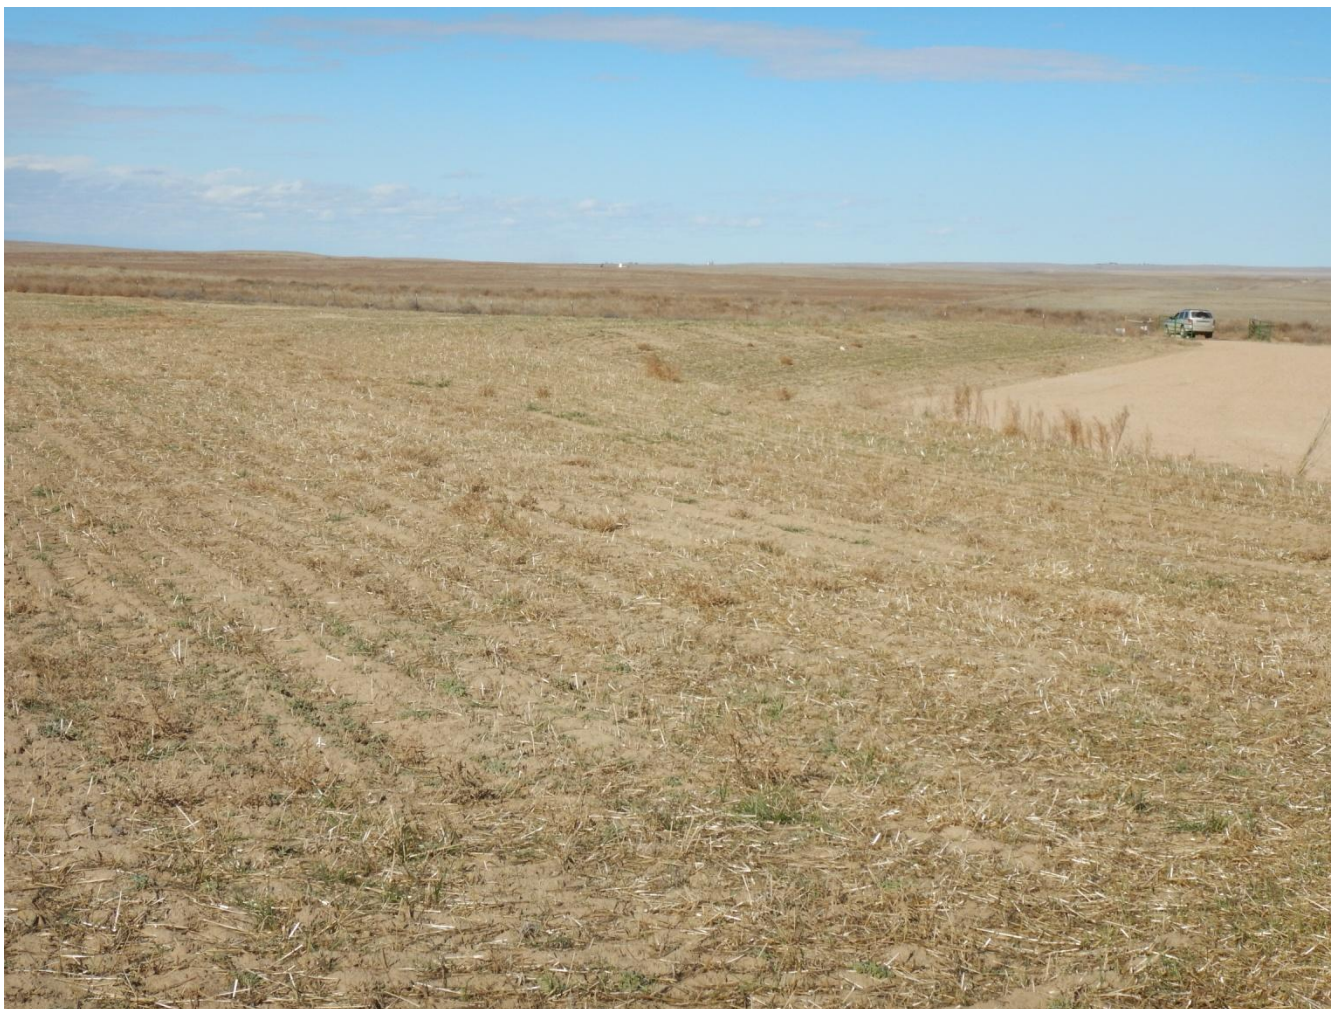
Photo 10: Photo taken from Southern end of location facing north. Interim reclamation in progress.

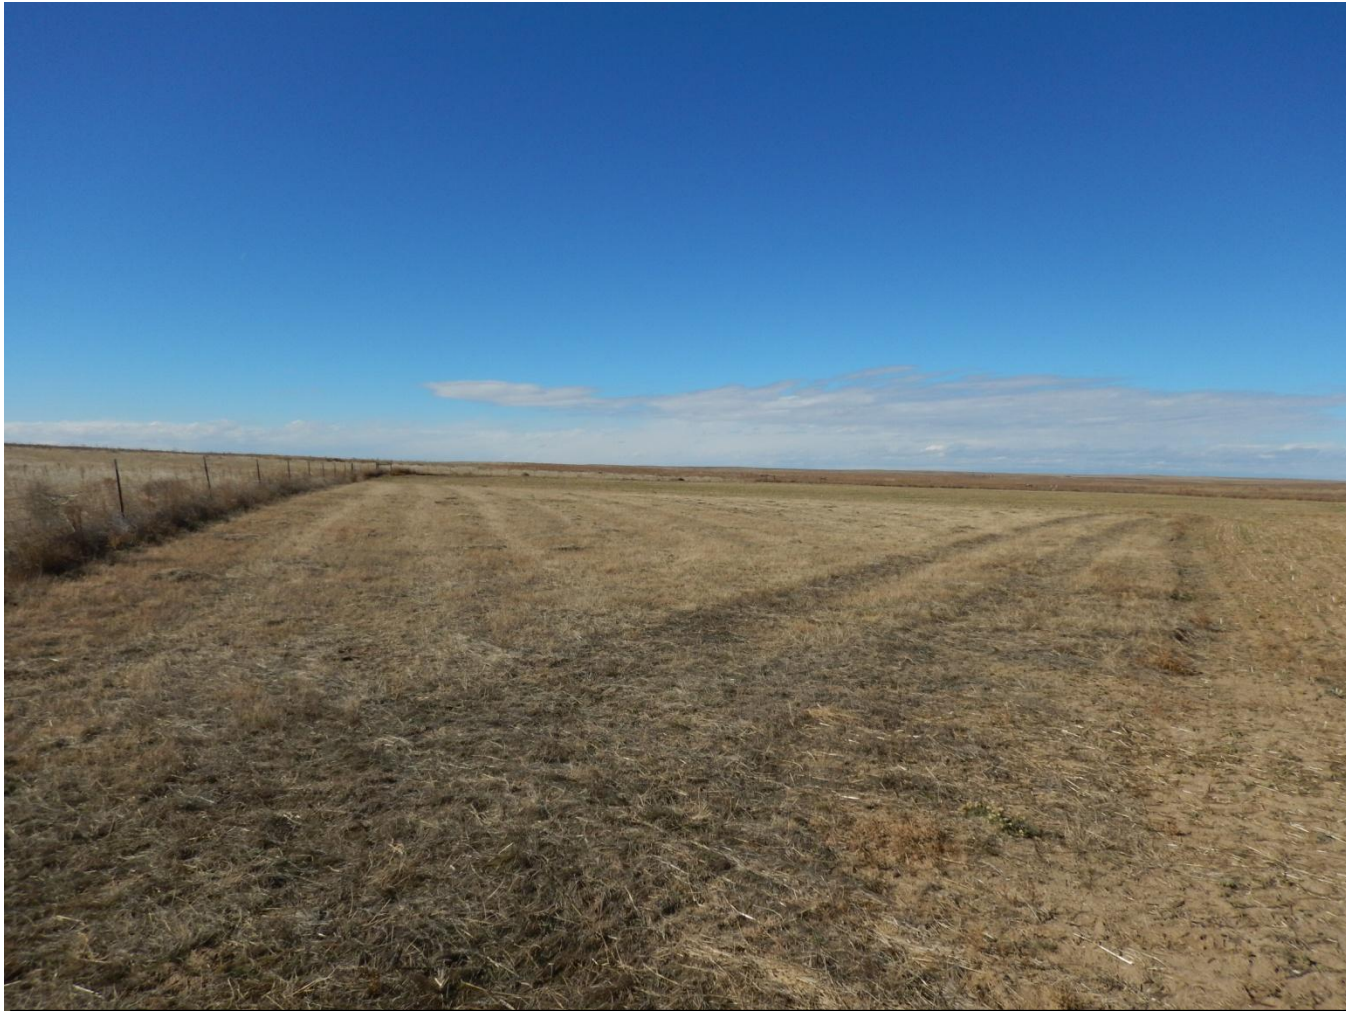
Photo 11: Photo taken from Southern end of location facing northwest. Interim reclamation in progress.

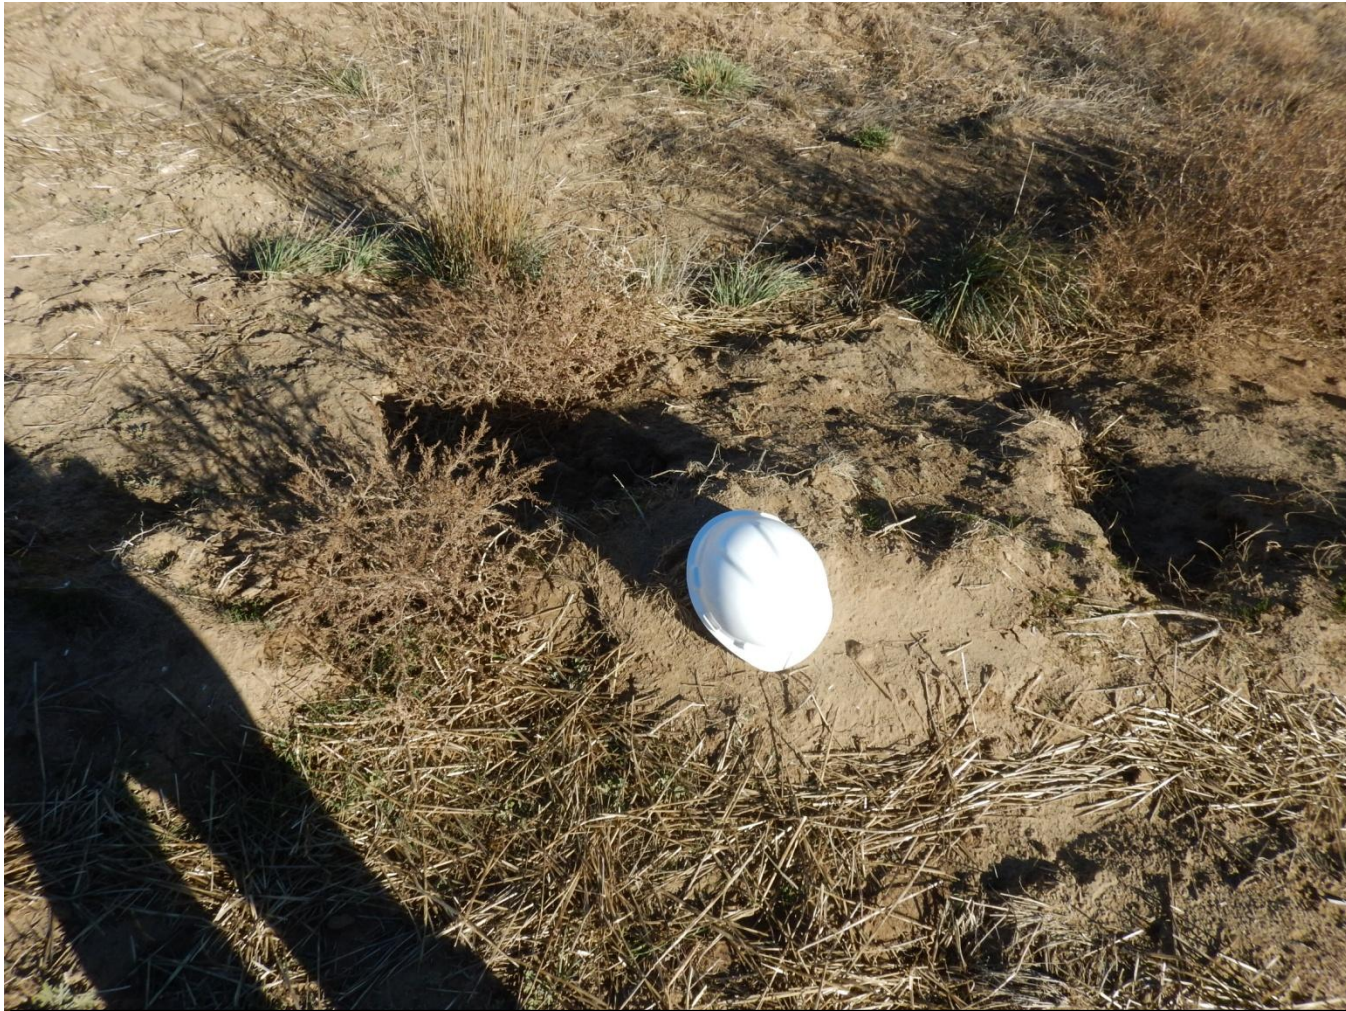
Photo 12: Photo taken from west end of location. Photo of rill erosion on slope.

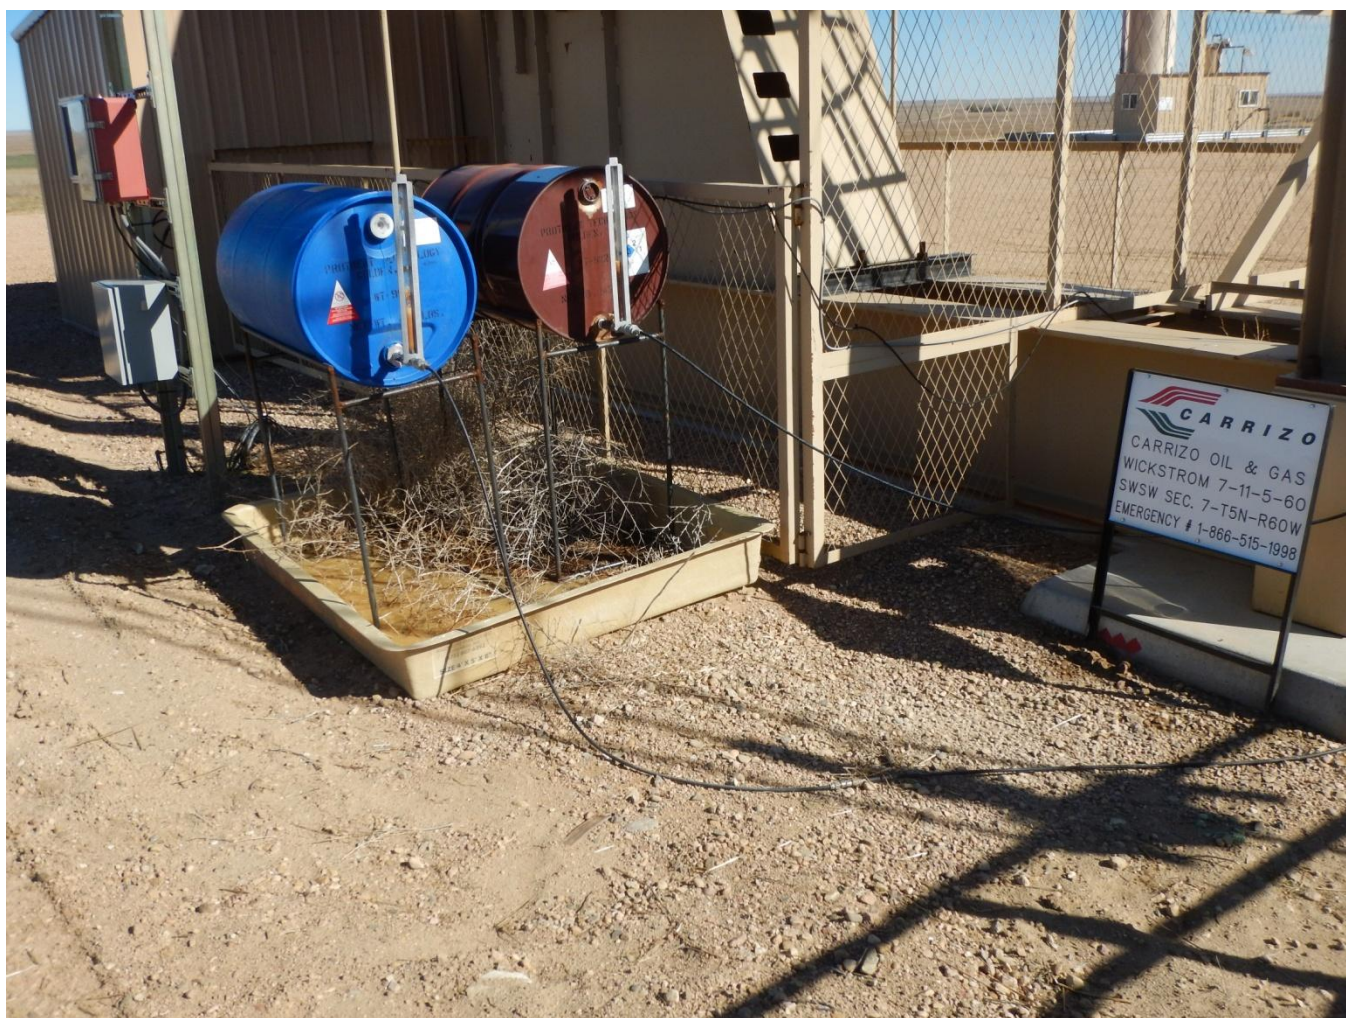
Photo 13: Photo of well pump. Note the weed debris among containers.
