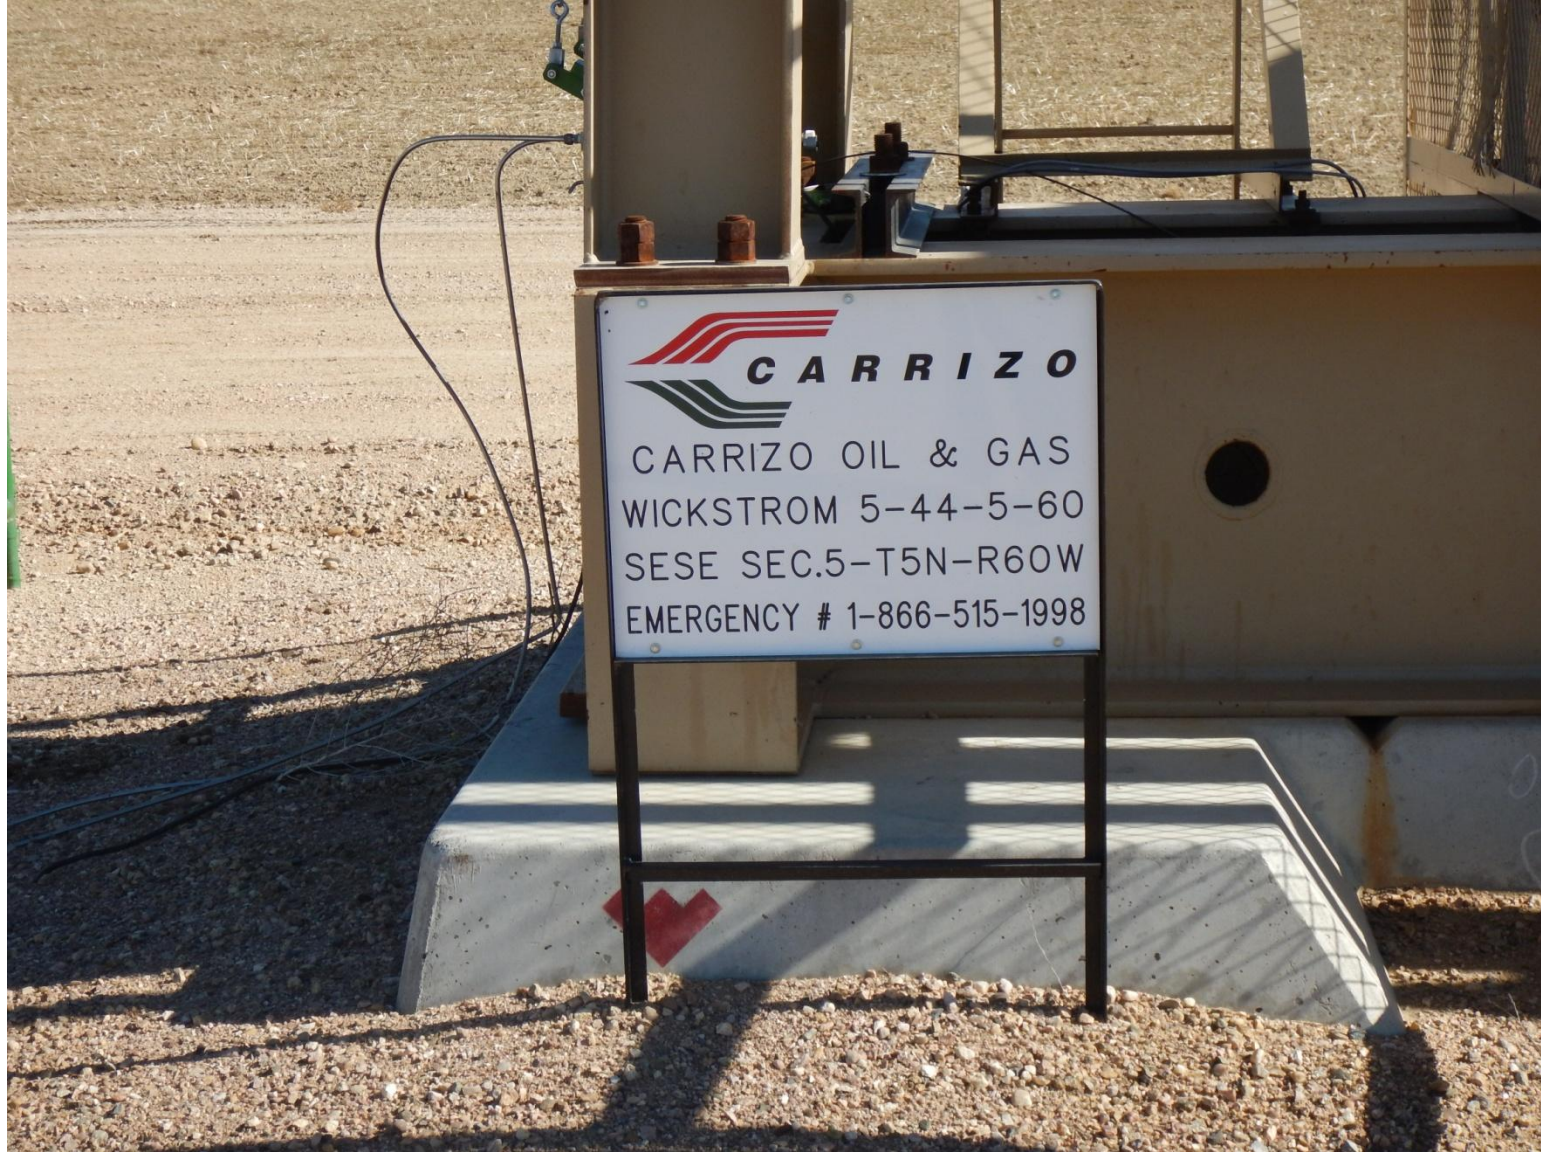
Photo 1: Photo of pump jack sign.

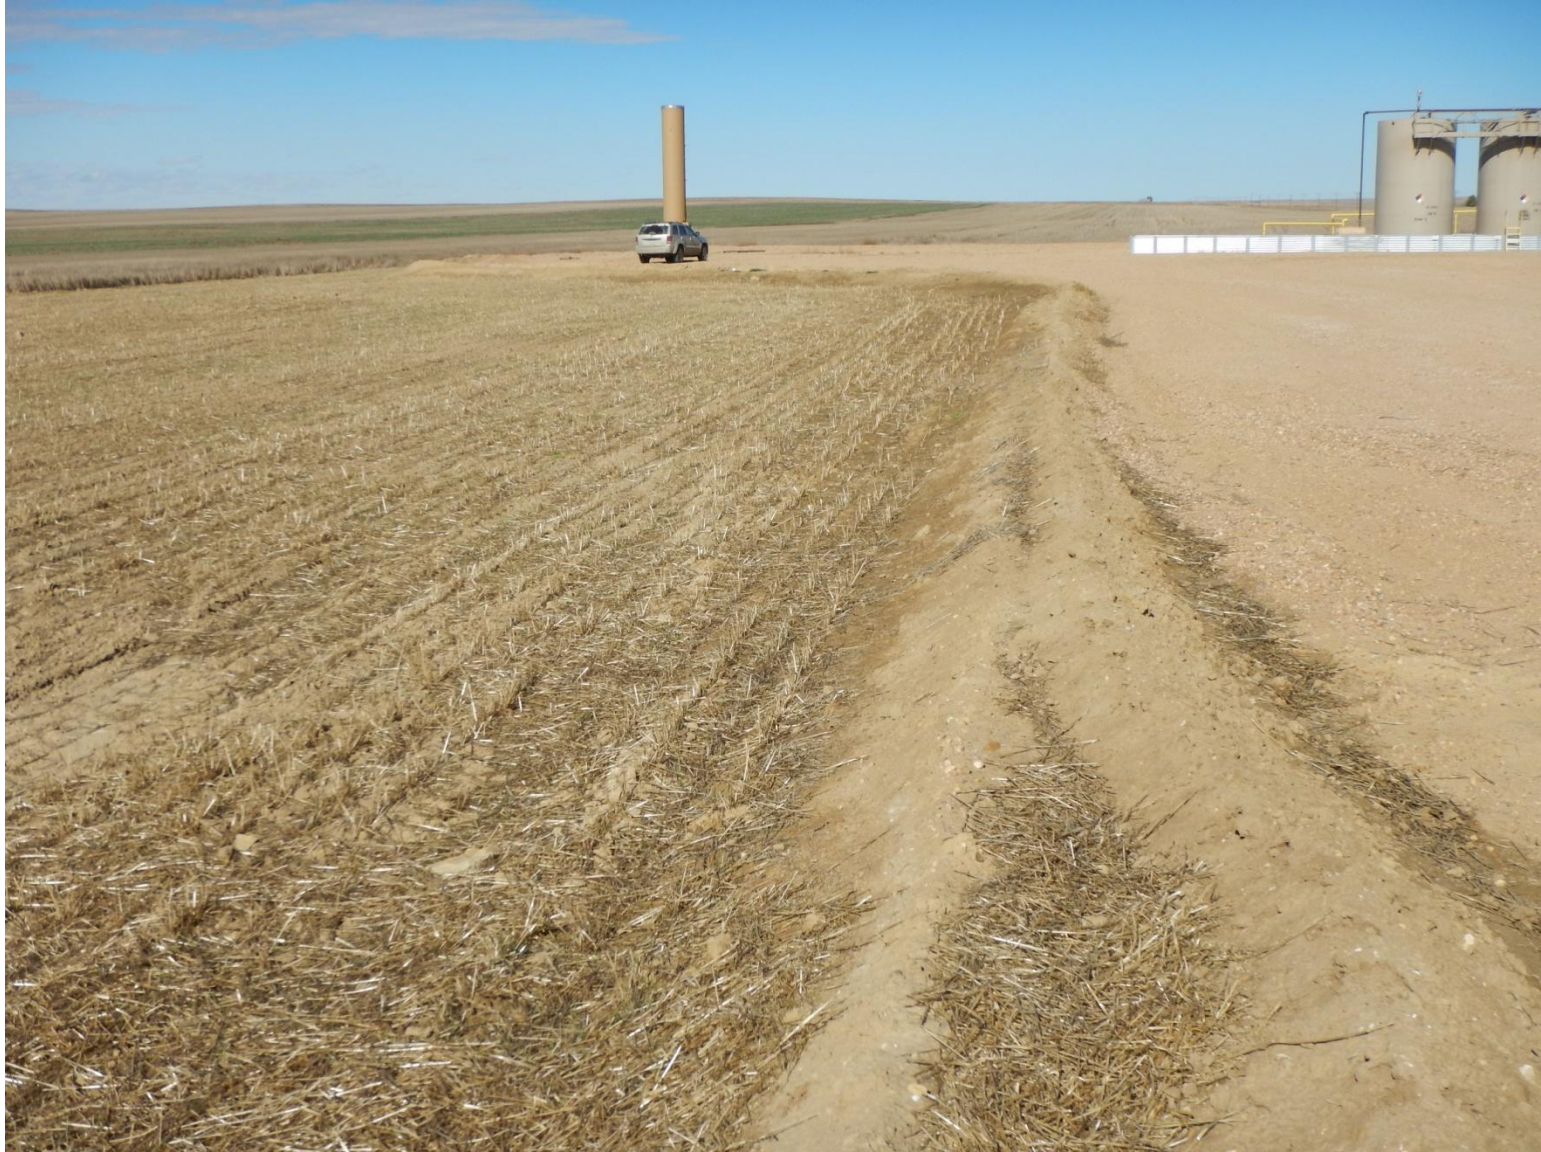
Photo 2: Photo taken from south end of location facing north. Photo of reclamation in progress.

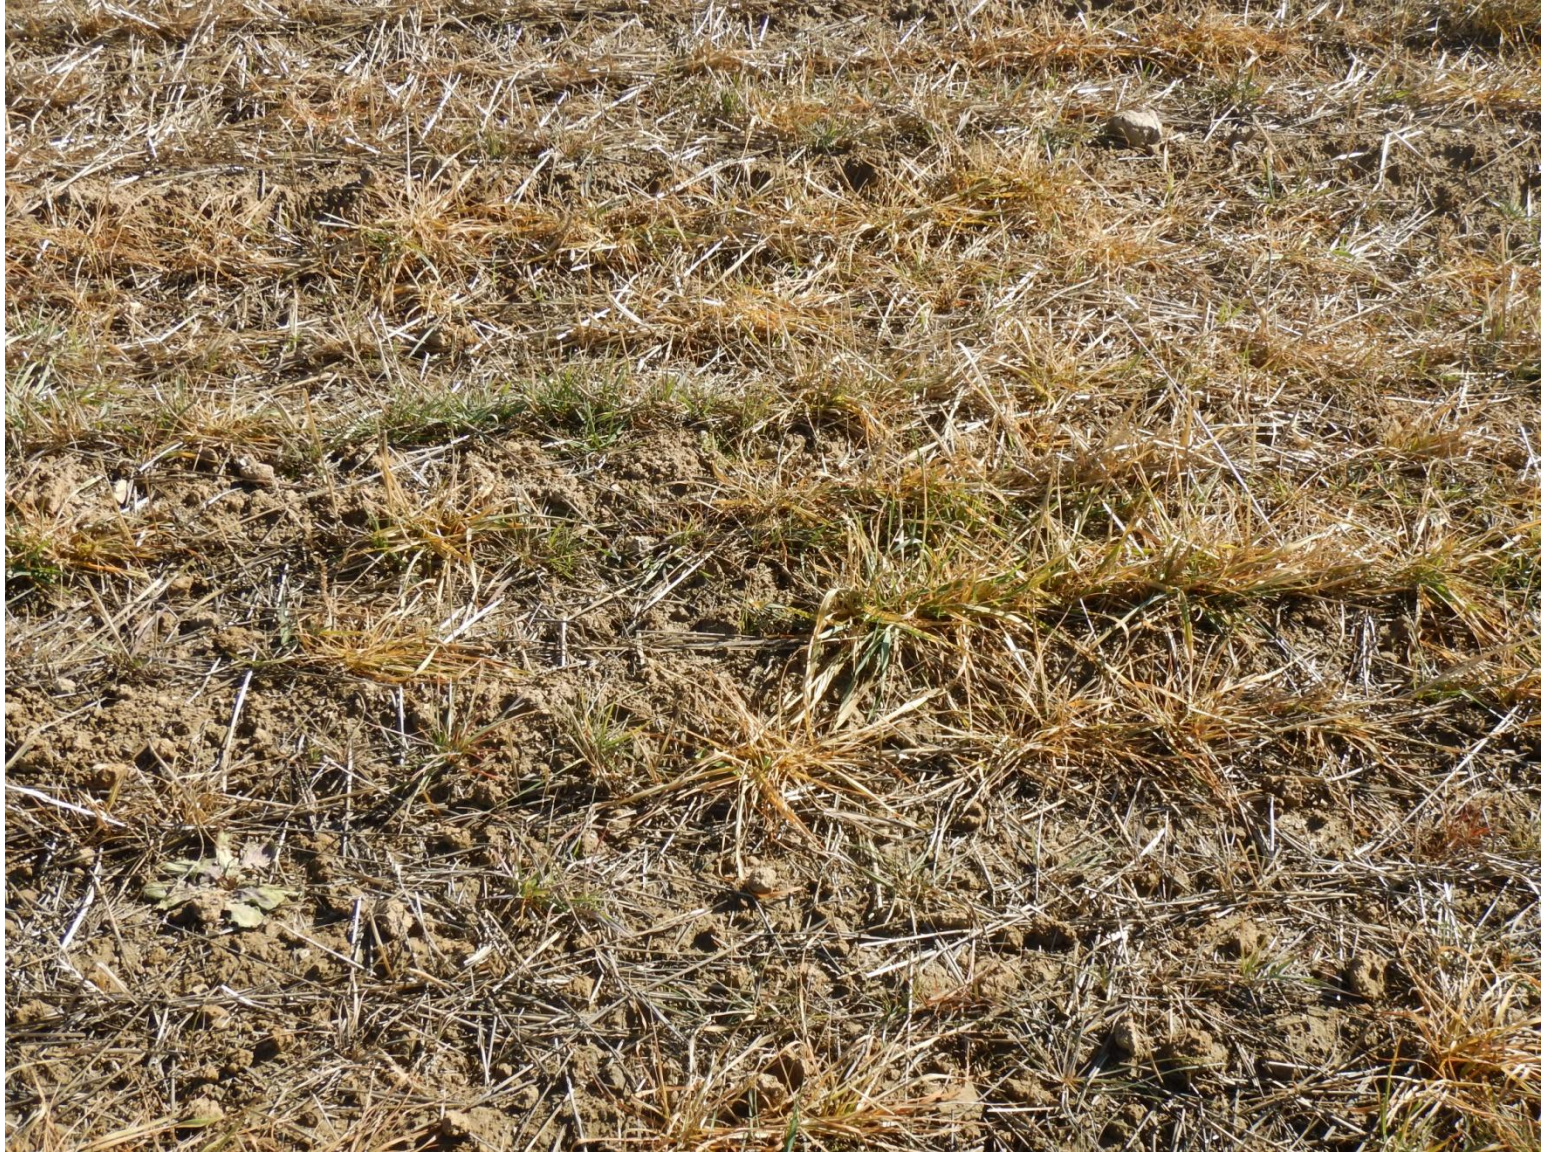
Photo 3: Photo of reclamation in progress.

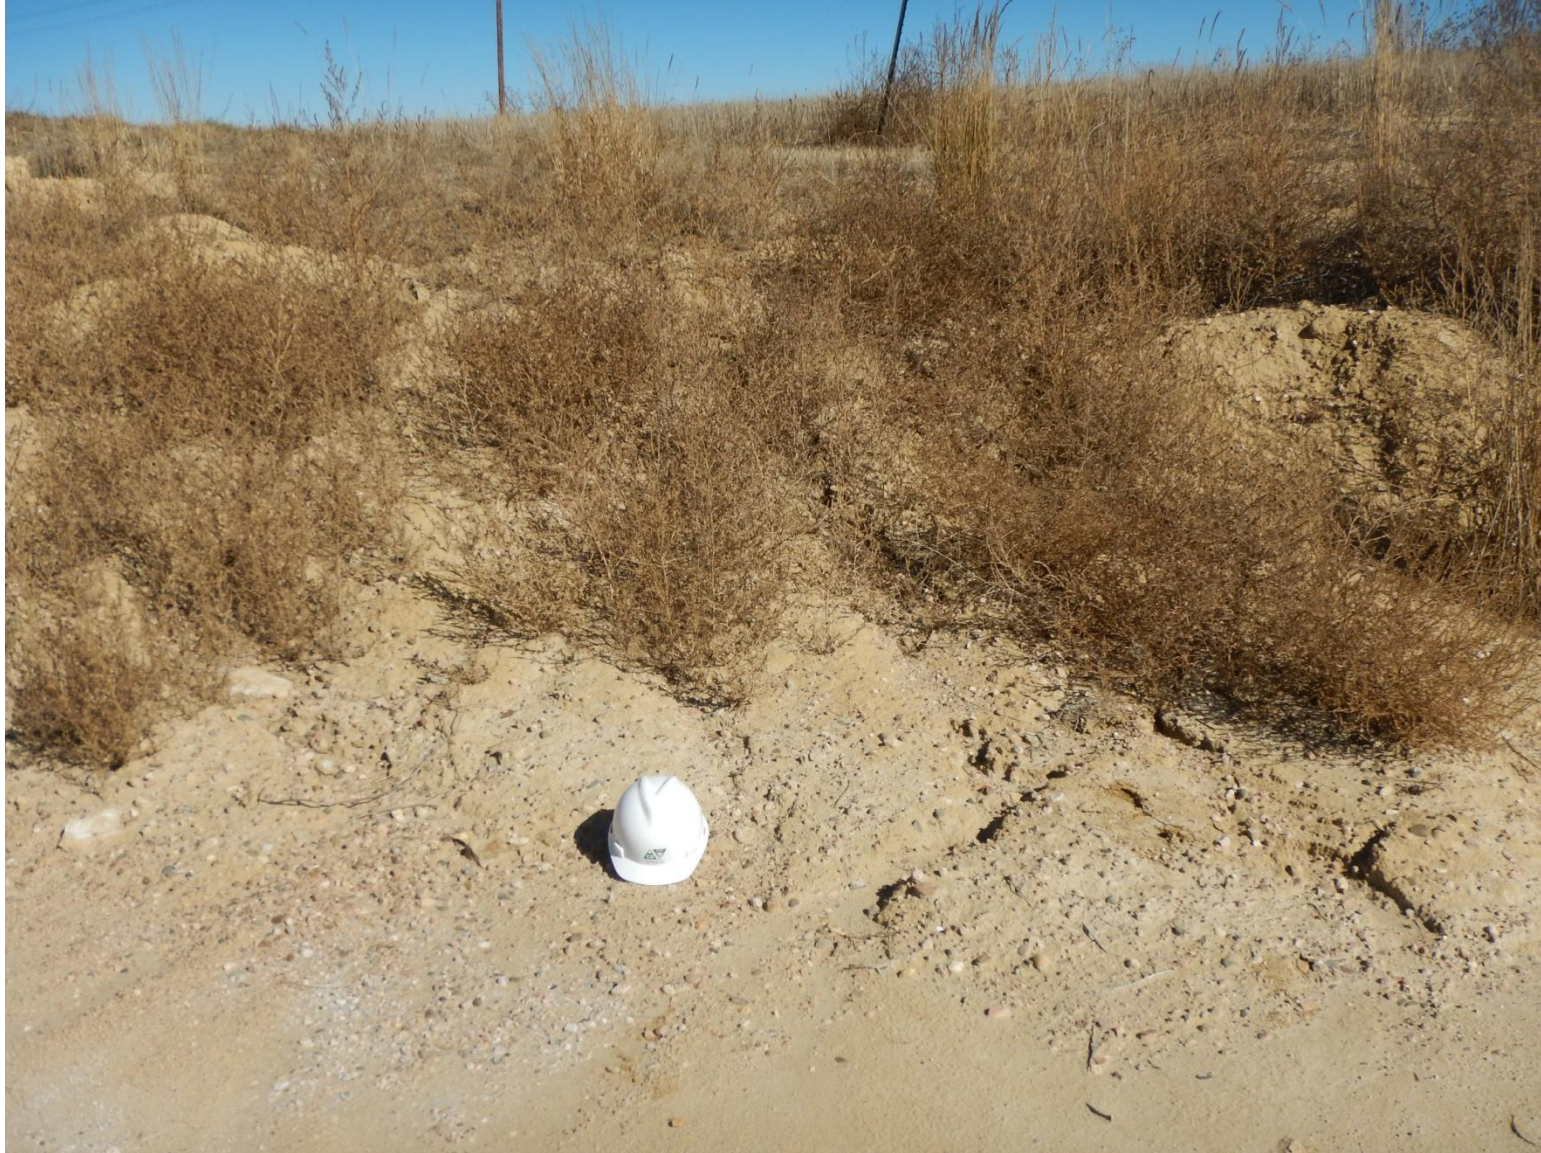
Photo 4: Photo taken on northeast of location. Photo of rill erosion and Russian thistle weed debris.

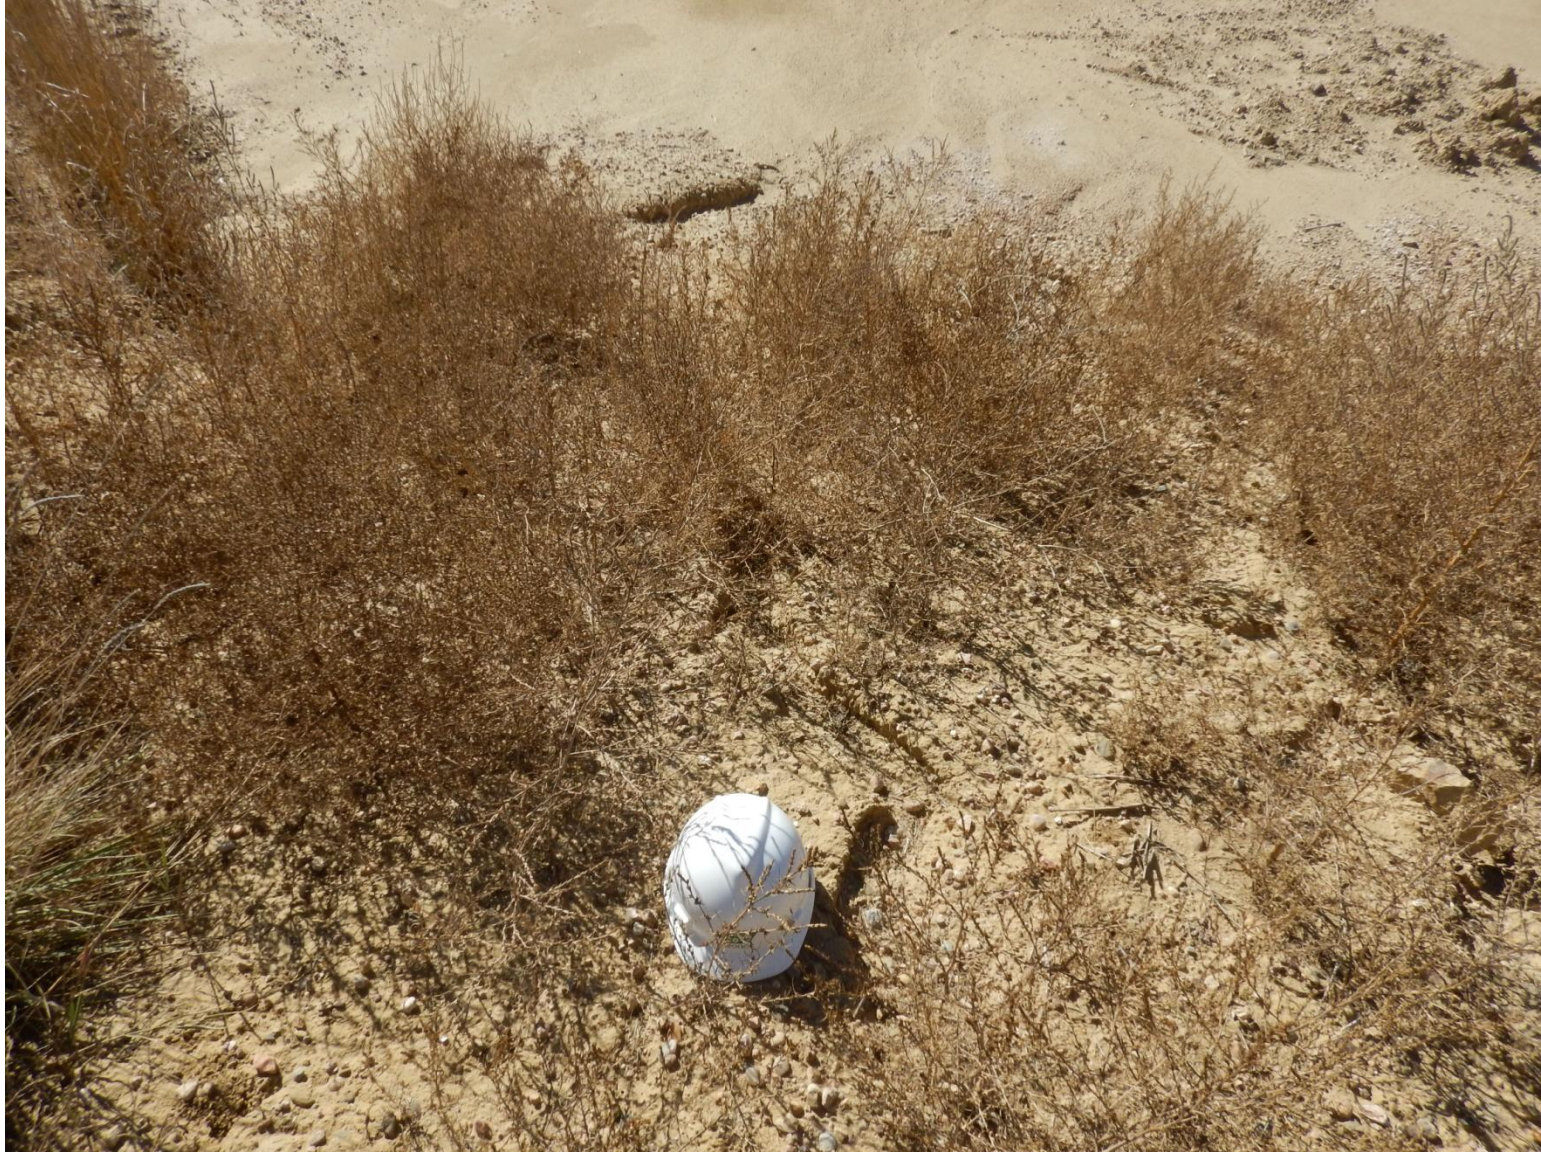
Photo 5: Photo taken on northeast of location. Photo of rill erosion and Russian thistle weed debris.

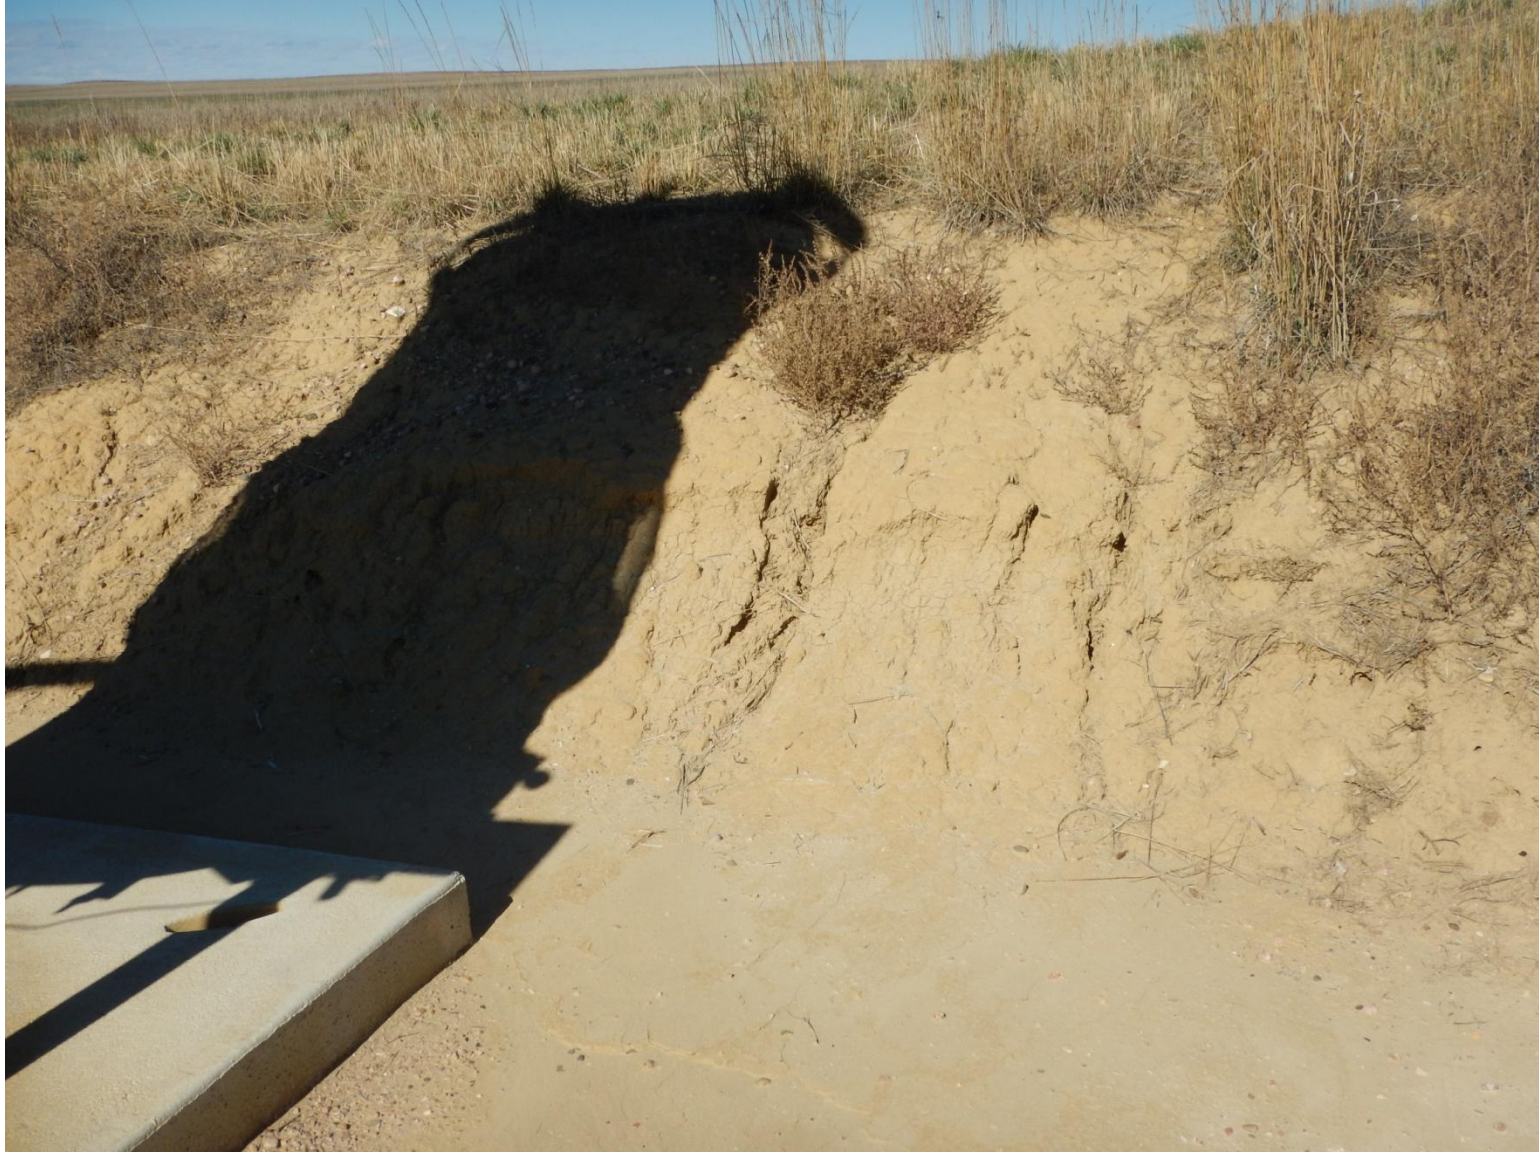
Photo 6: Photo taken on northeast of location. Photo of rill erosion and Russian thistle weed debris.

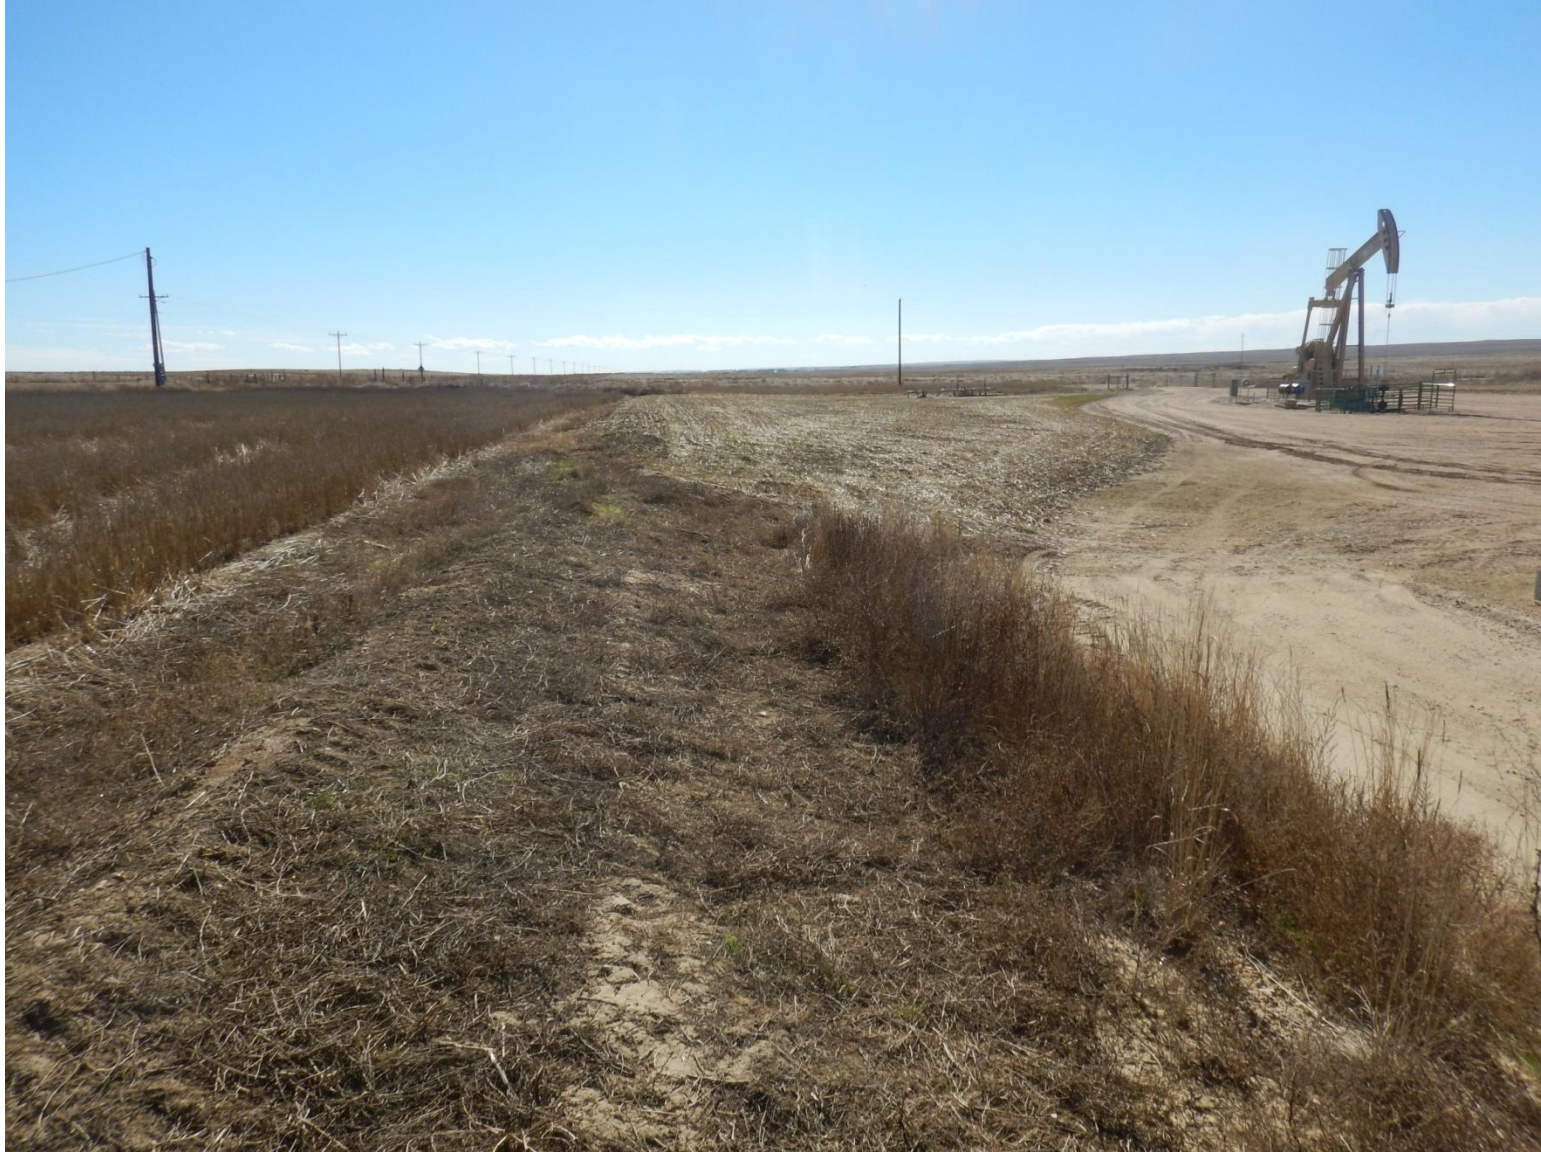
Photo 7: Photo taken on northeast of location facing south. Photo of reclamation in progress.

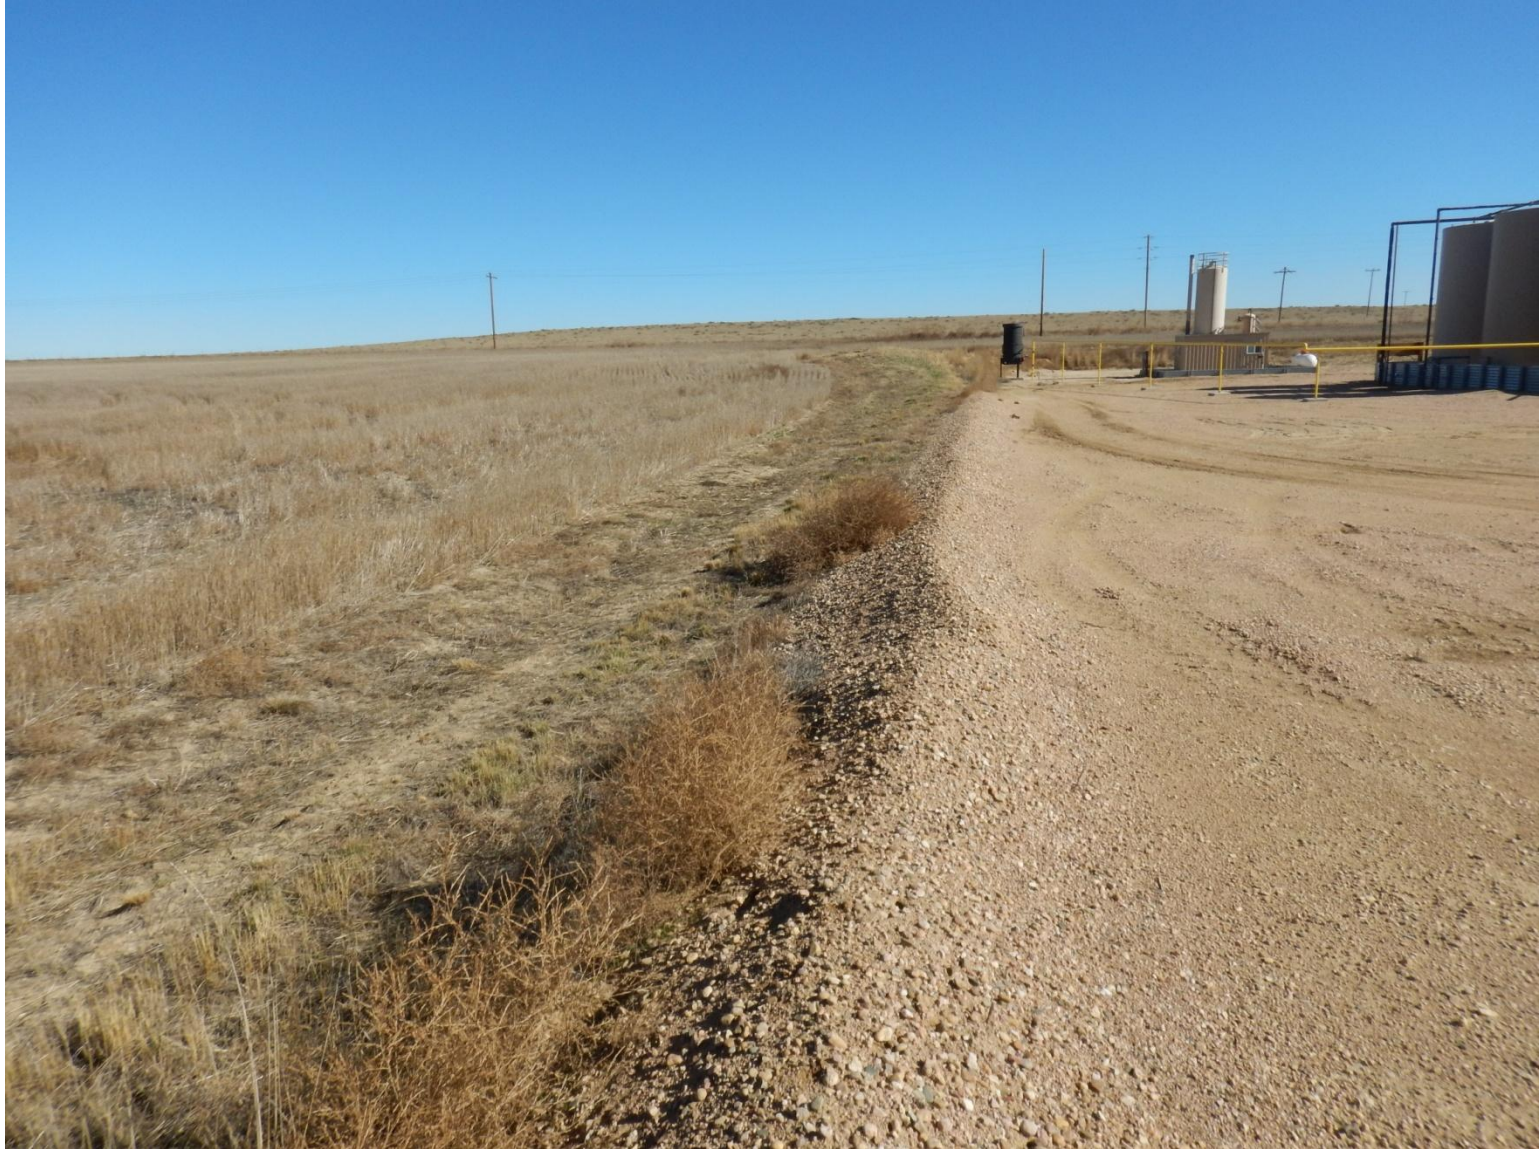
Photo 8: Photo taken from northwest of location facing east. Note the Russian thistle weed debris.

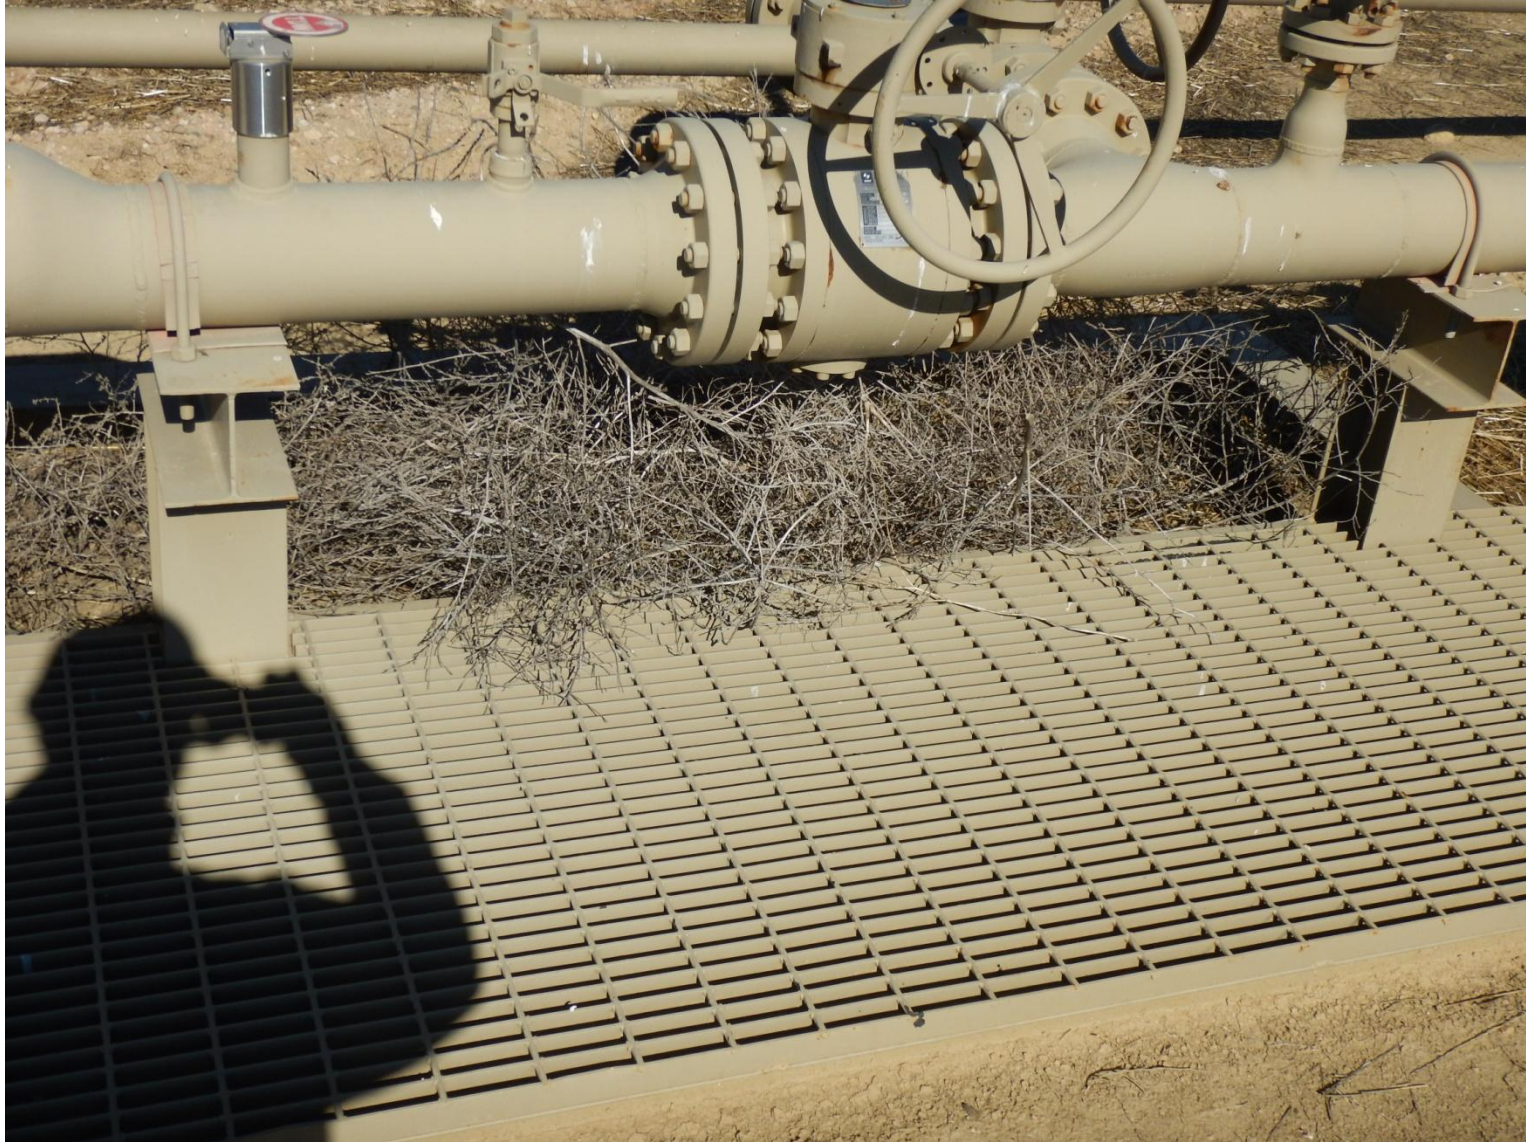
Photo 9: Photo taken on southern end of location. Note the weed debris in equipment.
