Oil & Gas Conservation
Commission

Document Number:
673502754

FIELD INSPECTION FORM

Response to COGCC Field Inspection Report (Document #673502754)
Greasewood 4-8H

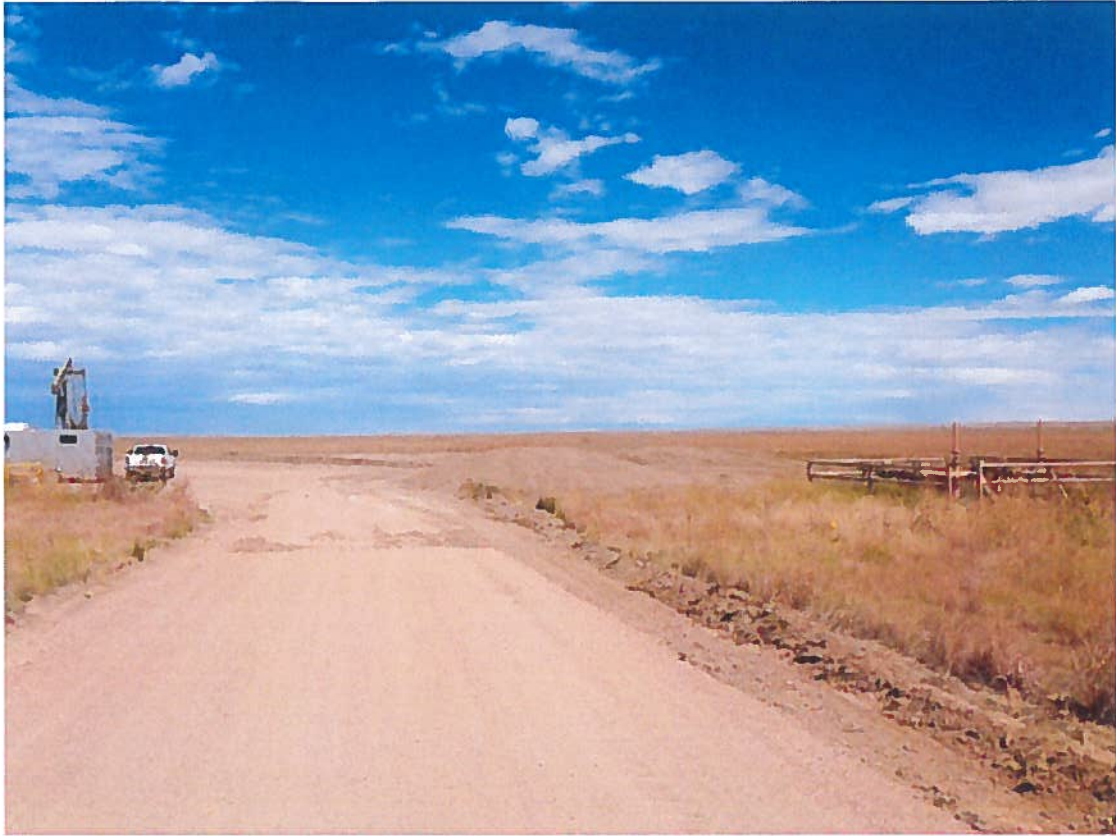
Entrance to Greasewood 4-8H location looking north – September 17, 2015

The well on this pad was recently re-frac'd and work related to interim reclamation had started prior to the COGCC field inspection. Materials and equipment related to the re-frac were in the process of being removed and flow-back equipment rearranged on the location to facilitate interim reclamation. Dirt work on the location commenced the morning of September 2, 2015 and will be completed by approximately September 21, 2015. Seeding of the location with an appropriate seed mix will take place as late in the fall of 2015 as possible but, pending weather conditions, should be completed by October 30, 2015. Photographs of the work in progress as of September 17, 2015 are attached.

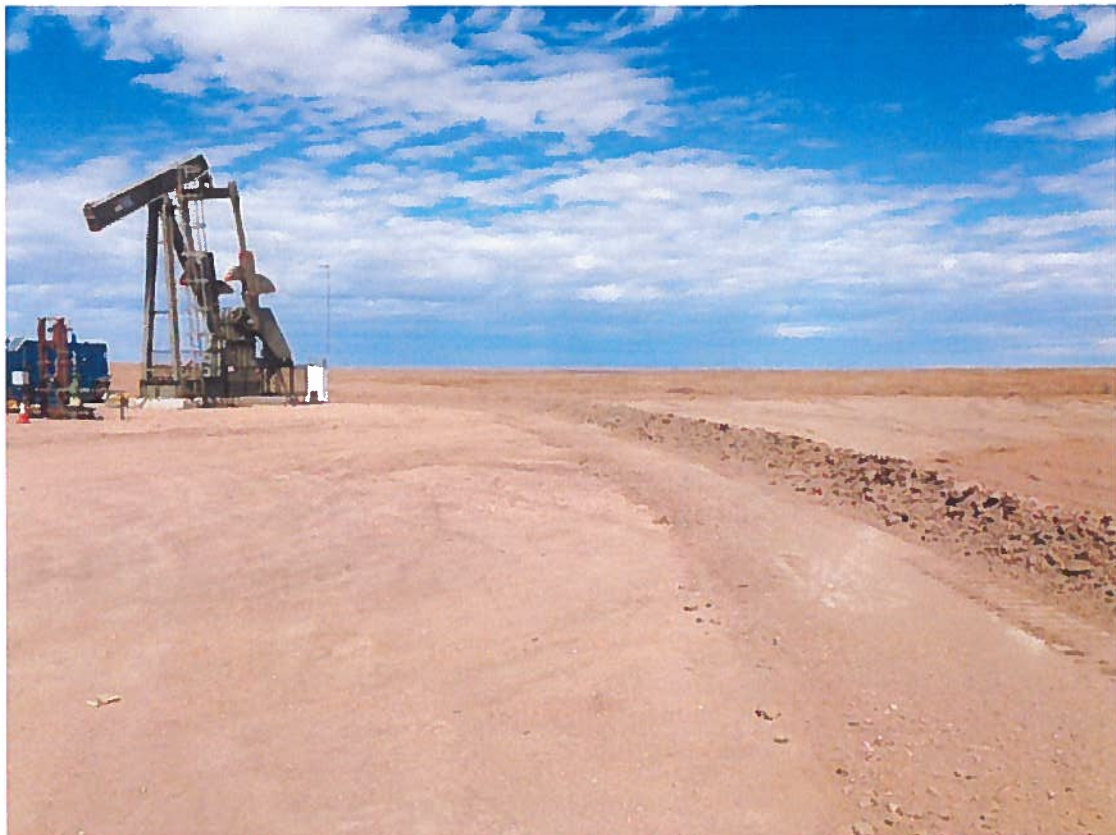
Greasewood 4-8H location looking north-northwest – September 17, 2015

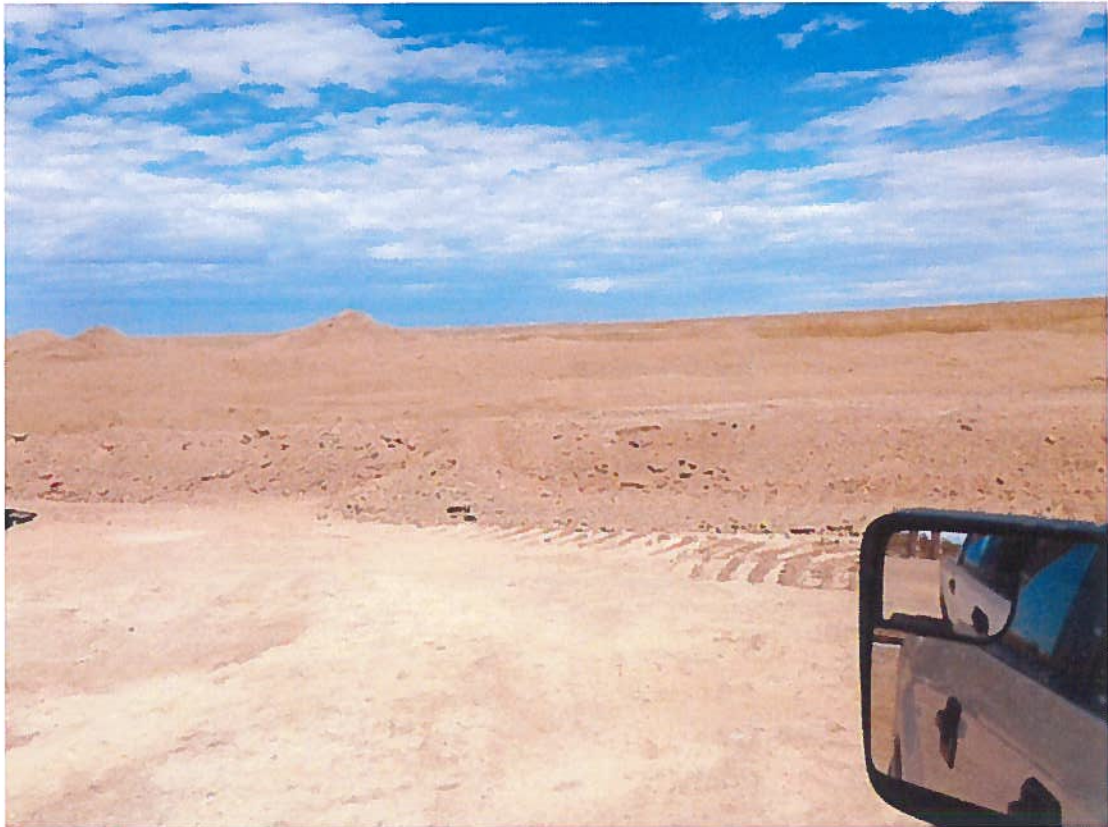
Greasewood 4-8H location looking north-northeast - September 17, 2015

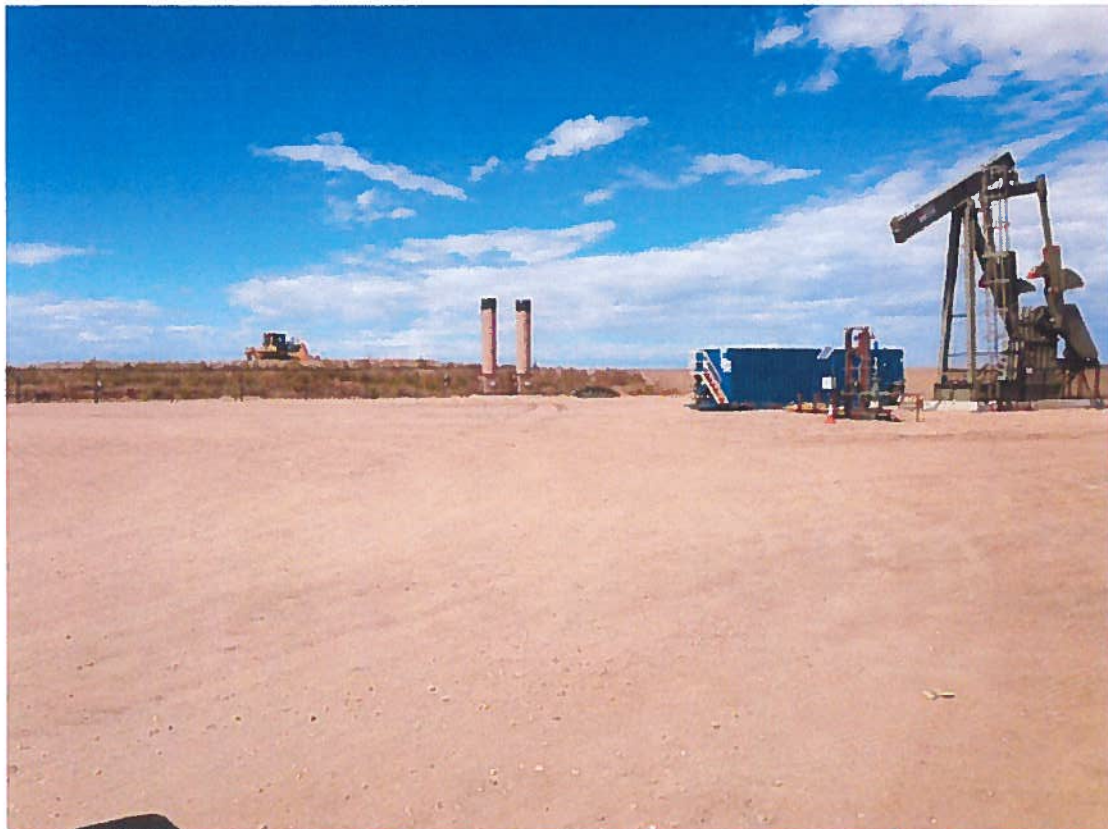
Greasewood 4-8H location looking west – September 17, 2015
