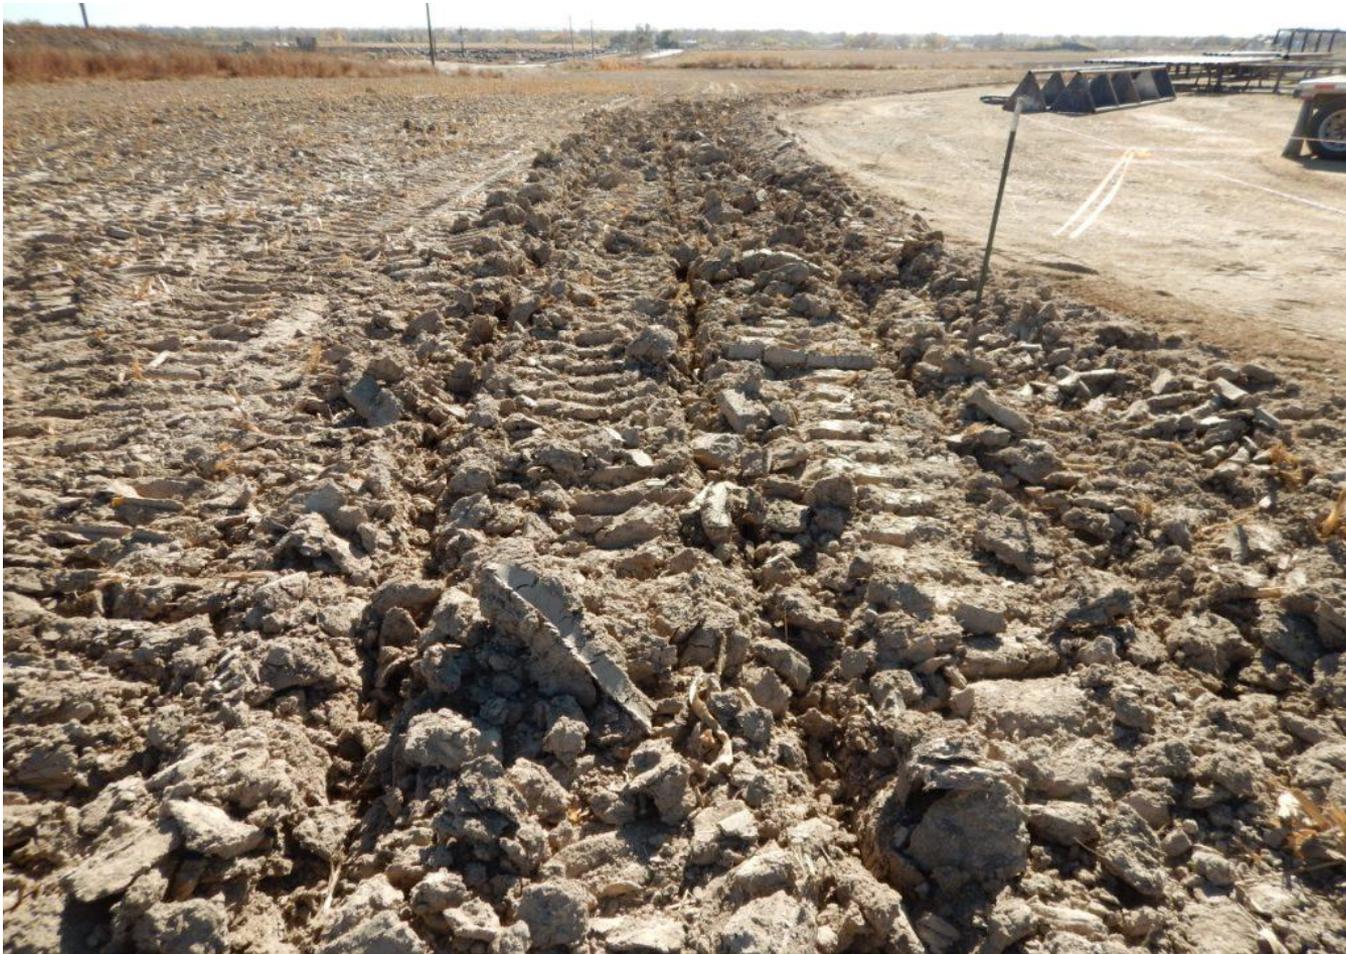
**Photo 1.** Photo taken from southeast location, facing South. Need to install stormwater control ditch. Surface roughening is inadequate.

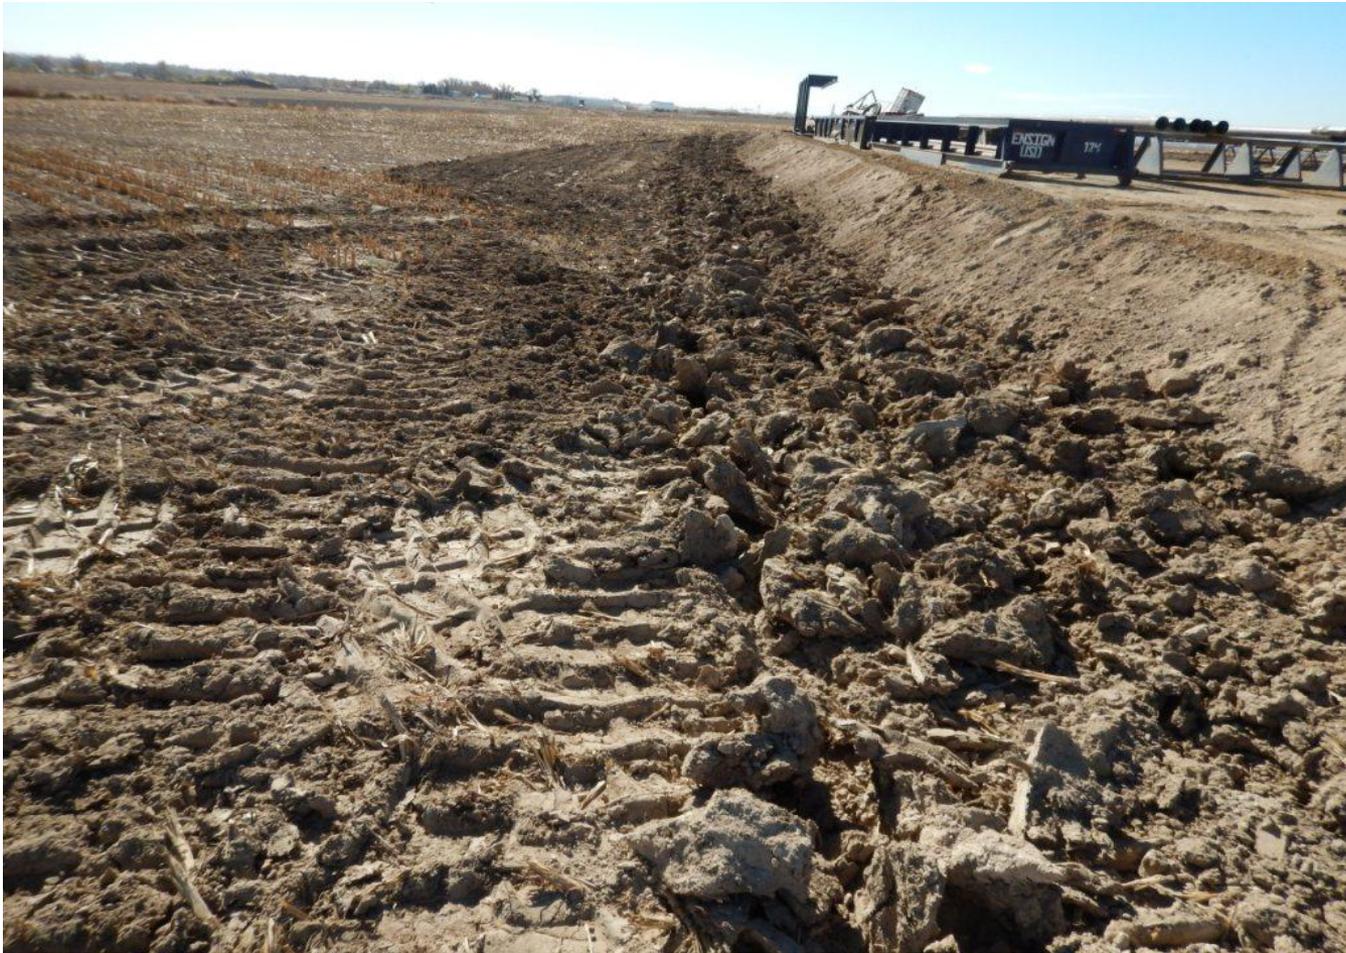
**Photo 2.** Photo taken from southeast location, facing Southwest. Need to install stormwater control ditch. Surface roughening is inadequate.

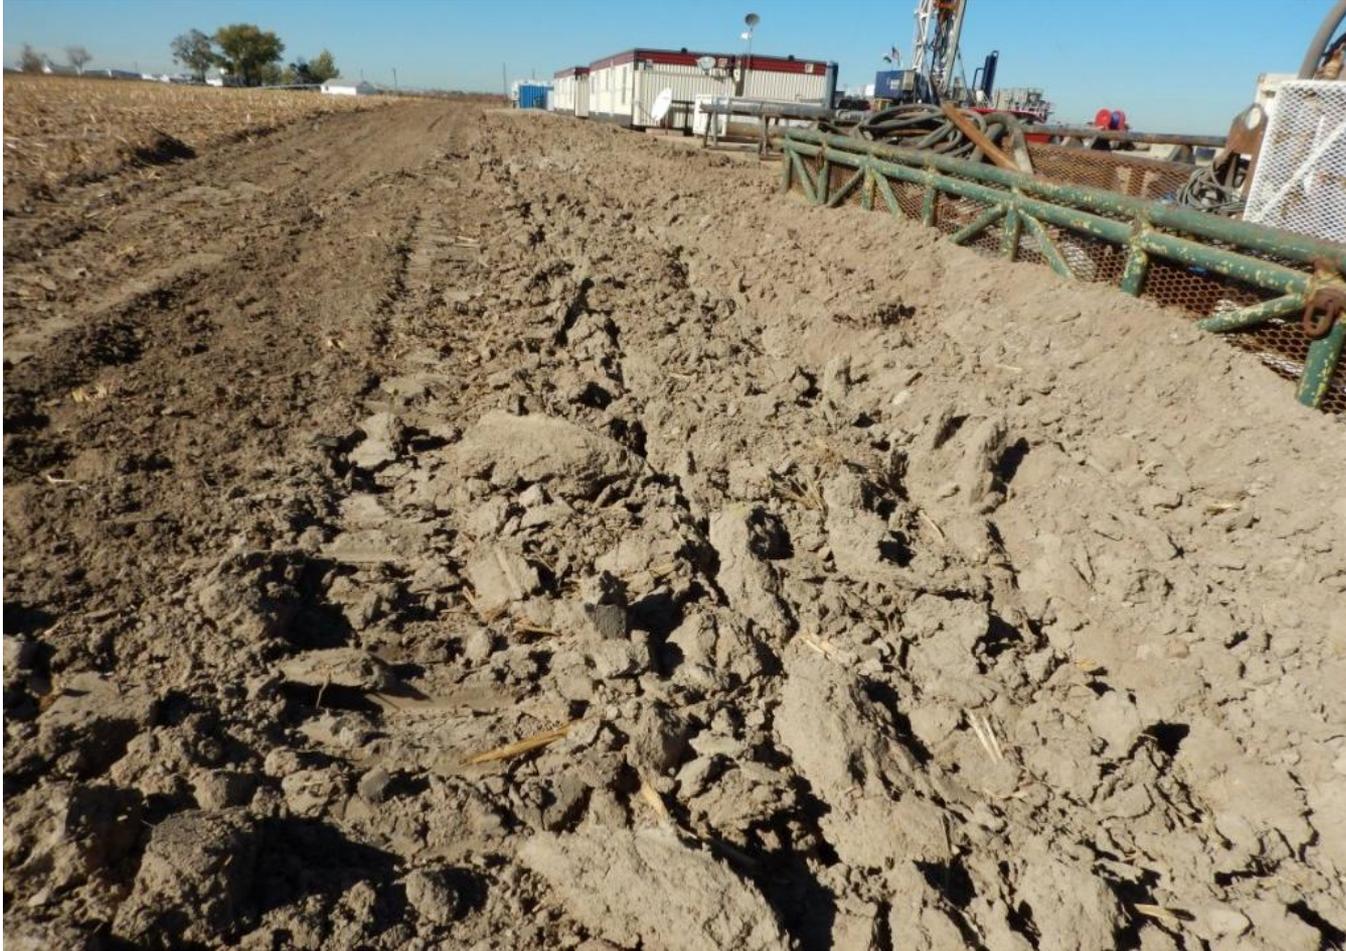
**Photo 3.** Photo taken from western location, facing Northwest. Need to install stormwater control ditch. Surface roughening is inadequate.

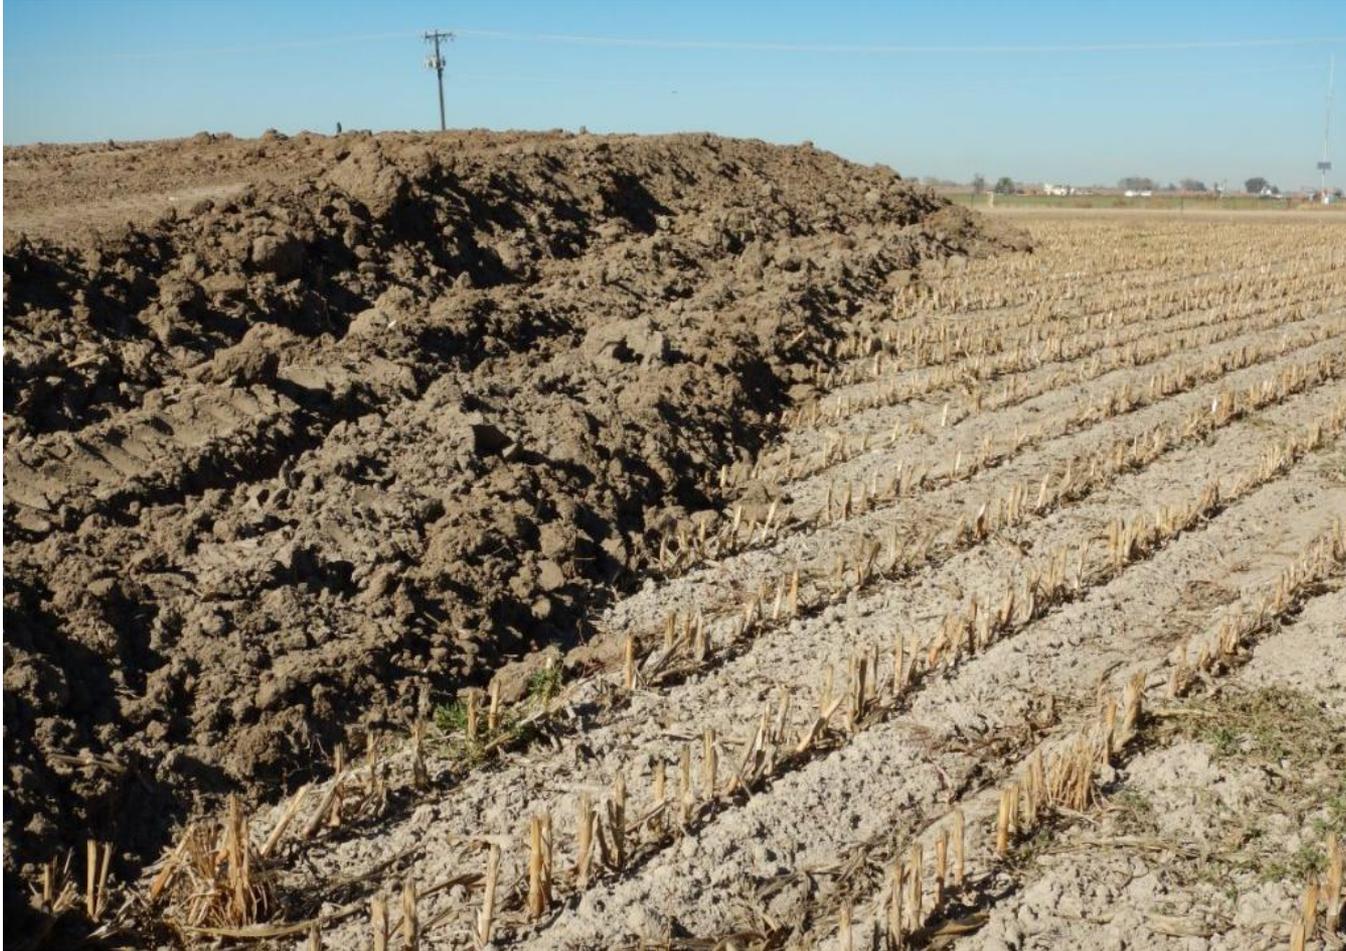
**Photo 4.** Photo taken from eastern topsoil location, facing North. Need to install stormwater control ditch around topsoil stockpile to prevent the loss of topsoil offsite.
