This is an interim reclamation and stormwater inspection. Any corrective actions from previous inspections that have not been addressed are still applicable.

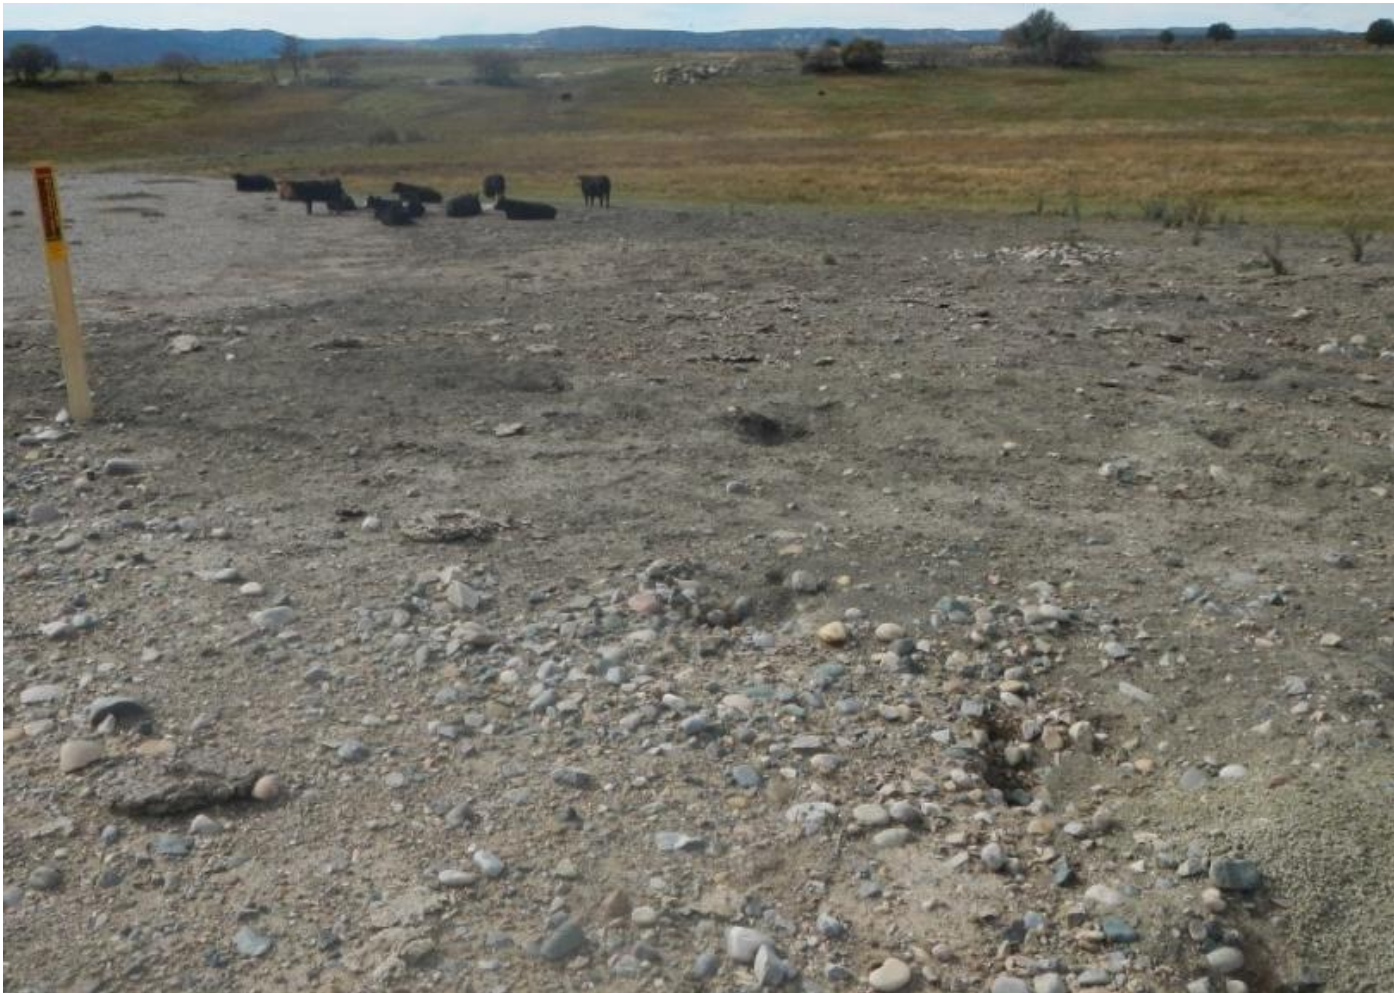
Photo 1. View of northern portion of project area from well pad entrance facing westward.

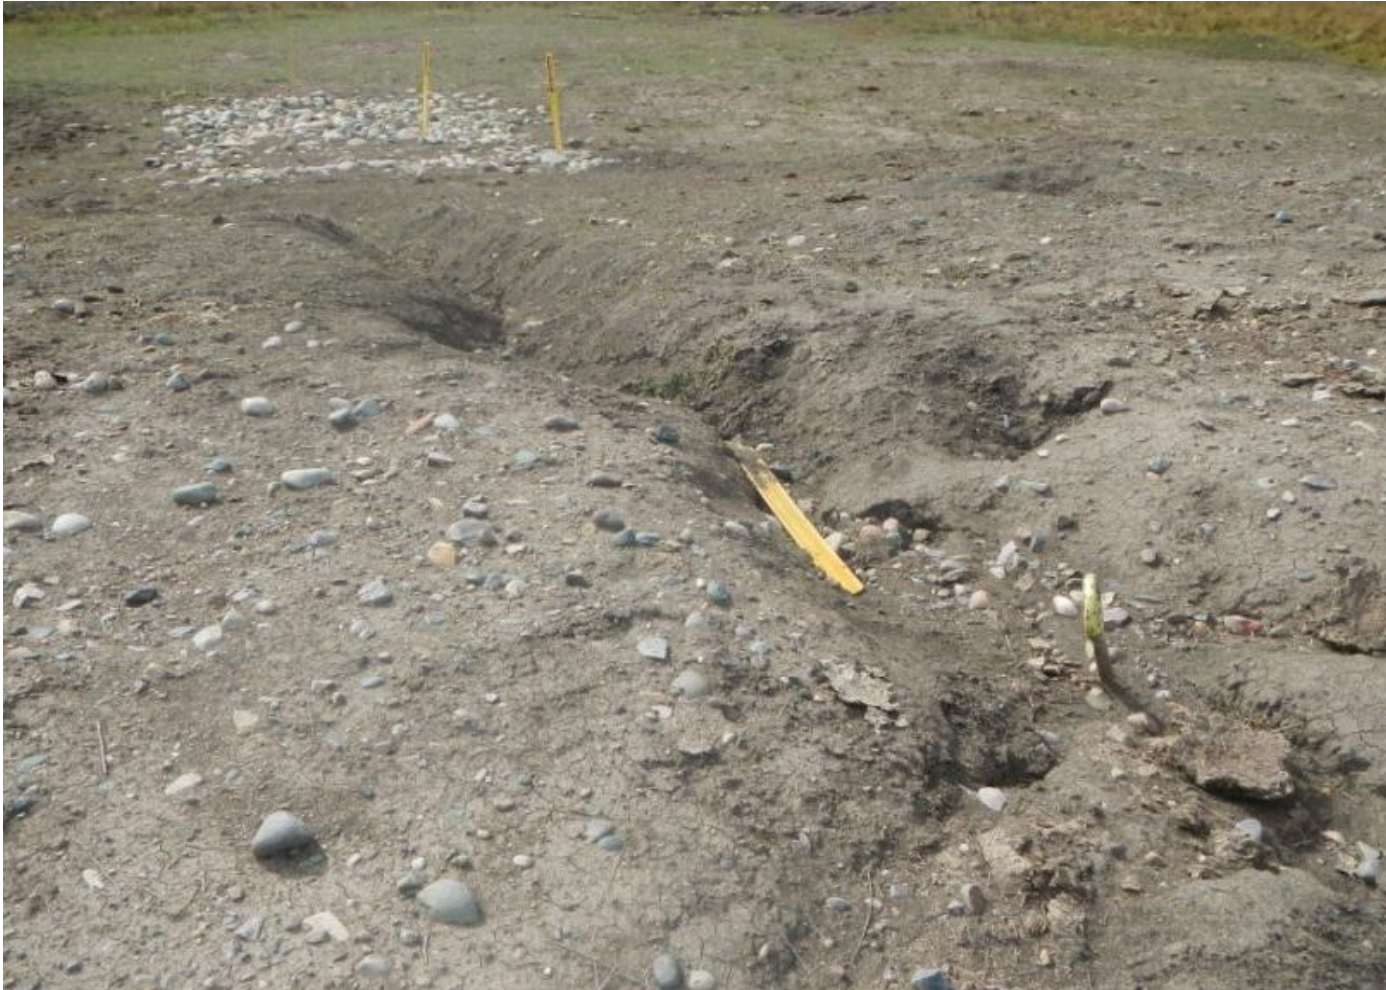
Photo 2. View of erosional channel (approximately 2 feet wide and 1 foot deep) and damaged anchor marker in southwestern portion of project area.

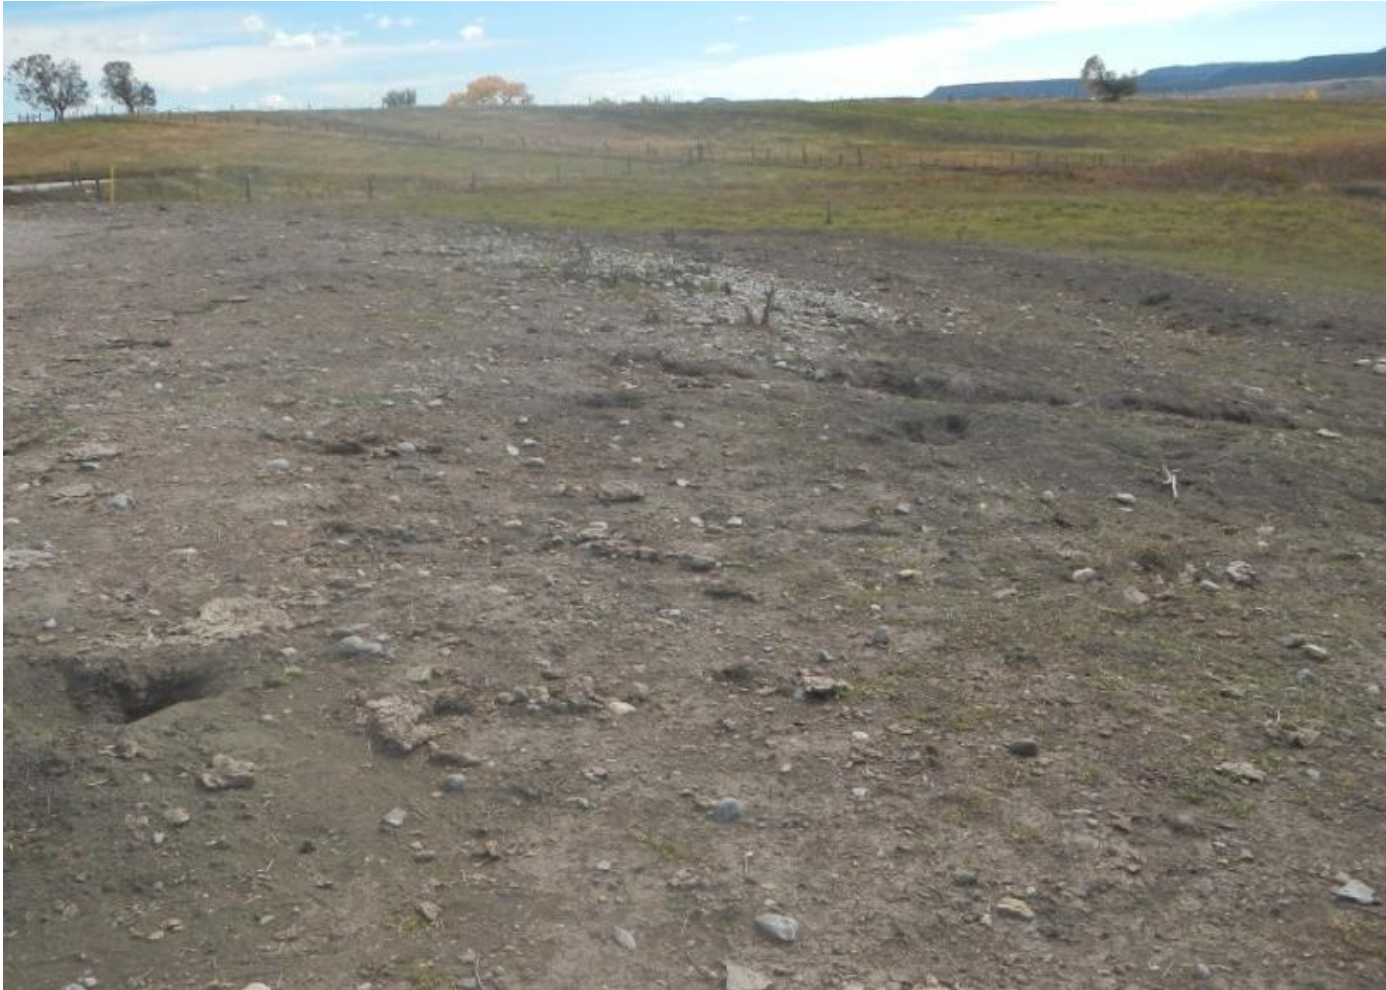
Photo 3. View of southern portion of the project area from southwestern portion facing eastward.
