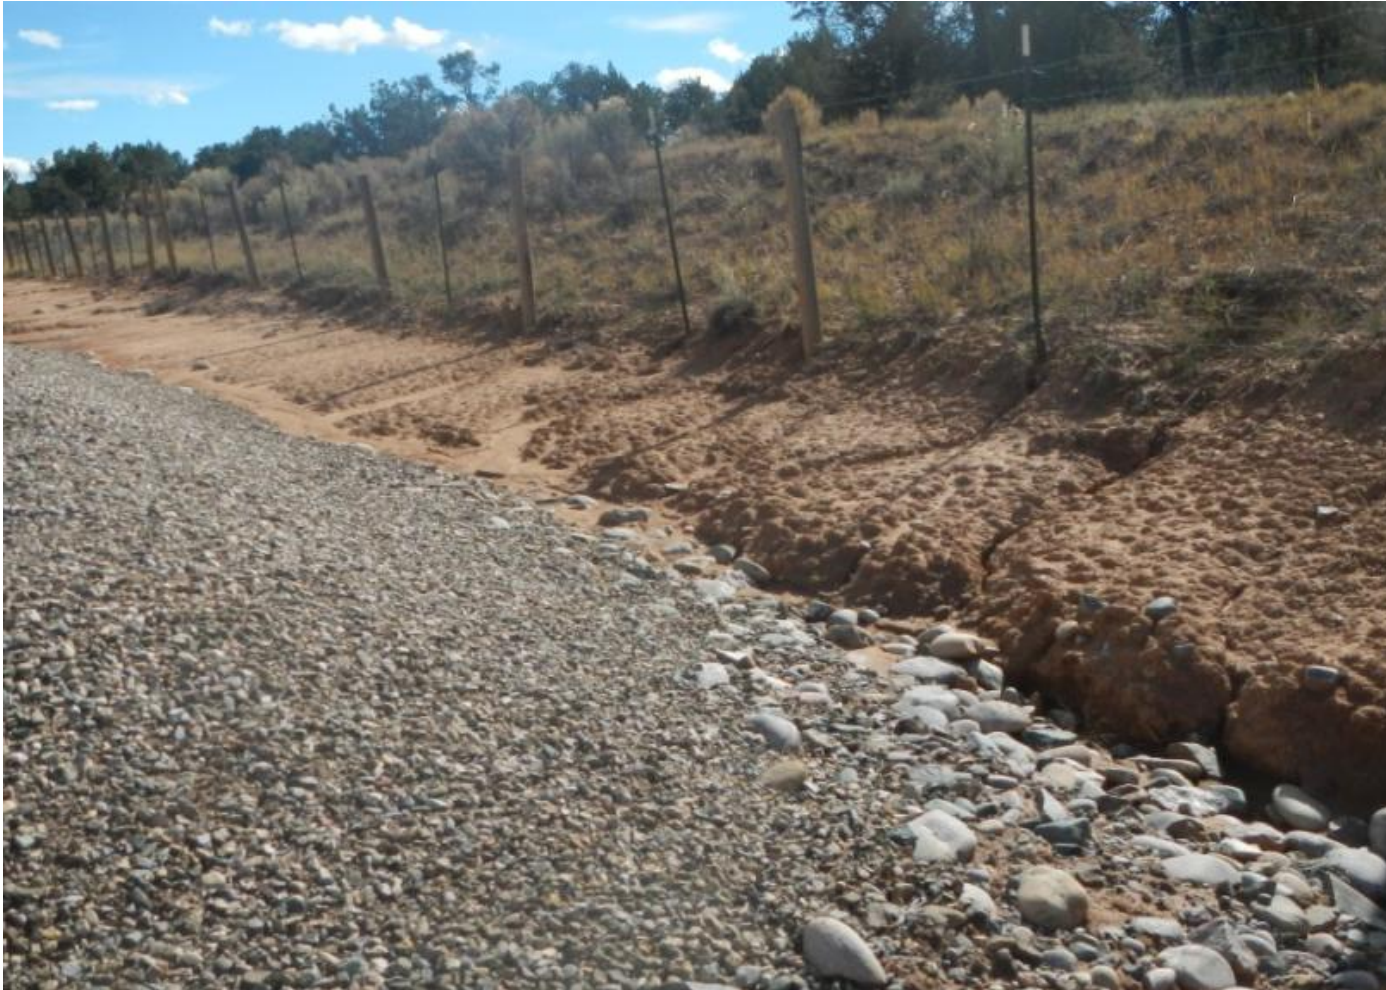
Photo 1. View of stormwater diversion on southwestern edge of the working area from northwestern corner facing southward.

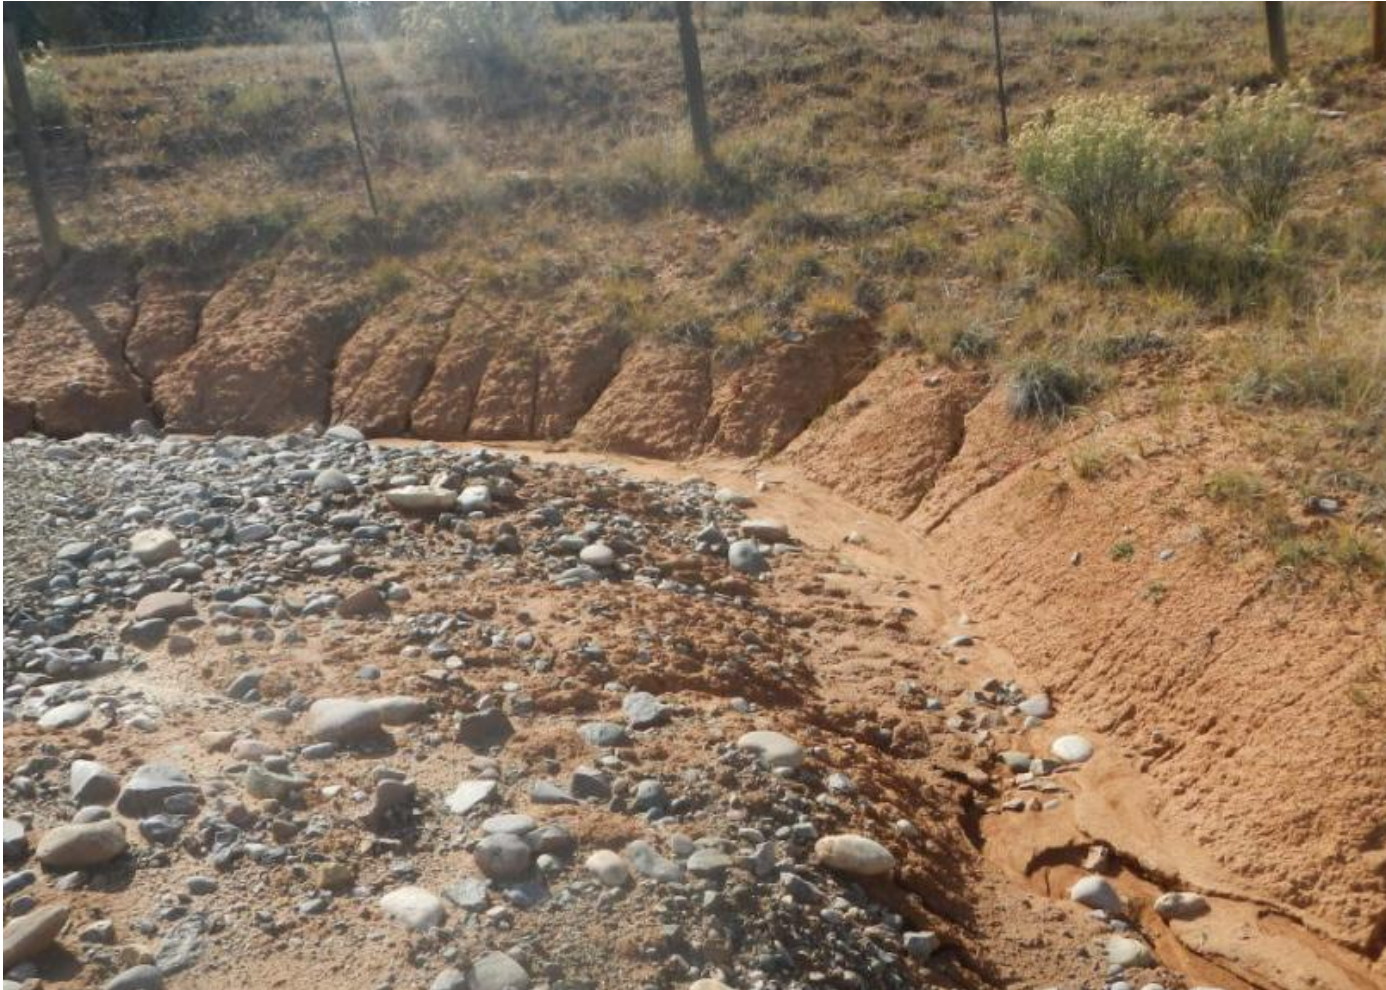
Photo 2. View of area where significant erosion begins within stormwater diversion in northwestern corner of working area.

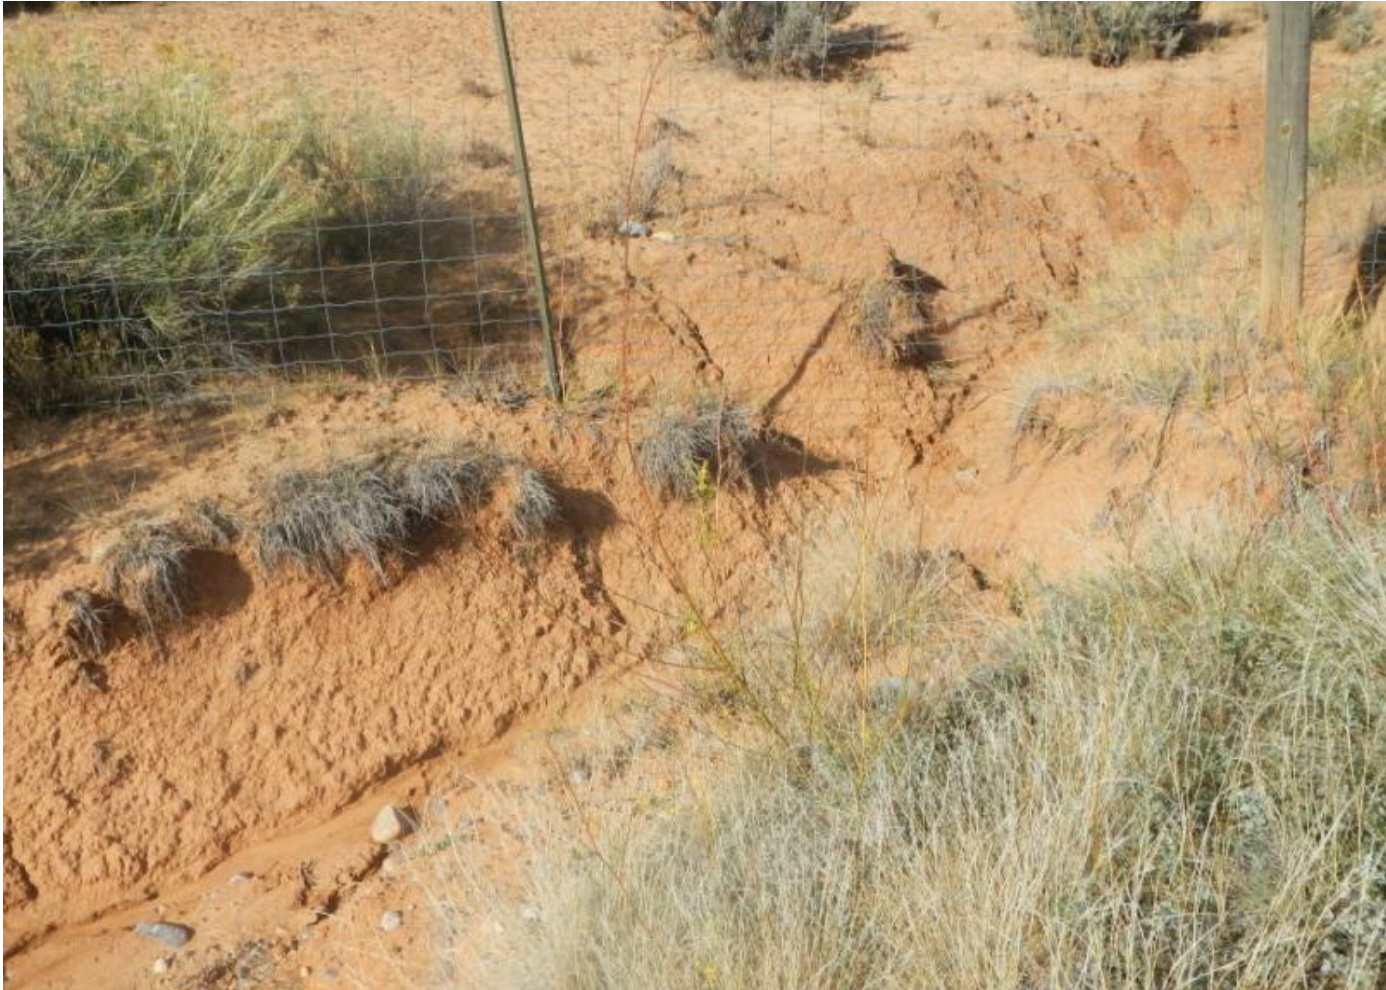
Photo 3. View of area where erosional channel flows outside of fenced area and through the northern portion of the project area.

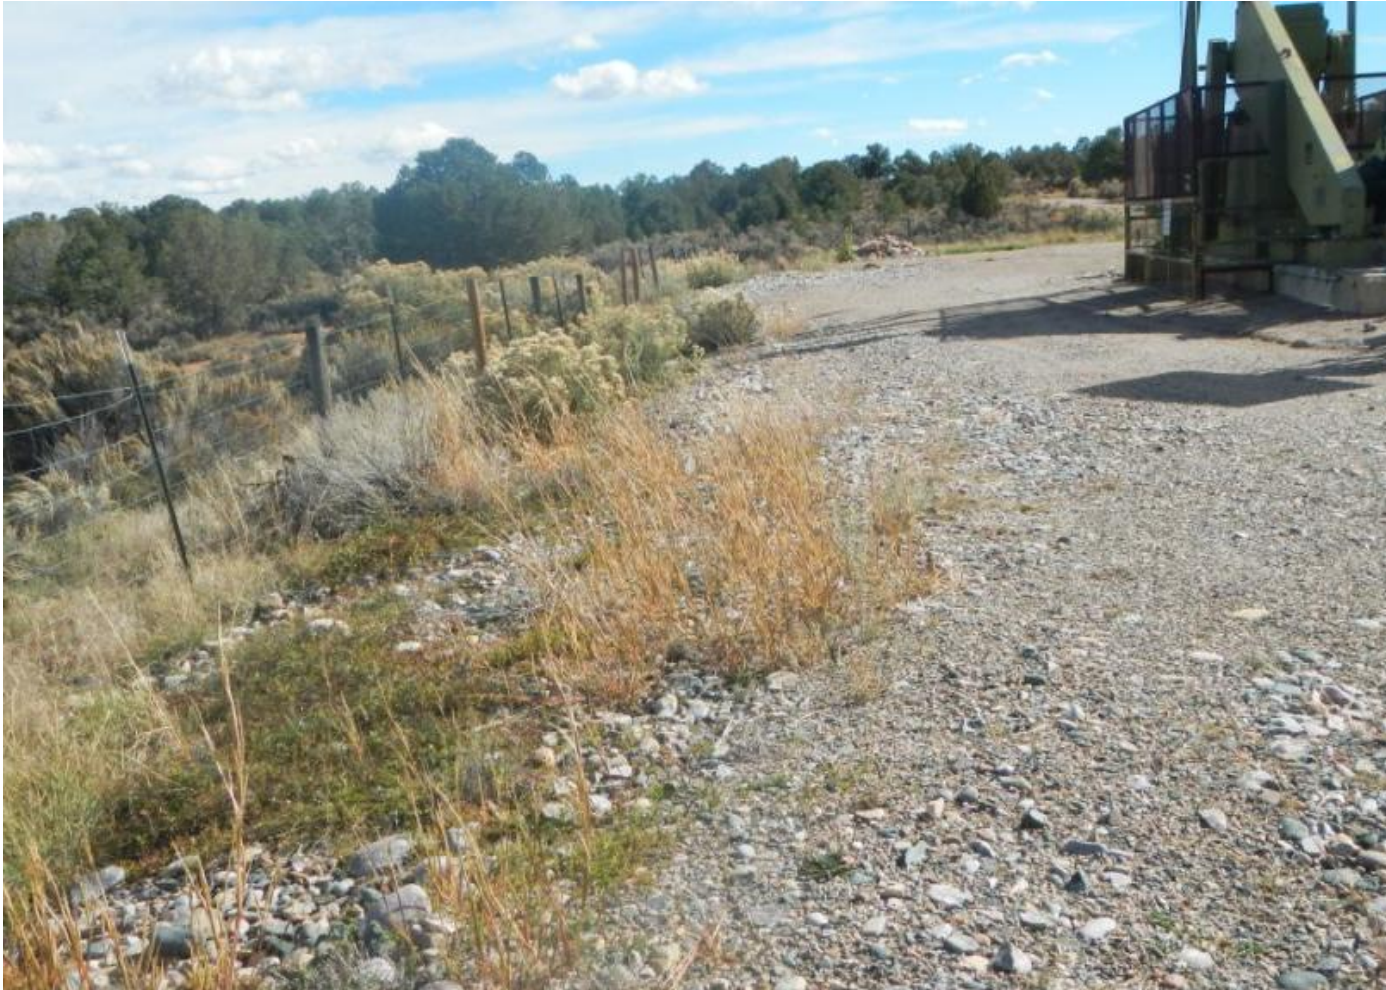
Photo 4. View of the northeastern portion of the working area from the northern corner facing southward.

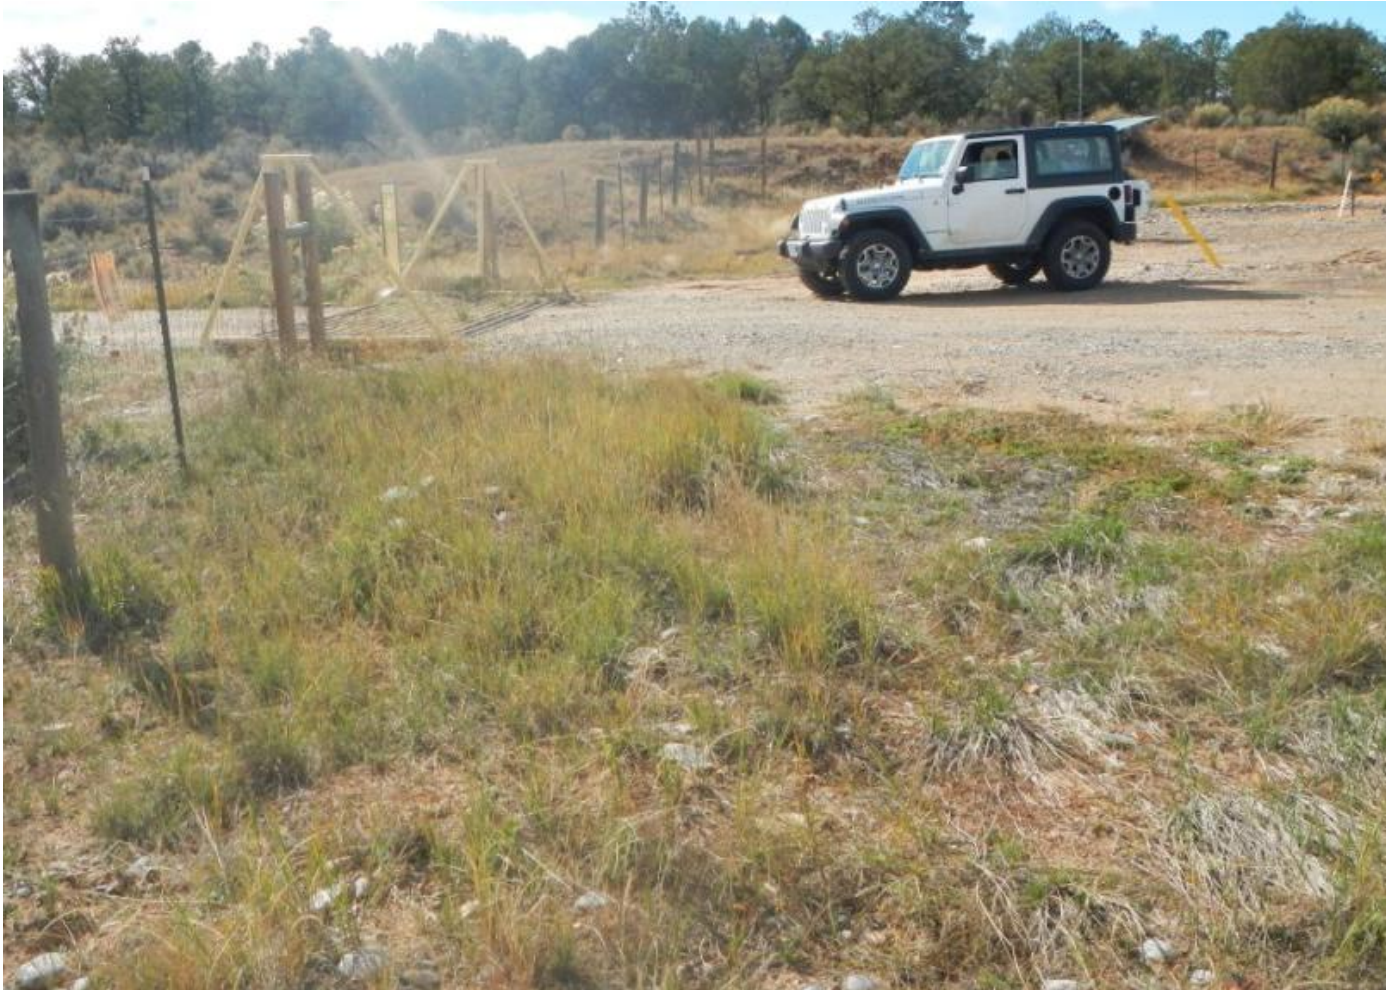
Photo 5. View of the southern portion of the project area from the southeastern corner facing westward.
