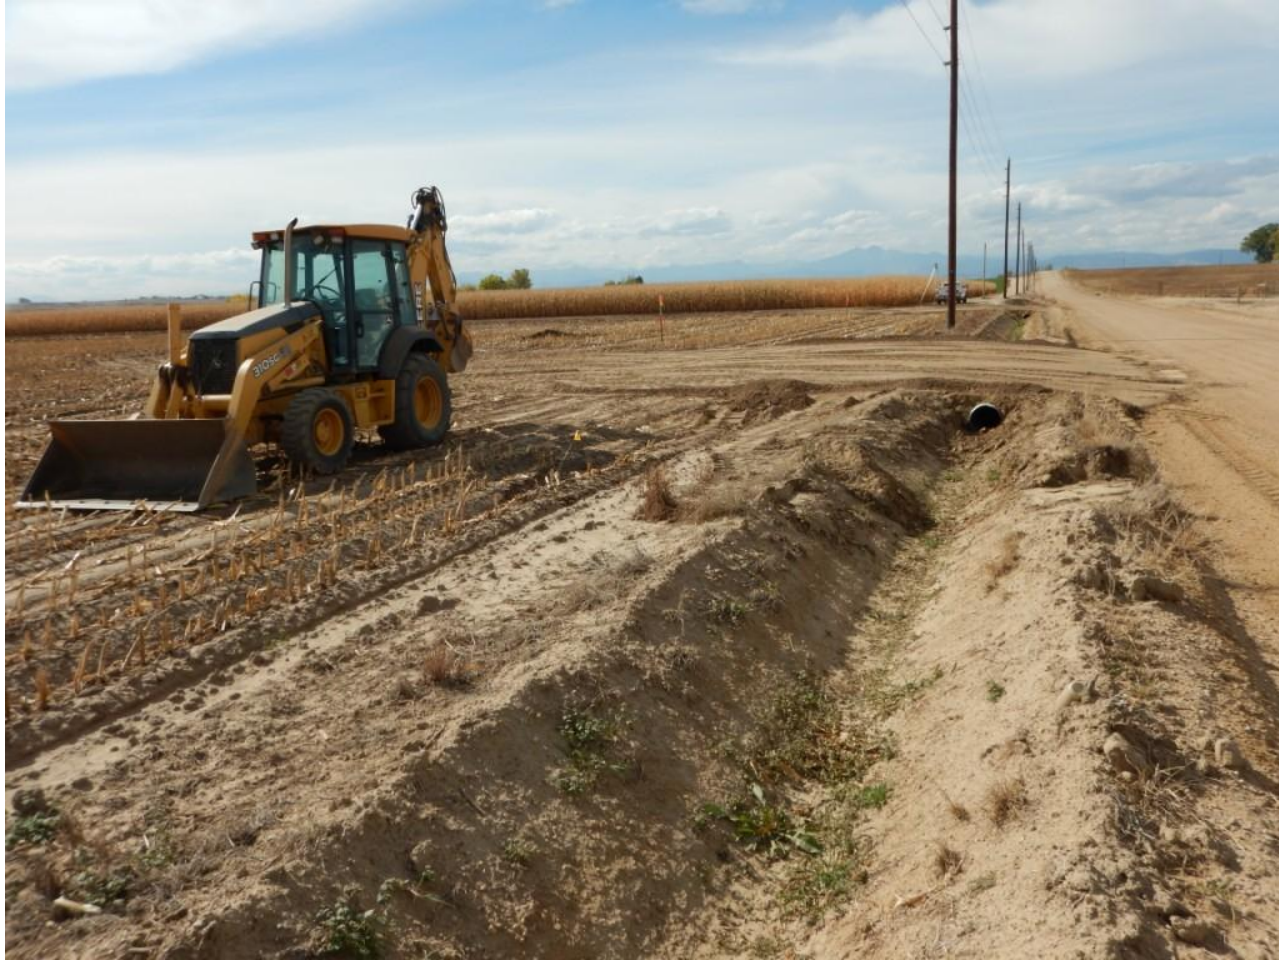
Photo 1. Photo taken of east, northern access road, facing West. Stormwater control ditch with culvert in center of photo.

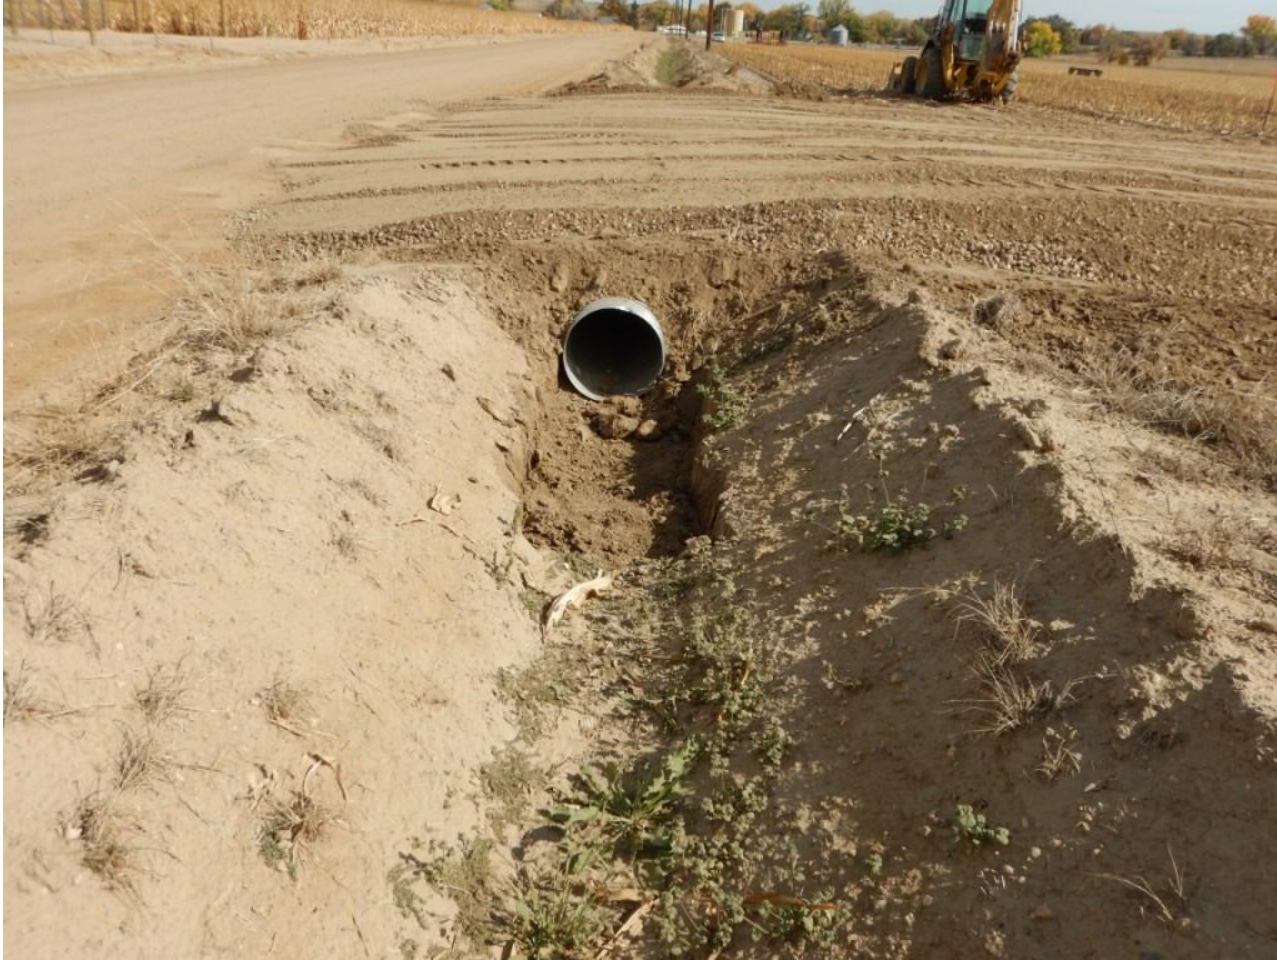
Photo 2. Photo taken of east, northern access road, facing East. Stormwater control ditch with culvert in center of photo.

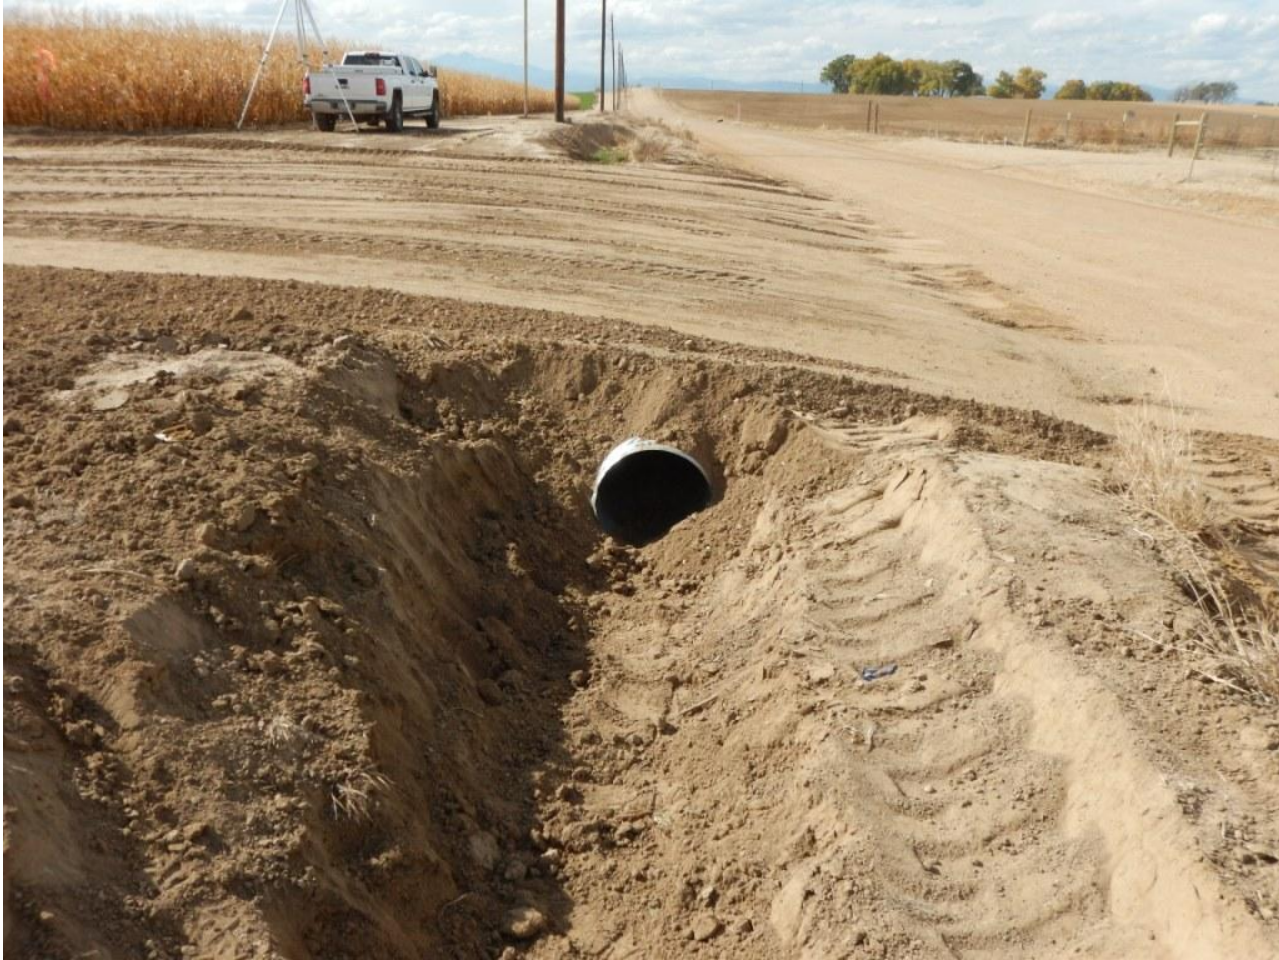
Photo 3. Photo taken of west, northern access road, facing West. Stormwater control ditch with culvert in center of photo.

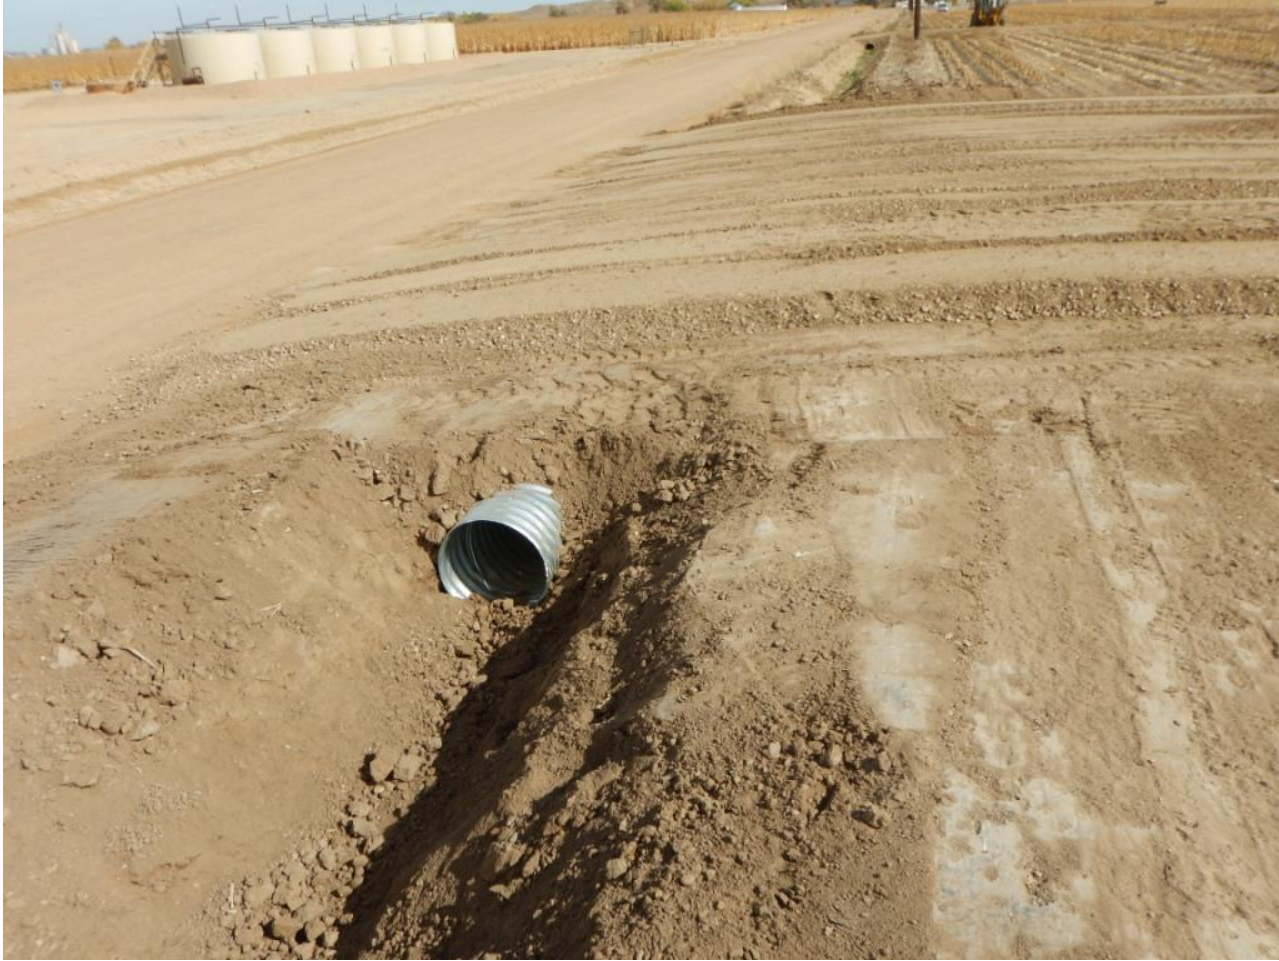
Photo 4. Photo taken of west, northern access road, facing East. Stormwater control ditch with culvert in center of photo.

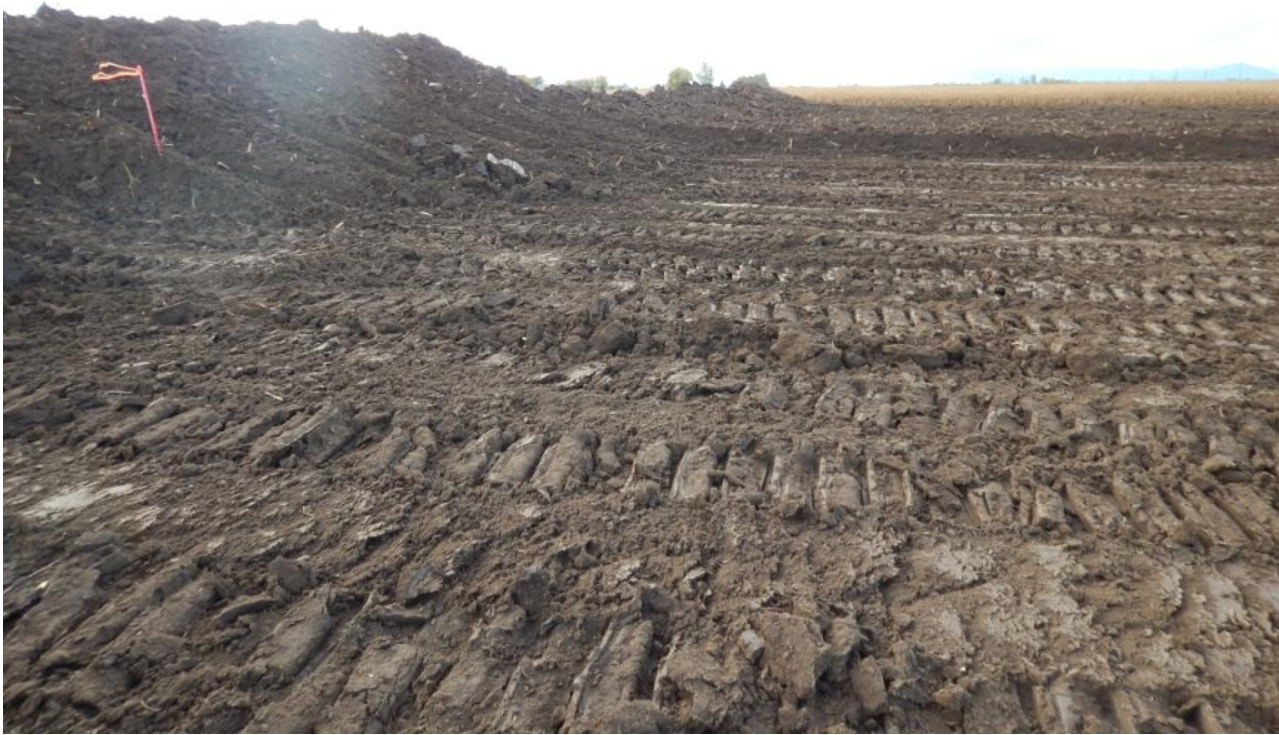
Photo 5. Photo taken of southern topsoil stockpile, facing Southwest.

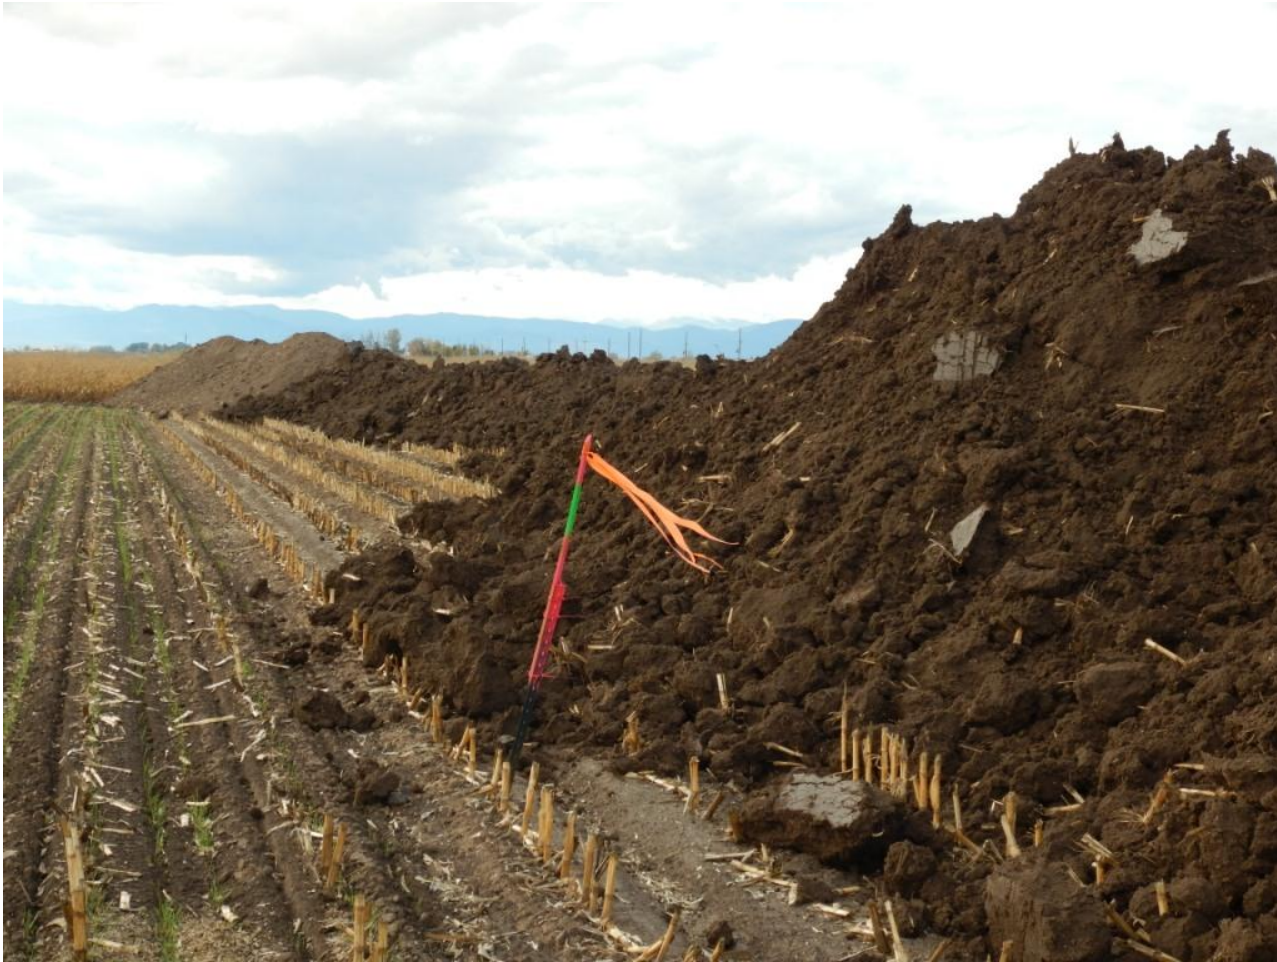
Photo 6. Photo taken of southern topsoil stockpile, facing Northwest. Need to stabilize topsoil stockpile. Topsoil salvage process was not complete during this inspection.

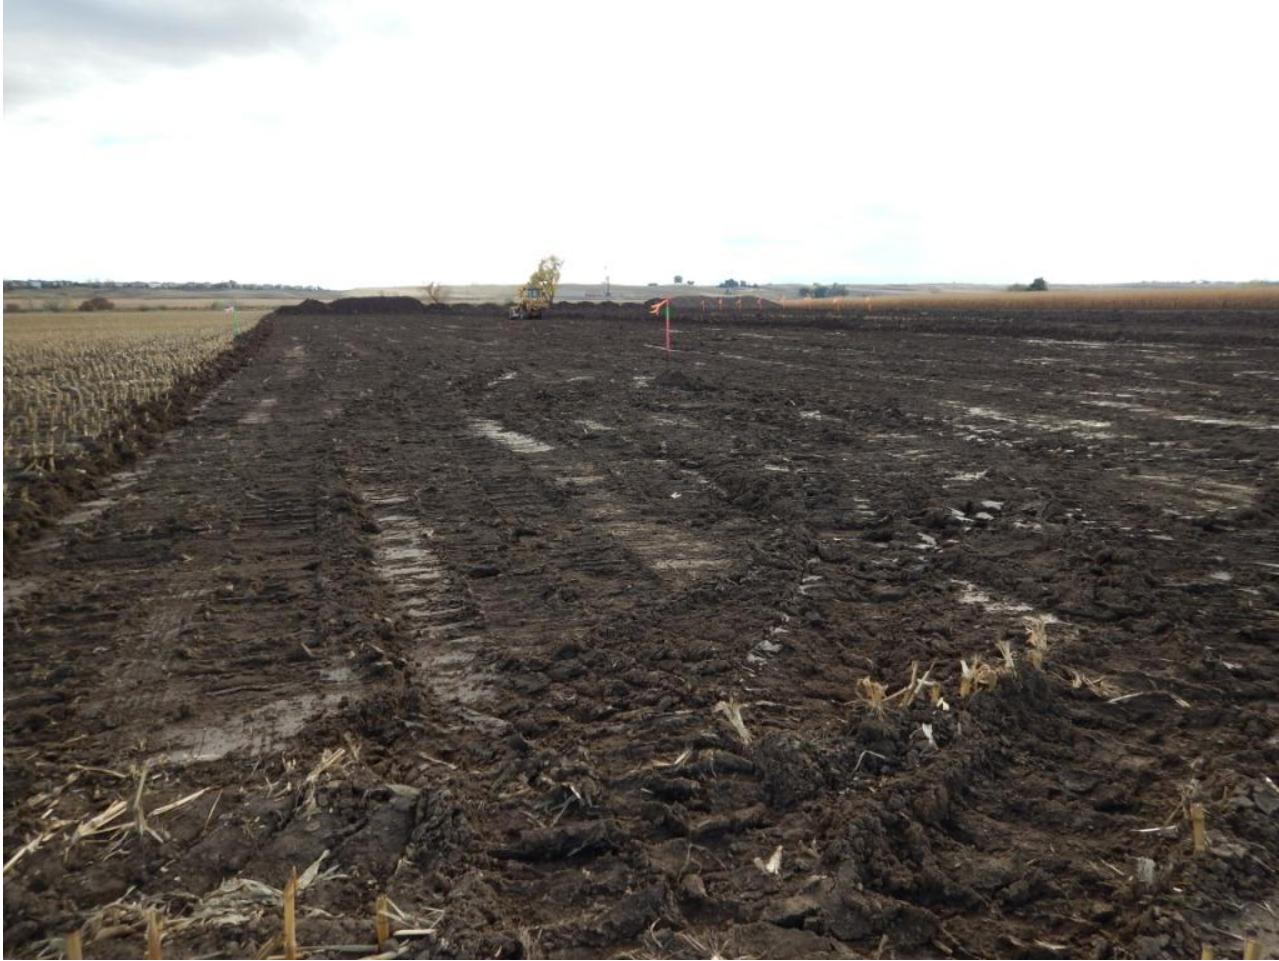
Photo 7. Photo taken of northern location, facing South. Topsoil removal in process.
