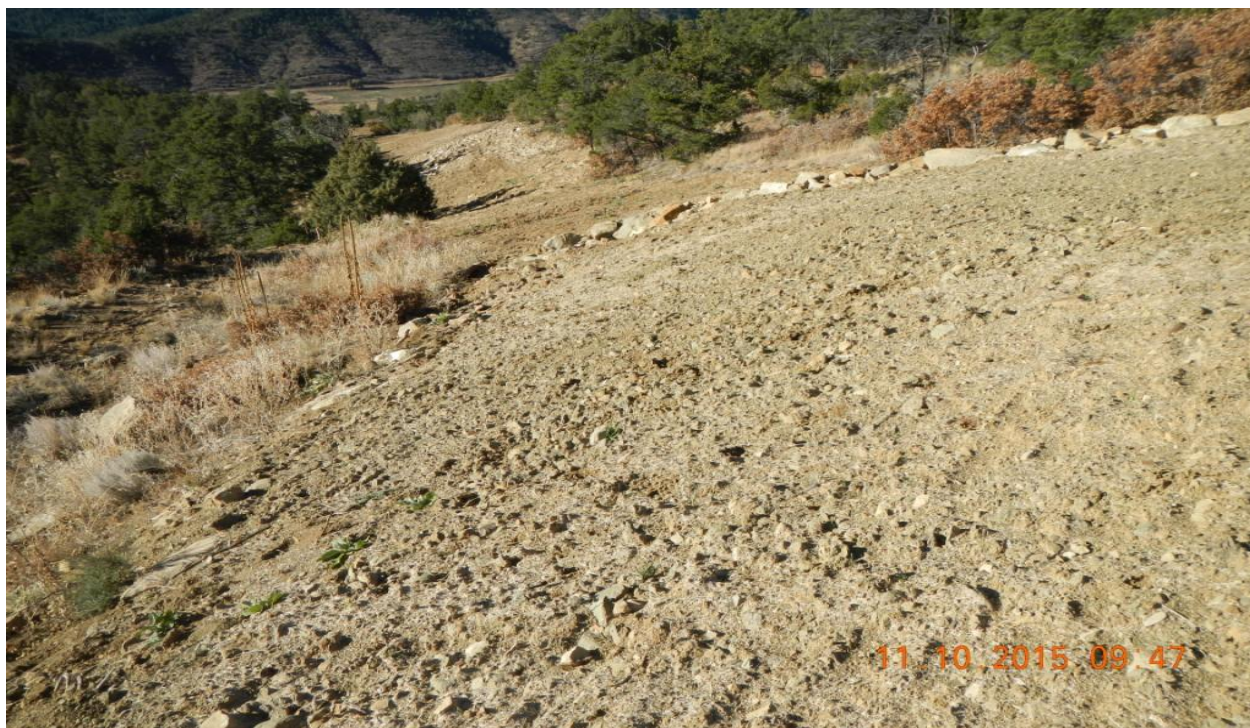
photo 1: Facing southwest towards the reclaimed access road.

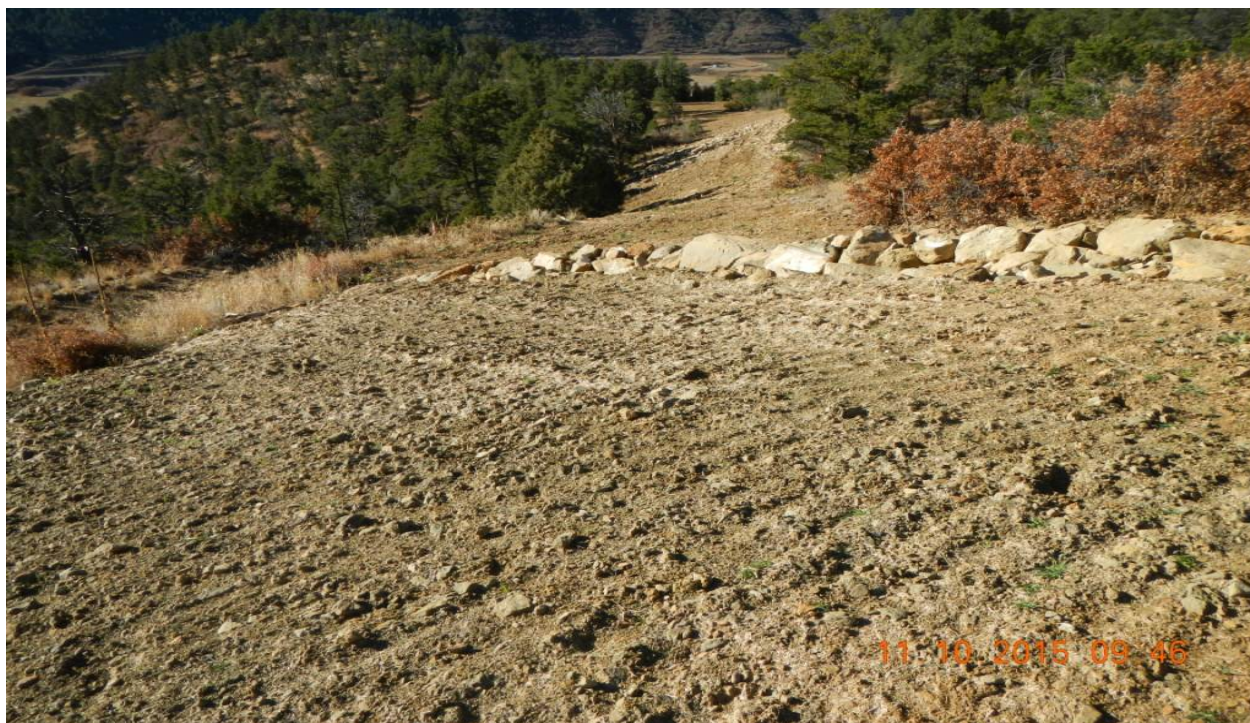
photo 2: Facing southwest towards the reclaimed access road.

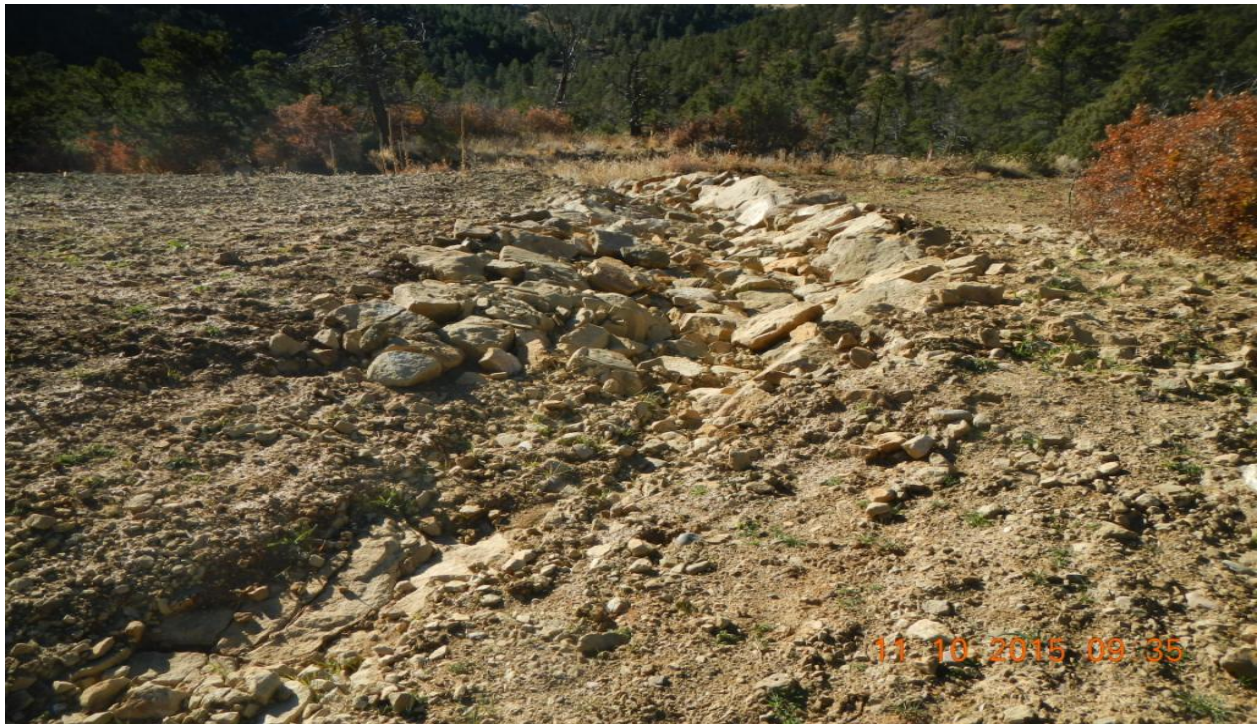
photo 3: Drainage channel installed where water is diverted from the main road.

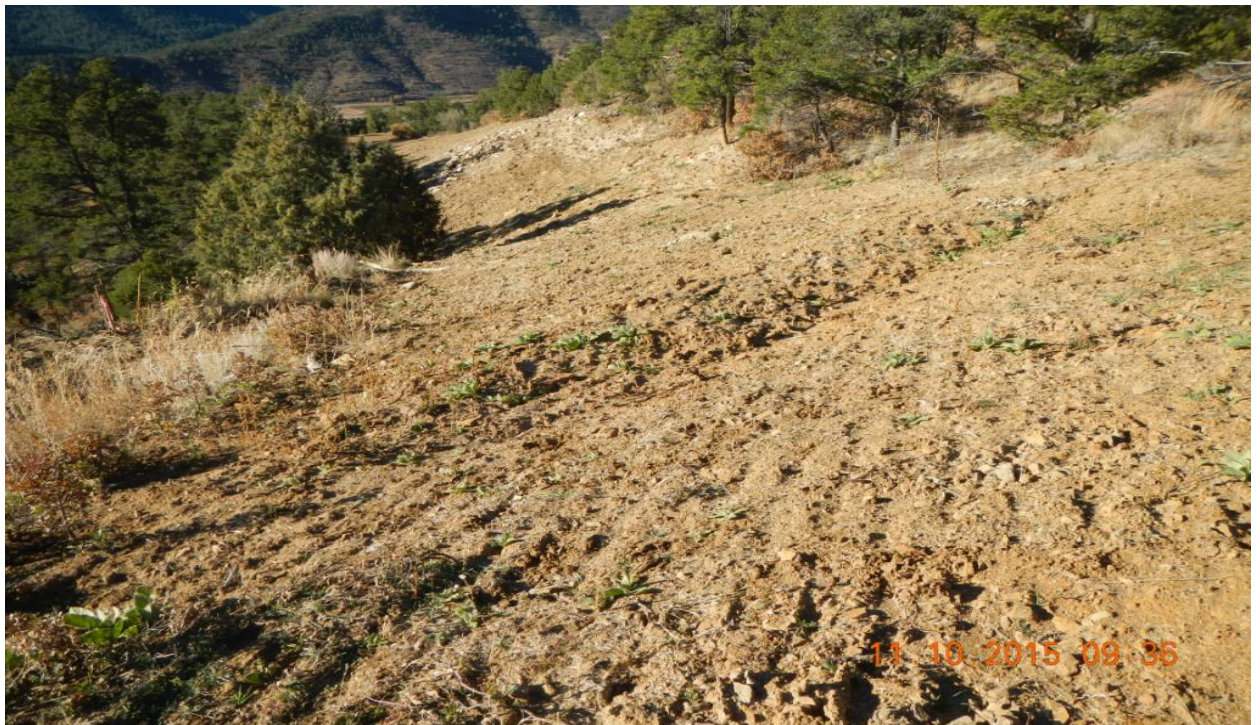
photo 4: Facing southwest along the reclaimed access road.

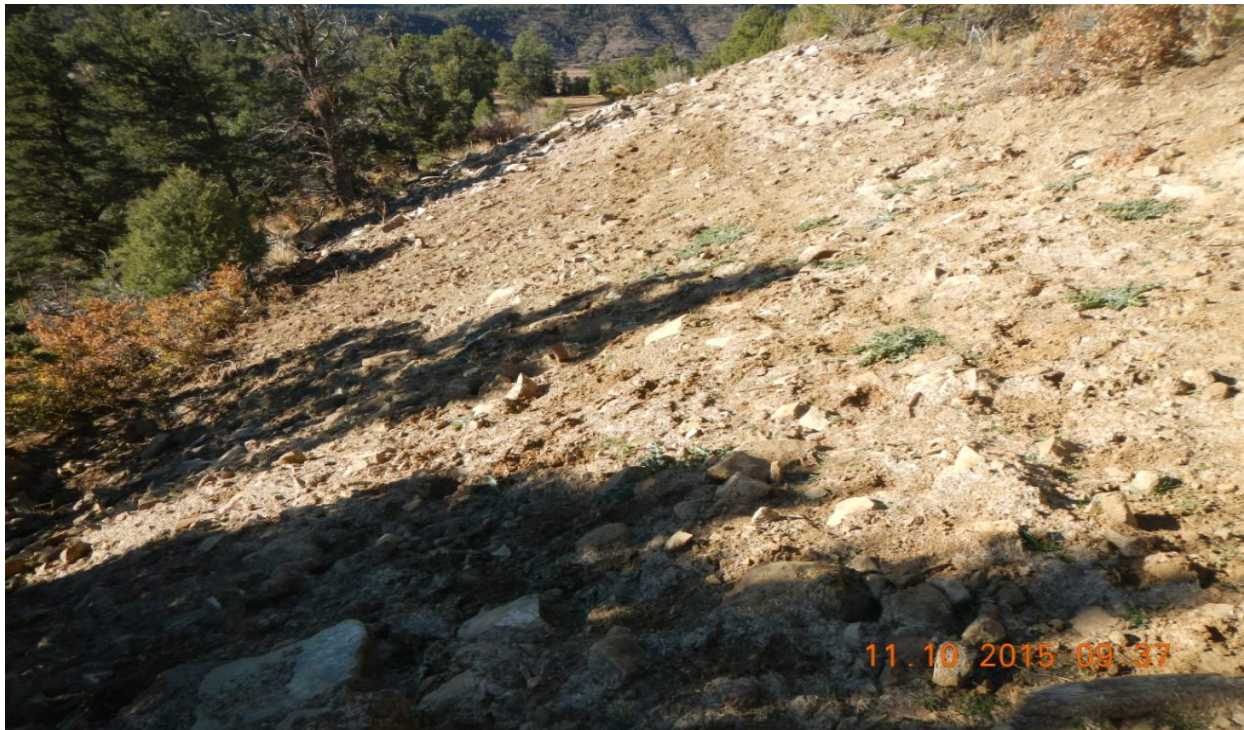
photo 5: Facing southwest along the reclaimed access road.

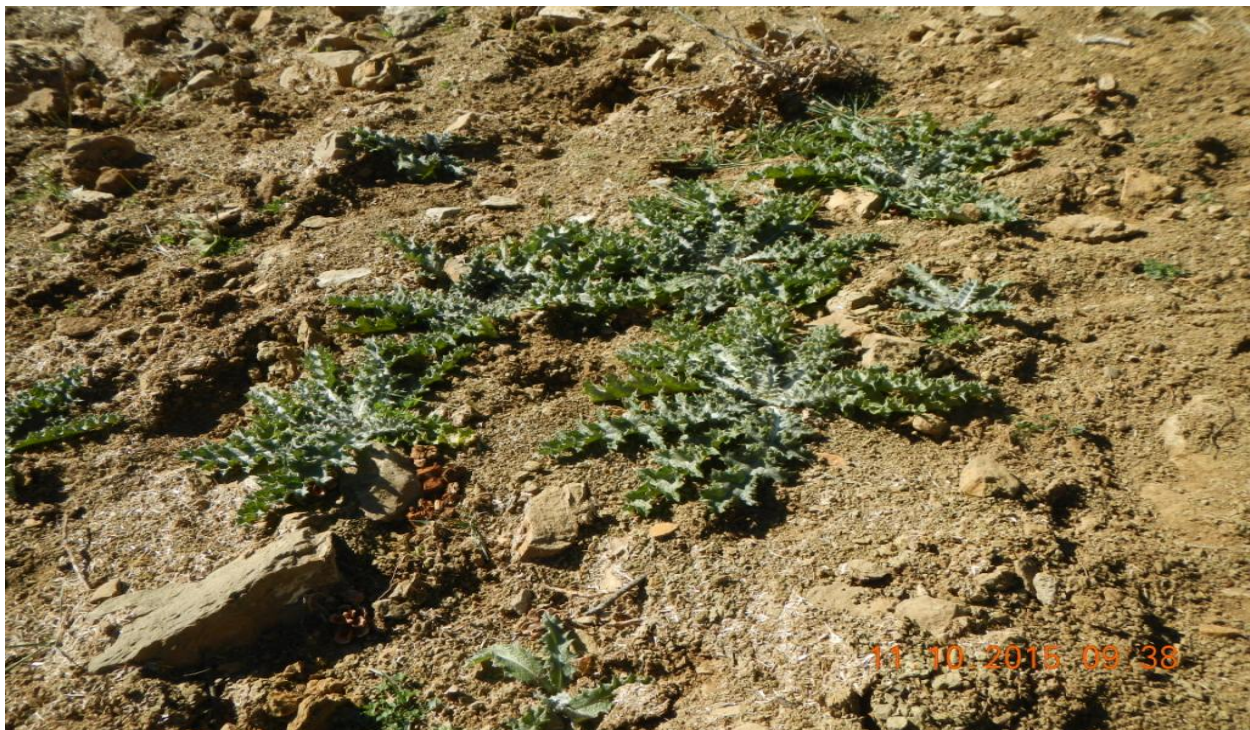
photo 6: Thistle has began to grow along the access road.

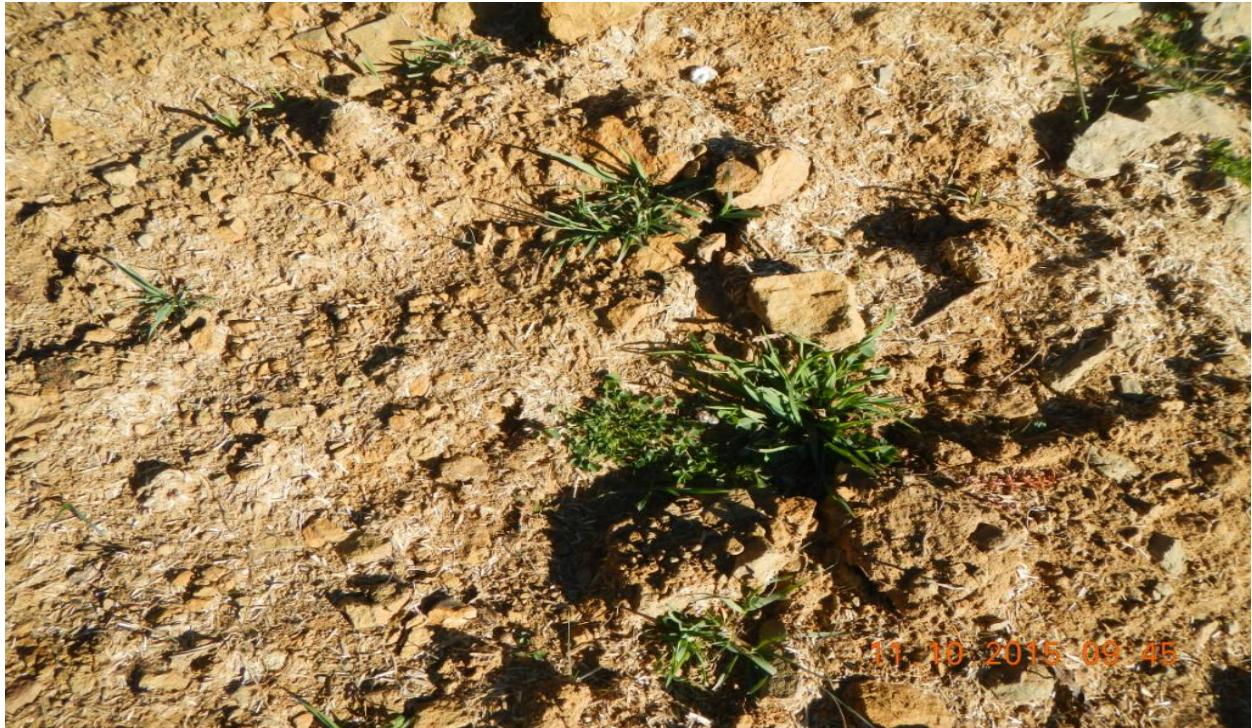
photo 7: Close up of new vegetation growth.

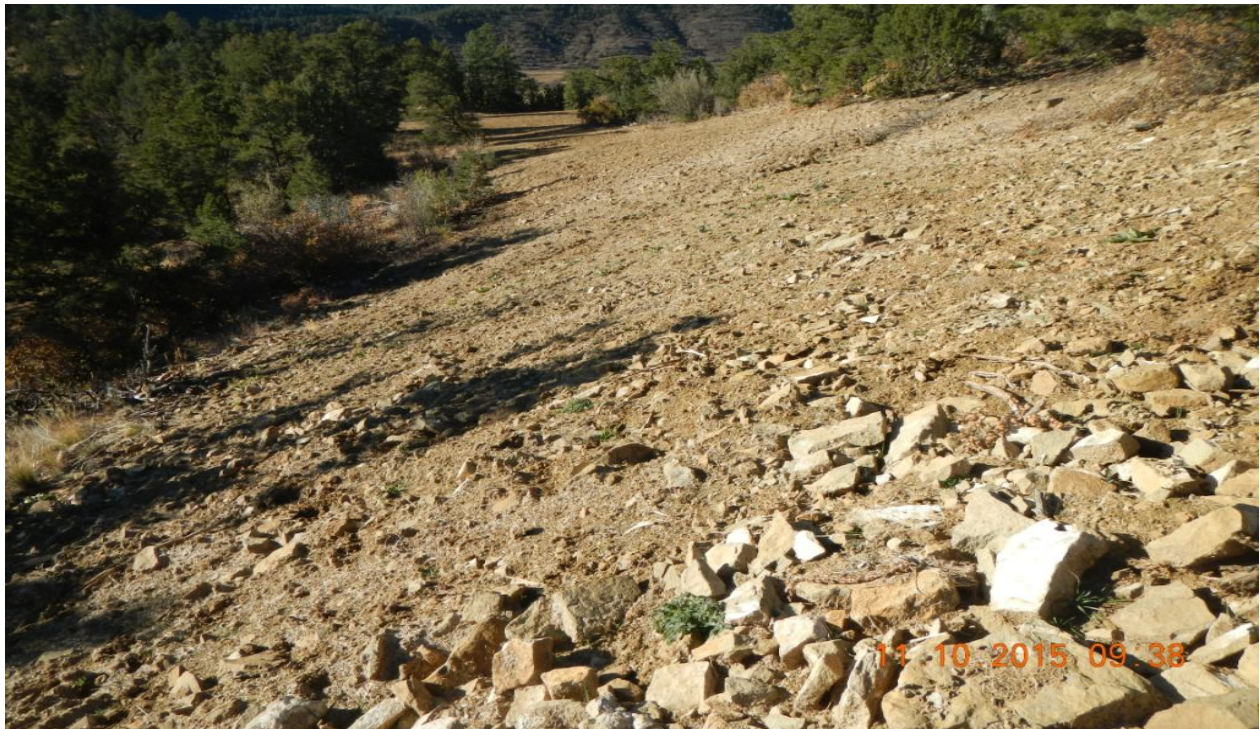
photo 8: Facing southwest towards the location.

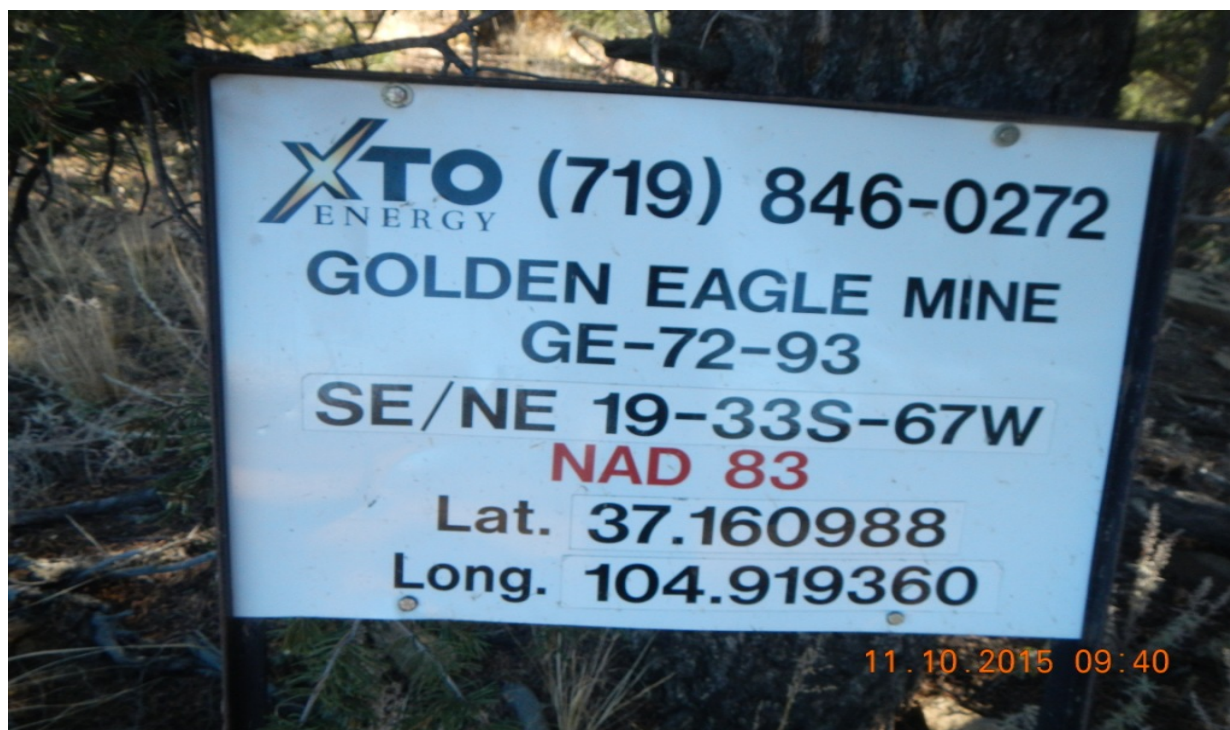
photo 9: Well sign at the location.

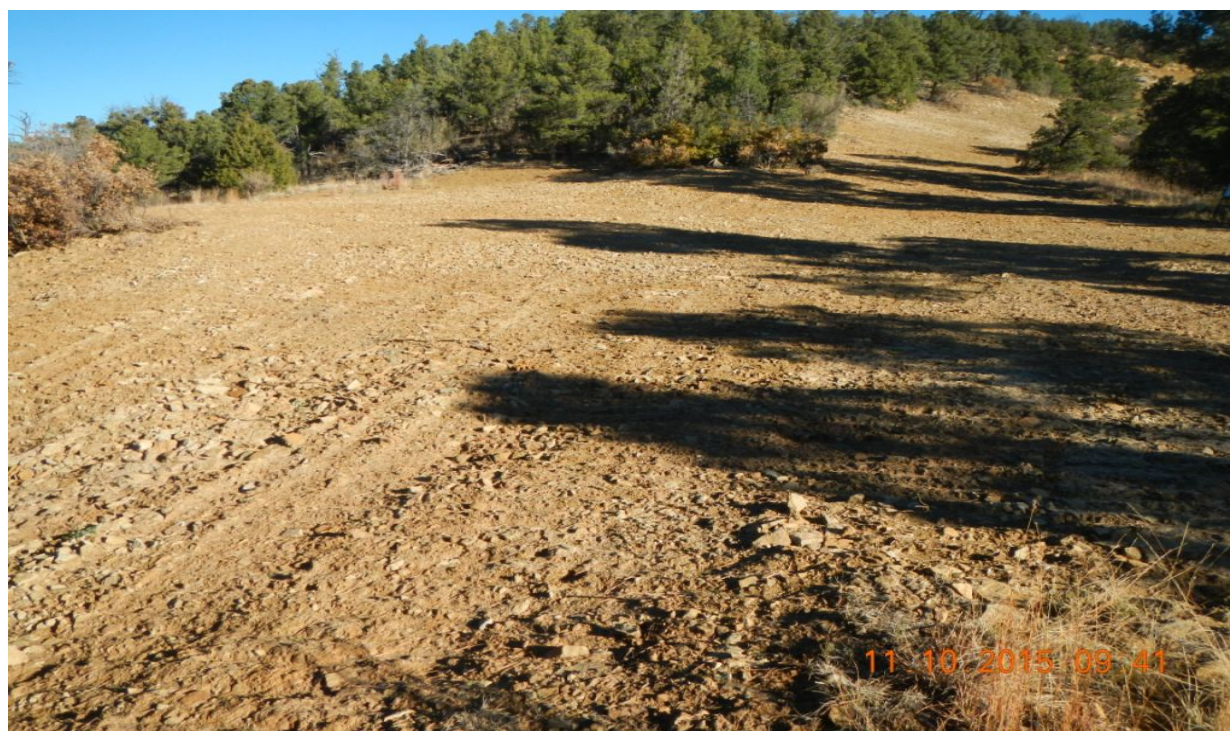
photo 10: South side of the location facing north.
