GV 52-3 Follow up

Inspection Doc# 675202211

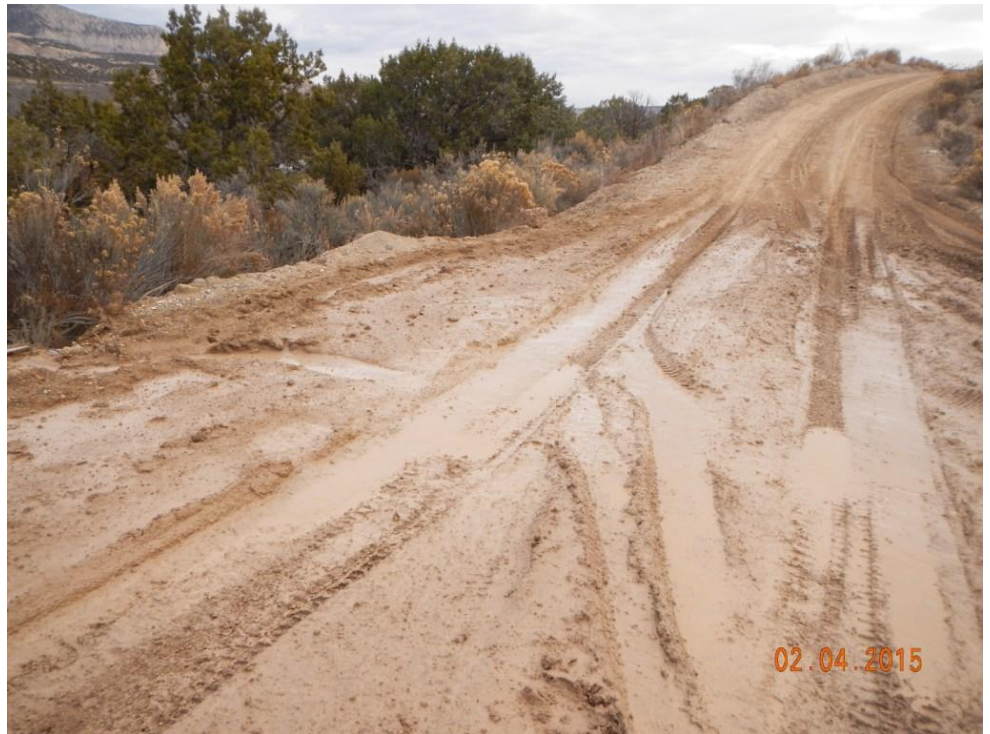
Erosion of road side. 2/4/15

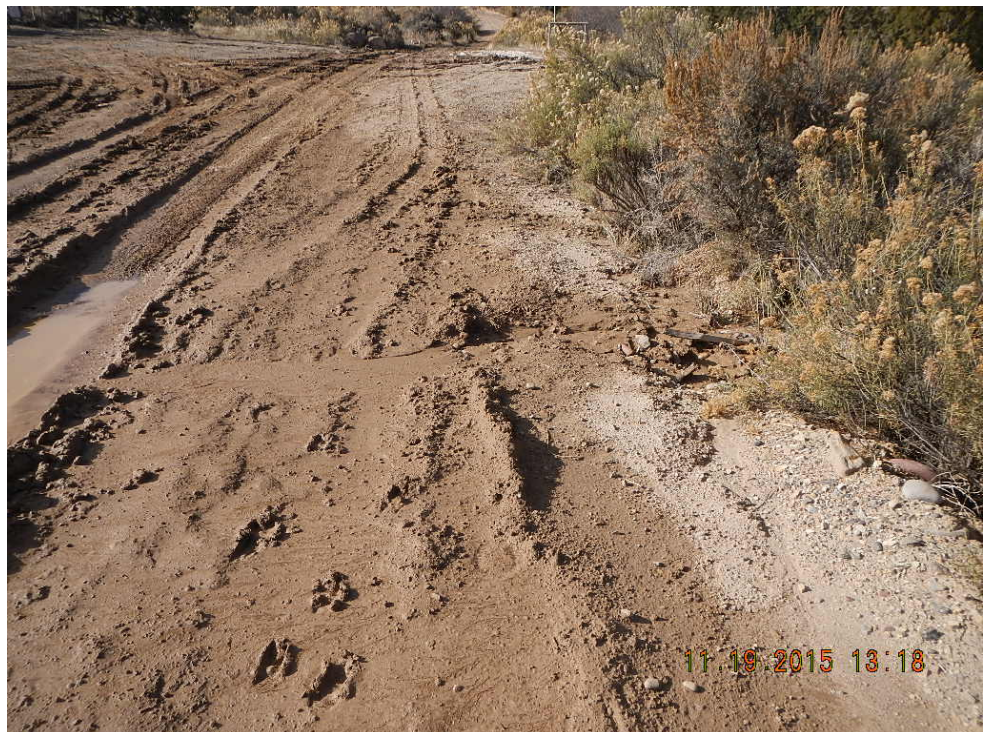
Same area with erosion and
sediment migration.
11/19/15

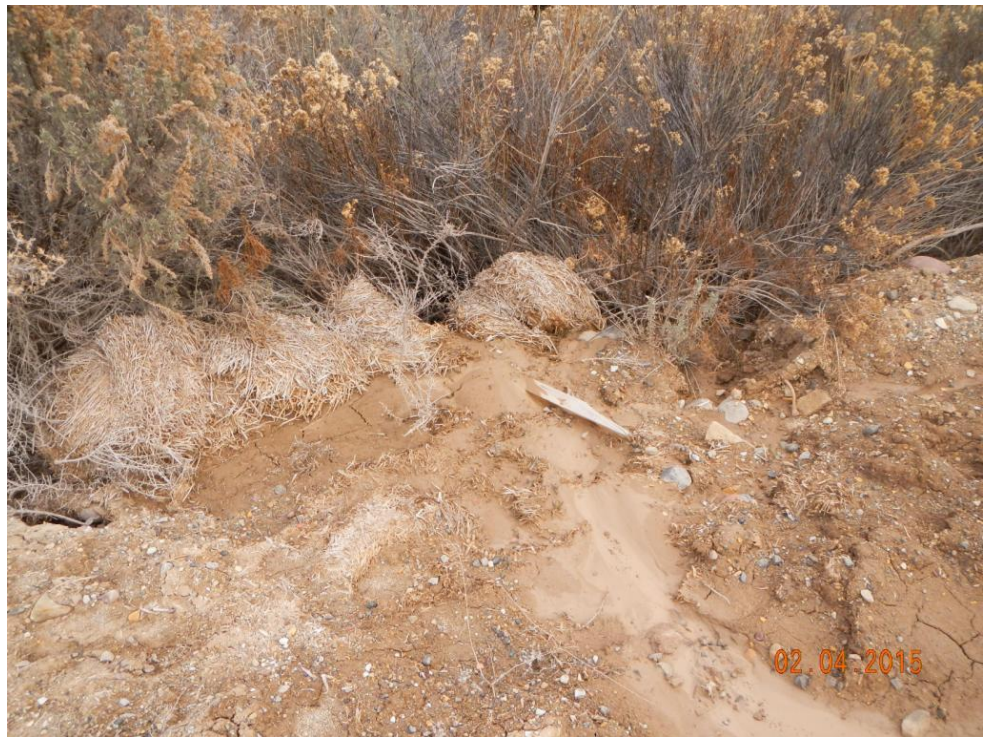
Failed BMP with sediment
migration. 2/4/15

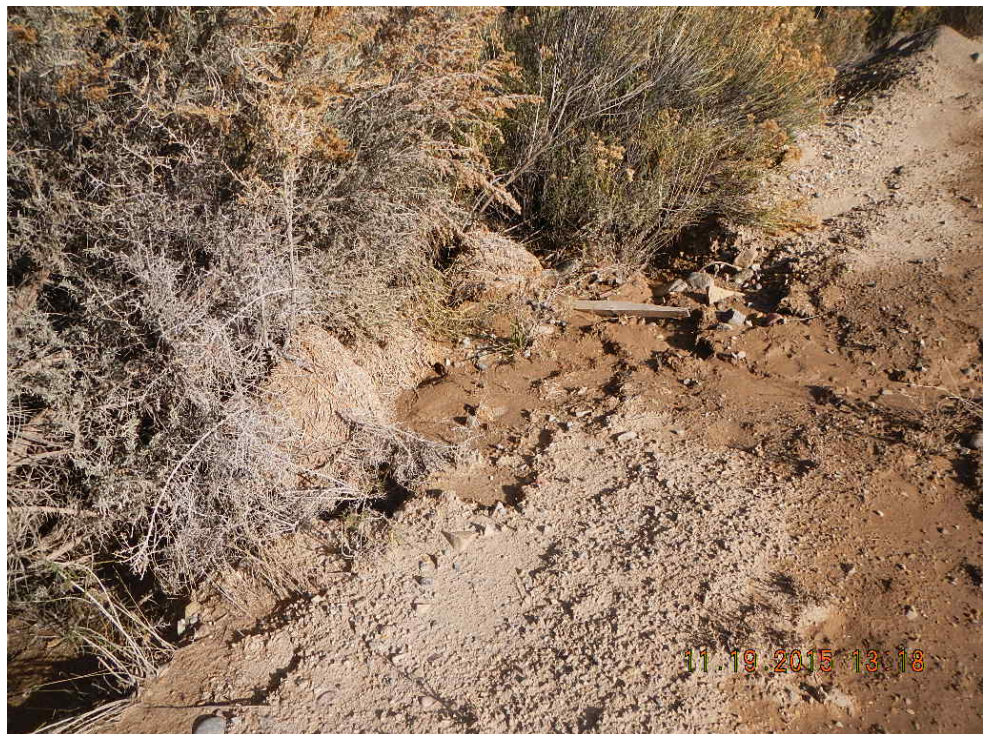
Same failed BMP. 11/19/15
