Loc. ID 435387- Reclamation and Stormwater Inspection

- Photos 2 through 5: Southwest quarter of location.
 - Photos of erosion issues on location.

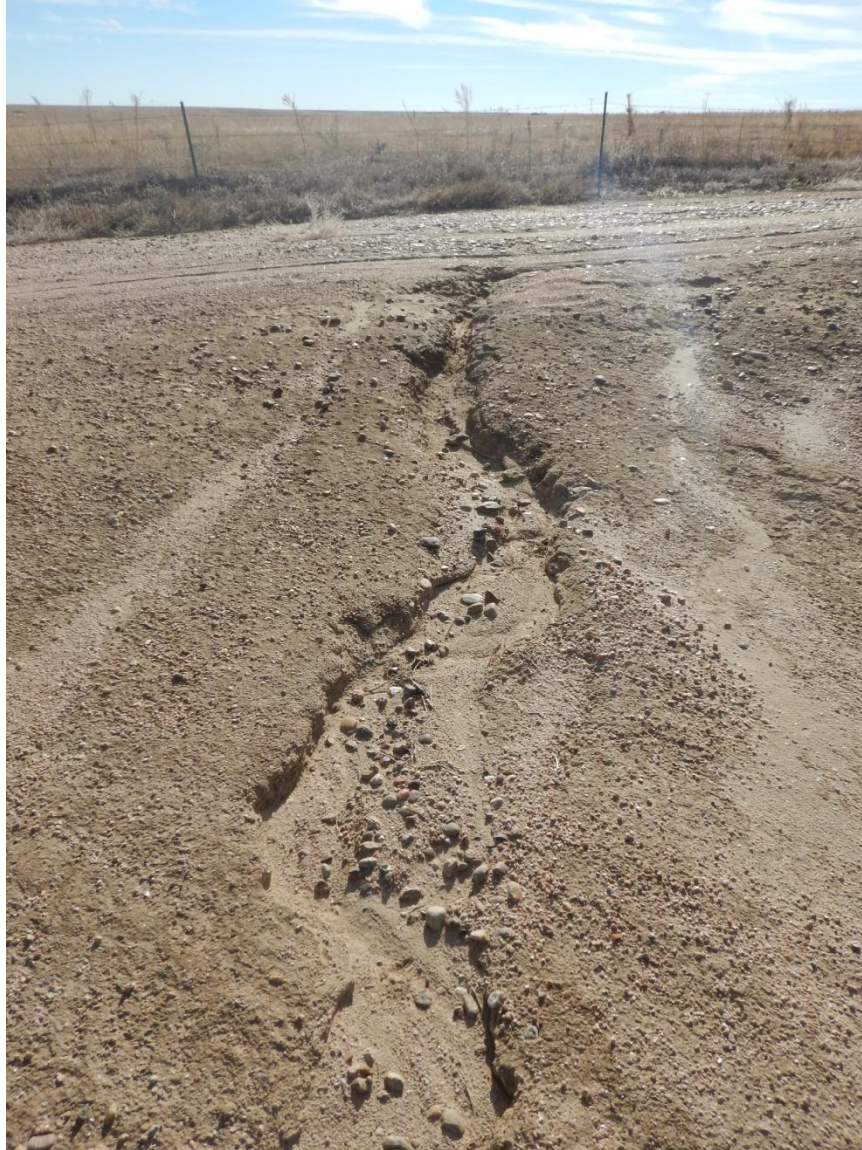
Photo 3: Photo taken on southern end of location. Photo of rill erosion.

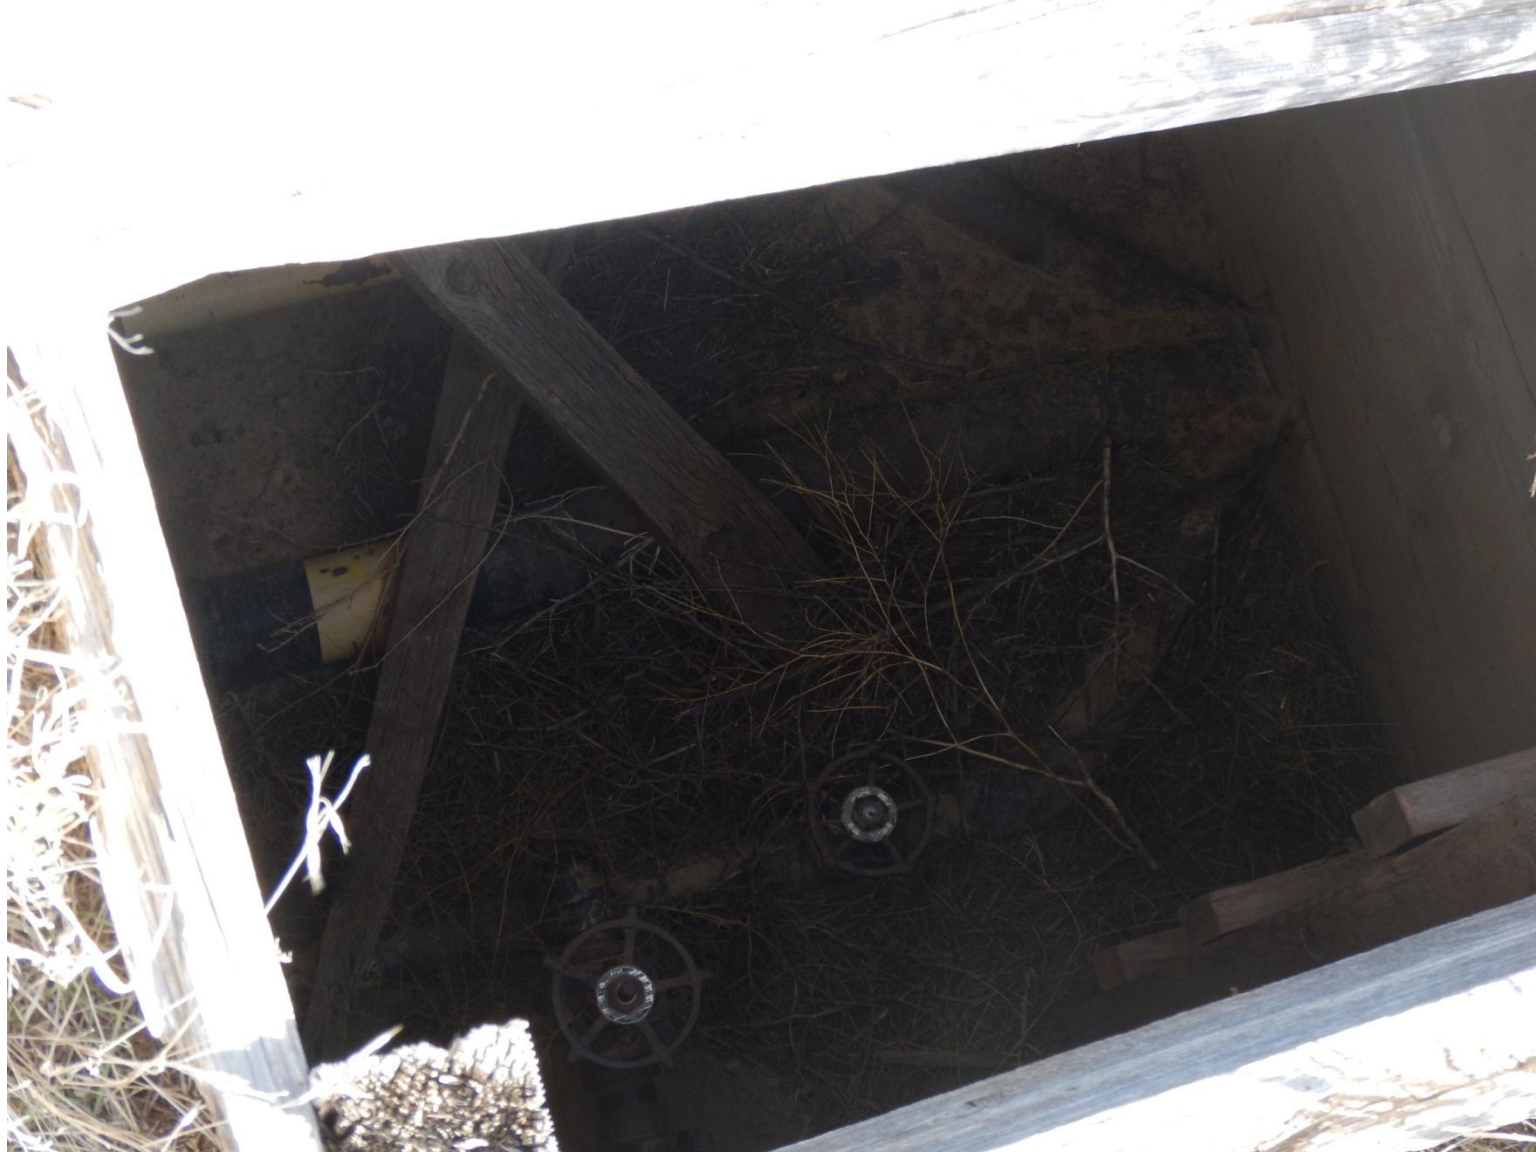
Photo 7: Photo of pipe and valves within exposed wooden sub-surface structure. This poses a hazard to wildlife and human safety.

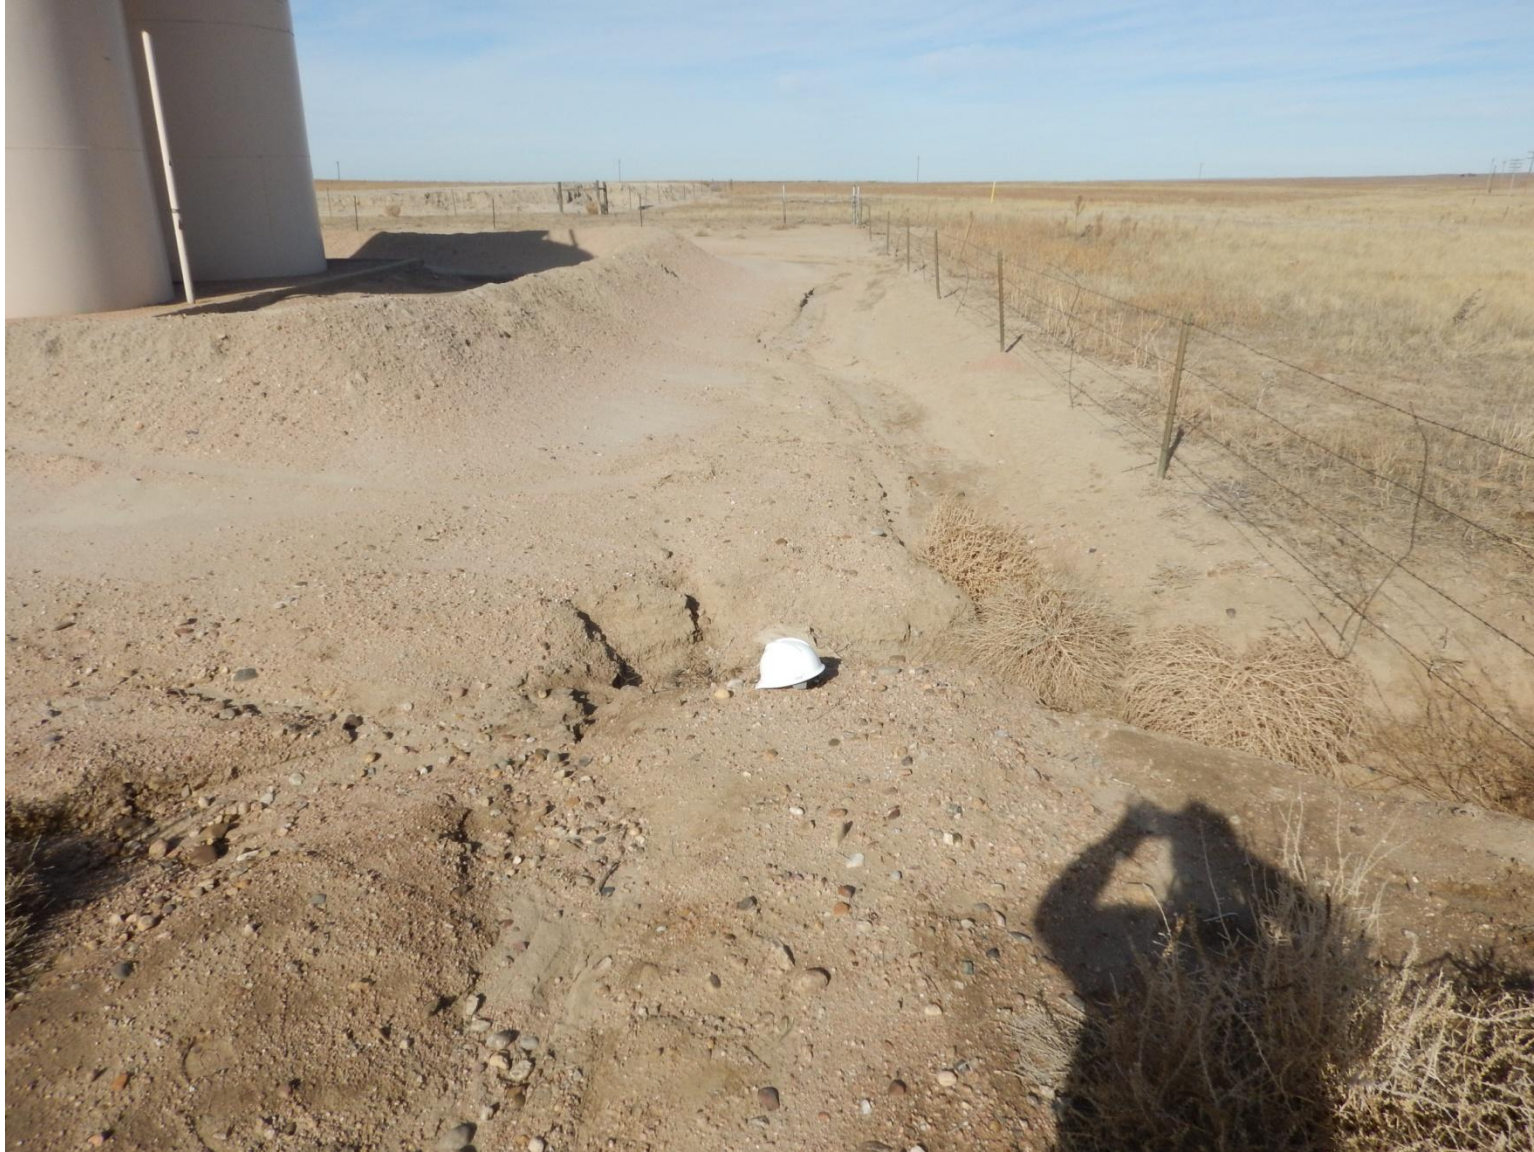
Photo 14: Photo taken from east end of location facing north. Photo shows confluence of storm water erosion channels from northern and southern halves of location.

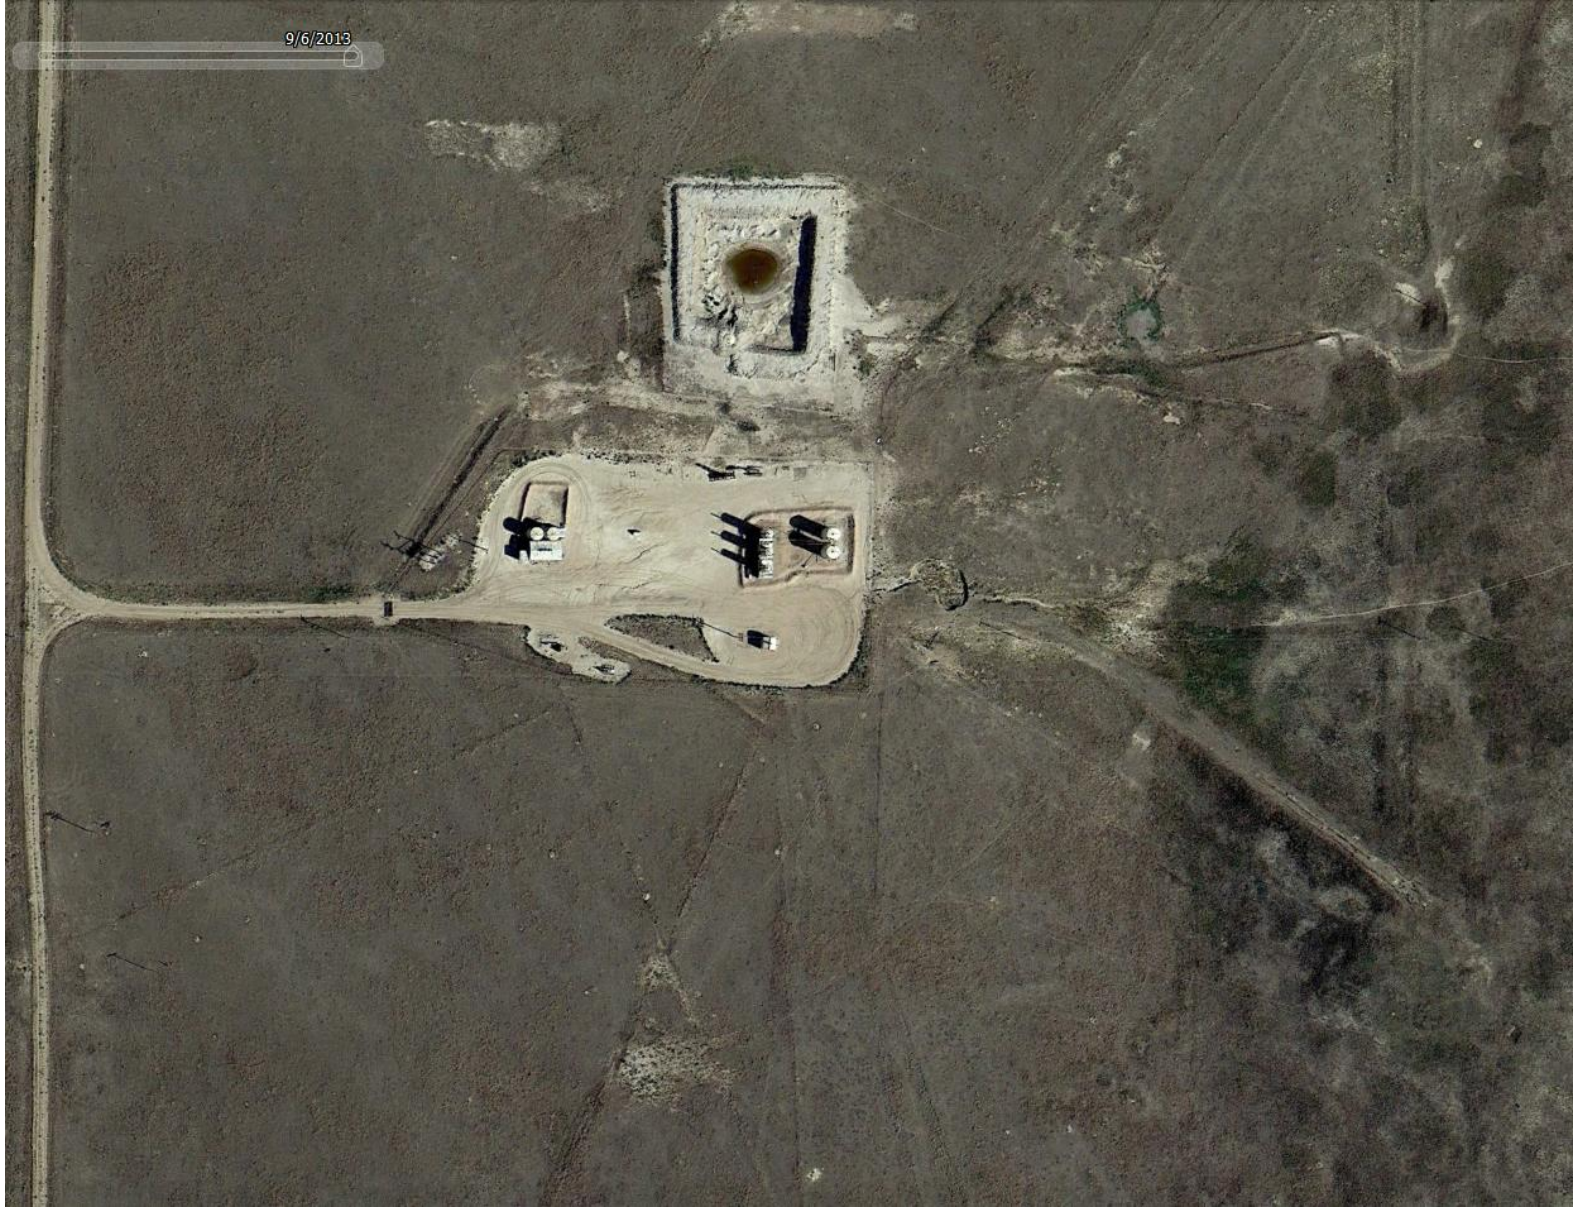
Photo 24: Aerial image date 9/2013. Most up-to-date aerial image or erosion east of location.

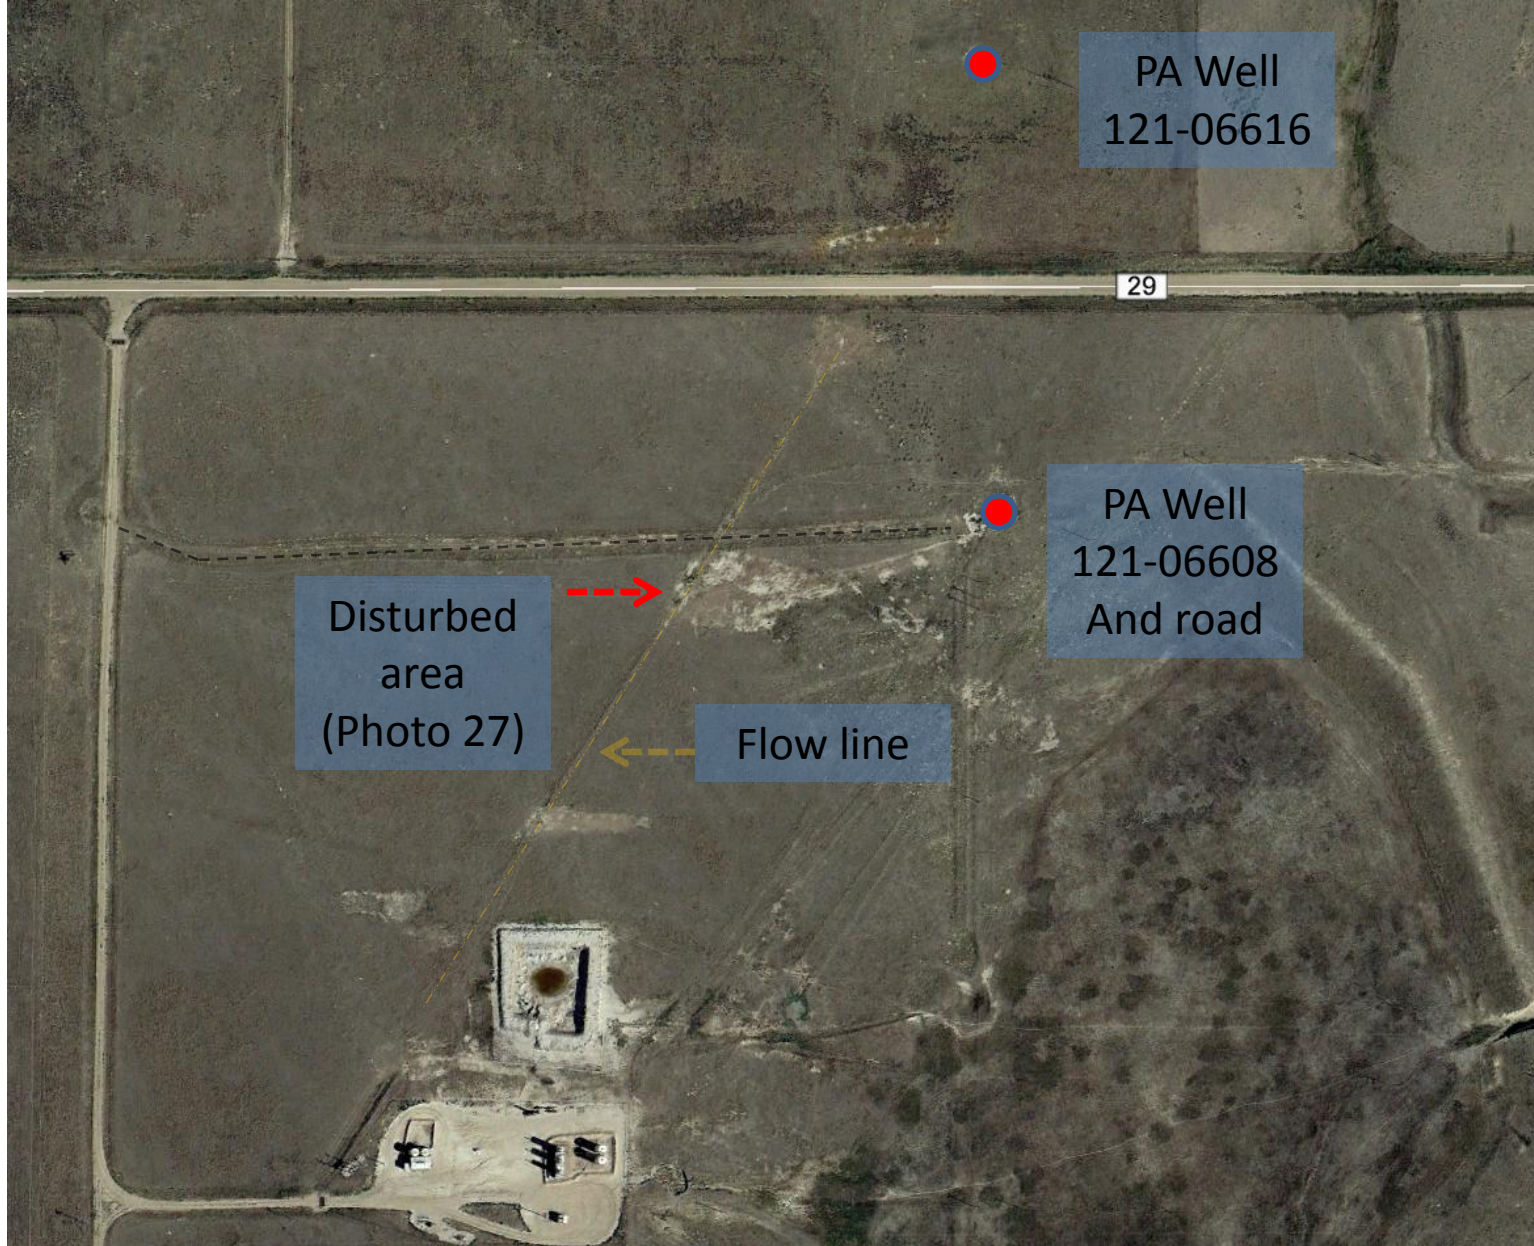
Photo 26: Aerial image date 9/2013. Note the disturbed areas along flow line. These areas need to be reclaimed.
