Loc. ID 435387- Reclamation and Stormwater Inspection

Loc. ID 435387- Reclamation Inspection

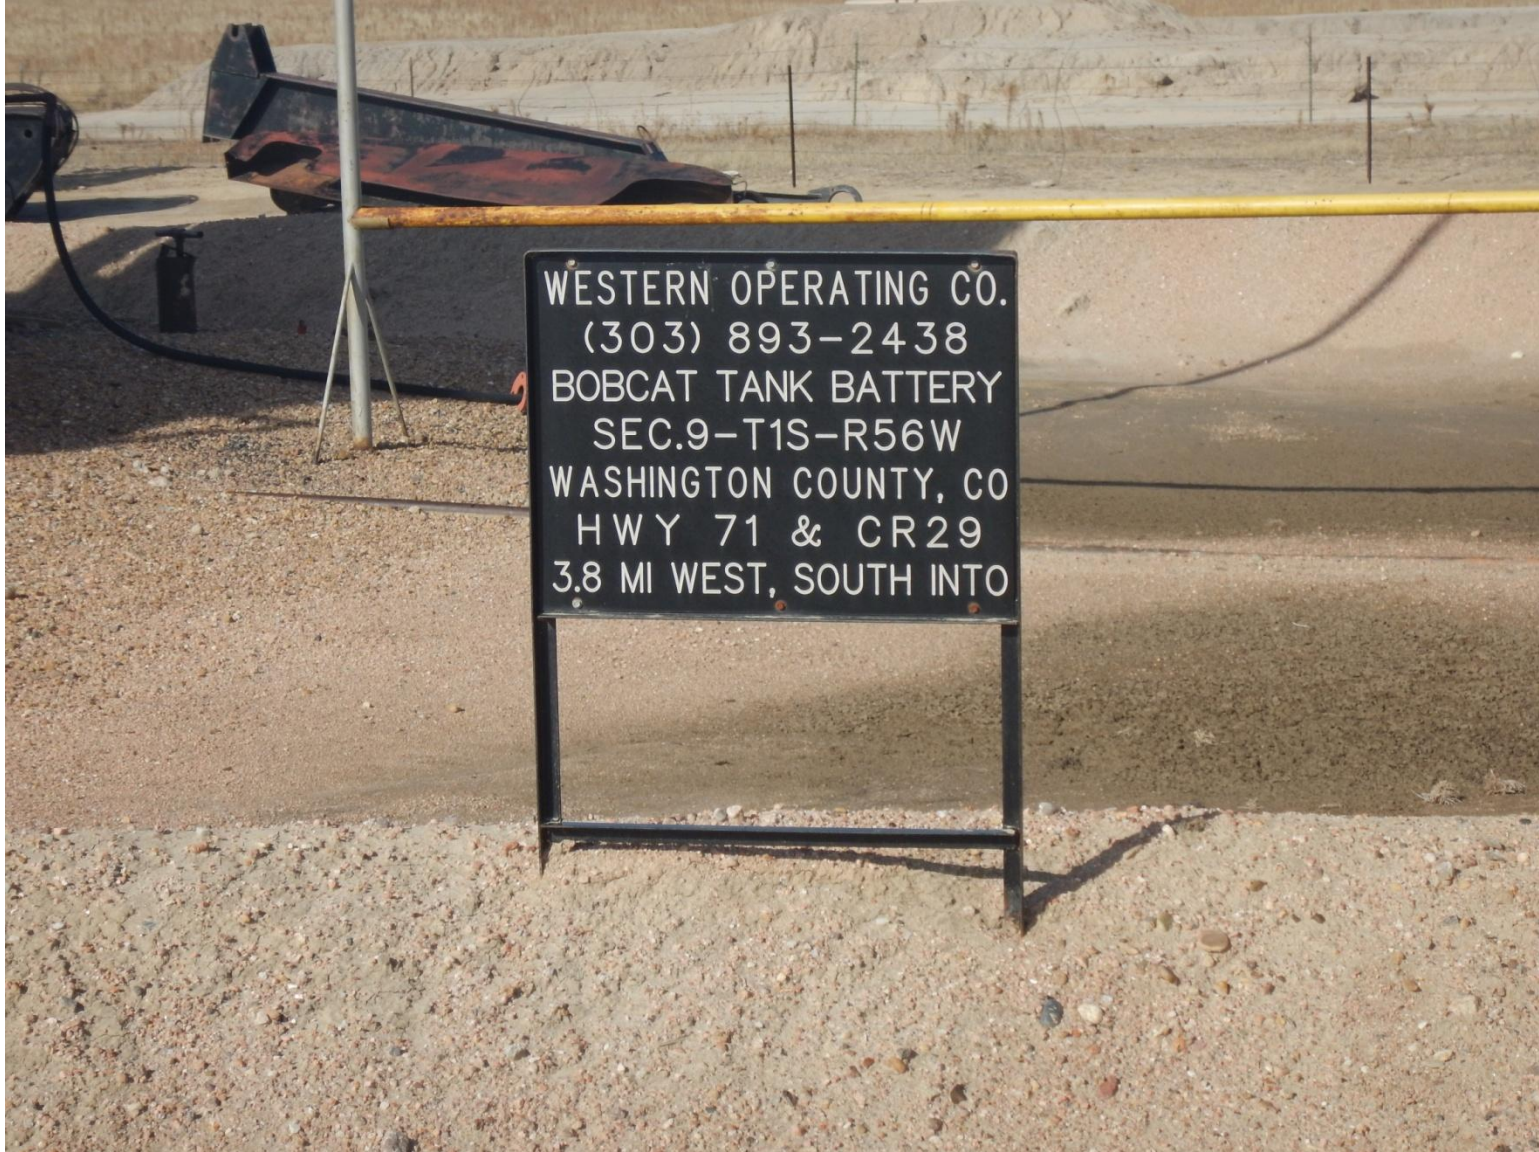
Photo 1: Photo of eastern battery sign.

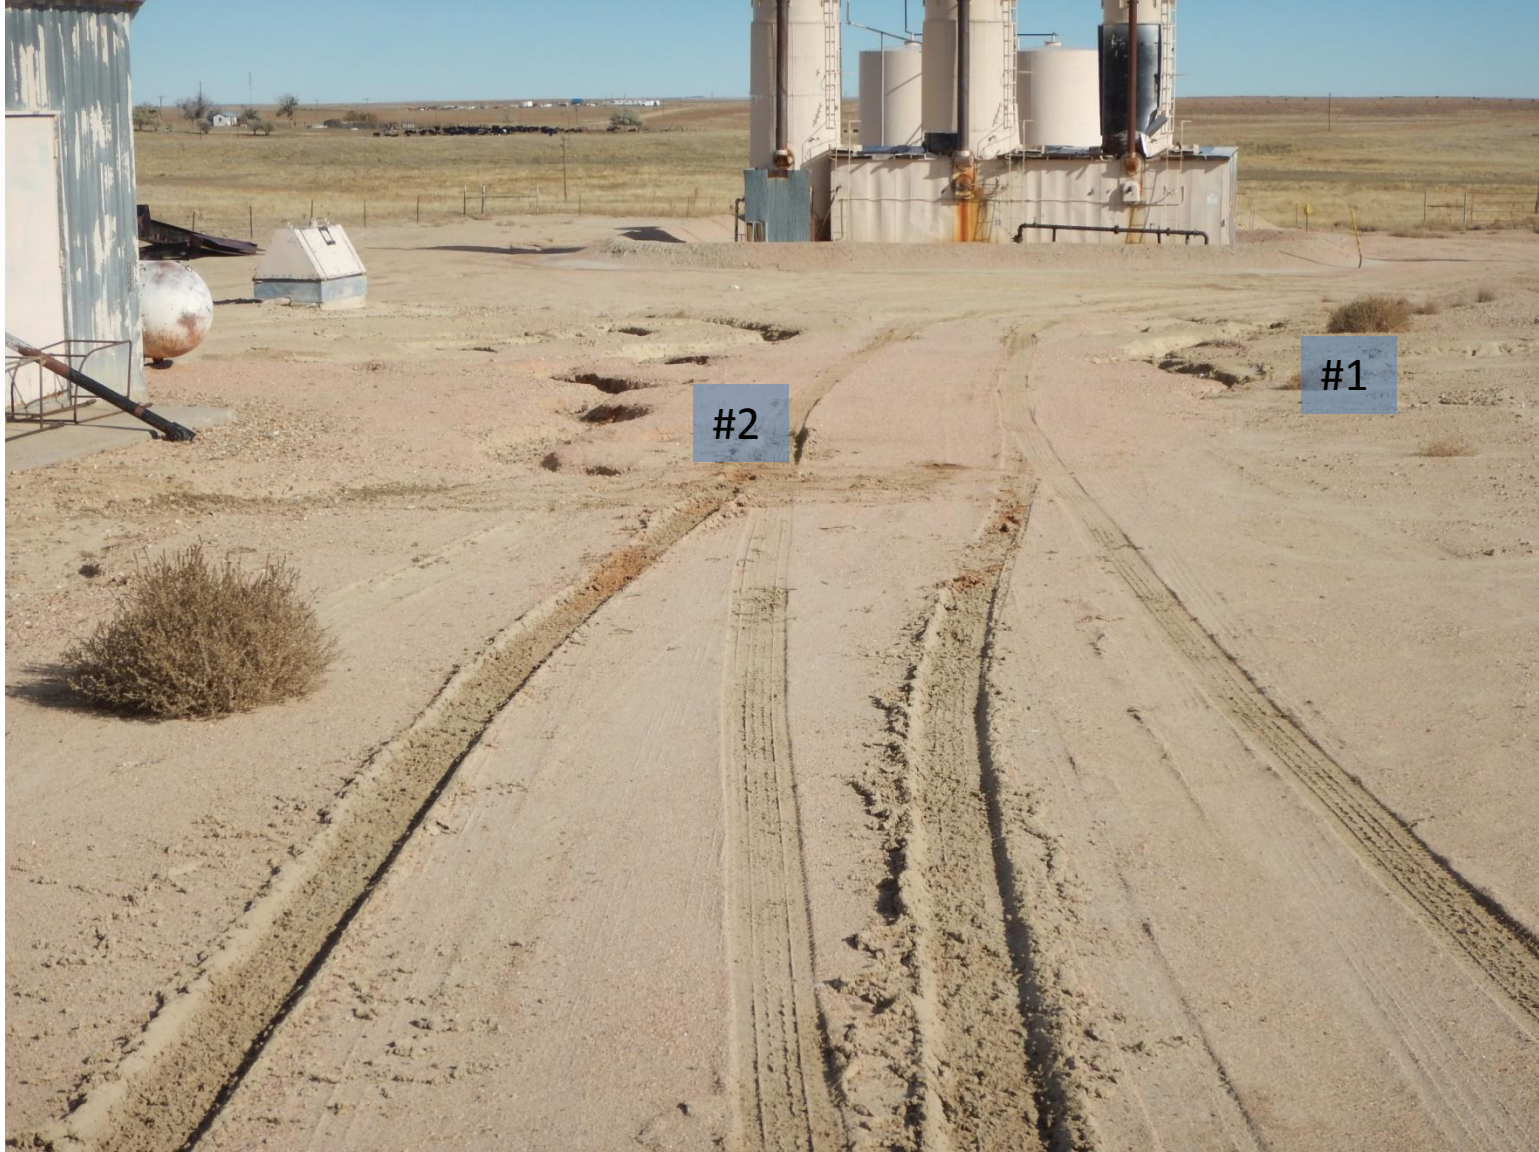
Photo 2: Photo taken from southwestern end of location, facing east. Note the erosion in center-right and center-left of photo forming stormwater erosion channels #1 and #2.

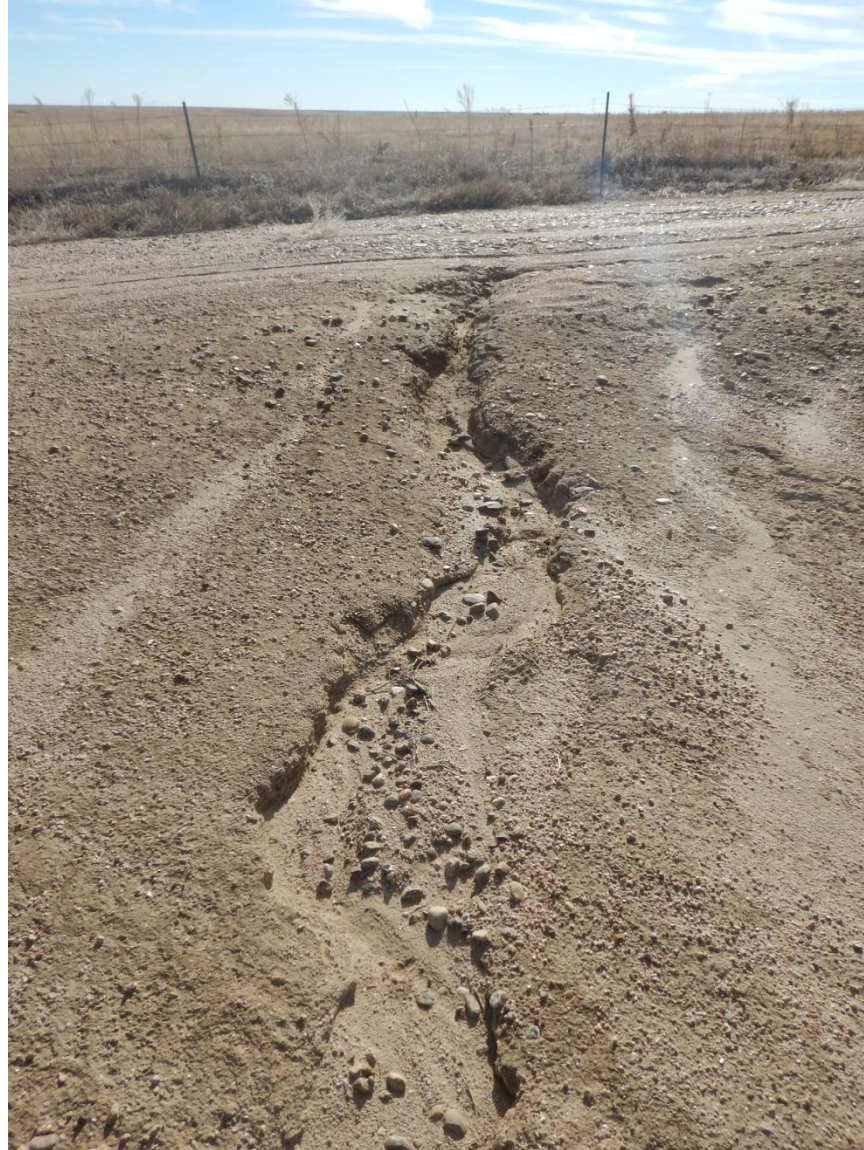
Photo 3: Photo taken on southern end of location. Photo of rill erosion.

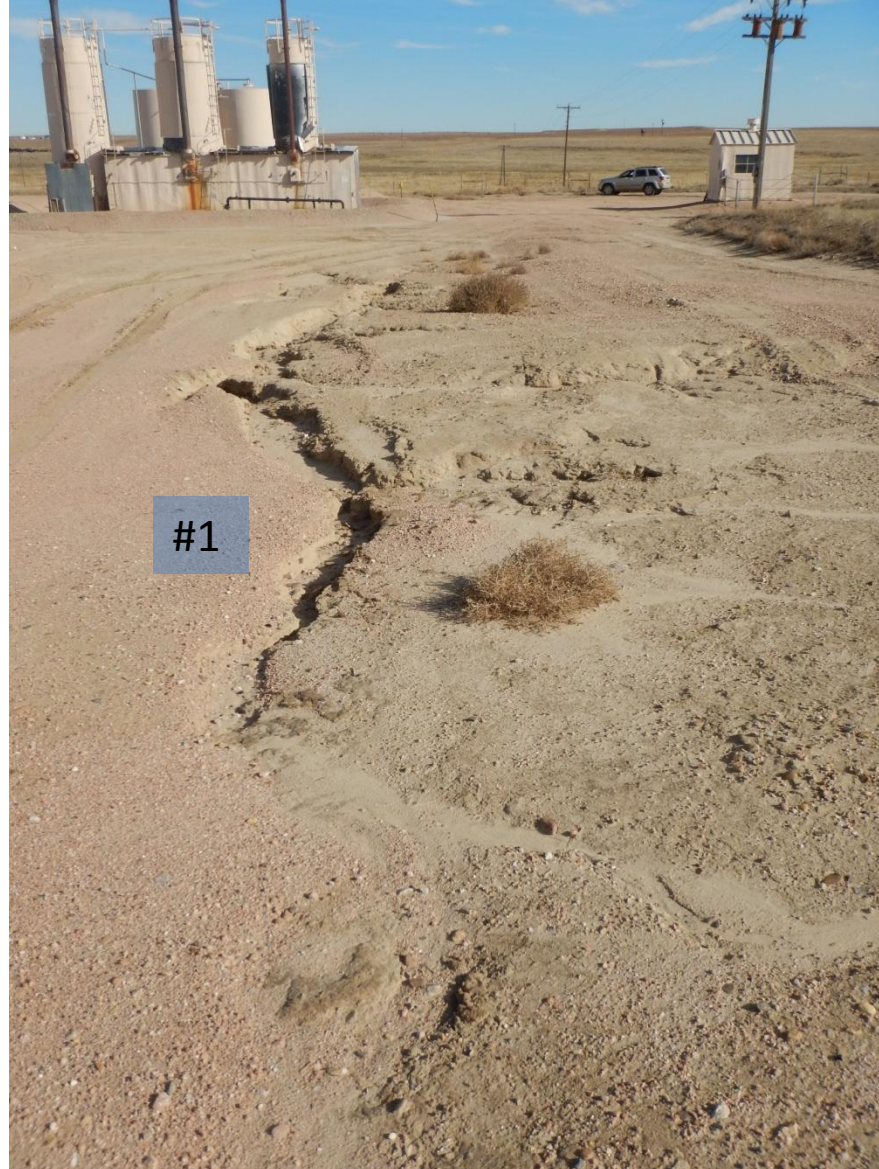
Photo 4: Photo taken from southern end of location, facing east. Note the rill erosion forming stormwater erosion channel #1.

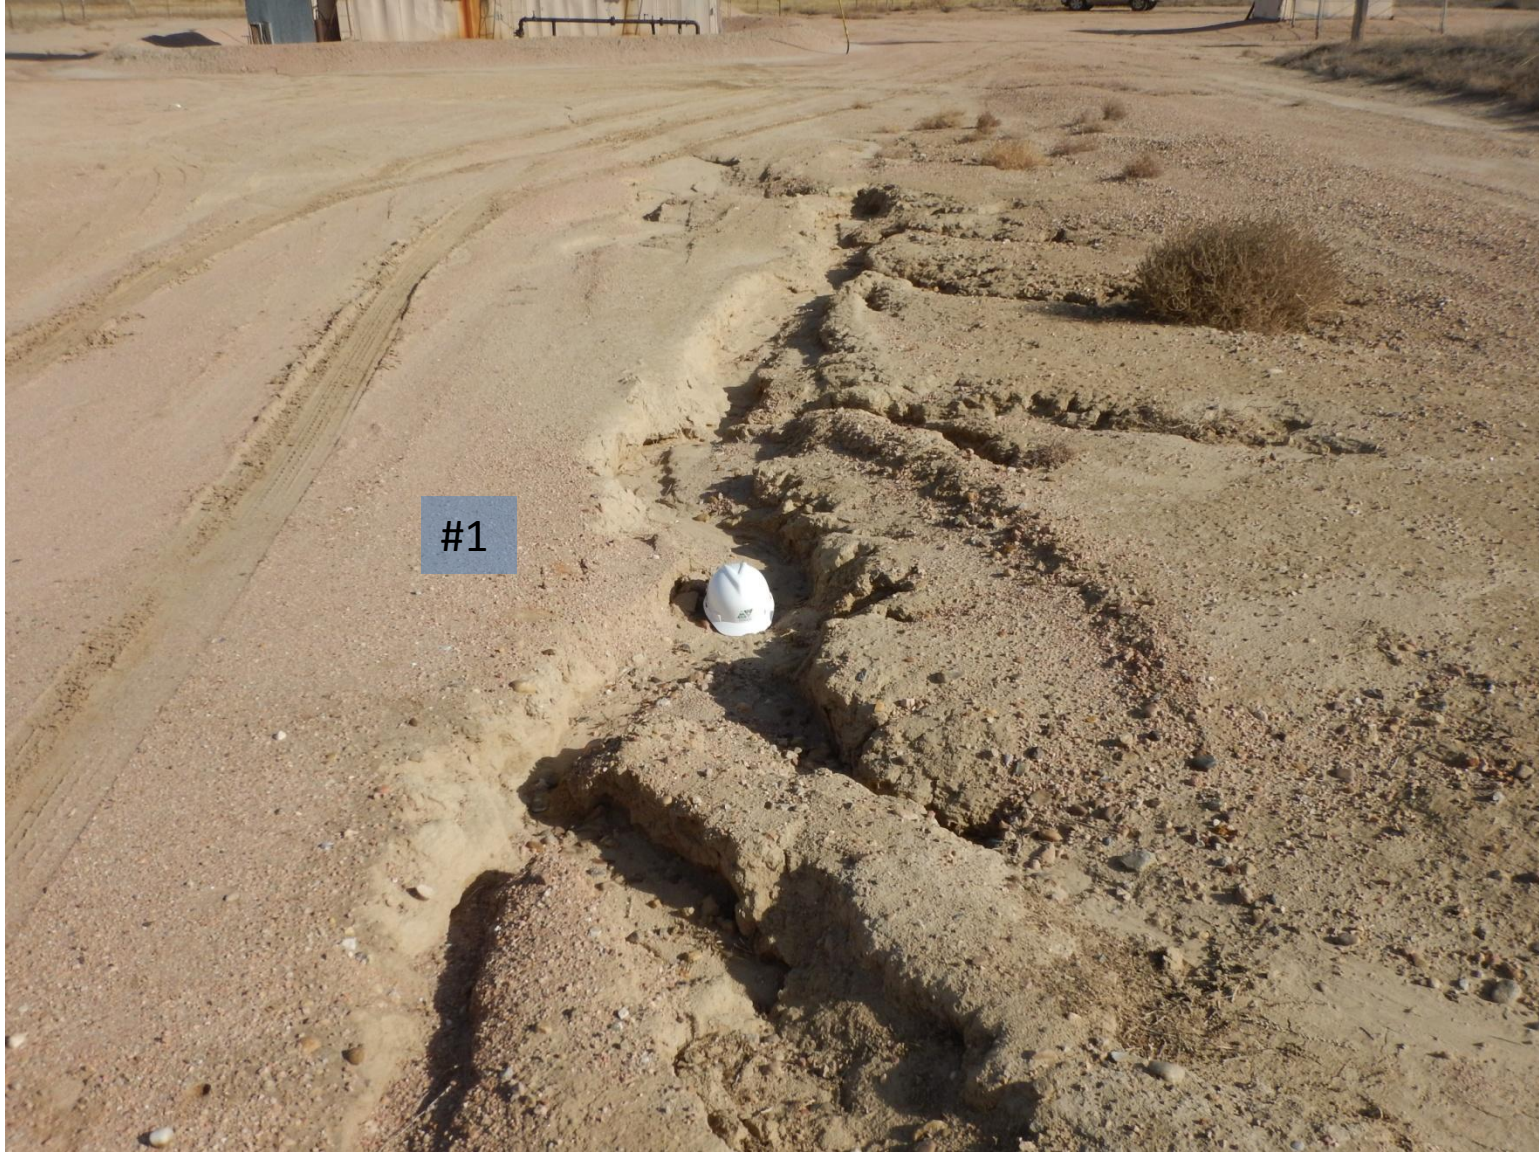
Photo 5: Photo taken from southern end of location, facing east. Note the rill erosion forming stormwater erosion channel #1.

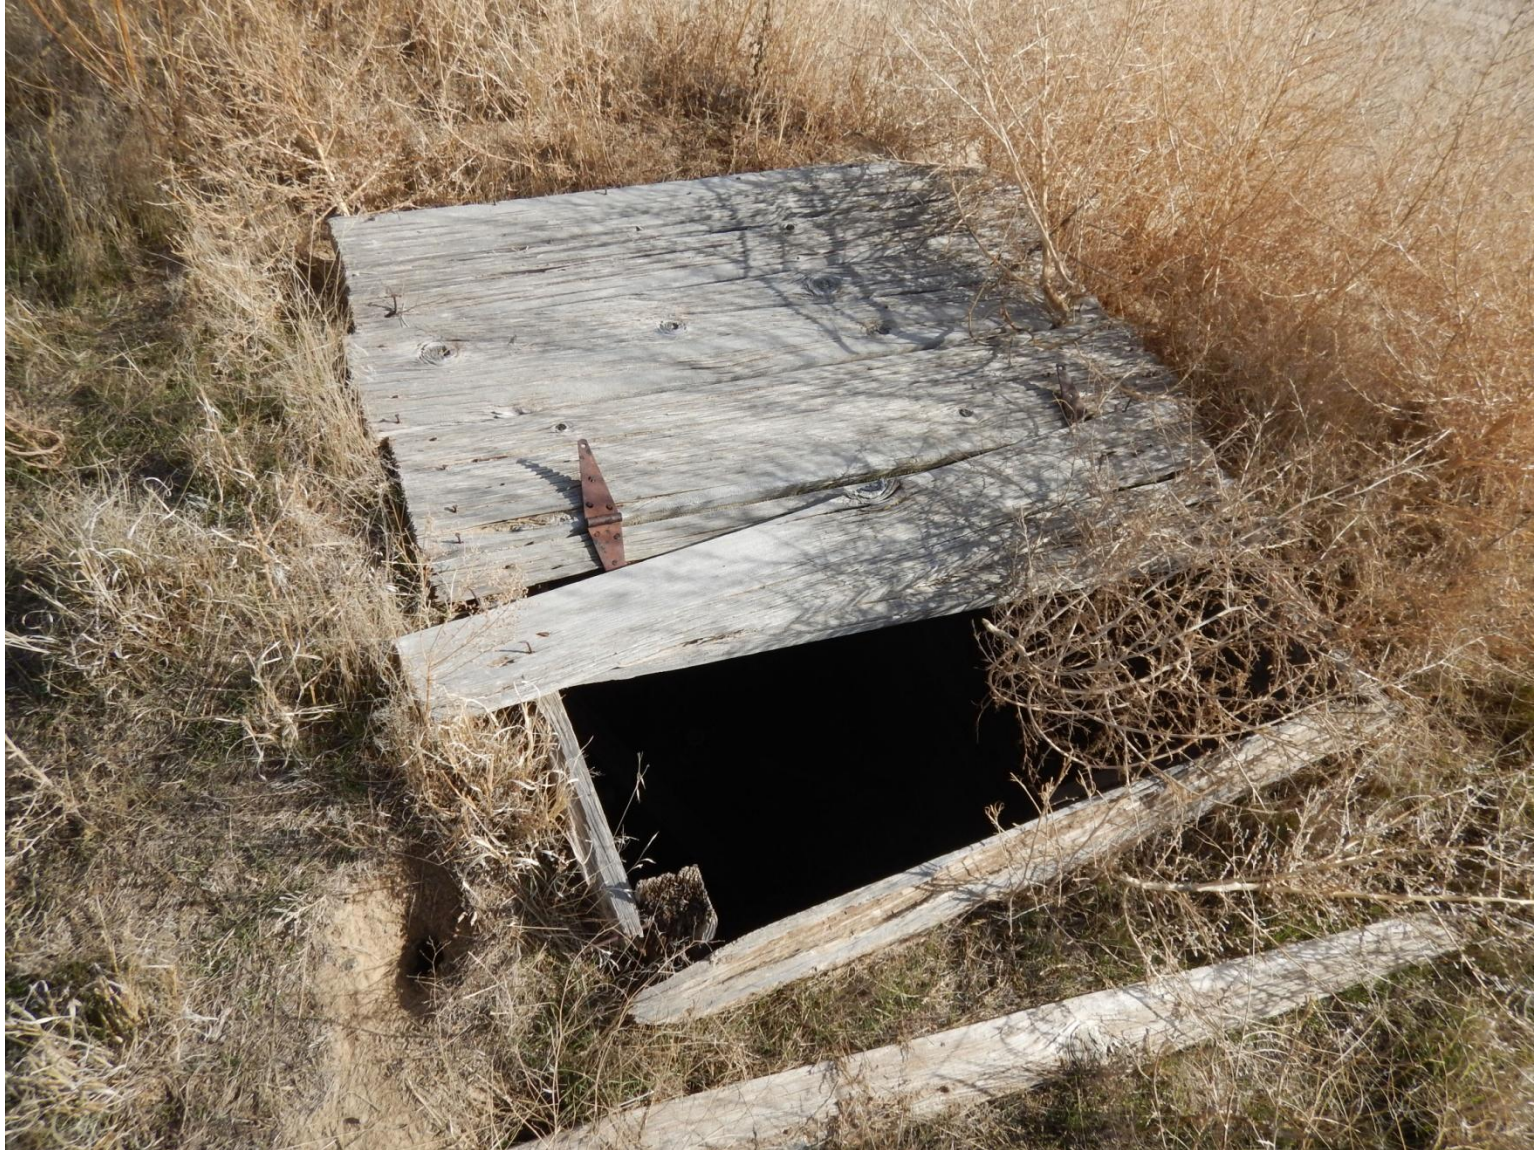
Photo 6: Photo taken from northwestern end of location. Photo of exposed wooden sub-surface structure.

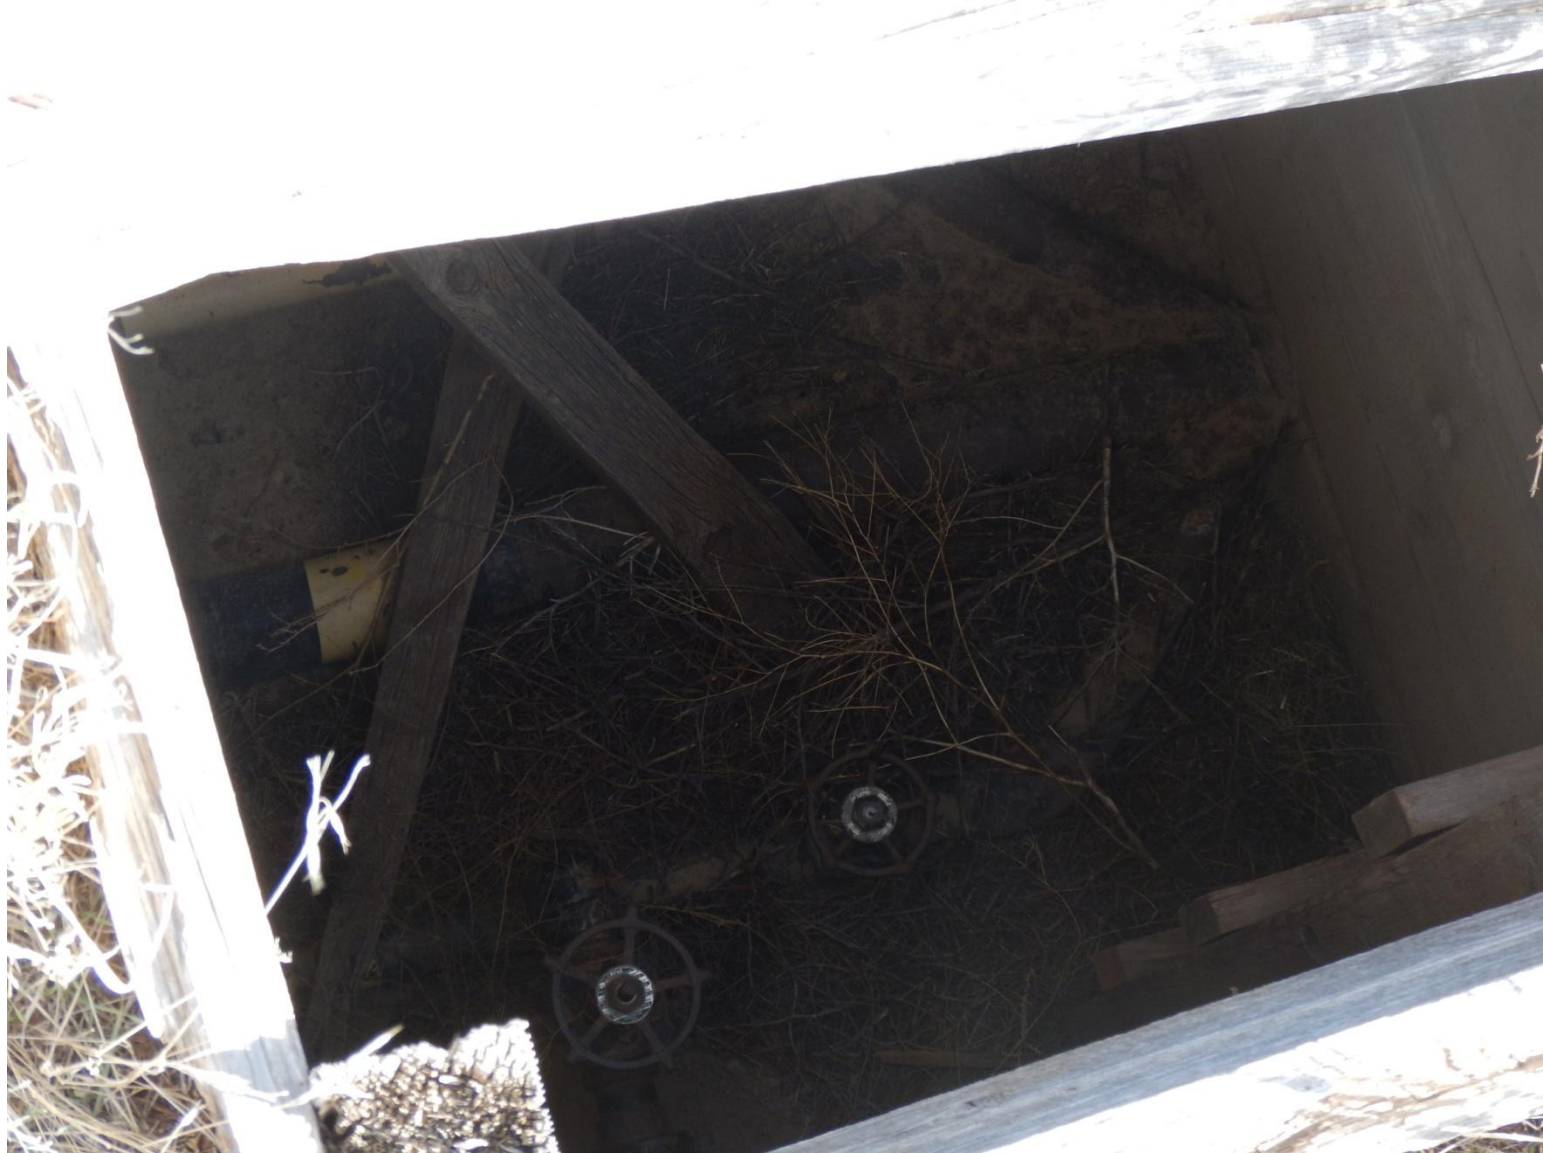
Photo 7: Photo of pipe and valves within exposed wooden sub-surface structure. This poses a hazard to wildlife and human safety.

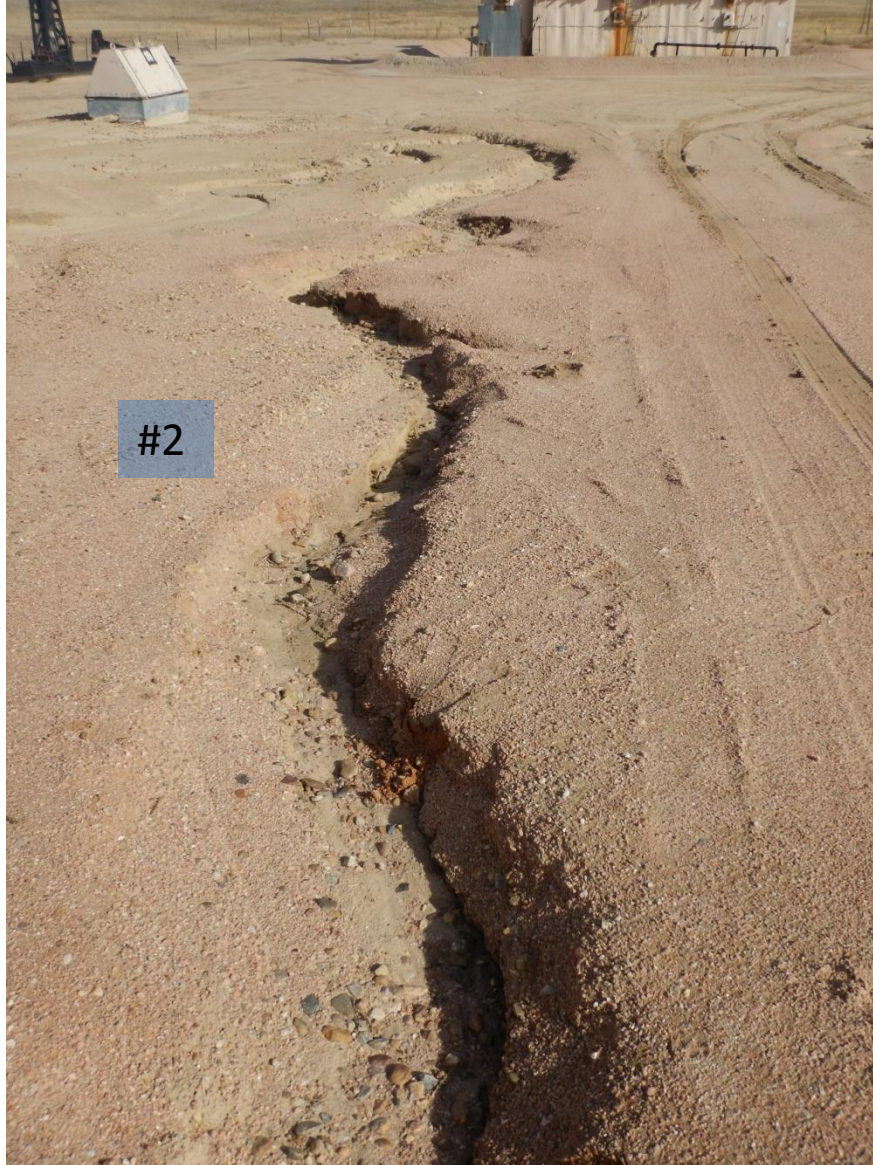
Photo 8: Photo taken from southwestern end of location facing east. Note erosion forming stormwater erosion channel #2.

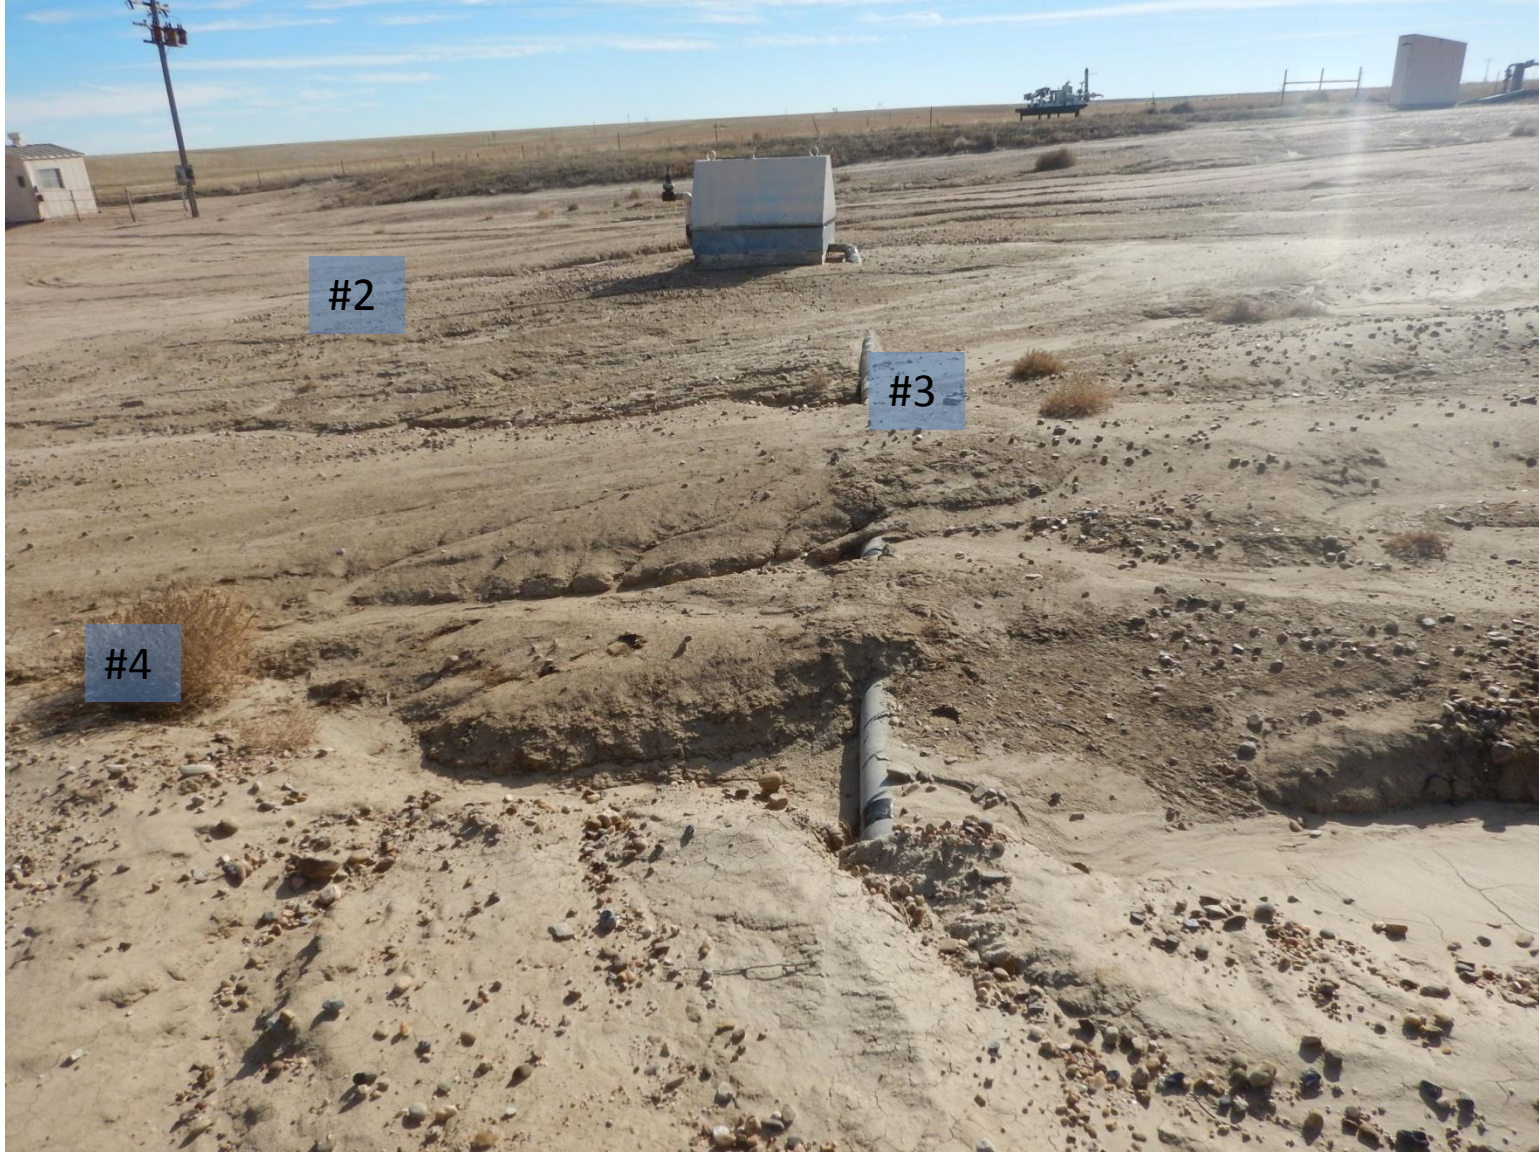
Photo 9: Photo taken from north end of location facing south. Photo of exposed pipe and stormwater erosion.

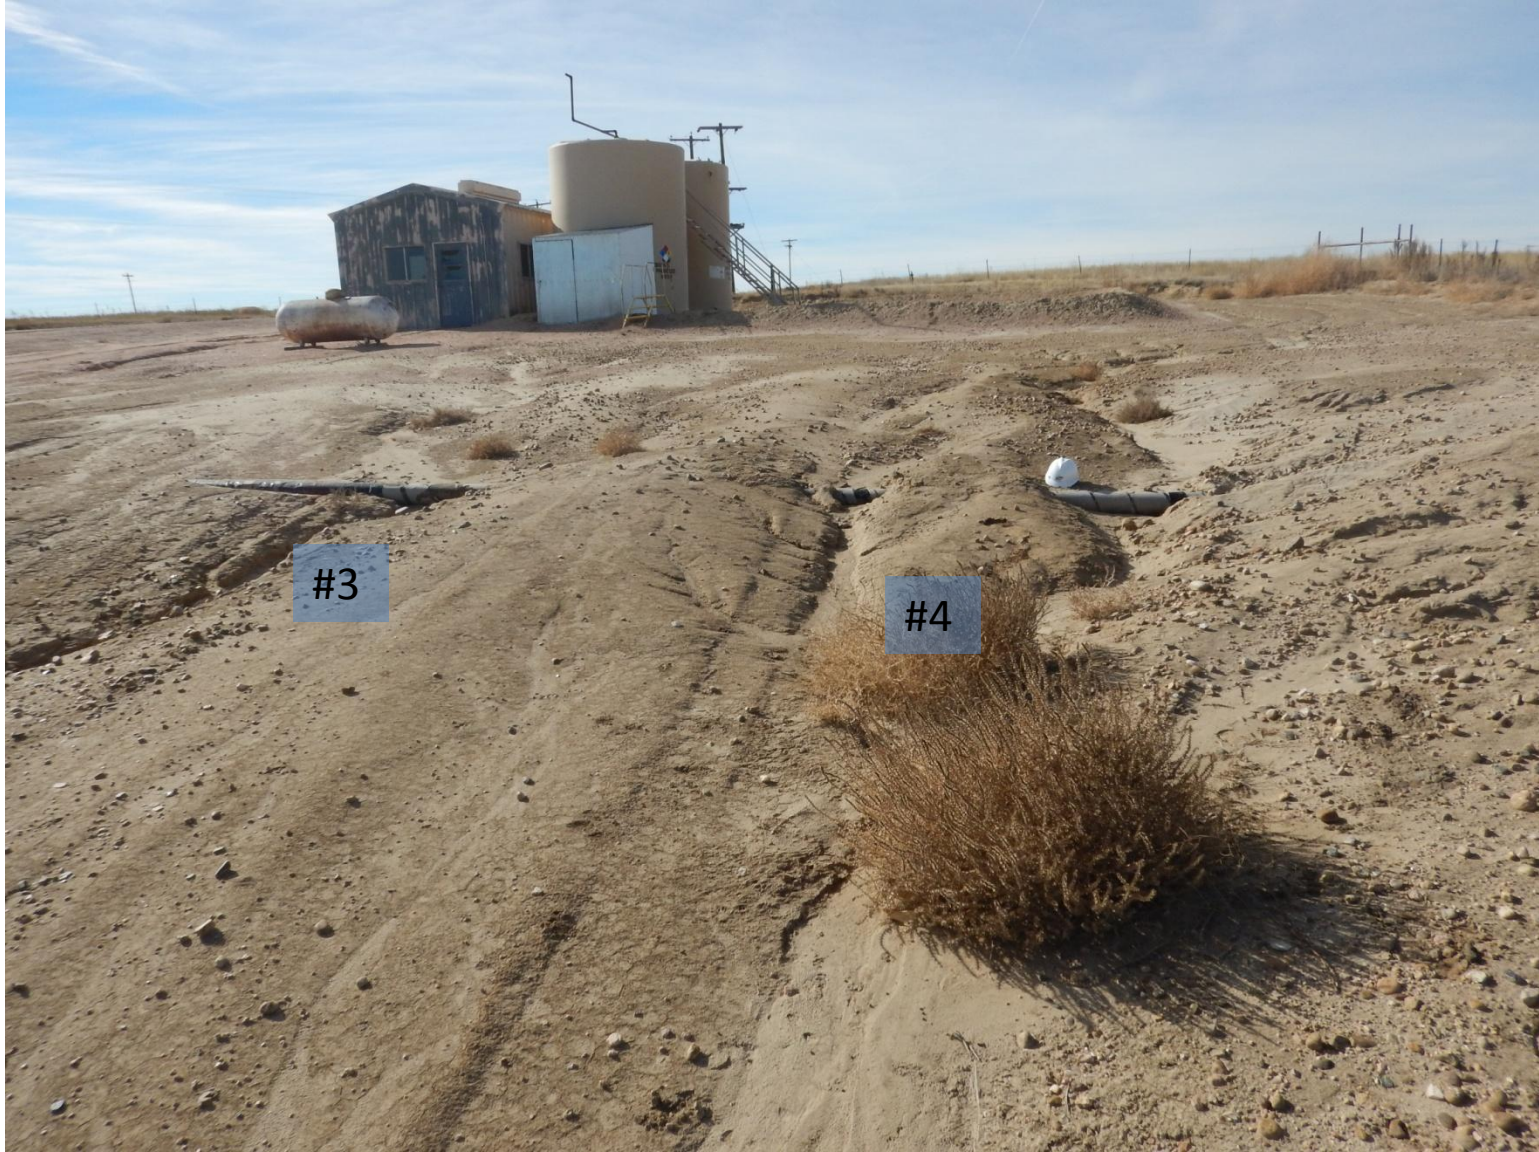
Photo 10: Photo taken from northern end of location facing west. Stormwater erosion channels #3 and #4 shown on northern half of location.

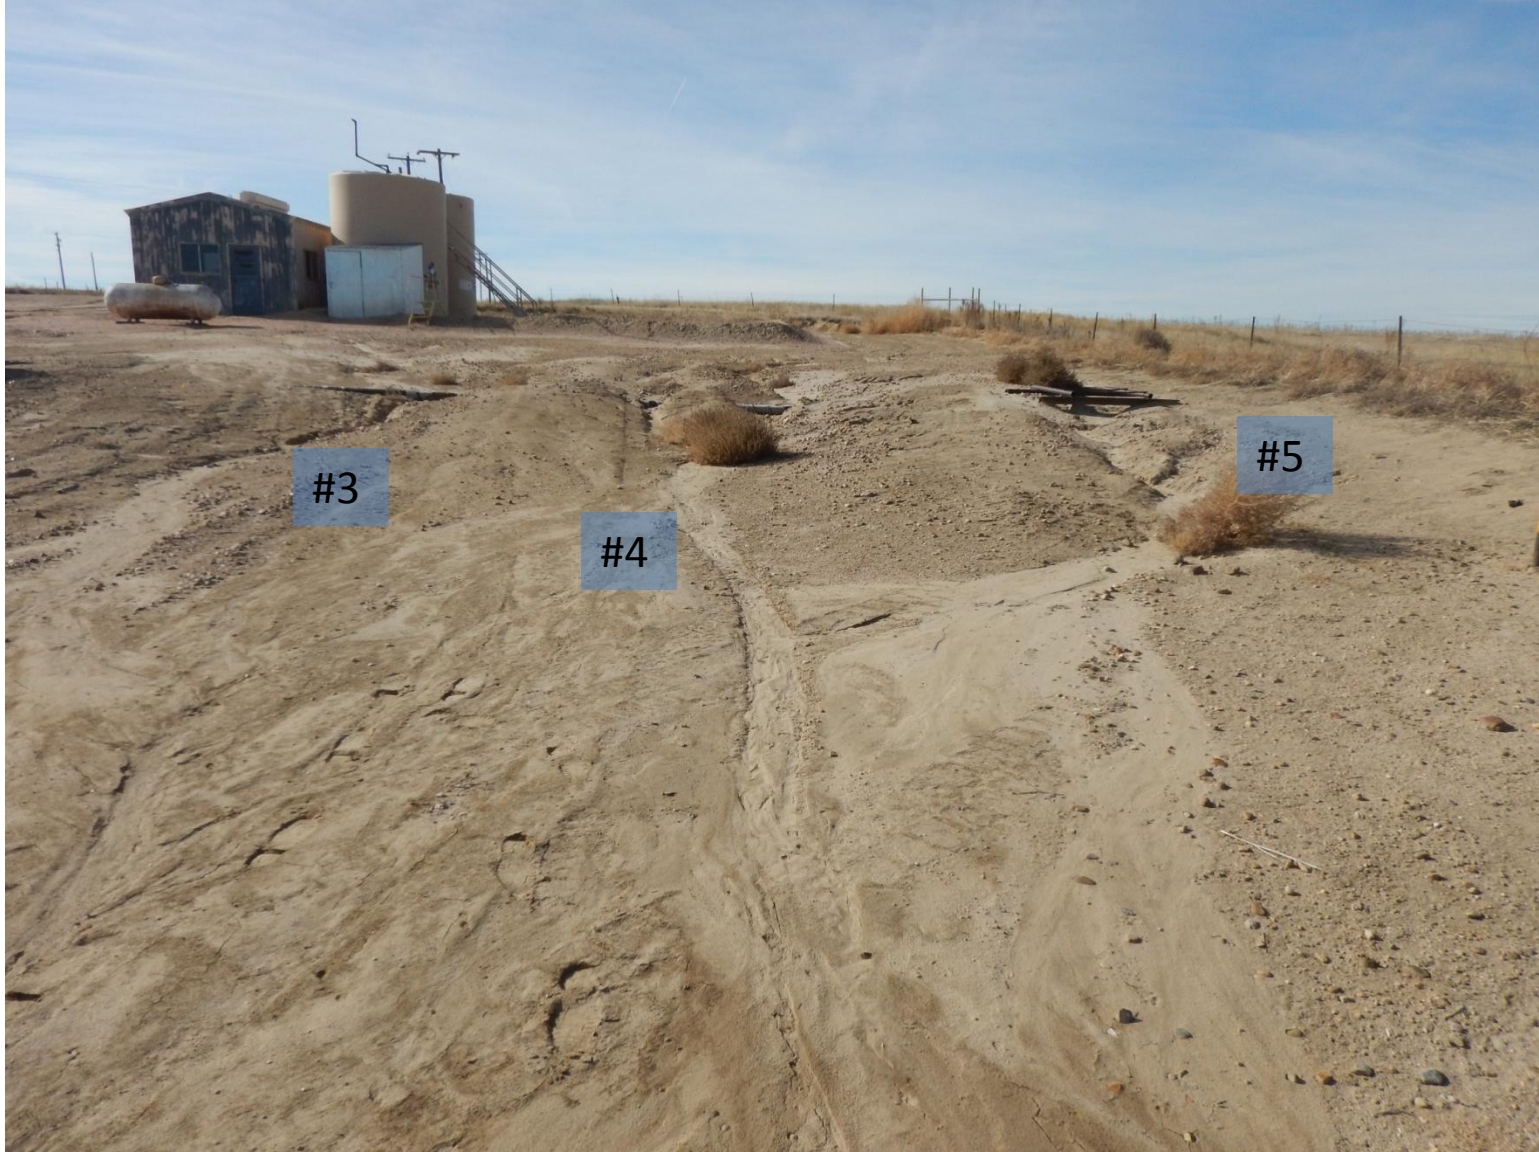
Photo 11: Photo taken from northern end of location facing west. Photo of stormwater erosion channels #3, #4, and #5 on northern half of location.

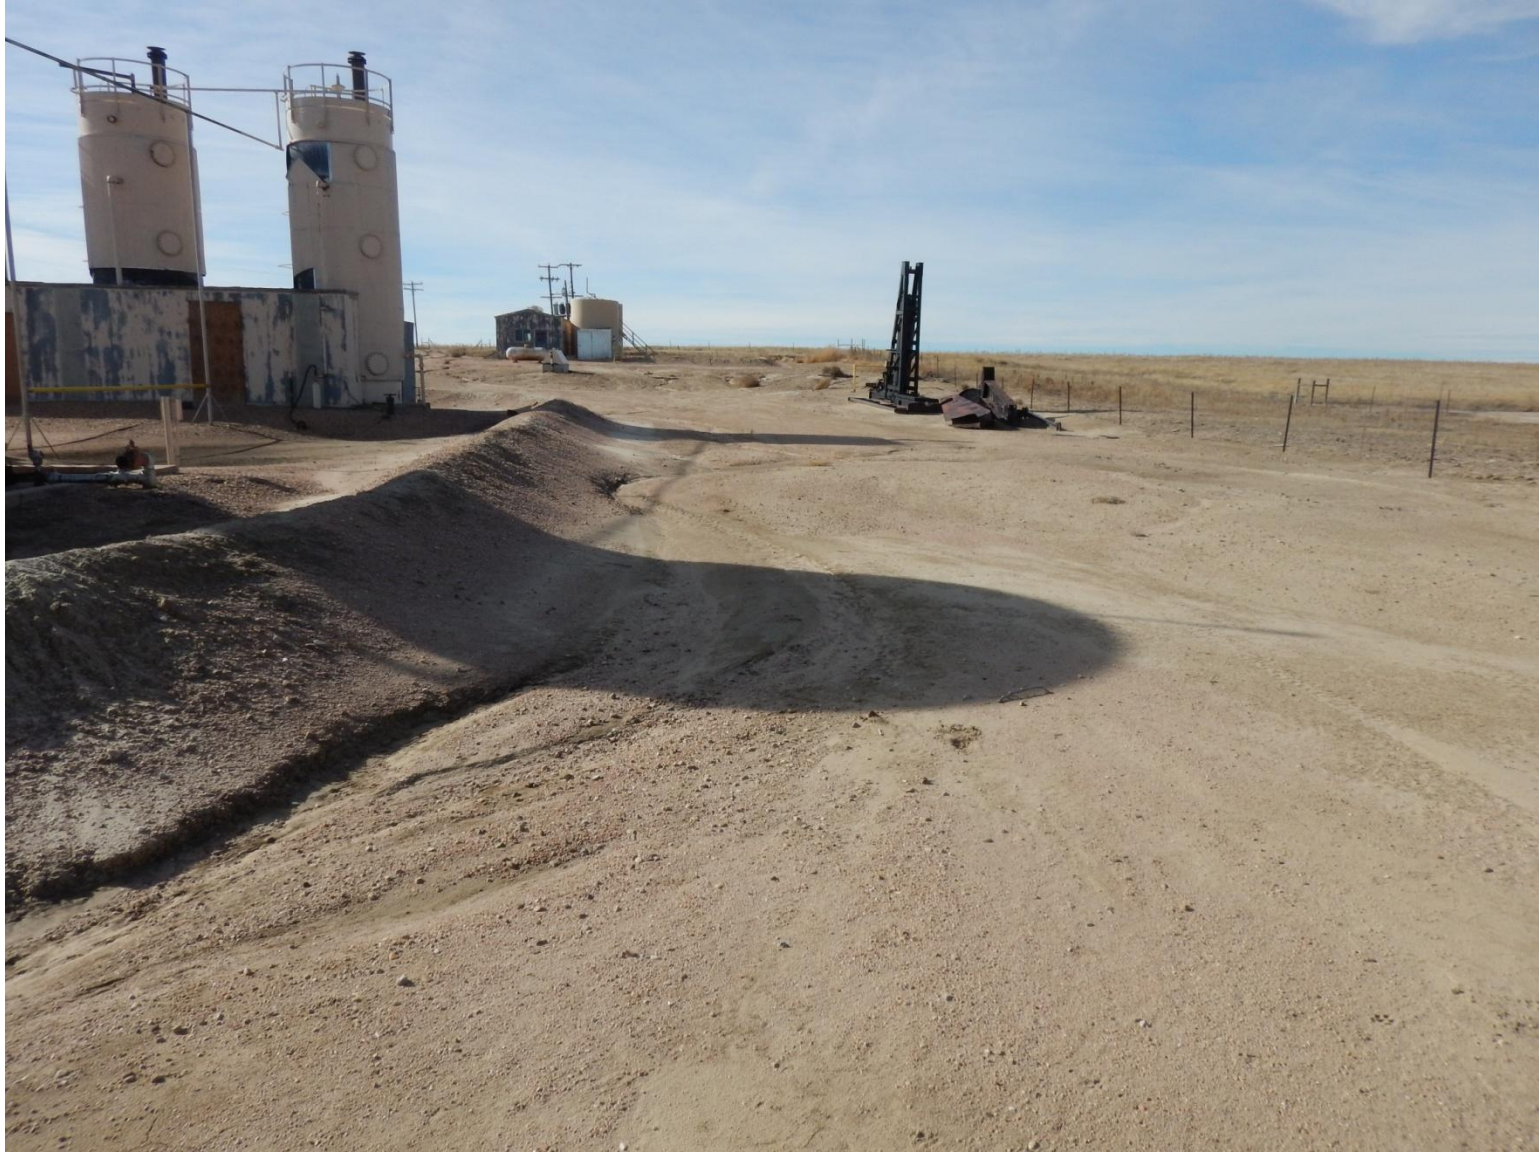
Photo 12: Photo taken from northeastern part of location, facing west. Photo of meander formed from stormwater.

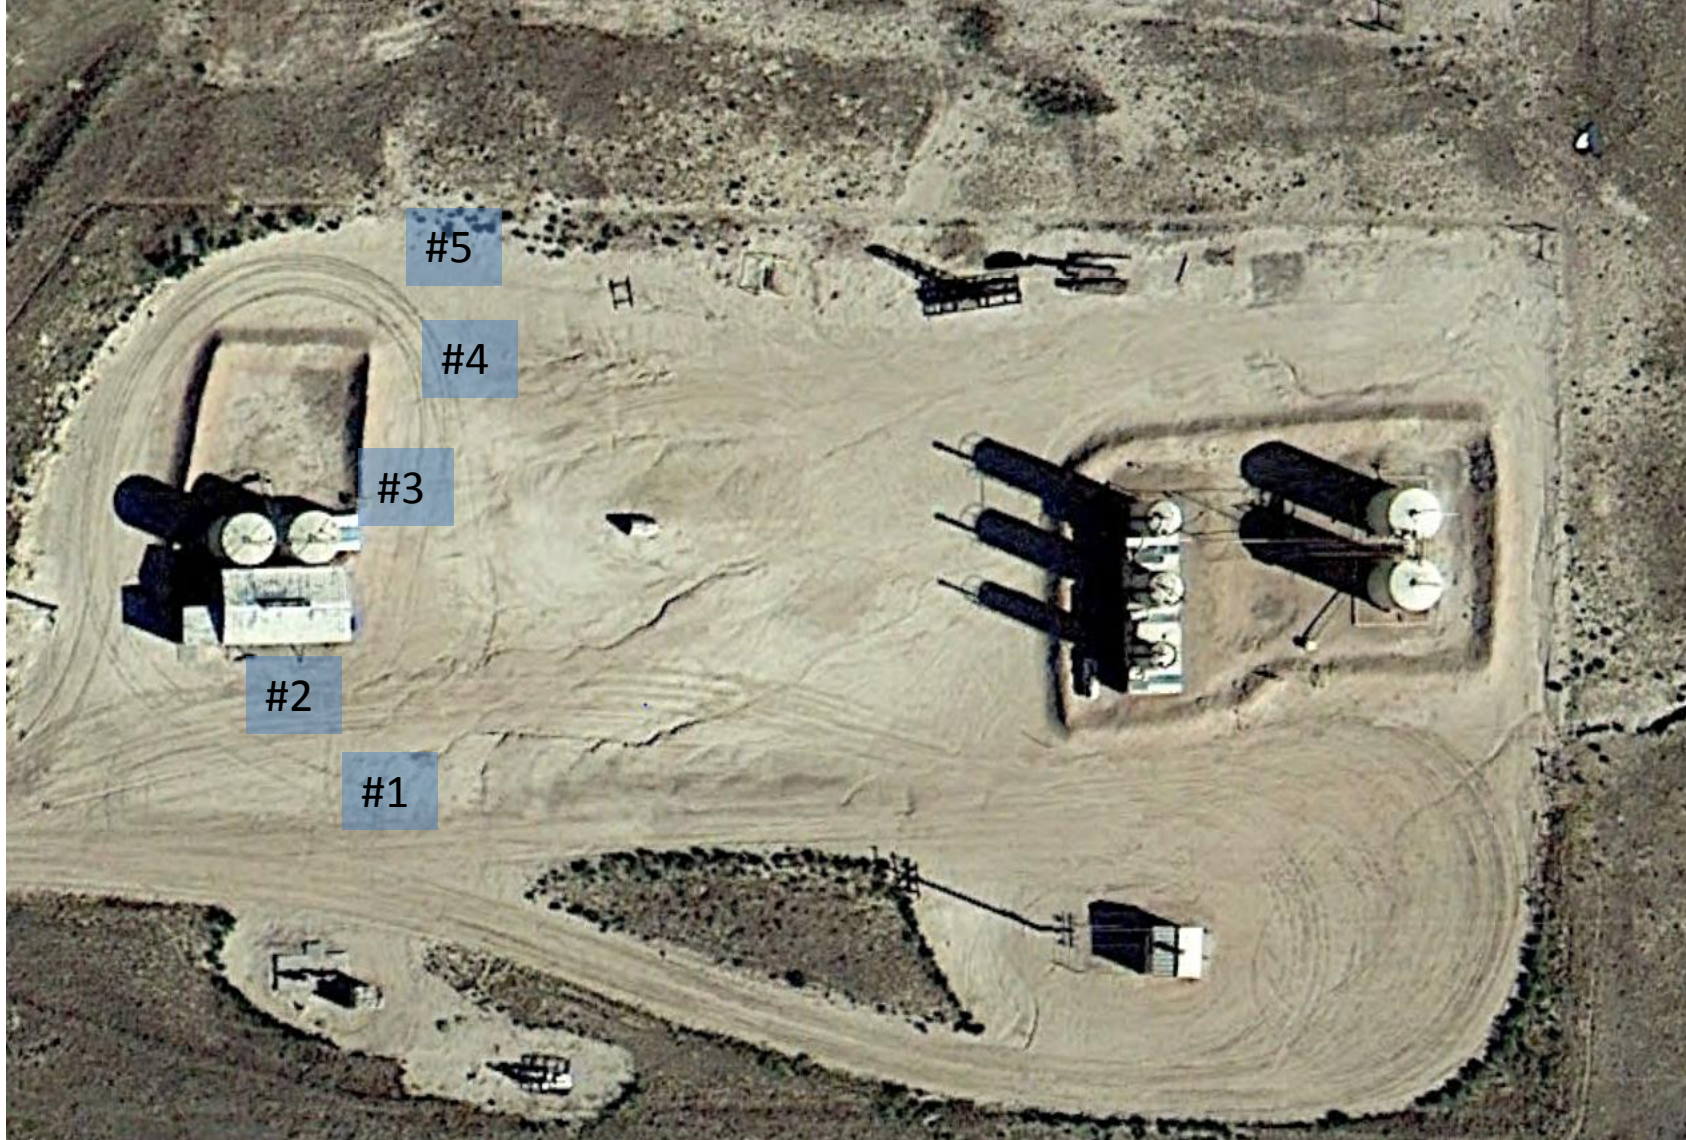
Photo 13: Aerial image date 09/2013. Image showing erosion channels on location.

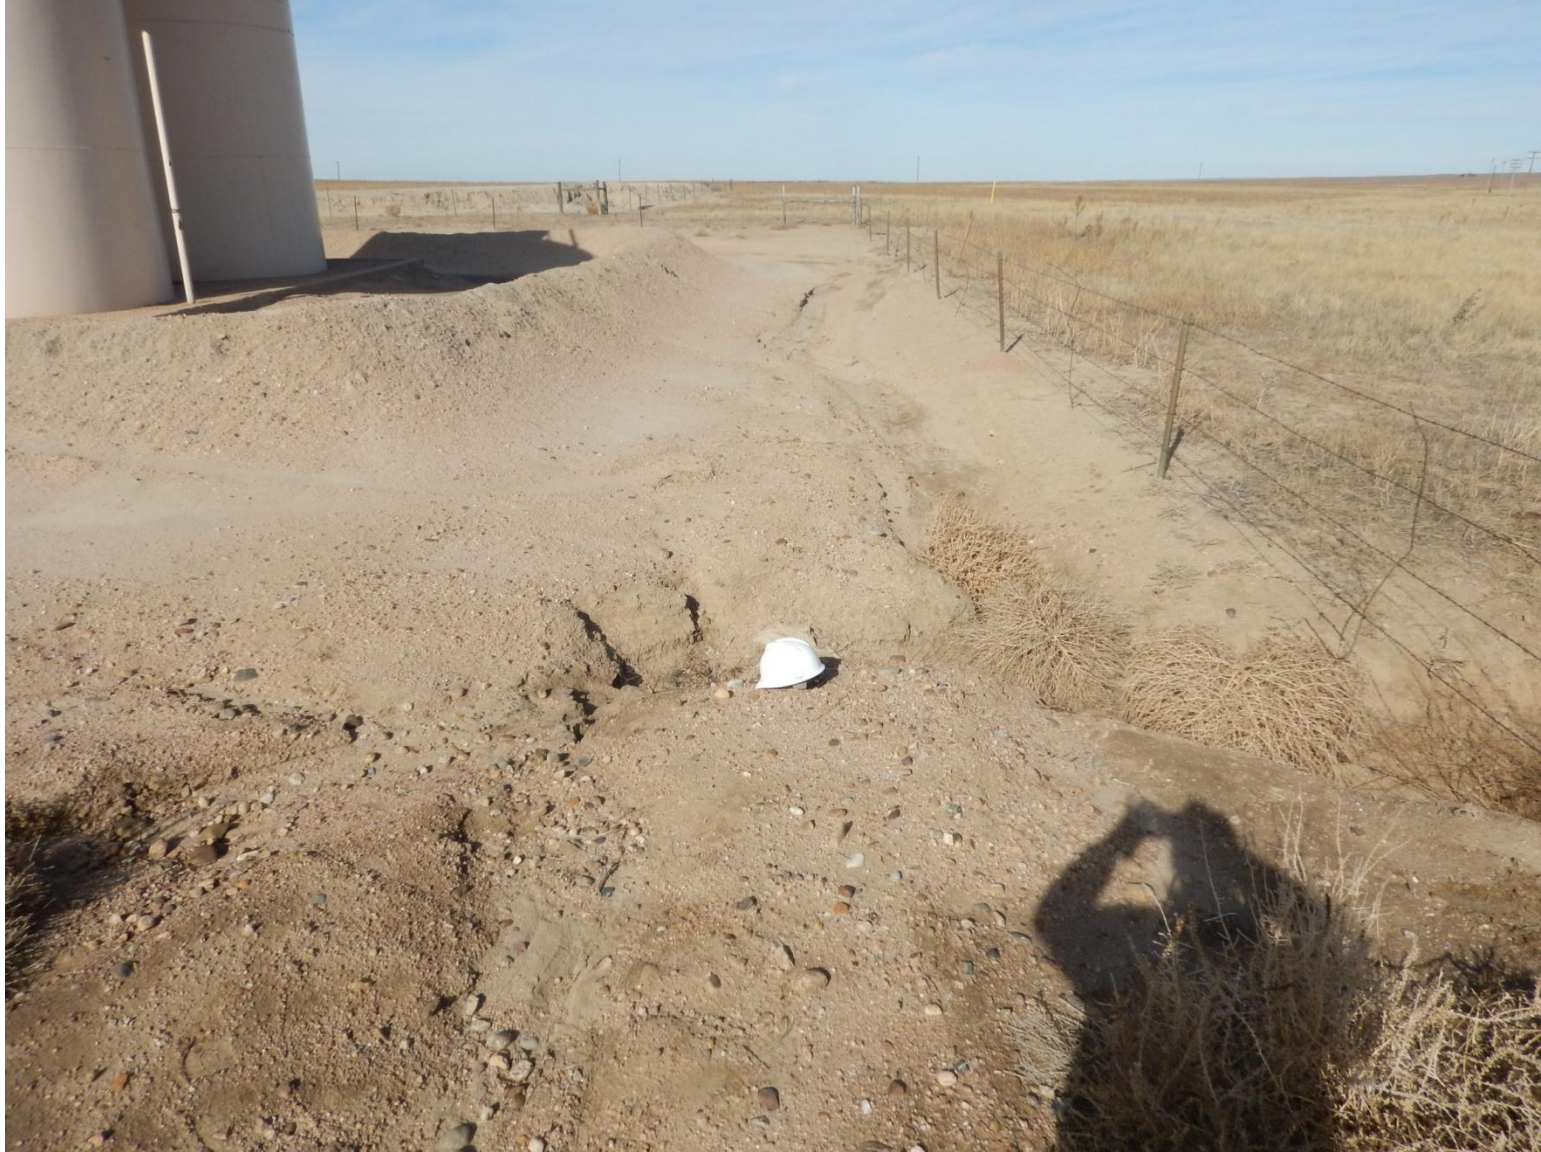
Photo 14: Photo taken from east end of location facing north. Photo shows confluence of storm water erosion channels from northern and southern halves of location.
