Loc. ID 435387- Reclamation and Stormwater Inspection

Loc. ID 435387- Reclamation Inspection

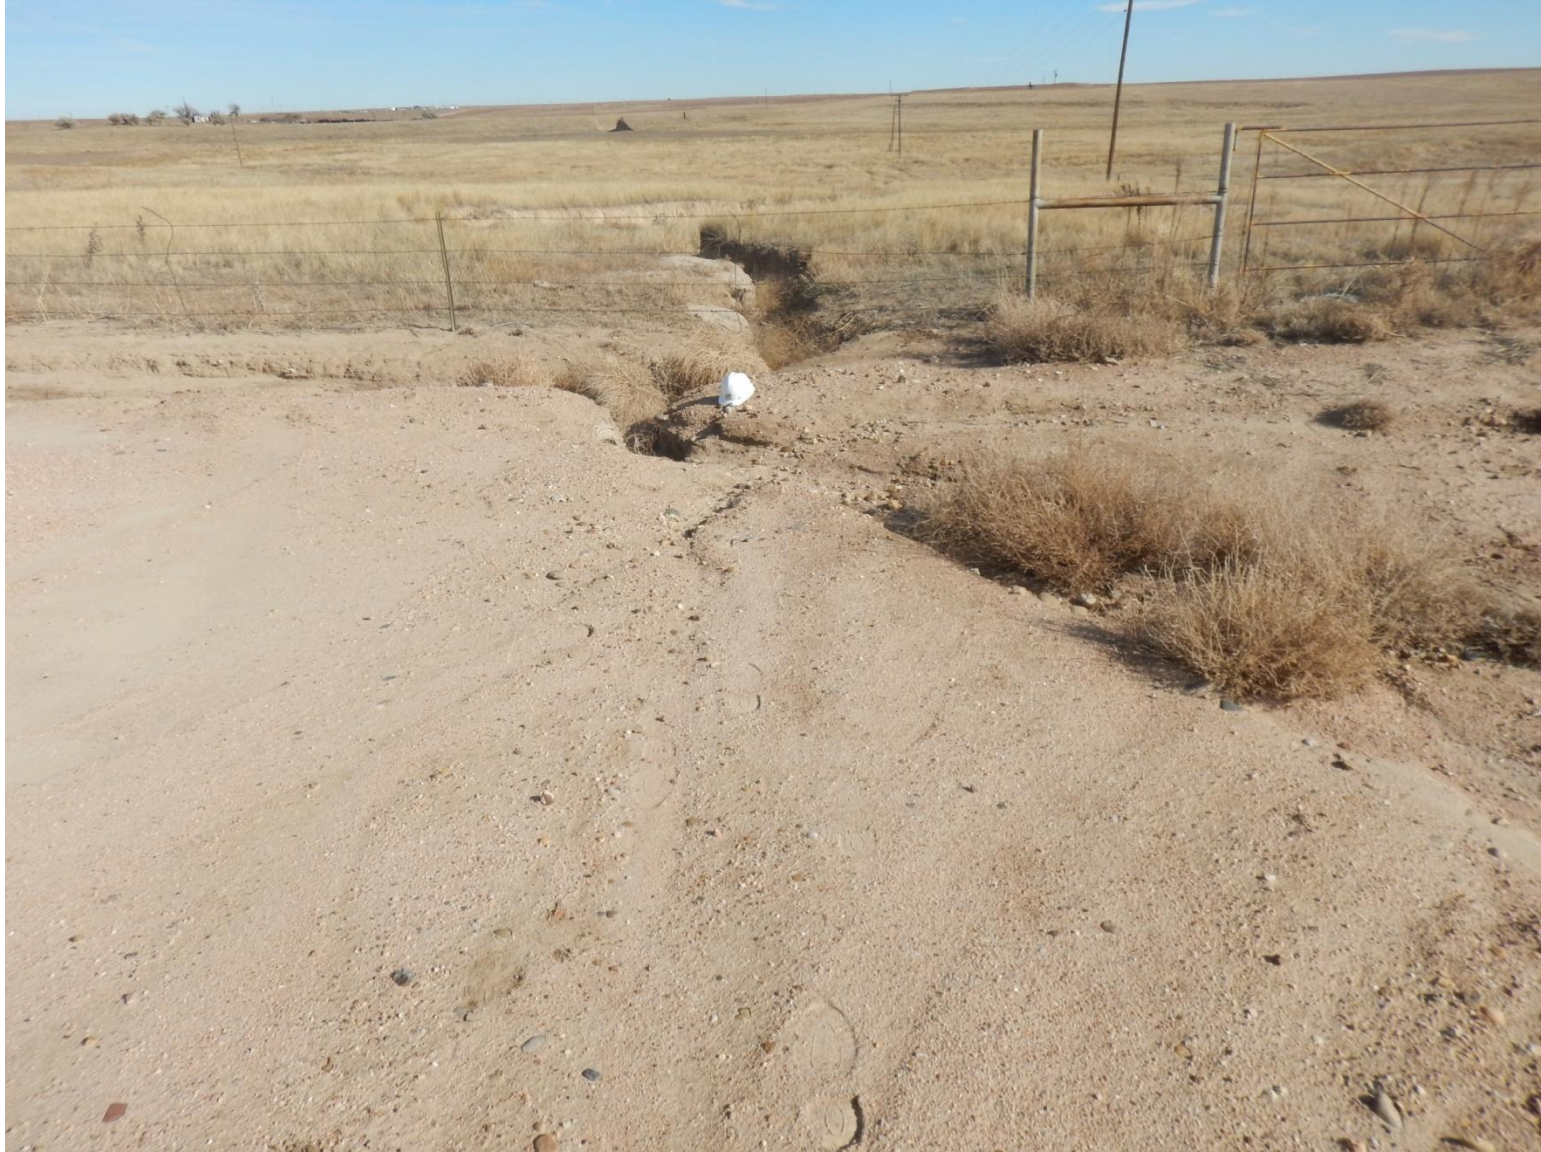
Photo 15: Photo taken from east end of location, facing east. Photo shows confluence of storm water erosion channels from northern and southern halves of location, leading off location

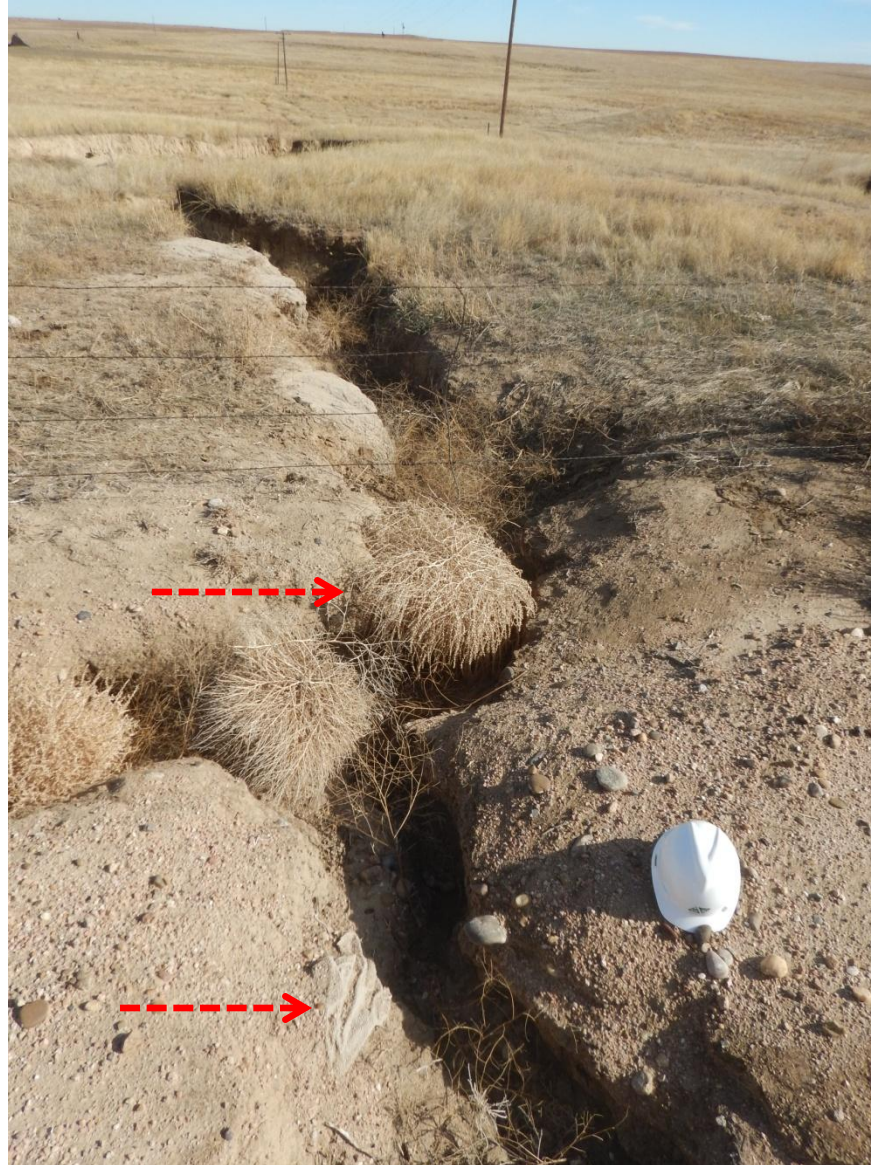
Photo 16: Photo taken from east end of location, facing east. Photo of gully on and off location area. Note vegetative and trash debris indicated with arrow. Trash appears to be cloth material.

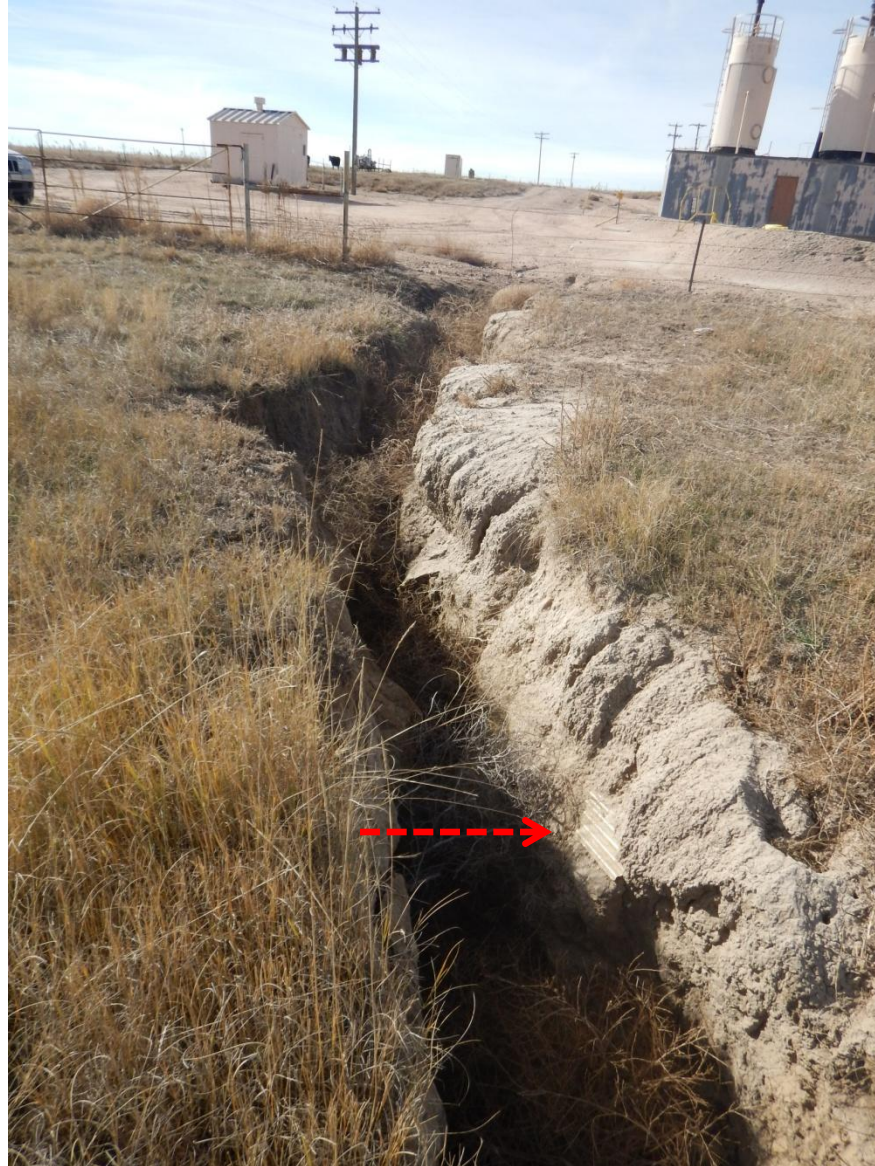
Photo 17: Photo taken east of location facing west towards location. Photo of gully. Note trash debris indicated with arrow. Trash debris appears to be metal panel.

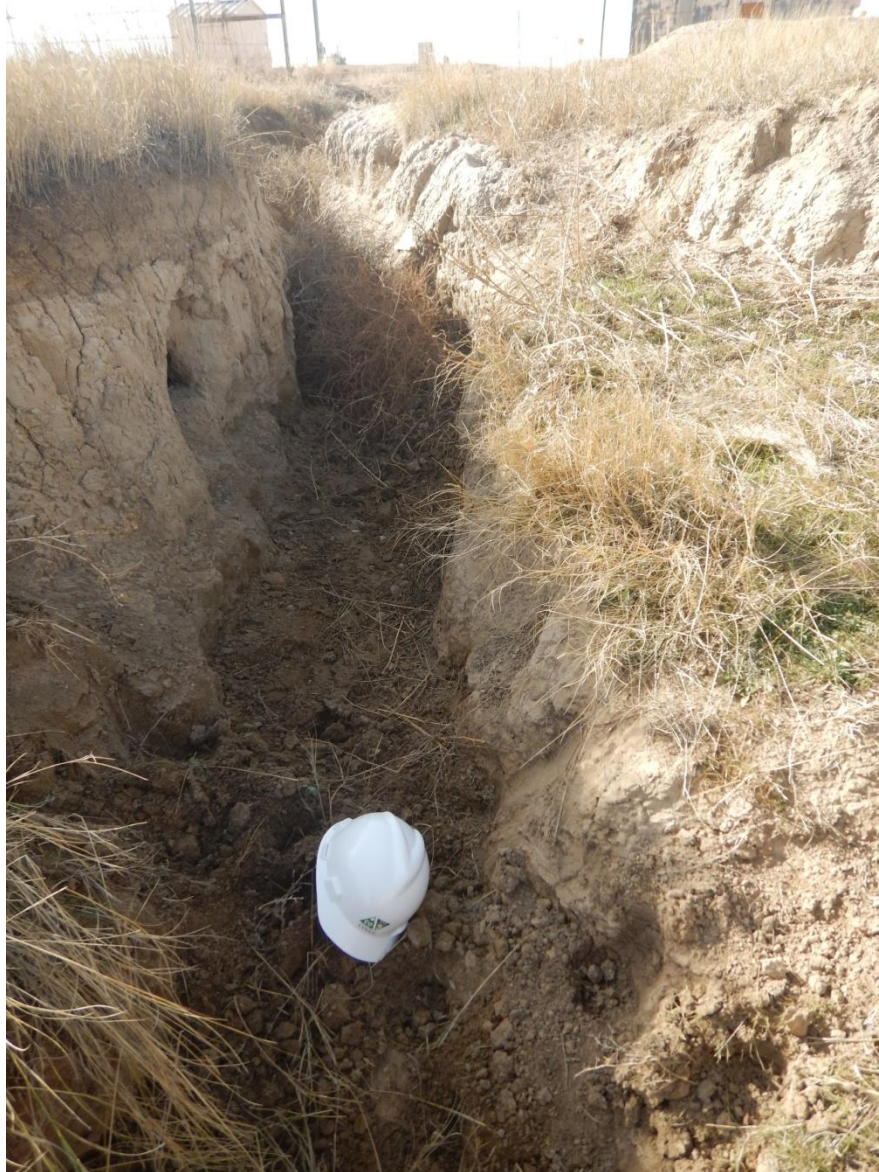
Photo 18: Photo taken east of location facing west towards location. Photo of gully and sediment.

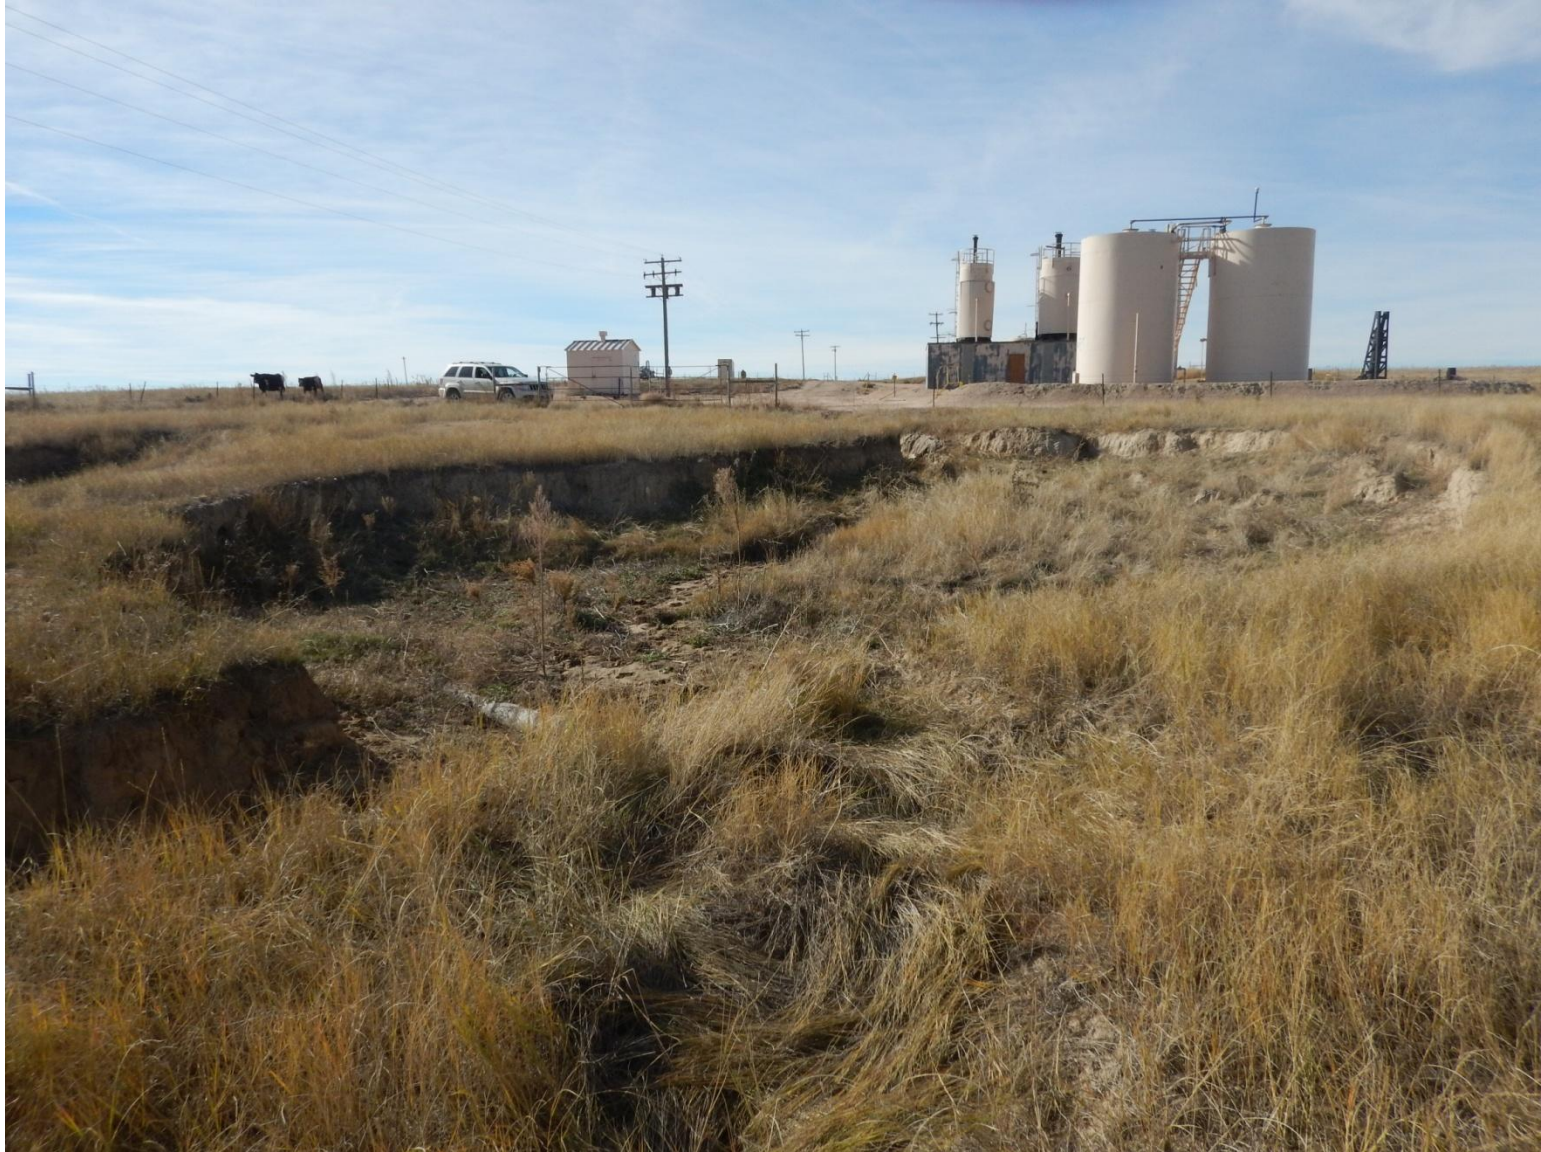
Photo 19: Photo taken east of location facing west towards location. Photo of “washed out”, eroded area.

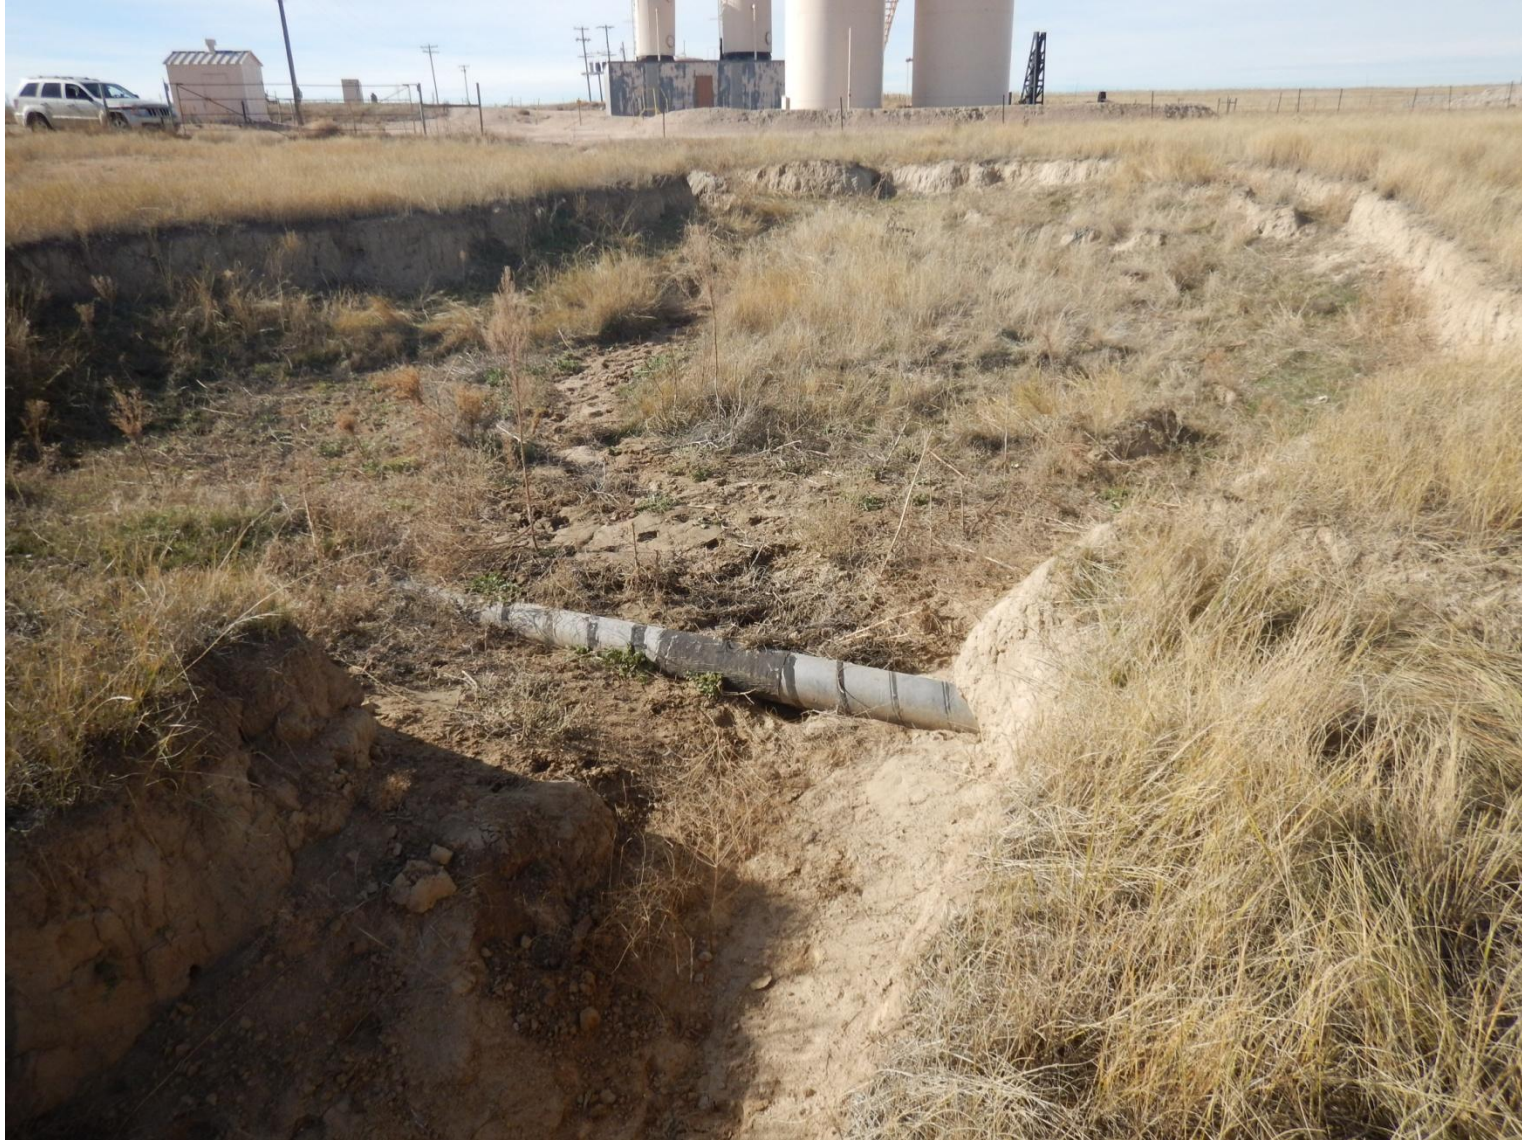
Photo 20: Photo taken east of location facing west towards location. Photo of exposed pipeline.

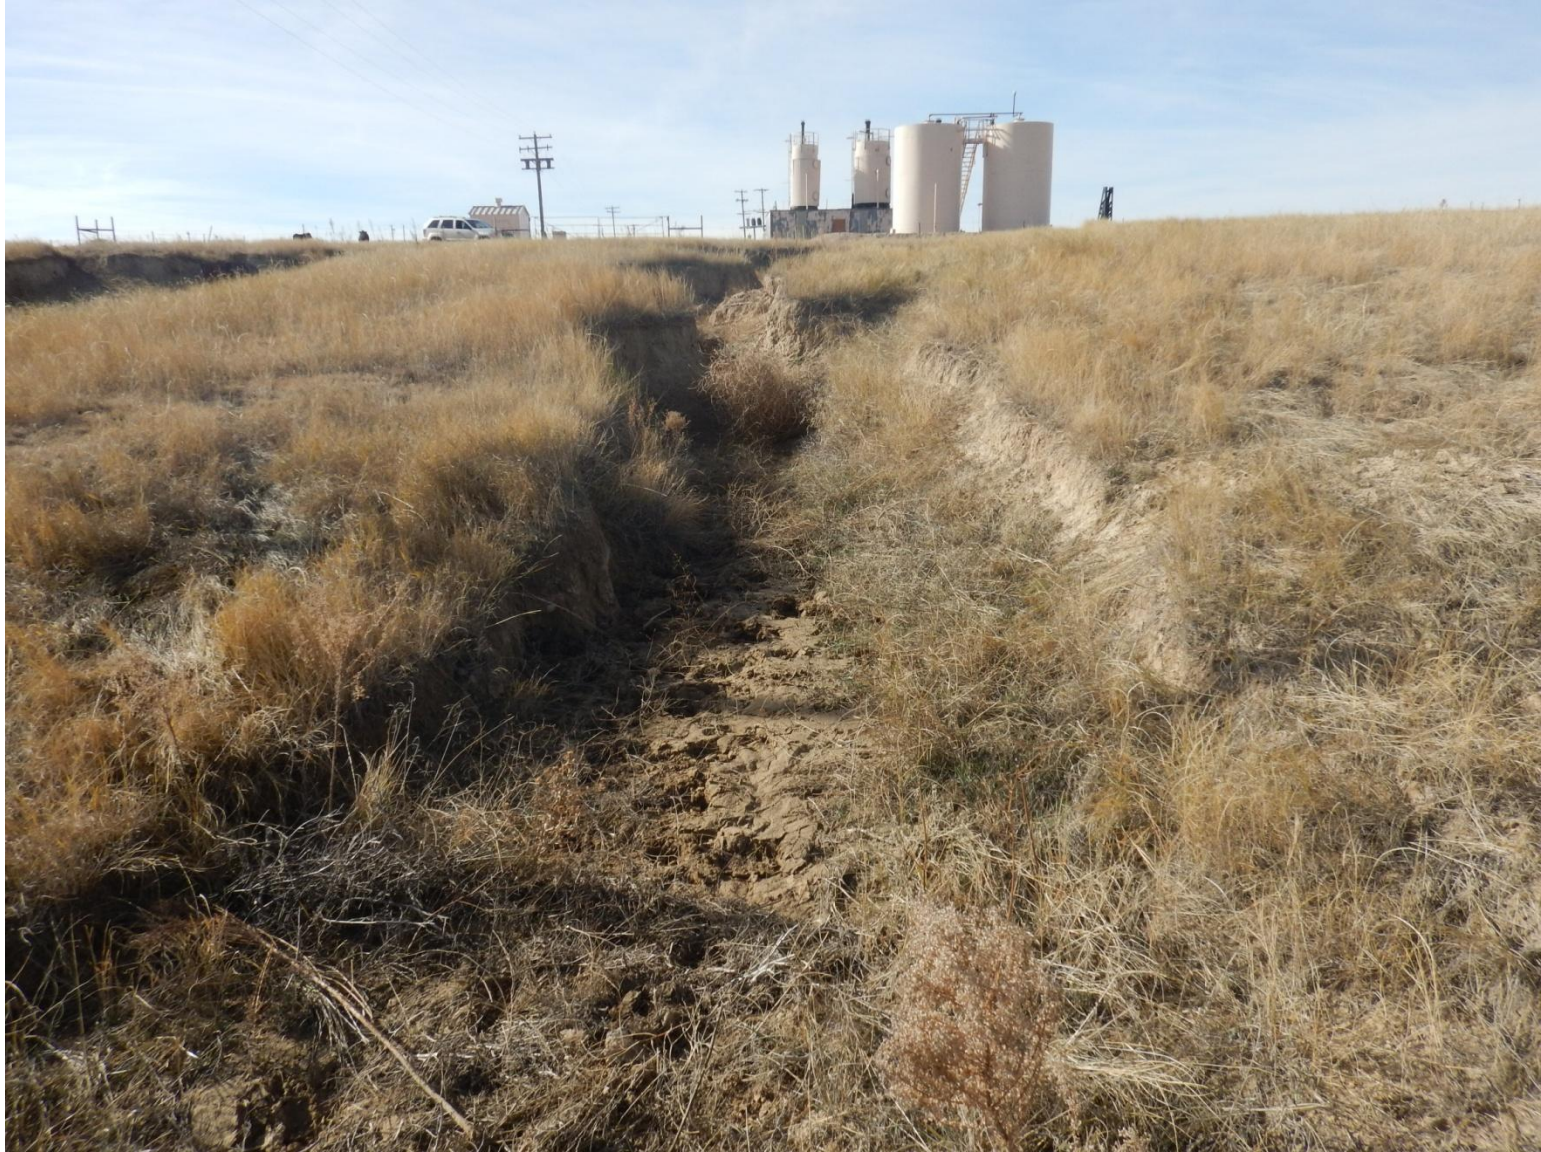
Photo 21: Photo taken east of location facing west. Photo of gully section below “washed out” location.

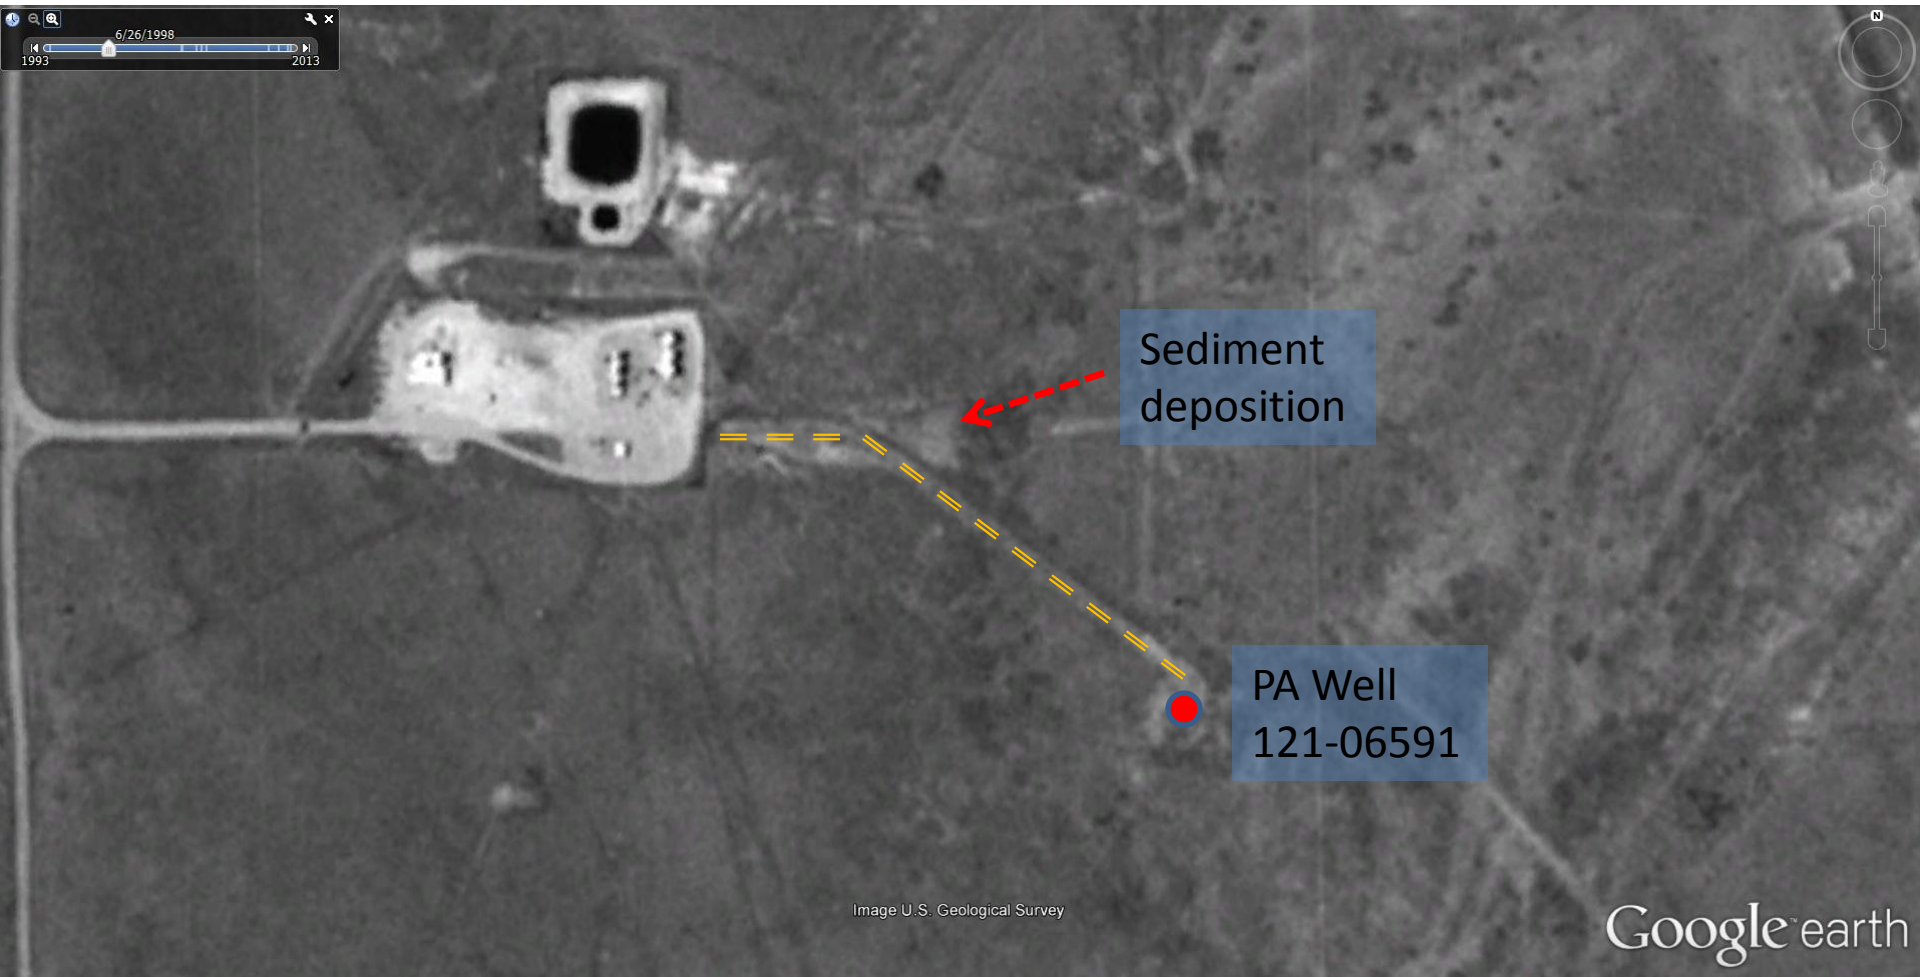
Photo 22: Aerial image date 6/1998. Image shows disturbance, either pipeline or road leading to well 121-06591. Image also shows sign of erosion including sediment deposition.

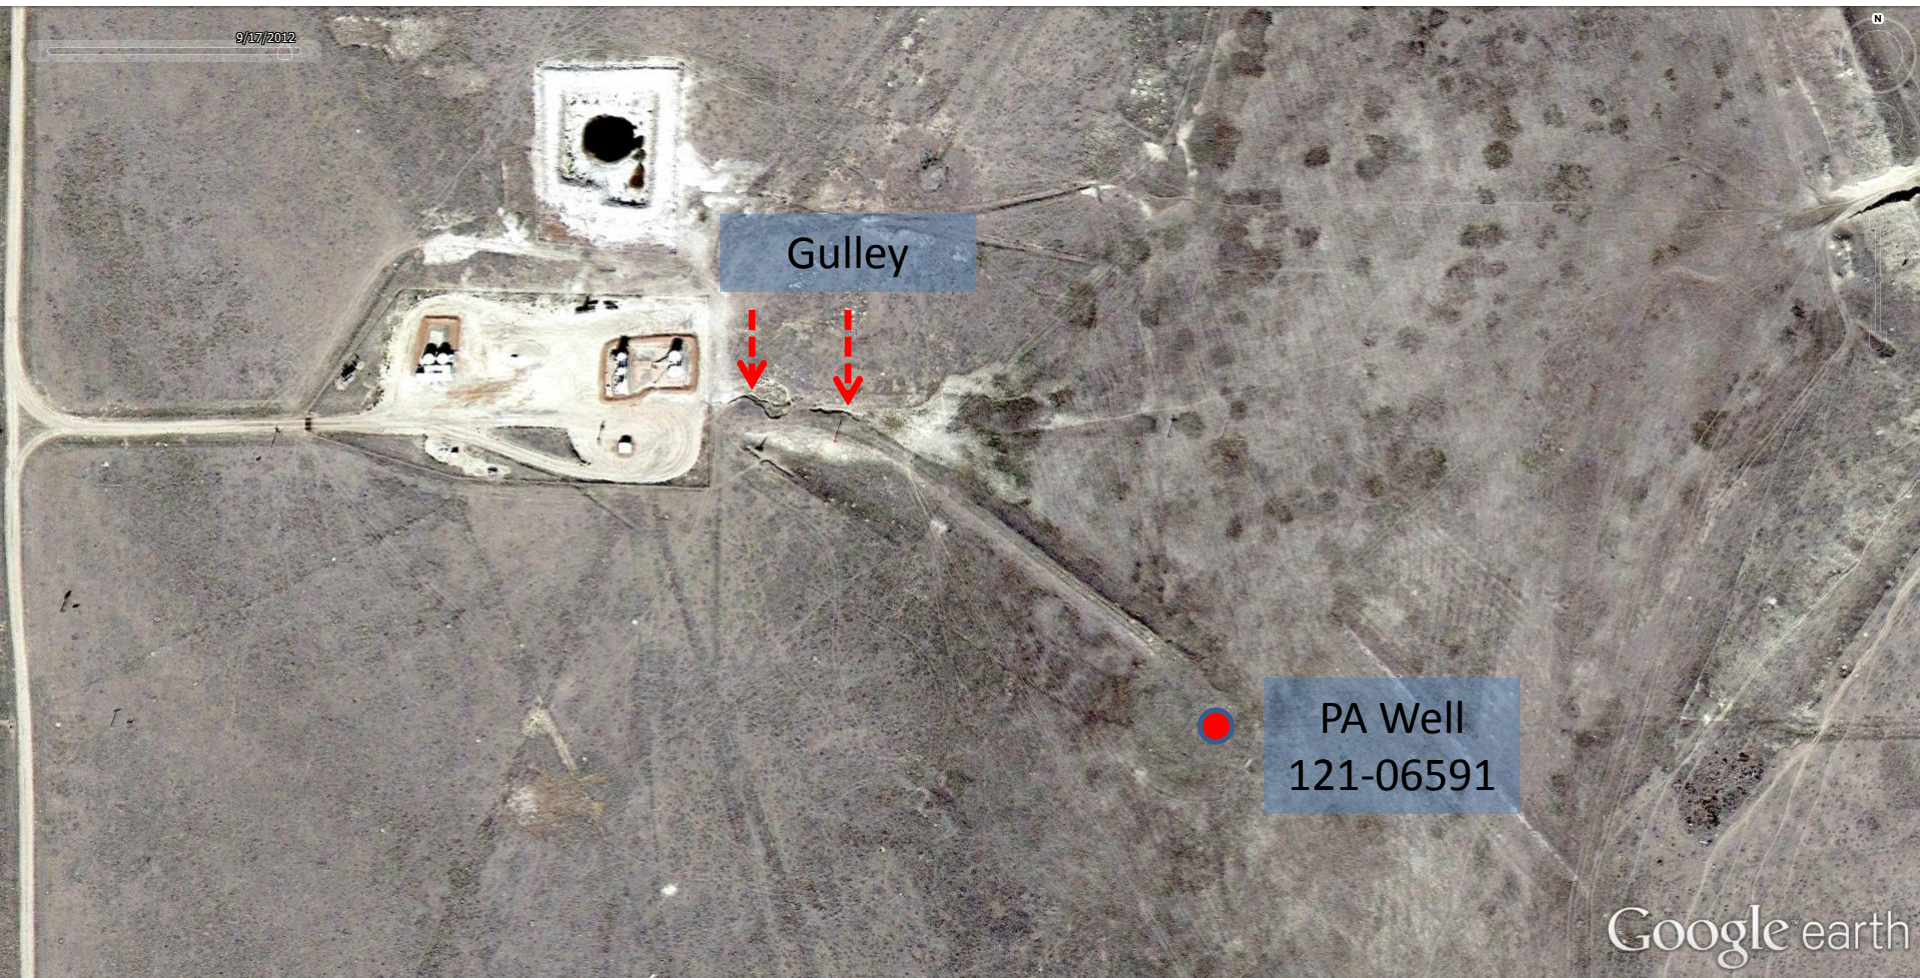
Photo 23: Aerial image date 9/2012. Deposition area shows sign of expansion.

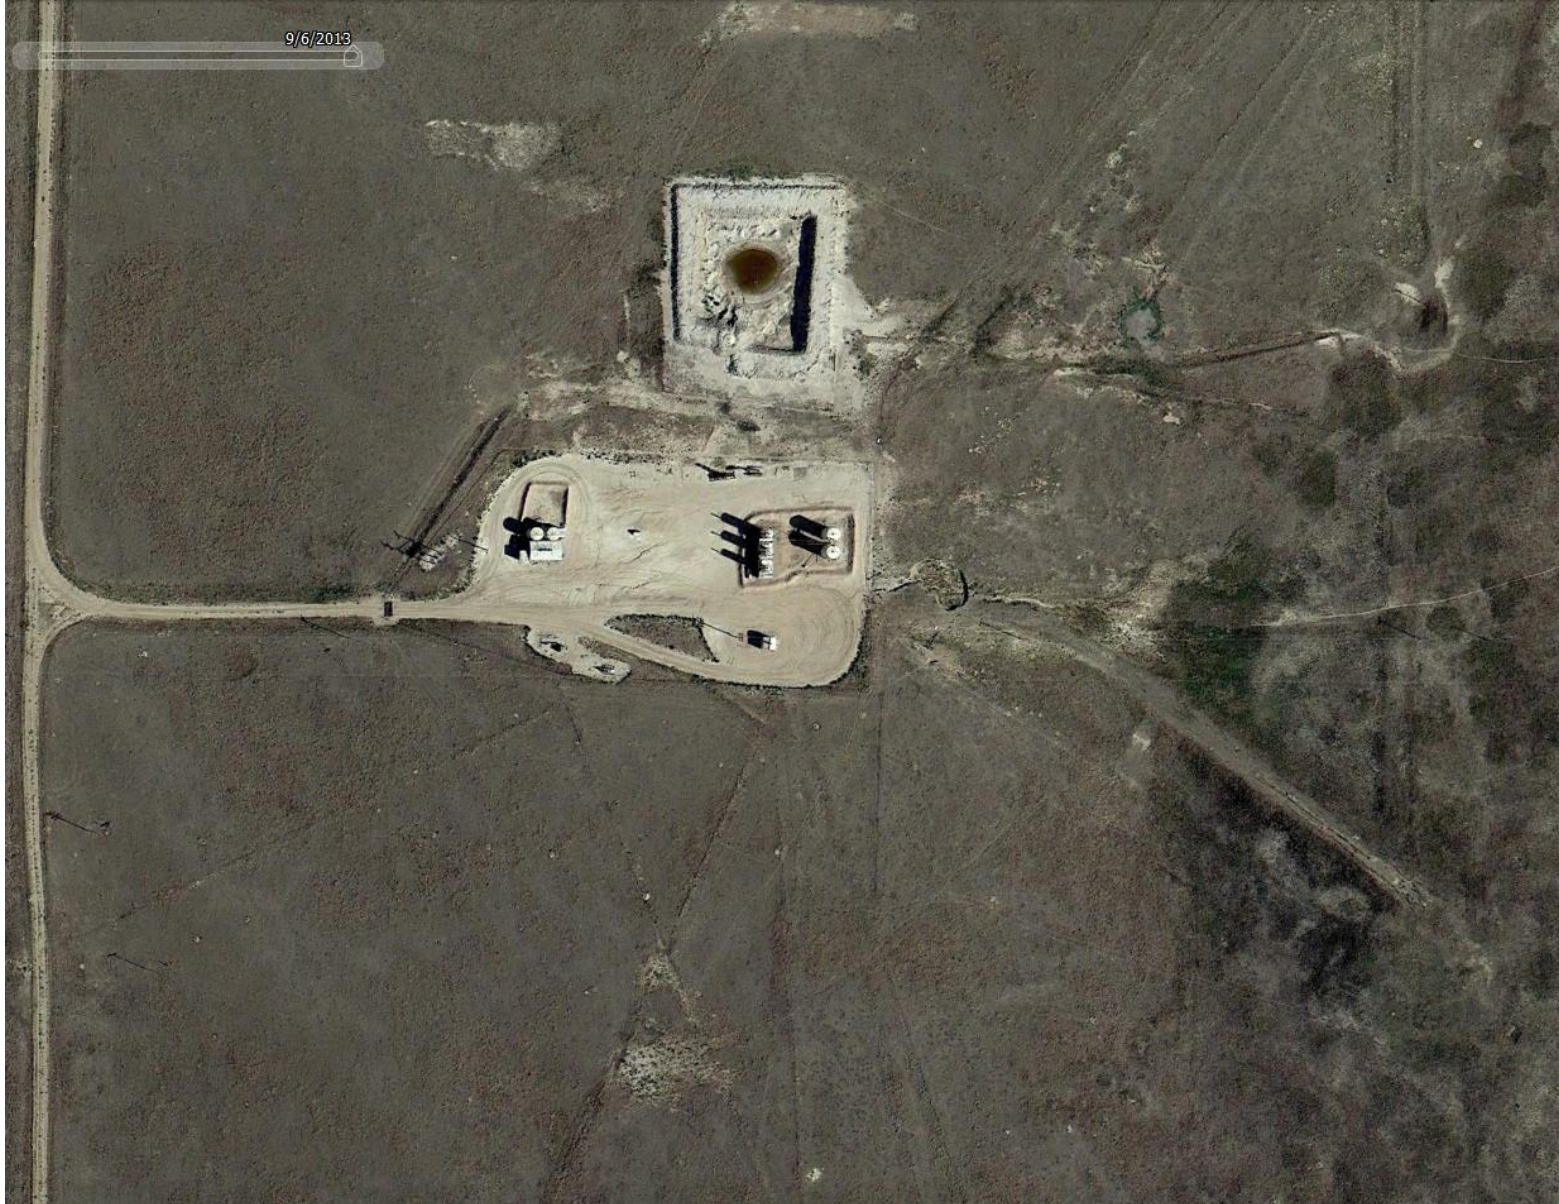
Photo 24: Aerial image date 9/2013. Most up-to-date aerial image or erosion east of location.

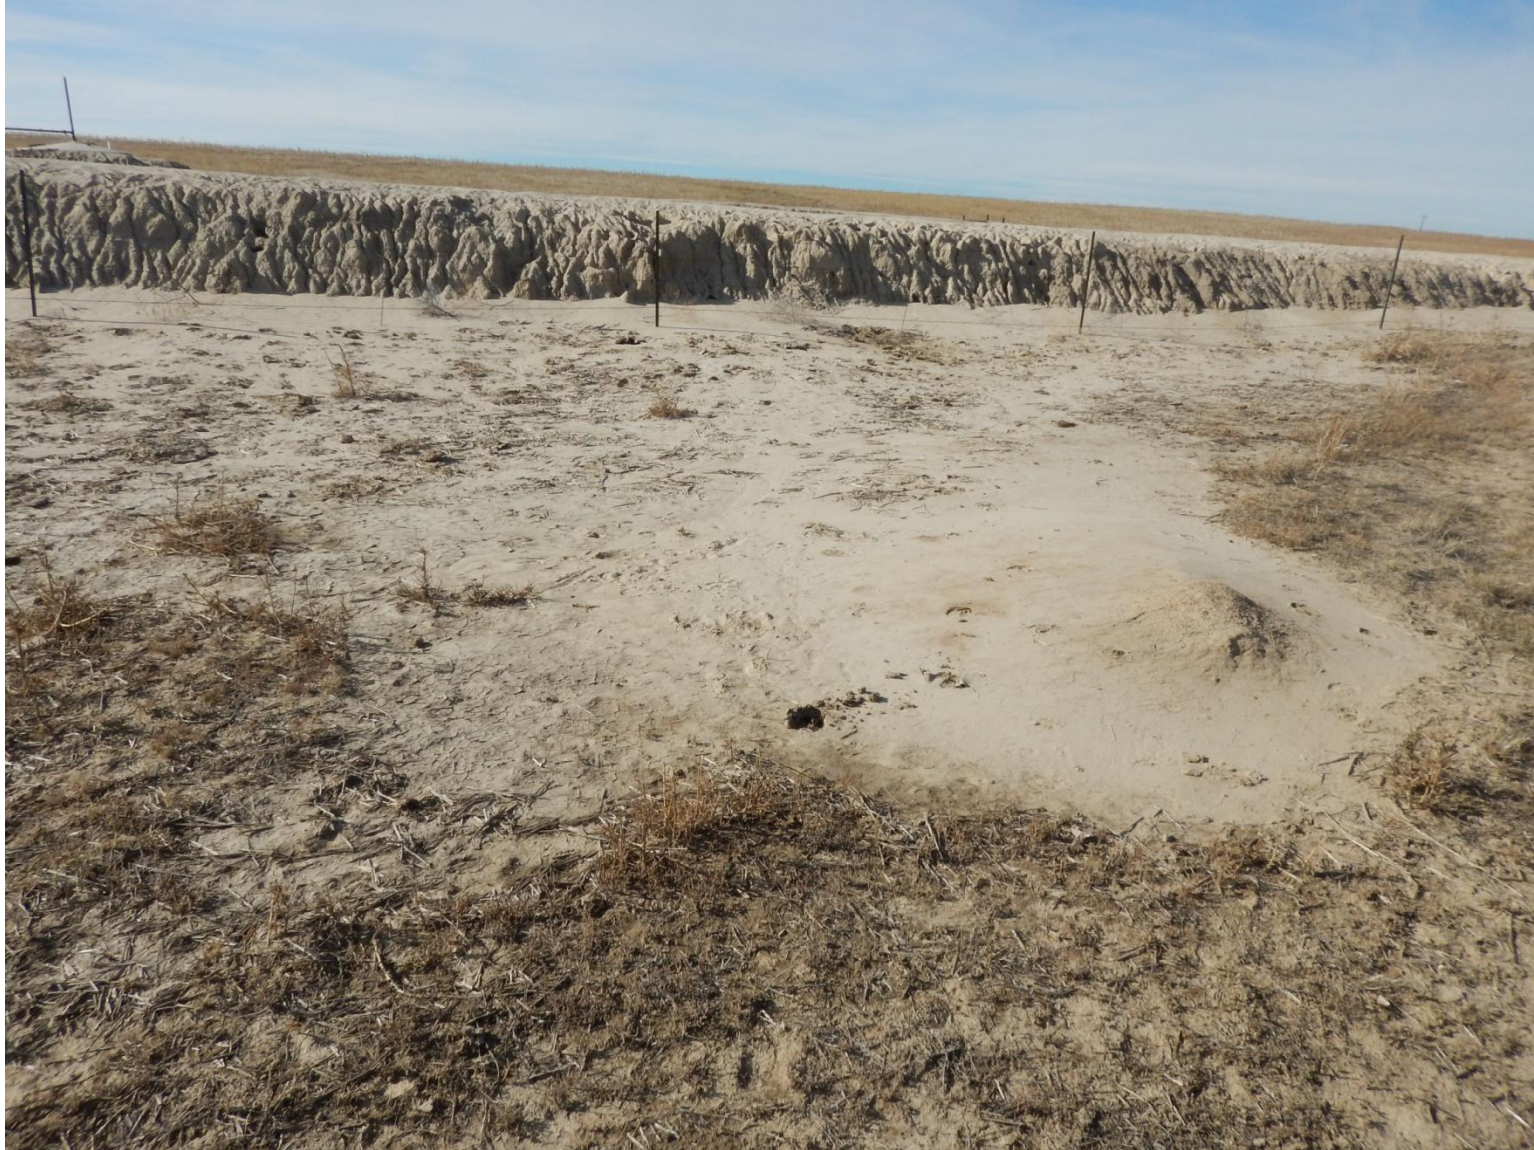
Photo 25: Photo taken from east end of pit location, facing west. Note rill erosion along slope of pit. The unvegetated portion center of photo (below pit) is sediment deposition coming off of pit location. This area needs to be reclaimed

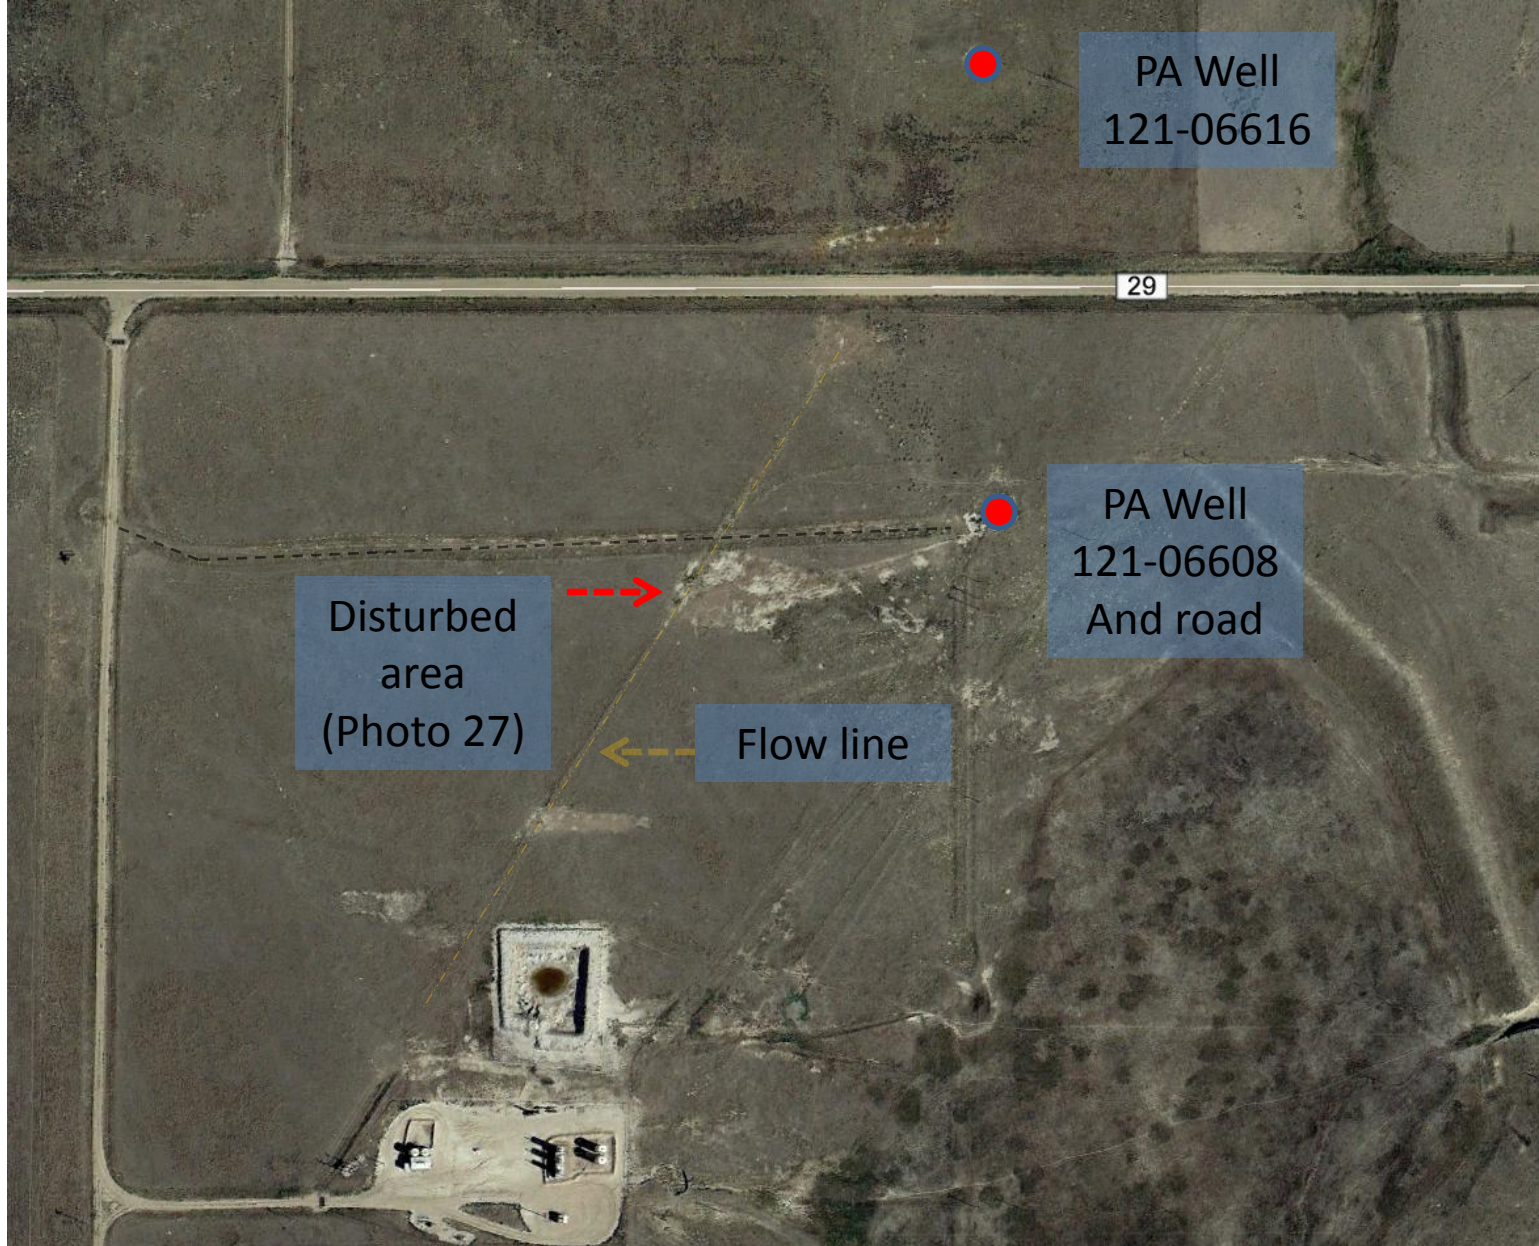
Photo 26: Aerial image date 9/2013. Note the disturbed areas along gathering/flow line. These areas need to be reclaimed.

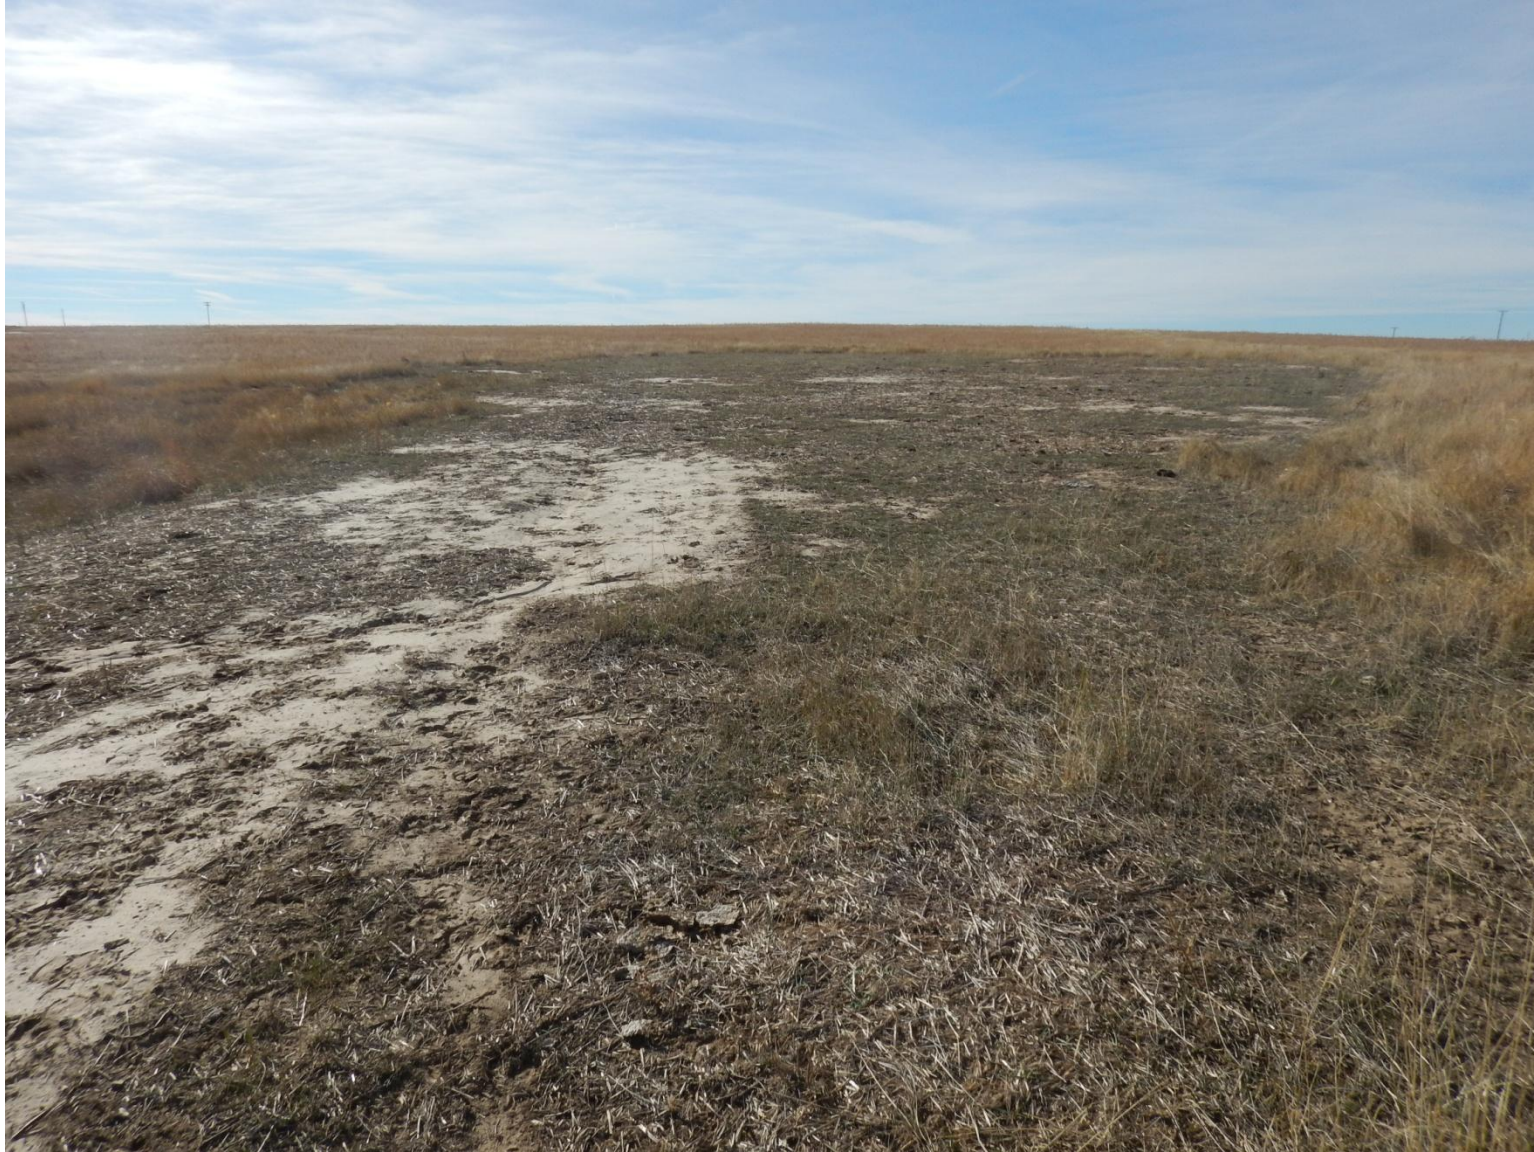
Photo 27: Photo of disturbed land related to flow line referred to in photo 26. Area located at $39^{\circ}59'12.59''\text{N}$, $103^{\circ}39'39.63''\text{W}$. These areas need to be reclaimed.
