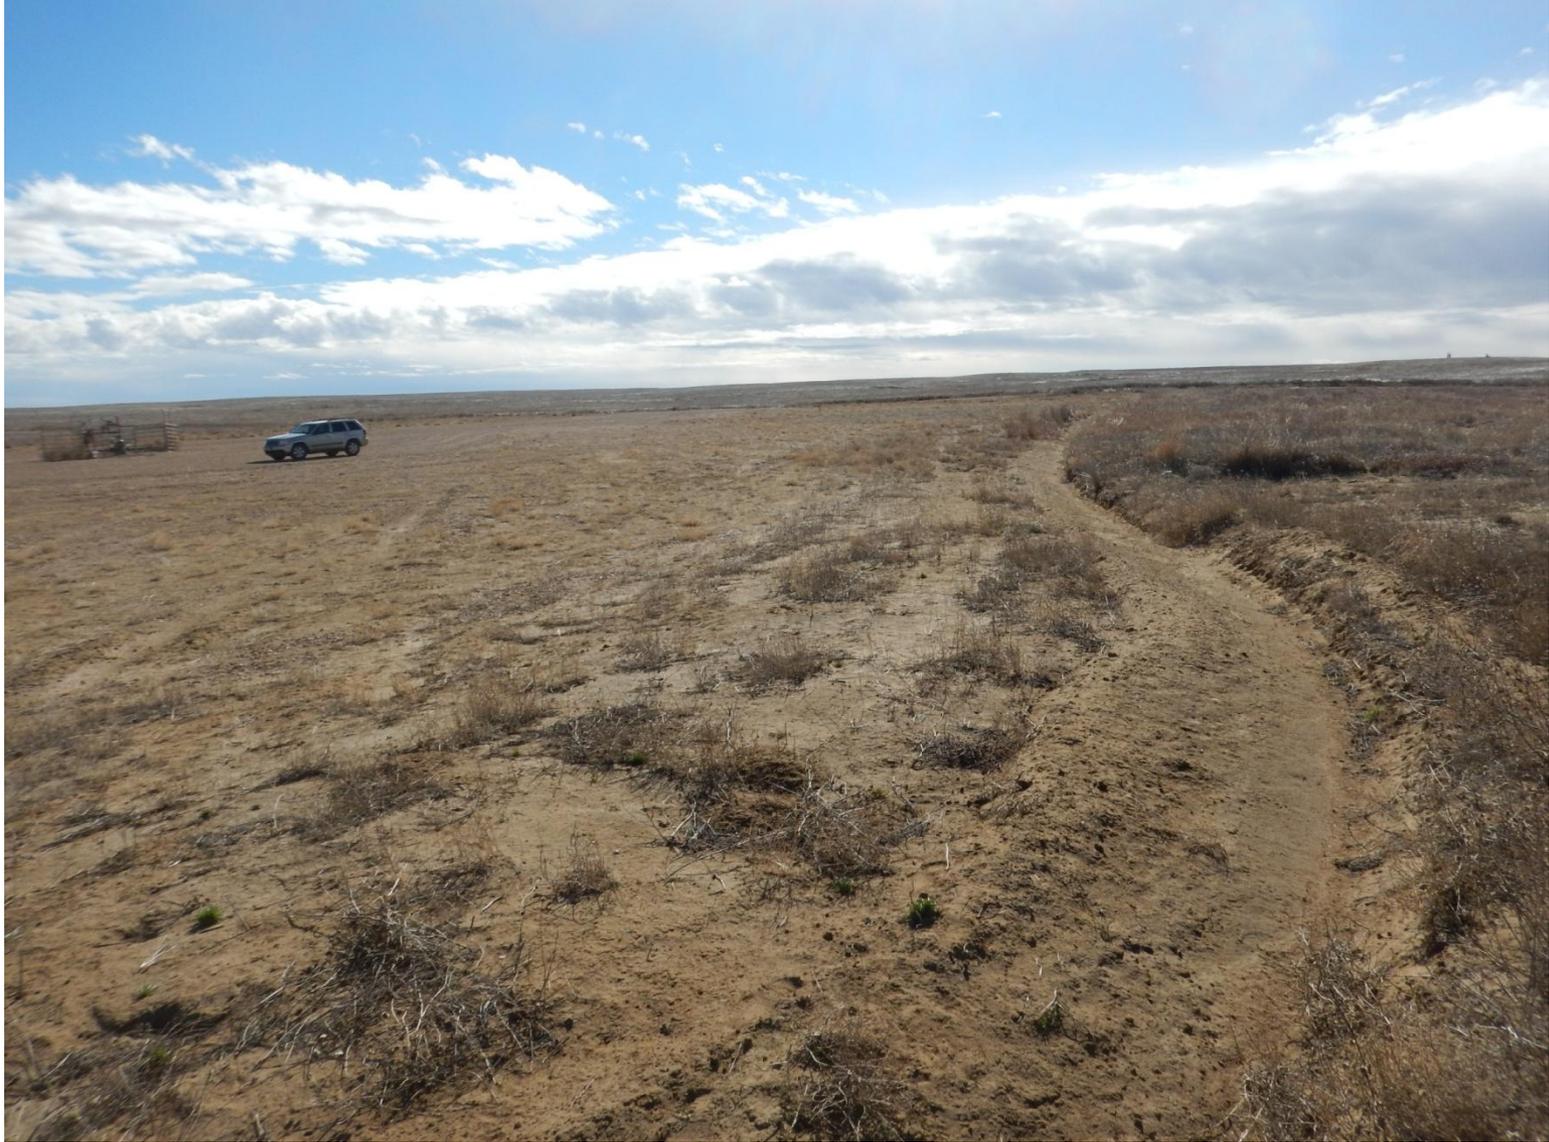
**Photo 1:** Photo taken from Northern side of location facing South. Photo of interim reclamation. These areas need to be minimized and reclaimed.

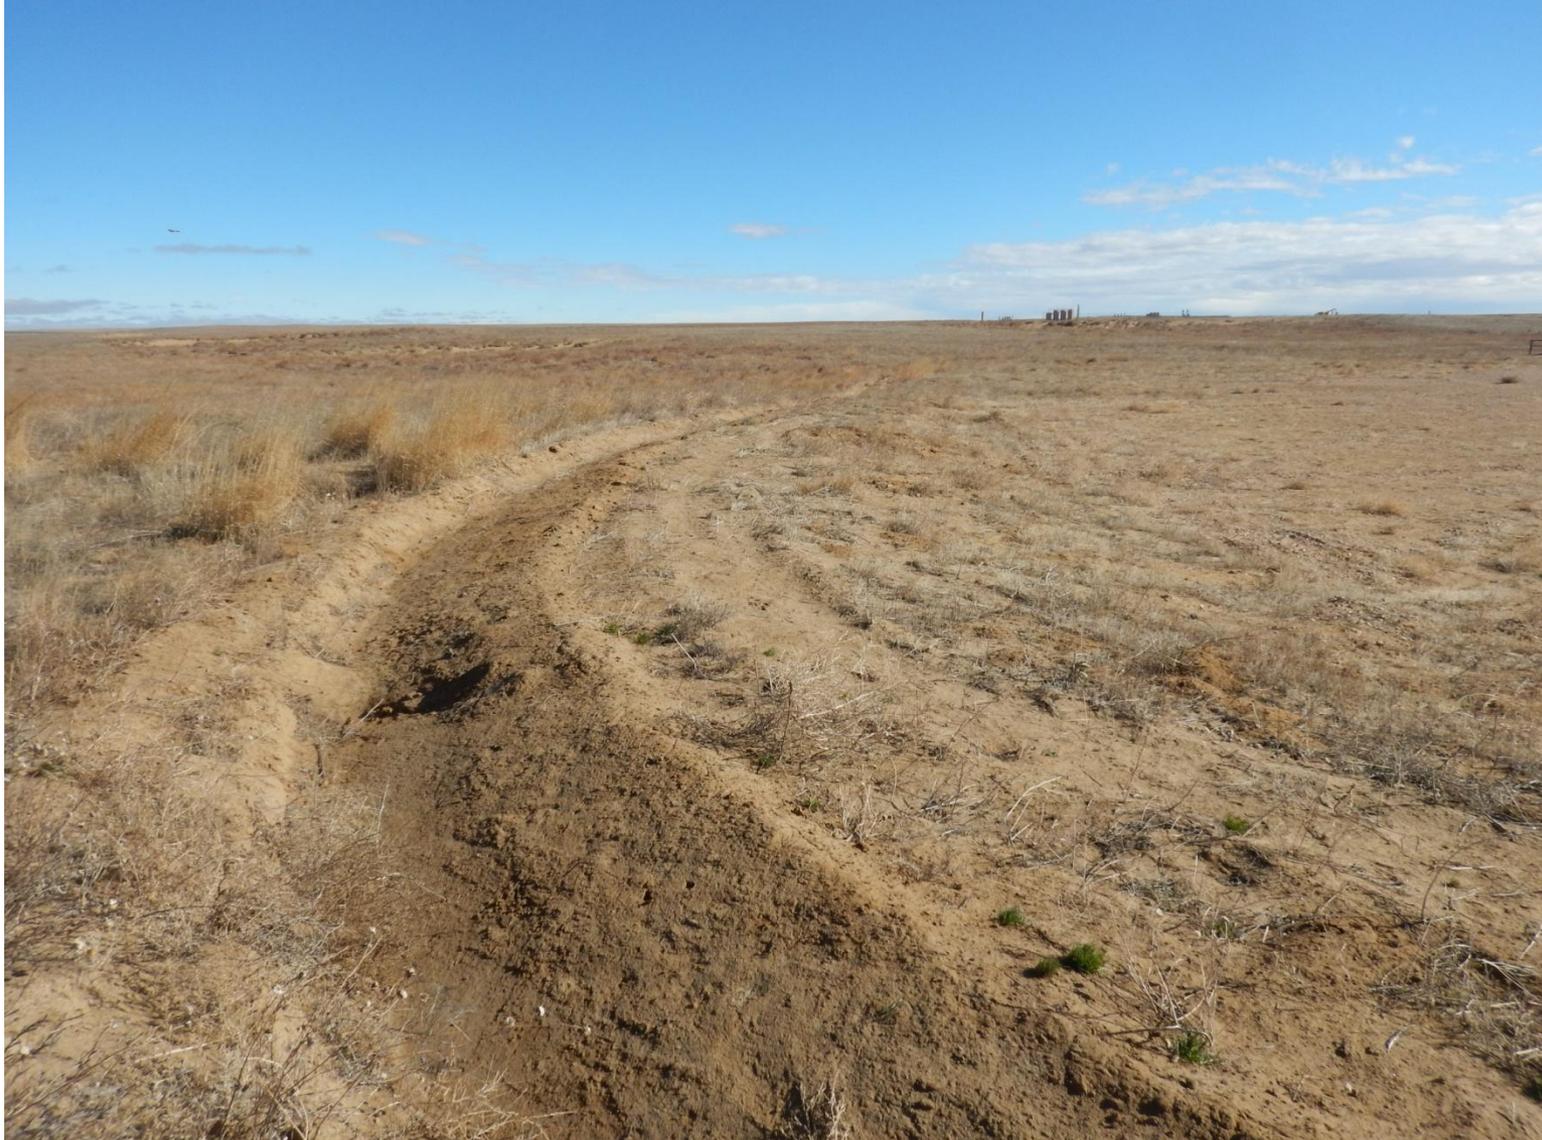
**Photo 2:** Photo taken on northwest side of location, facing east. Photo of interim reclamation. Note the lack of perennial vegetation.

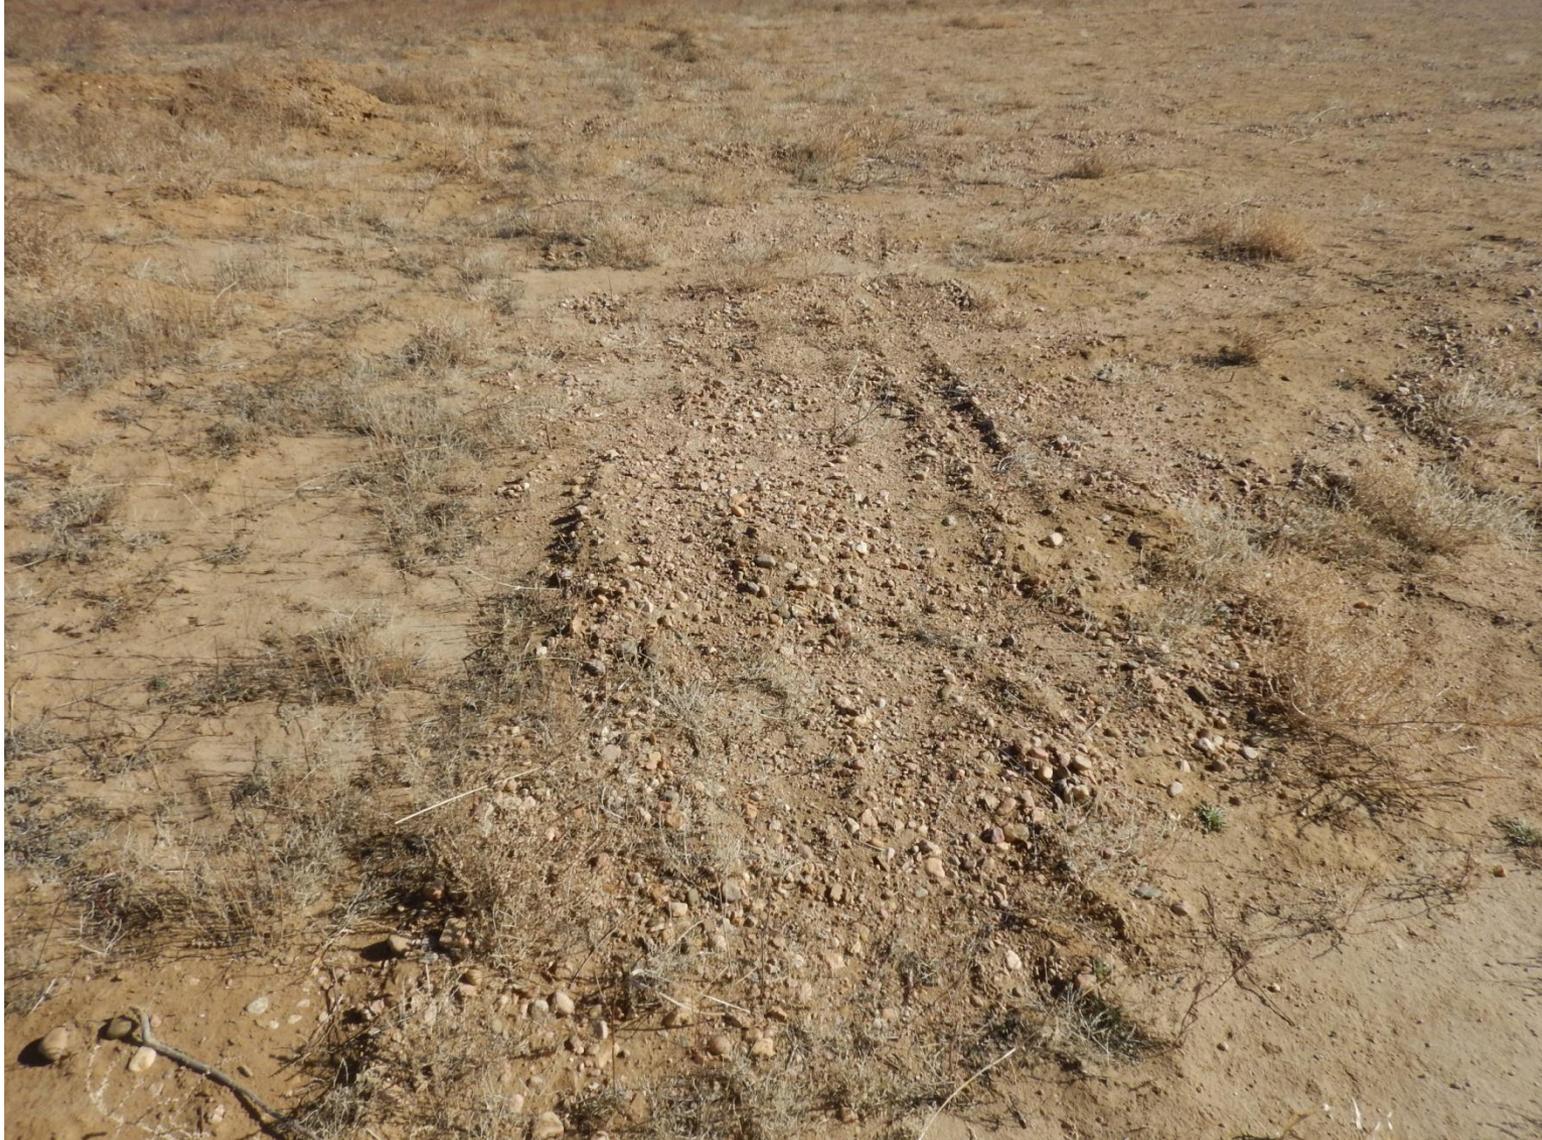
**Photo 3:** Photo taken on north end of location. Photo of gravel remaining on interim portion of location.

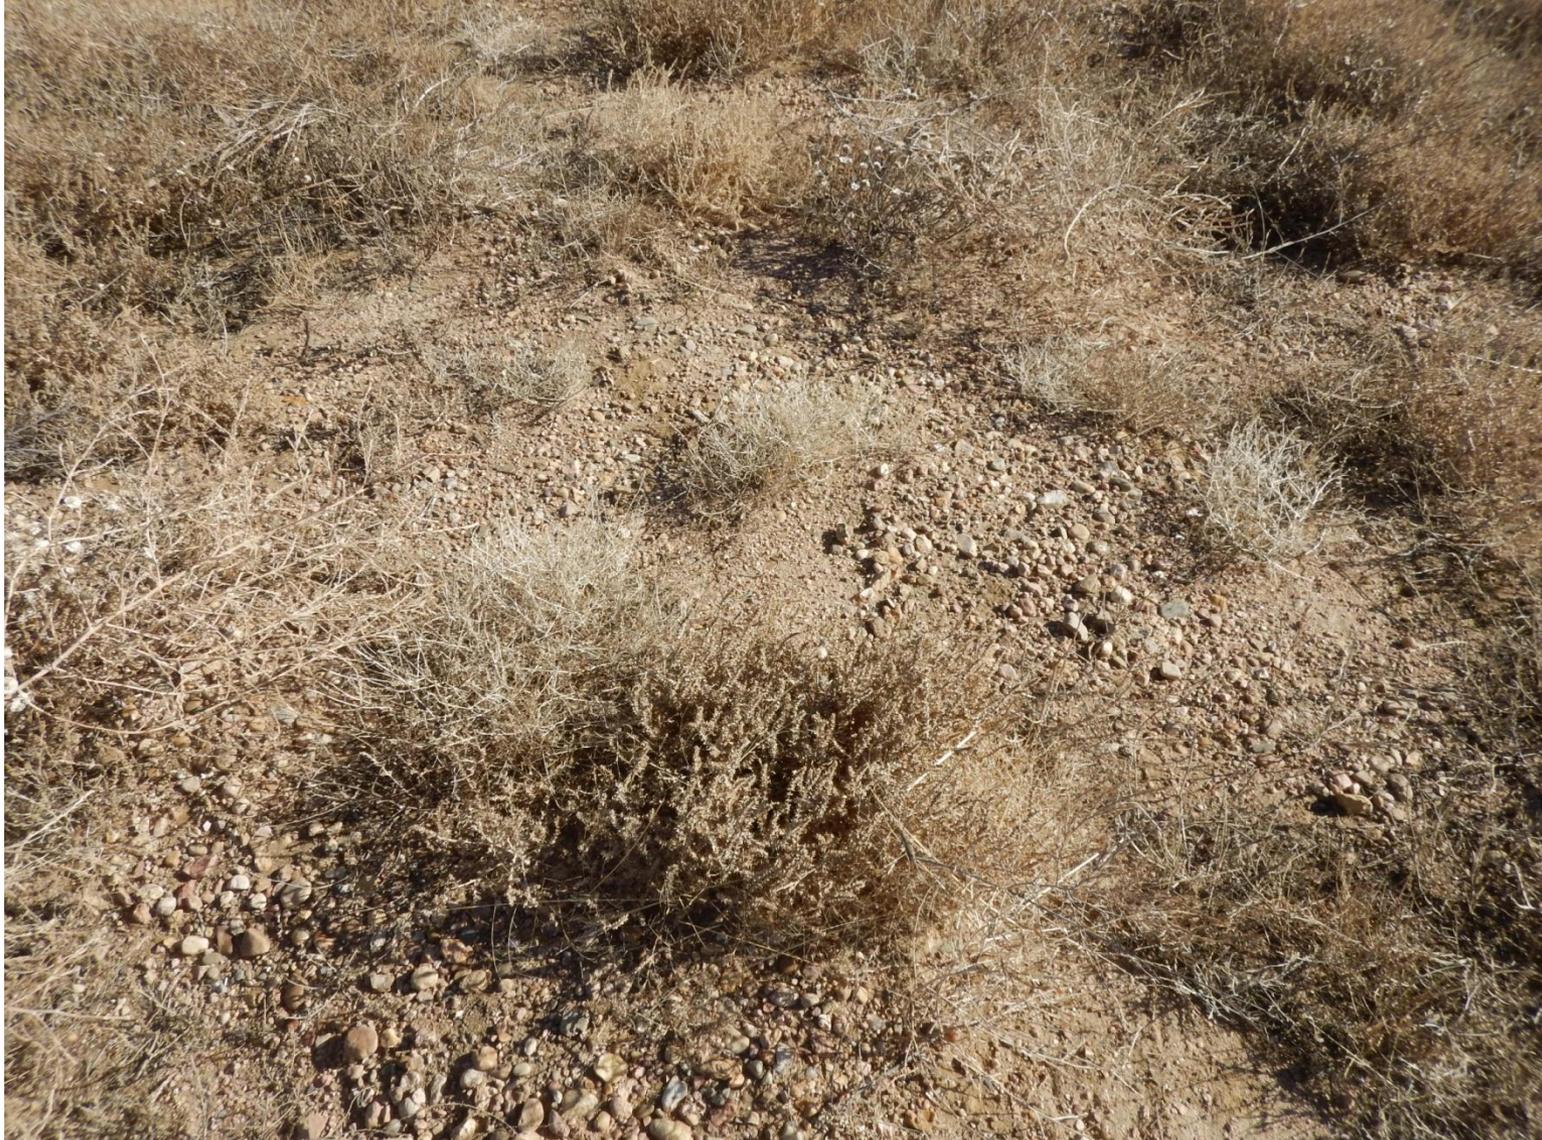
**Photo 4:** Photo taken from north side of location, facing North. Photo of Russian thistle weed debris, and gravel.

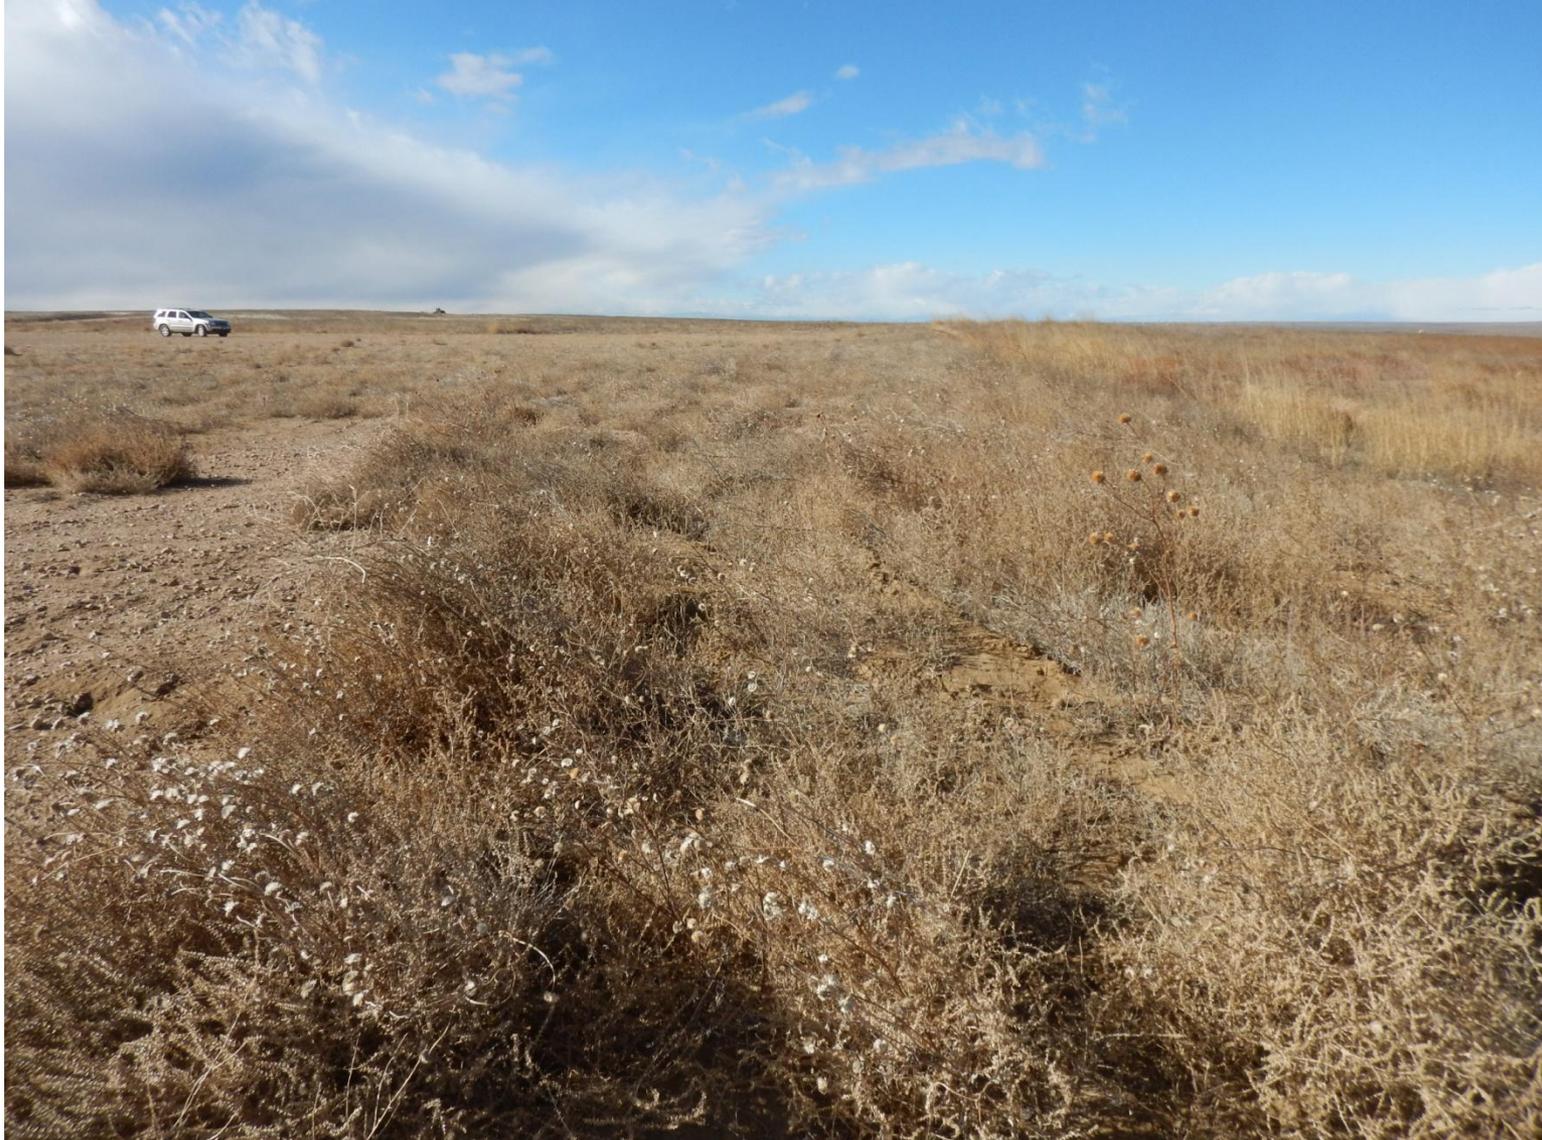
**Photo 5:** Photo taken from northeast side of location, facing west. Photo of interim reclamation. Note the lack of perennial vegetation. Vegetation in photo predominantly Russian thistle.

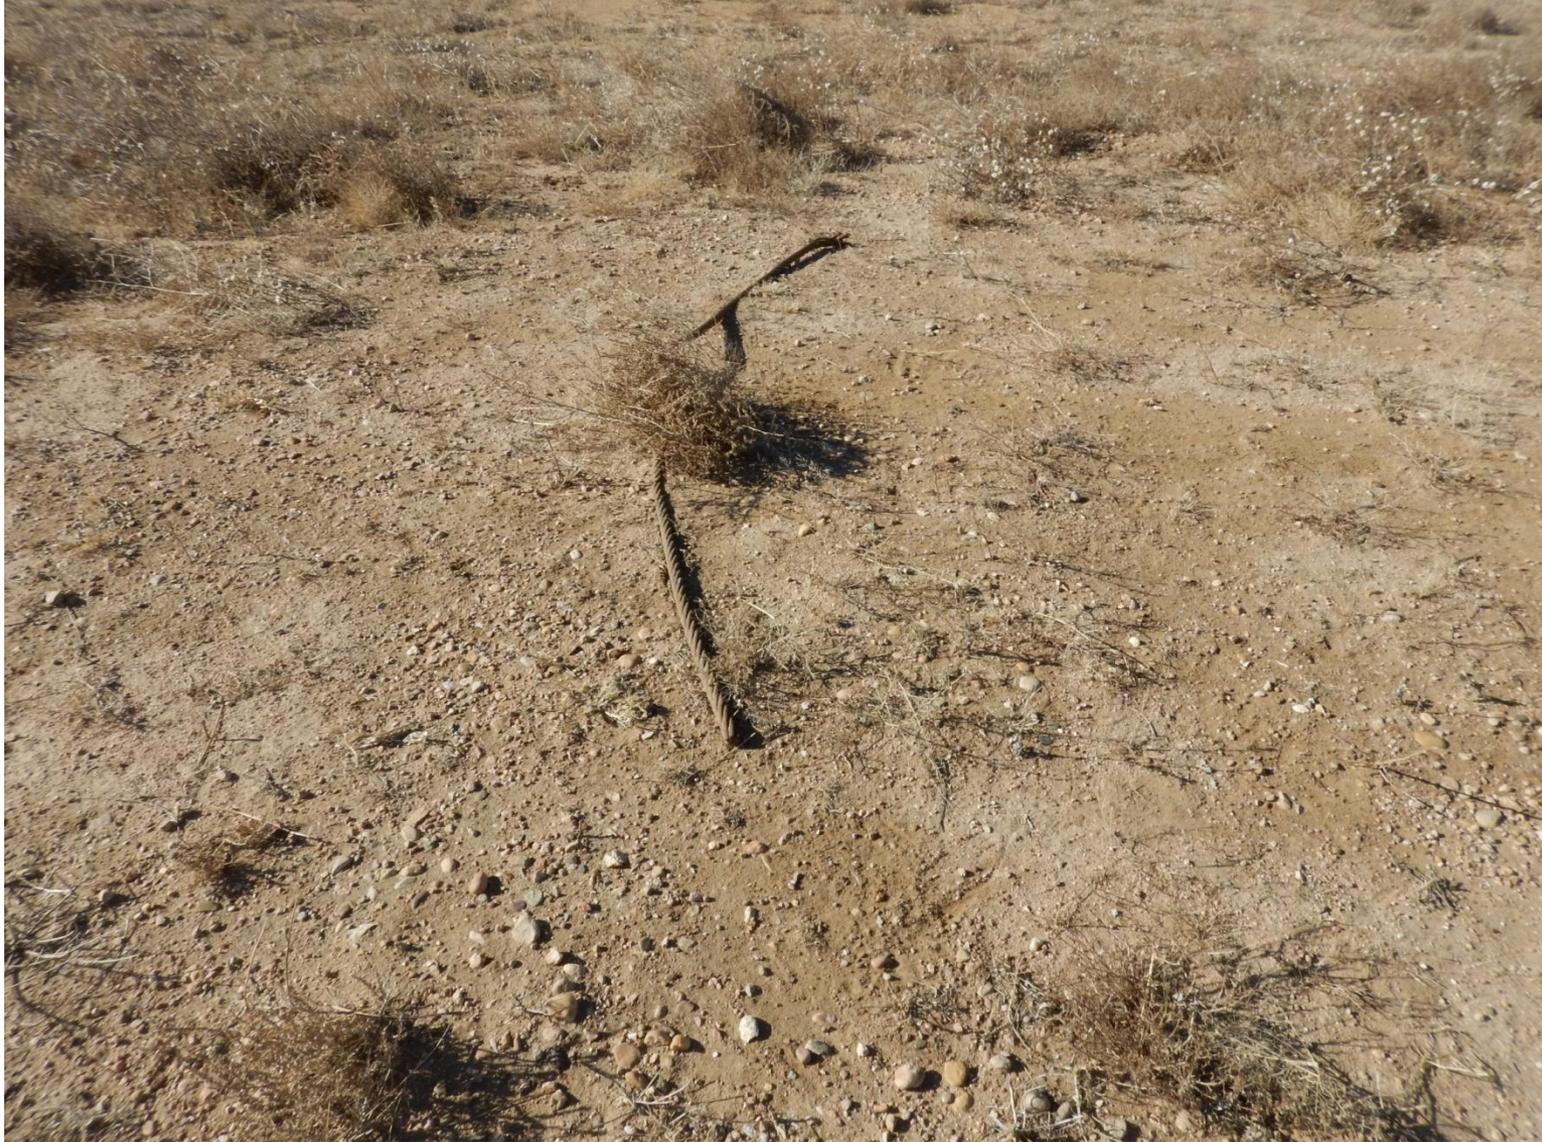
**Photo 7:** Photo taken from east side of location. Photo of trash on location, appears to be cable.

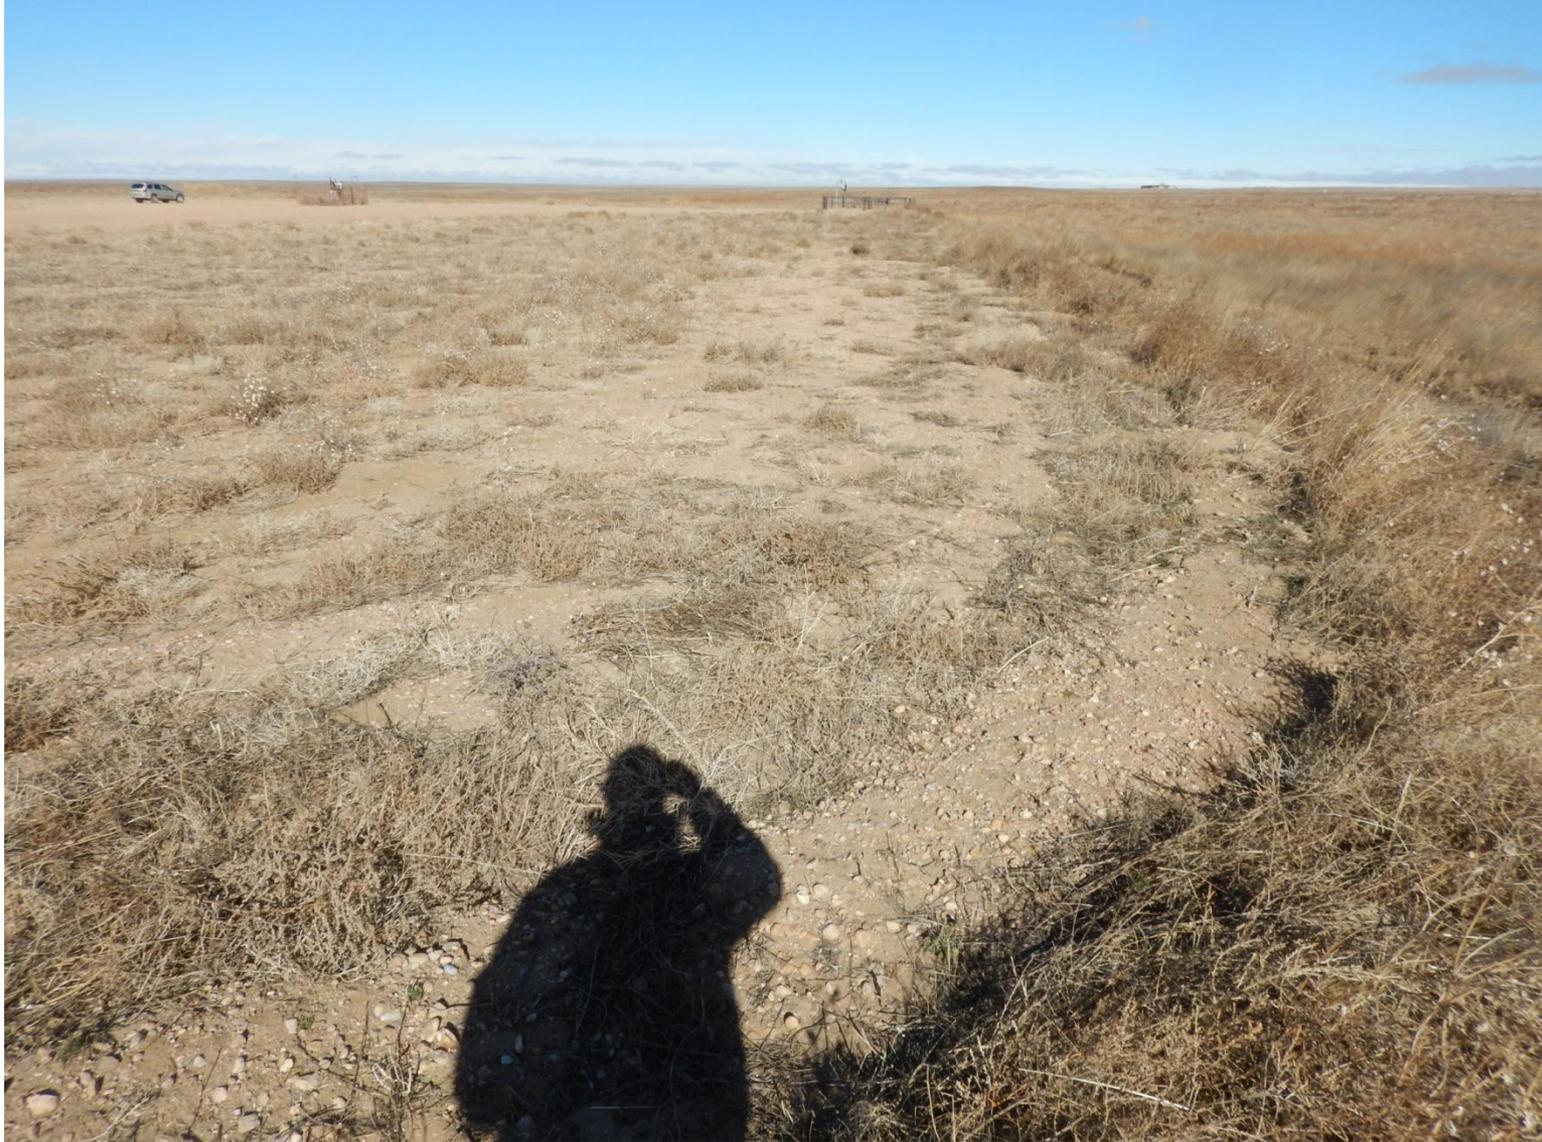
**Photo 8:** Photo taken from southeast side of location, facing North. Photo of interim reclamation. Vegetation predominantly Russian thistle and Kochia weed debris.

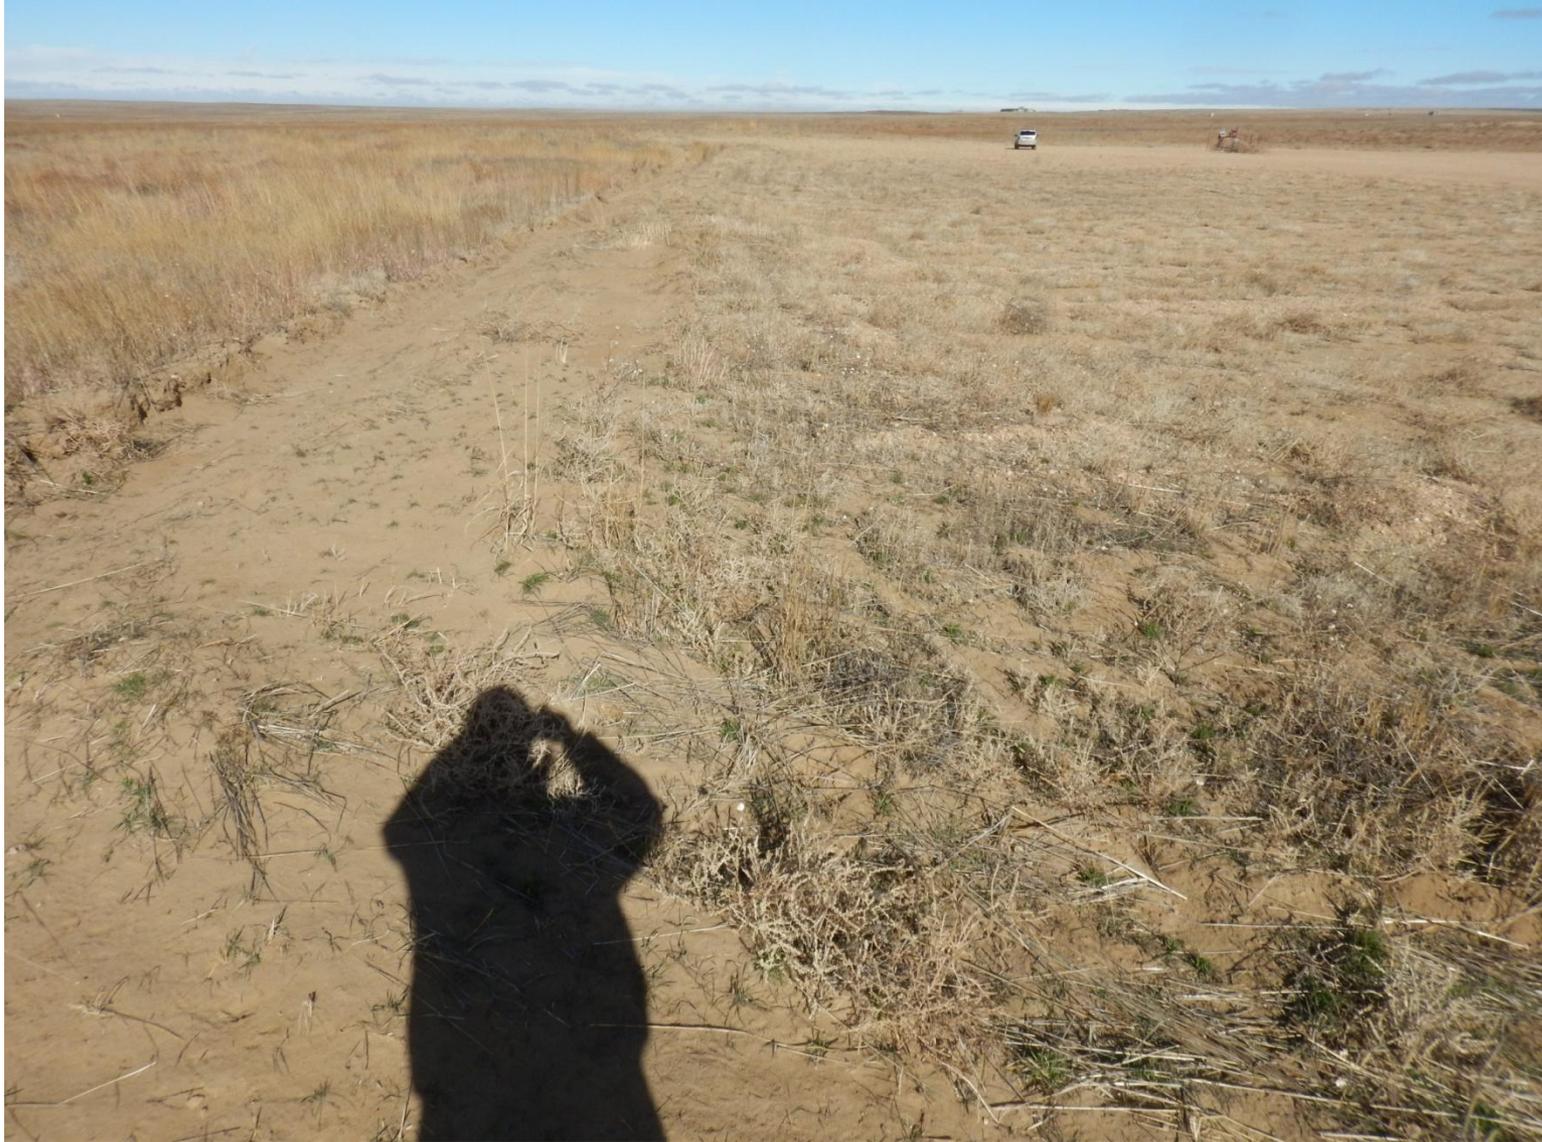
**Photo 10:** Photo taken from southwest side of location, facing North. Photo of interim reclamation. Note the lack of perennial vegetation.

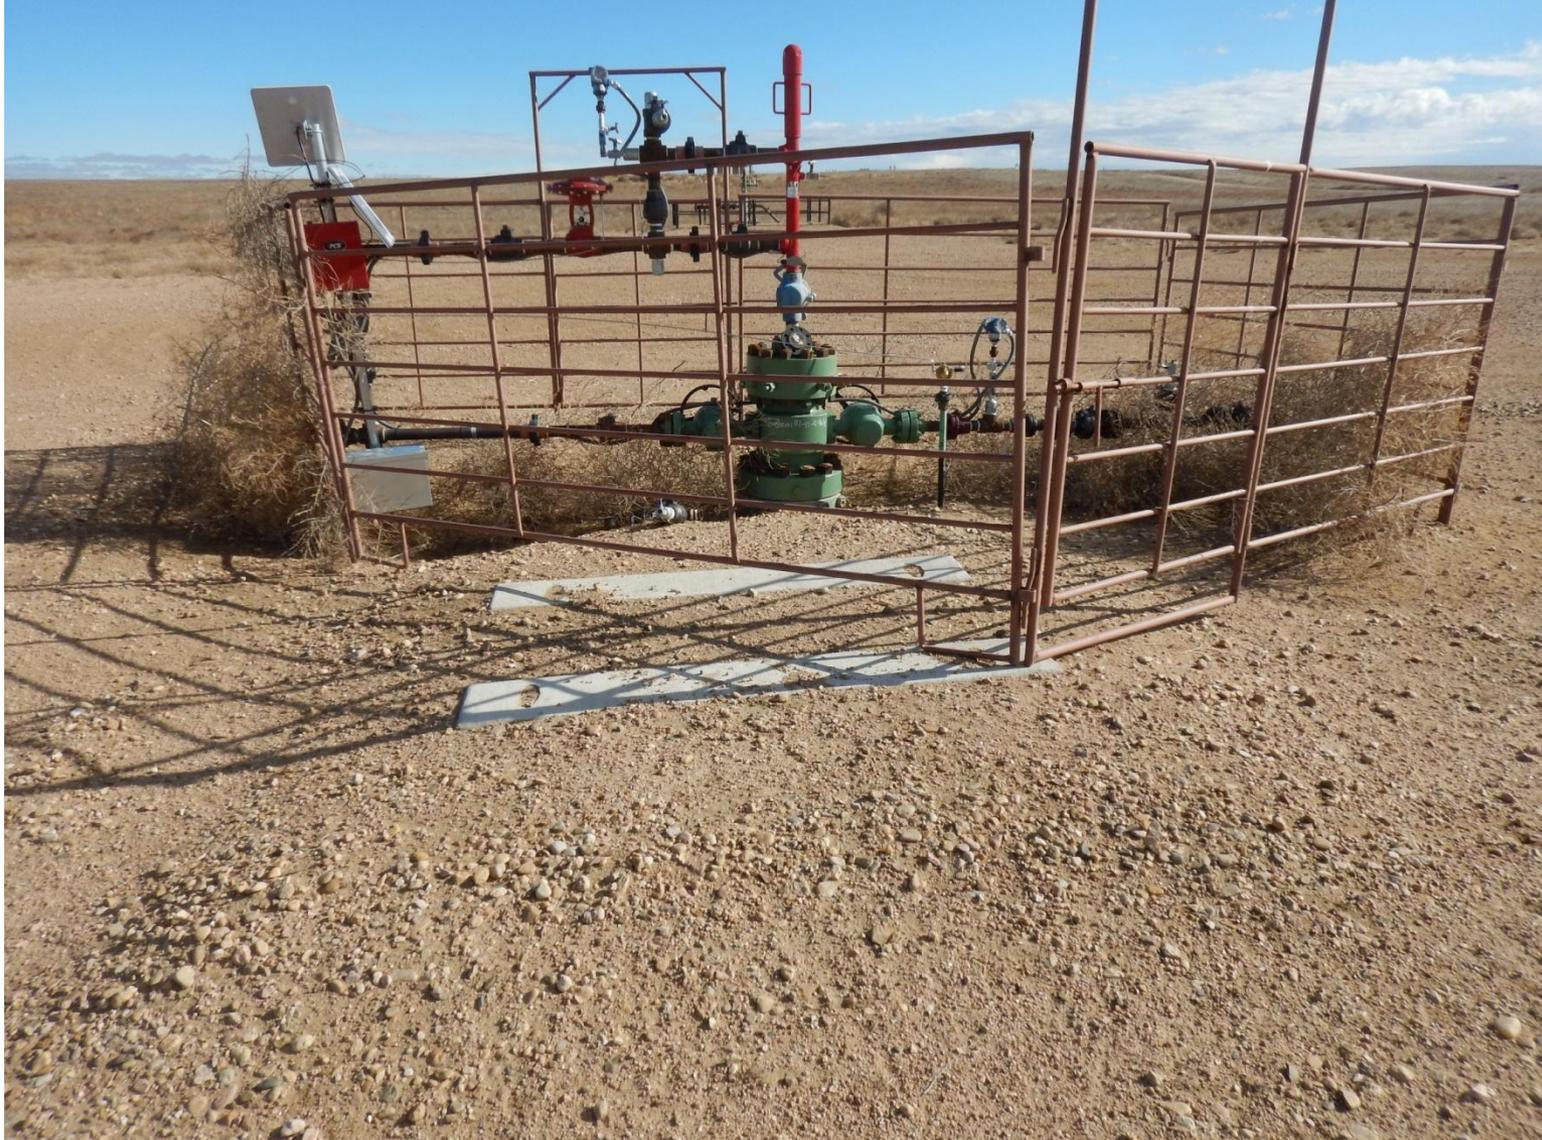
**Photo 12:** Photo taken from well on location. Photo of weed debris in equipment.
