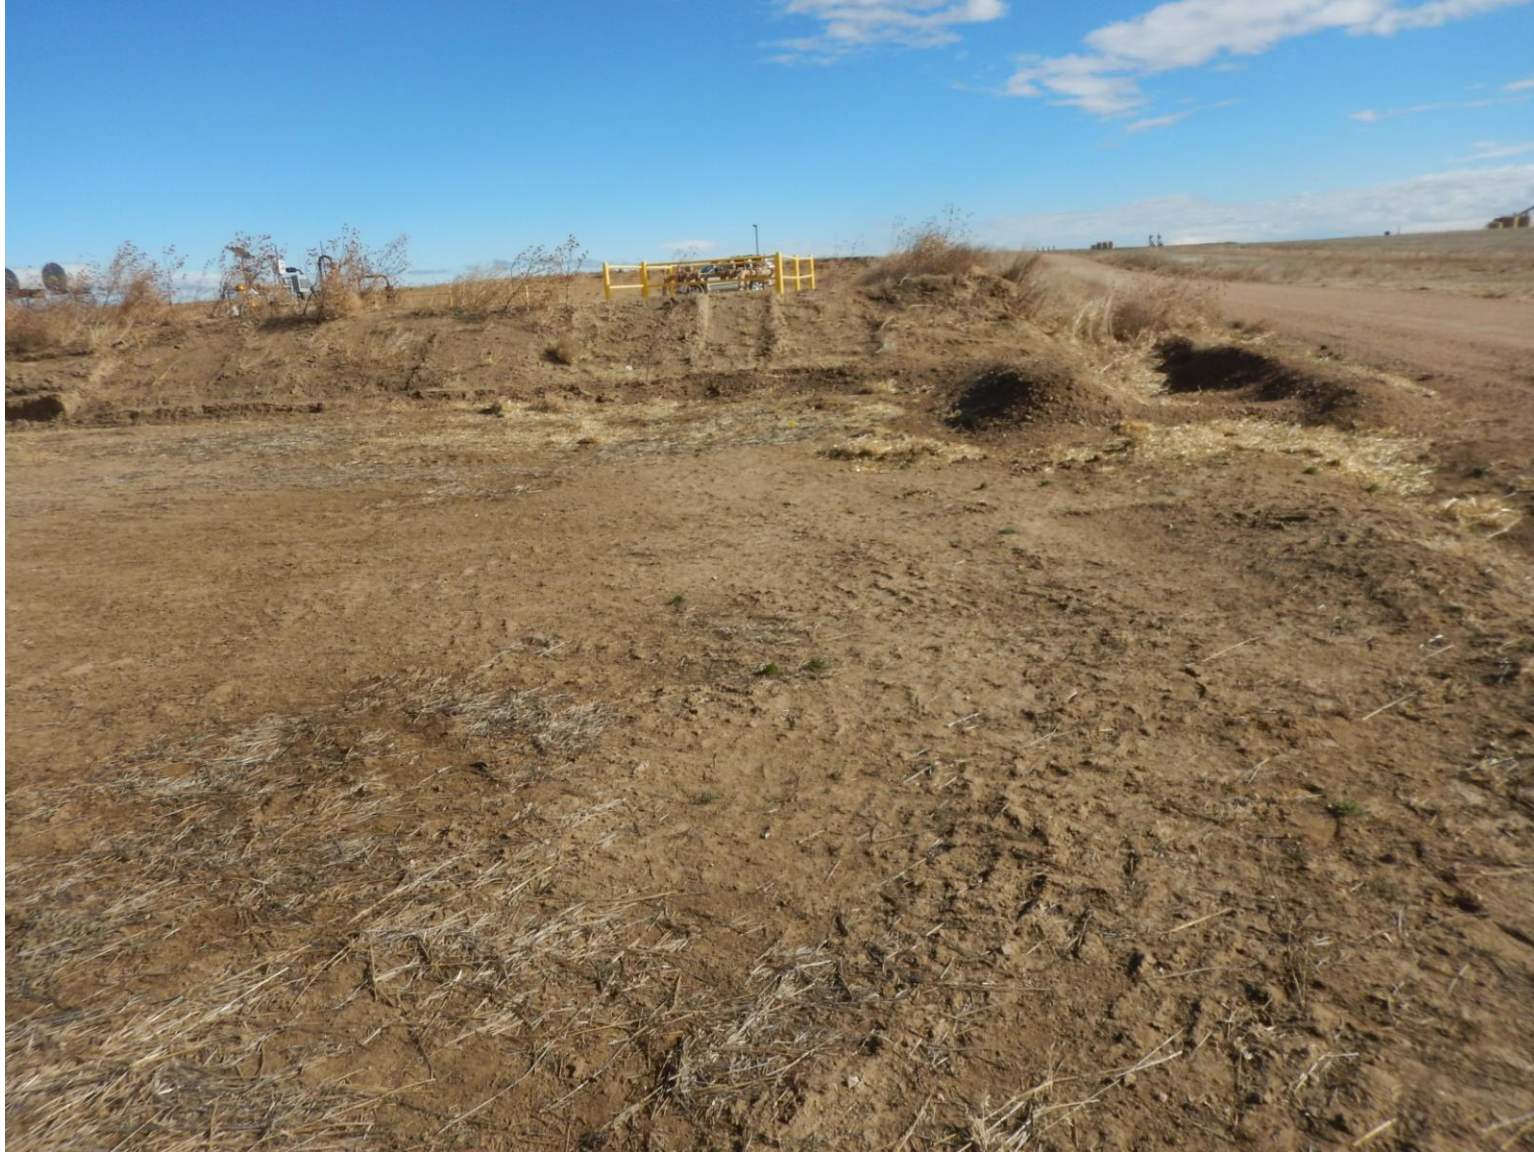
Photo 1: Photo taken from southwest portion of location facing east. Photo of pipeline and slope on perimeter of location. Note the lack of perennial vegetation.

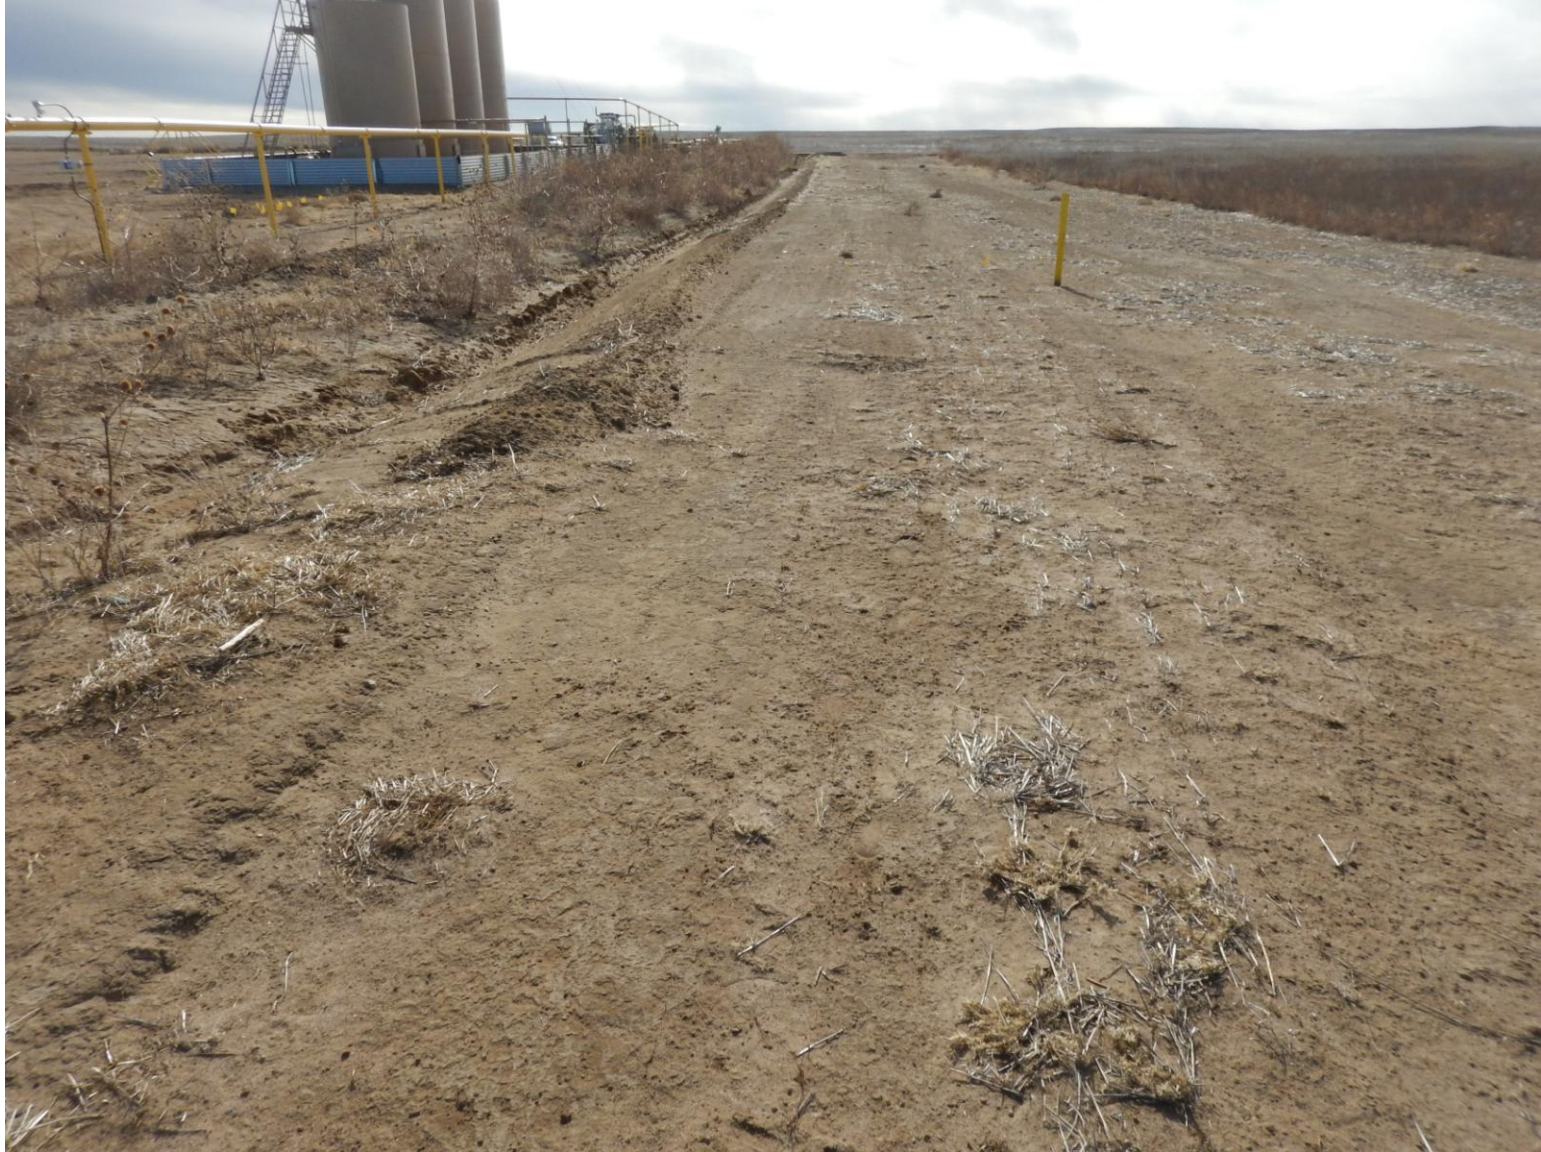
Photo 3: Photo taken from northwest portion of location facing south. Photo lack of perennial vegetation on perimeter slopes of location, and pipeline. These areas need to be reclaimed.

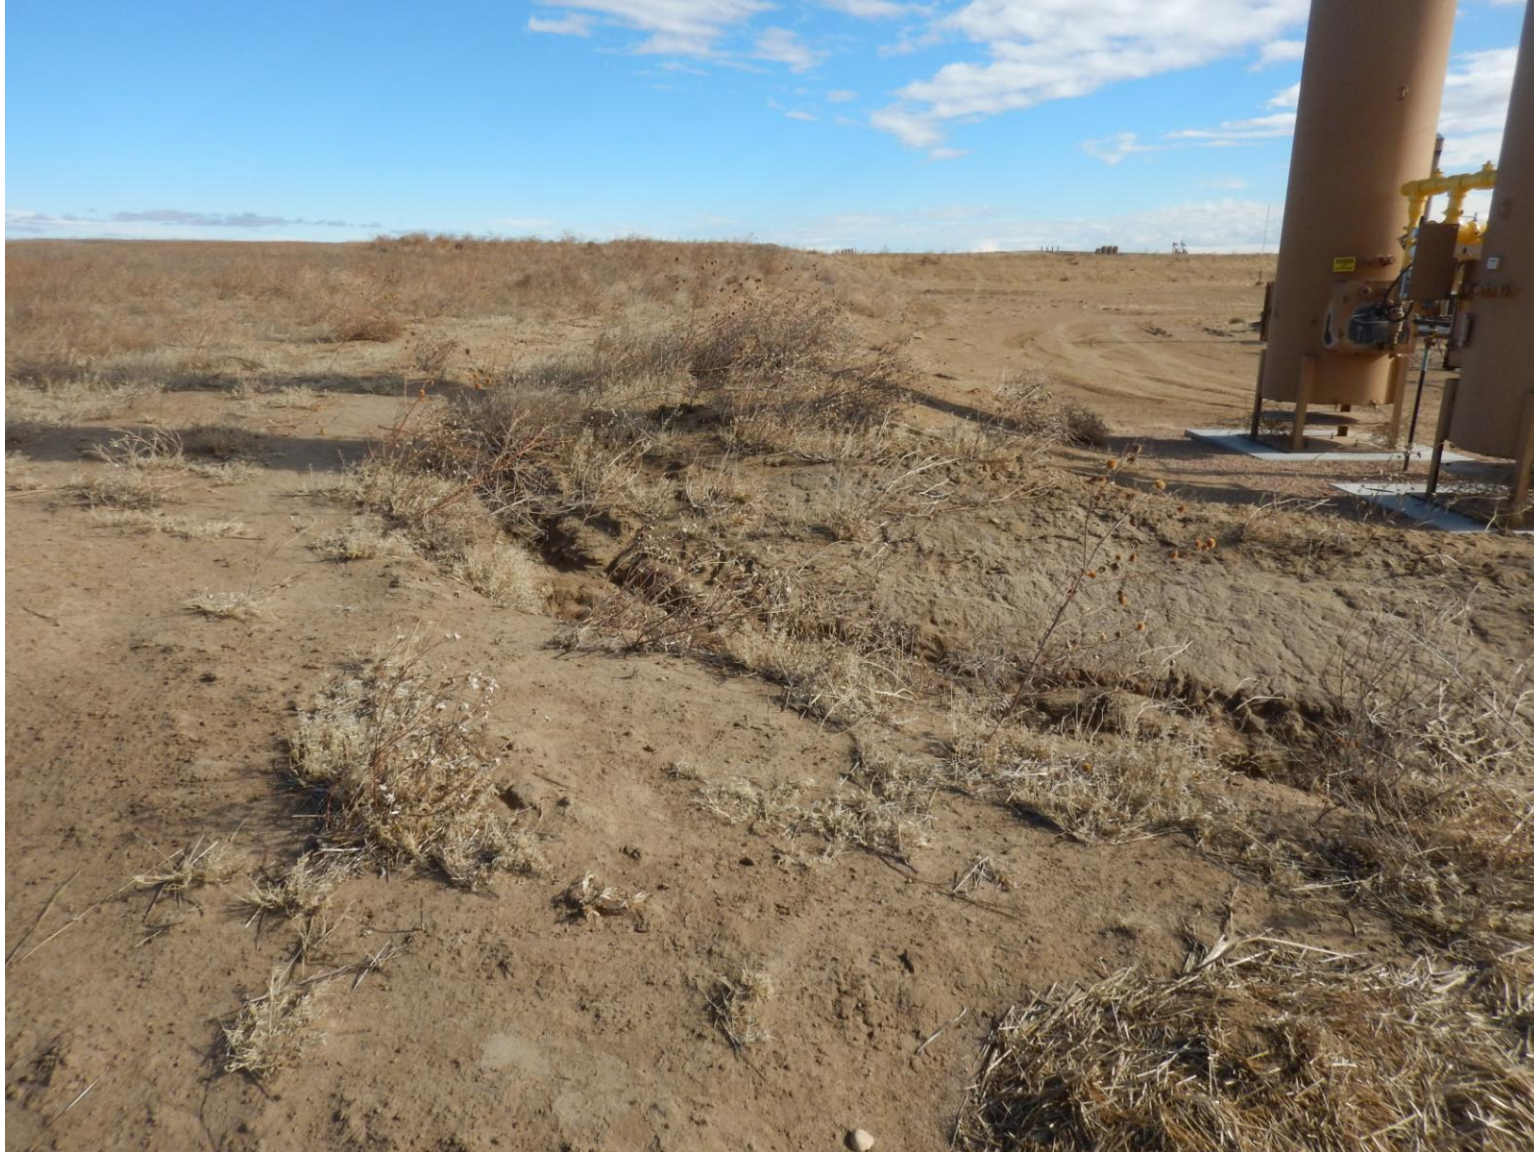
Photo 4: Photo taken from northwest portion of location facing east. Photo shows lack of perennial vegetation.

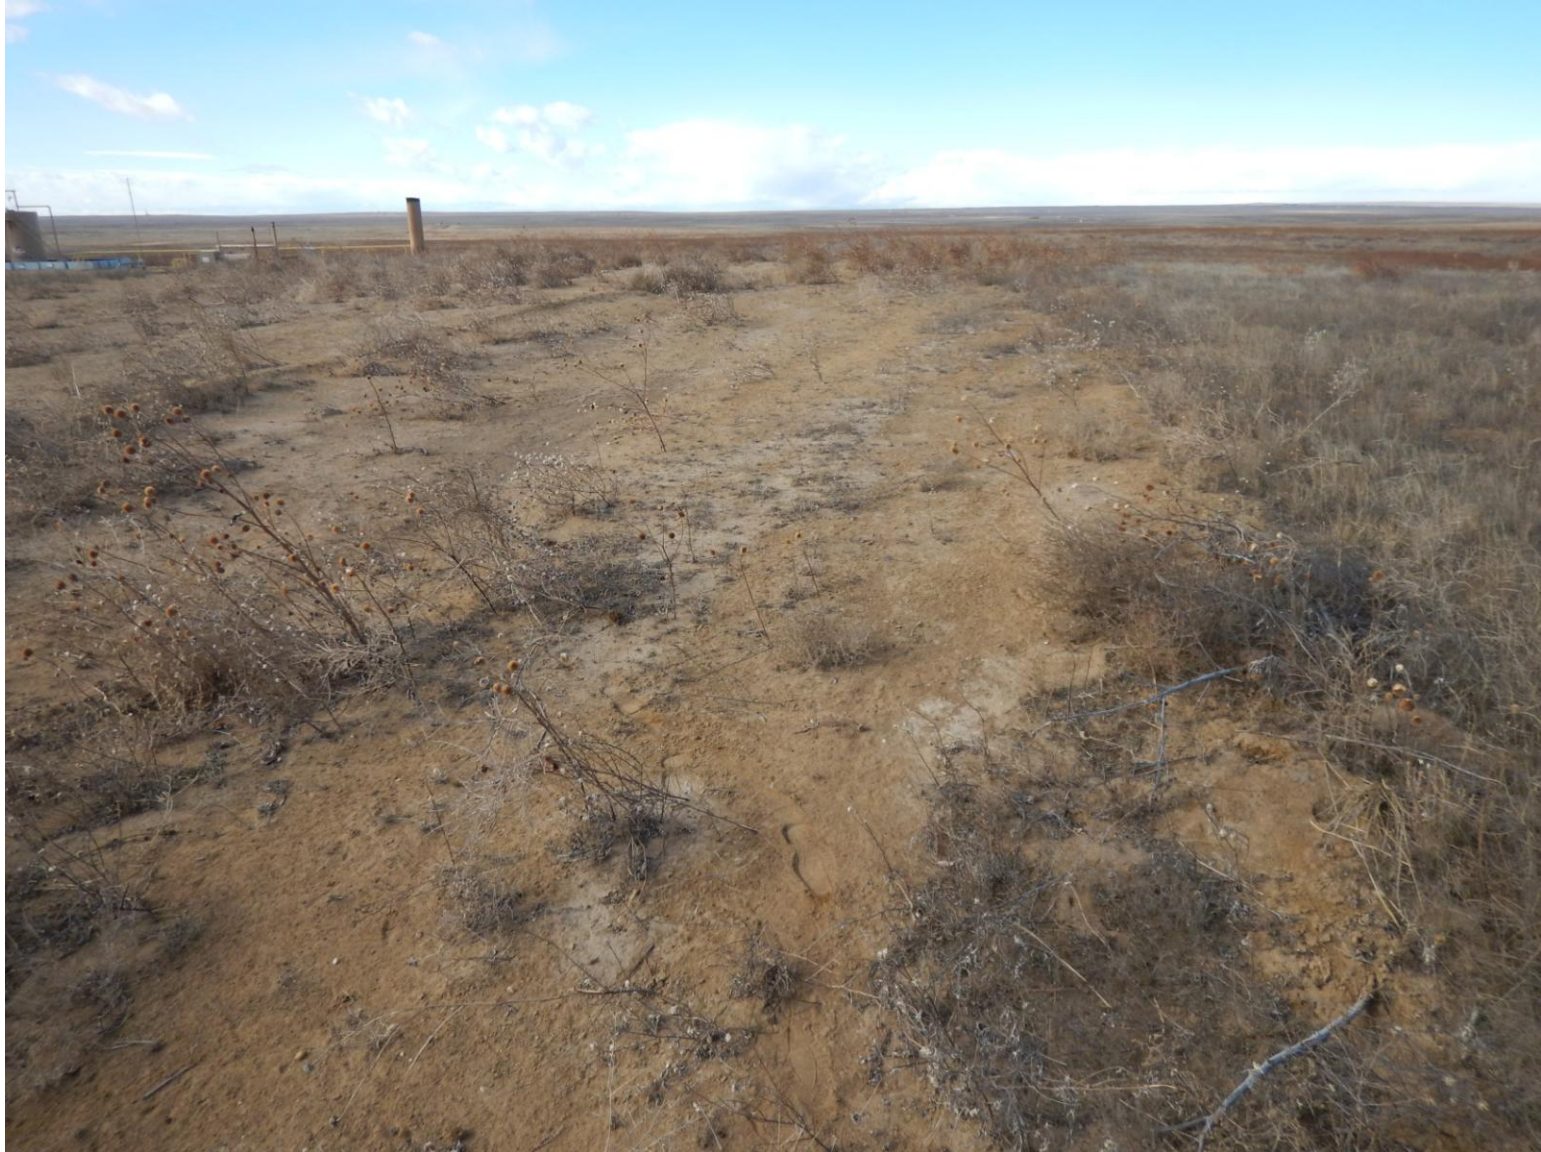
Photo 5: Photo taken from northeastern part of location facing west. Photo shows lack of perennial vegetation.

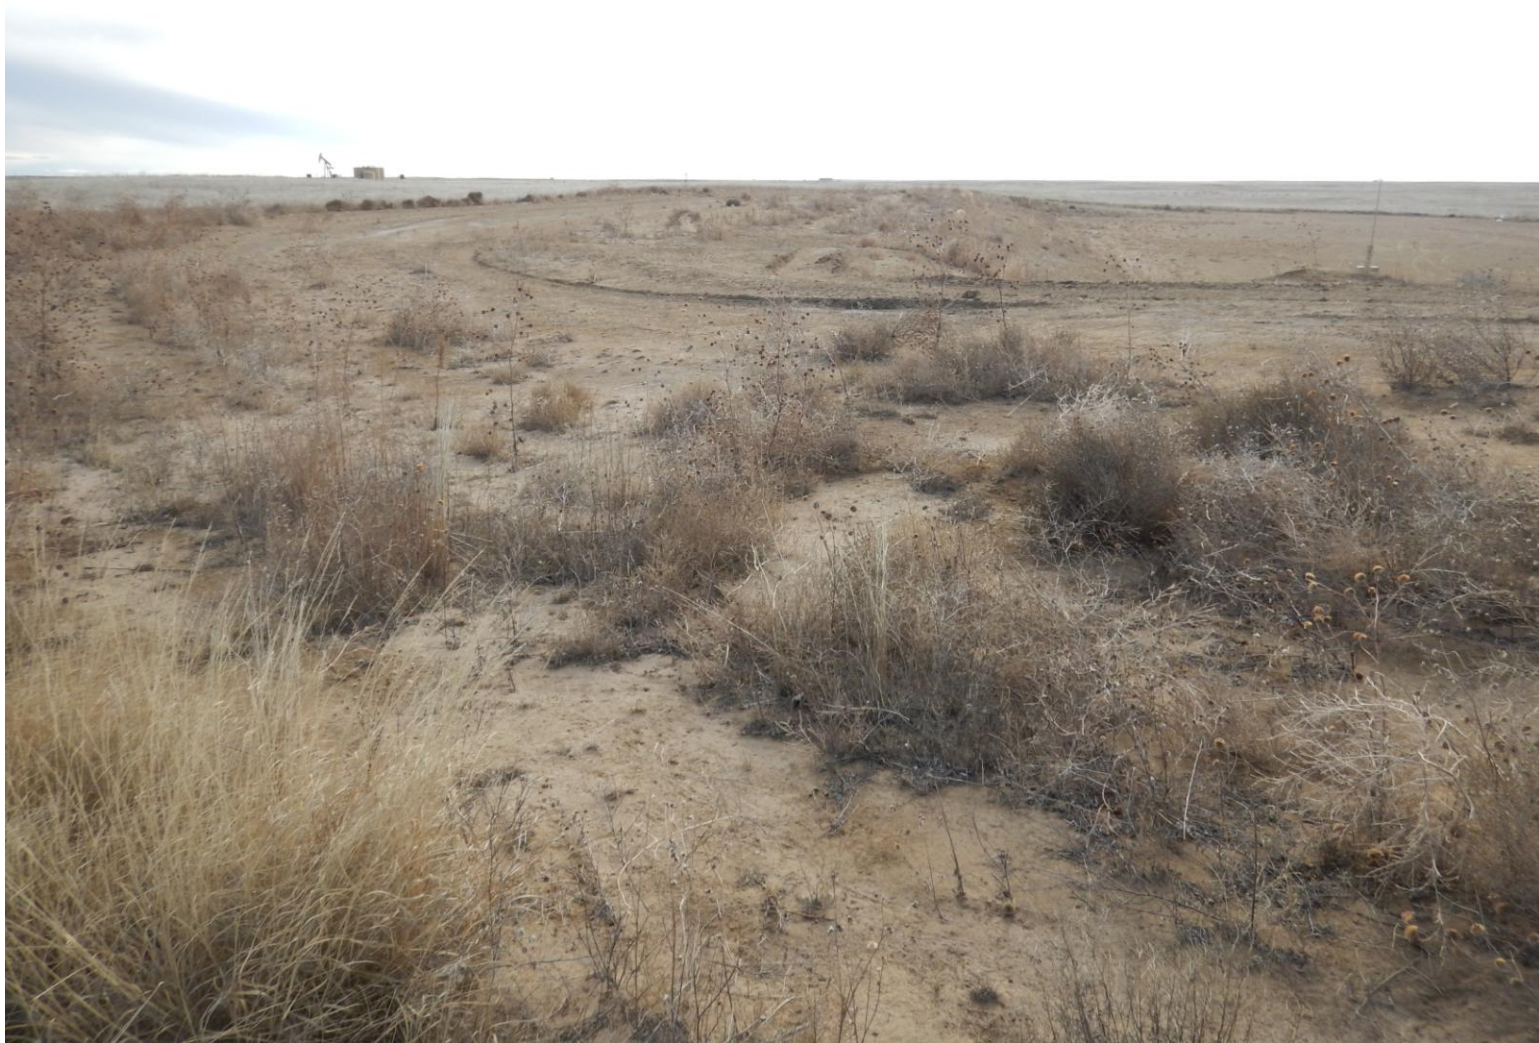
Photo 6: Photo taken from northeastern part of location facing south. Photo shows lack of perennial vegetation. Vegetation predominantly Russian thistle.

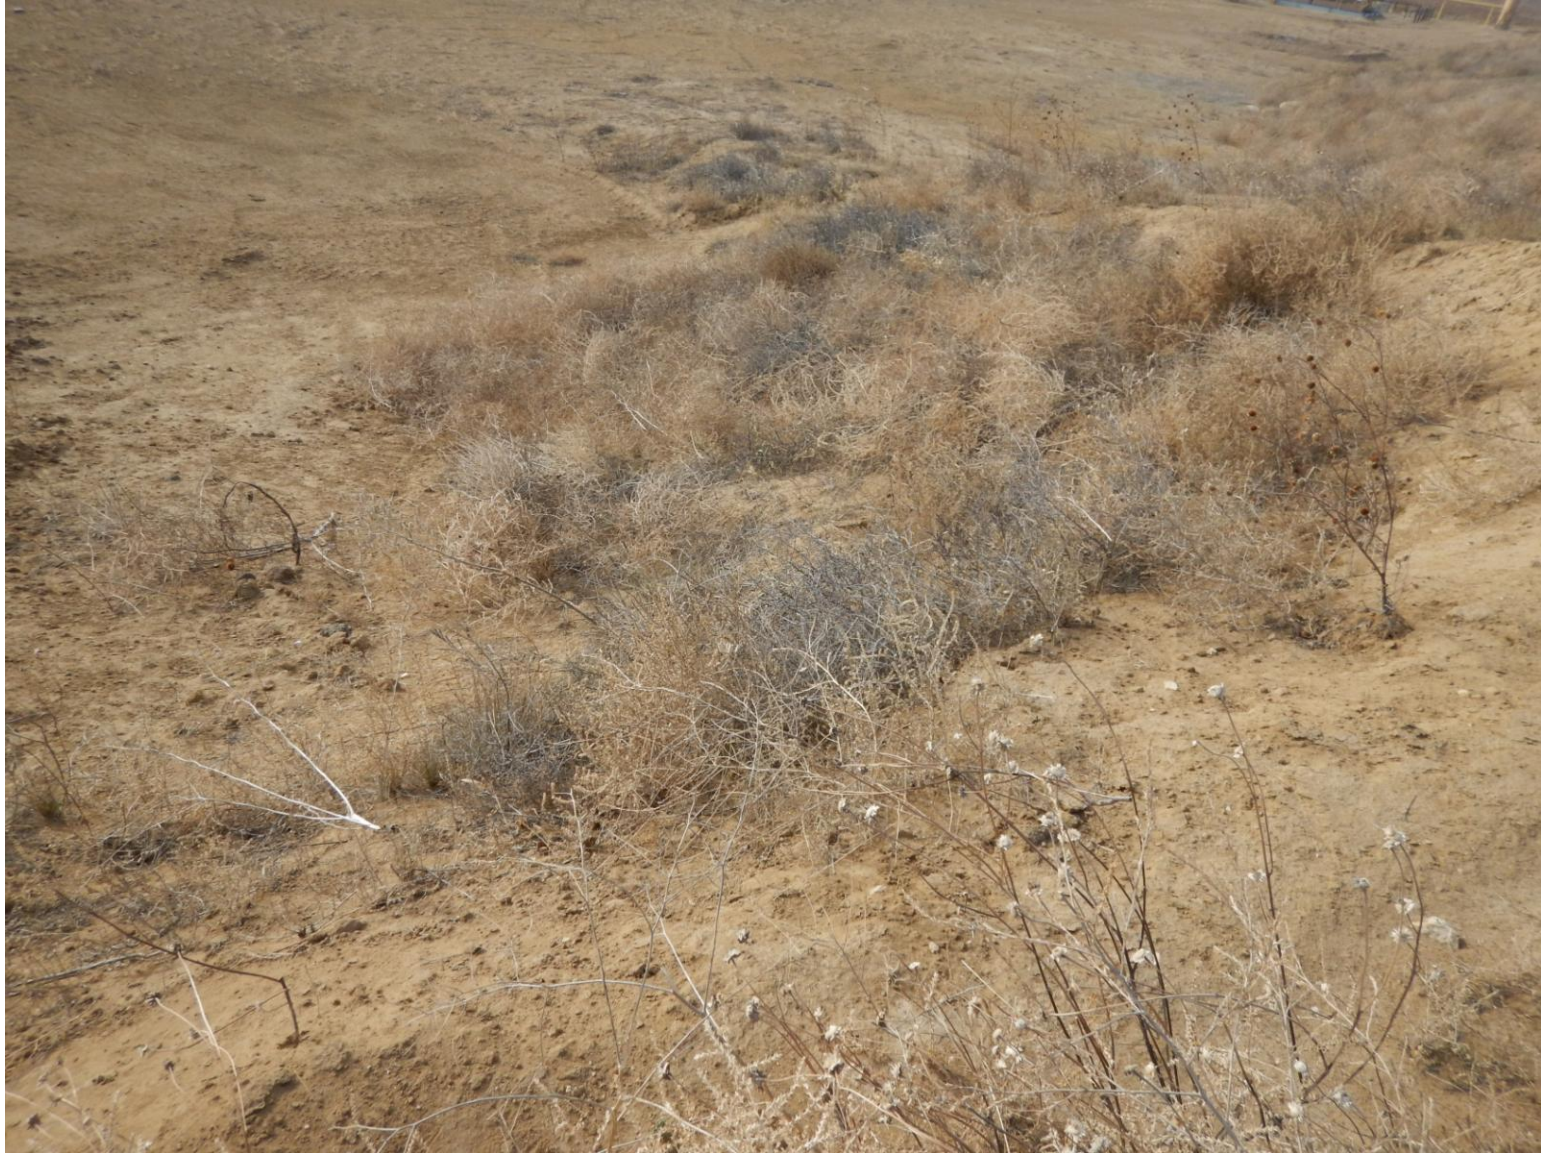
Photo 7: Photo taken from northern part of location. Photo of Russian thistle weed debris.

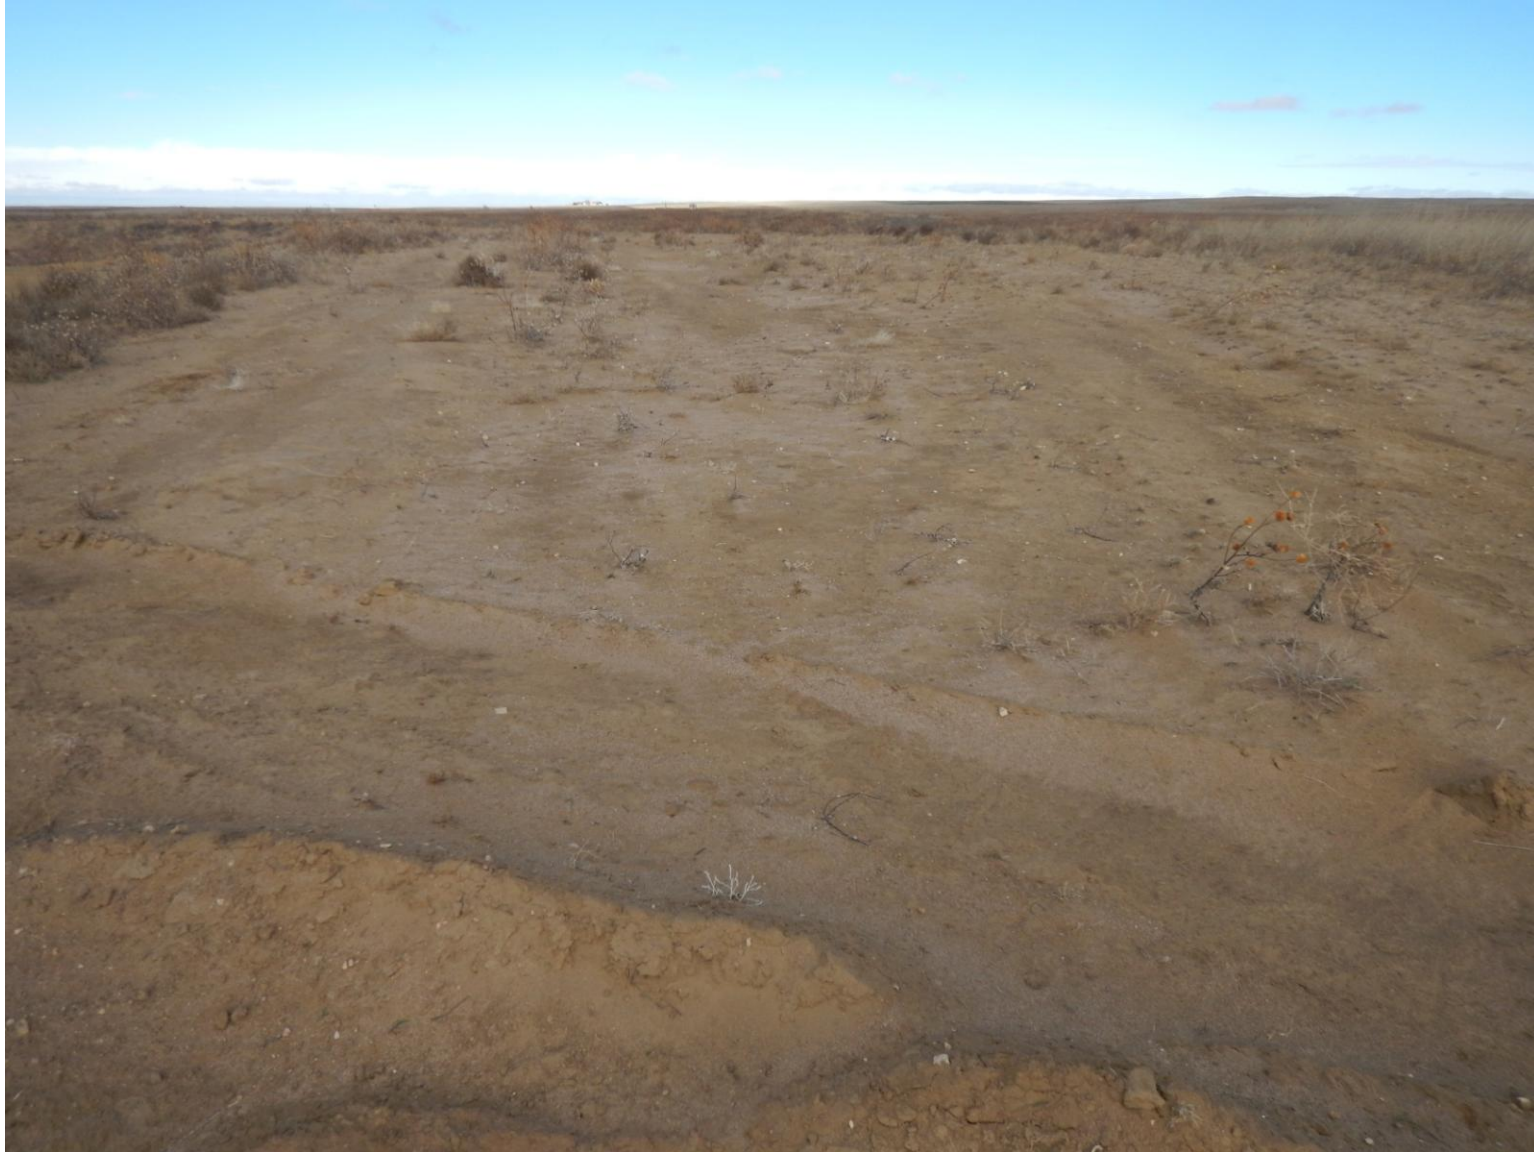
Photo 8: Photo taken from southeastern part of location, facing north. Photo shows lack of perennial vegetation.

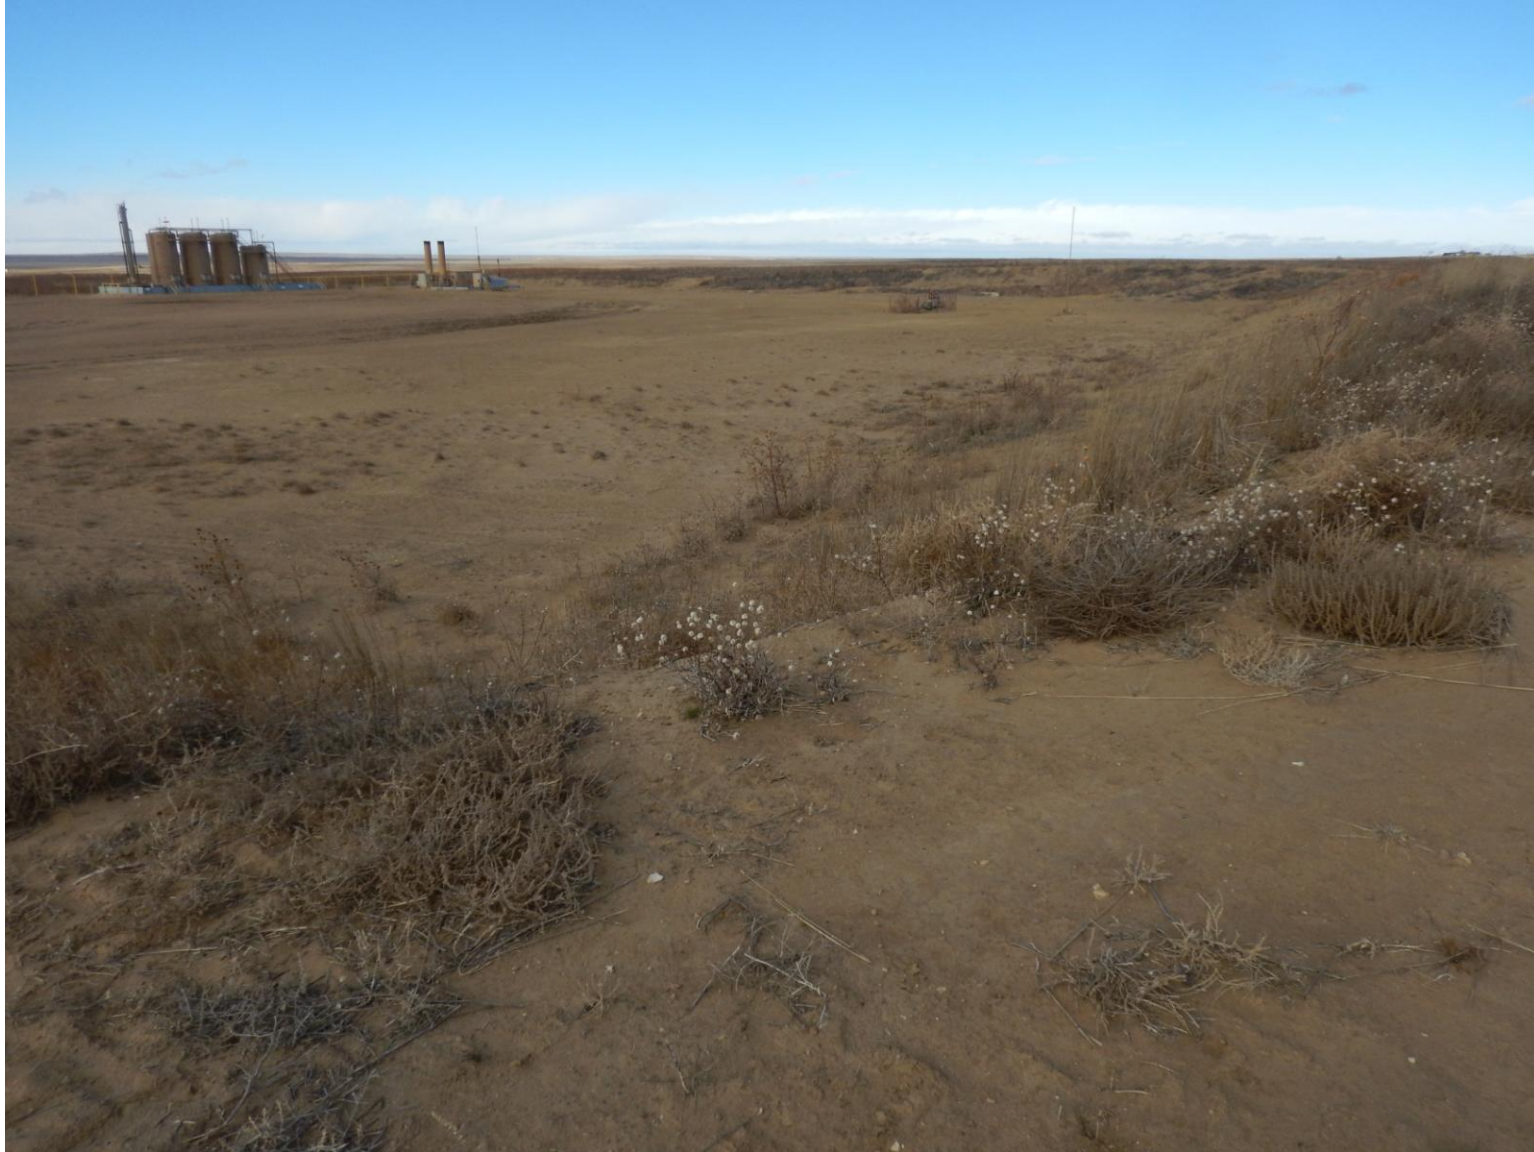
Photo 9: Photo taken from southeastern part of location, facing northwest. Photo shows lack of perennial vegetation, vegetation is predominantly Russian thistle. Photo also shows large areas of location not needed for production not reclaimed.

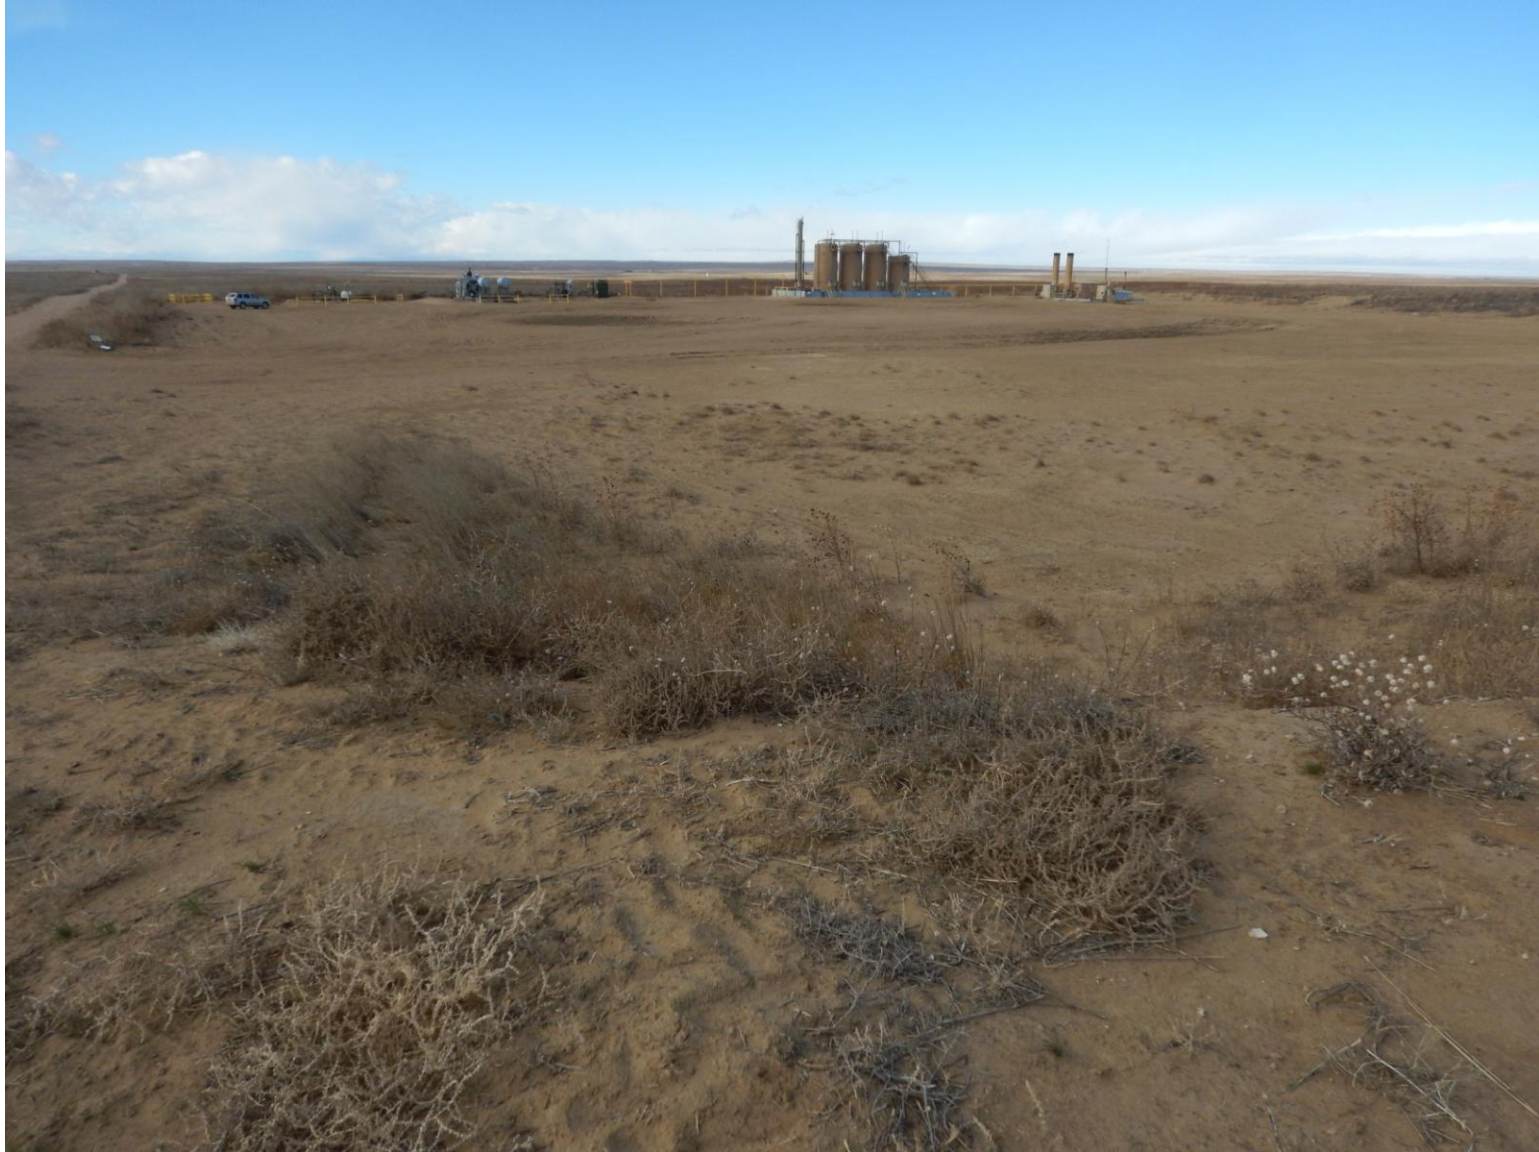
Photo 10: Photo taken from southeastern part of location, facing northwest. Photo shows lack of perennial vegetation, vegetation is predominantly Russian thistle. Photo also shows large areas of location not needed for production not reclaimed.

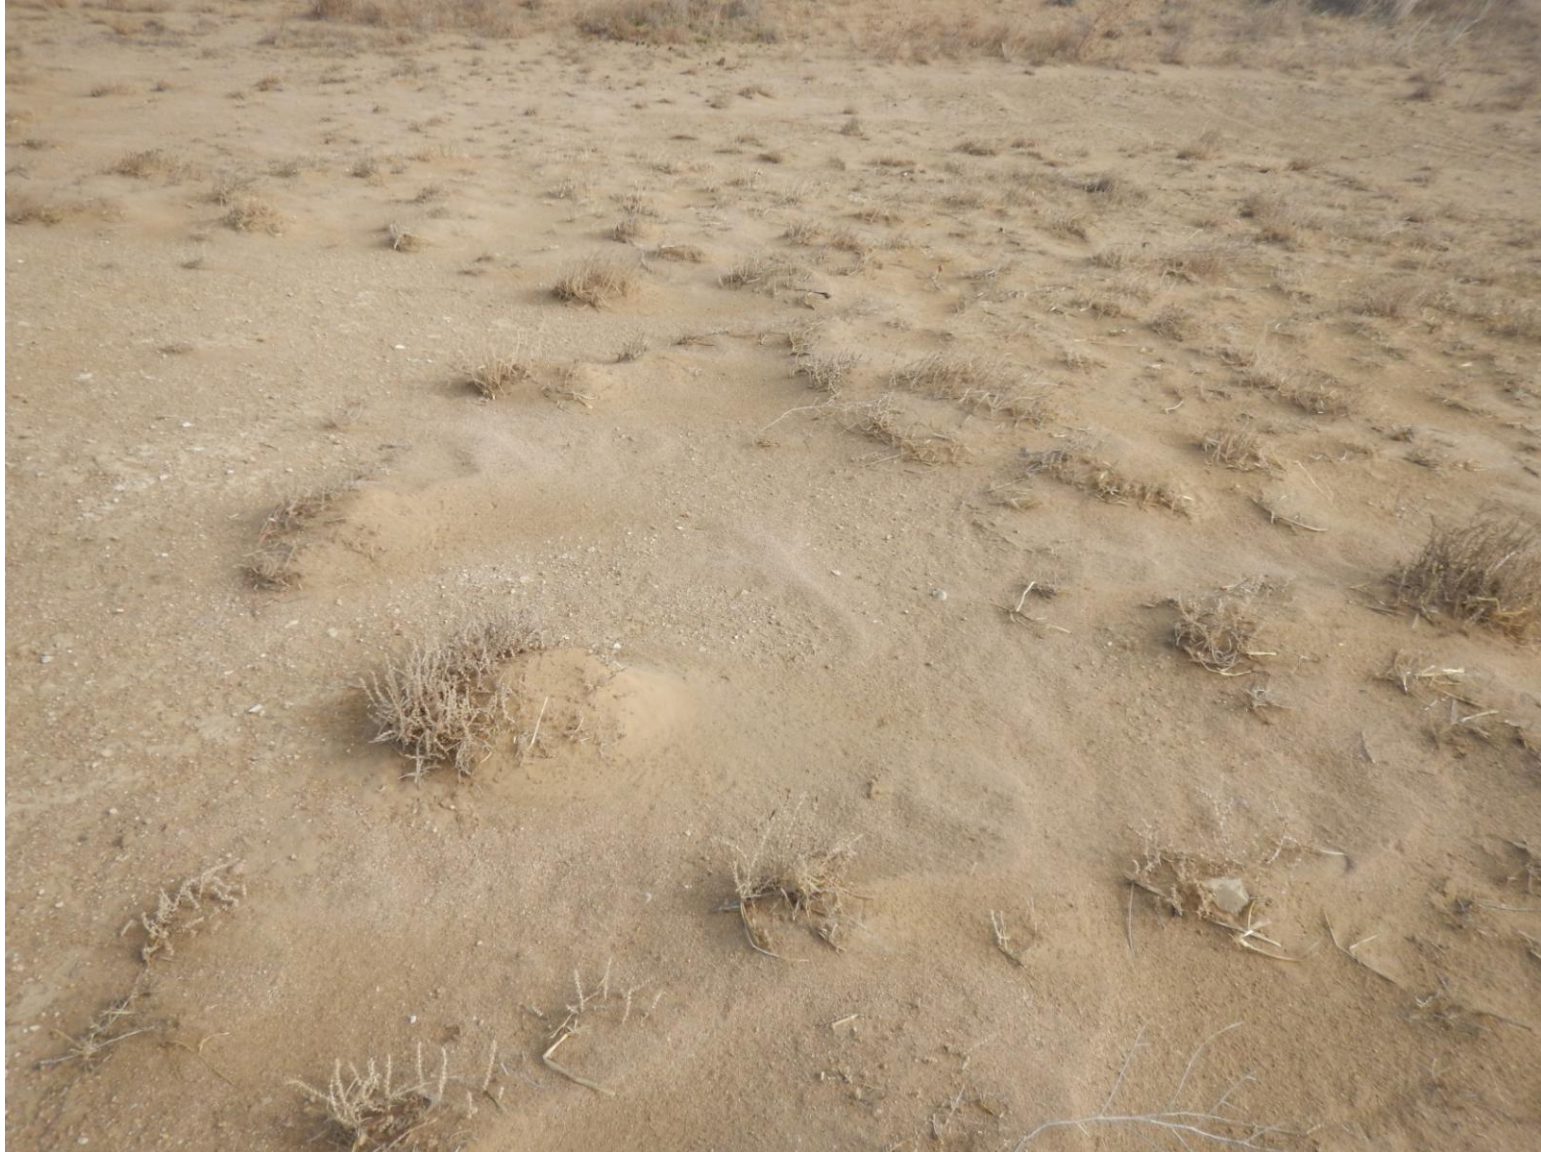
Photo 11: Photo taken on eastern part of location. Photo shows eolian deposits (wind erosion) of sand on side of Kochia weed debris.

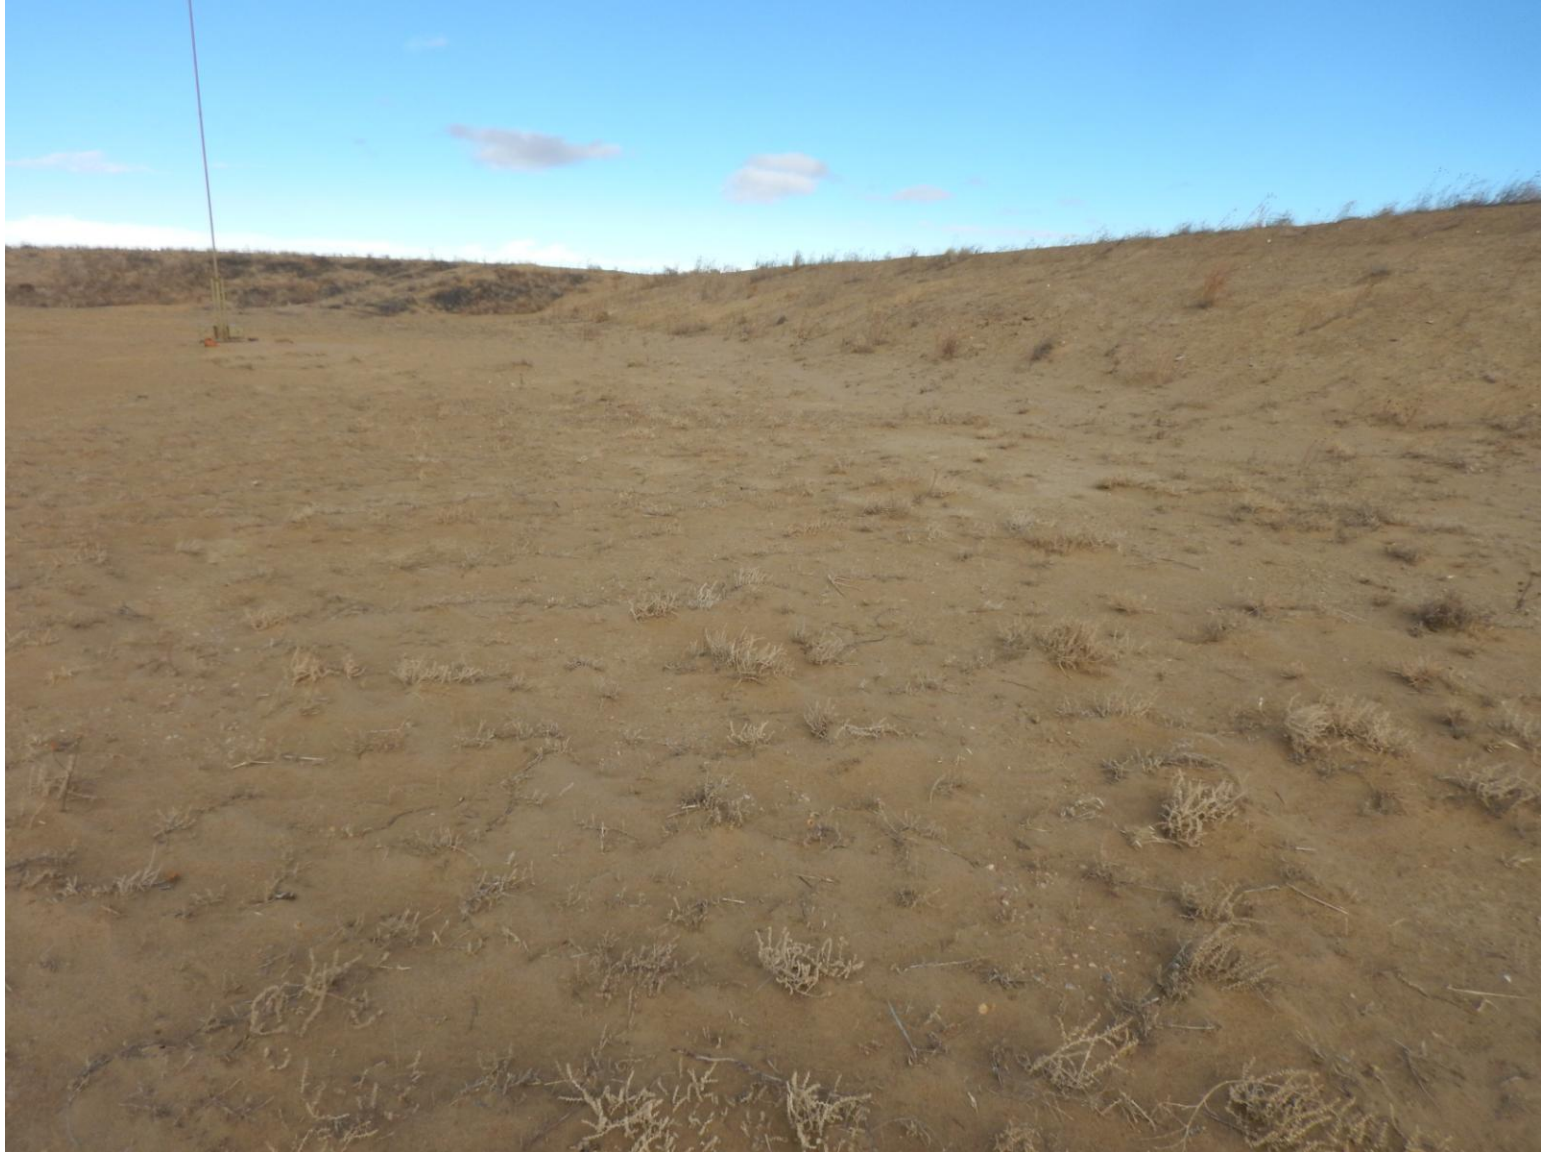
Photo 12: Photo taken from eastern end of location. Photo shows lack of perennial vegetation.

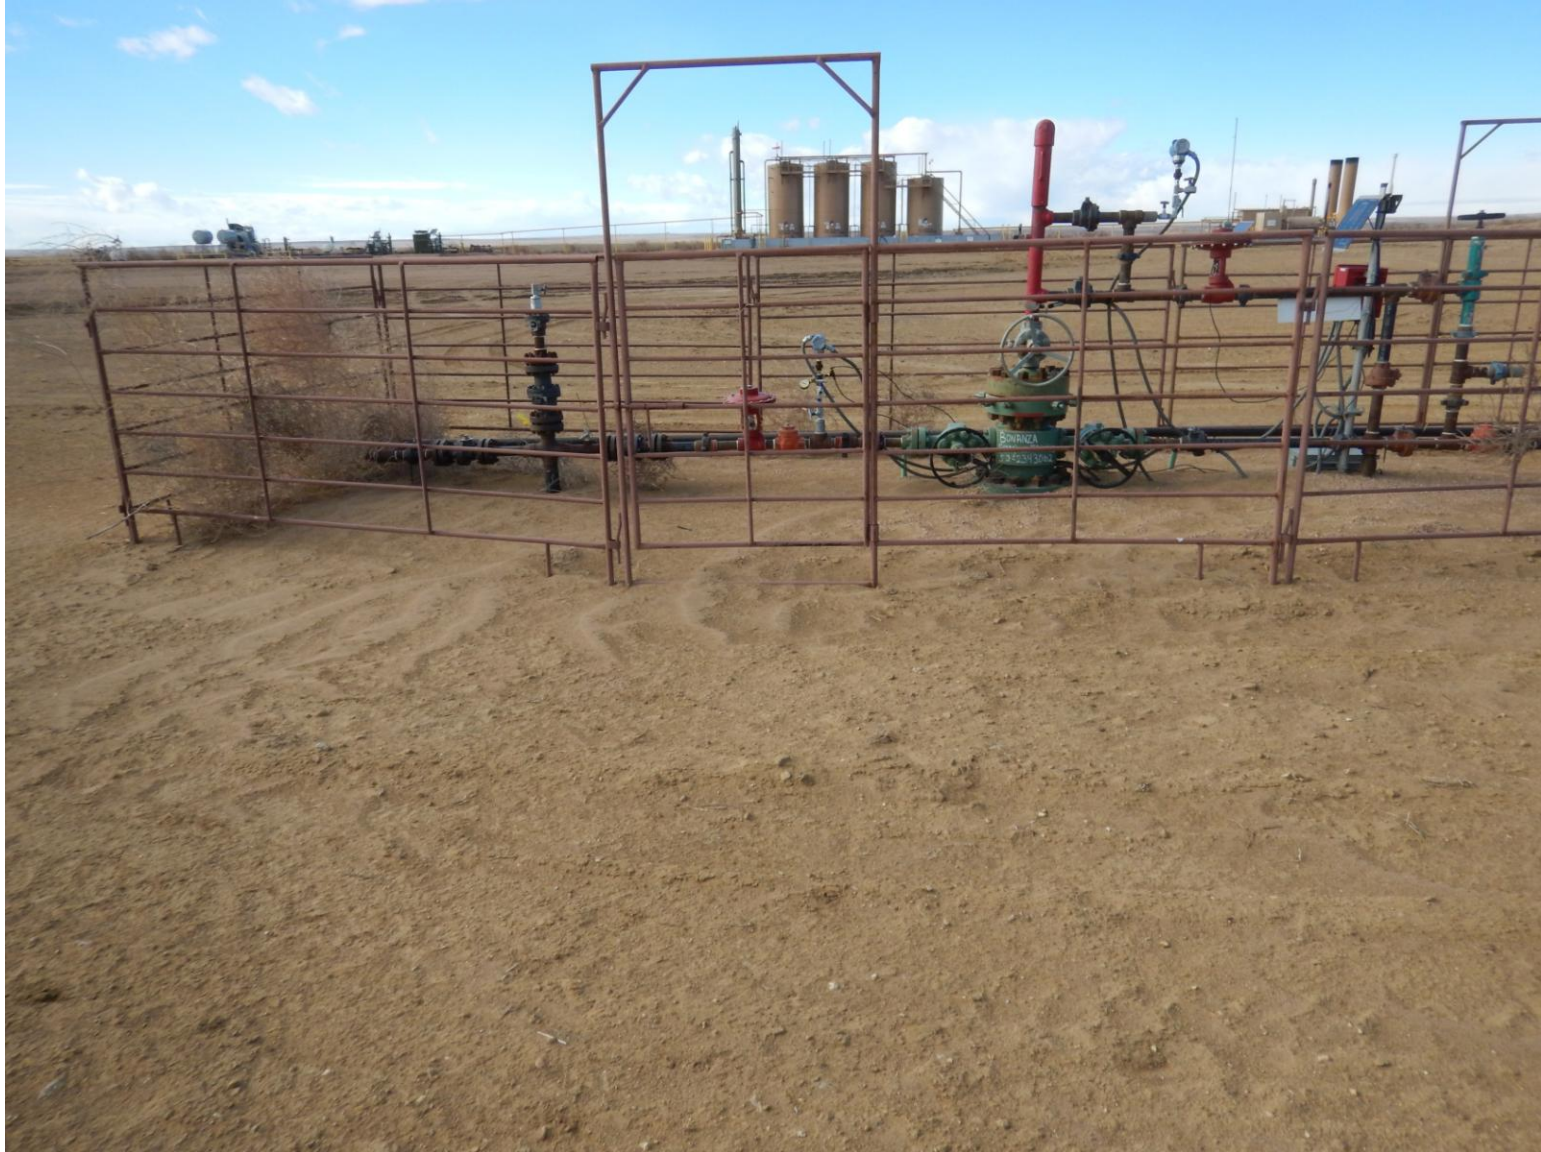
Photo 13: Photo taken at well on location. Photo shows weed debris in equipment.
