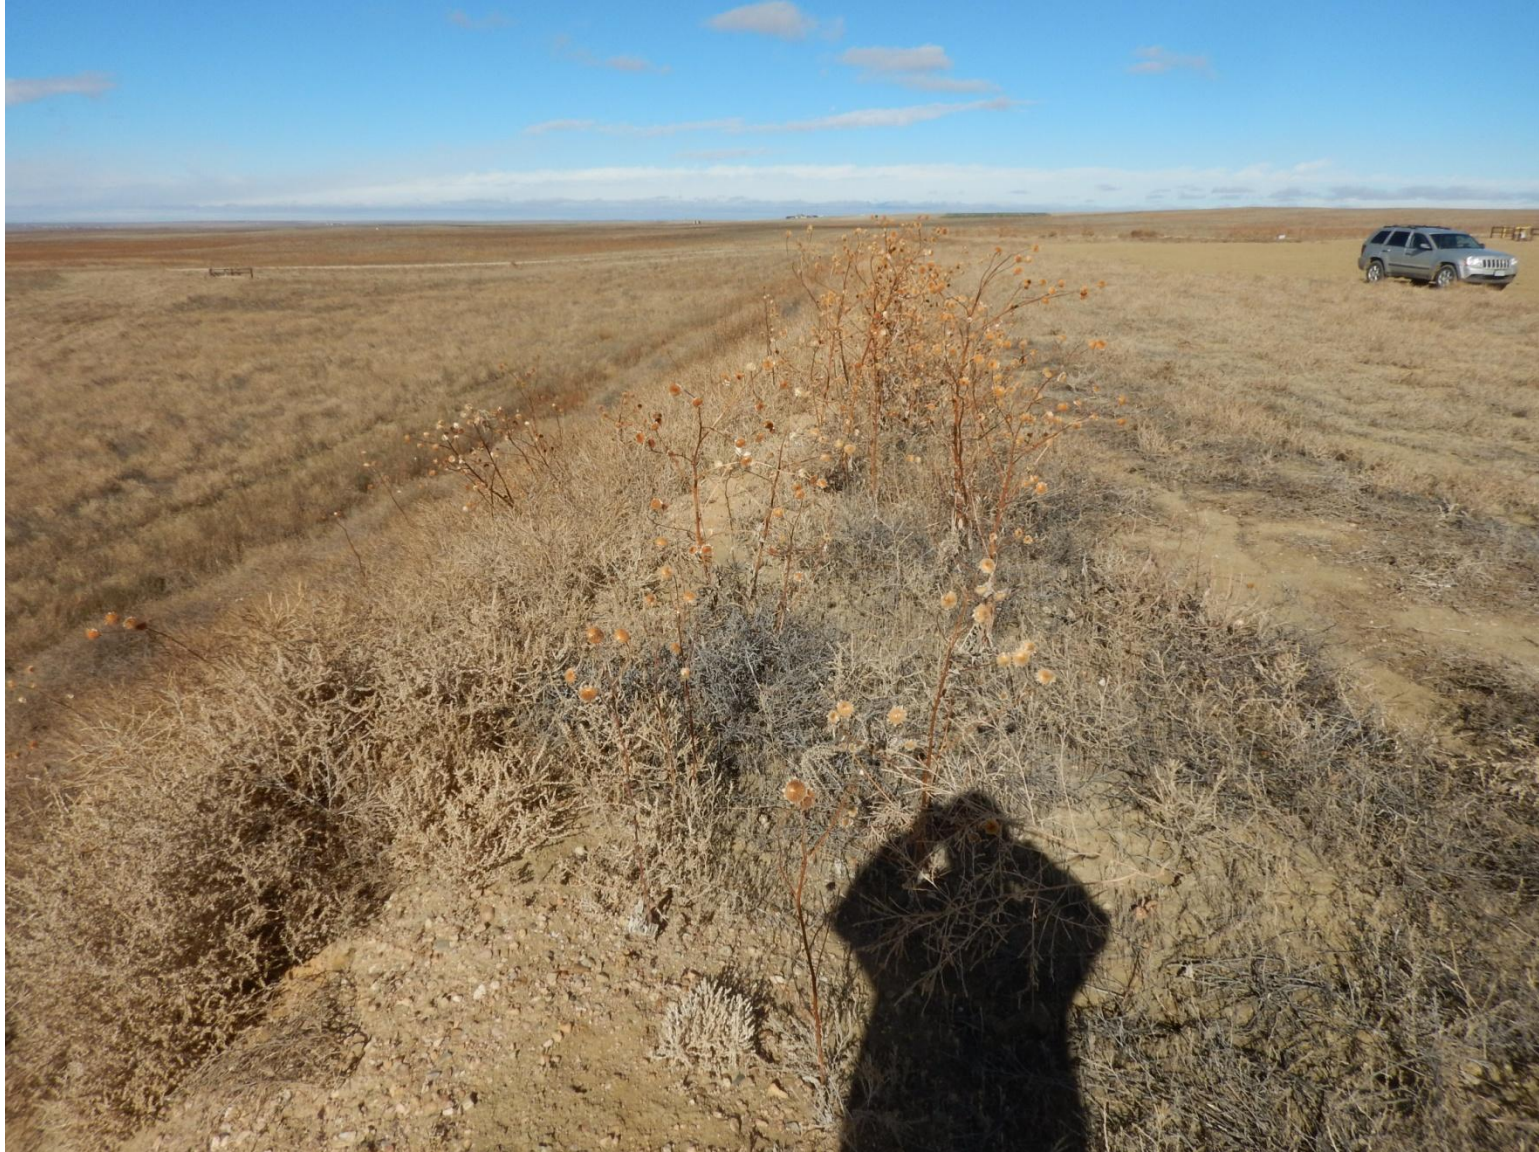
Photo 1: Photo taken from southwest portion of location facing north. Note the lack of perennial vegetation. Vegetation primarily Russian thistle.

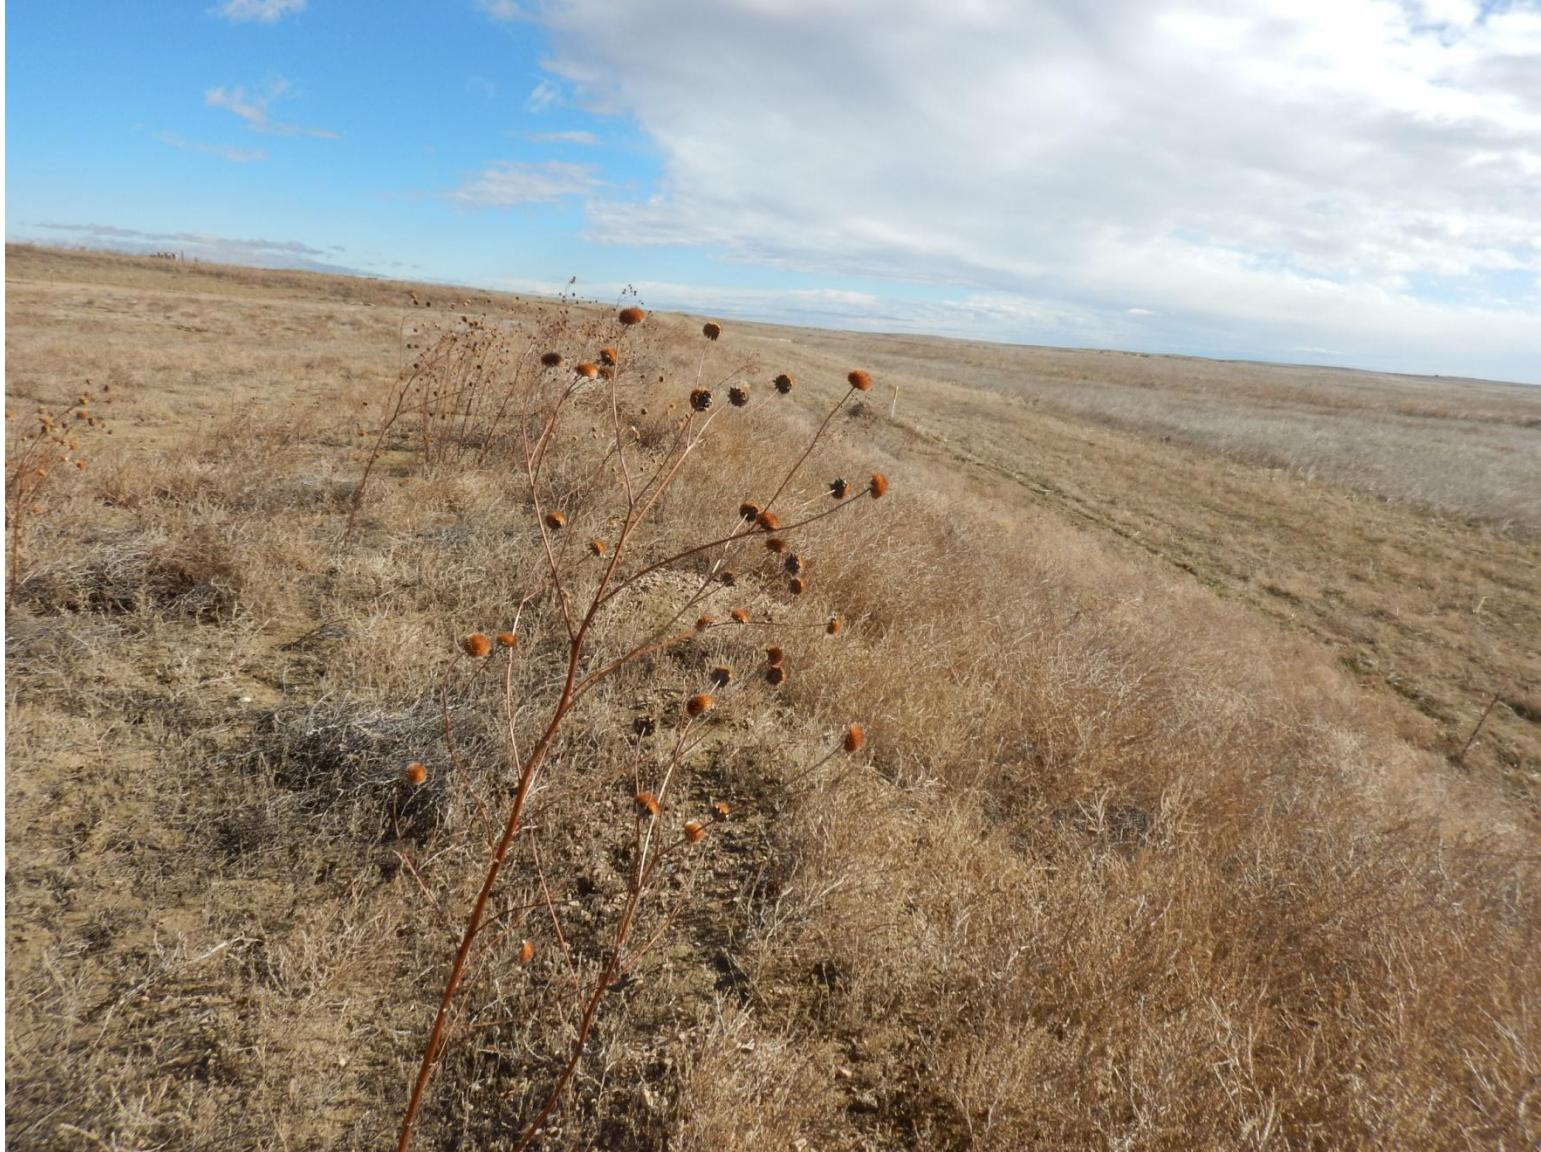
Photo 2: Photo taken from southwest portion of location, facing east. Note the lack of perennial vegetation. Vegetation primarily Russian thistle.

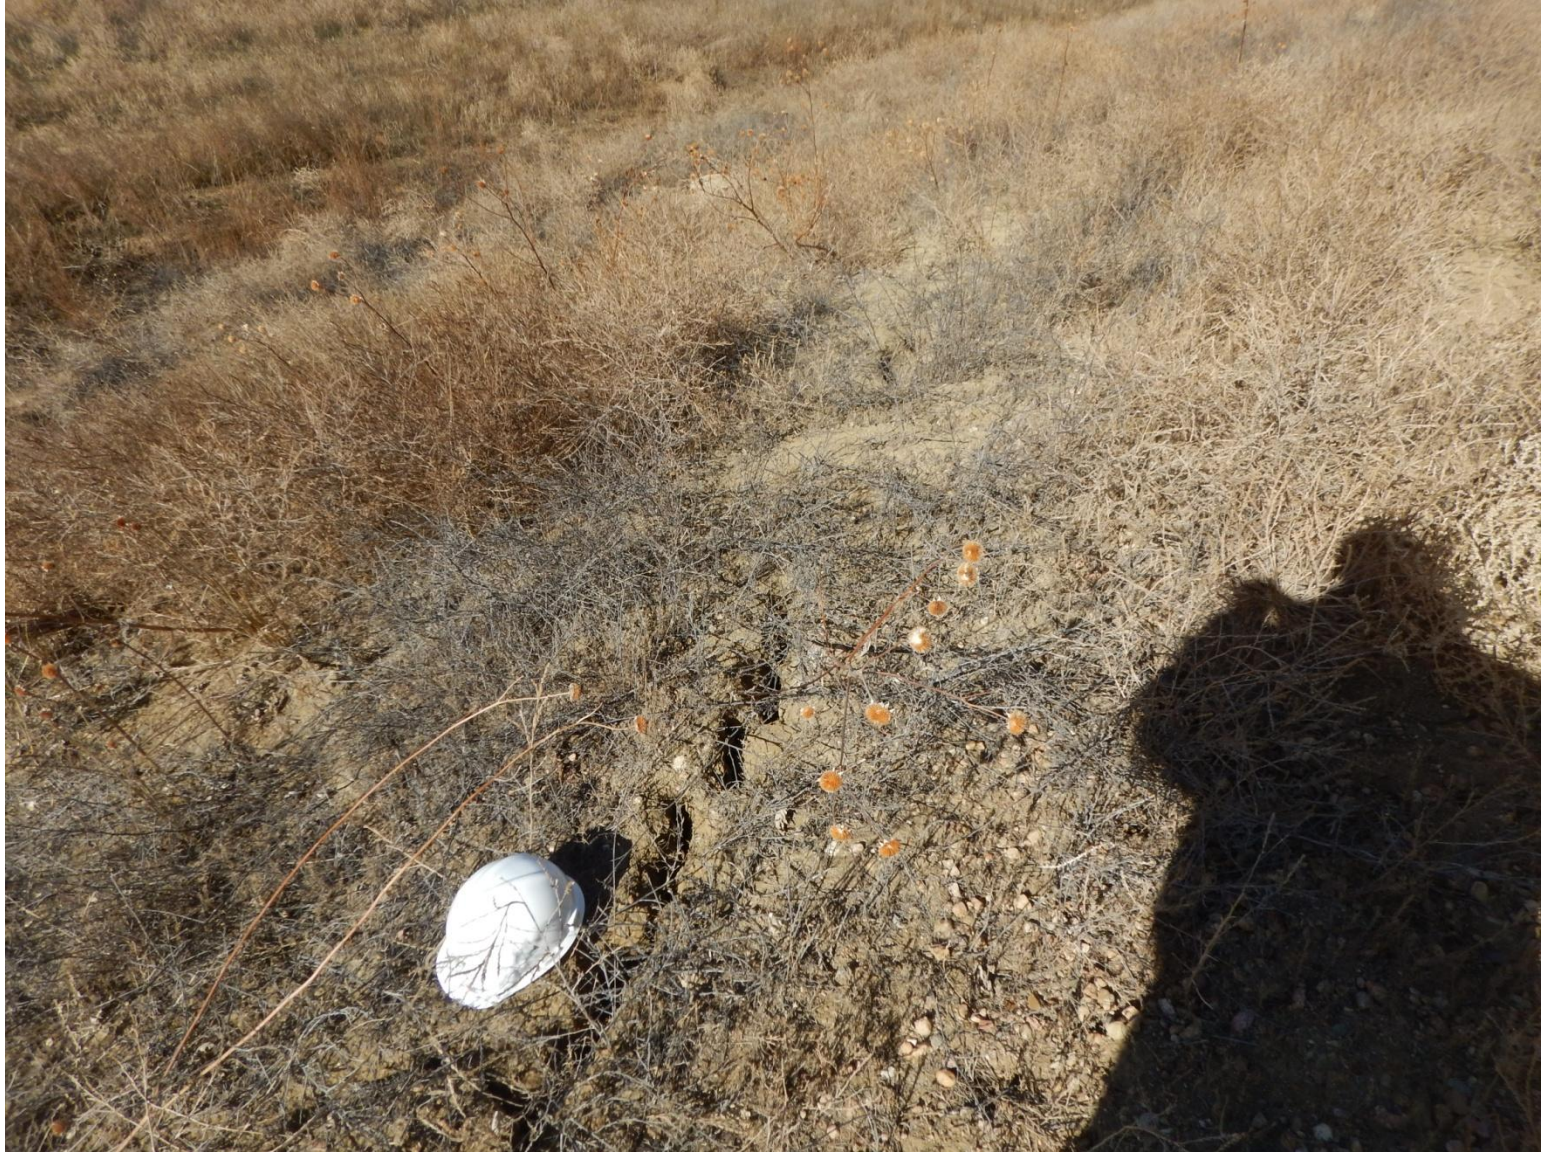
Photo 3: Photo taken from western side of location. Photo shows crack forming on slope, this is an indication of soil erosion occurring on slope.

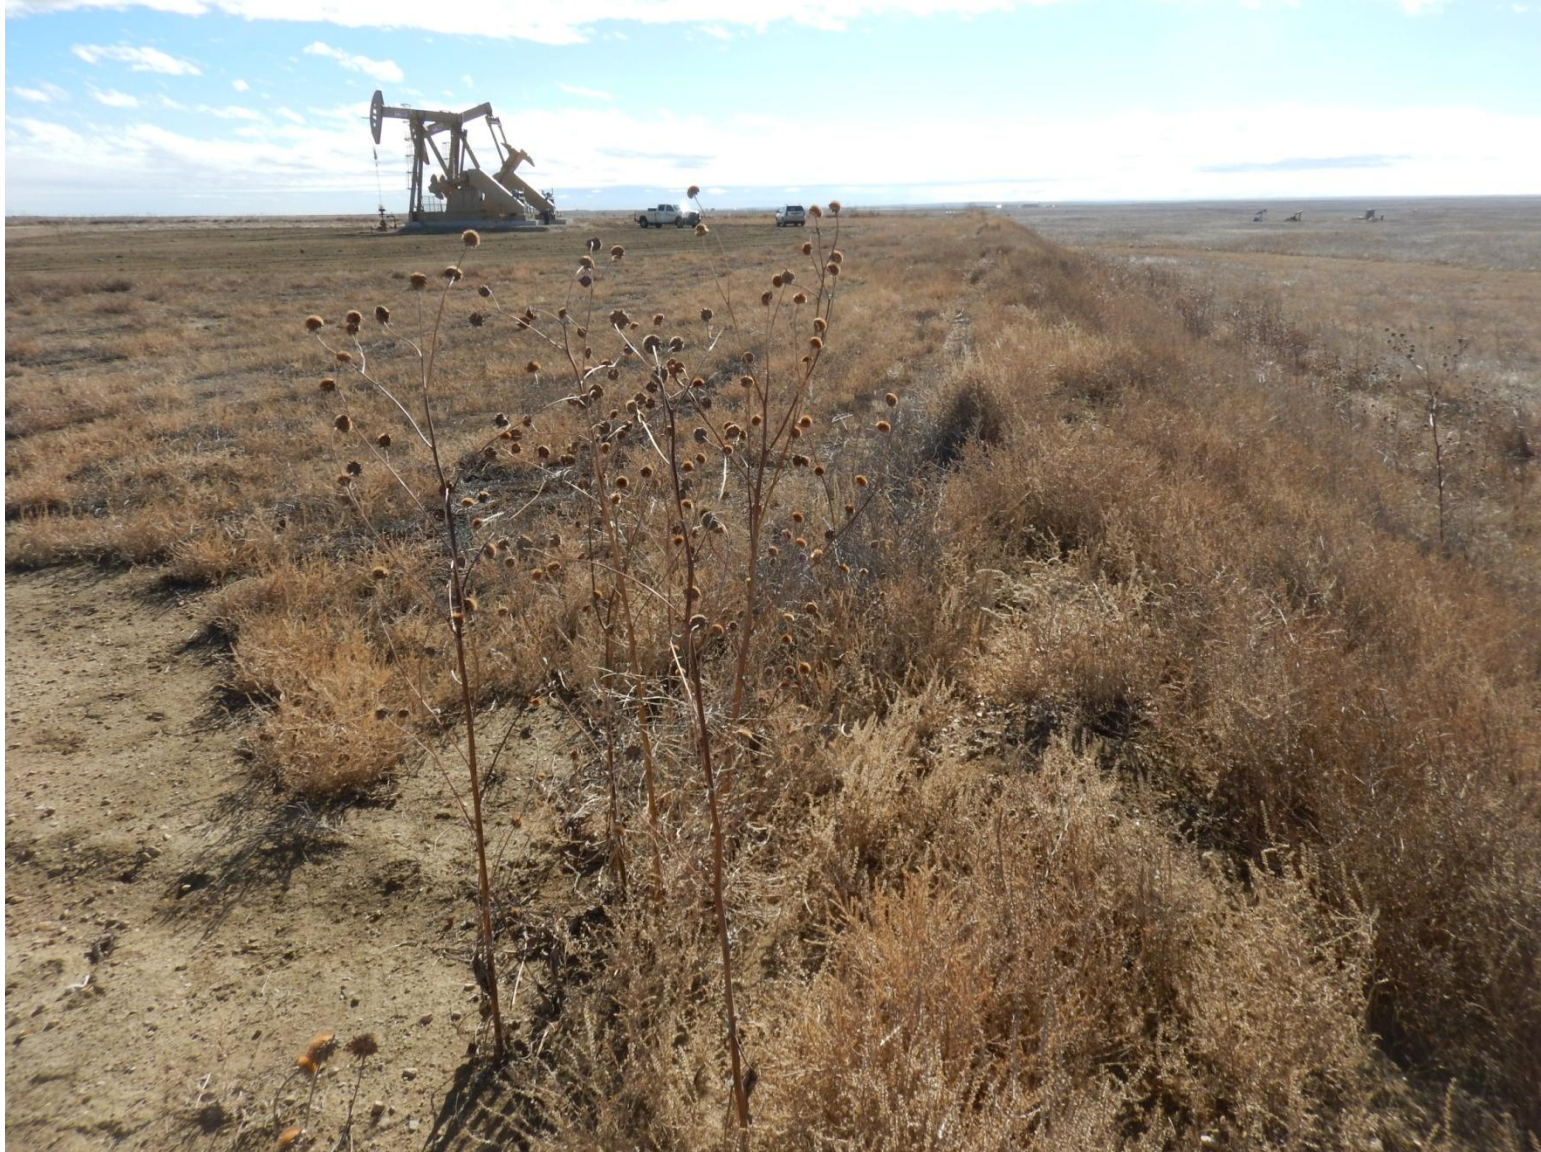
Photo 4: Photo taken from northwest portion of location facing south. Photo shows lack of perennial vegetation. Vegetation predominantly Russian thistle.

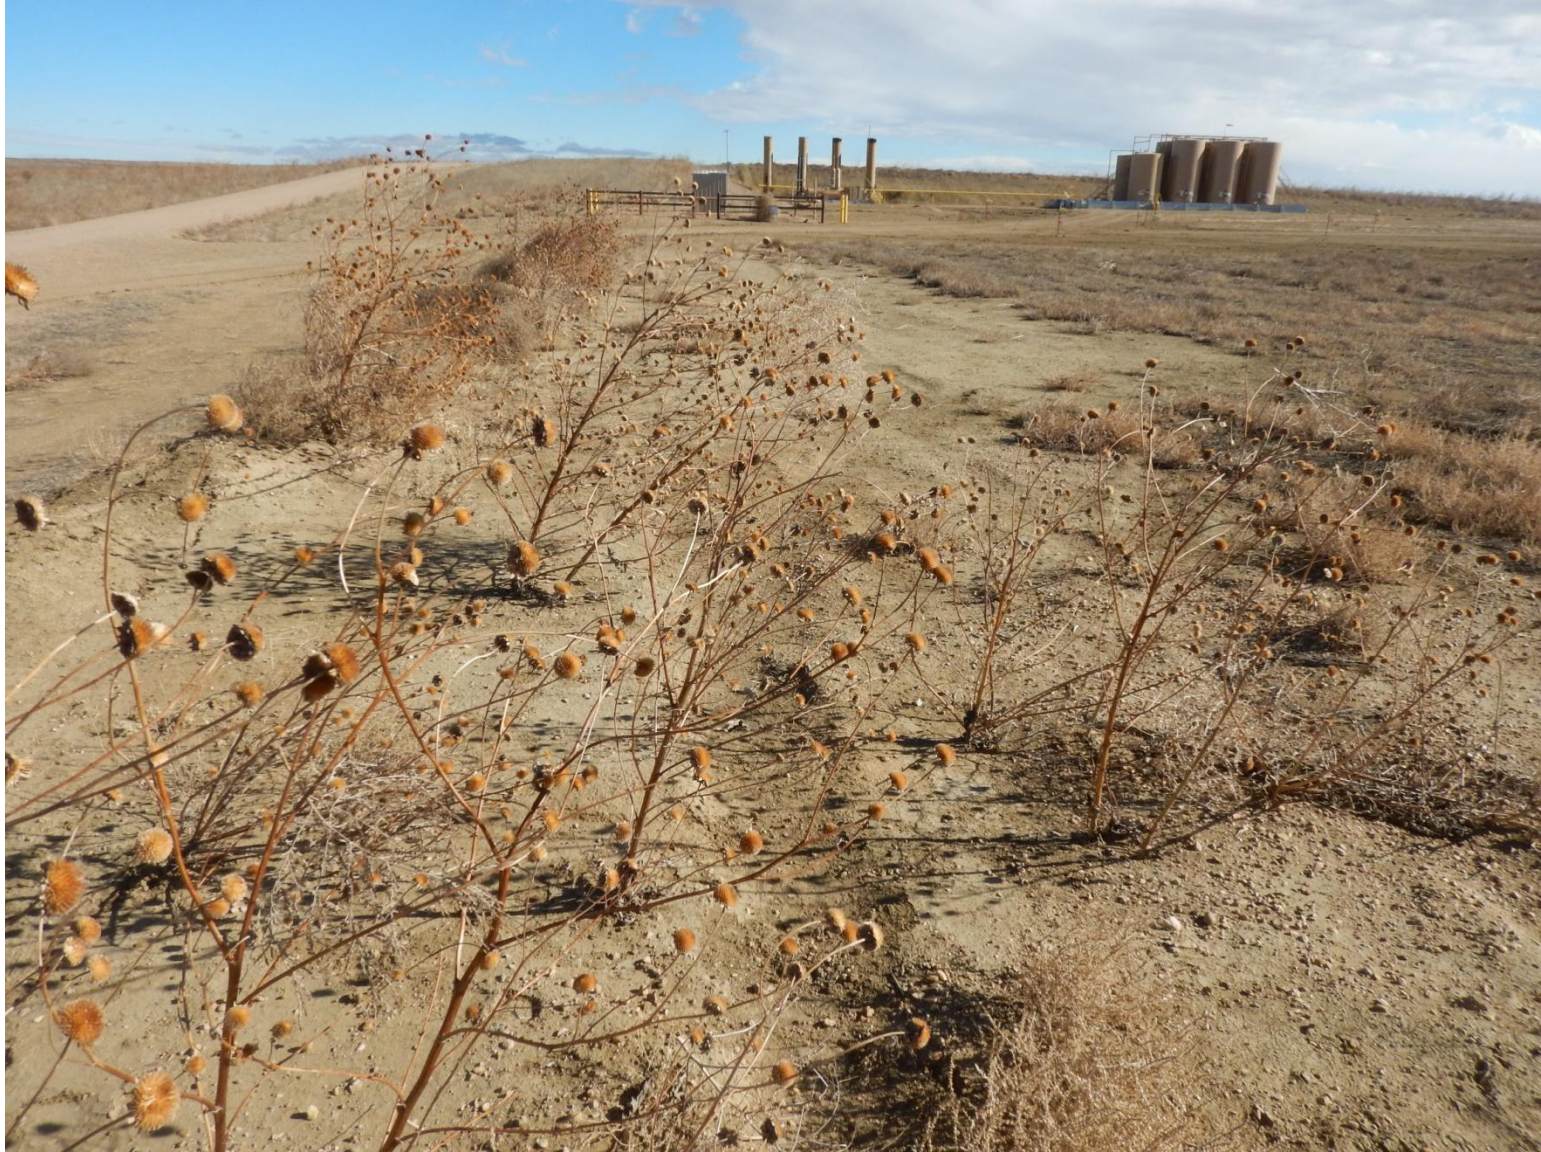
Photo 5: Photo taken from northeastern part of location facing east. Photo shows lack of perennial vegetation.

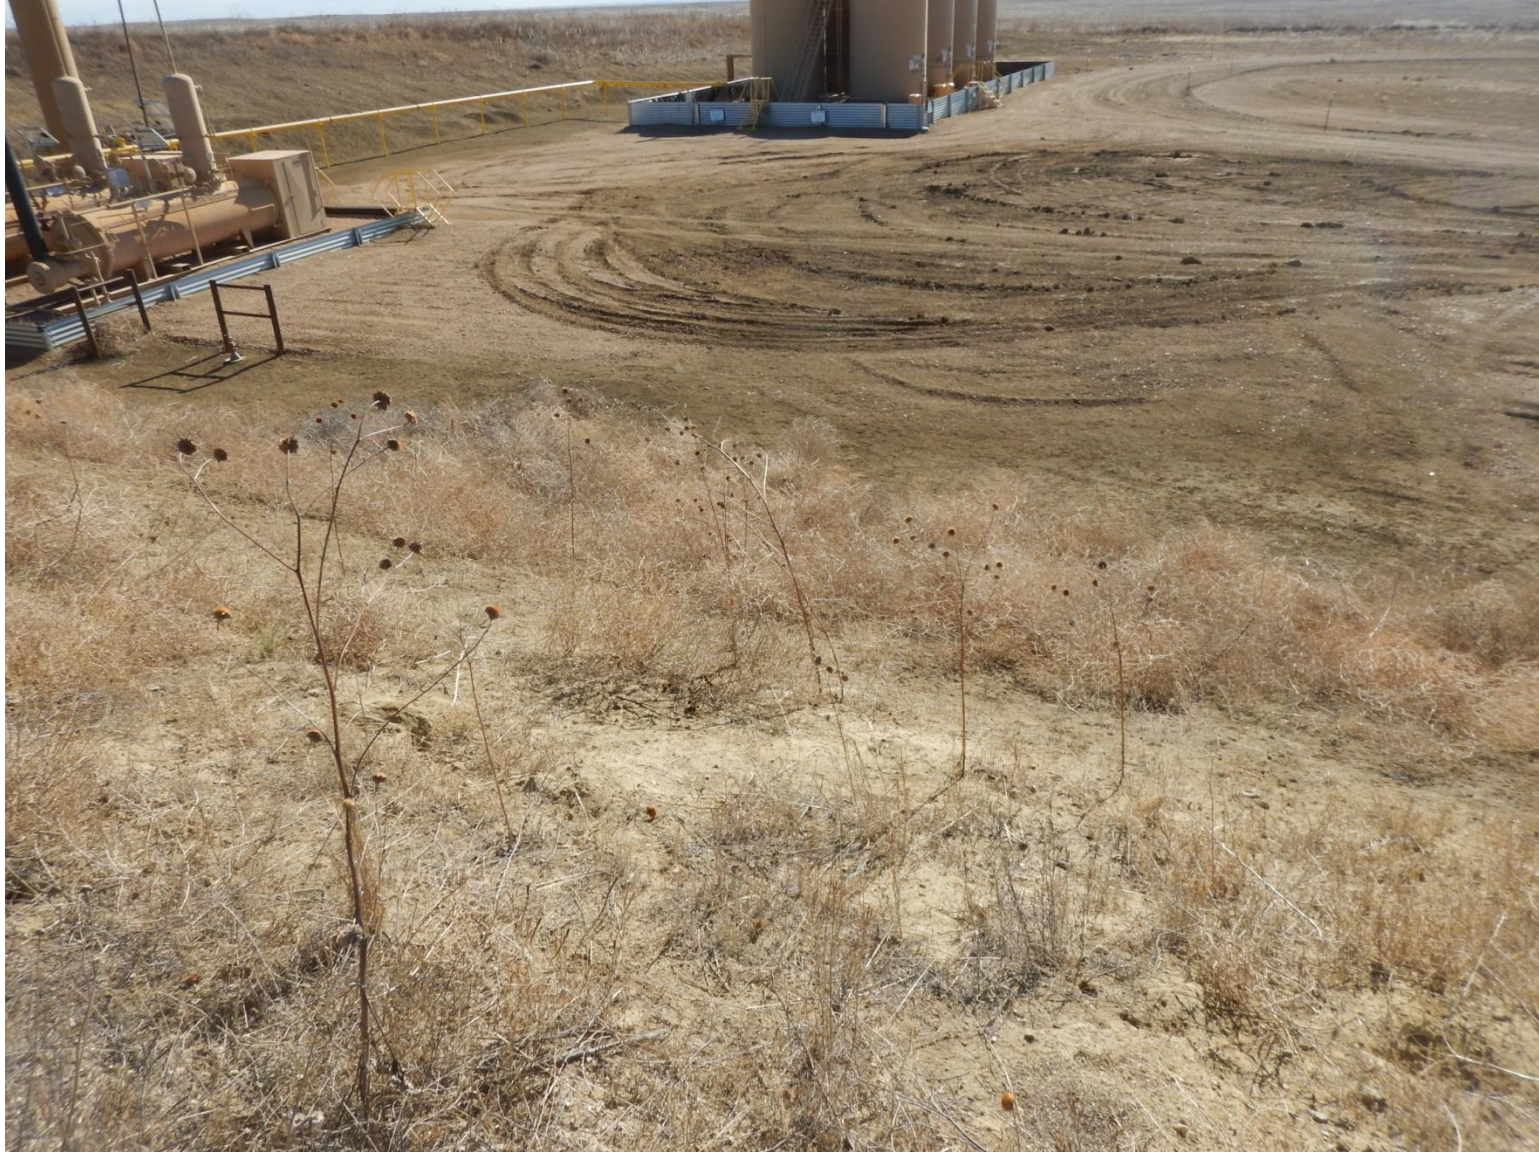
Photo 6: Photo taken from northern end of location. Photo of weed debris.

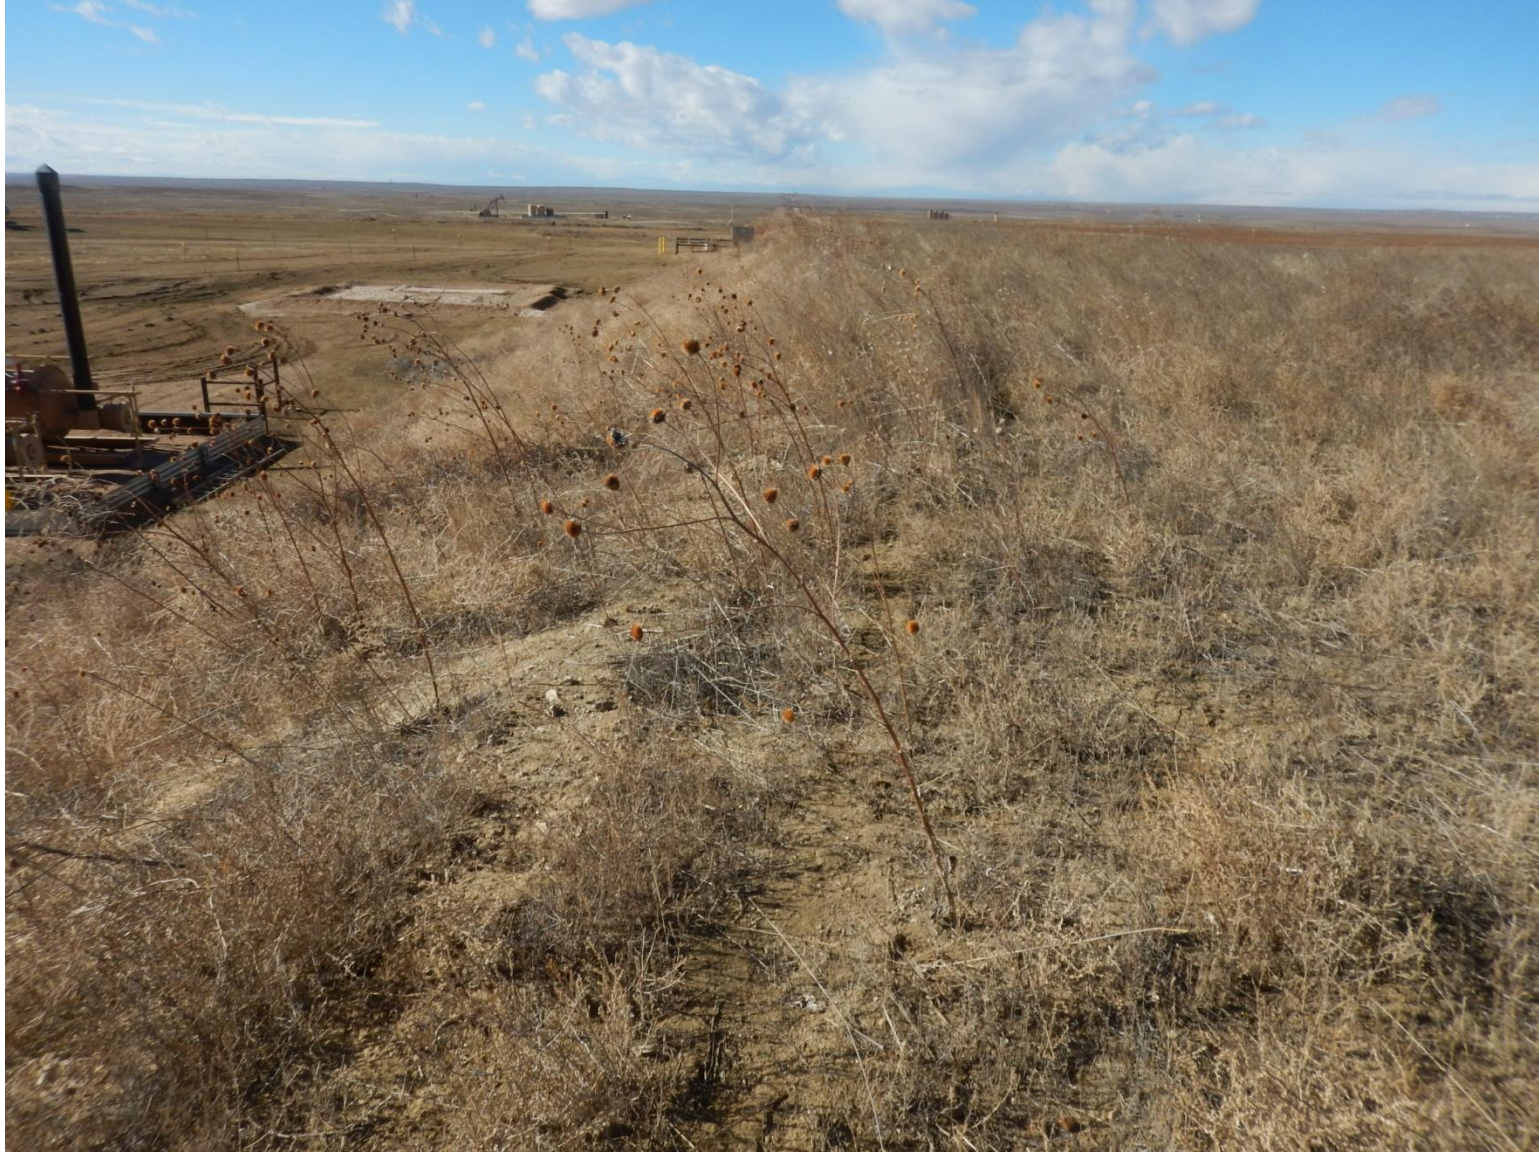
Photo 7: Photo taken from northeastern part of location, facing west. Photo shows lack of perennial vegetation. Vegetation predominantly Russian thistle.

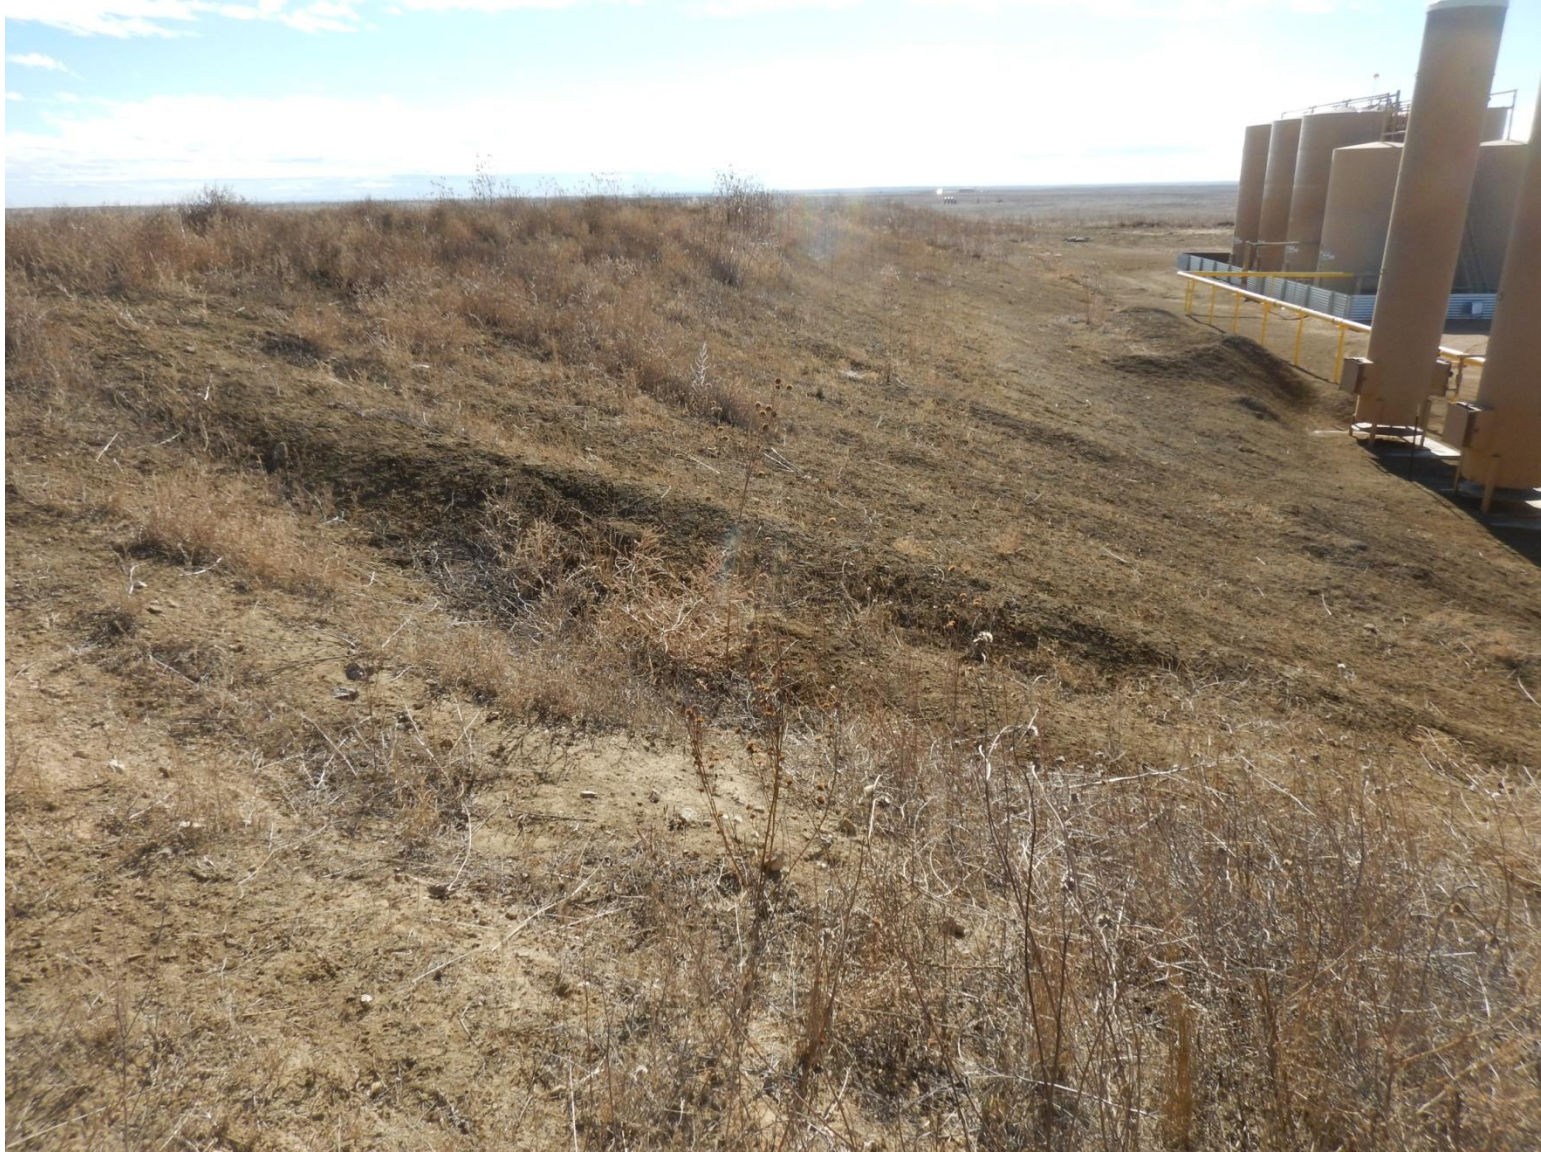
Photo 8: Photo taken from southeastern part of location, facing south. Photo shows lack of perennial vegetation.

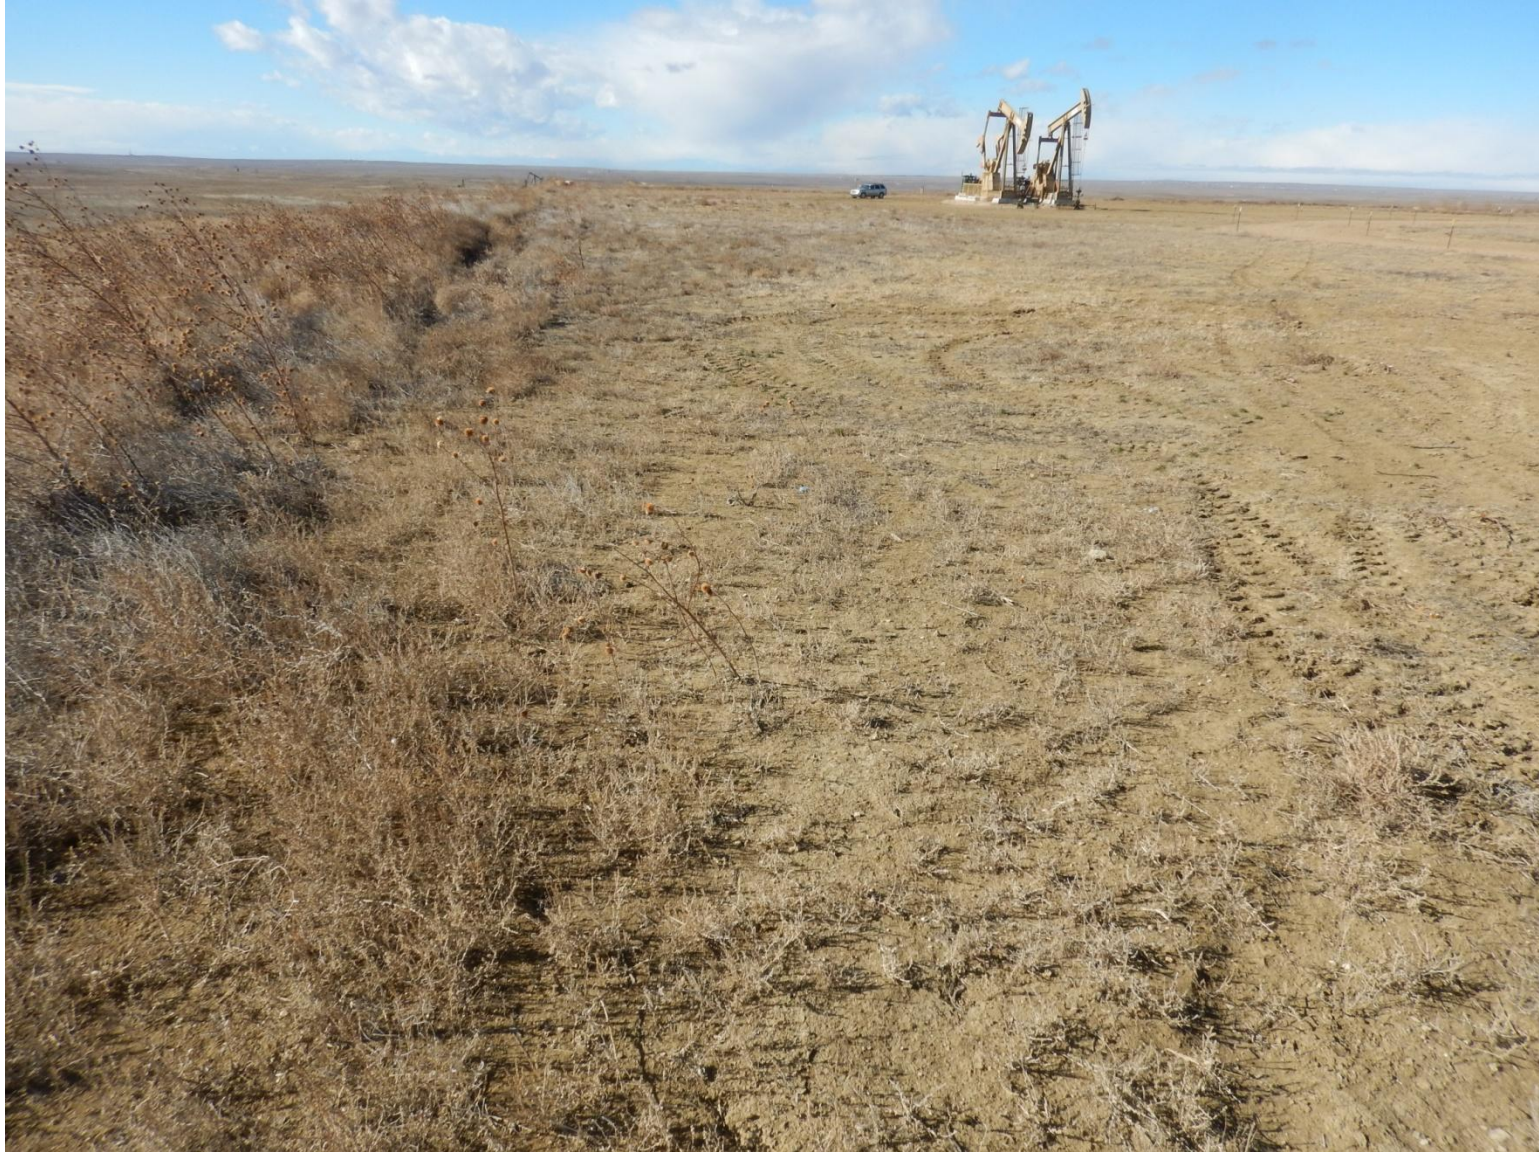
Photo 10: Photo taken from southeastern part of location, west. Photo shows lack of perennial vegetation on interim reclamation area.
