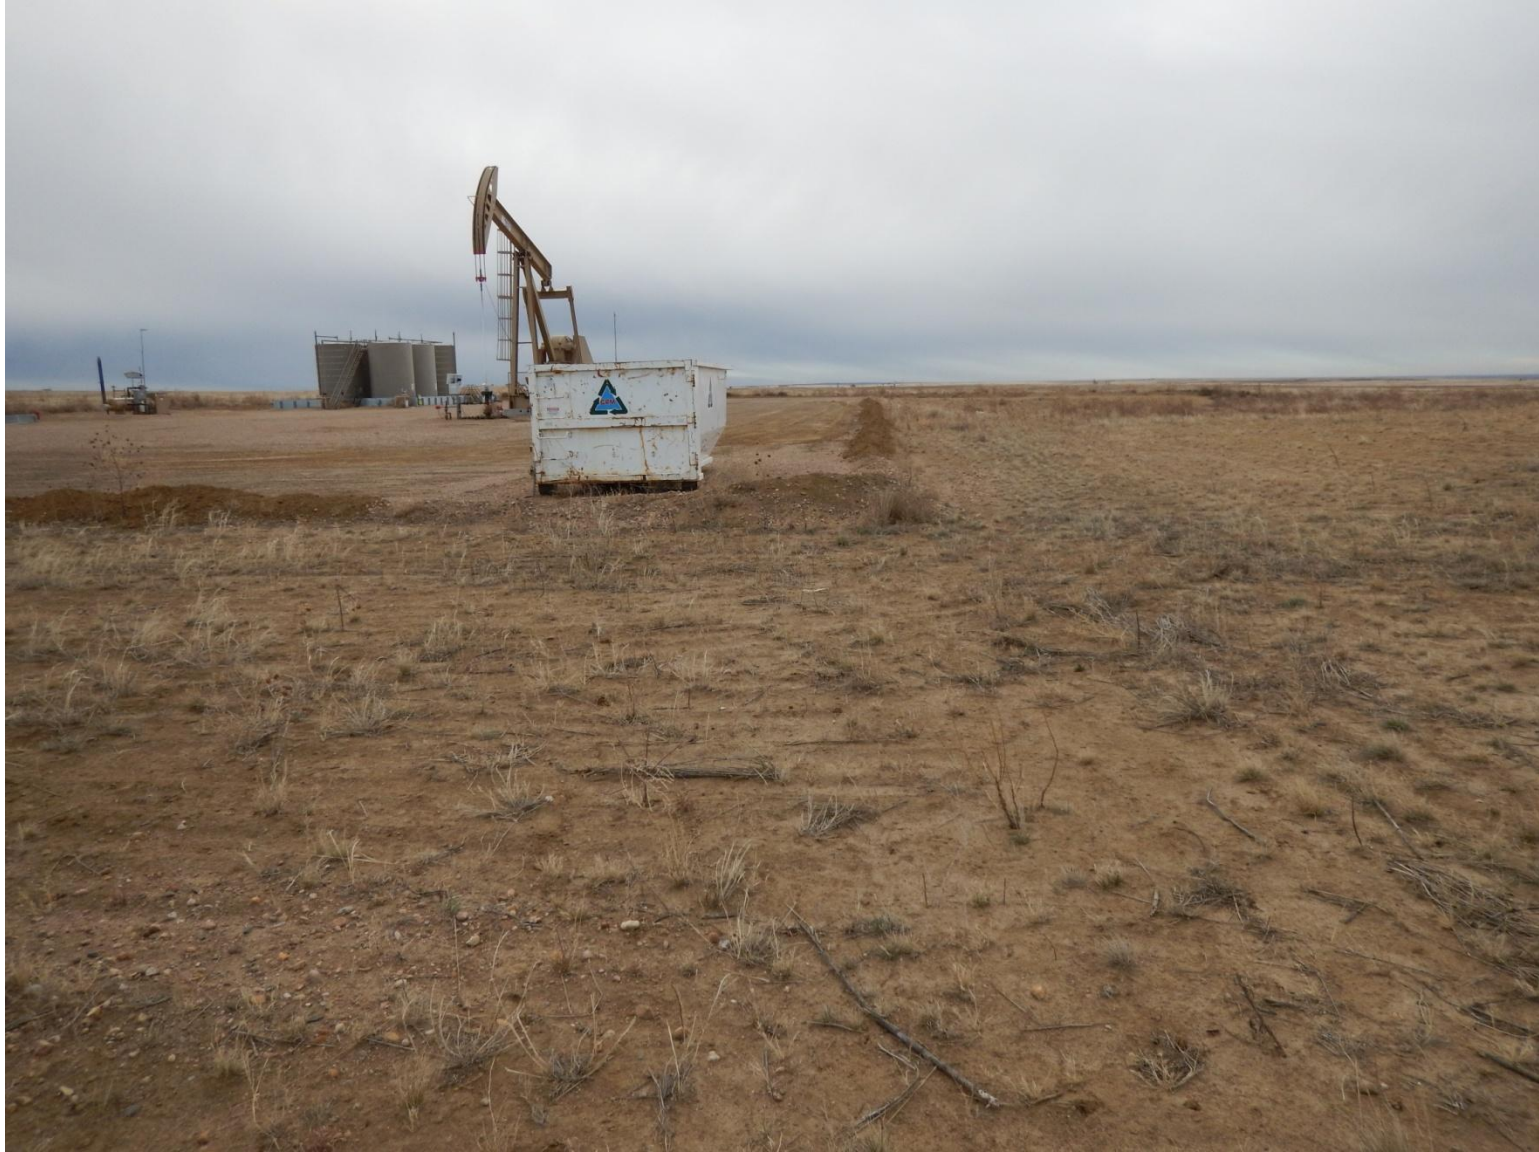
**Photo 1:** Photo taken from northwest part of location, facing south. Photo of interim reclamation. Note dumpster in center of photo, unnecessary equipment needs to be removed.

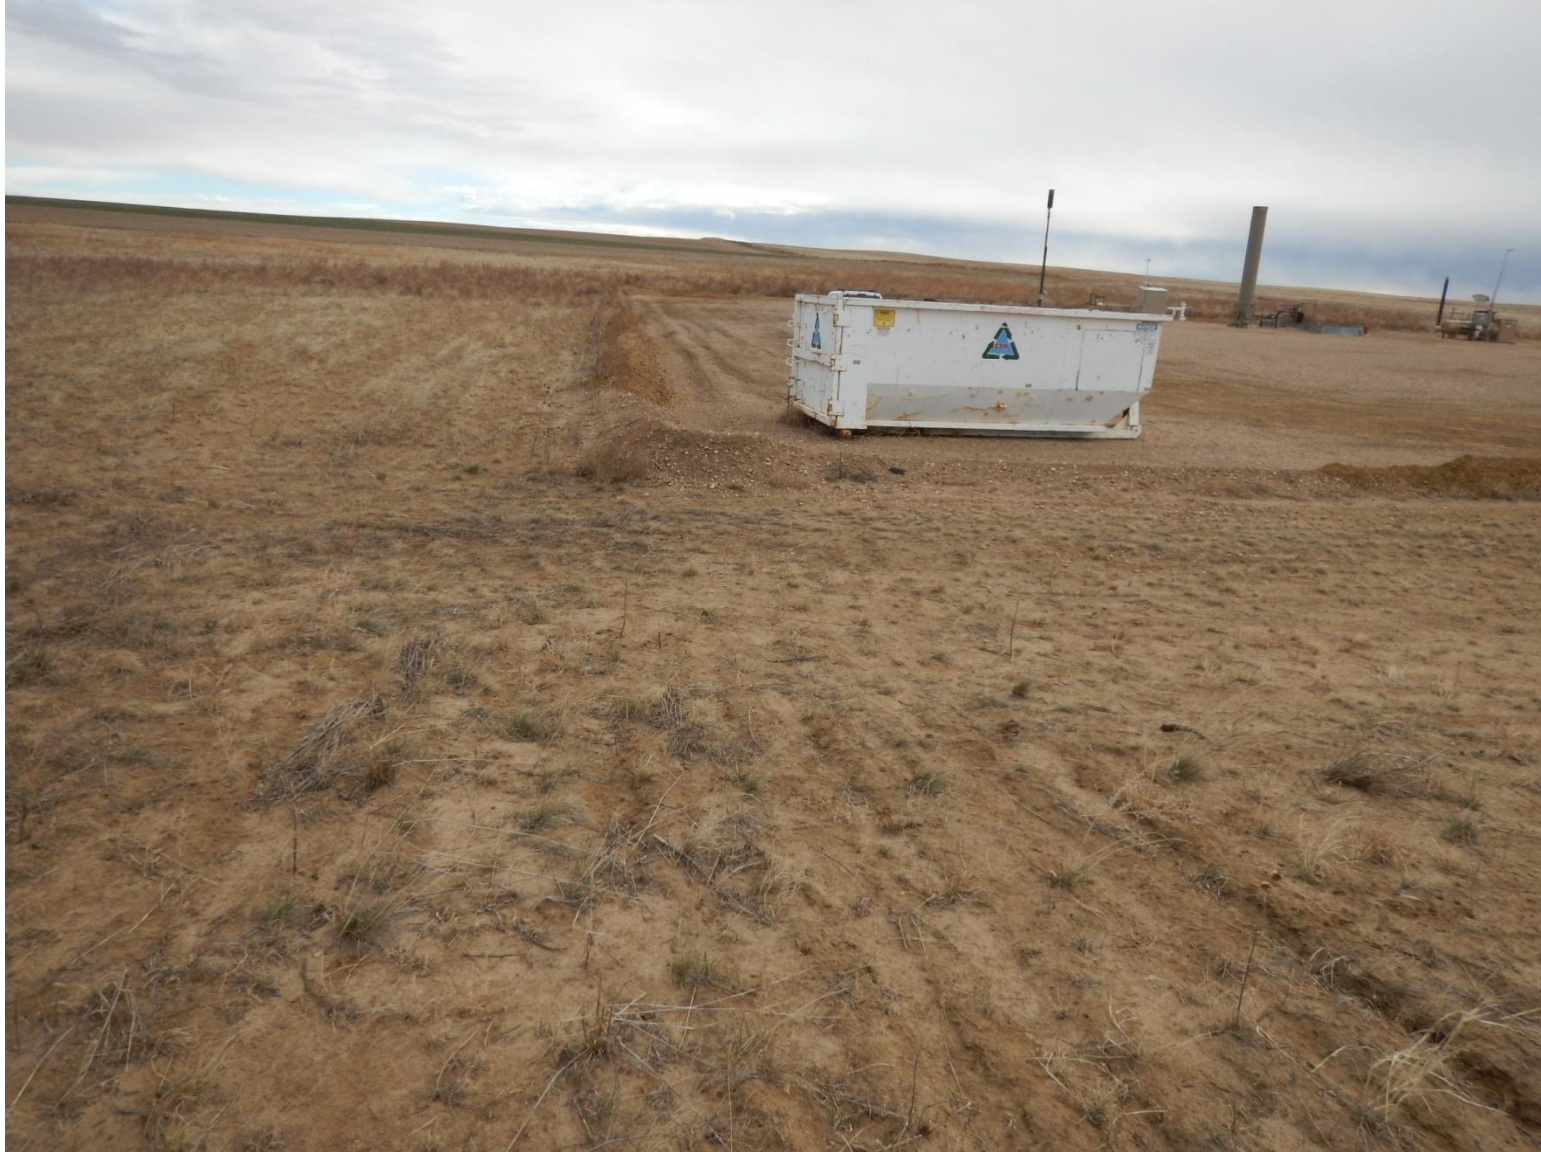
**Photo 2:** Photo taken from northwestern part of location, facing east. Photo of interim reclamation and dumpster equipment.

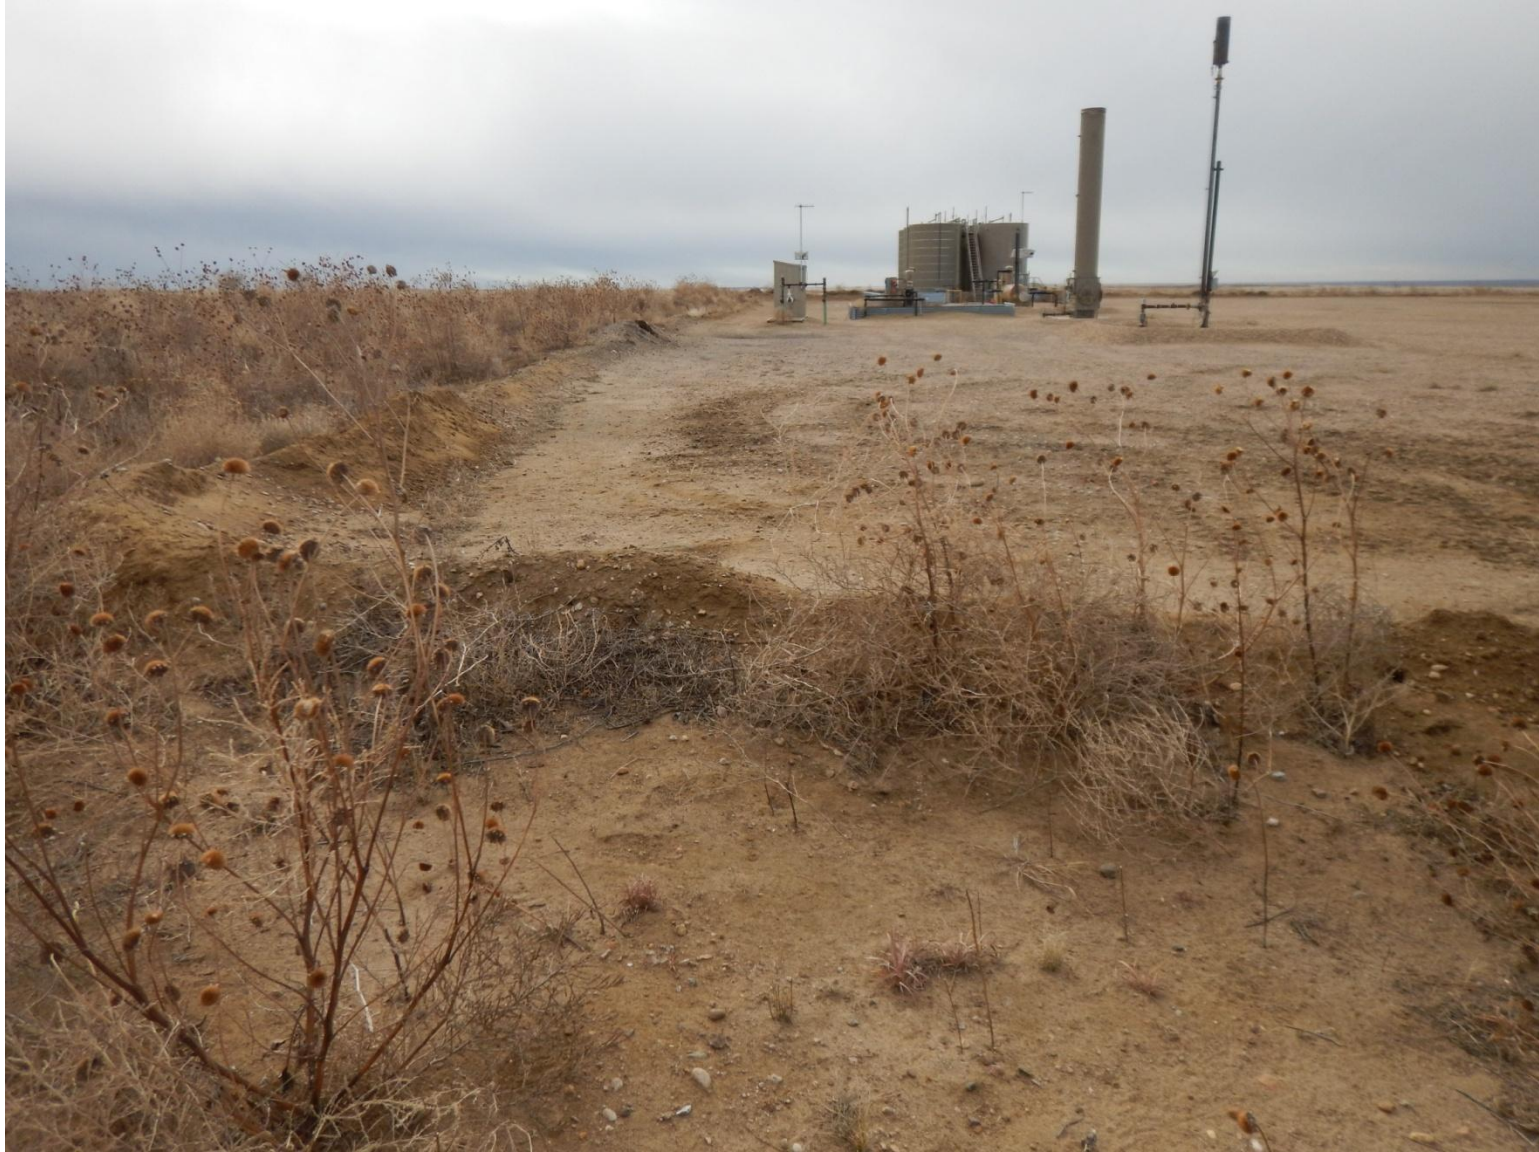
**Photo 3:** Photo taken from northeastern part of location, facing south. Photo of interim reclamation. Not the lack of perennial vegetation and Russian thistle weed debris.

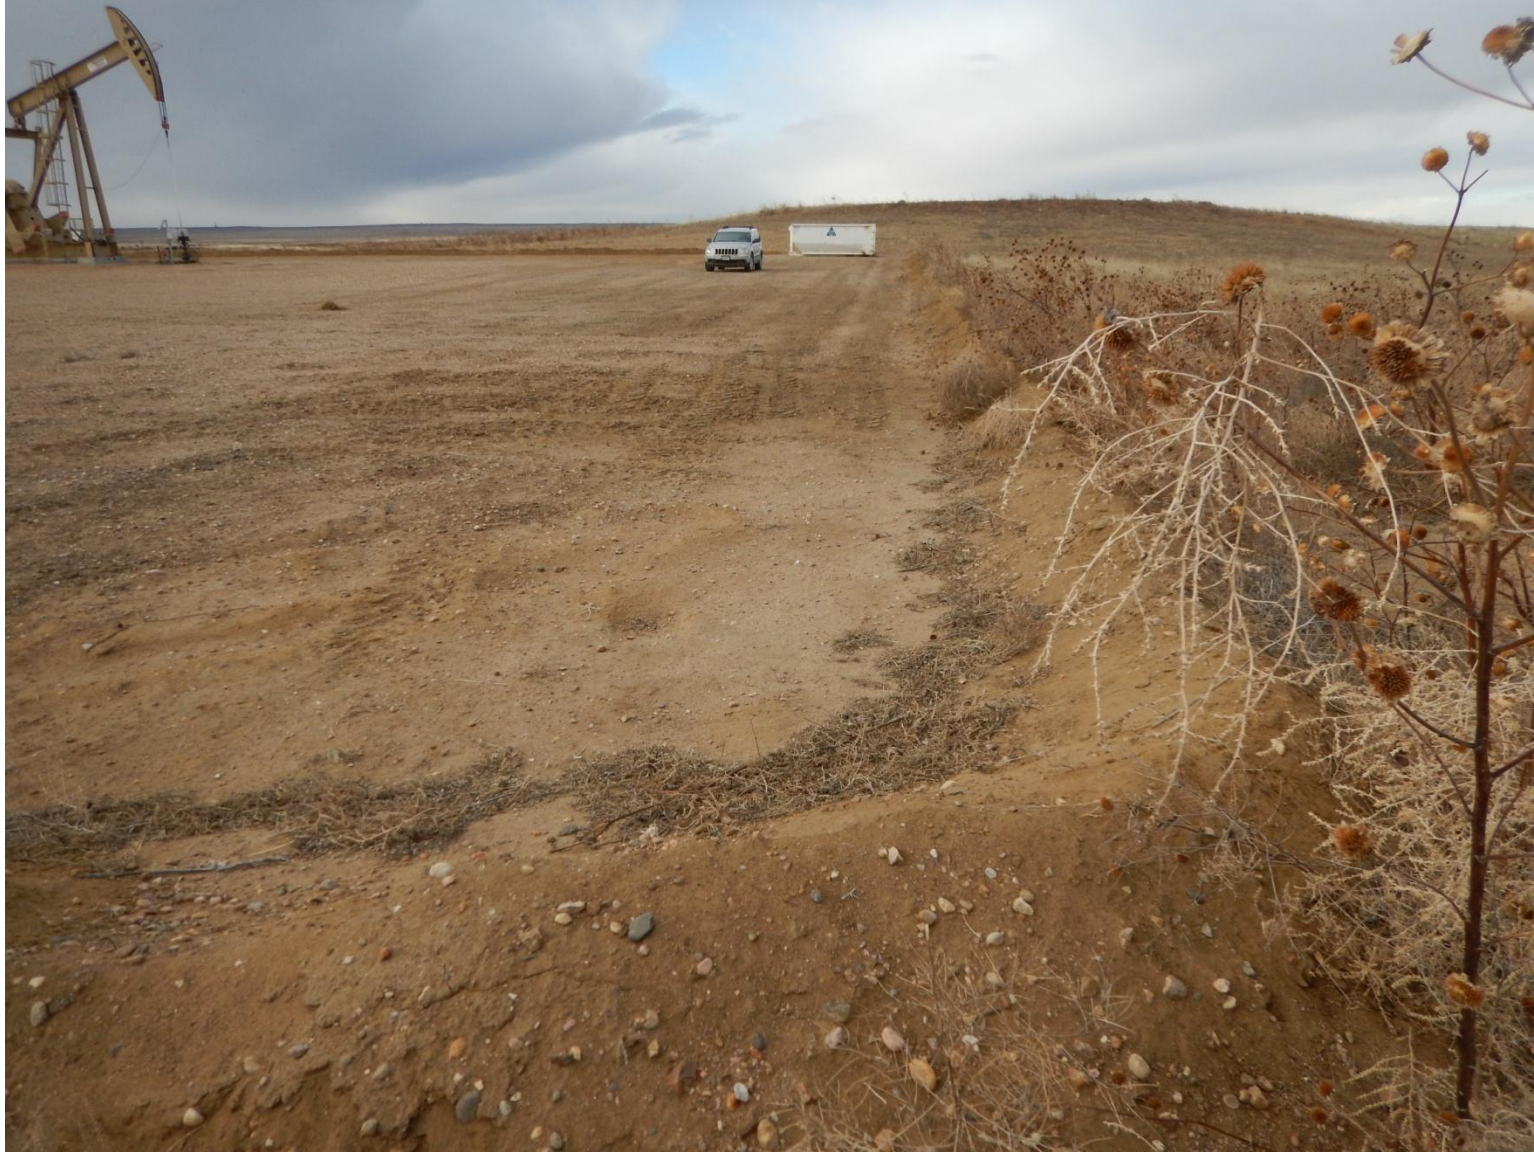
**Photo 4:** Photo taken from northeastern part of location, facing west. Photo of interim reclamation.

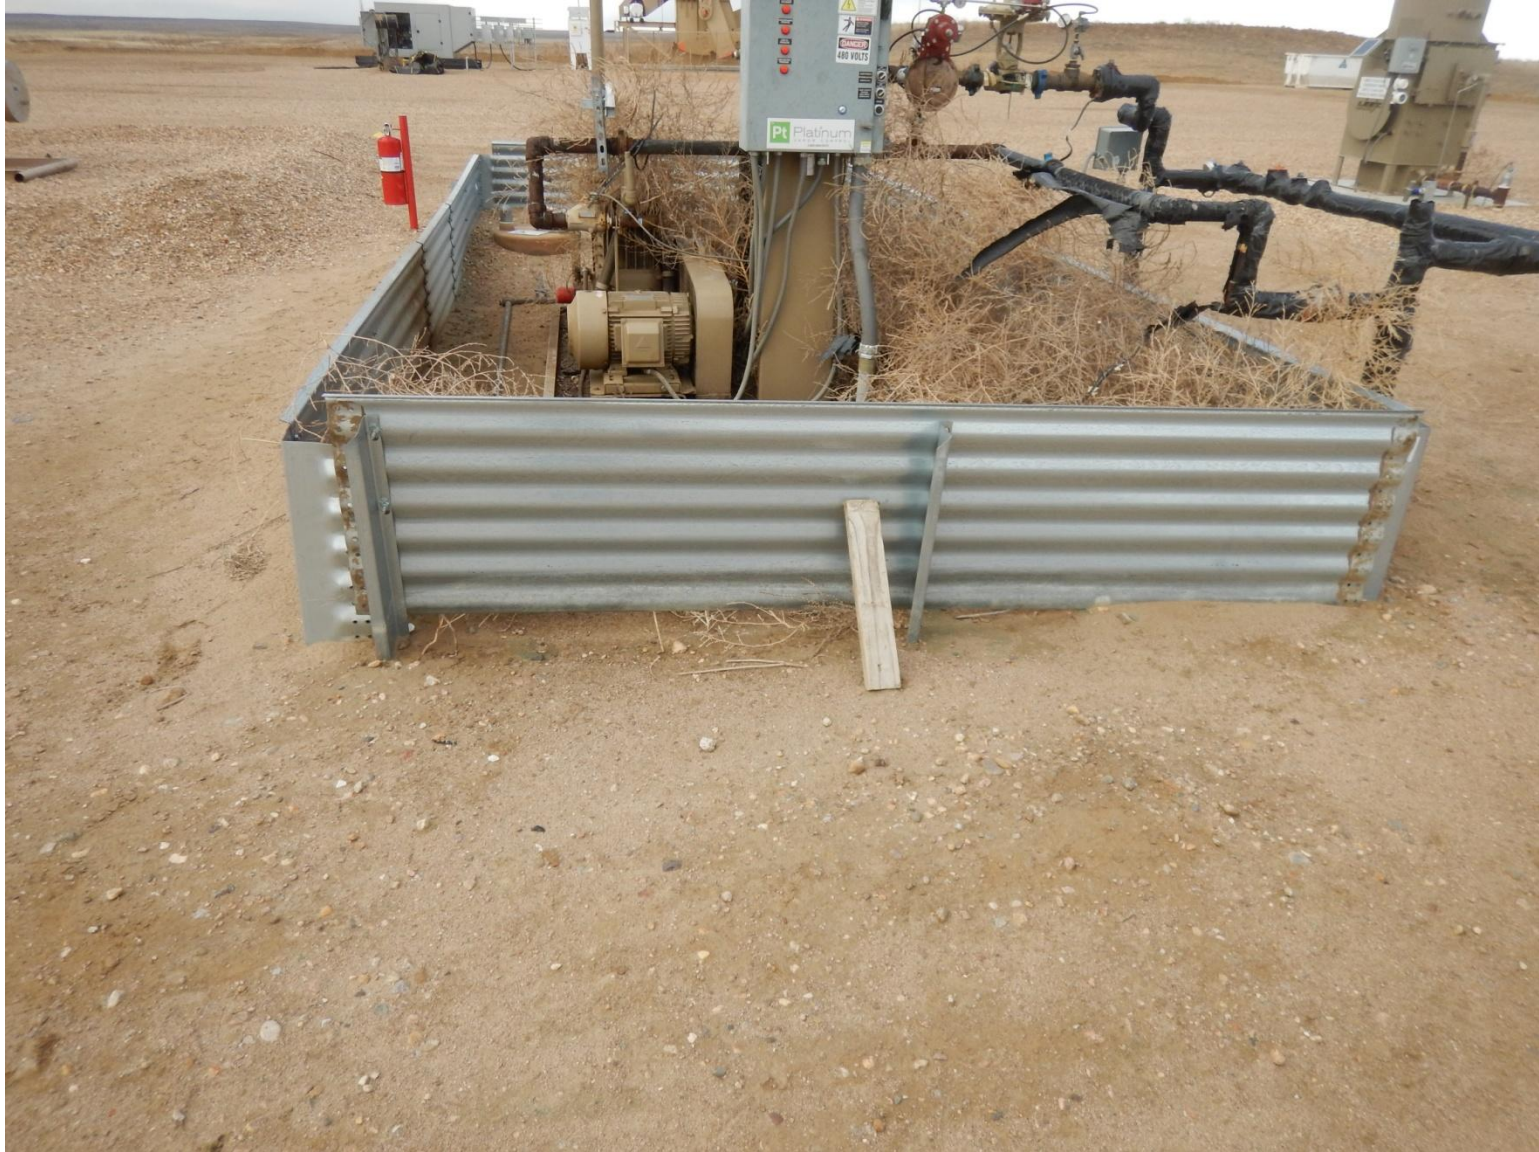
**Photo 5:** Photo taken from eastern part of location. Photo of panel surrounding equipment in disrepair and weed debris.

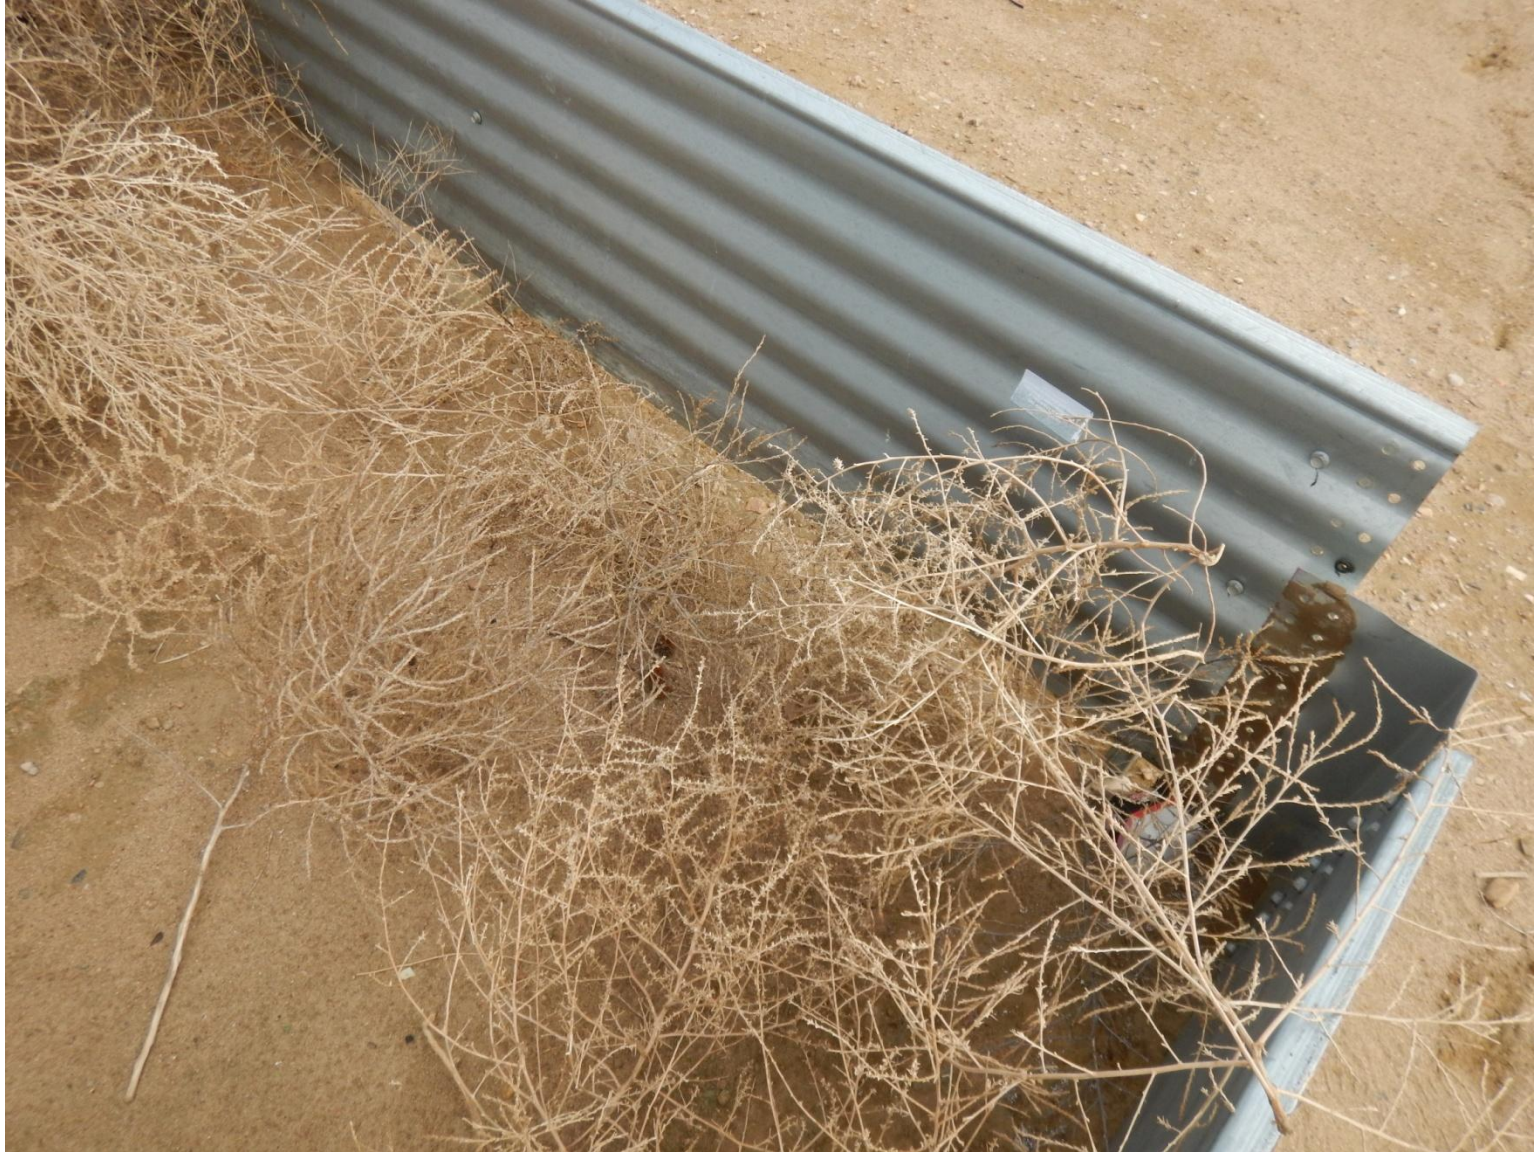
**Photo 6:** Photo taken from eastern part of location. Photo of panel surrounding equipment in disrepair and weed debris.

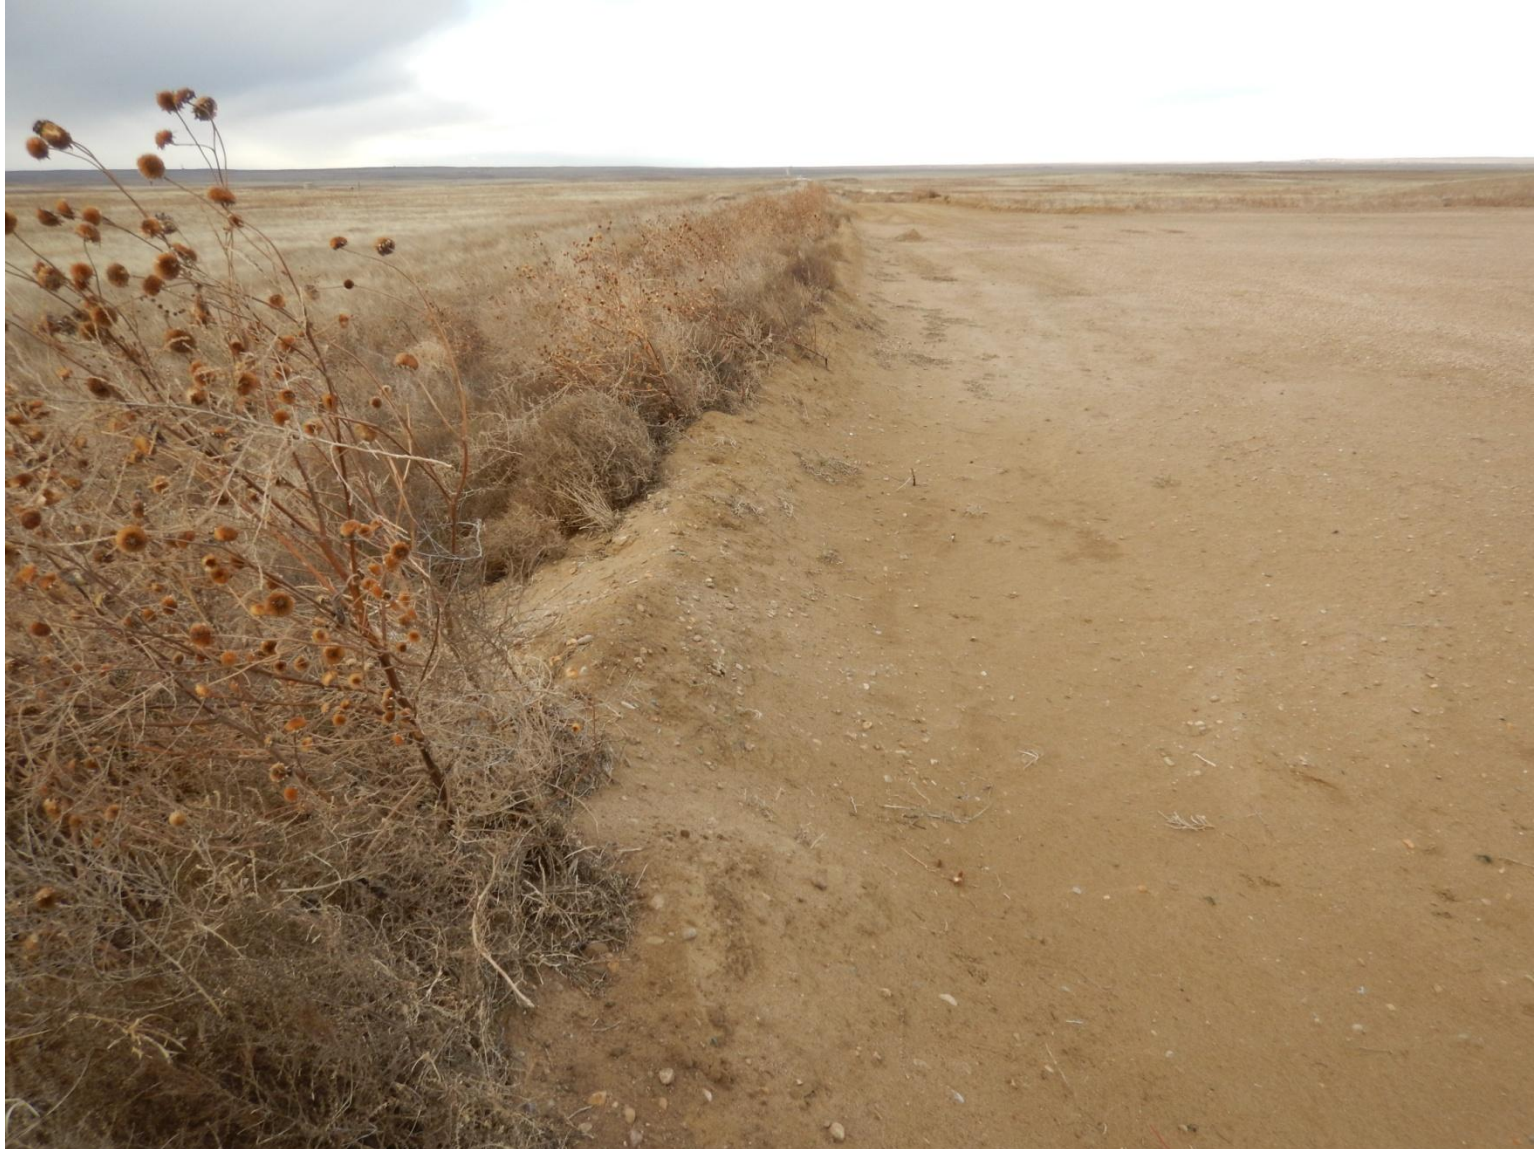
**Photo 8:** Photo taken from southeastern part of location, facing west. Vegetation is predominantly Russian thistle.

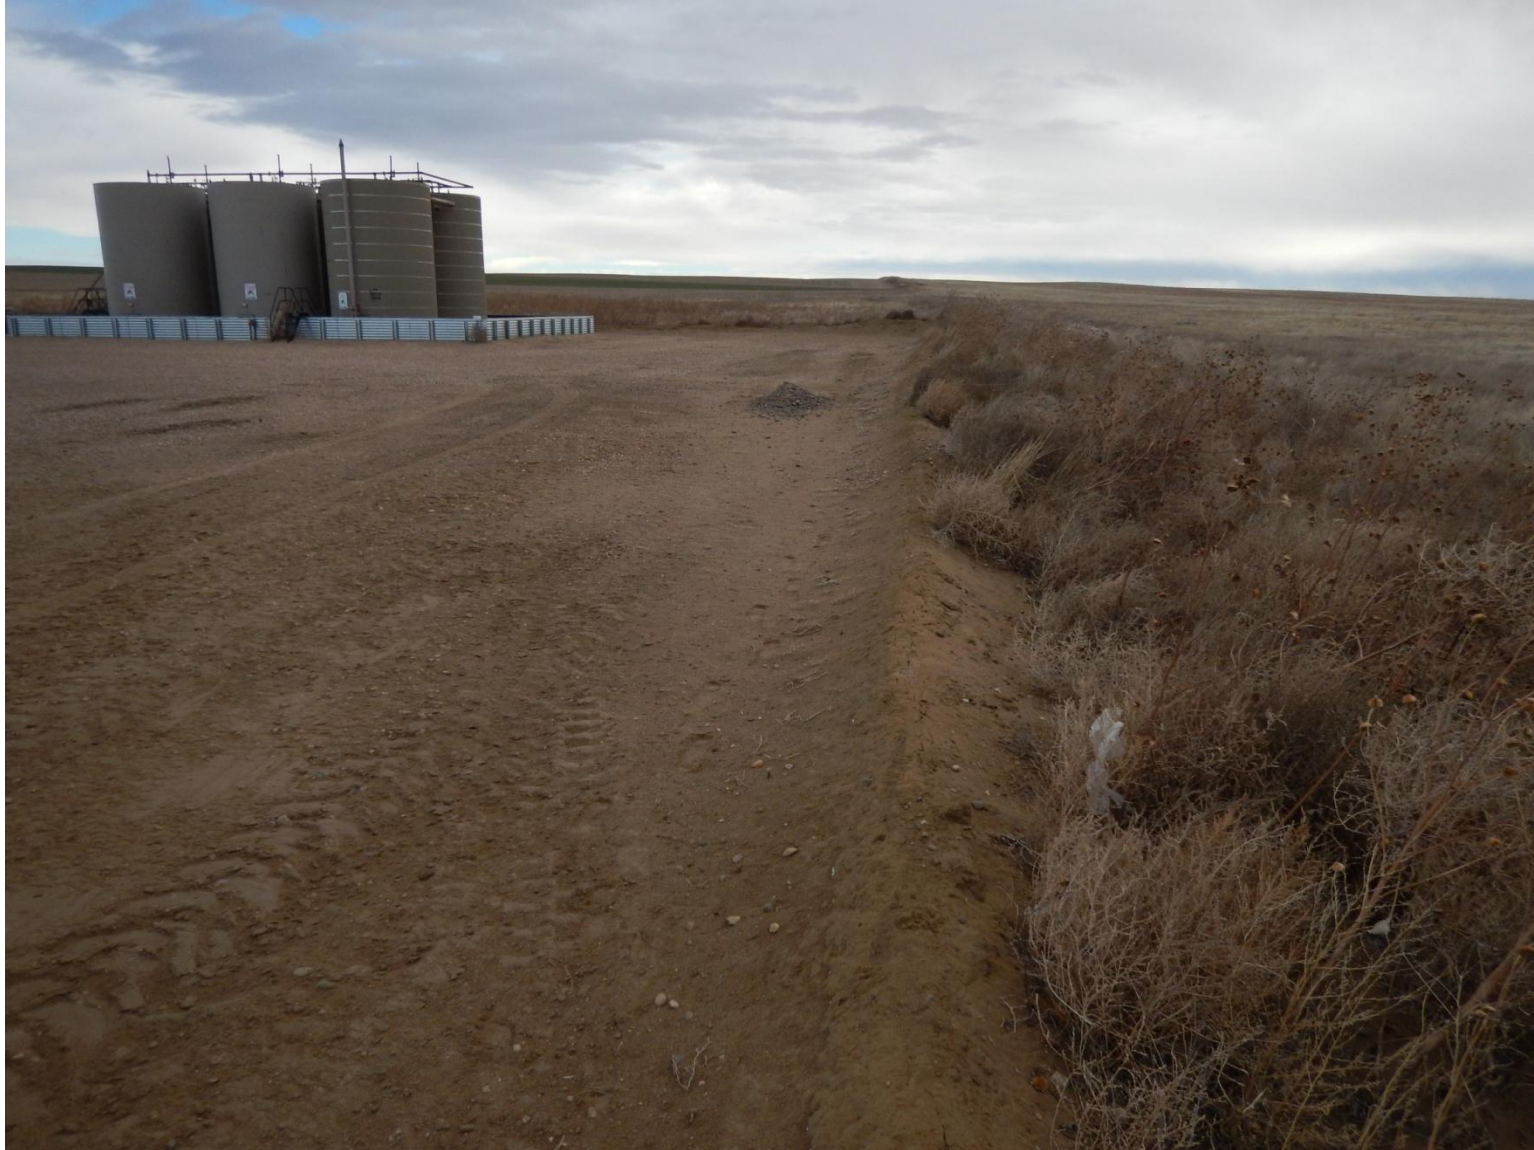
**Photo 9:** Photo taken from southwestern part of location, facing east. Vegetation is predominantly Russian thistle.

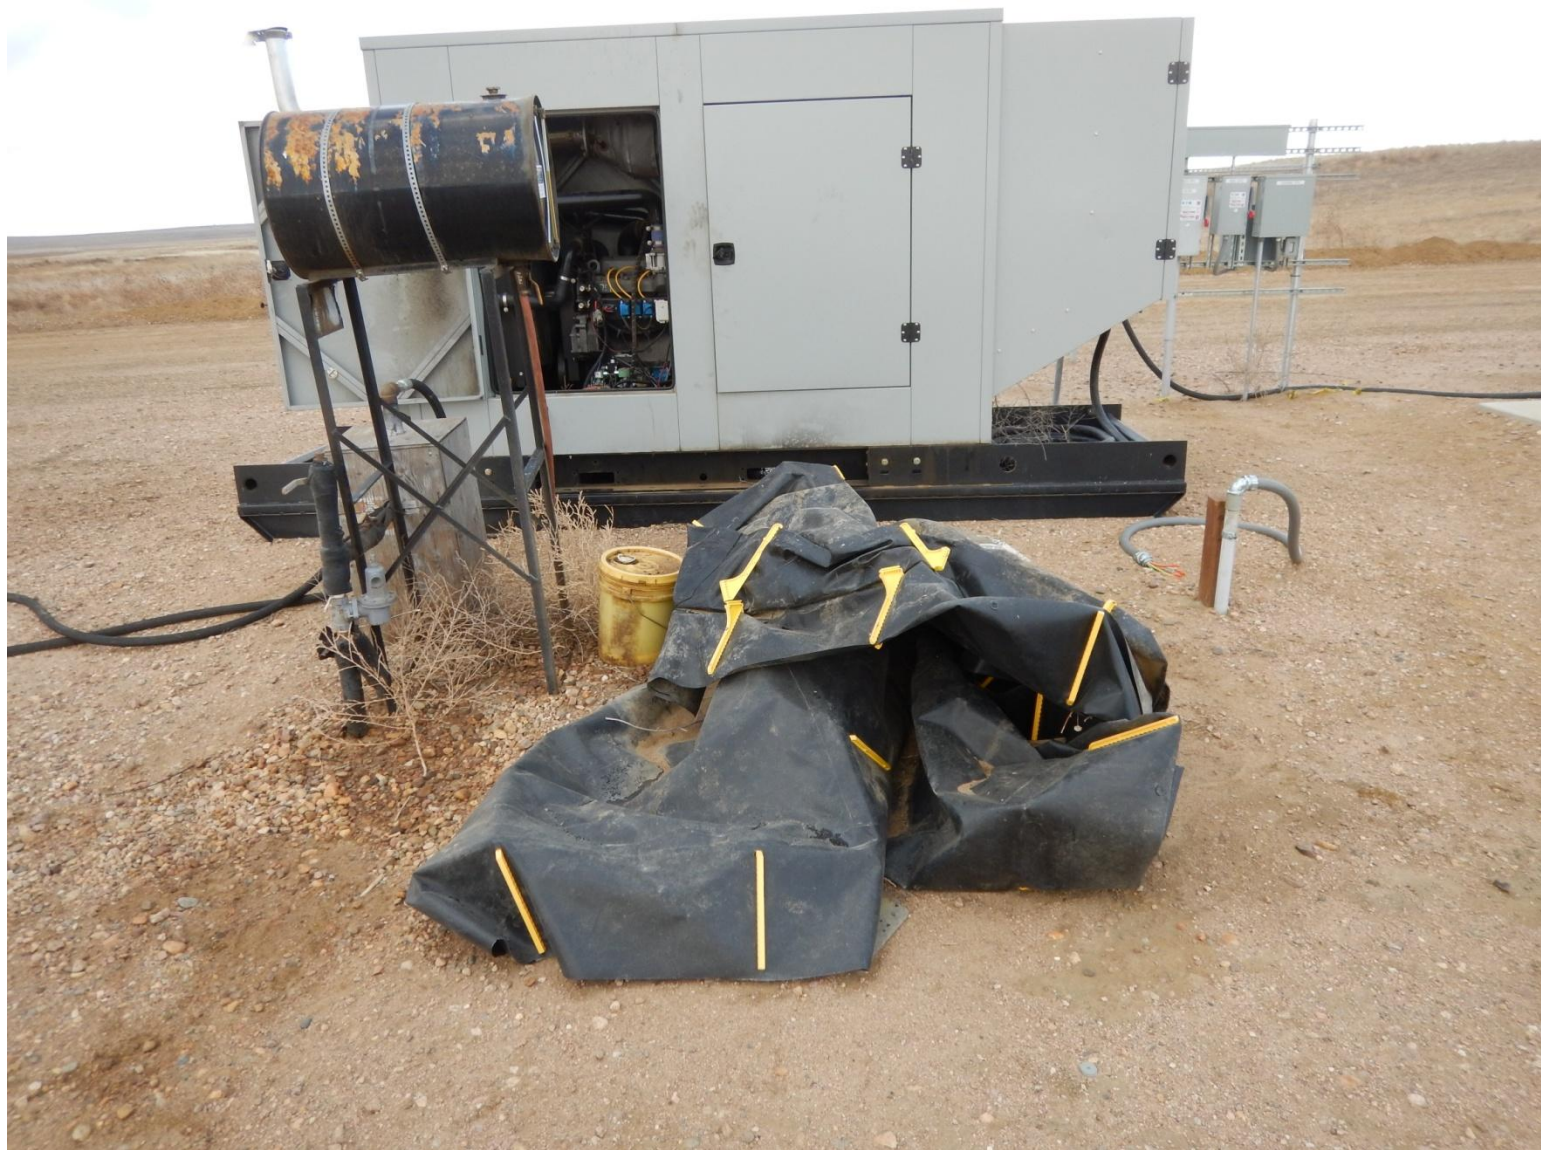
**Photo 11:** Photo taken from western part of location. Photo of weed debris in equipment, and trash debris. Trash debris appears to be a black tarp. Stained soil evident on ground below equipment.

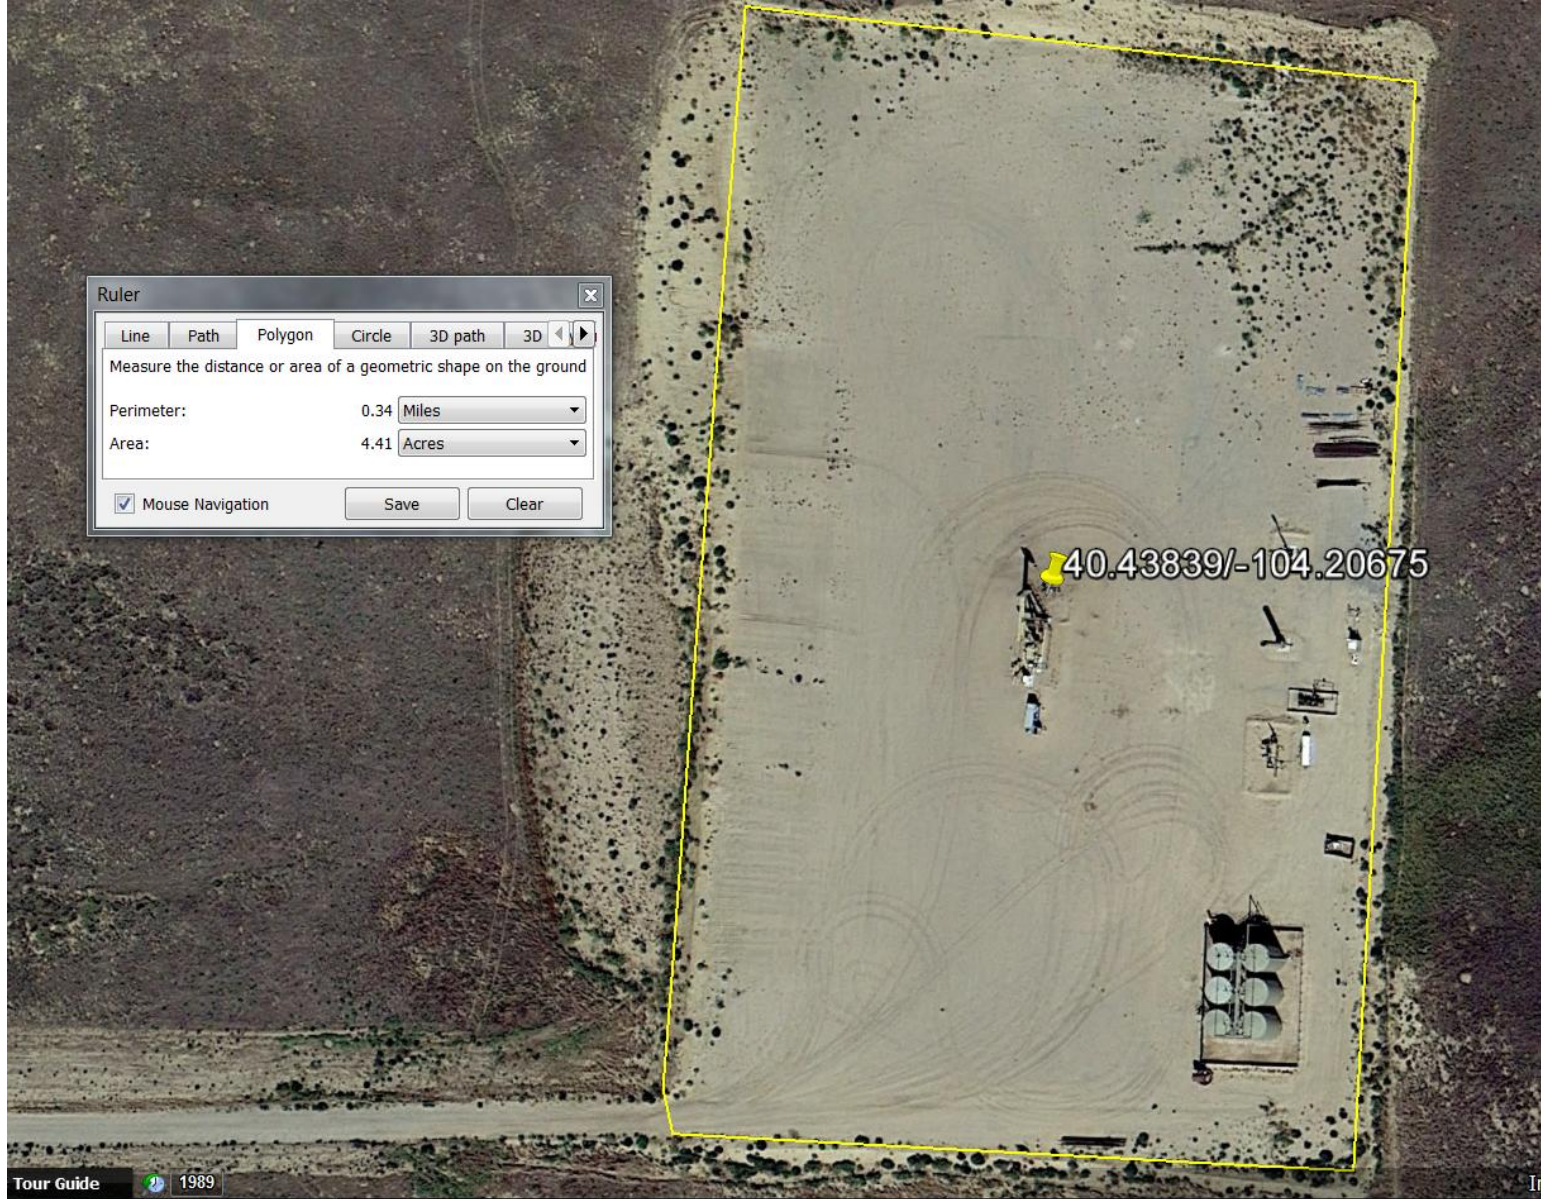
**Photo 12:** Aerial photo of location. Image shows location area currently is approximately 4.4 acres.
