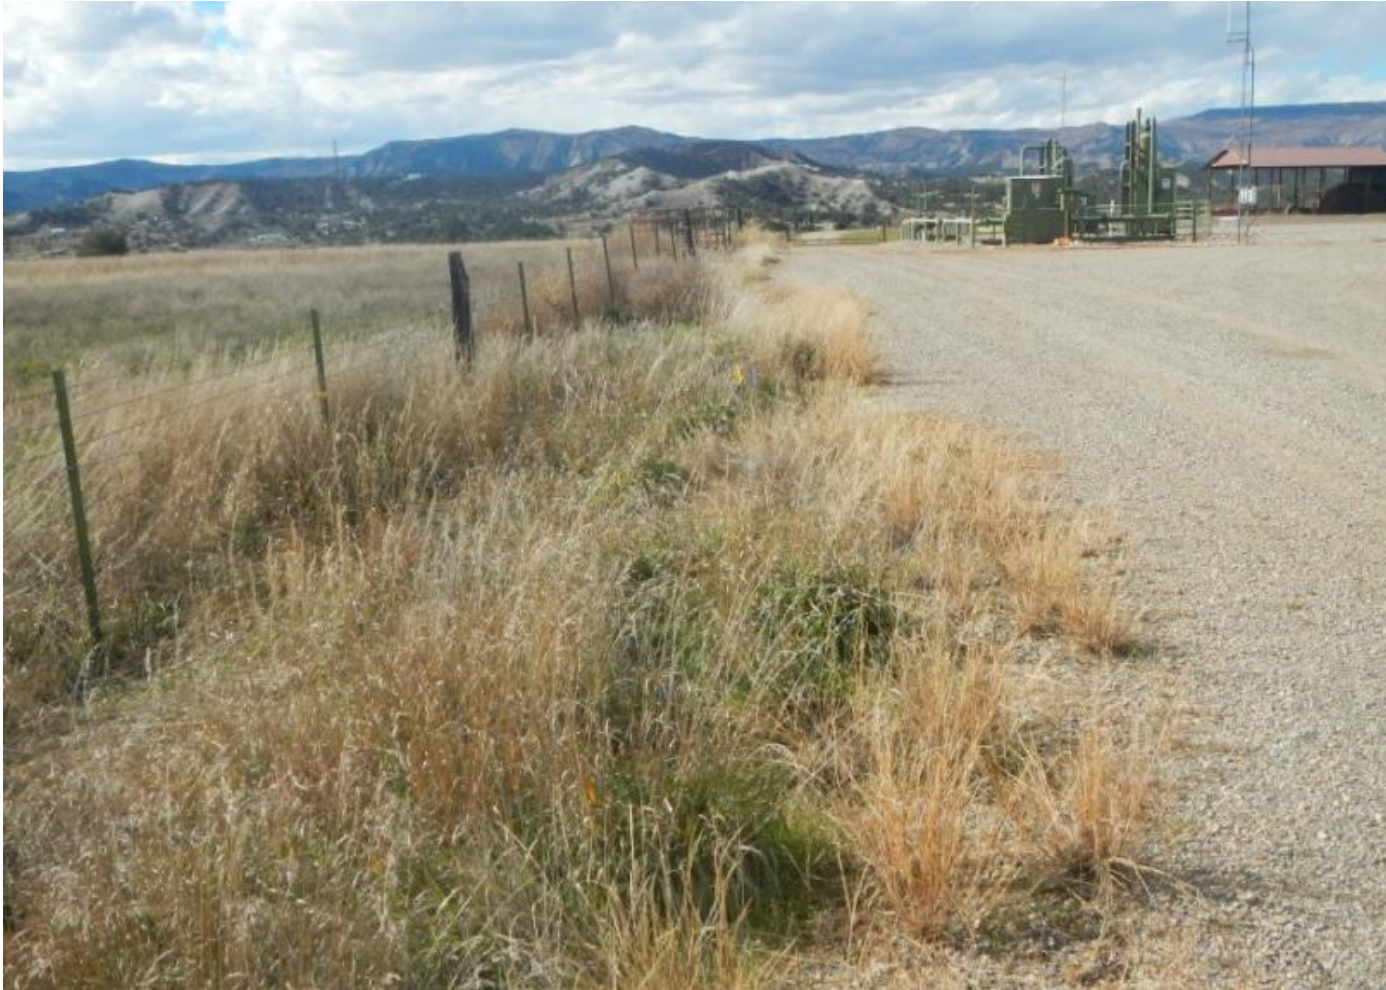
Photo 1. View of southern portion of the project area from the southeastern corner facing westward. Grasses such as smooth brome (*Bromus inermis*) and dropseed (*Sporobolus* sp.) are growing here.

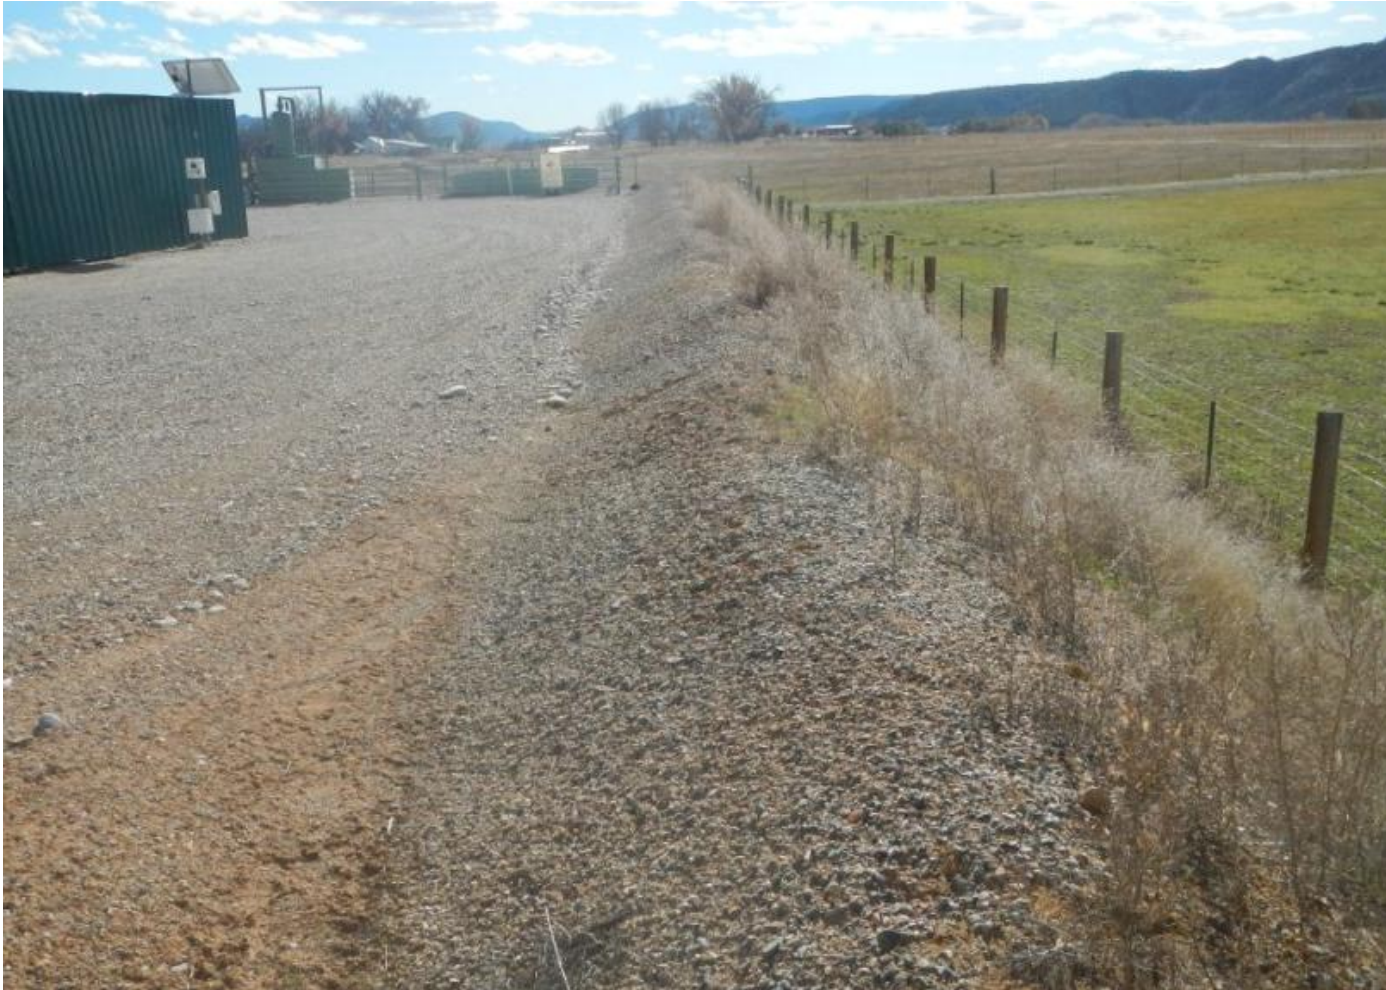
Photo 2. View of western portion of project area from northwestern corner facing southward. Berm appears to be in good condition. However, vegetation on the berm is largely kochia (*Kochia scoparia*) and cheatgrass (*Bromus tectorum*).

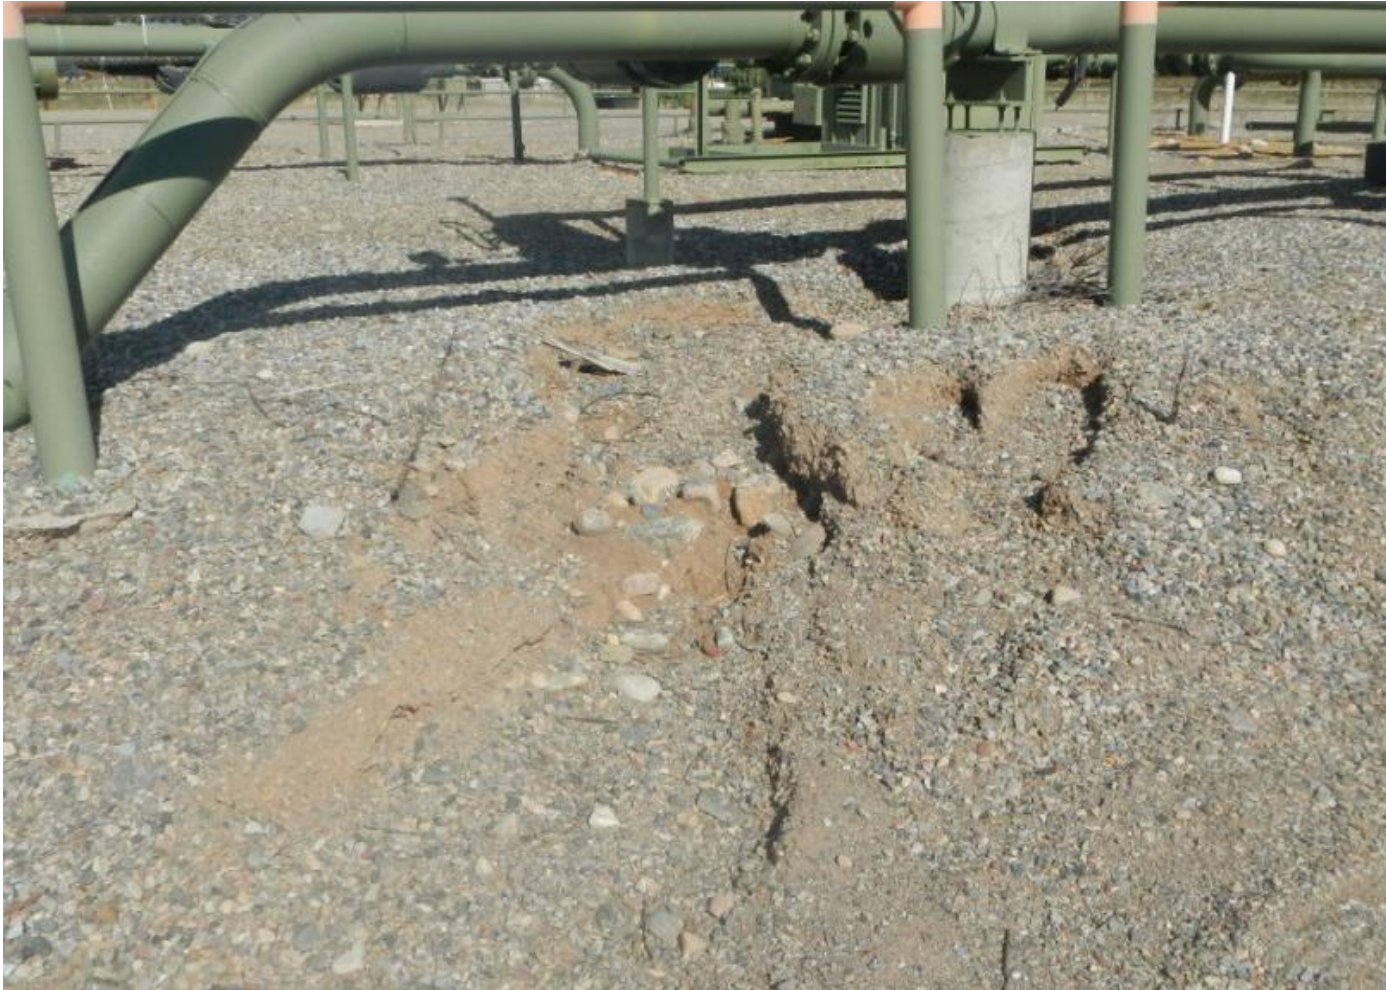
Photo 4. View of erosion in southern portion of project area that appears to be eroding off of facilities area. This should be monitored and repaired if it worsens.
