Complaint #200438020

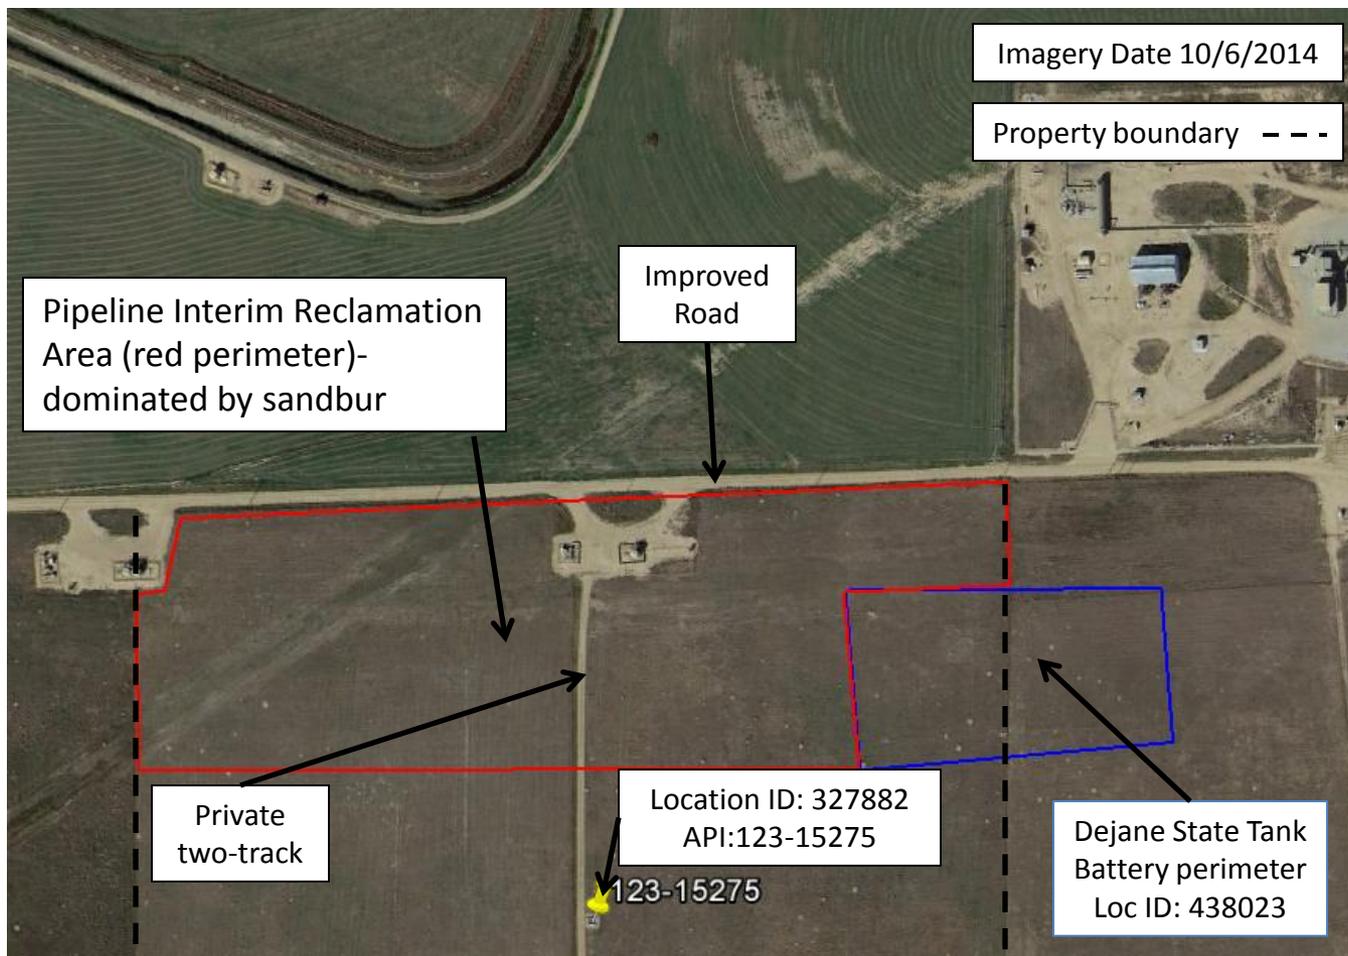
Pipeline interim reclamation, highlighted in red, is the area of concern. The red perimeter is also a fence line (see attached photos). Approximately 11.0 acres of disturbed land has not met reclamation standards per 1003 Rule series. The disturbed area has not been treated to prevent invasion of undesirable plant species, in this case longspine sandbur (*Cenchrus longispinus*) dominates the entire vegetative community. Refer to photos 1-6 indicating sandbur infestation.

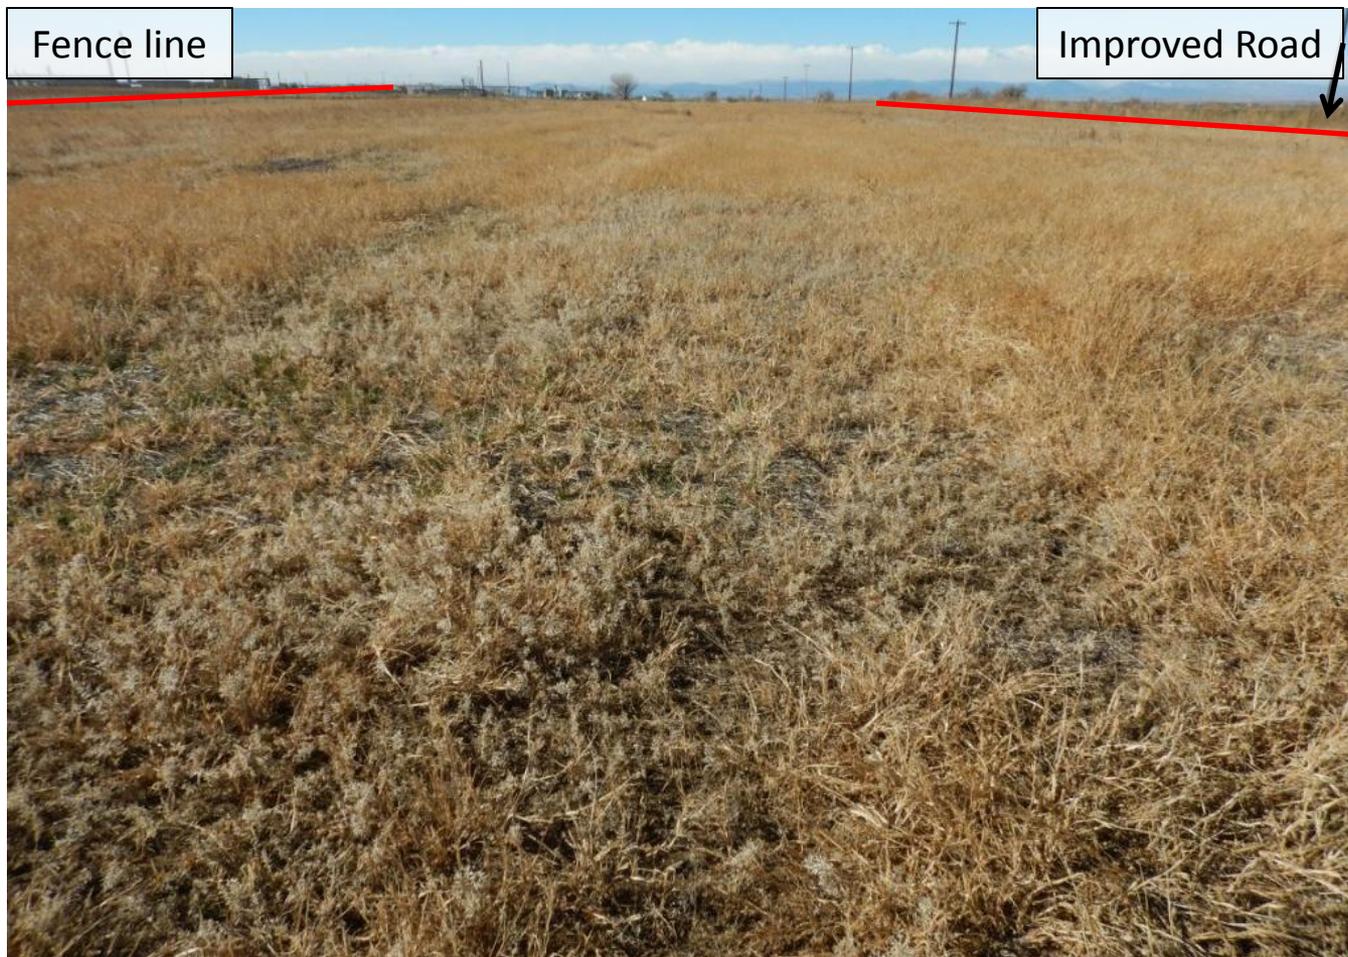
Photo 1. Photo taken from private two-track, facing West within the pipeline interim reclamation area. The area west of the private two-track has been overtaken by sandbur. Very little to no perennial vegetation has established. This area can no longer be used for hay production and livestock grazing.

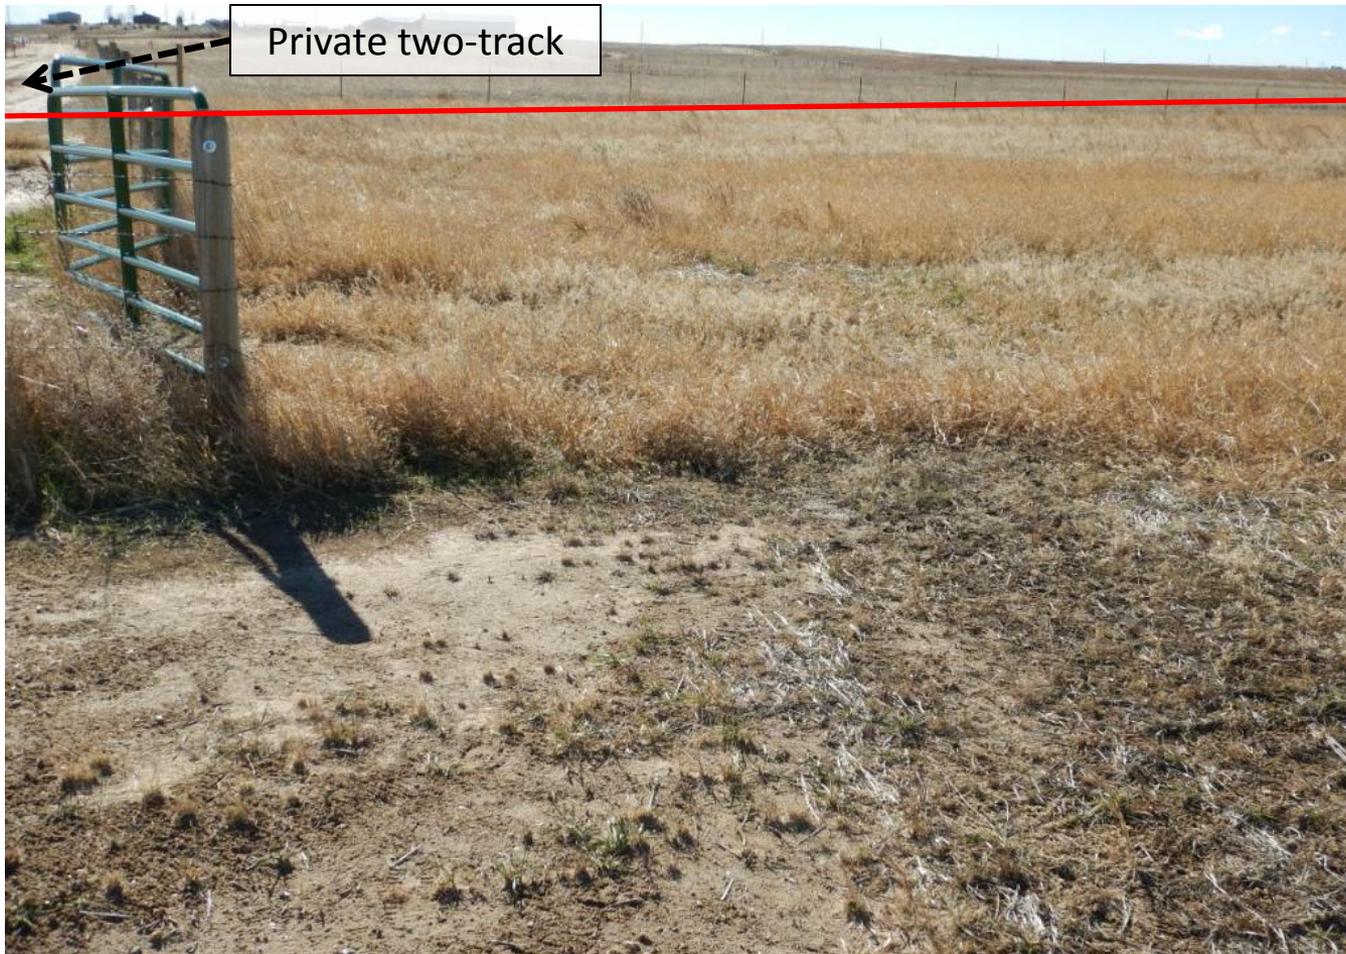
Photo 2. Photo taken from private two-track, facing South. Sandbur is the dominant plant species with no vegetative growth in areas.

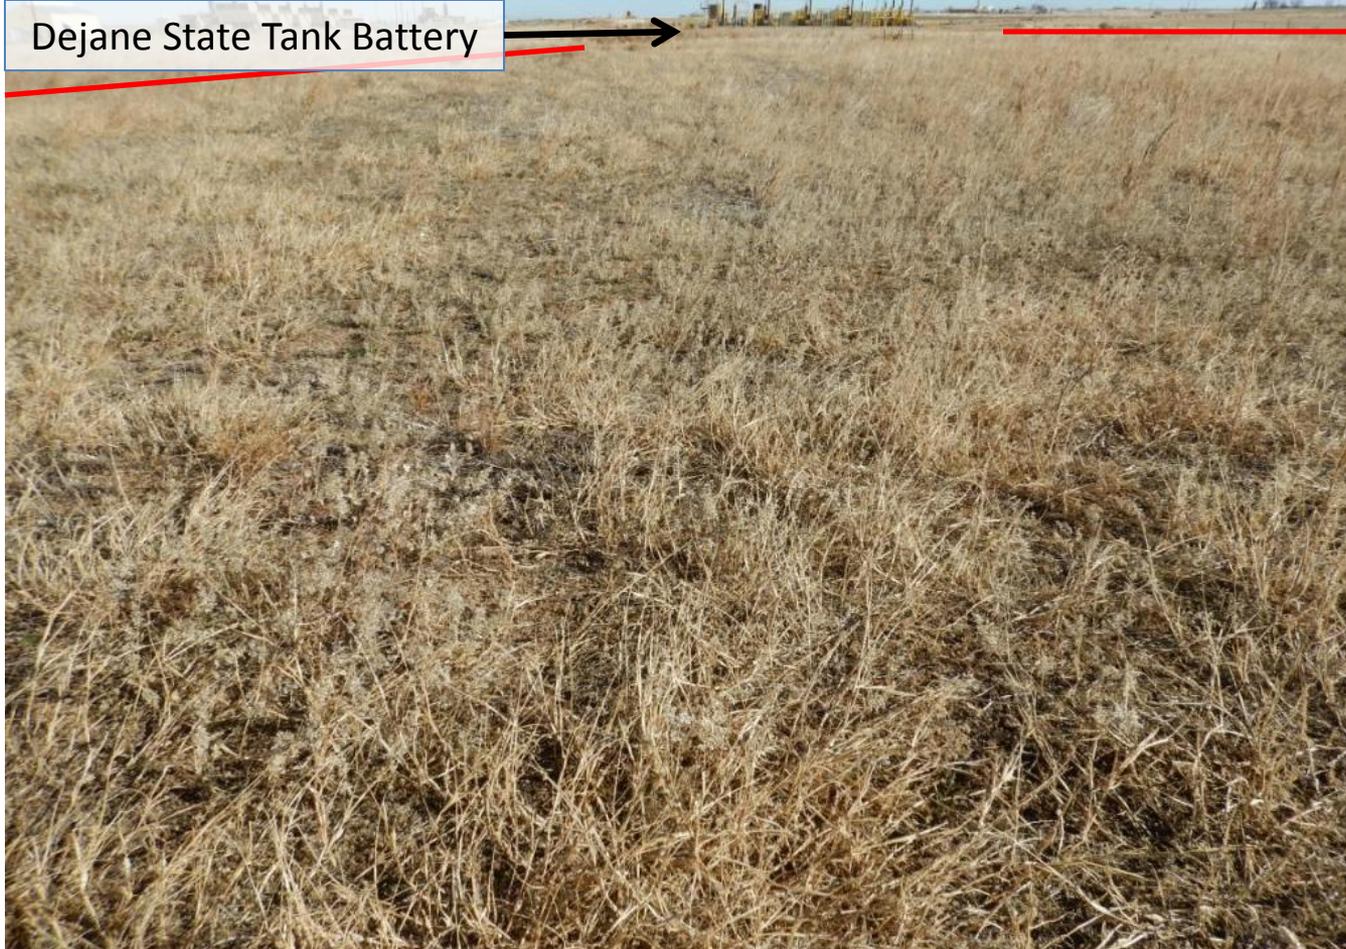
Photo 3. Photo taken from private two-track, facing East within the pipeline interim reclamation area. The area East of the private two-track has been overtaken by sandbur. Very little to no perennial vegetation has established. This area can no longer be used for hay production and livestock grazing.

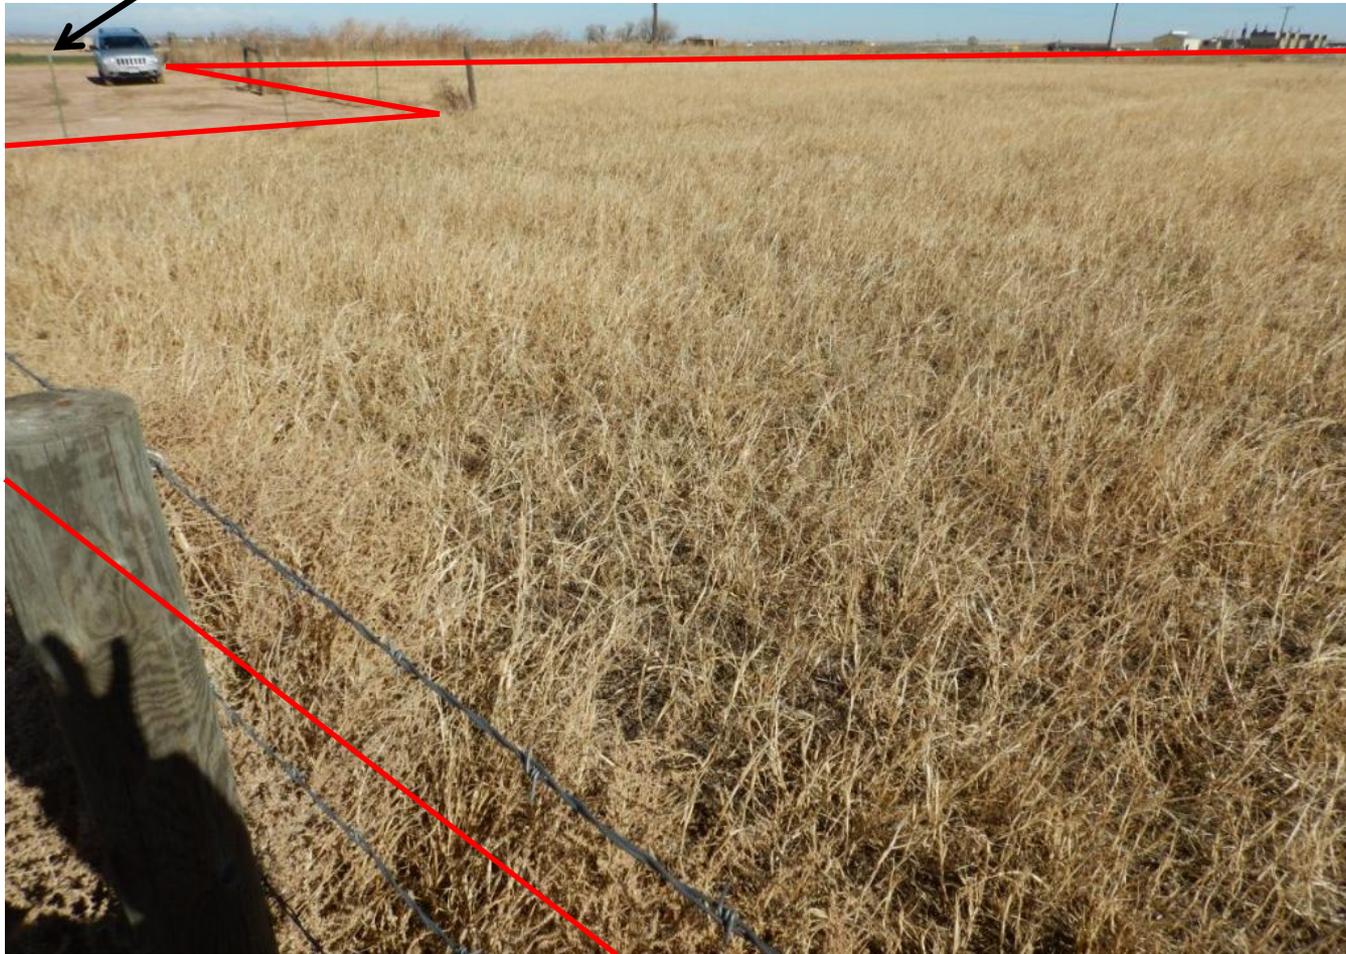
Photo 4. Photo taken from western pipeline interim reclamation area, facing North within the pipeline interim reclamation area. Sandbar is the dominant plant species with little to no perennial vegetation.

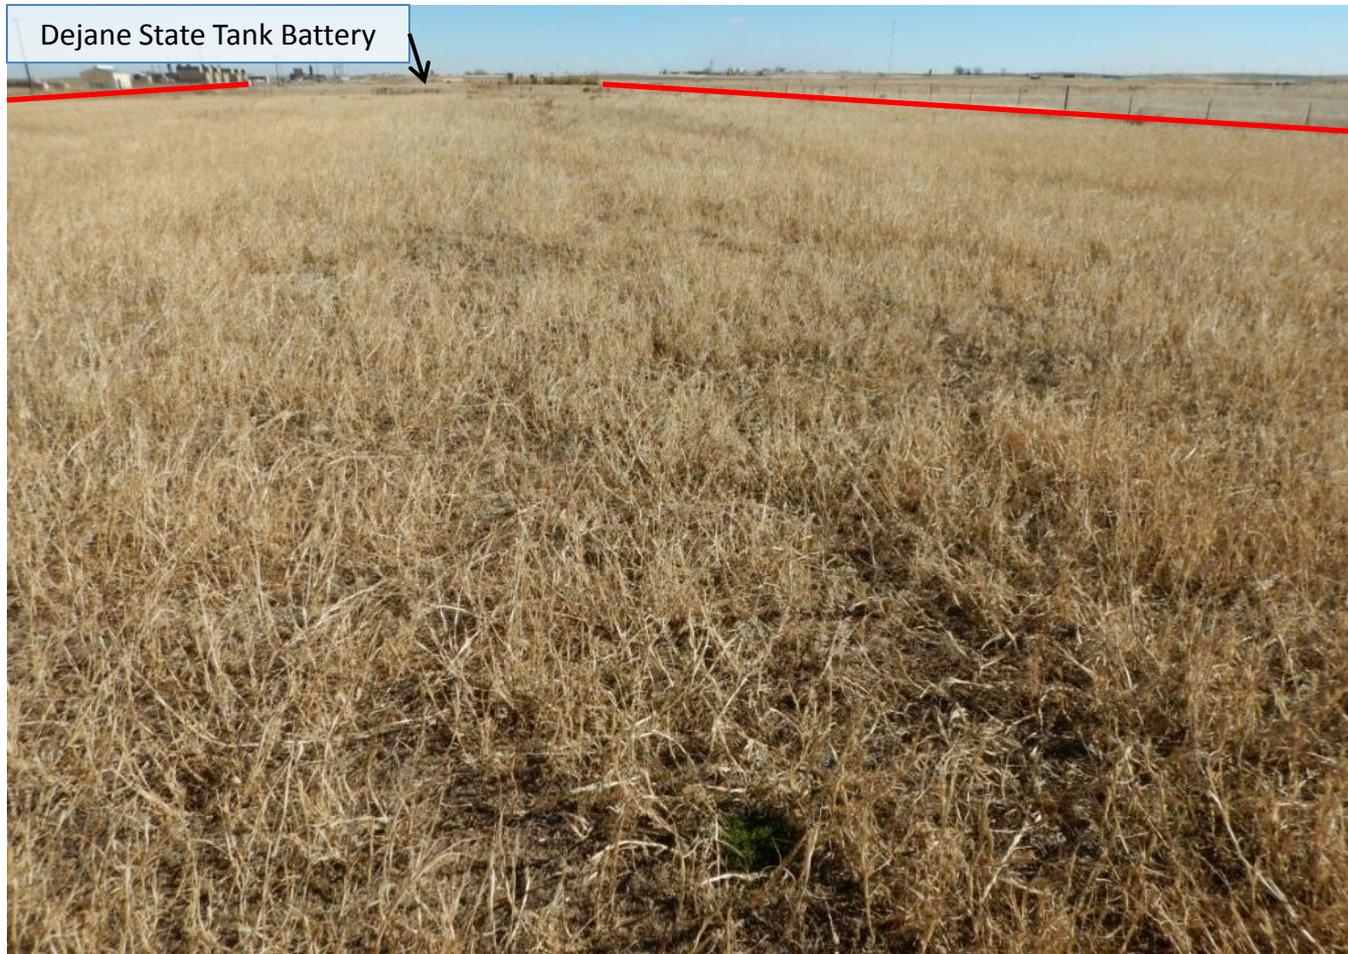
Photo 5. Photo taken from western pipeline interim reclamation area, facing East within the pipeline interim reclamation area. Sandbur is the dominant plant species with little to no perennial vegetation.

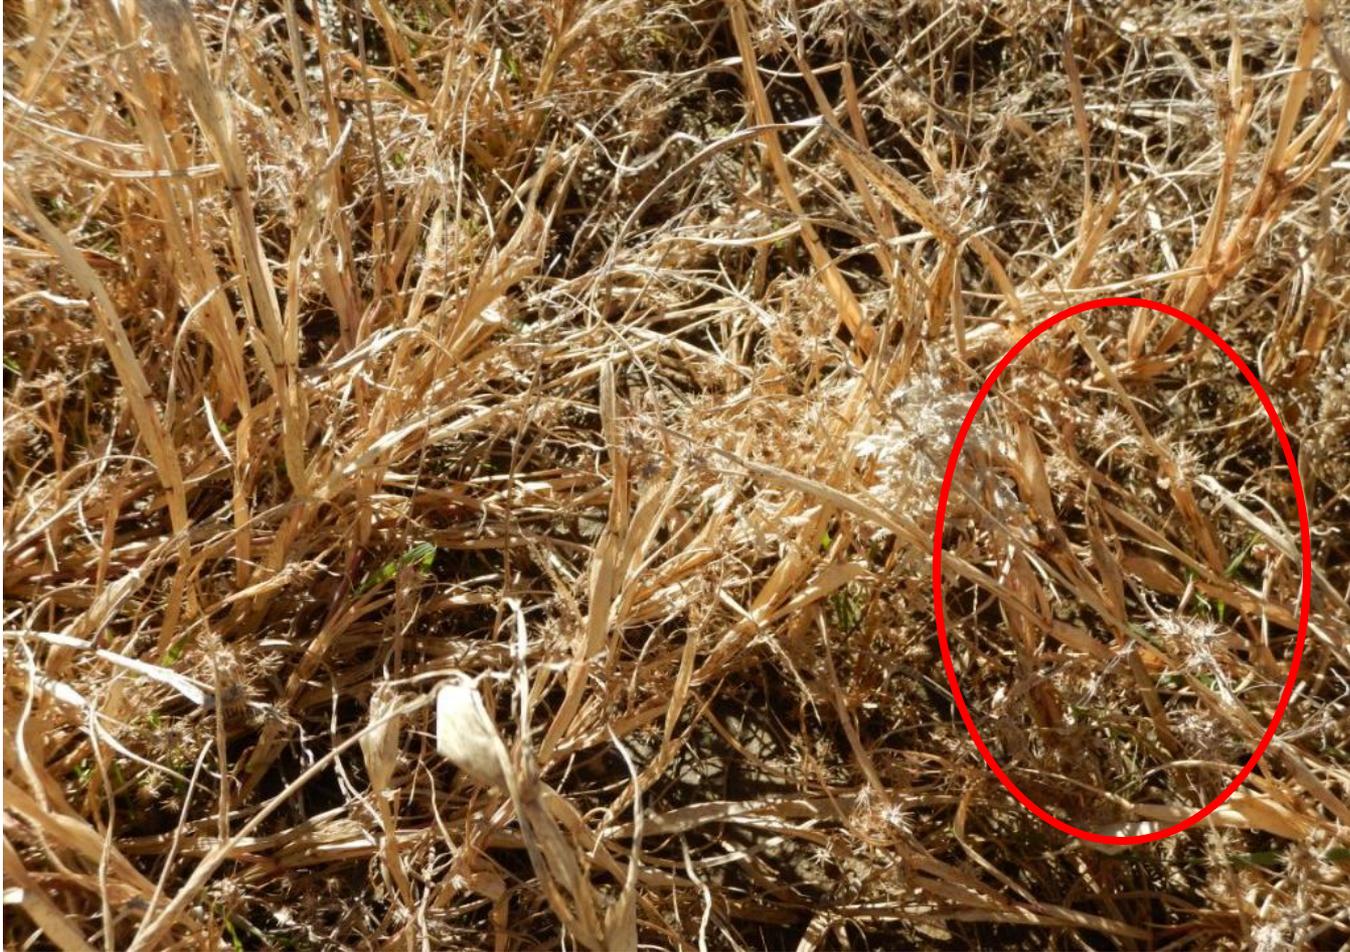
Photo 6. Close-up photo of longspine sandbur.
