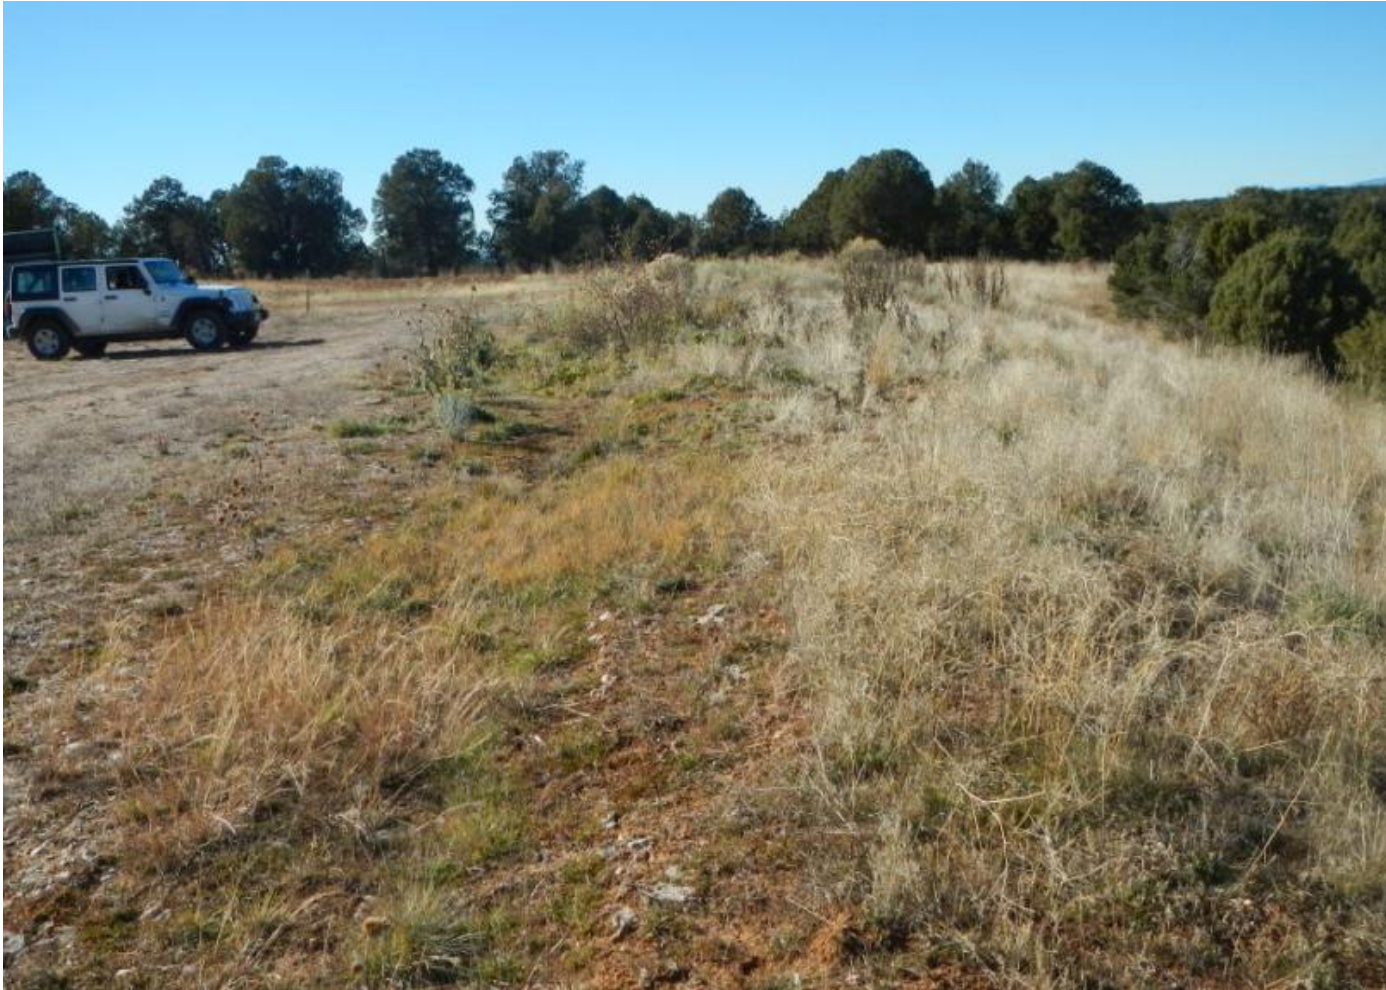
Photo 1. View of northern portion of the project area from northeastern corner facing westward. An infestation of Canada thistle (*Cirsium arvense*) and musk thistle (*Carduus nutans*) is present.

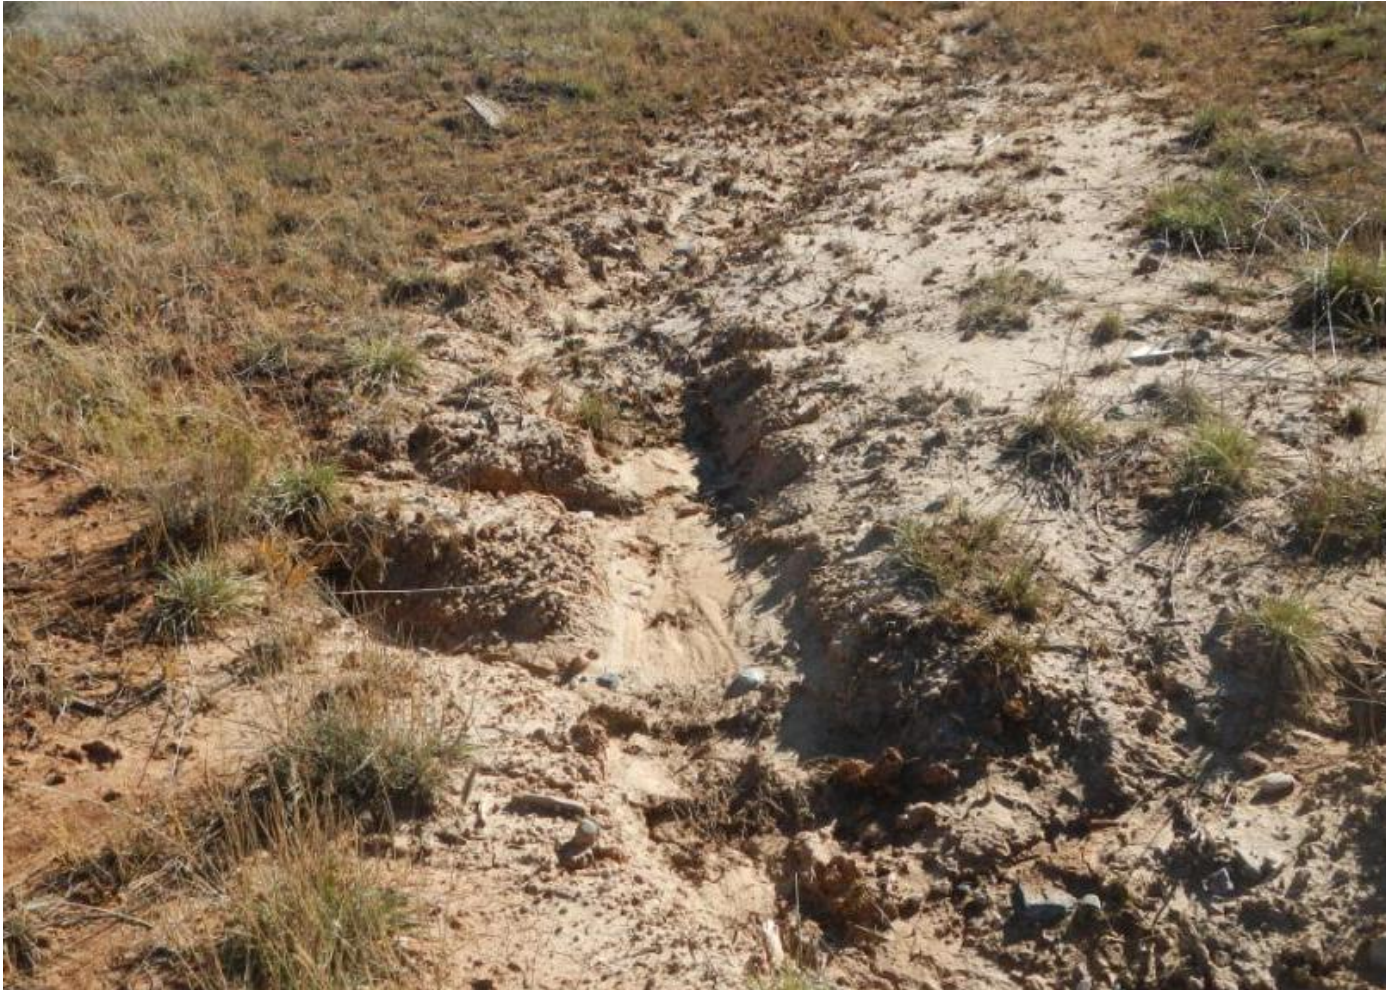
Photo 3. View of where stormwater diversion is eroding in northwestern corner of the project area. Erosional channel is approximately 2 feet wide and 1 foot deep. Stormwater BMPs are needed to de-energize and filter stormwater flows in this area.

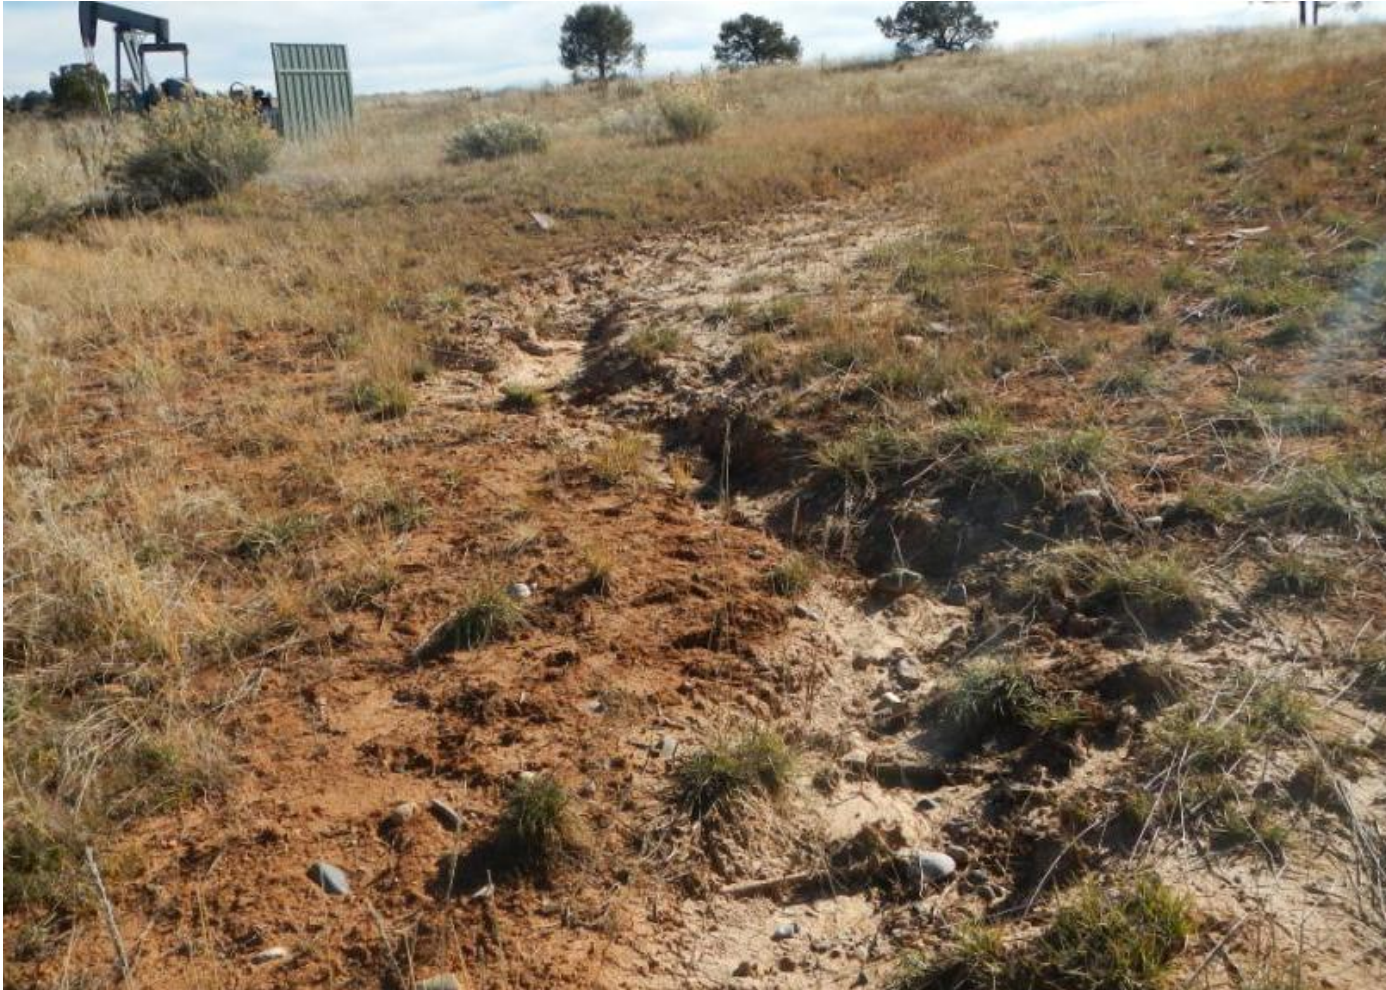
Photo 4. Another view of diversion channel that is eroding in northwestern portion of the project area. Stormwater BMPs are needed here.

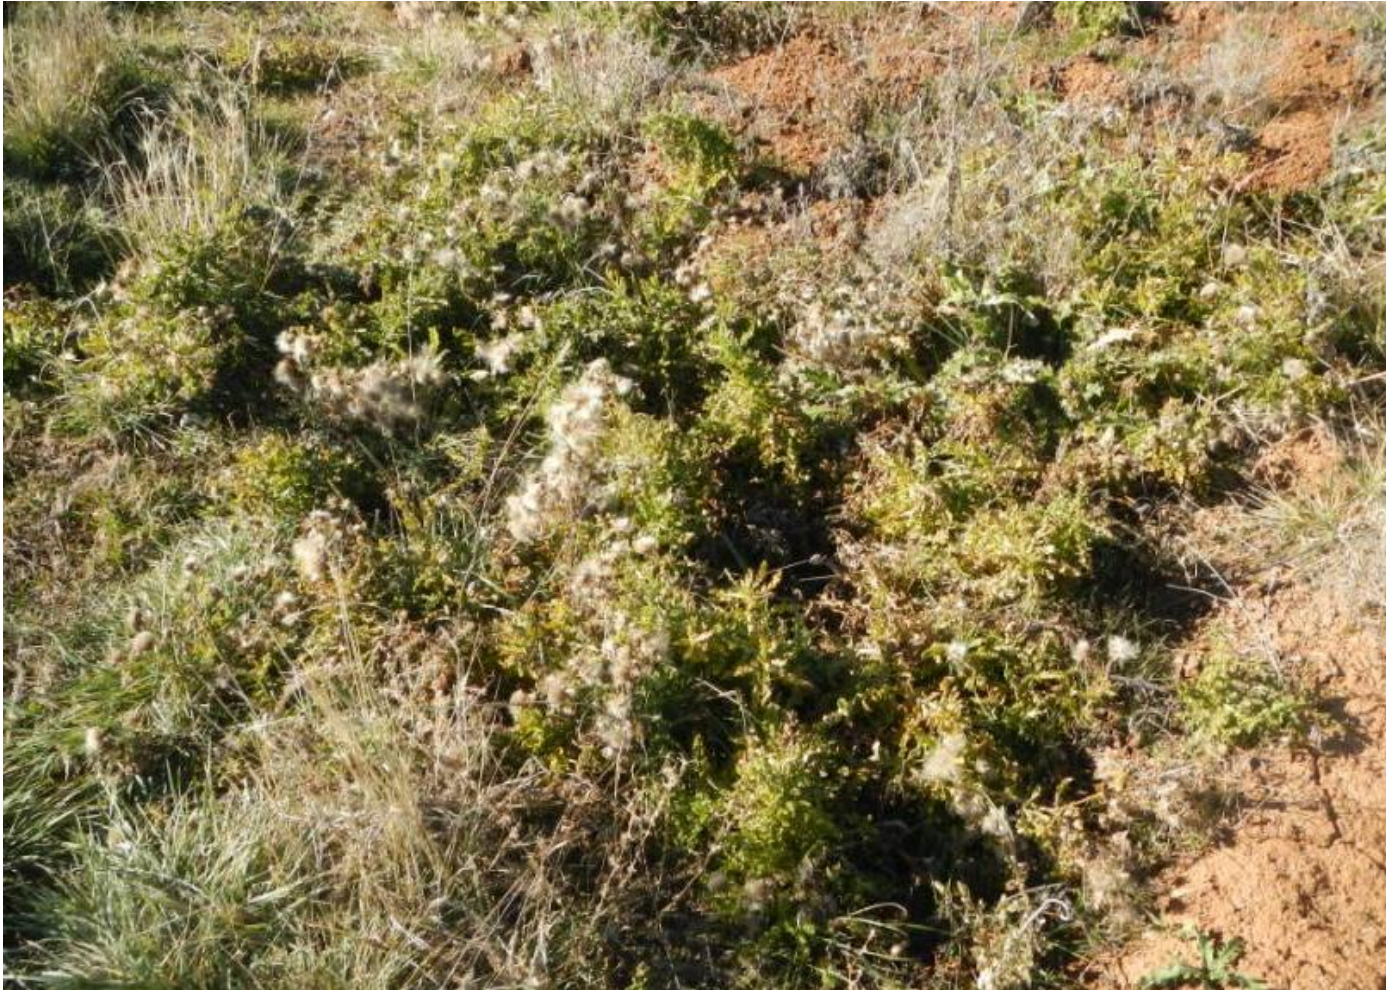
Photo 5. View of a cluster of Canada thistle plants growing within the northern portion of the interim reclamation area.

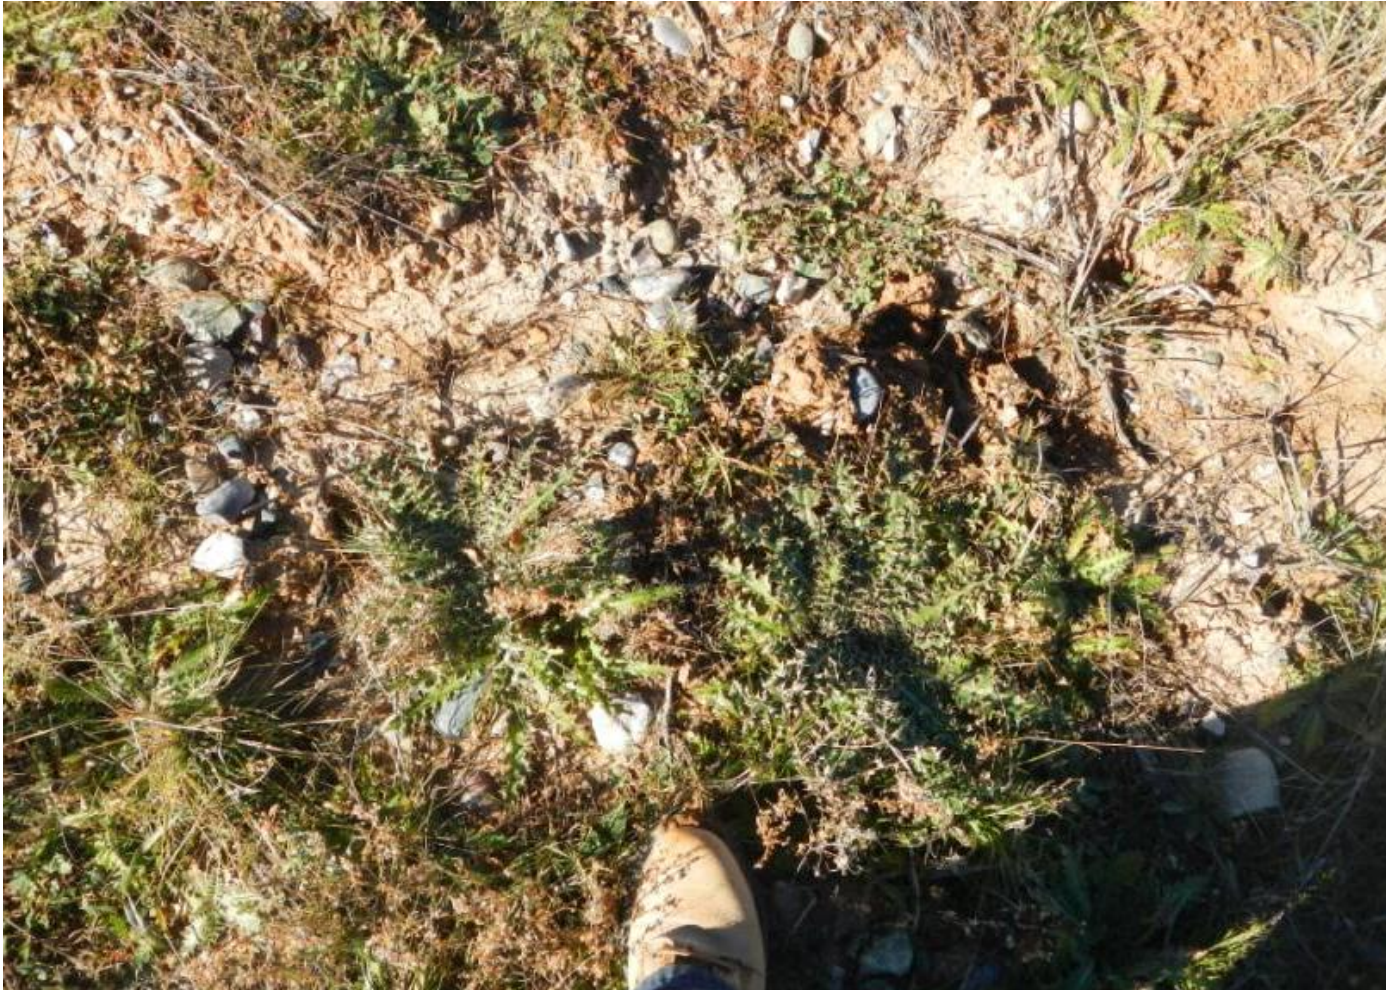
Photo 6. View of approximately 23 musk thistle rosettes growing within the northern portion of the interim reclamation area.

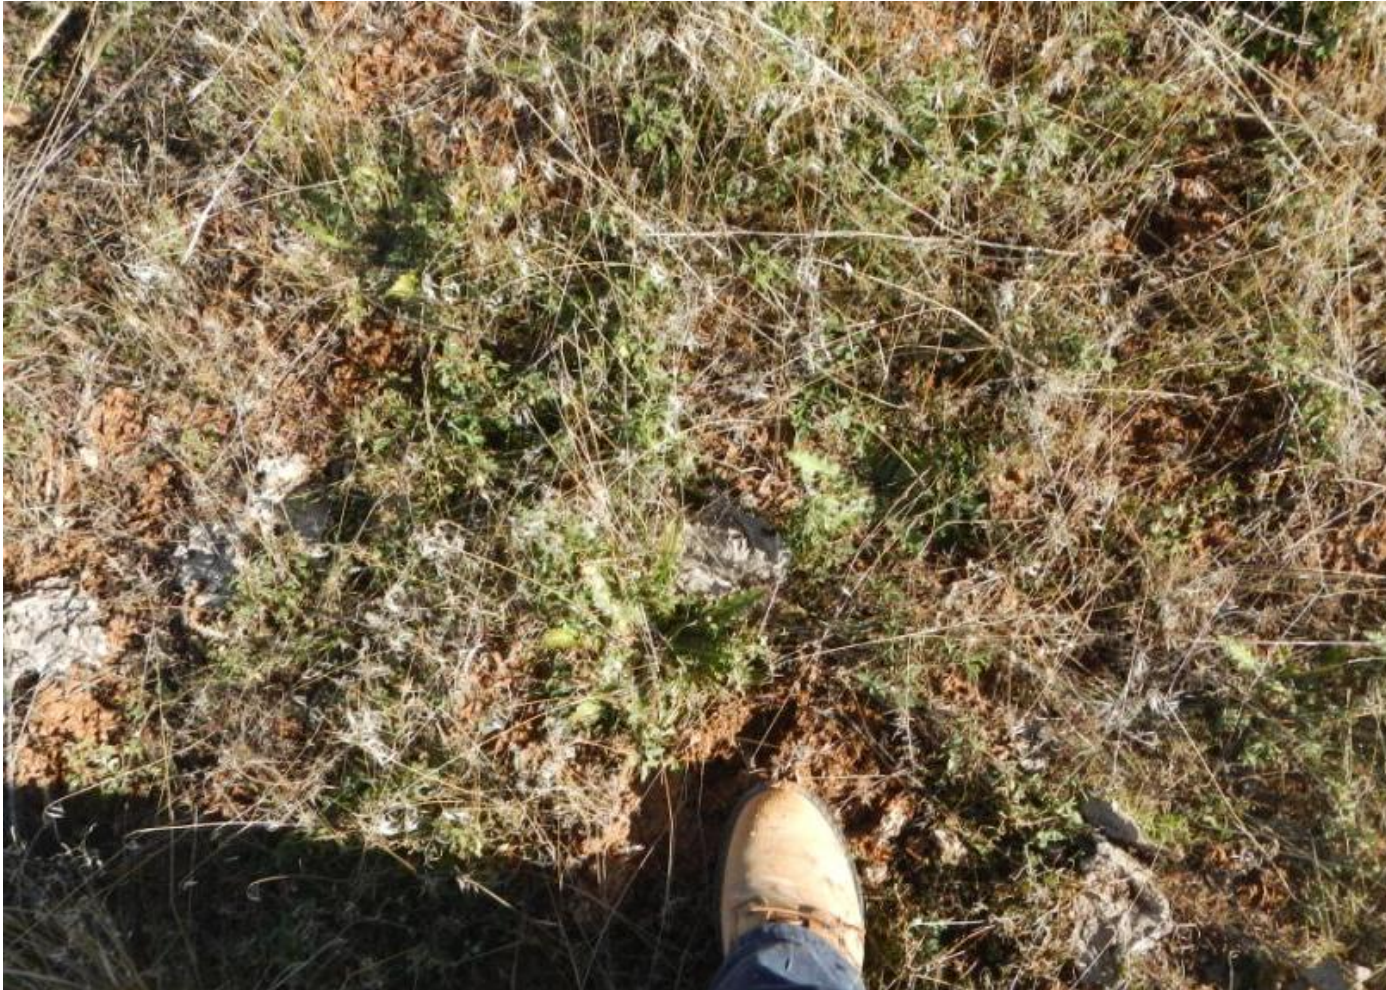
Photo 5. View of approximately 10 musk thistle rosettes growing within the southern portion of the interim reclamation area. Noxious weeds are growing throughout the interim reclamation area.
