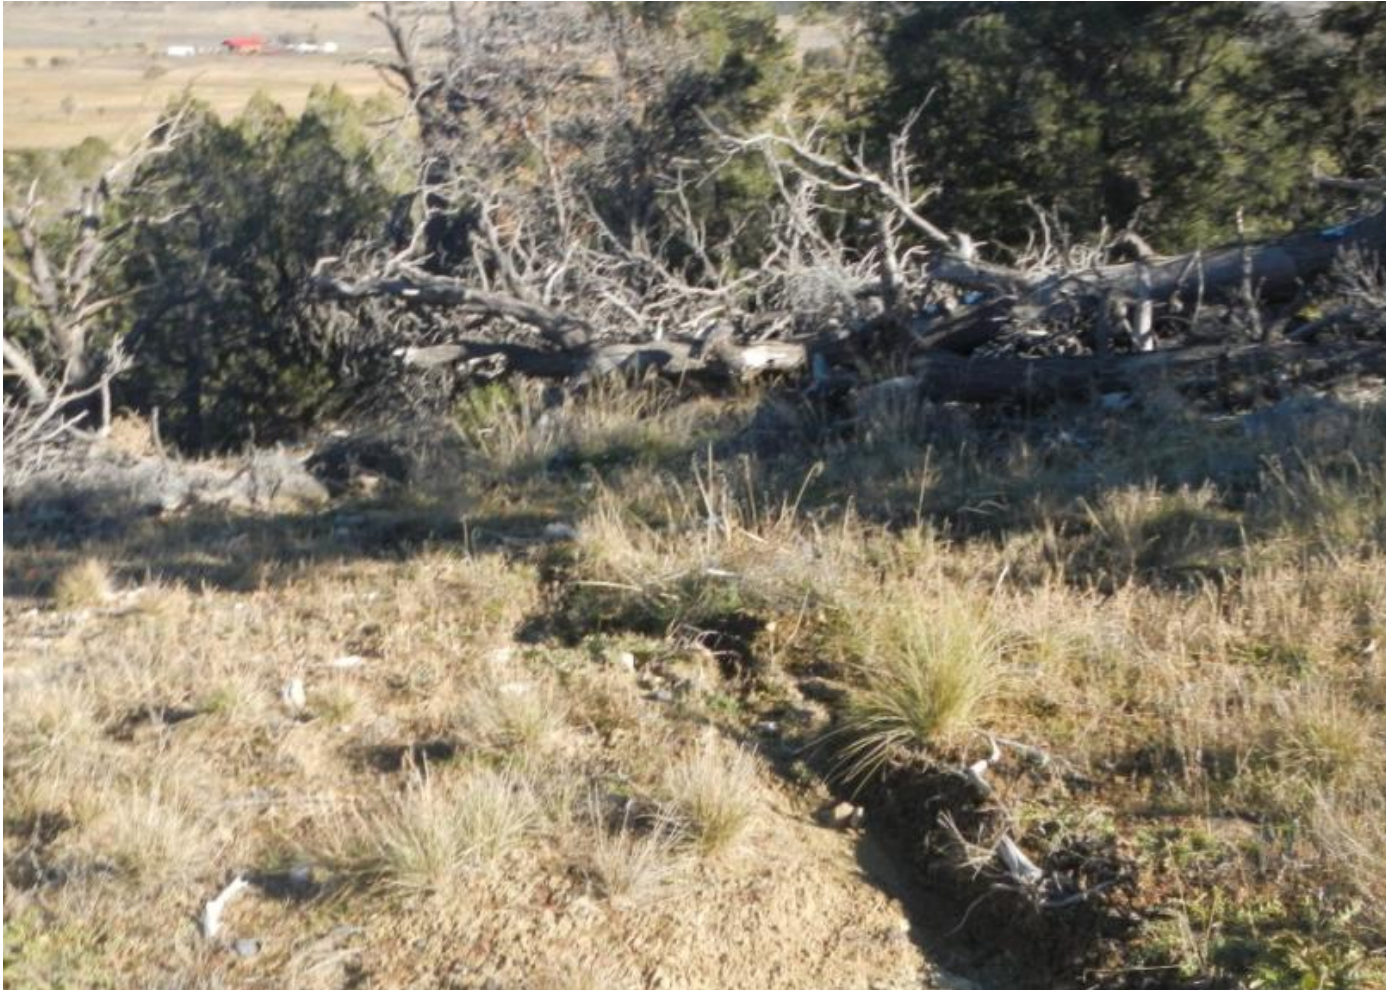
Photo 1. View of erosional channel approximately 1 foot wide and one foot deep eroding off of the northeastern portion of the project area .

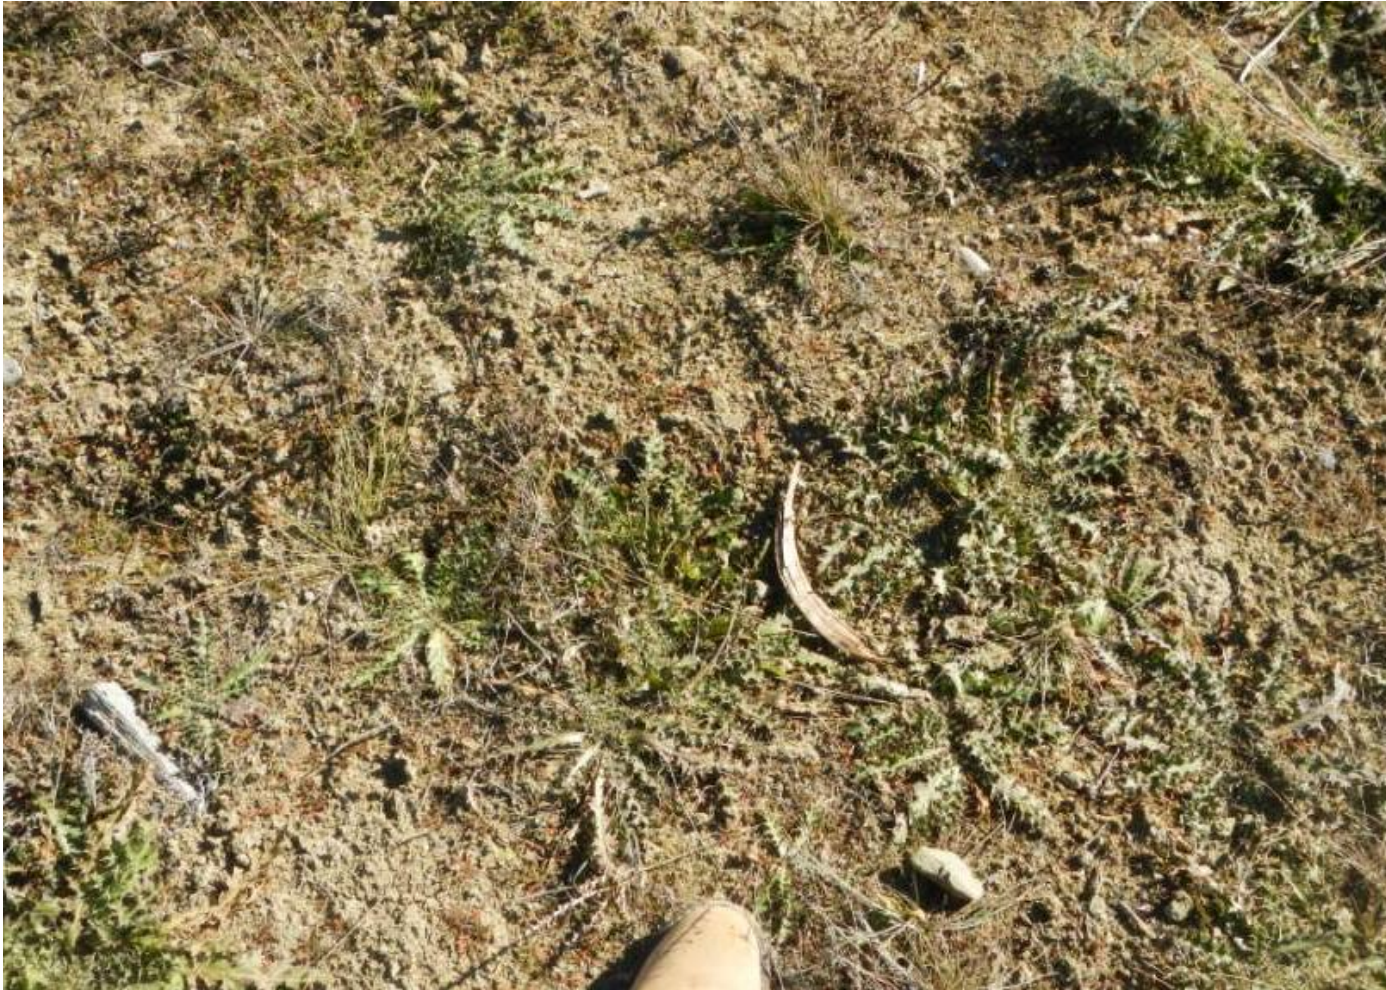
Photo 2. View of approximately 17 musk thistle (*Carduus nutans*) within the interim reclamation area.

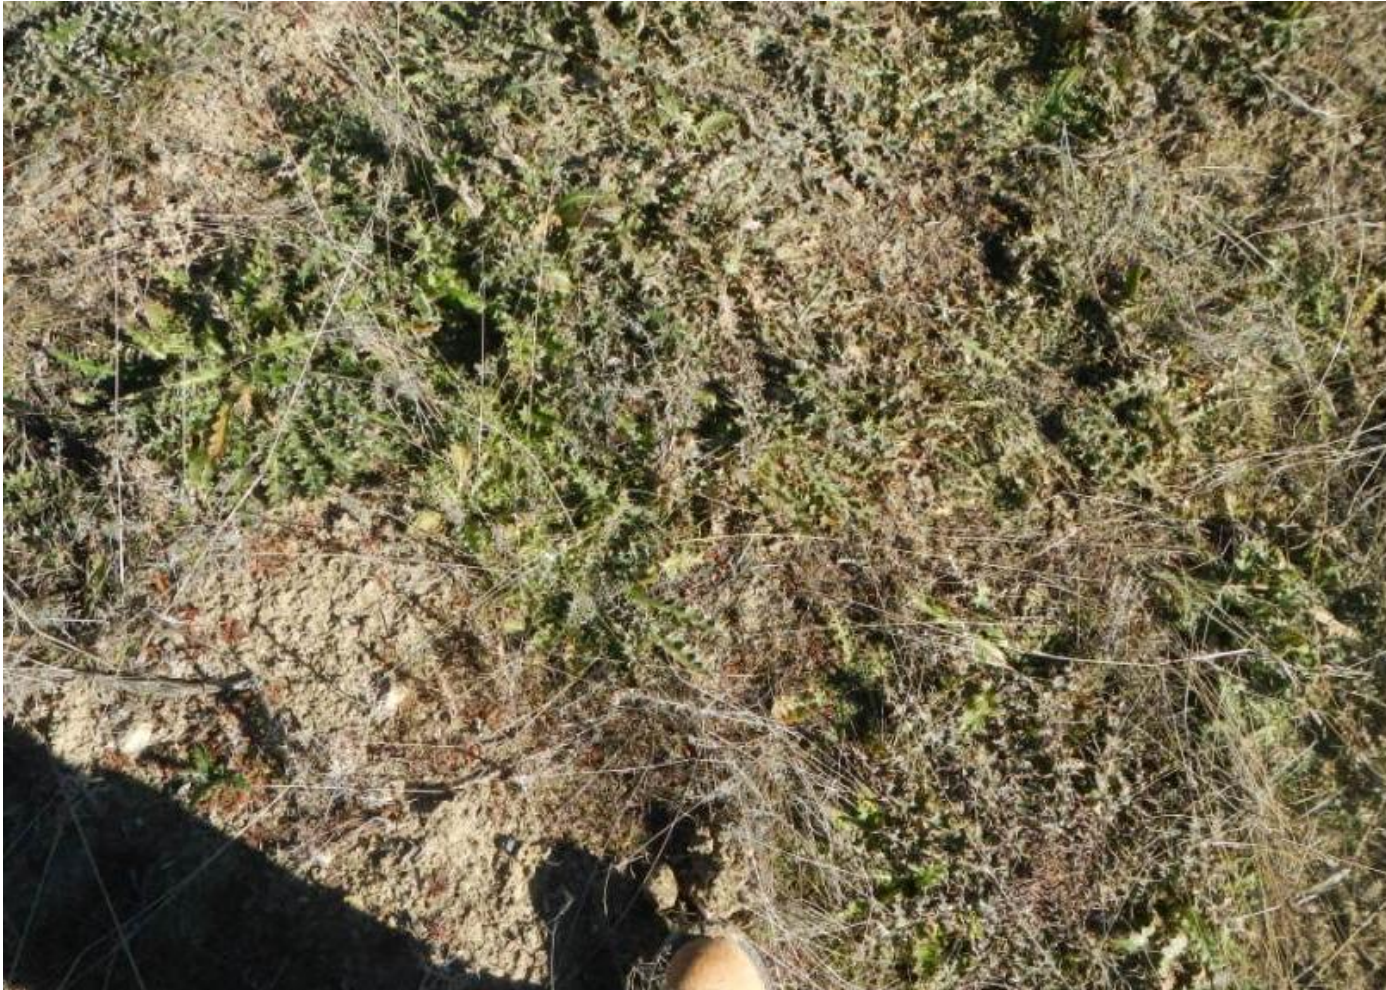
Photo 3. Another view of dense musk thistle rosettes within the interim reclamation area.

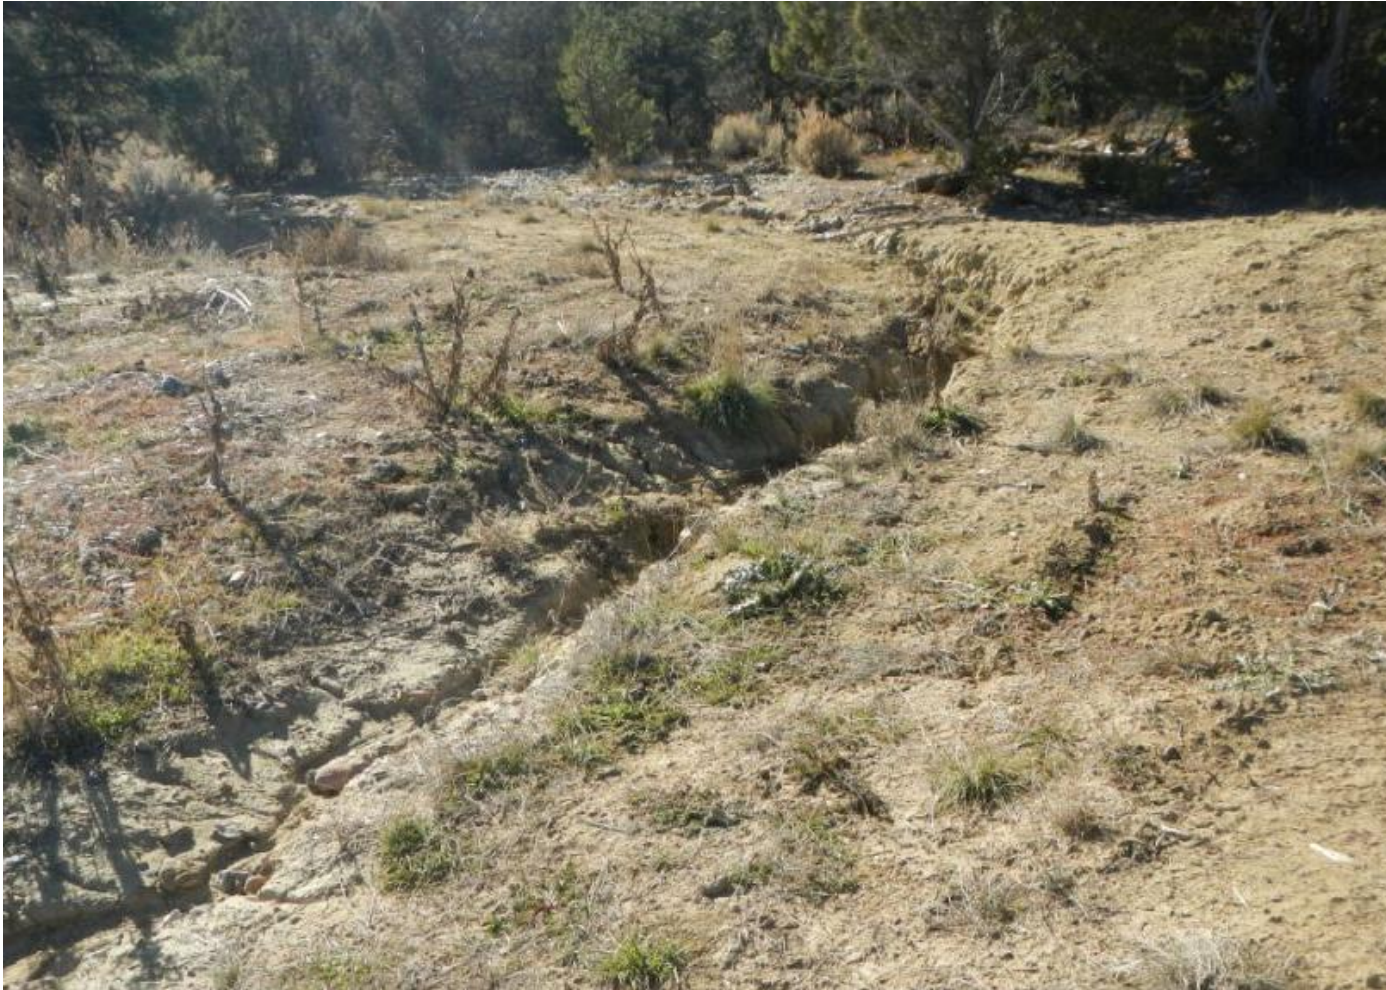
Photo 4. View of diversion channel that is eroding in northwestern portion of the project area. This portion of the project area needs stabilization measures and stormwater BMPs.

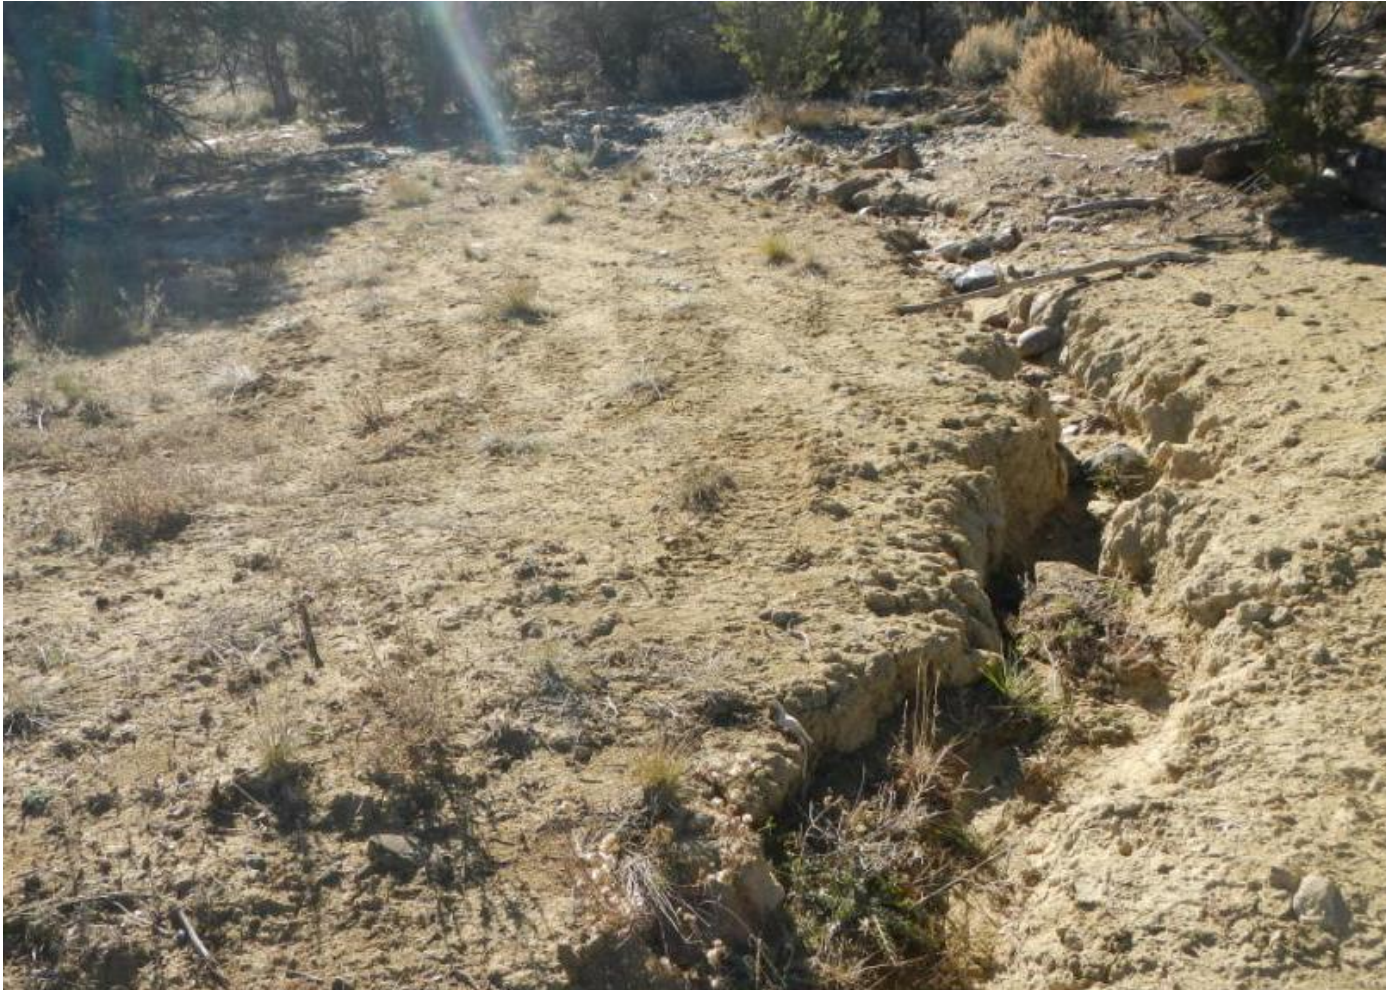
Photo 5. Another view of stormwater erosion in the northwestern corner of the project area (approximately 2 feet wide and 1.5 feet deep).

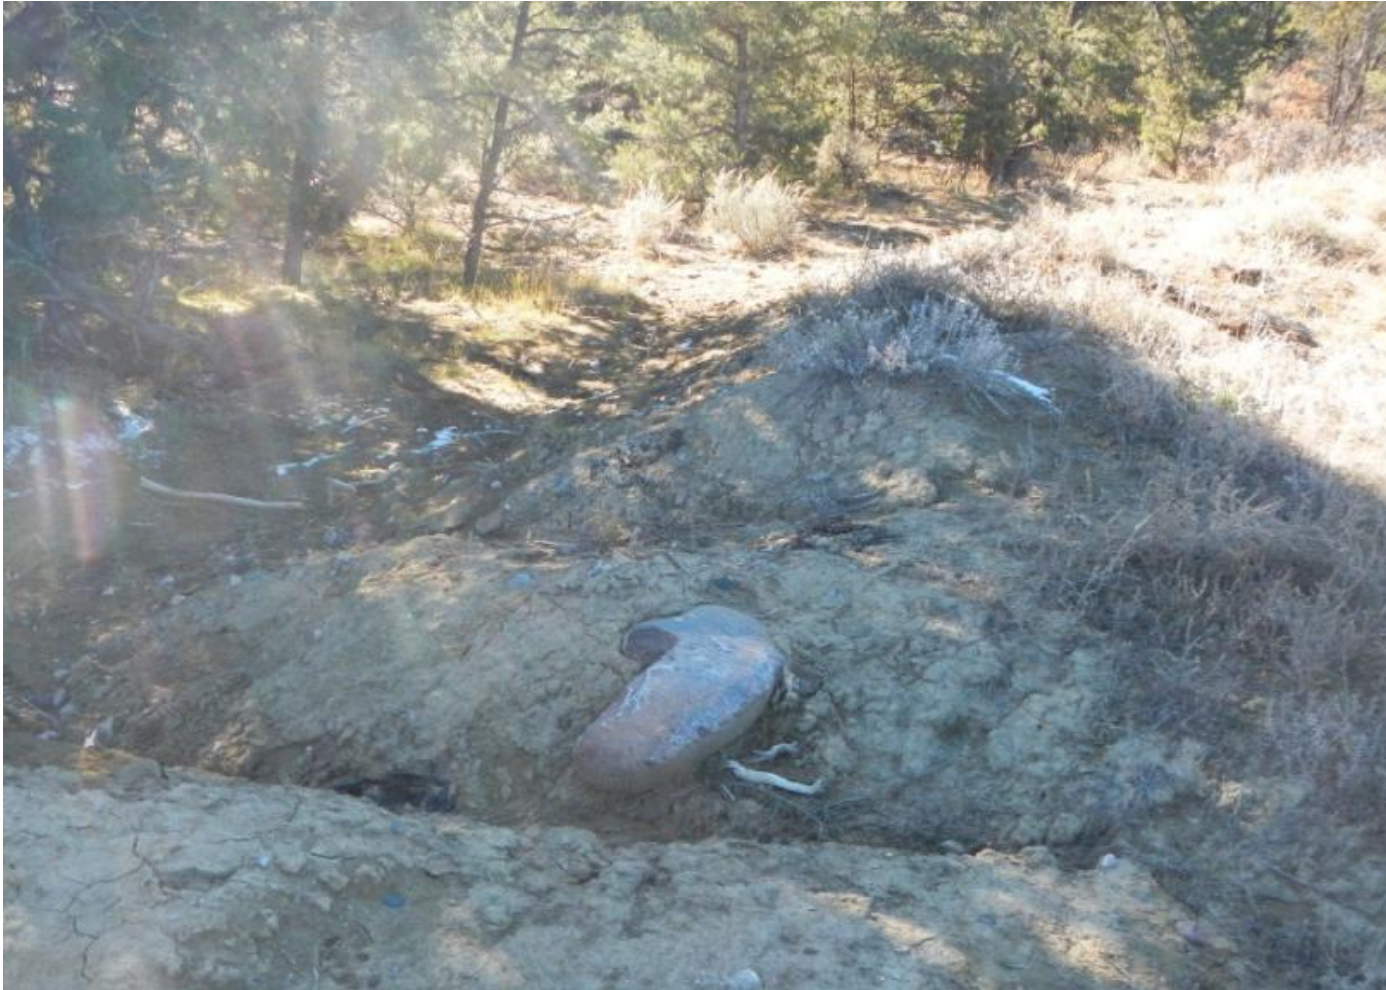
Photo 8. View of stormwater erosion in the southern portion of the project area. Appears to be carrying sediment off of the project area.
