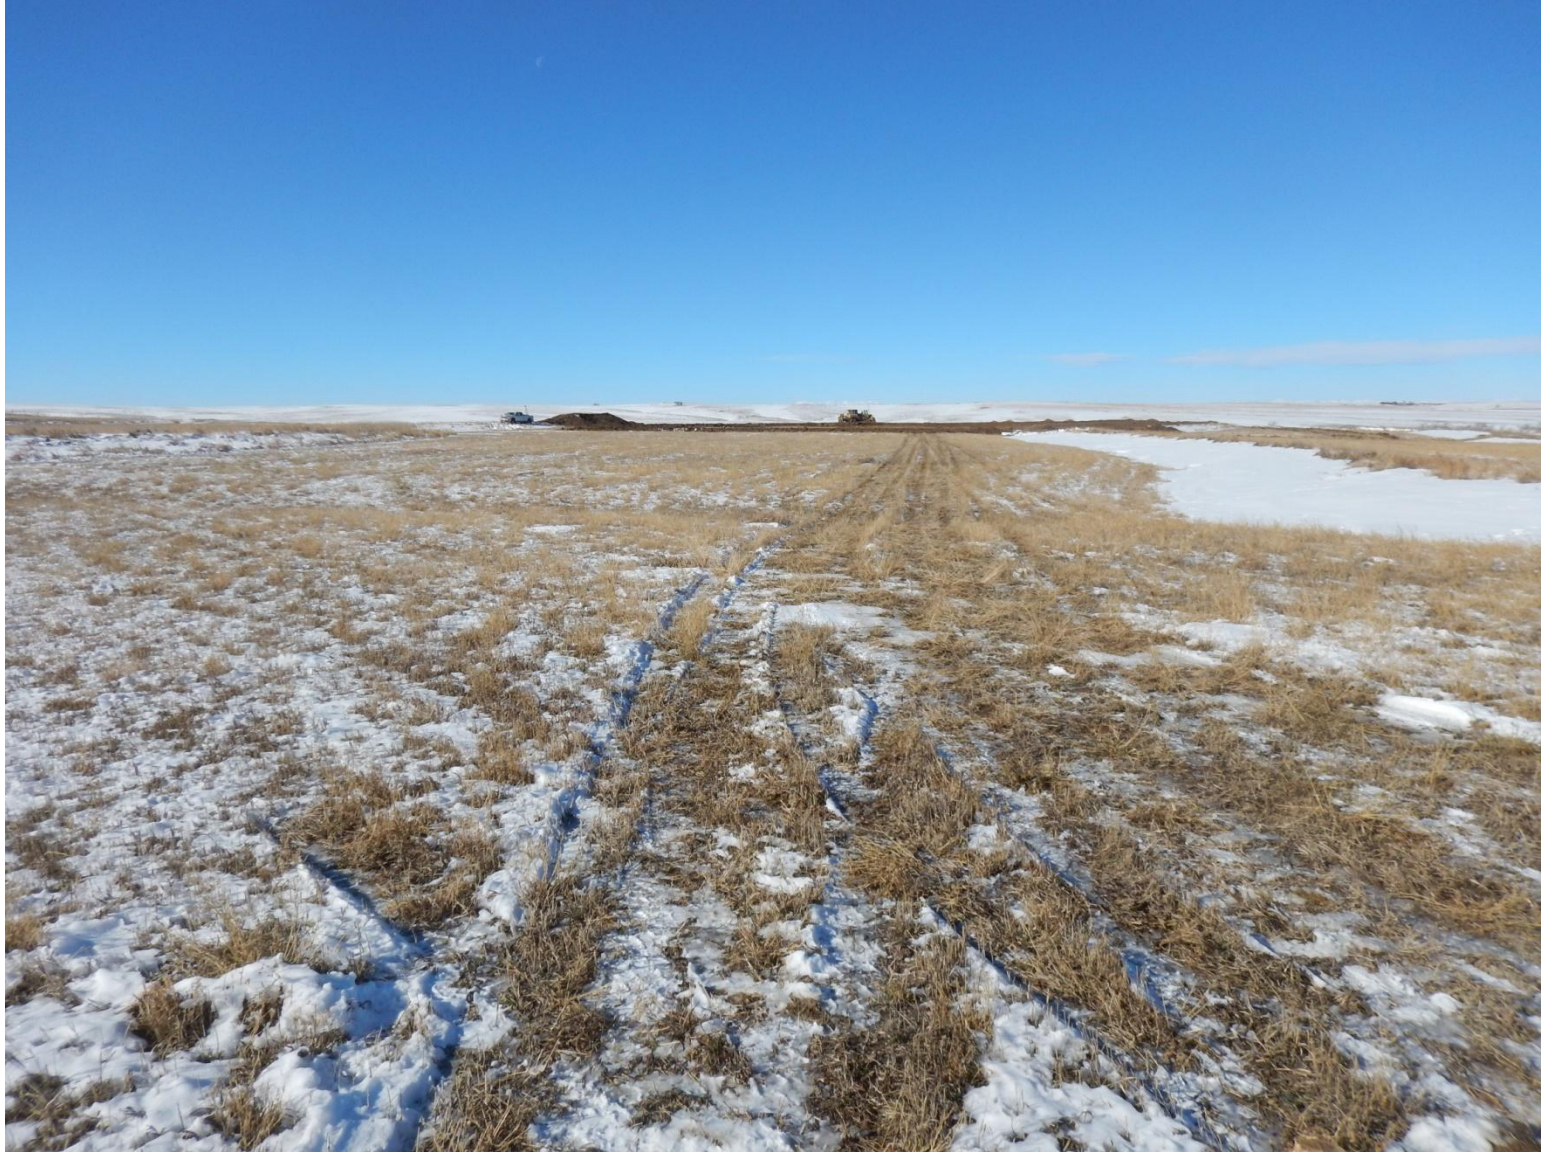
Photo 1: Photo taken from east of location facing west. Photo shows construction location. Topsoil berm on left of location. Note no defined access road or vehicle tracking BMPs in place to minimize disturbance and control sediment displacement by vehicles and/or equipment.

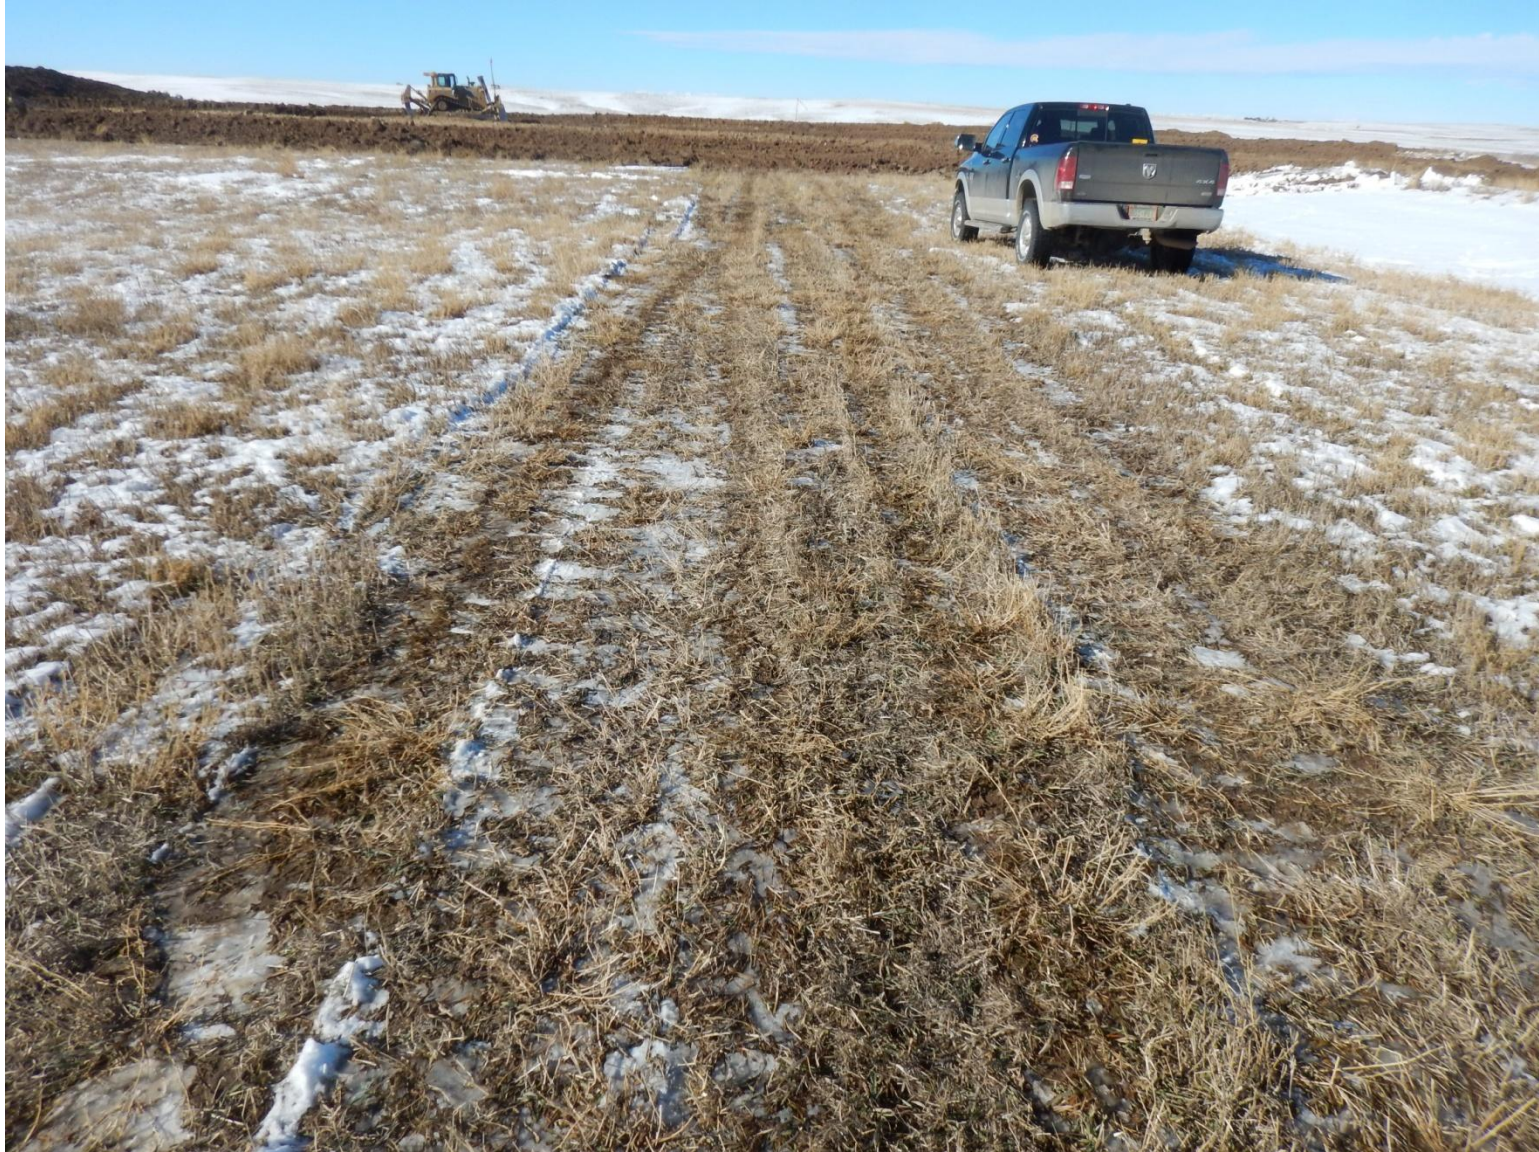
Photo 2: Photo taken east of location facing west. Note no defined access road or vehicle tracking BMPs in place to minimize disturbance and control sediment displacement by vehicles and/or equipment.

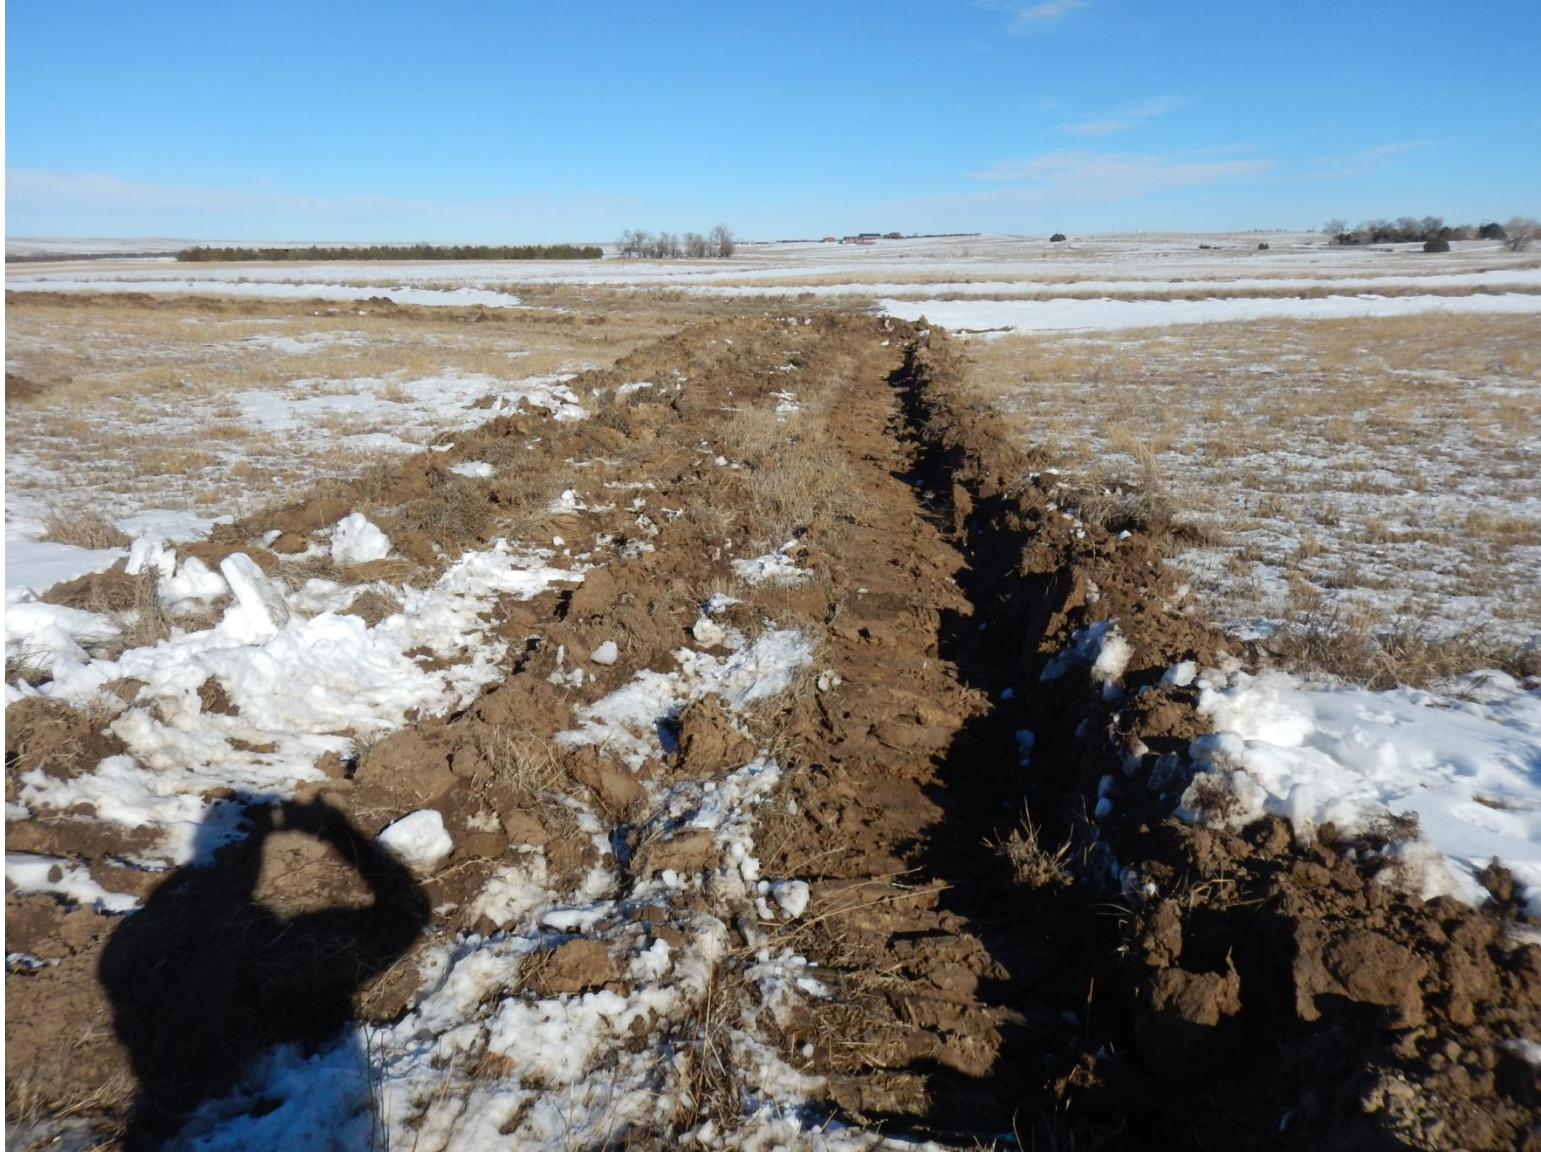
Photo 3: Photo taken from east end of location, facing north. Photo shows stormwater control ditch.

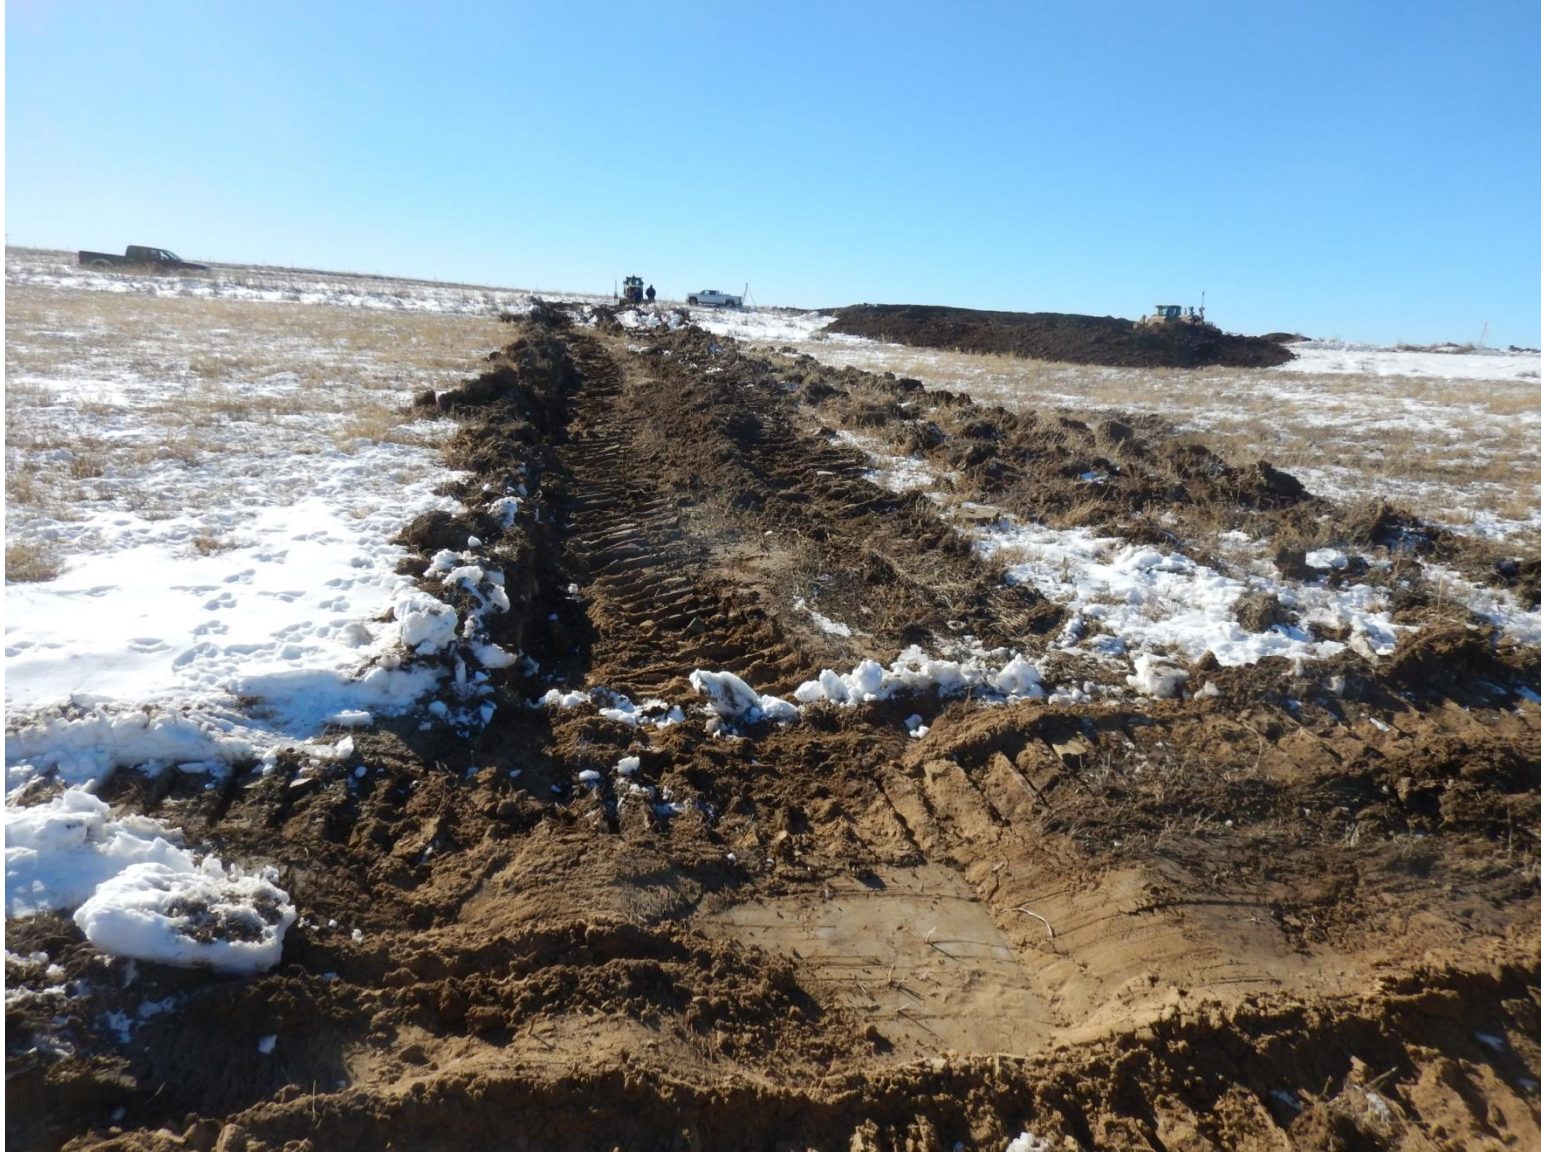
Photo 4: Photo taken from northeast corner of location, facing south. Photo shows stormwater control ditch.

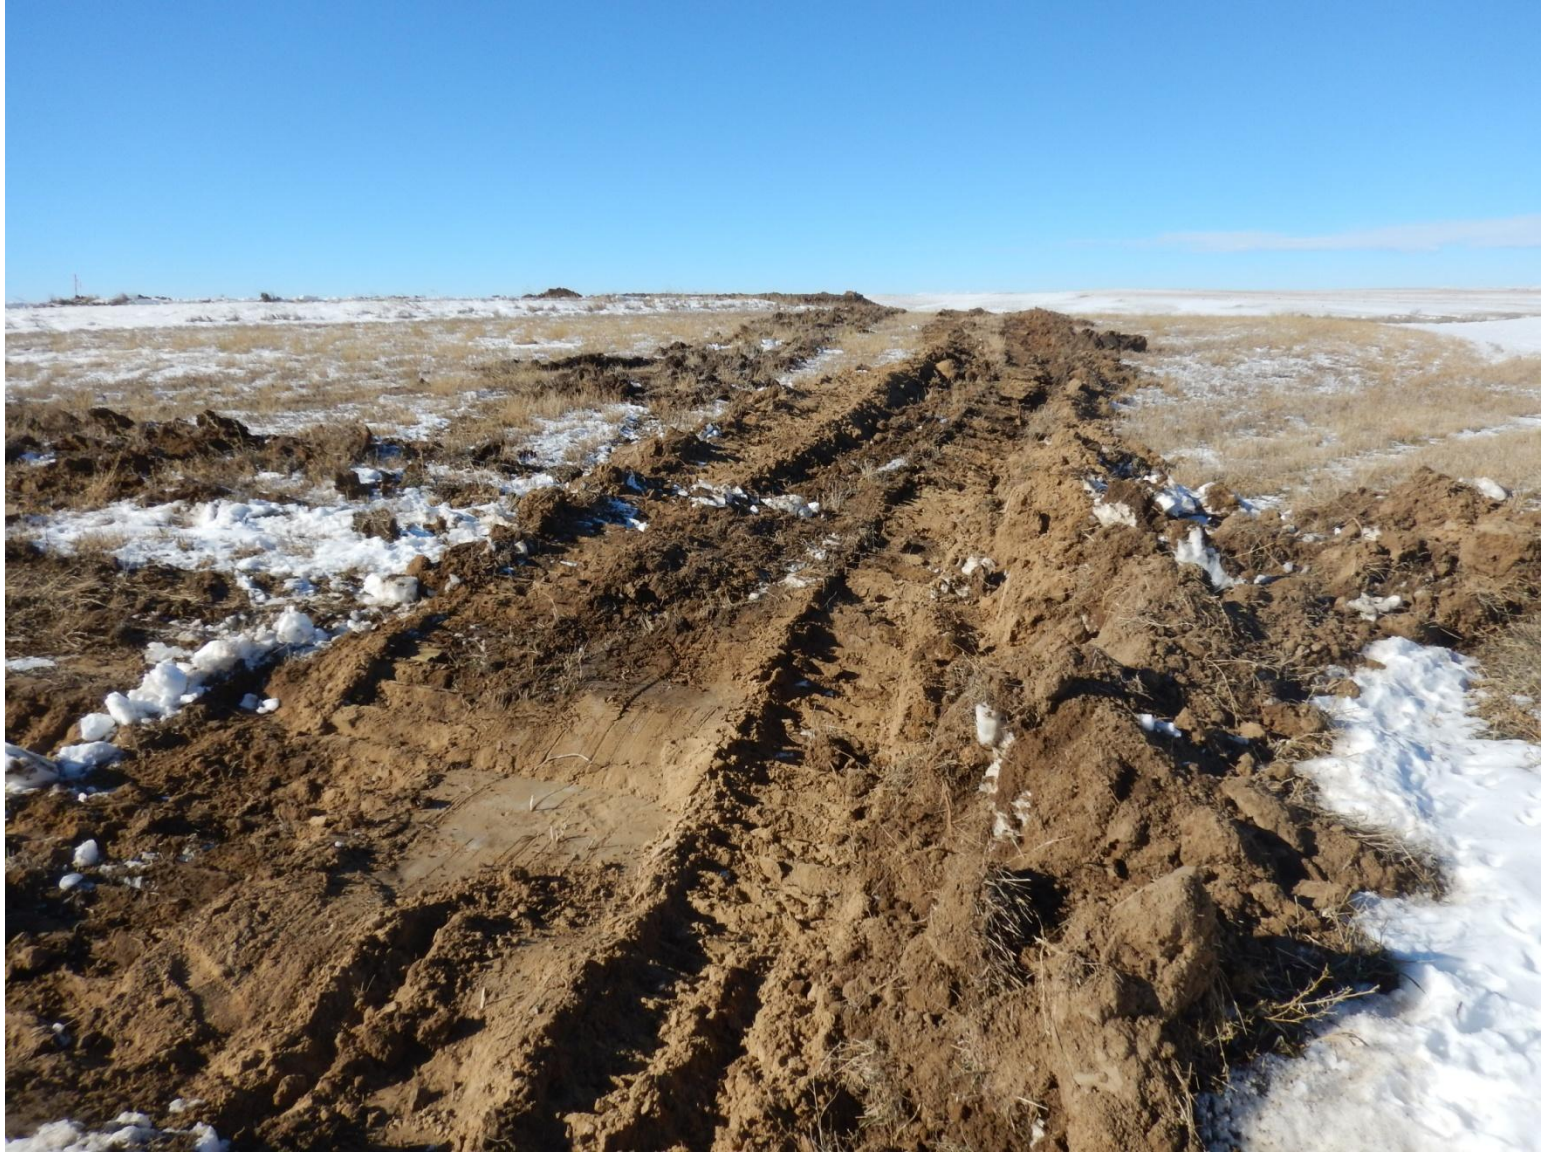
Photo 5: Photo taken from northeast end of location, facing west. Photo shows stormwater control ditch.

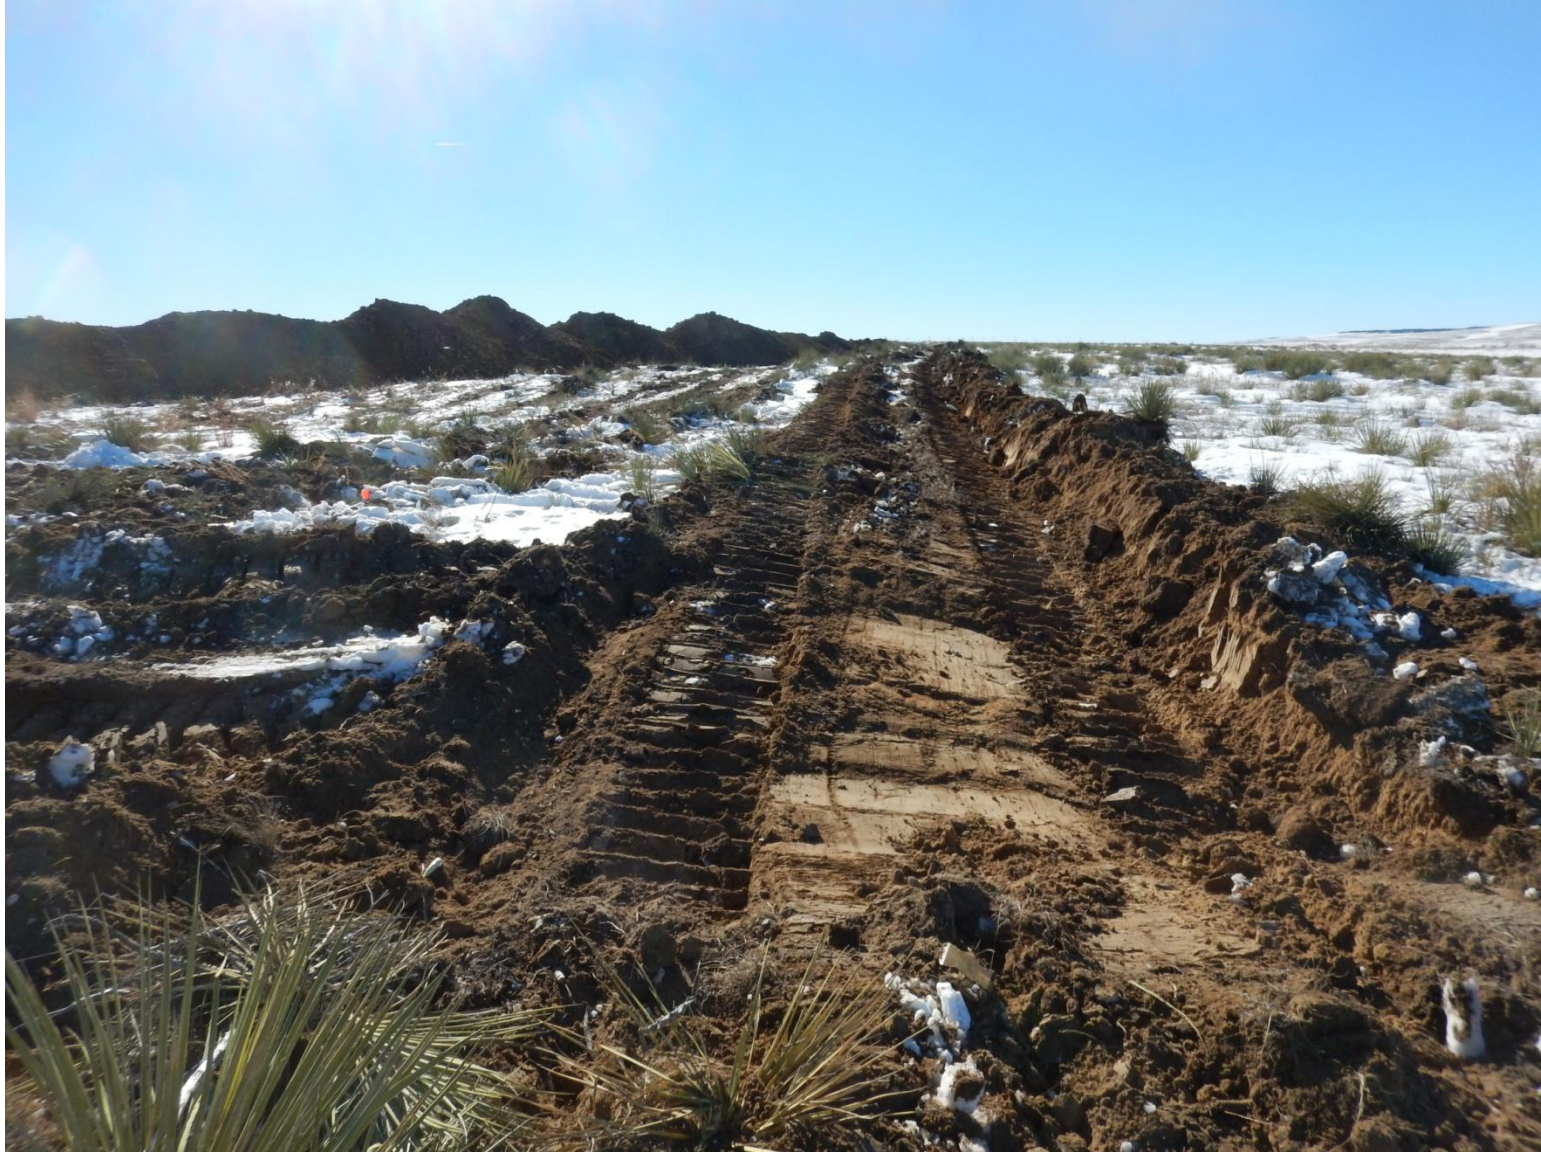
Photo 6: Photo taken from northwest corner of location, facing south. Photo shows stormwater control ditch.

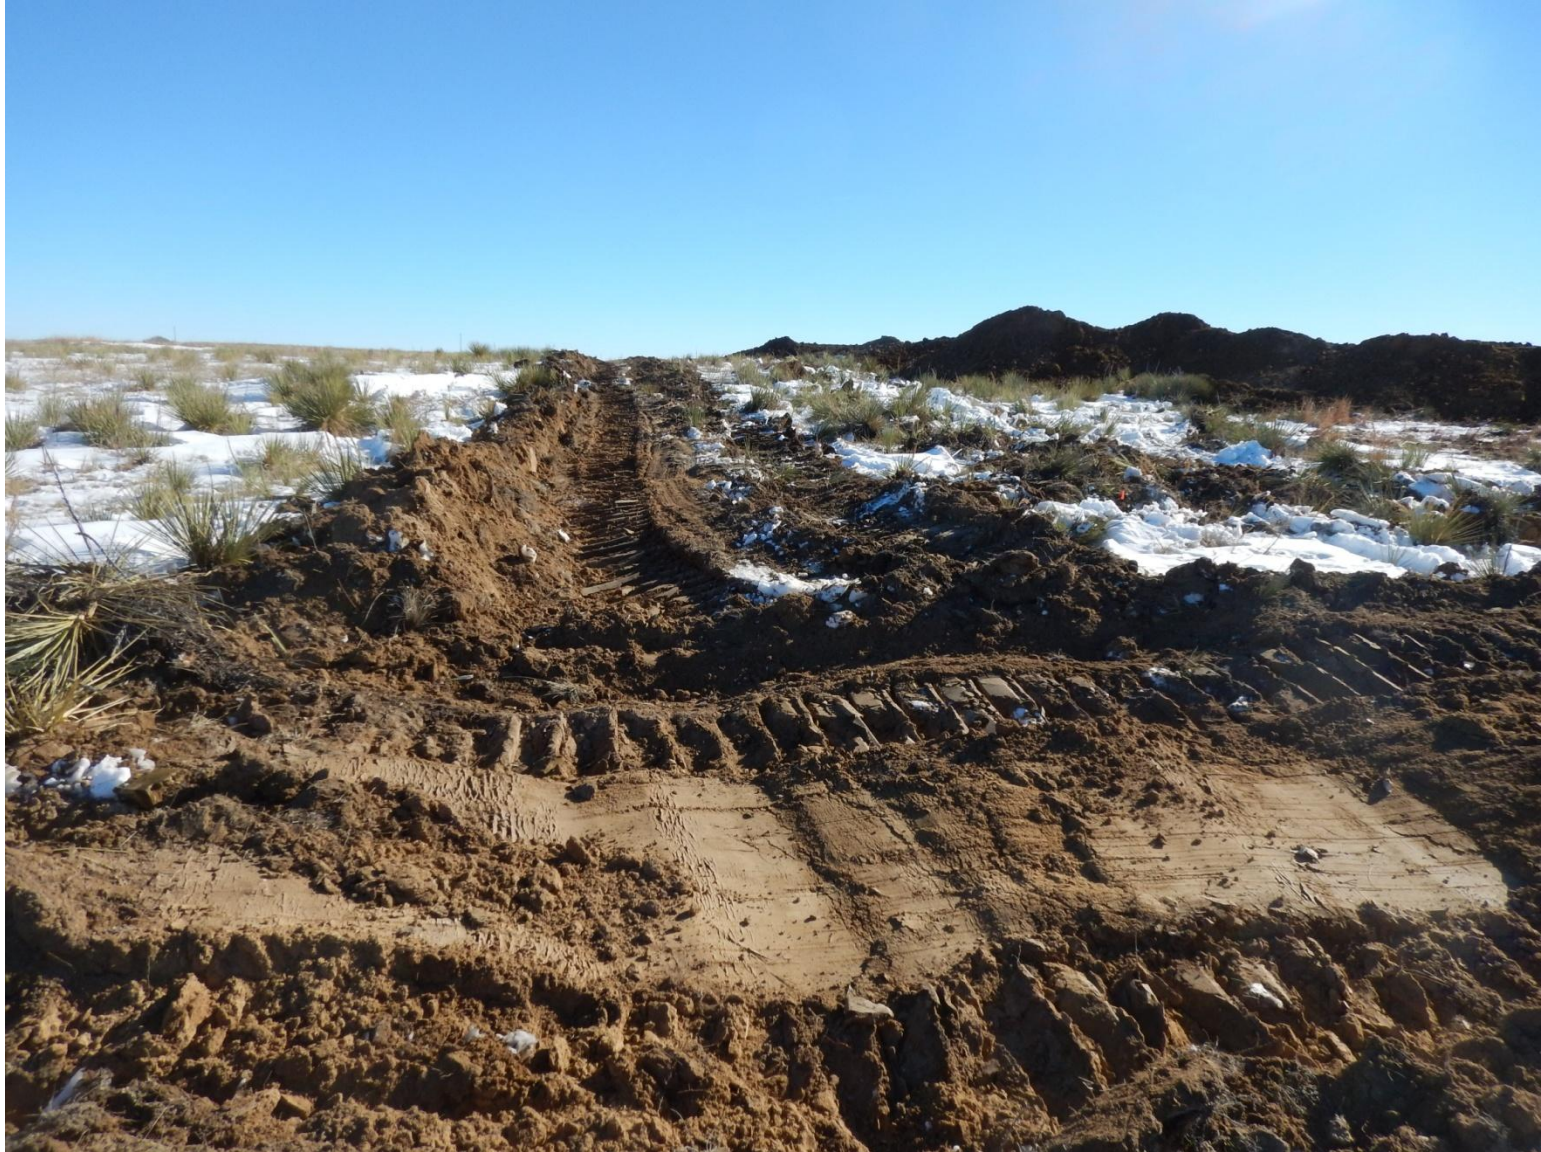
Photo 7: Photo taken from southwest corner of location, facing north. Photo shows stormwater control ditch.

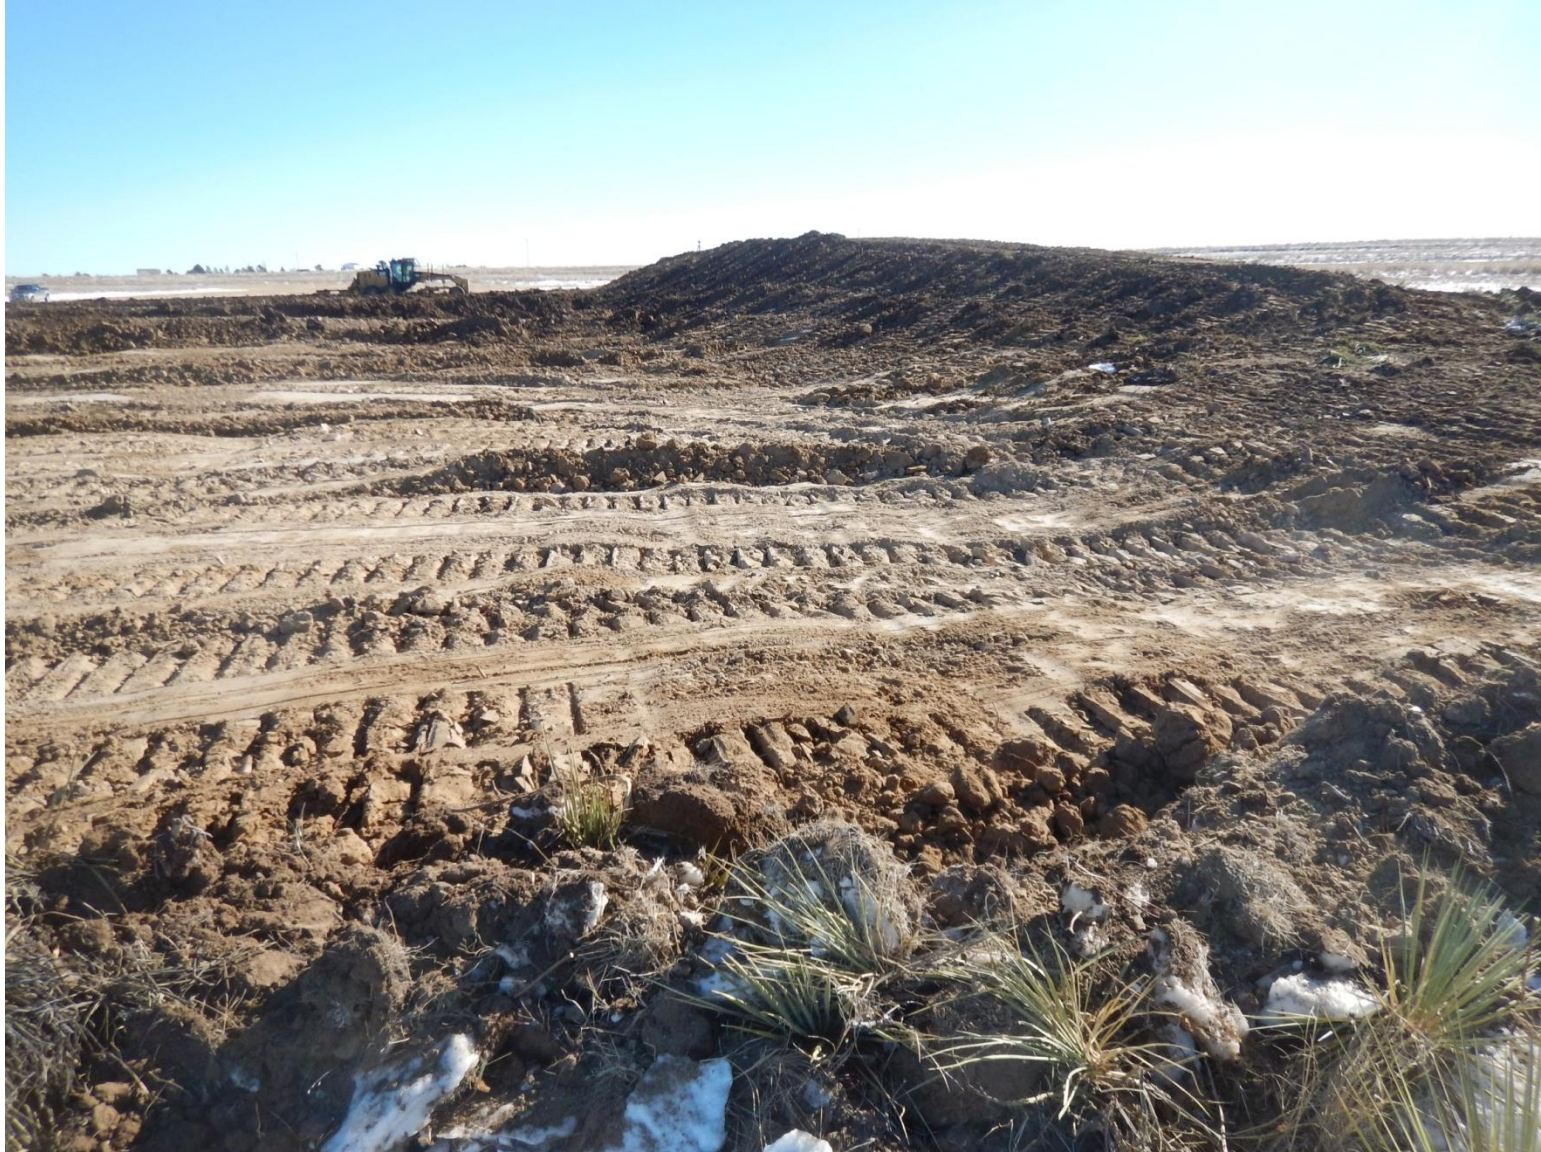
Photo 8: Photo taken from northwest end of location facing east. Photo of topsoil berm.

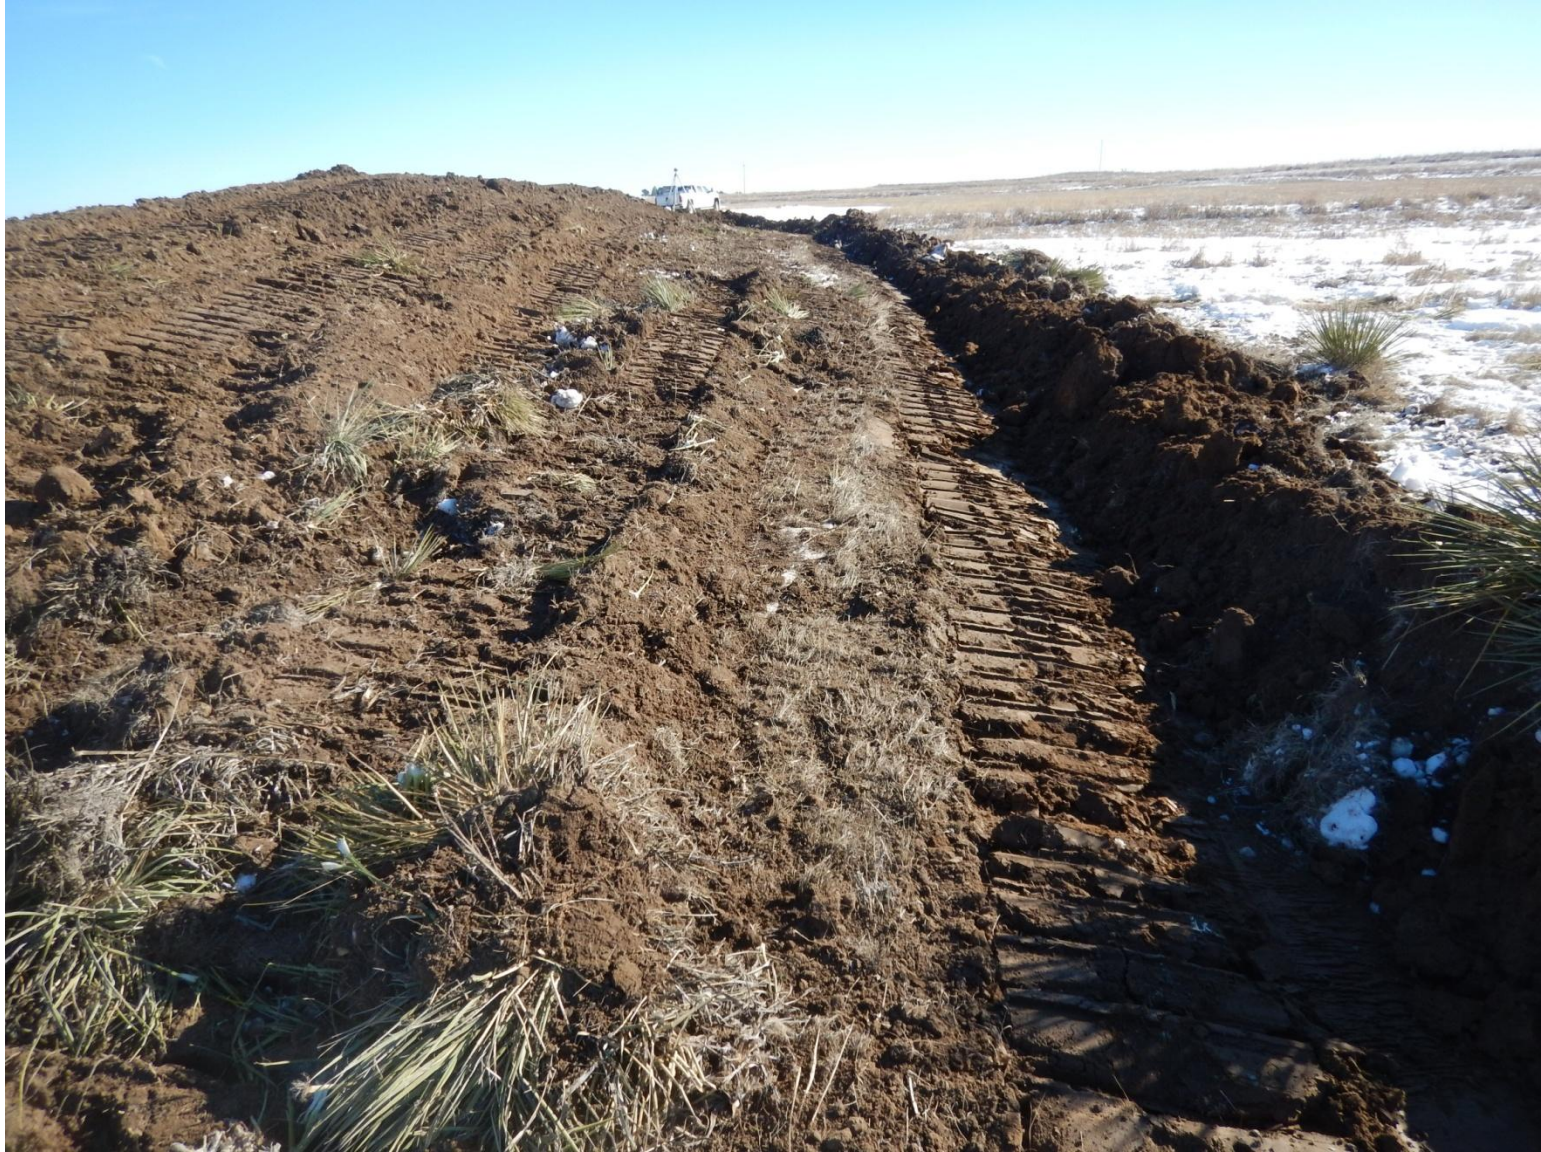
Photo 9: Photo taken from north end of location, facing east. Photo of topsoil berm and stormwater ditch.

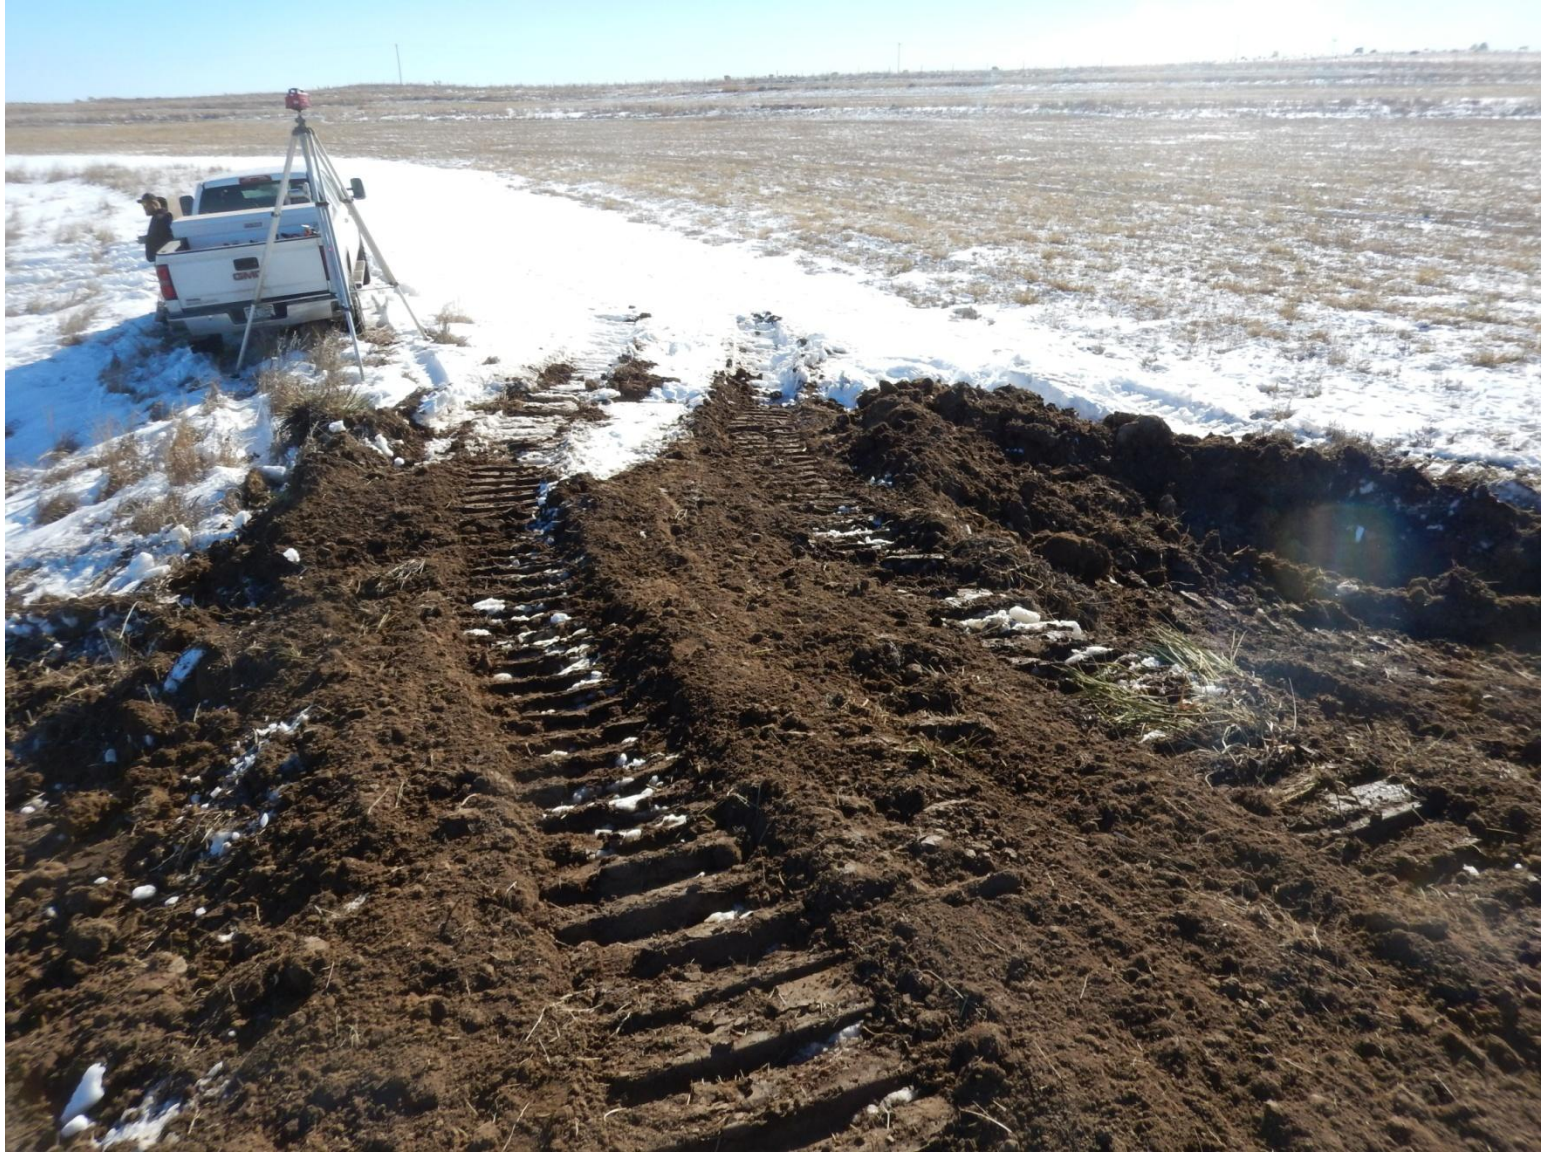
Photo 10: Photo taken from southeast end of location, facing southeast. Photo show insufficient stormwater BMPs in southeast corner of location.

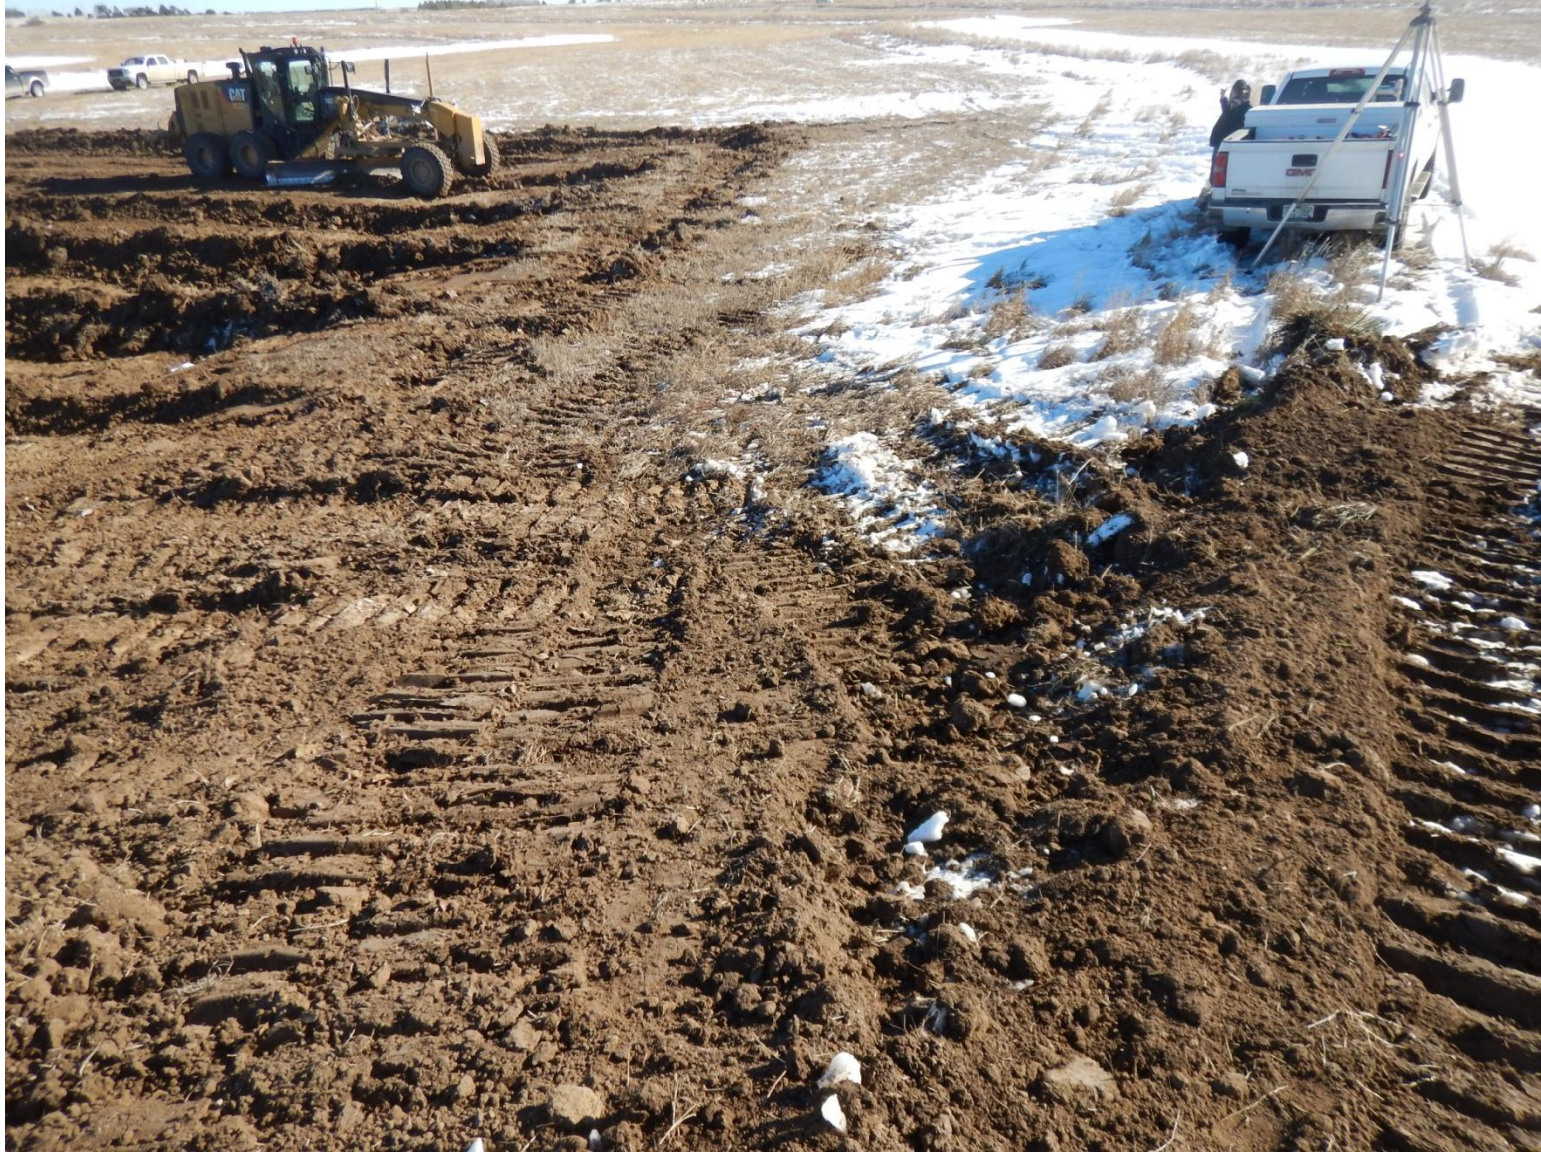
Photo 11: Photo taken from southeast end of location, facing east. Photo show insufficient stormwater BMPs in southeast corner of location.
