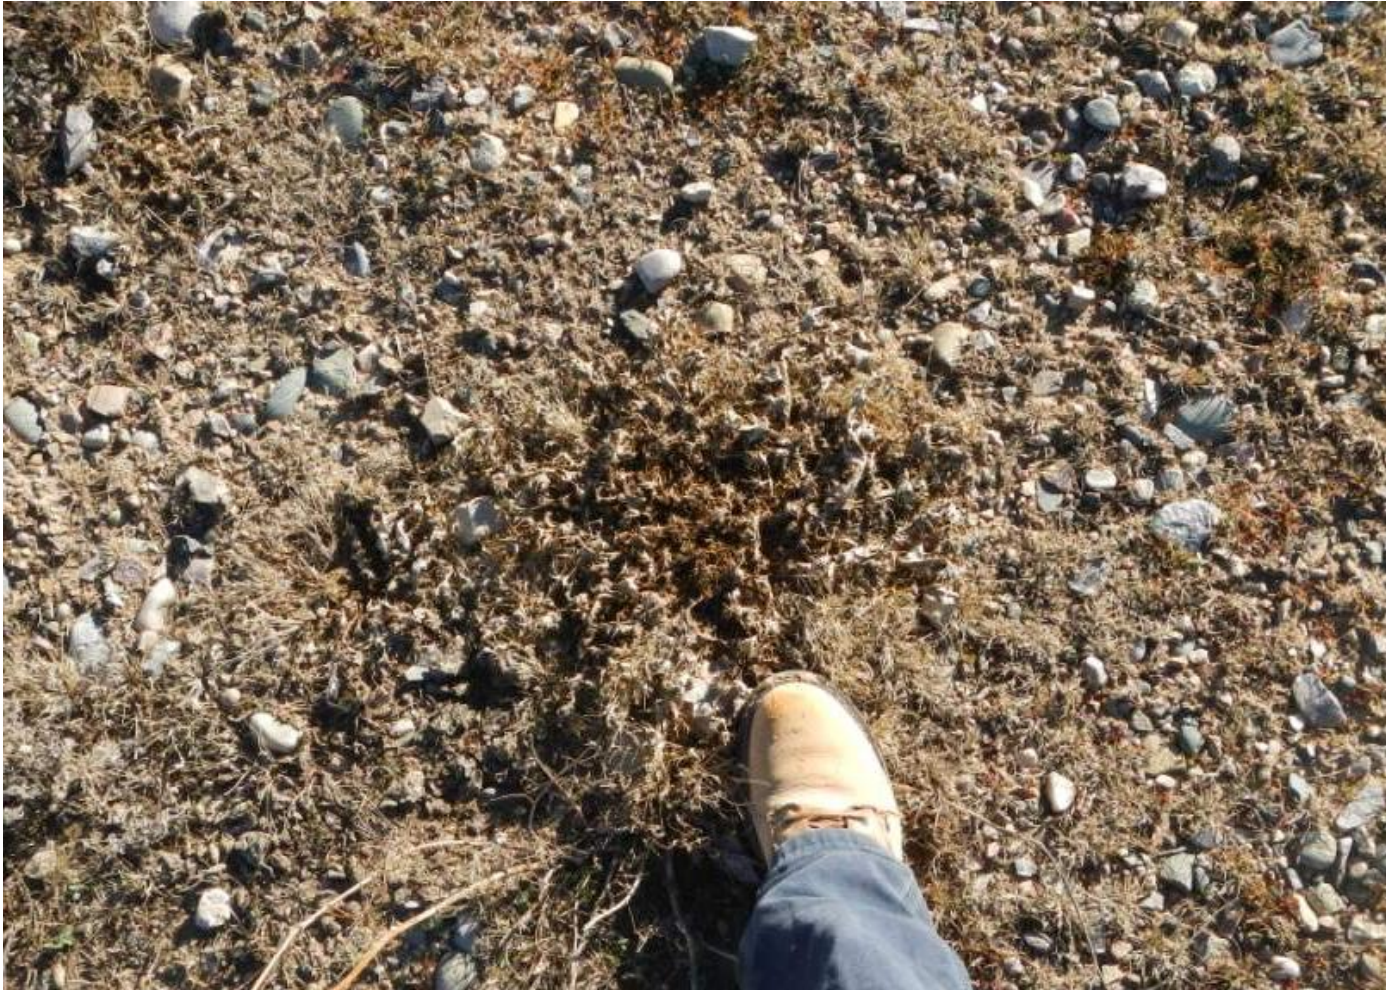
Photo 1. View of treated musk thistle (*Carduus nutans*) within the interim reclamation area.

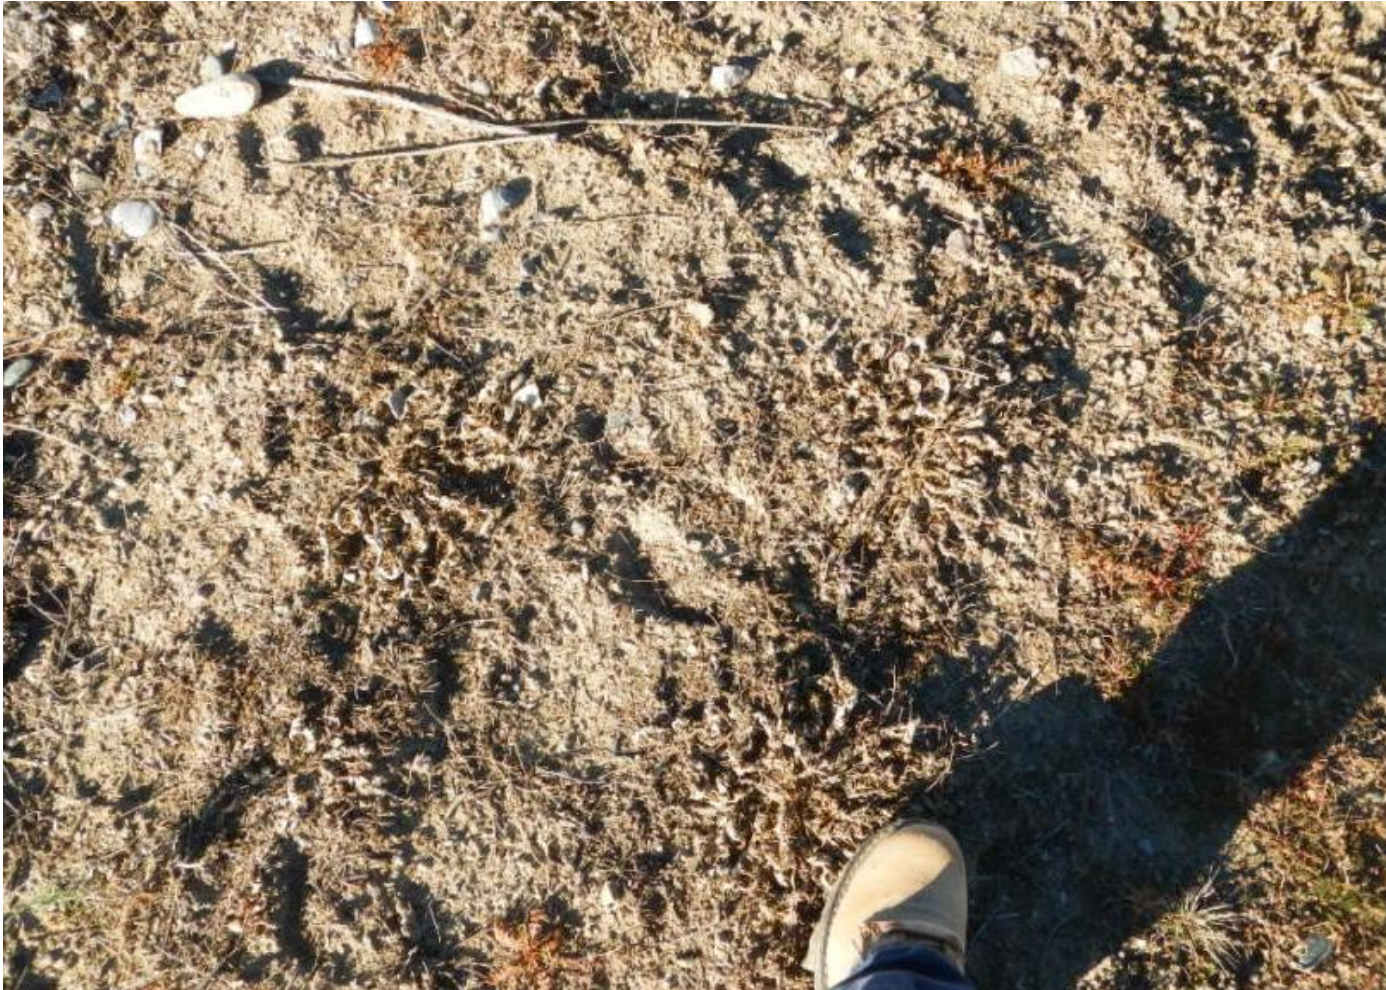
Photo 2. Another view of treated musk thistle within the interim reclamation area.

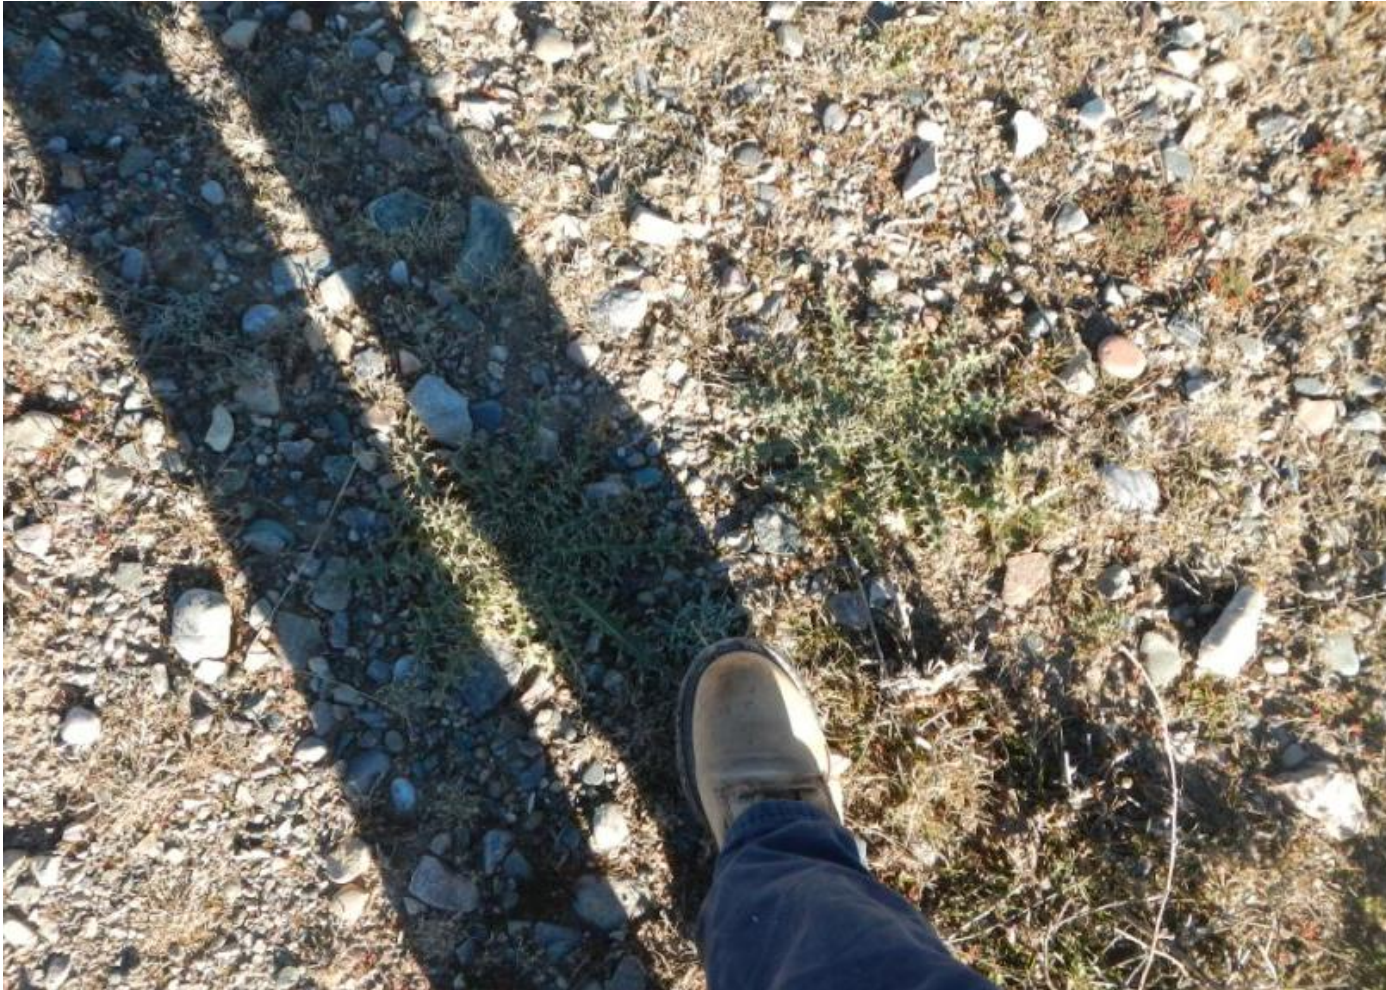
Photo 3. View of living musk thistle within the interim reclamation area.

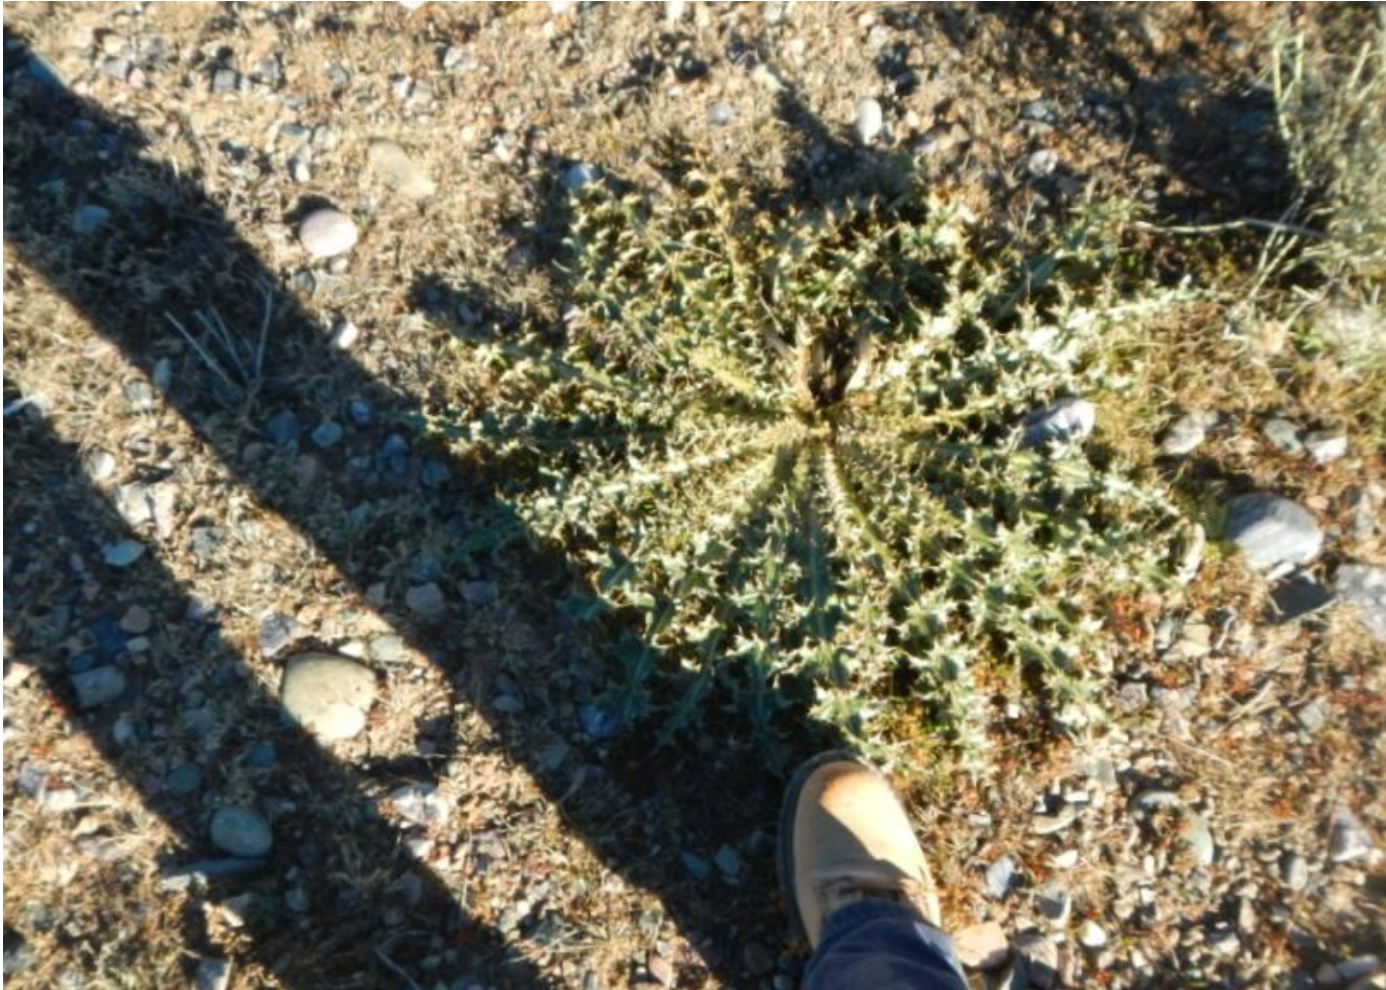
Photo 4. Another view of living musk thistle within the interim reclamation area.
