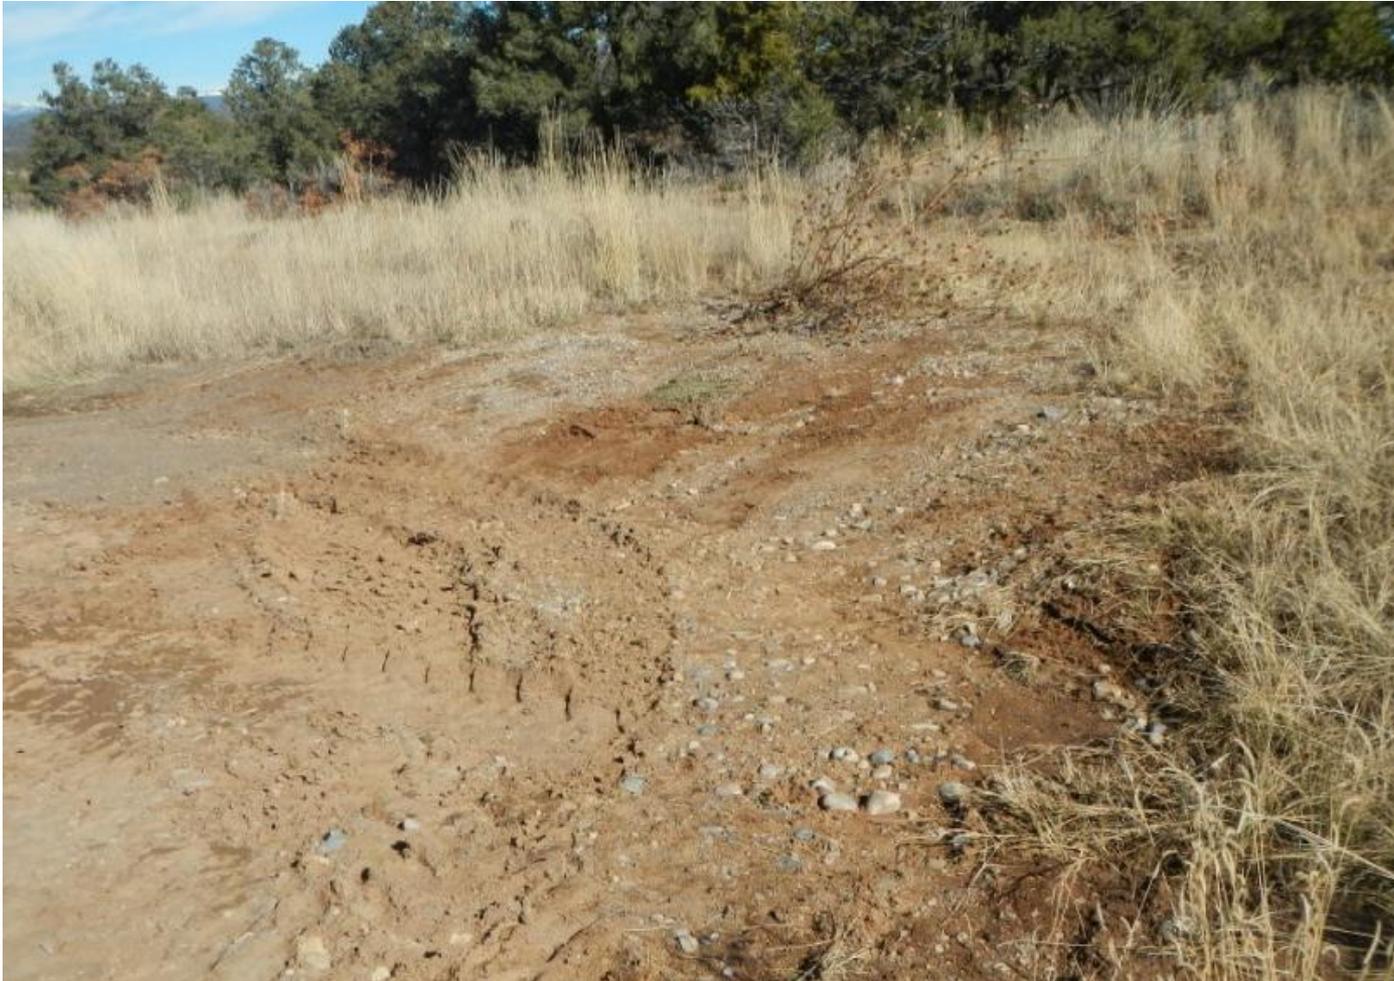
Photo 1. View of an area in the eastern portion of the project area where it appears vegetation was recently scraped. Surface owner said BP has scheduled to seed this and other spill-affected areas in spring 2016.

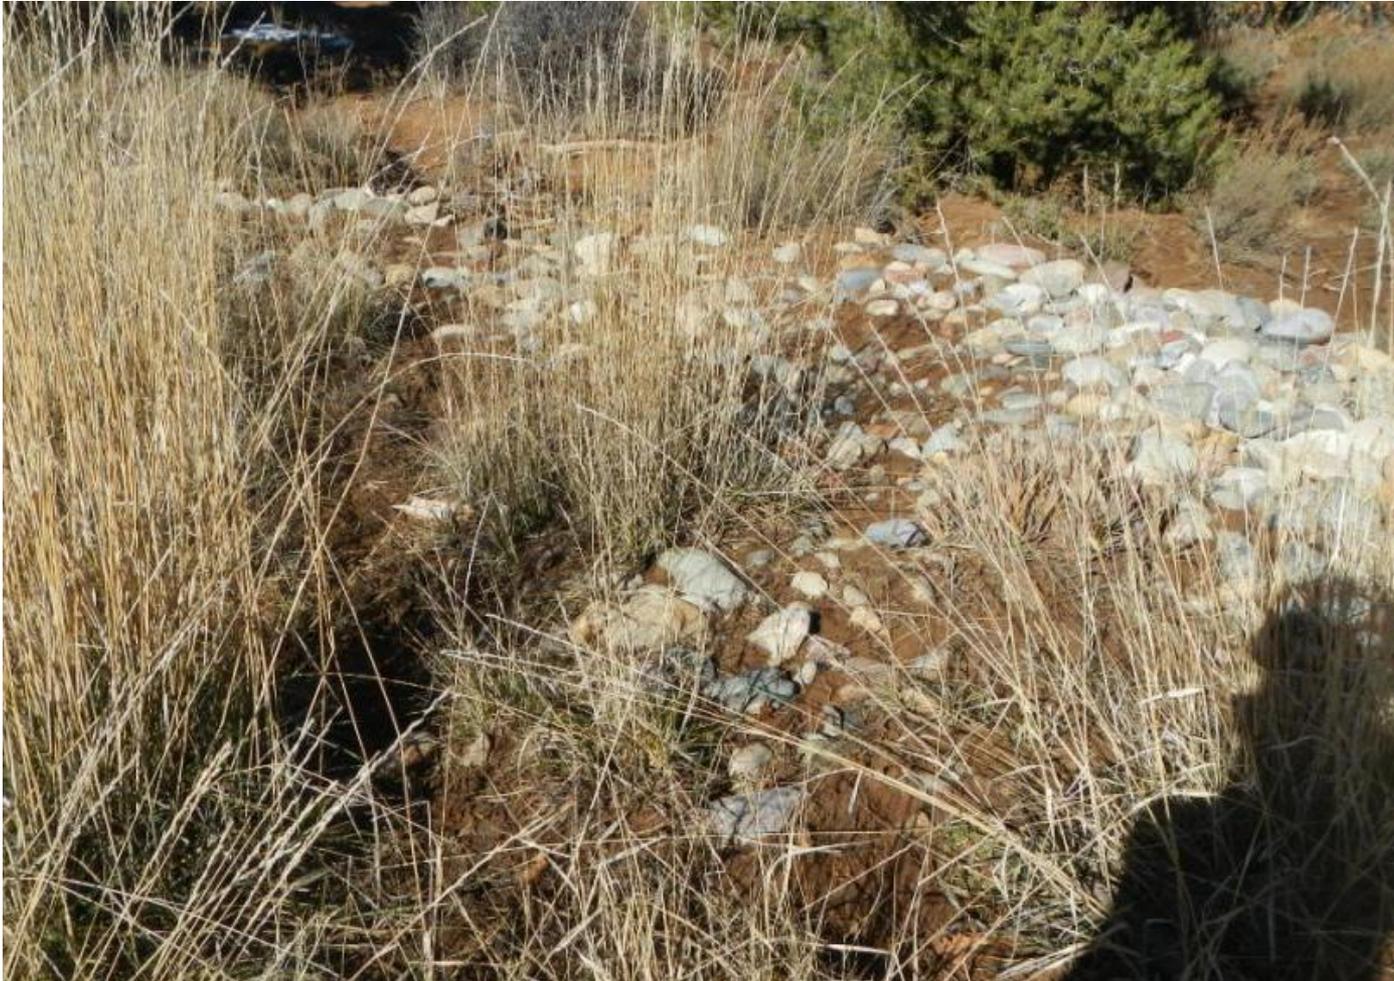
Photo 2. View of stormwater BMP in northeastern corner of project area. Sediment is accumulating here and it appears to need maintenance. If concentrated flows downstream of this area worsen, additional BMPs will be needed.

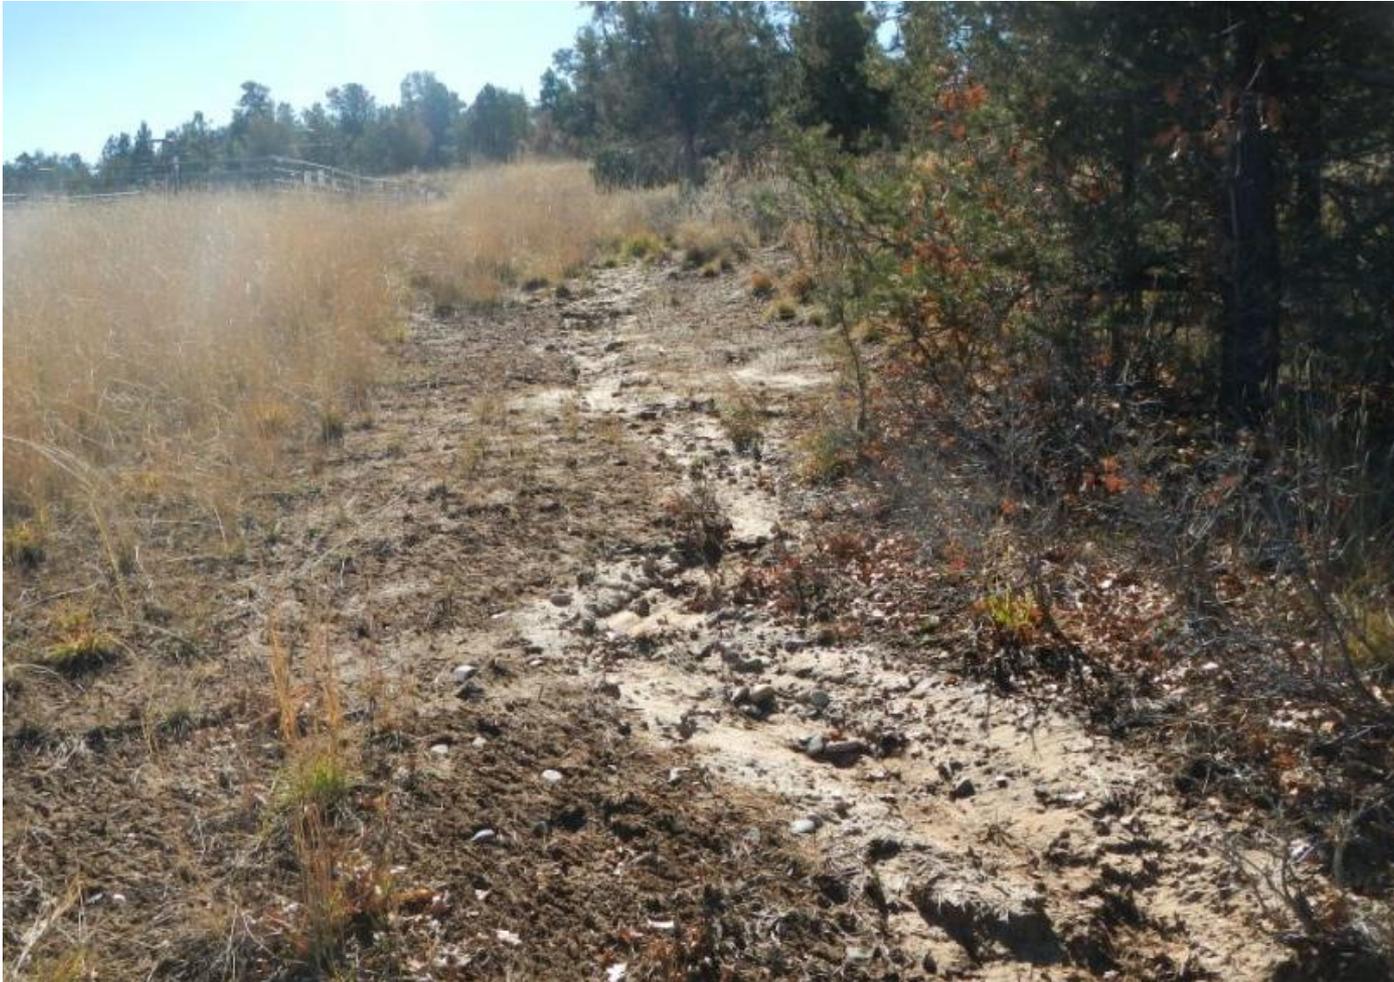
Photo 3. View of stormwater erosion in the western portion of the project area from the northwestern corner facing southward (upstream).

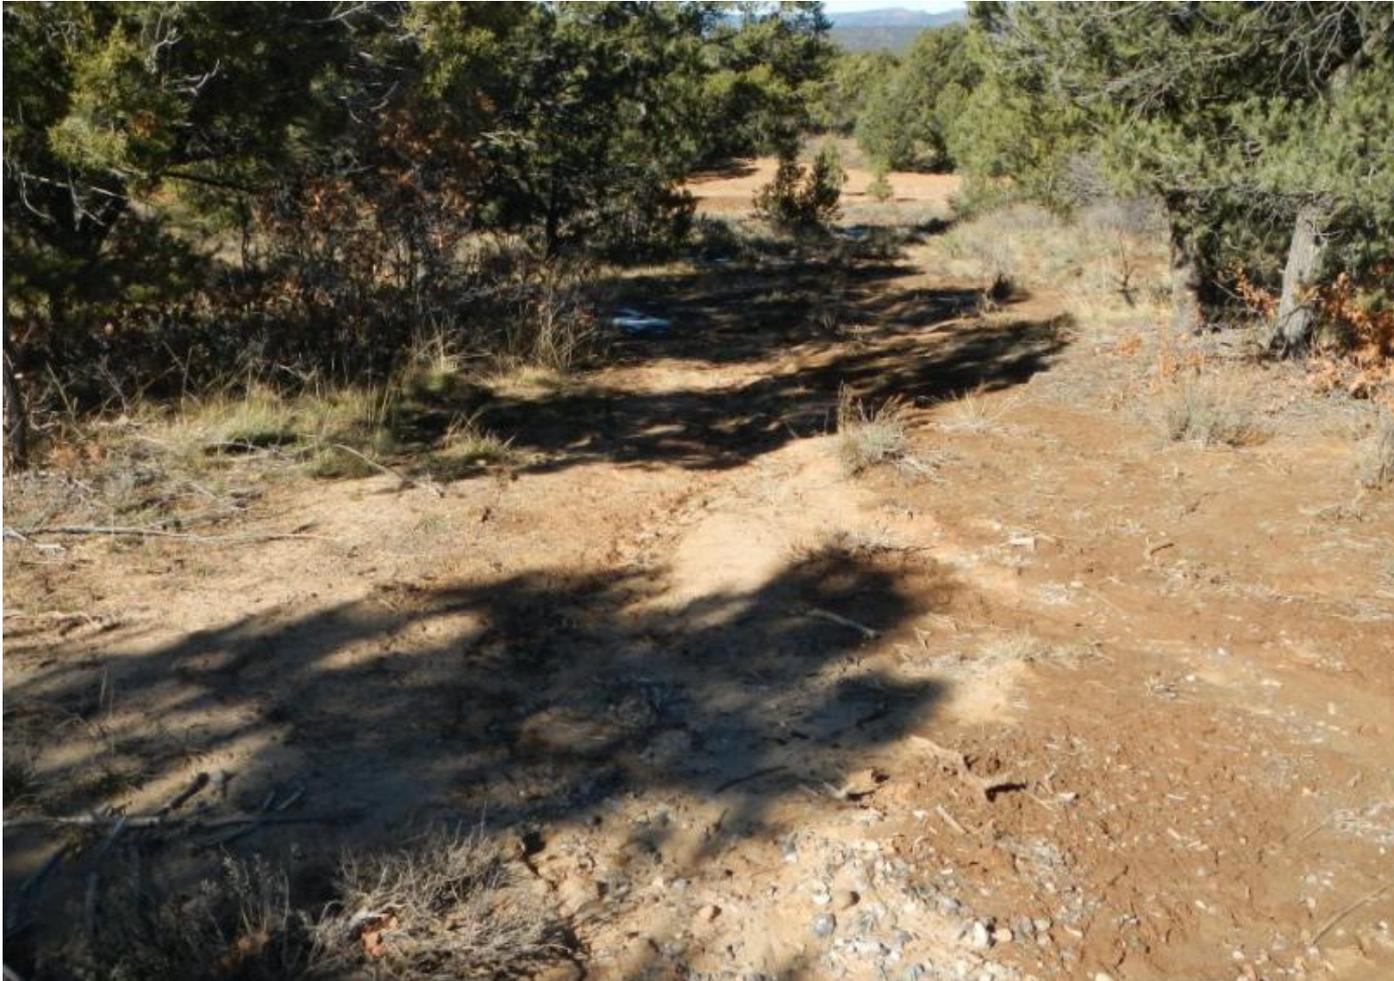
Photo 4. View of stormwater erosion where flows exit the northwestern corner of the project area (downstream).

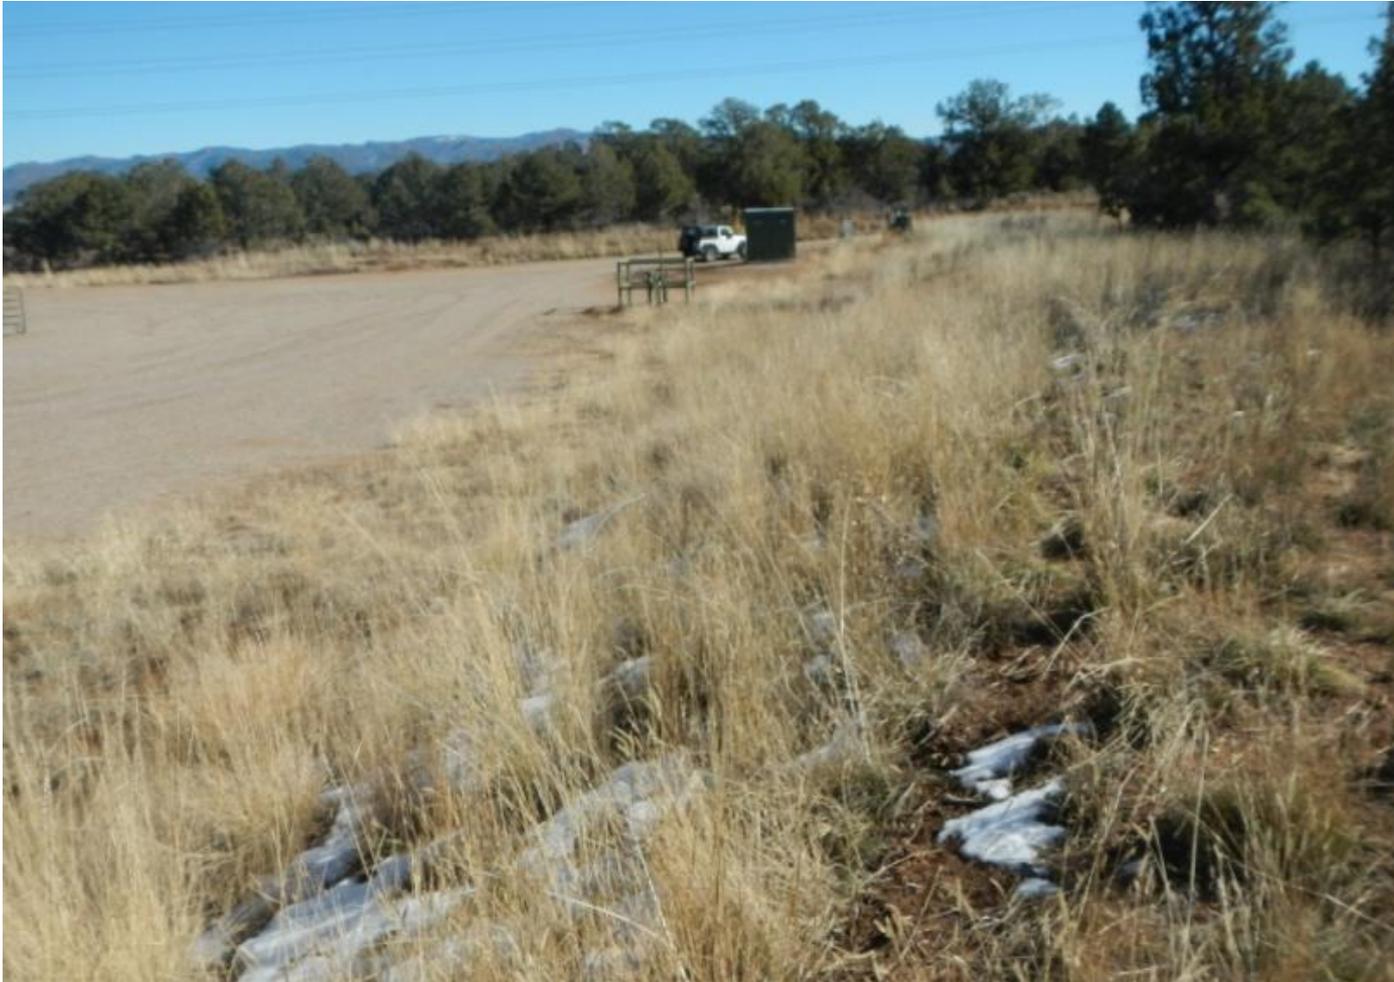
Photo 5. View of the southern portion of the project area from the southwestern corner facing eastward. Good cover of grasses such as intermediate wheatgrass (*Thinopyron intermedium*).
