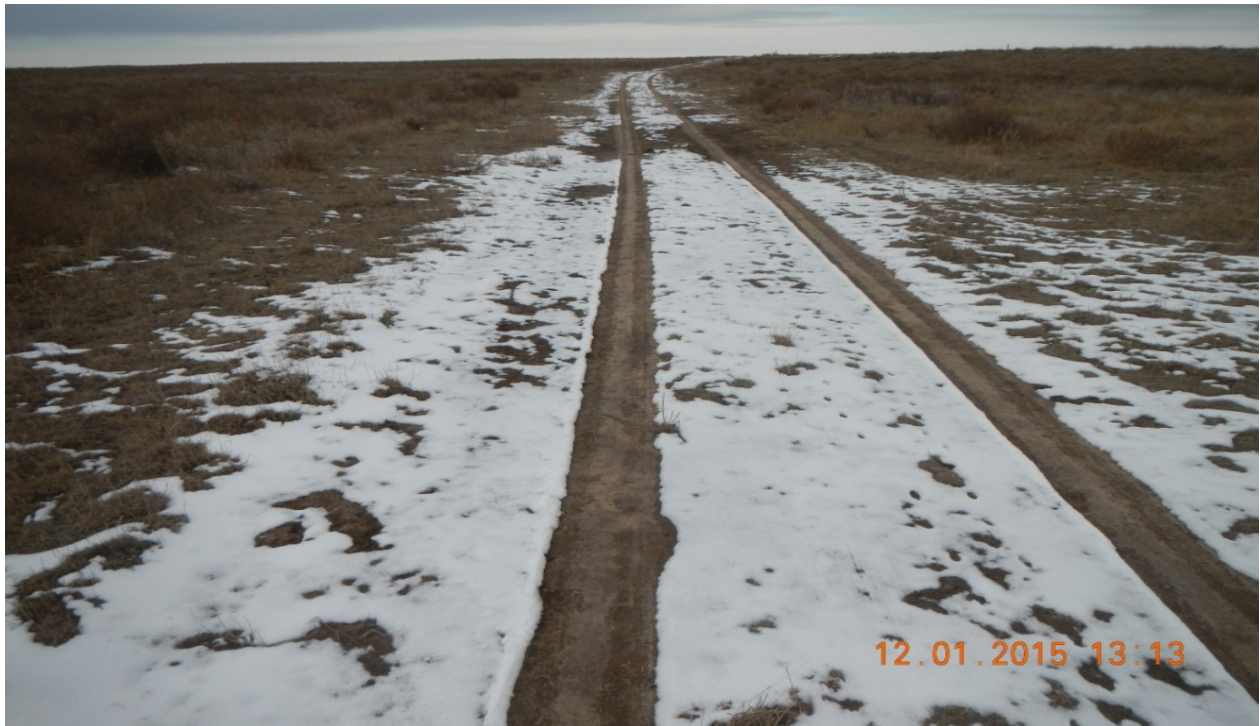
photo 1: Facing north along the access road towards the location.

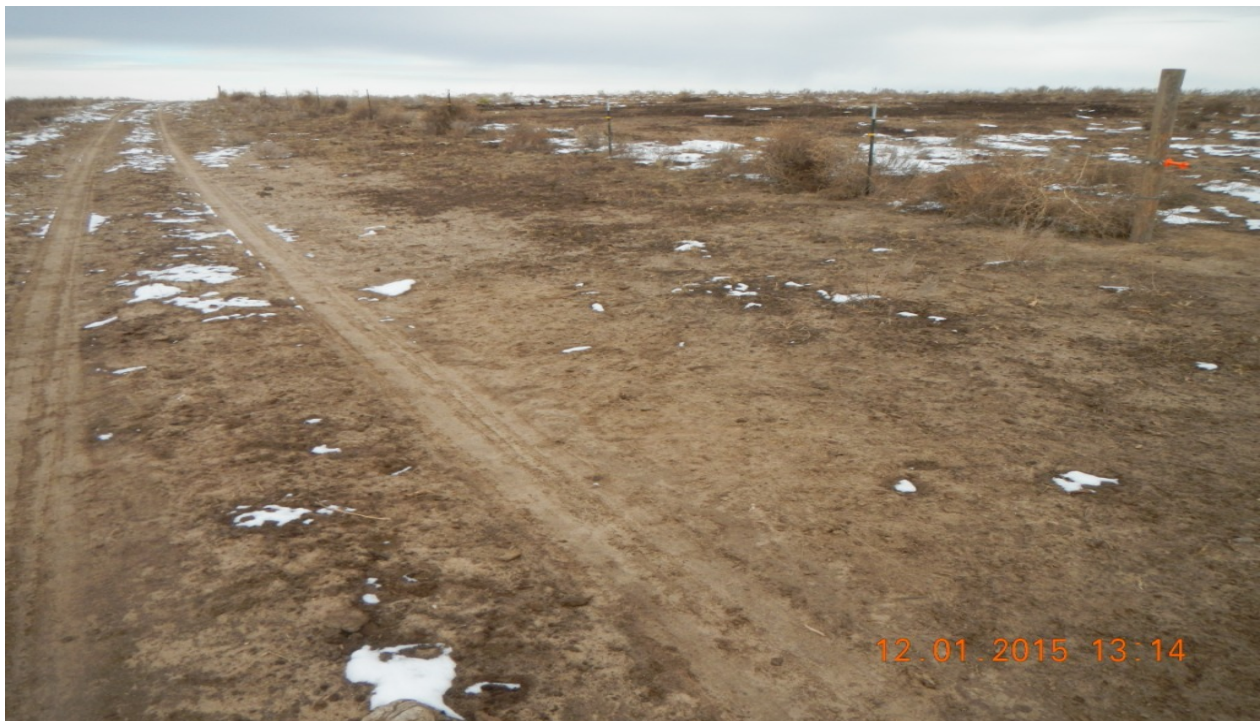
photo 2: Facing northeast, access road continues north past the location.

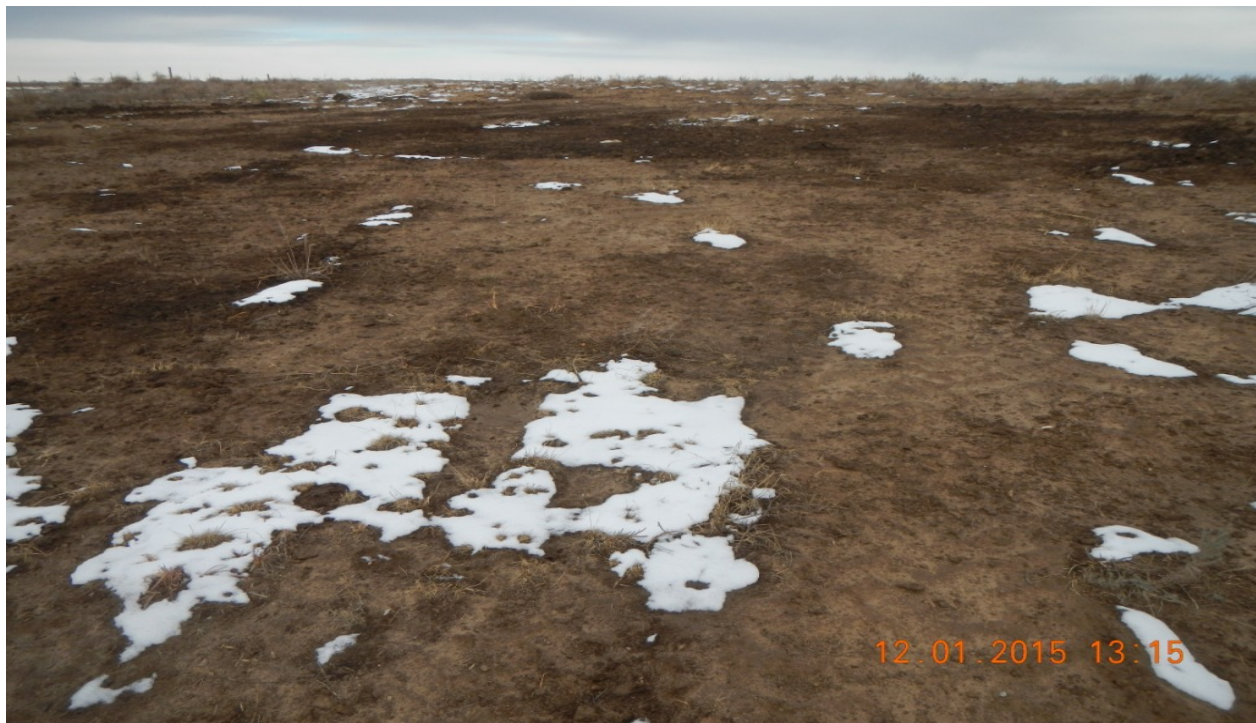
photo 3: Southwest side of the location facing northeast

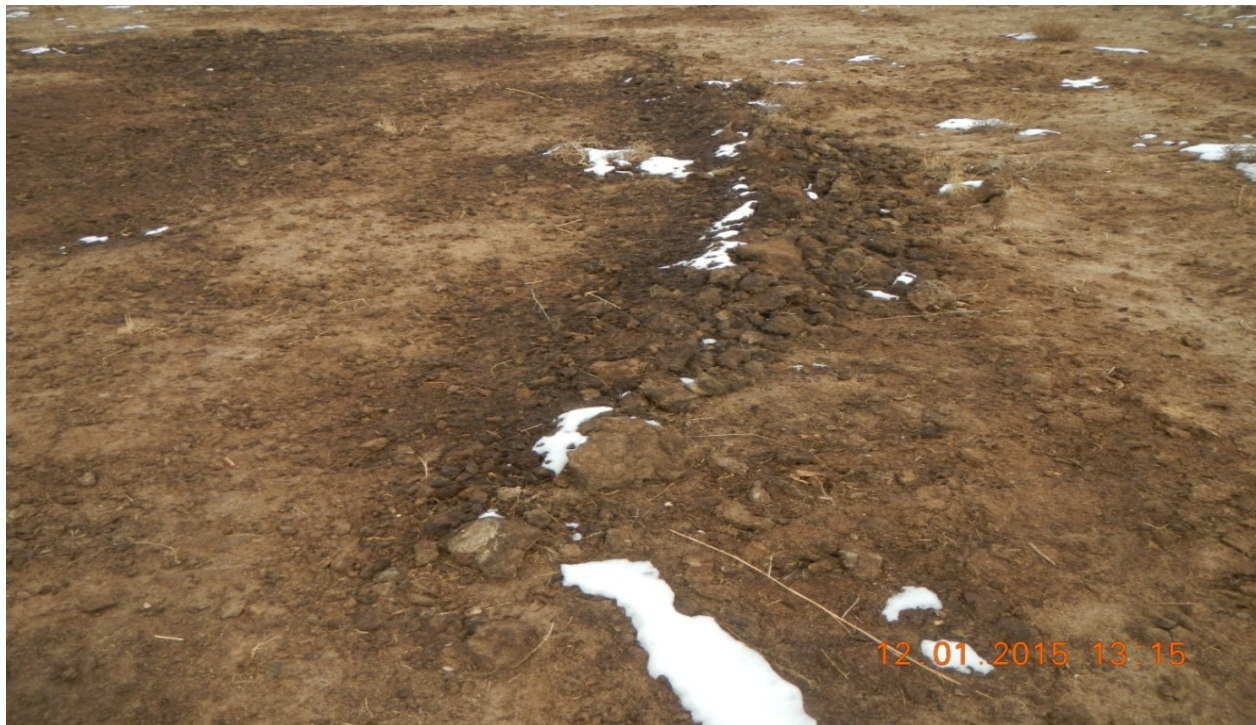
photo 4: Manure has been spread throughout the location

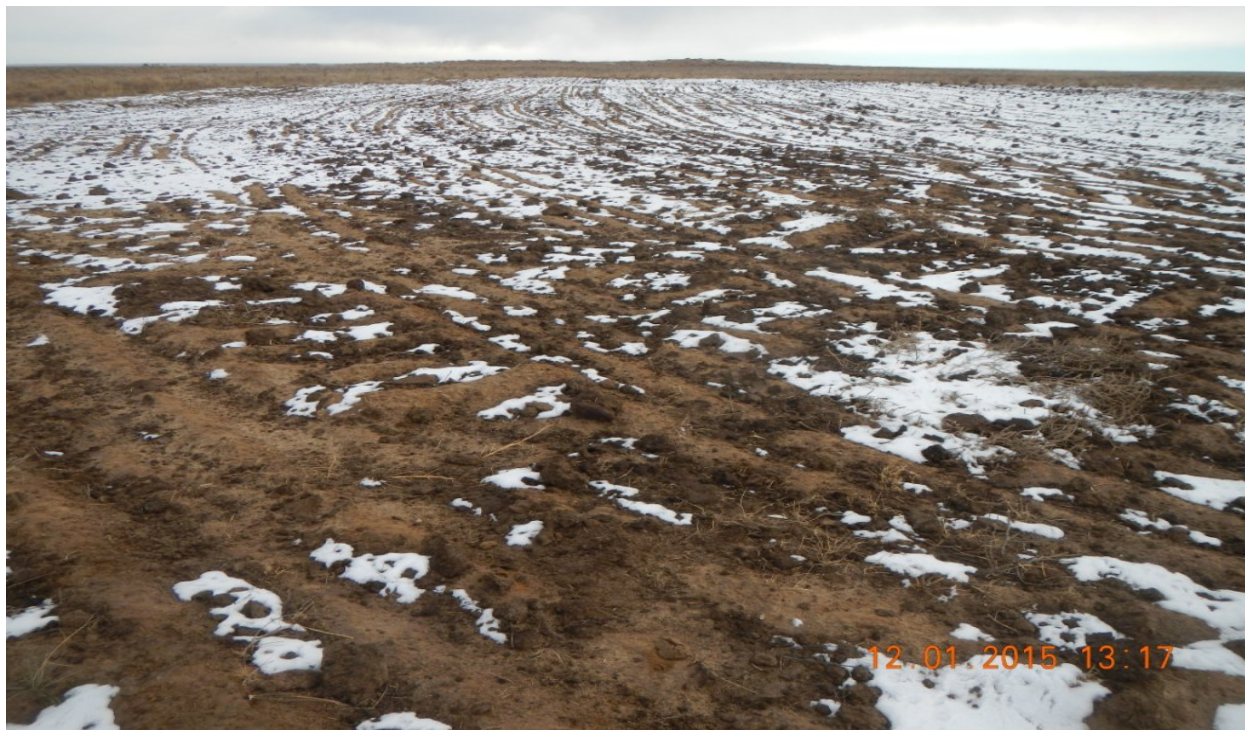
photo 5: Northwest side of the location facing east.

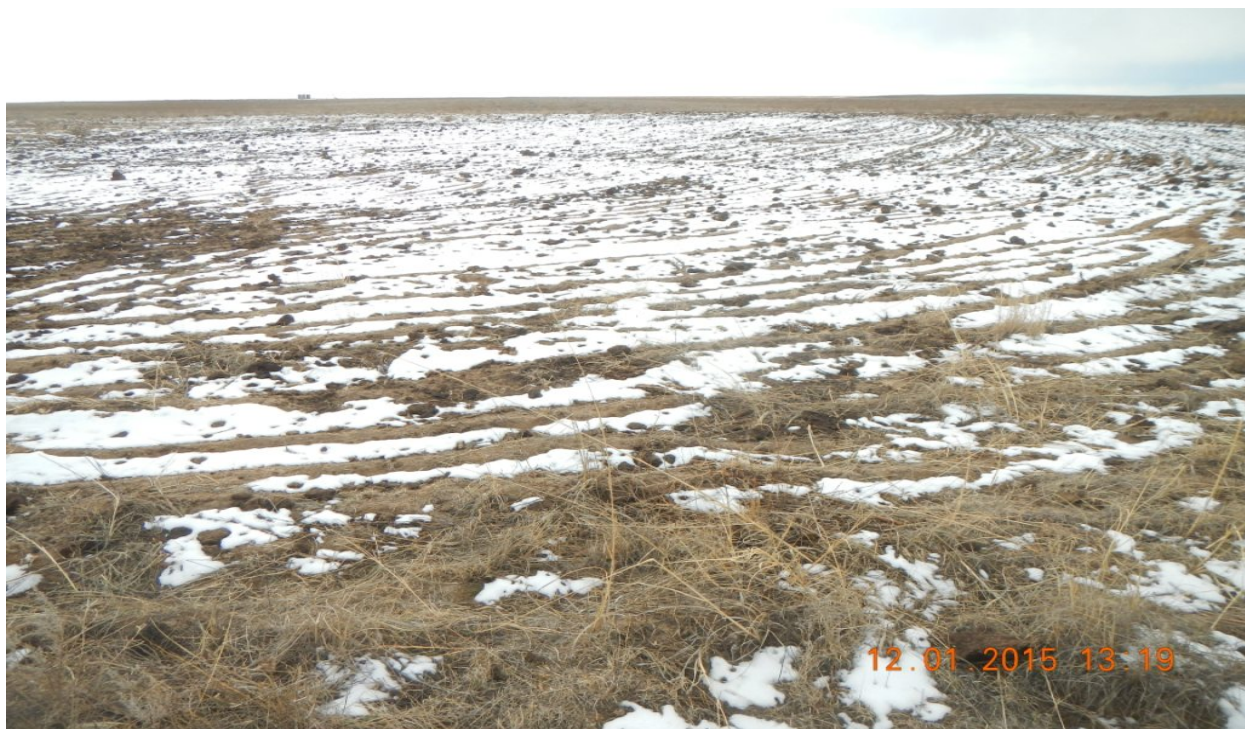
photo 6: Southwest side of the location facing west.

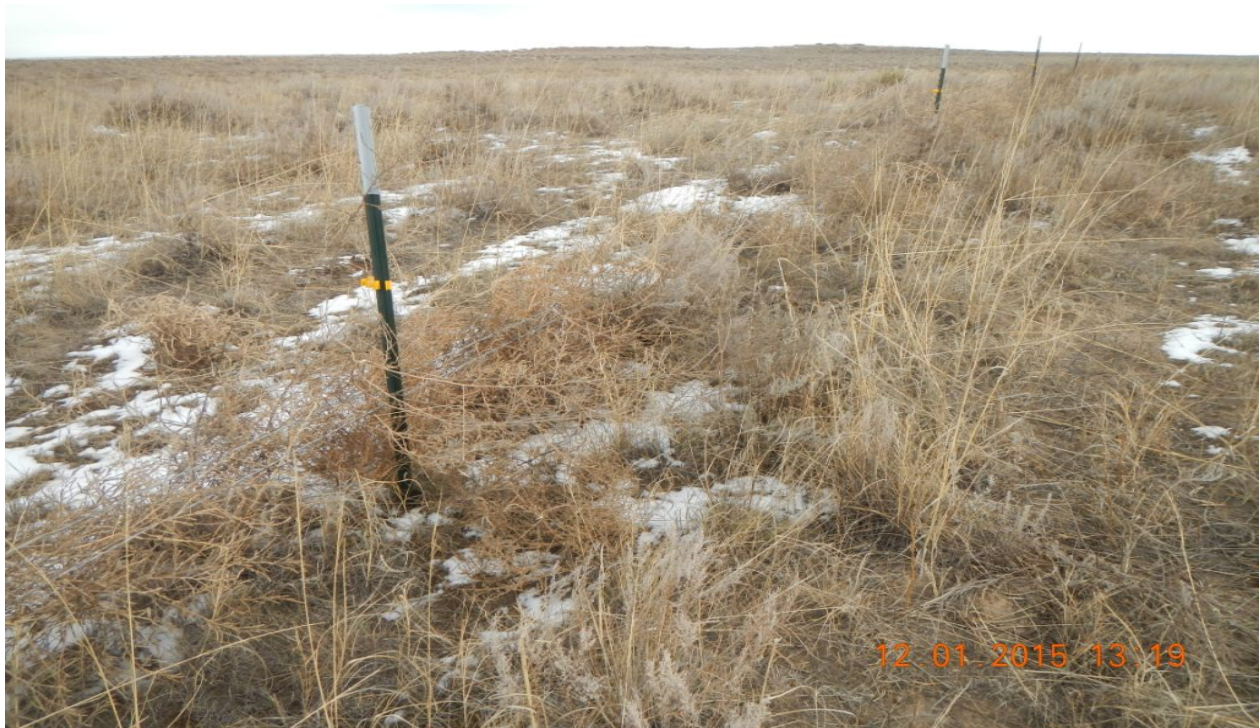
photo 7: North side of the location. The two wire strand fence is down low to the ground.

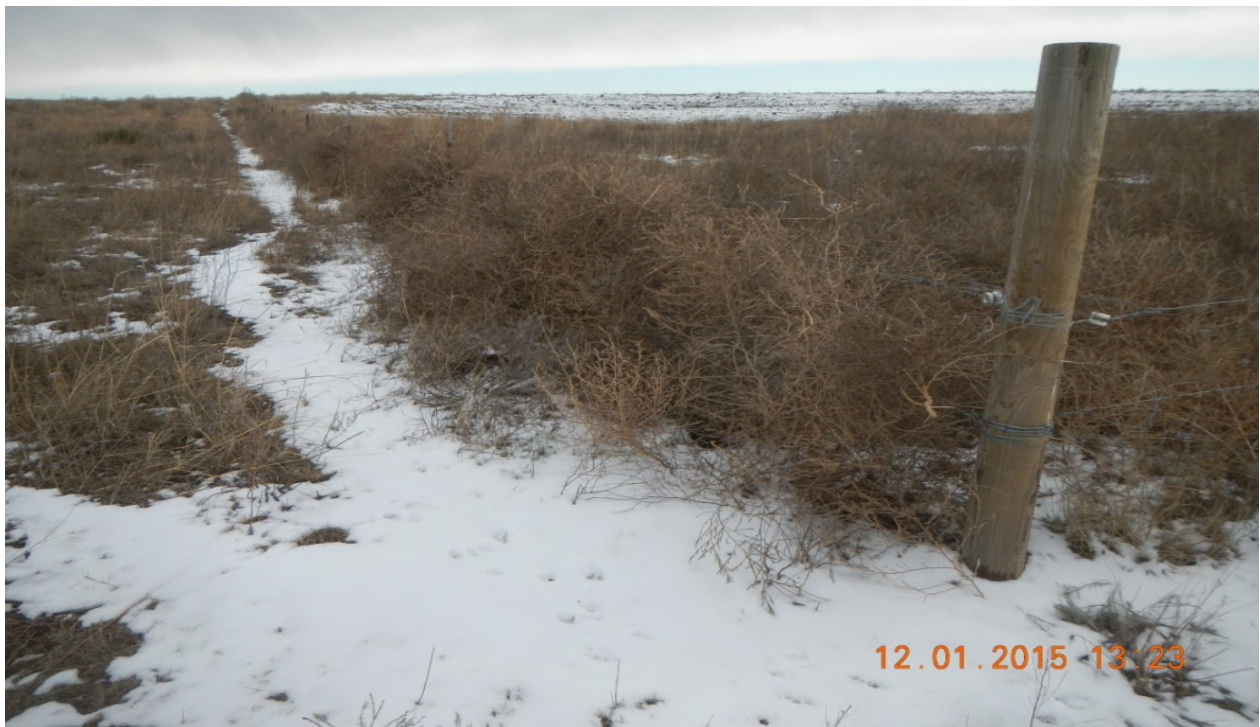
photo 8: Northwest corner, weed debris is beginning to accumulate along the fence line.
