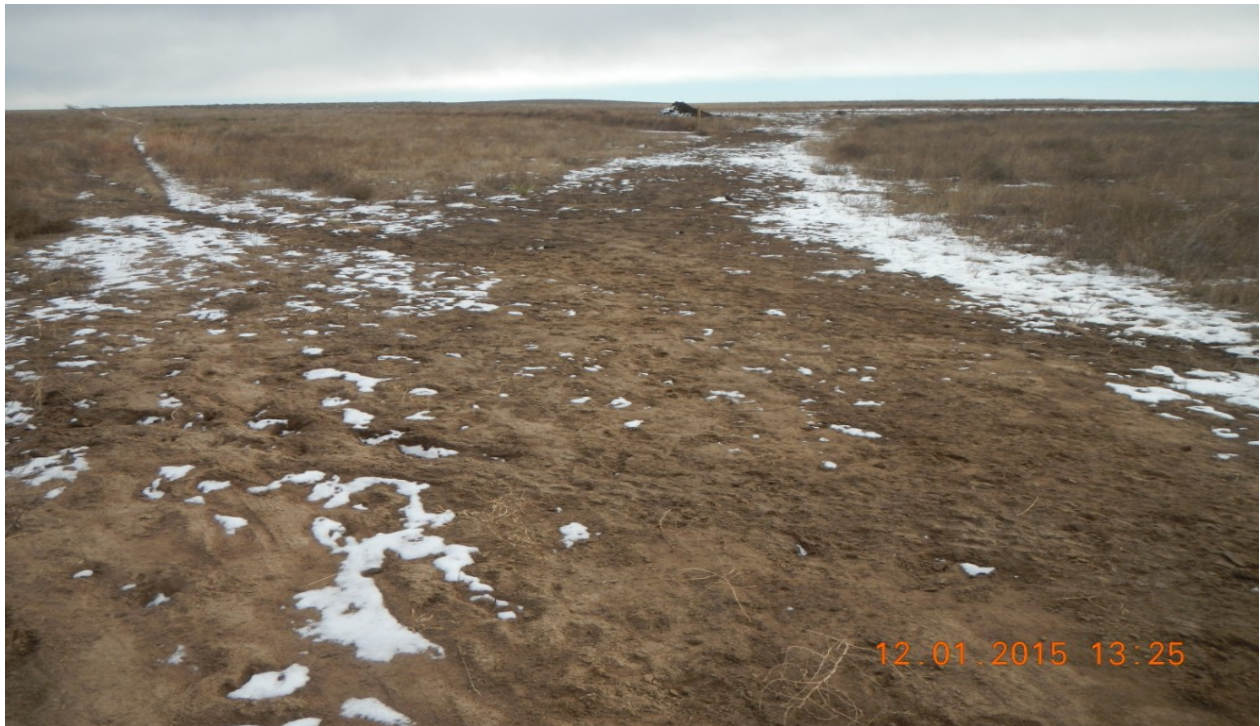
photo 1: Facing southeast along access road towards the location.

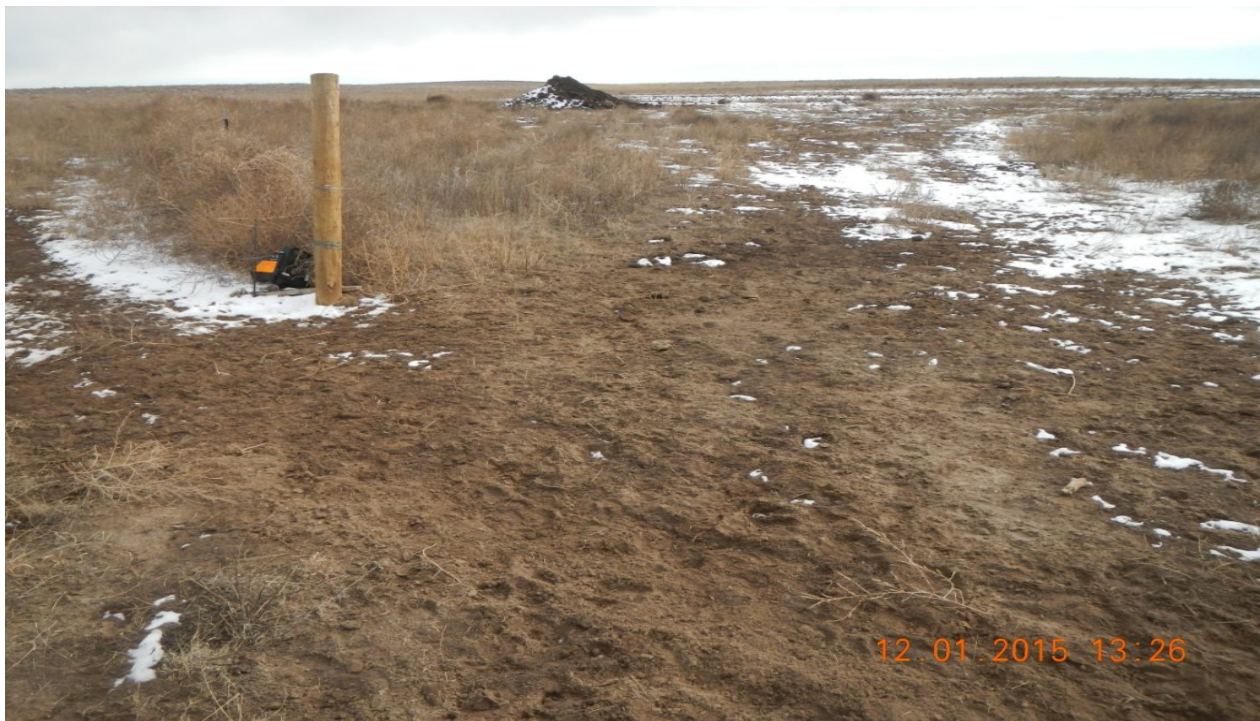
photo 2: Northwest corner of the location facing southeast.

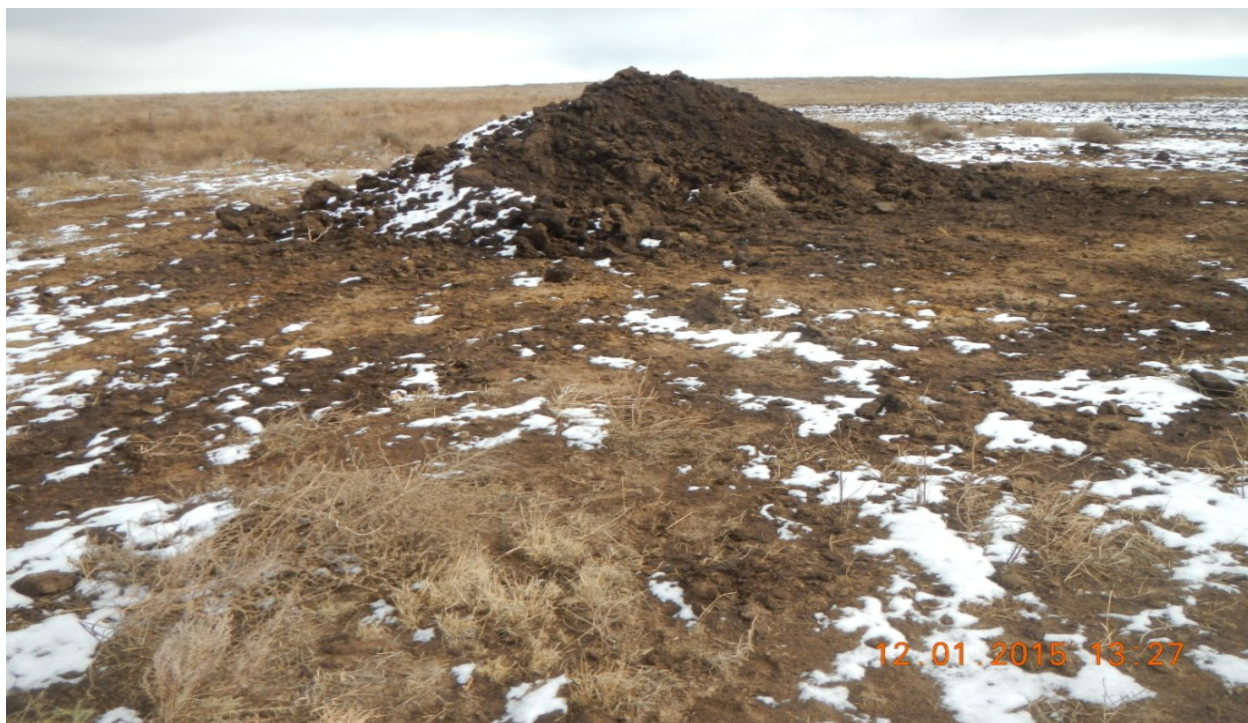
photo 3: Manure pile near the center of the location.

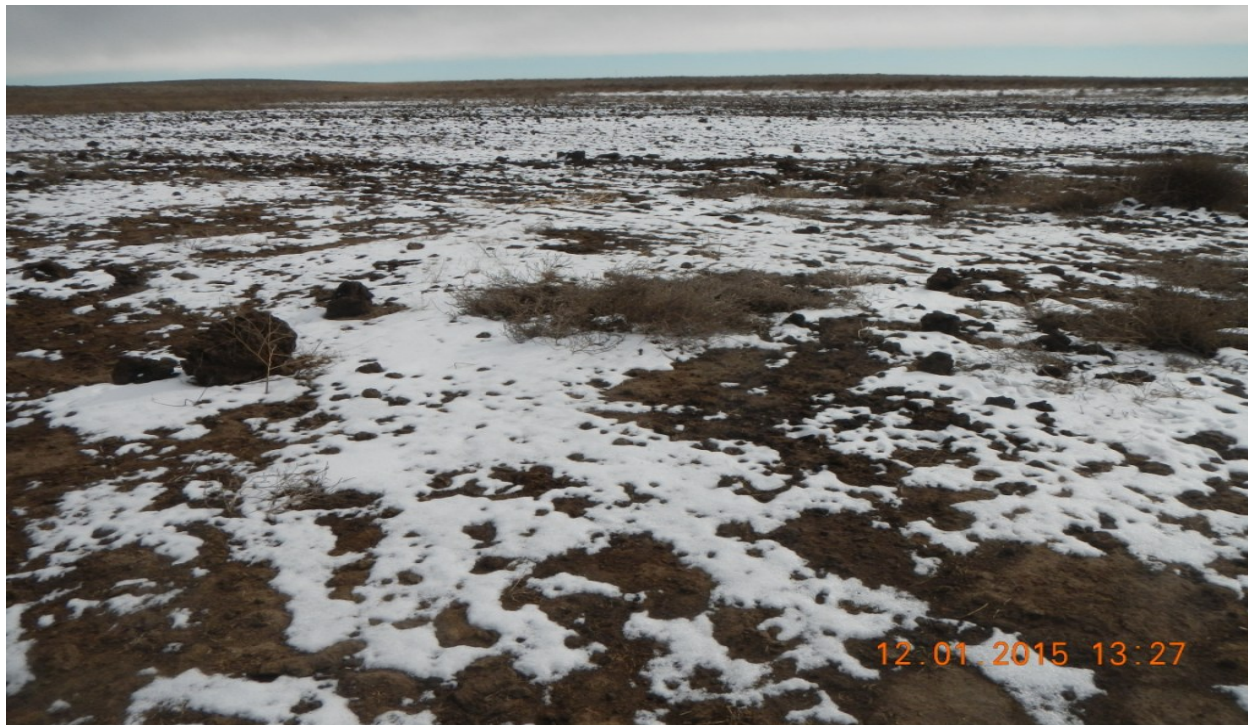
photo 4: Facing southeast at the location.

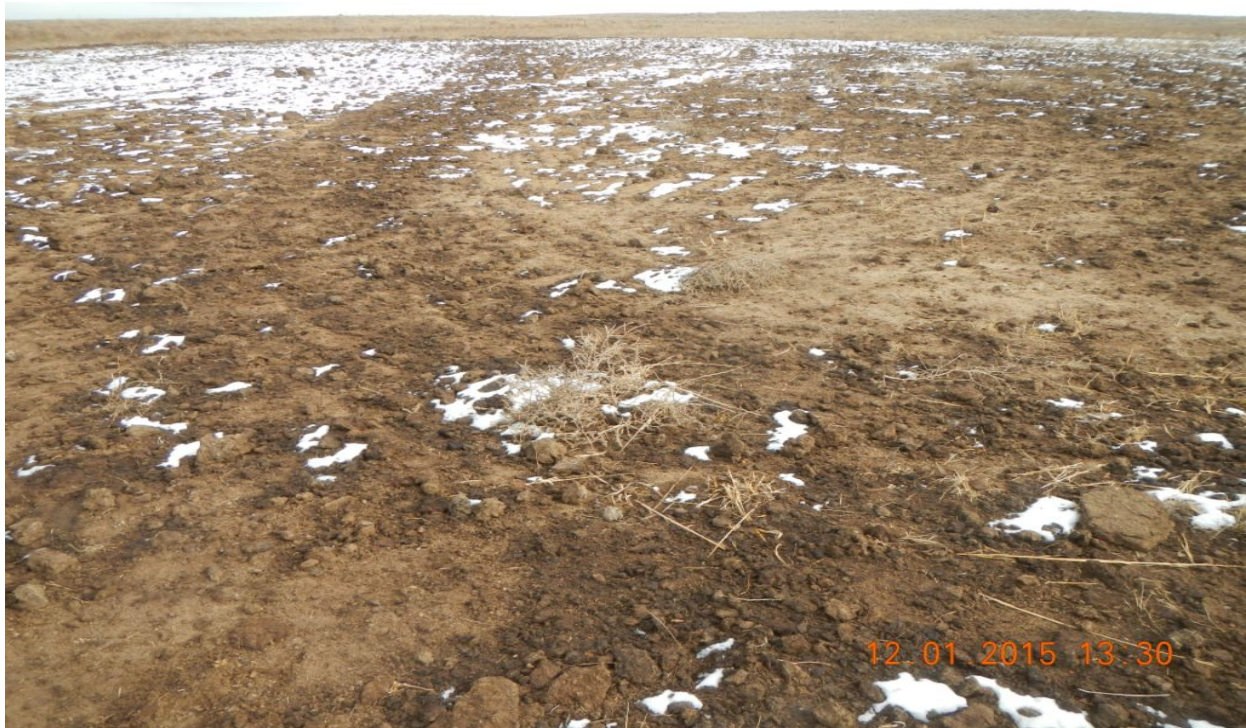
photo 5: Facing east towards the location. Manure has been applied to disturbed areas.

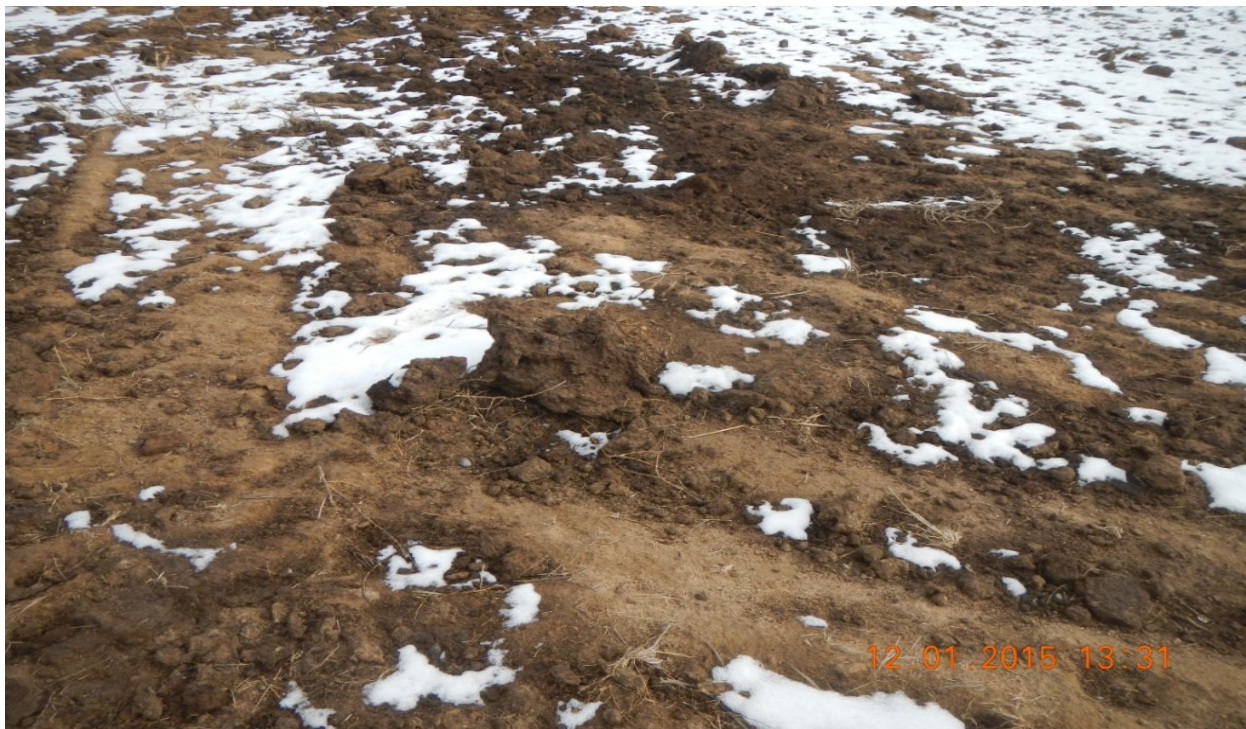
photo 6: Manure has been applied to disturbed areas.

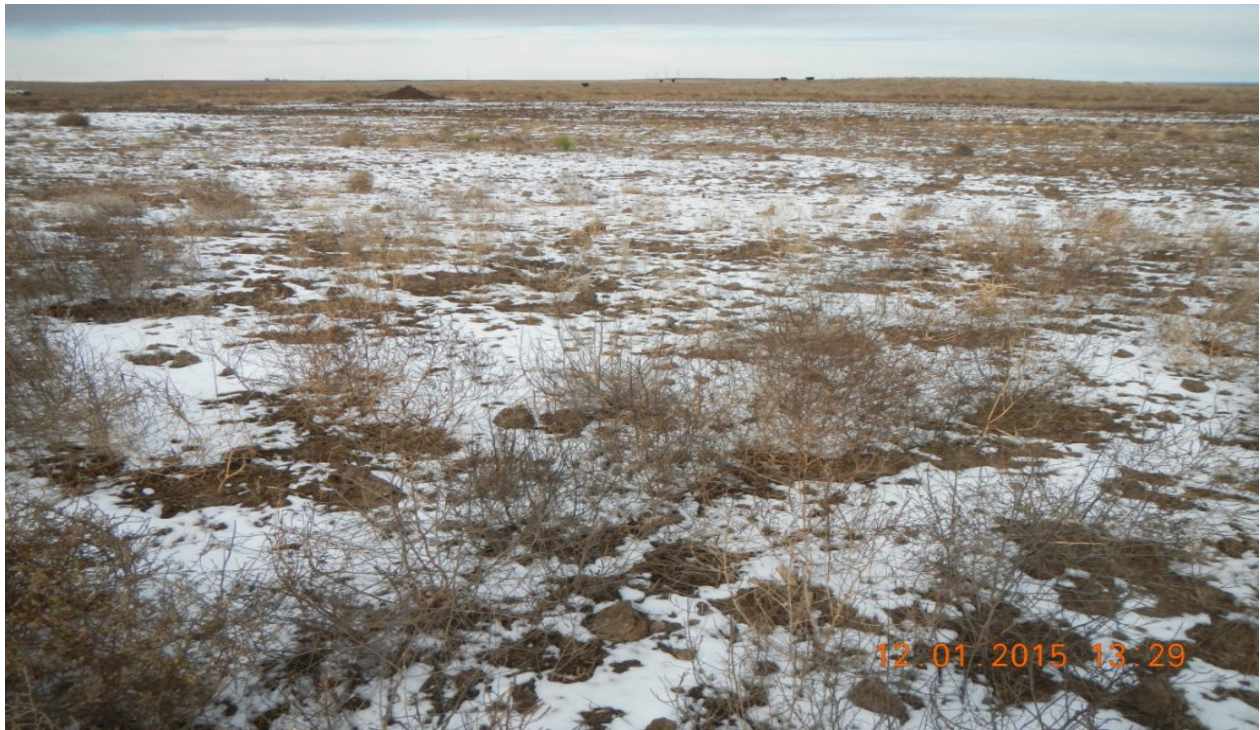
photo 7: South side of the location facing north.

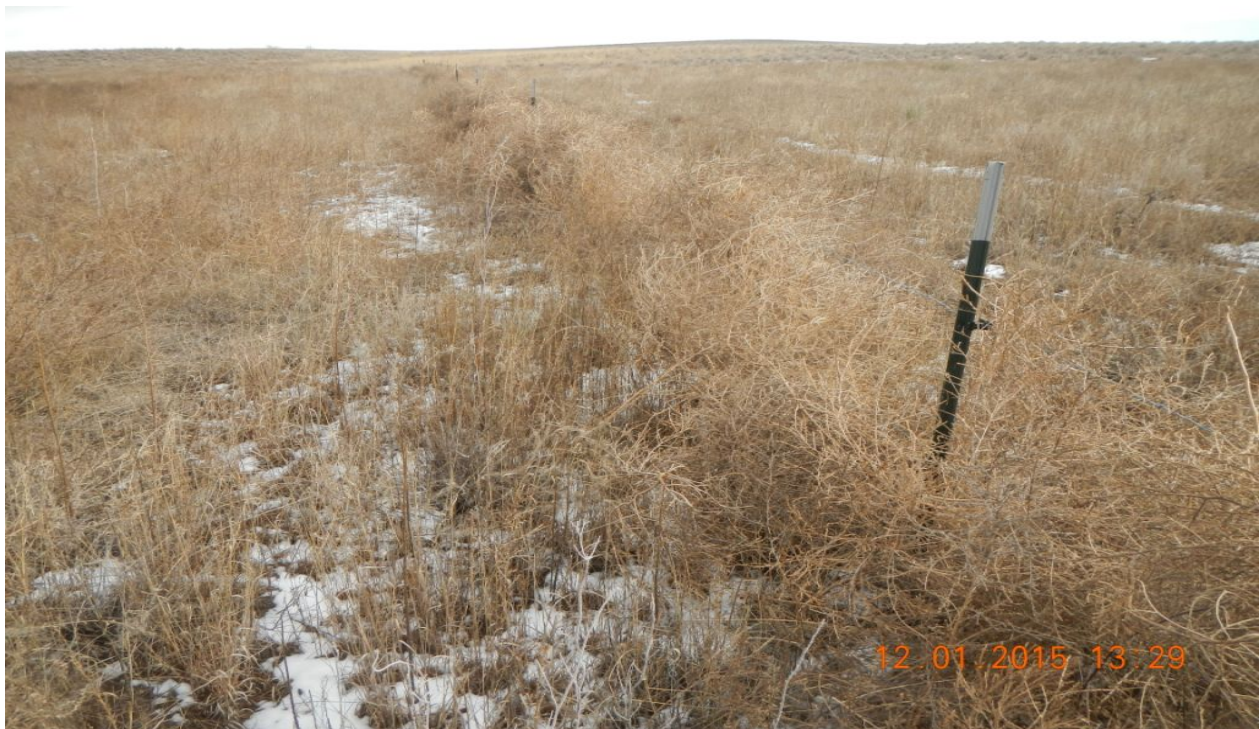
photo 8: Fence along south side of the location. Weed debris is accumulating along the fence line.
