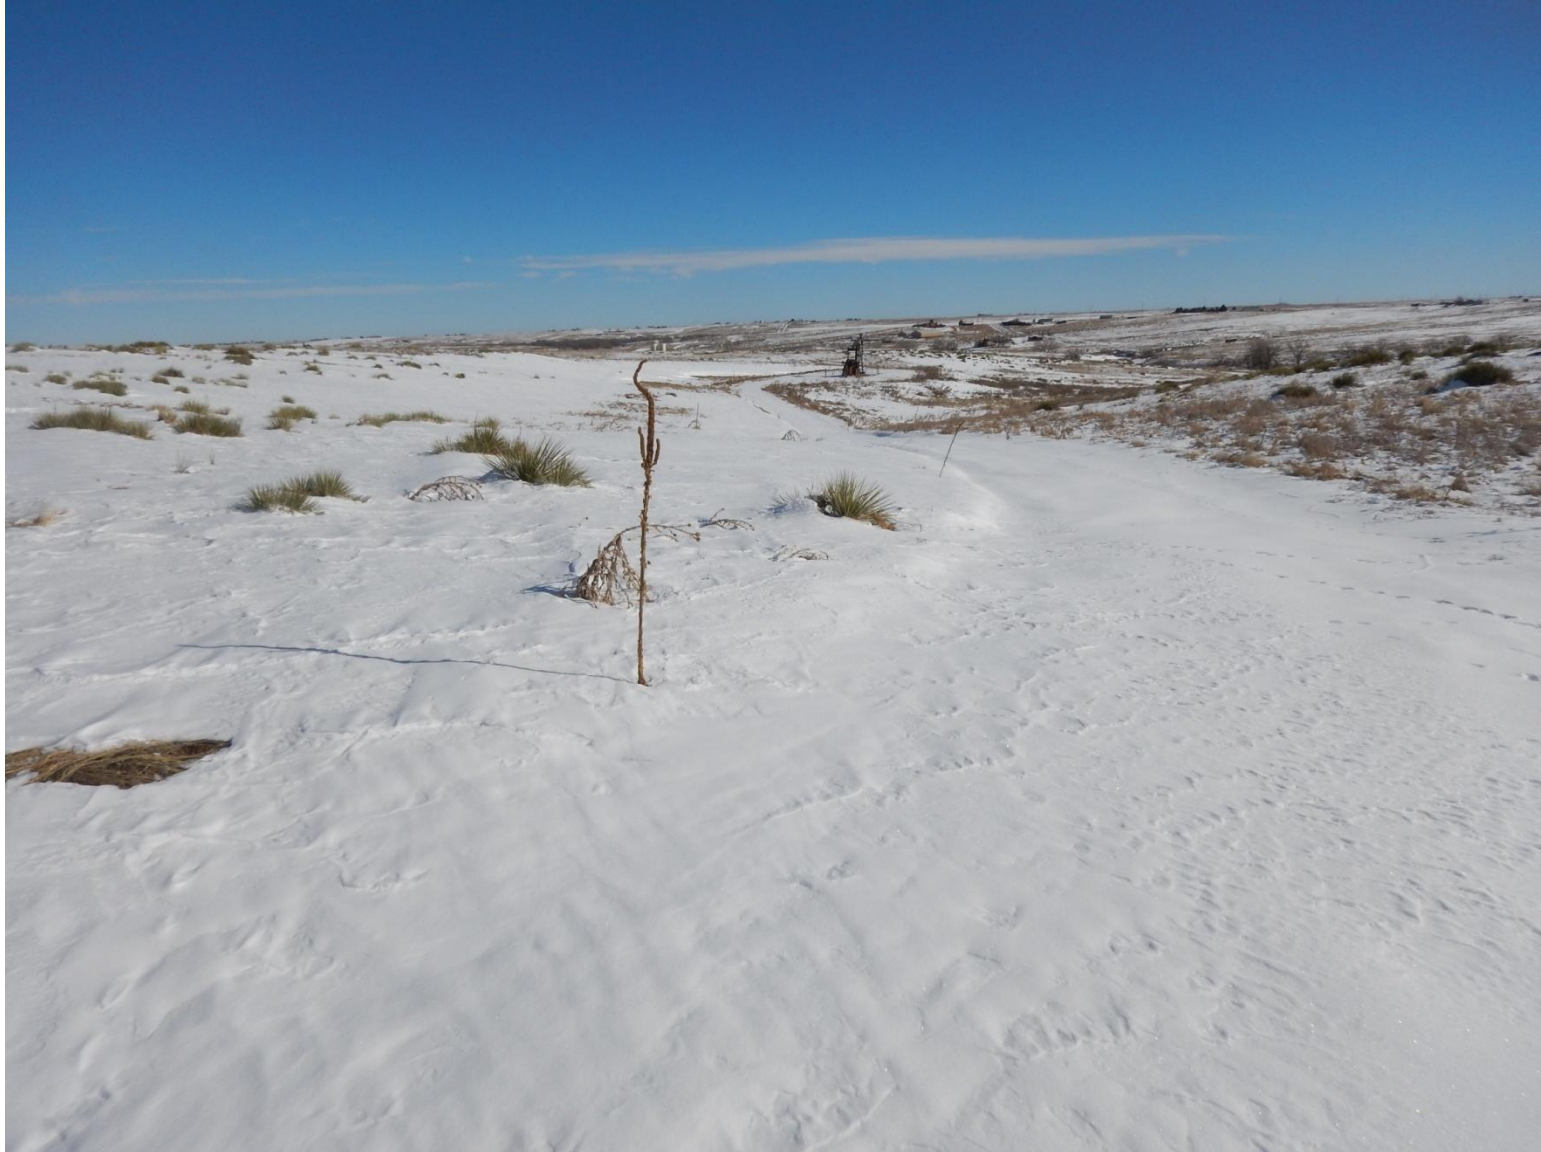
Photo 1: Photo taken from west of location facing east. Photo shows well location.

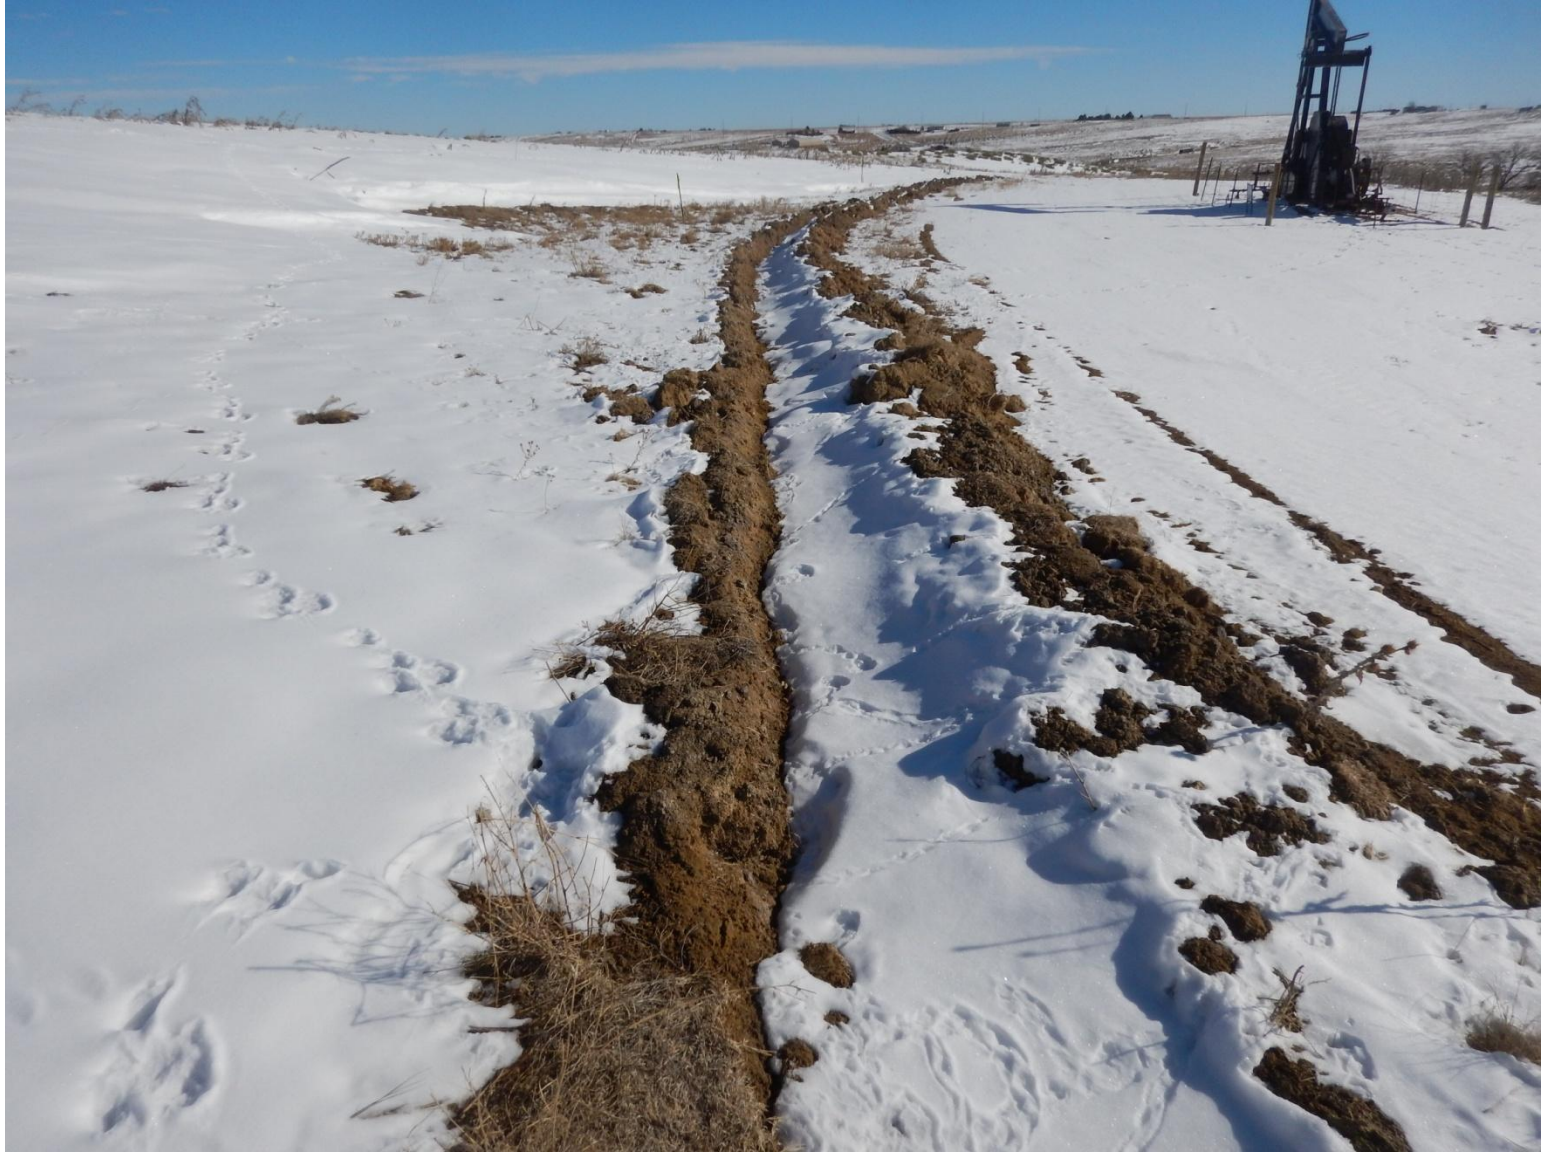
Photo 2: Photo taken from northwest end of location, facing east. Photo shows stormwater control ditch.

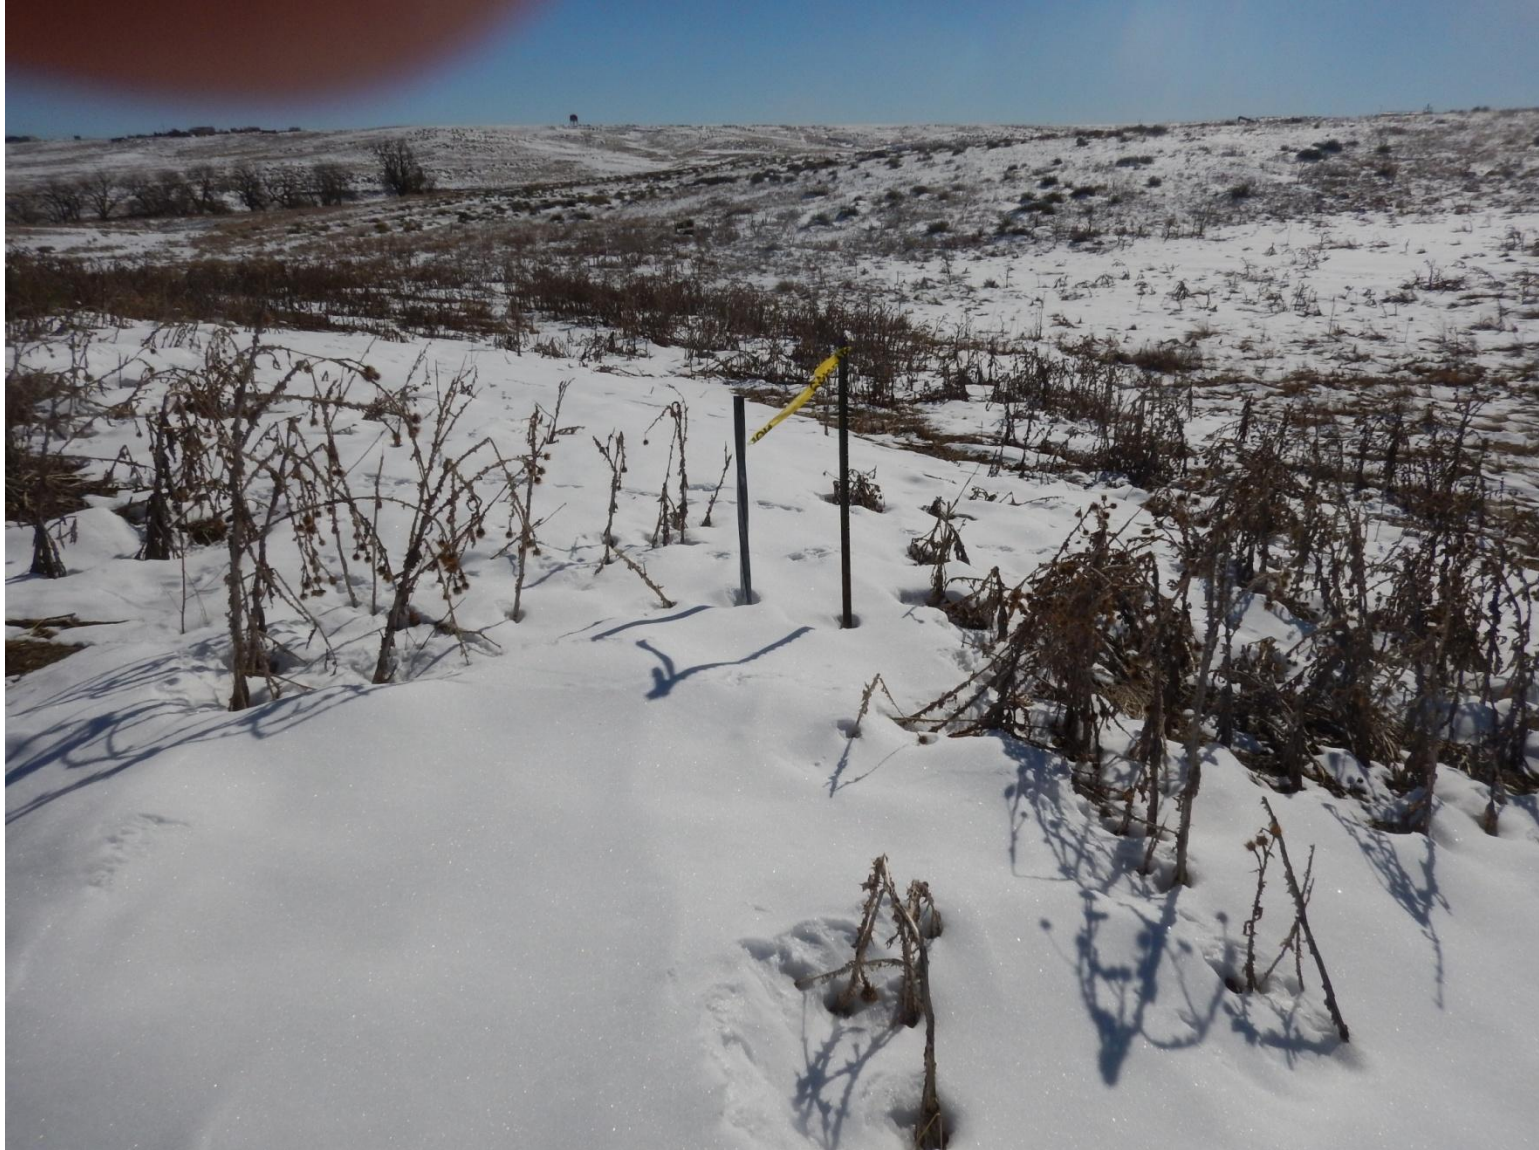
Photo 3: Photo taken from southwest corner of location. Photo shows guy line anchor and marker.

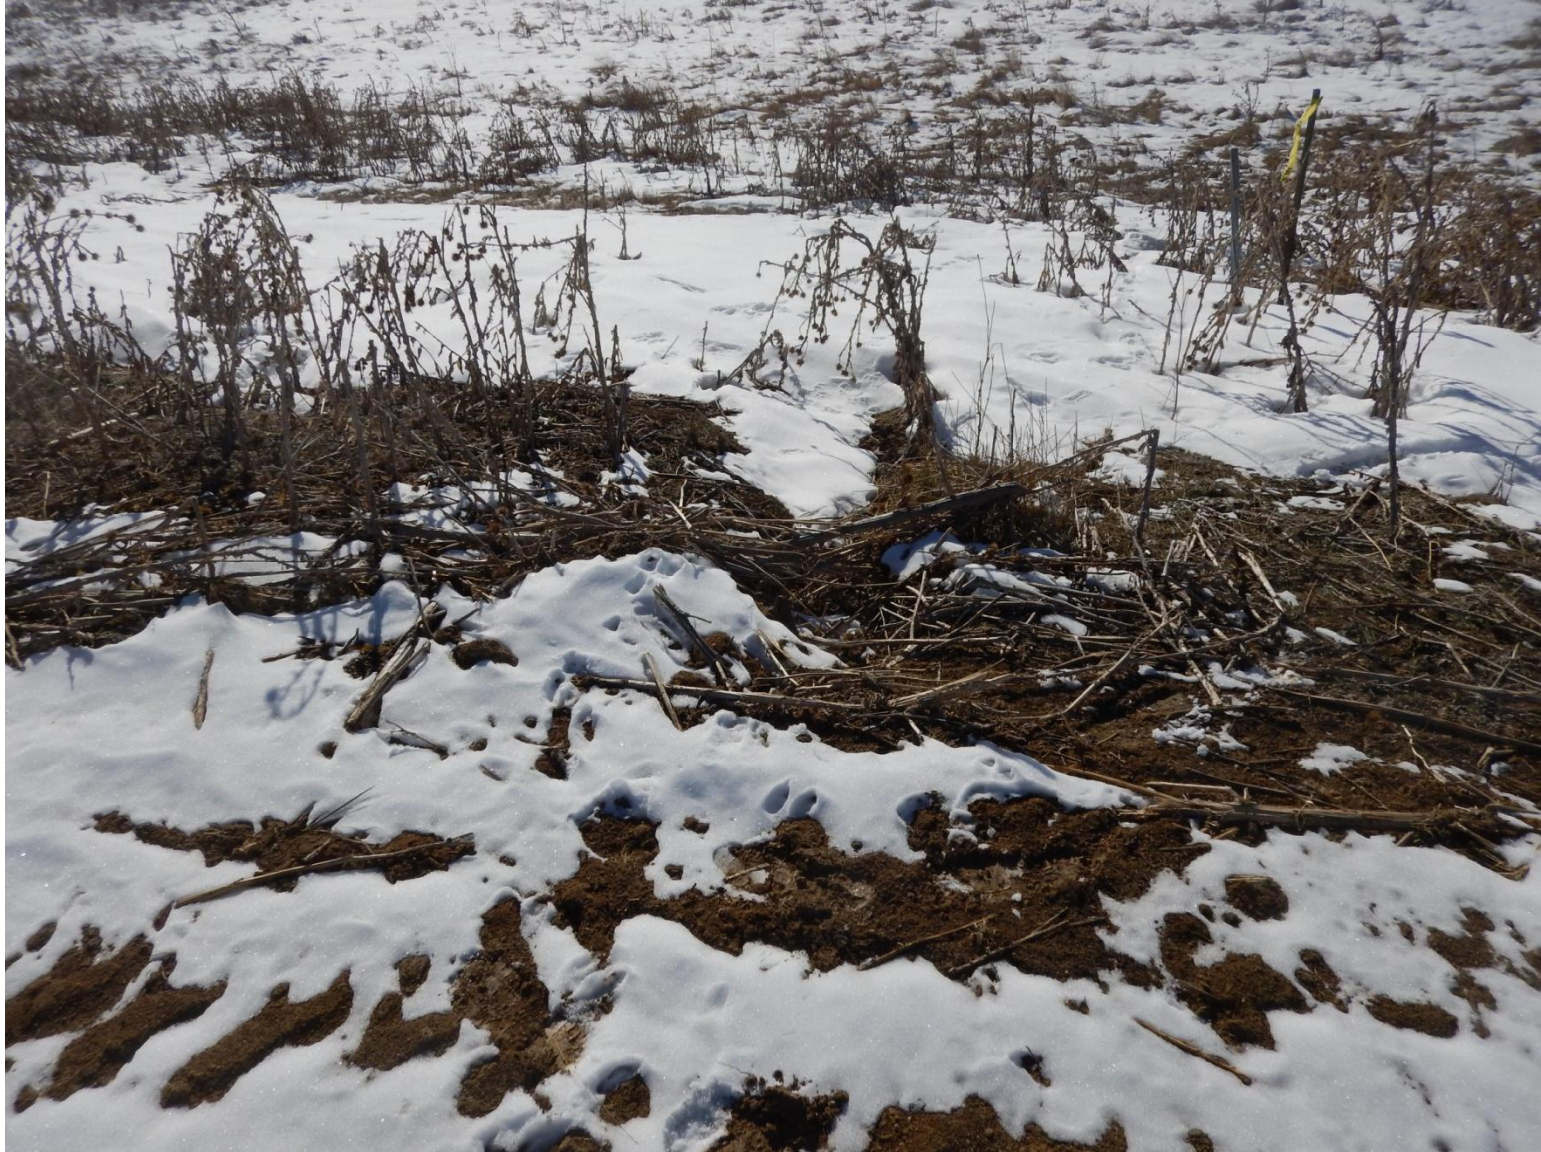
Photo 4: Photo taken from southern end of location, facing south. Photo of Scotch thistle.

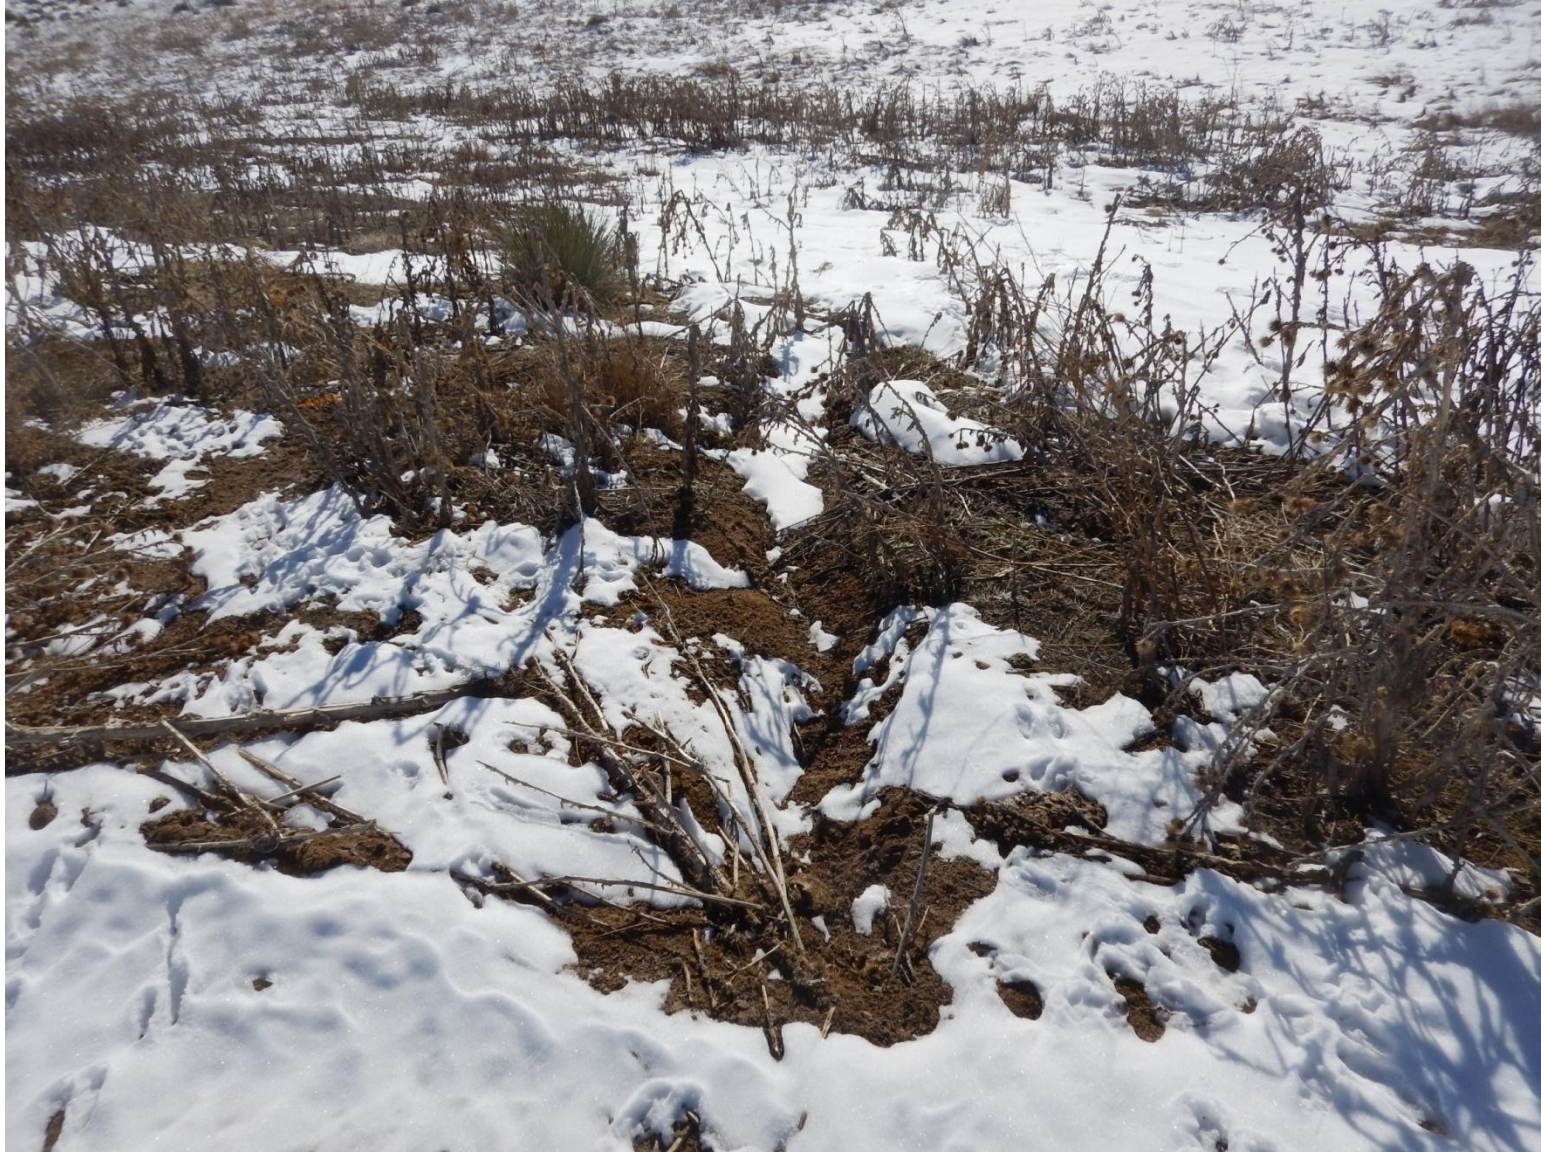
Photo 5: Photo taken from southern end of location, facing south. Photo shows insufficient stormwater BMPs, and rill erosion.

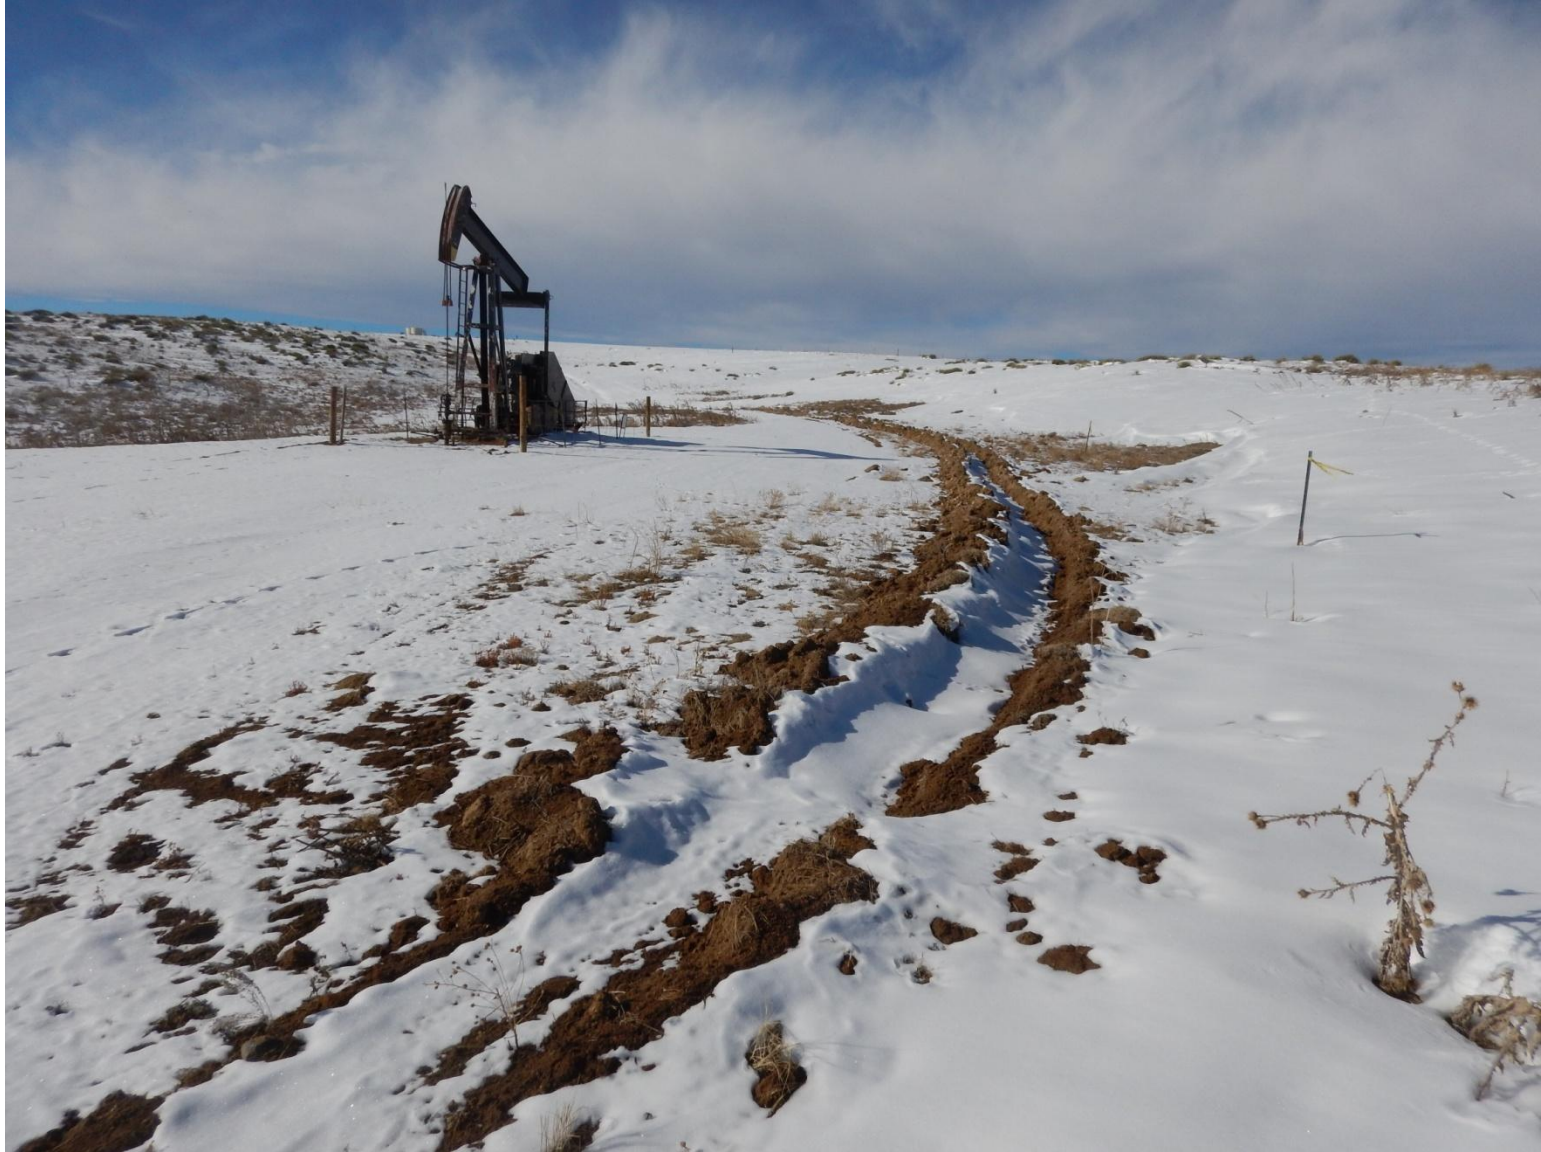
Photo 6: Photo taken from northeast end of location facing east. Photo shows stormwater BMP on northern end of location.

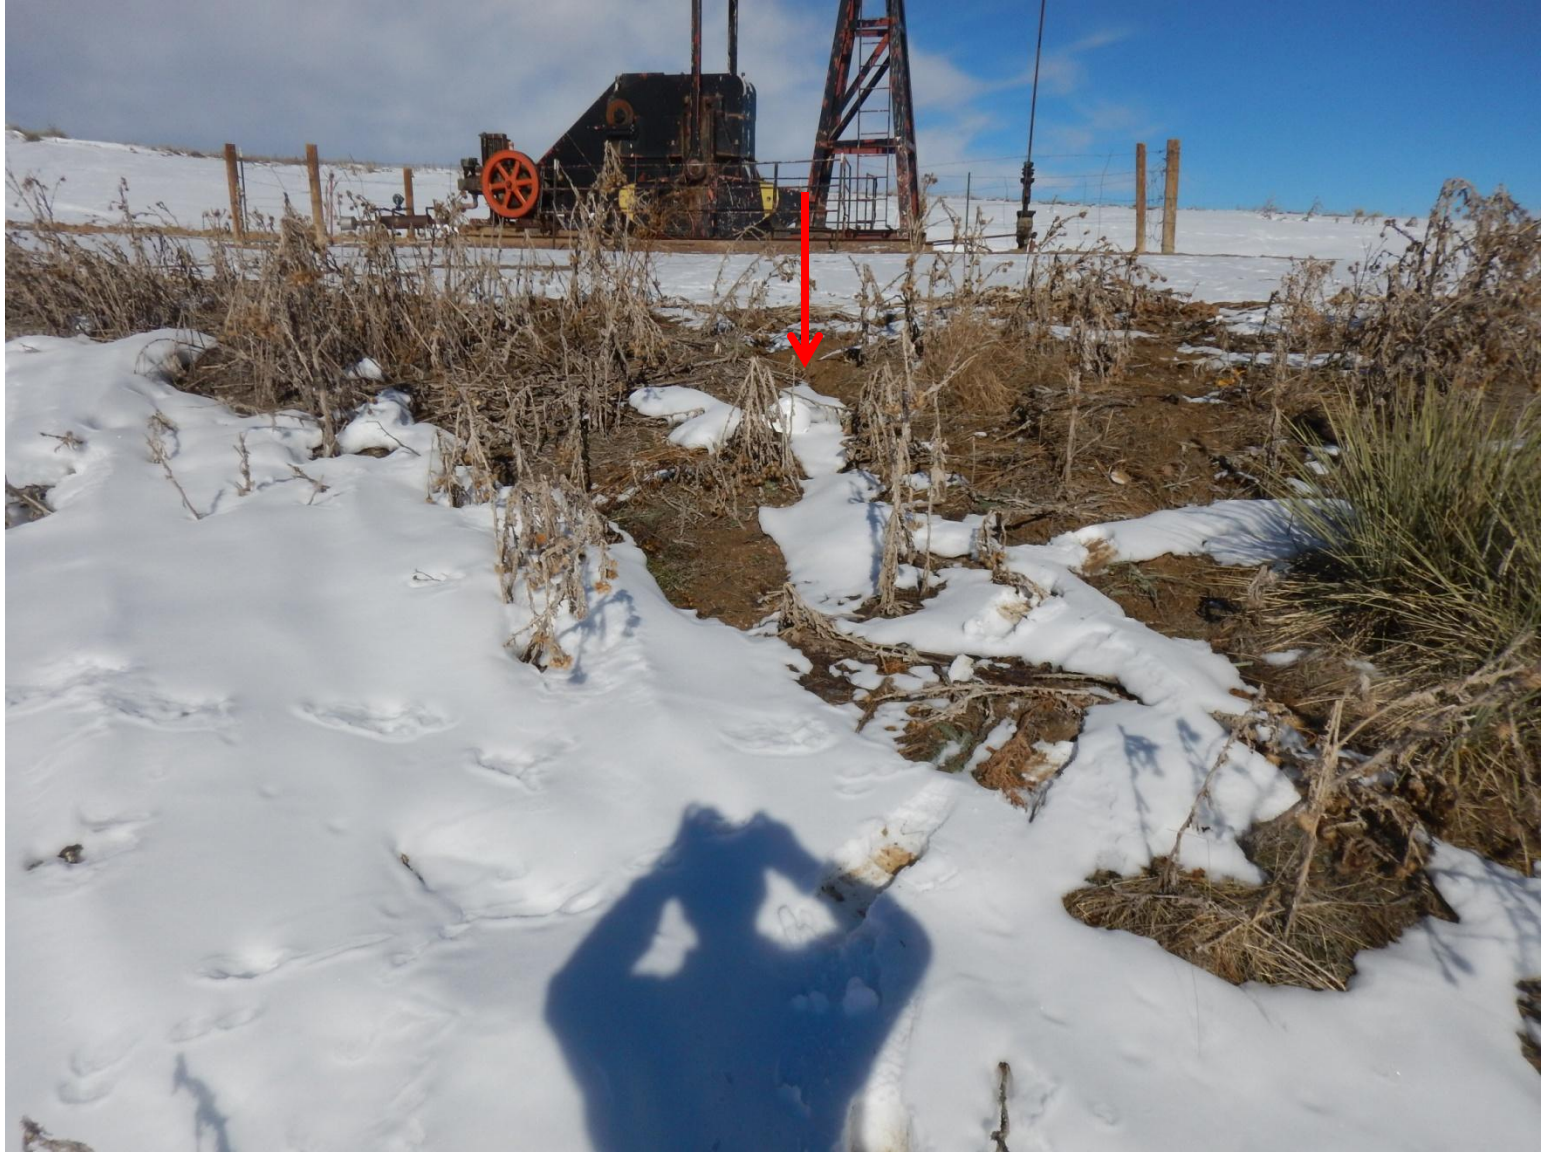
Photo 7: Photo taken from south end of location, facing north. Photo shows insufficient stormwater BMPs, and rill erosion (indicated with arrow). Photo shows Scotch thistle.

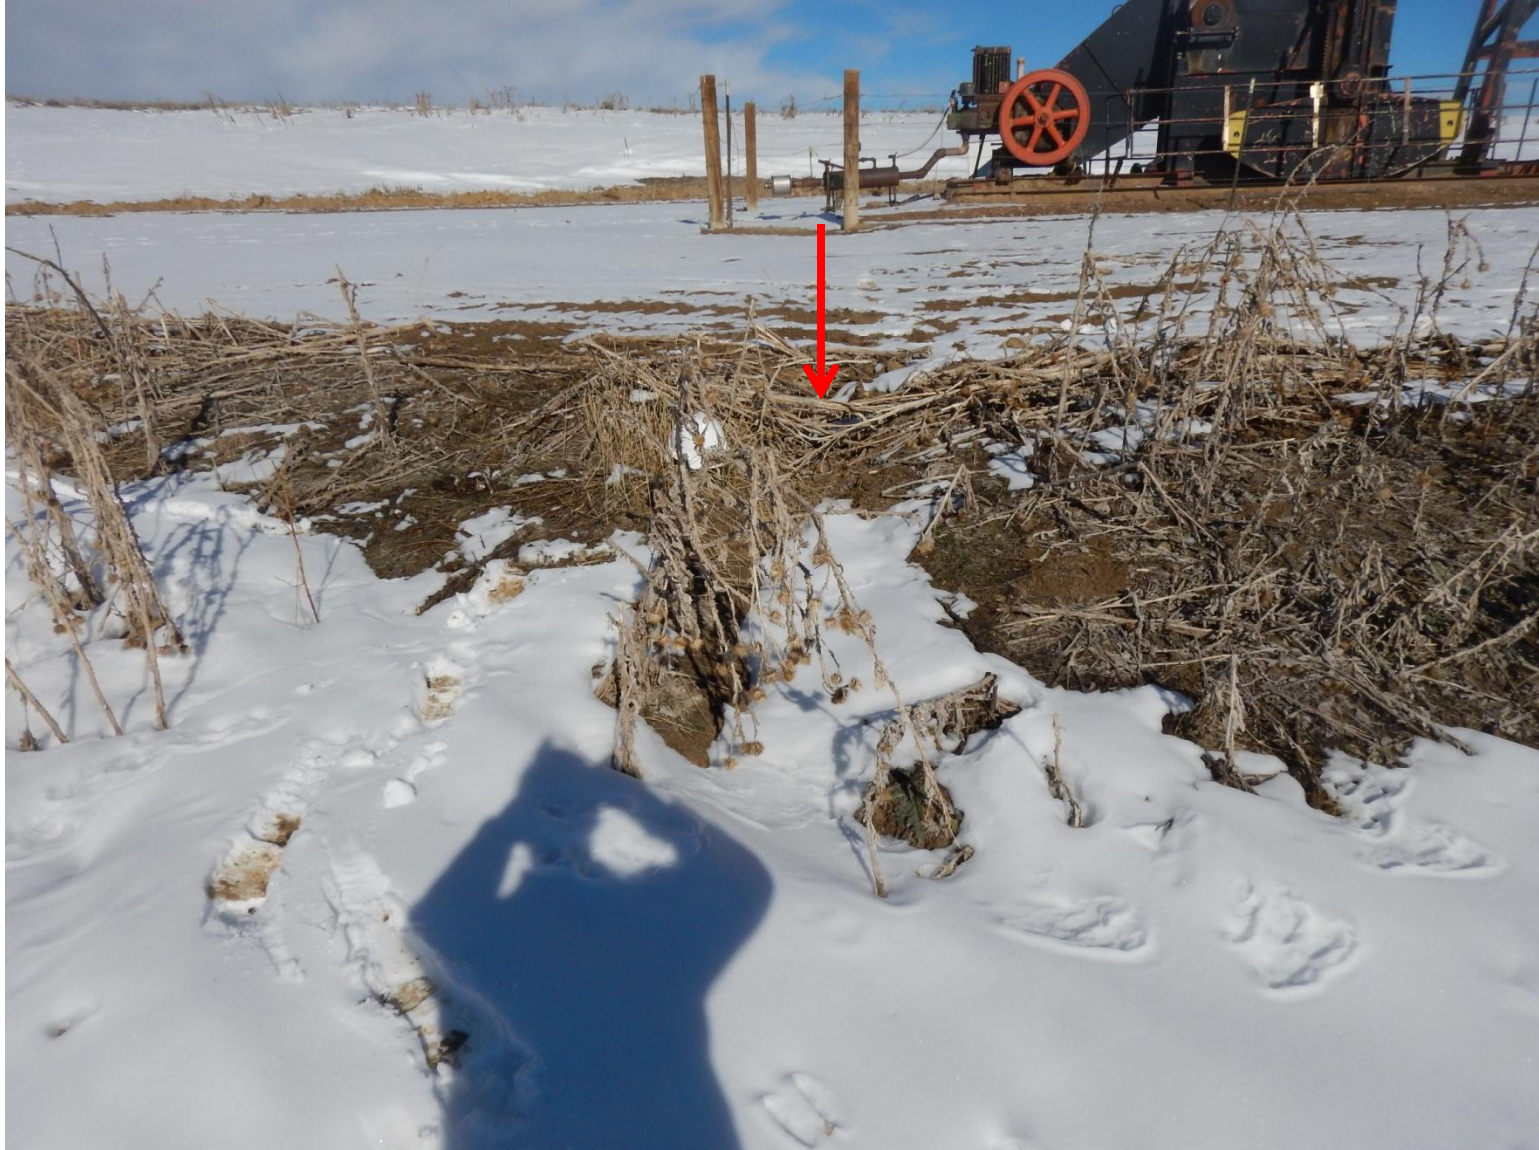
Photo 8: Photo taken from south end of location, facing north. Photo shows insufficient stormwater BMPs, and rill erosion (indicated with arrow). Photo shows Scotch thistle.

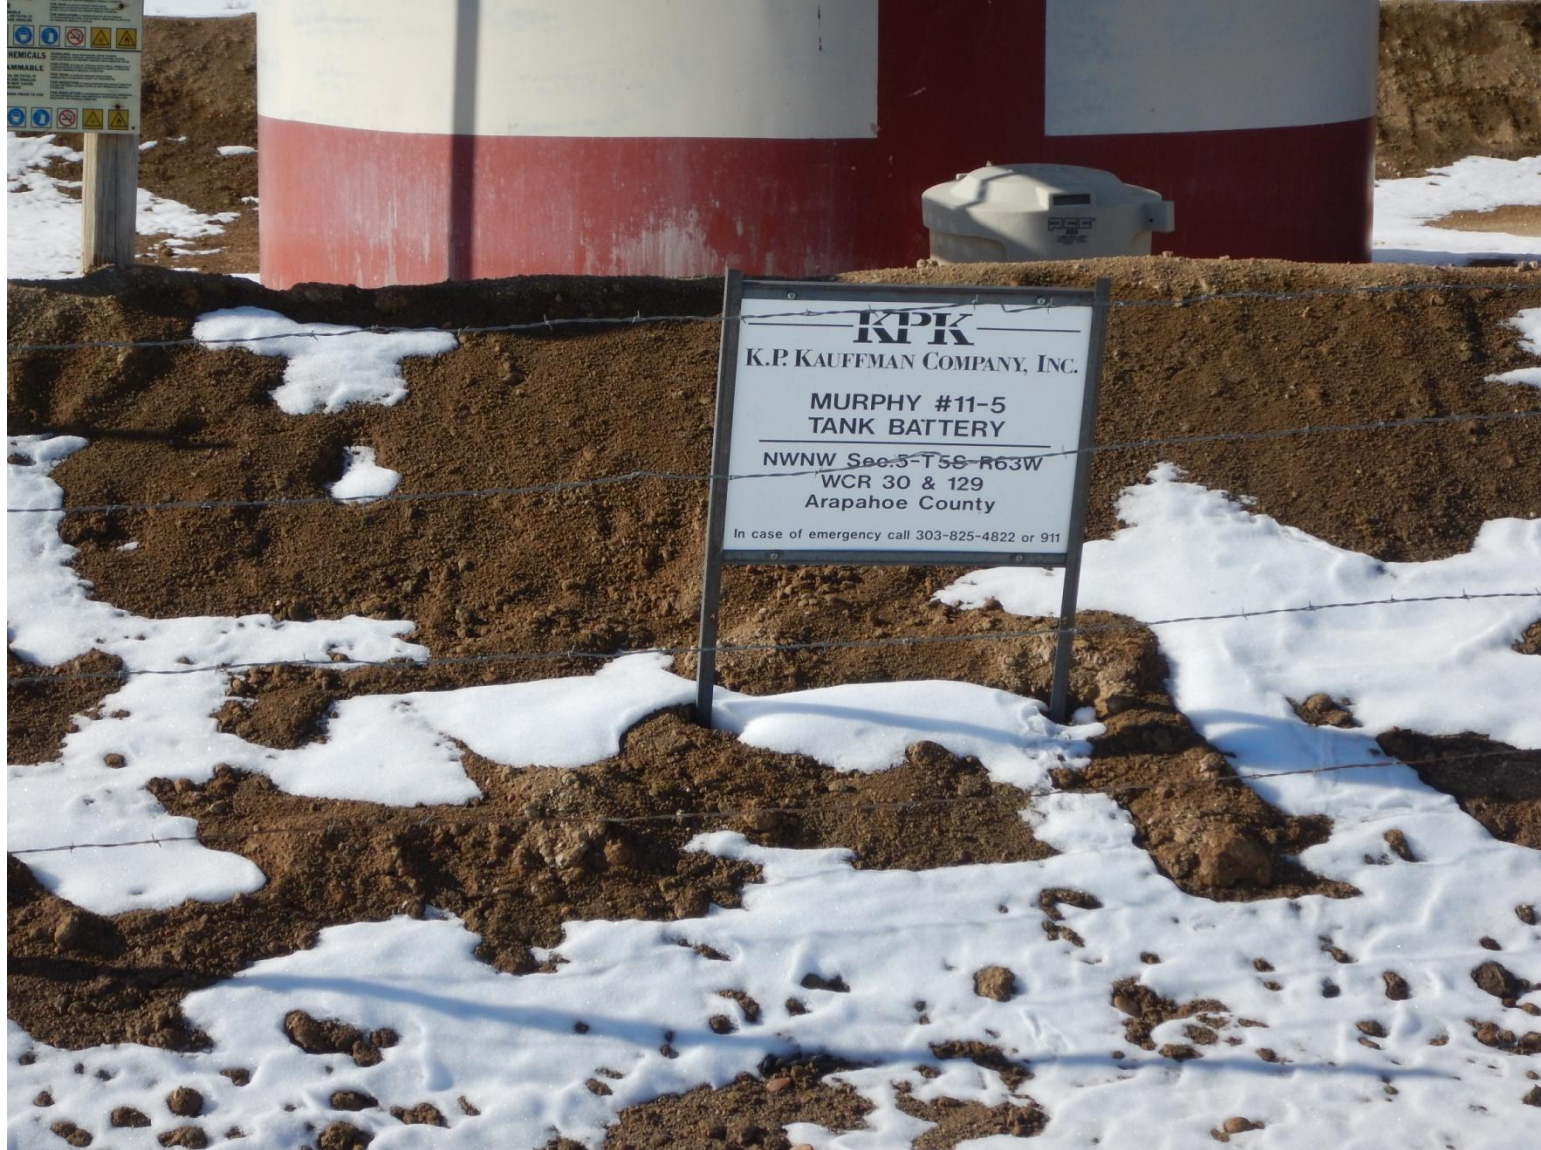
Photo 9: Photo of tank batter location sign.

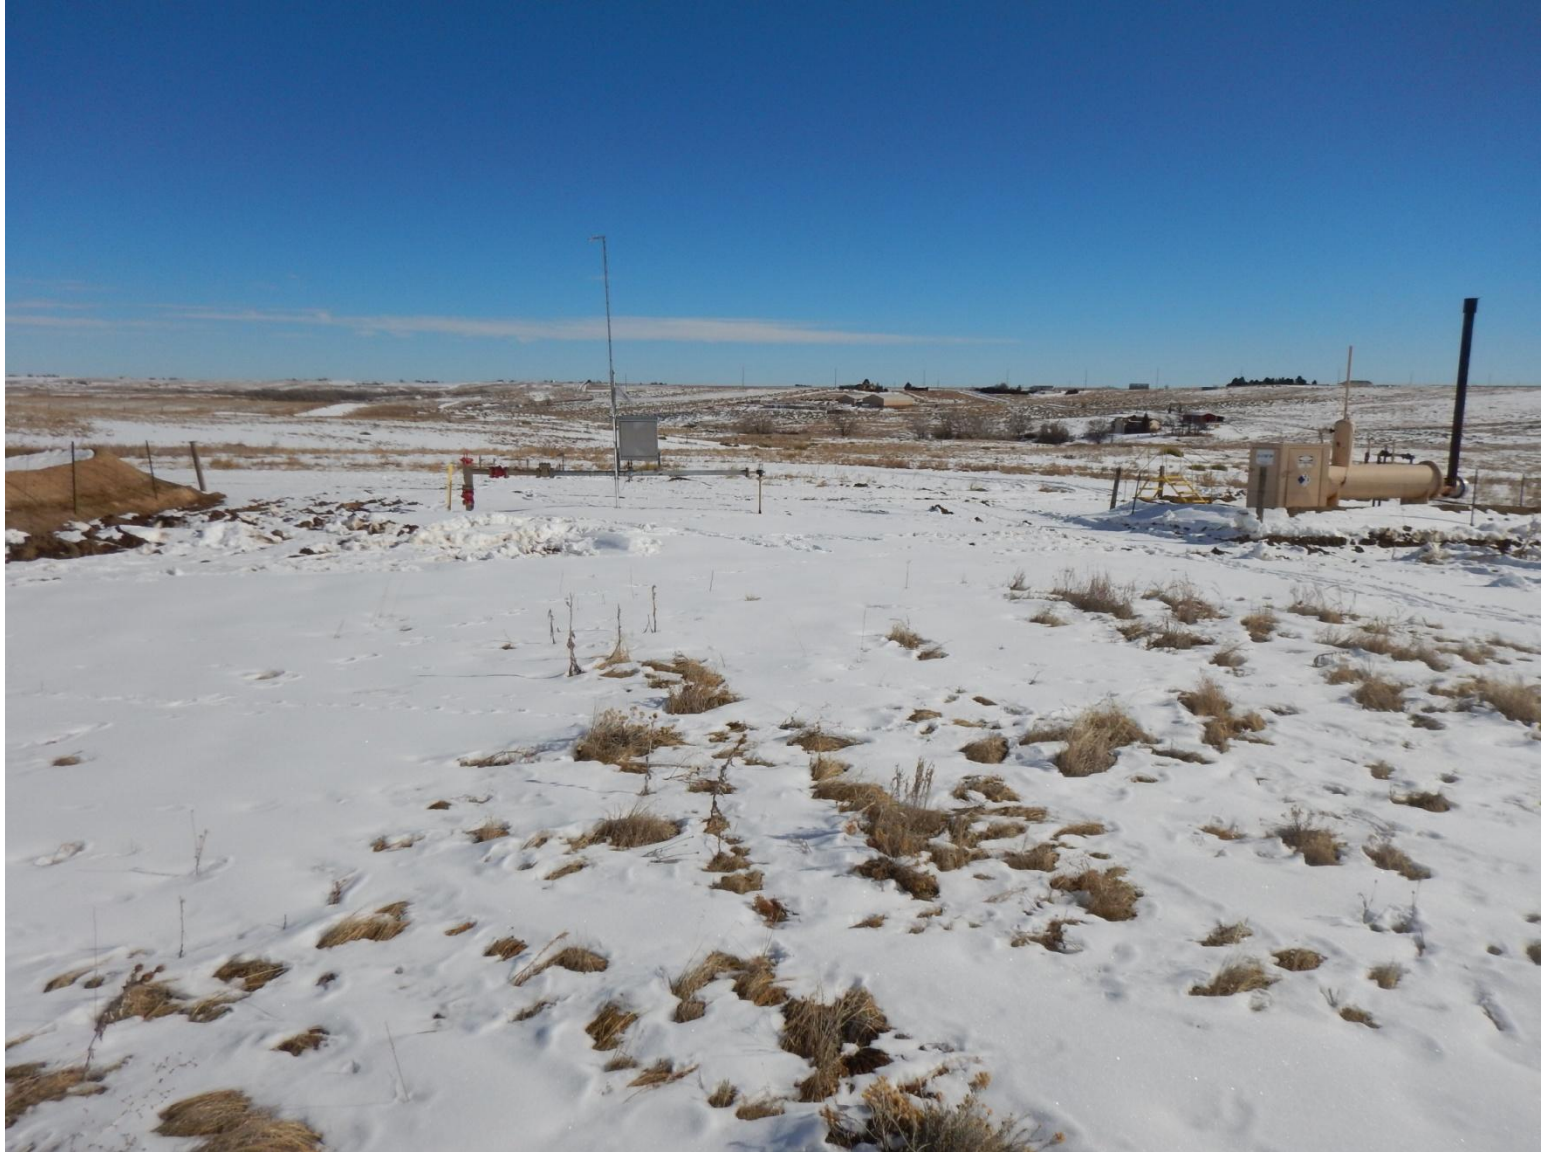
Photo 10: Photo taken from west end of tank battery location, facing east.

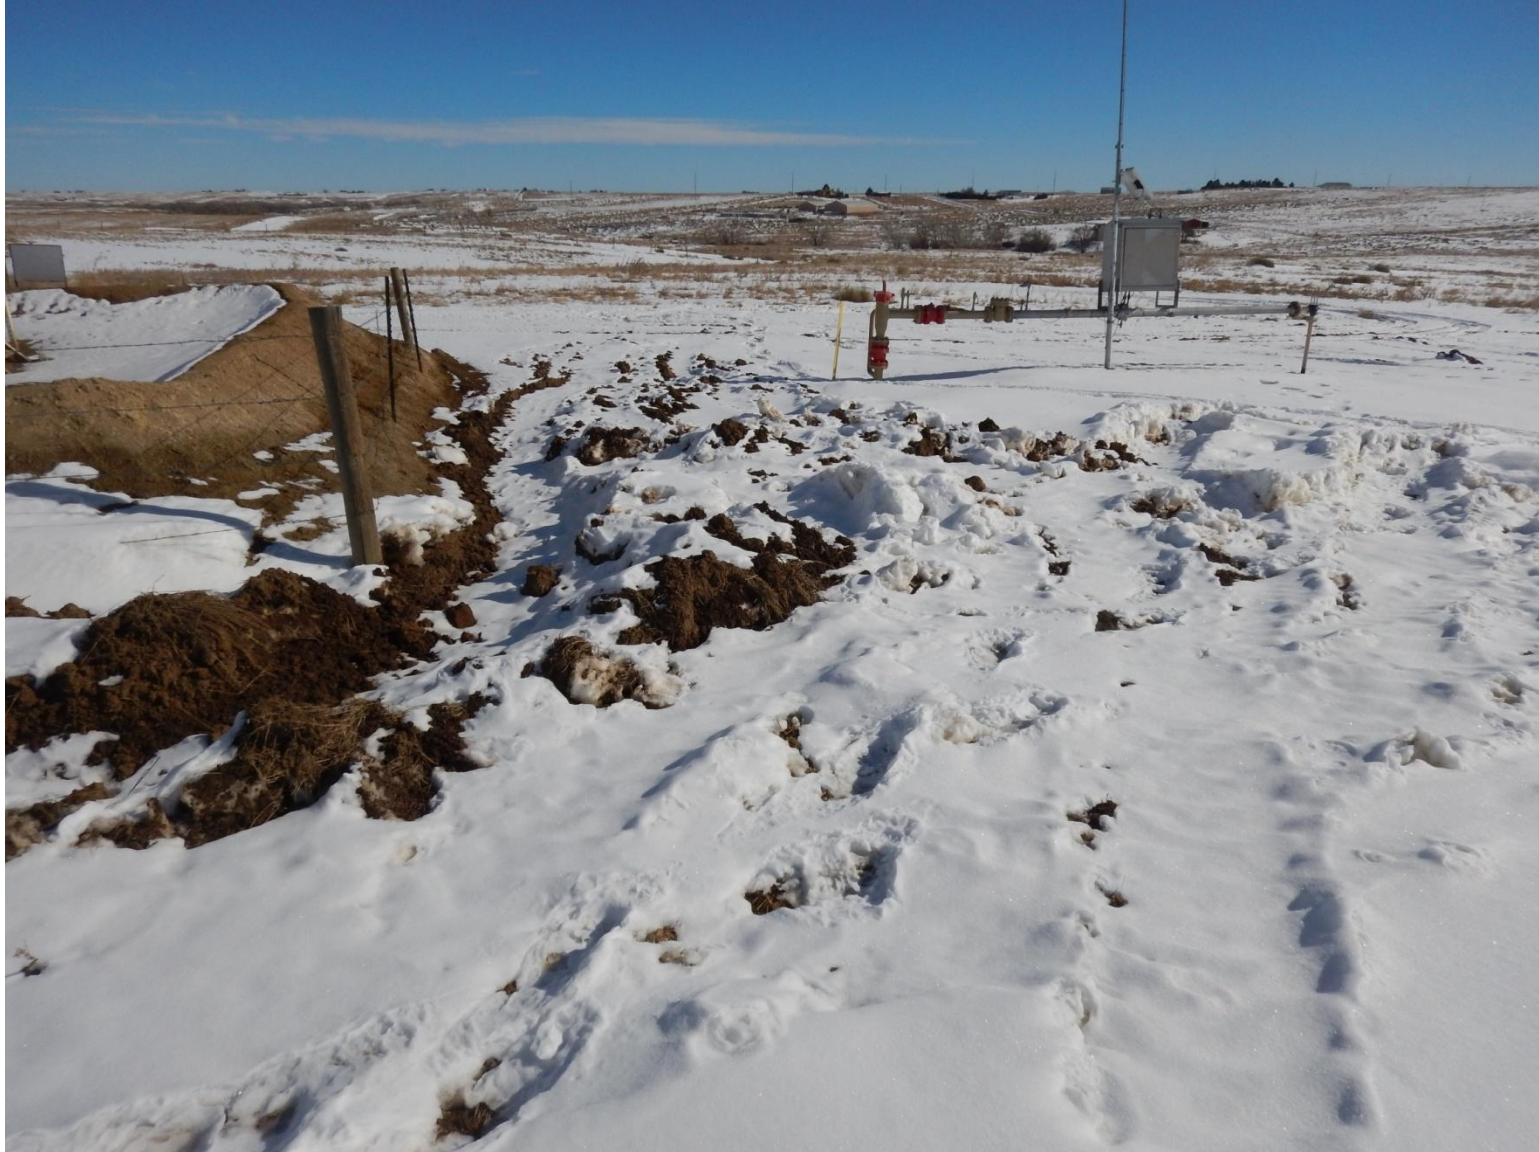
Photo 11: Photo taken from west end of tank battery location, facing east. Photo of stormwater ditch.

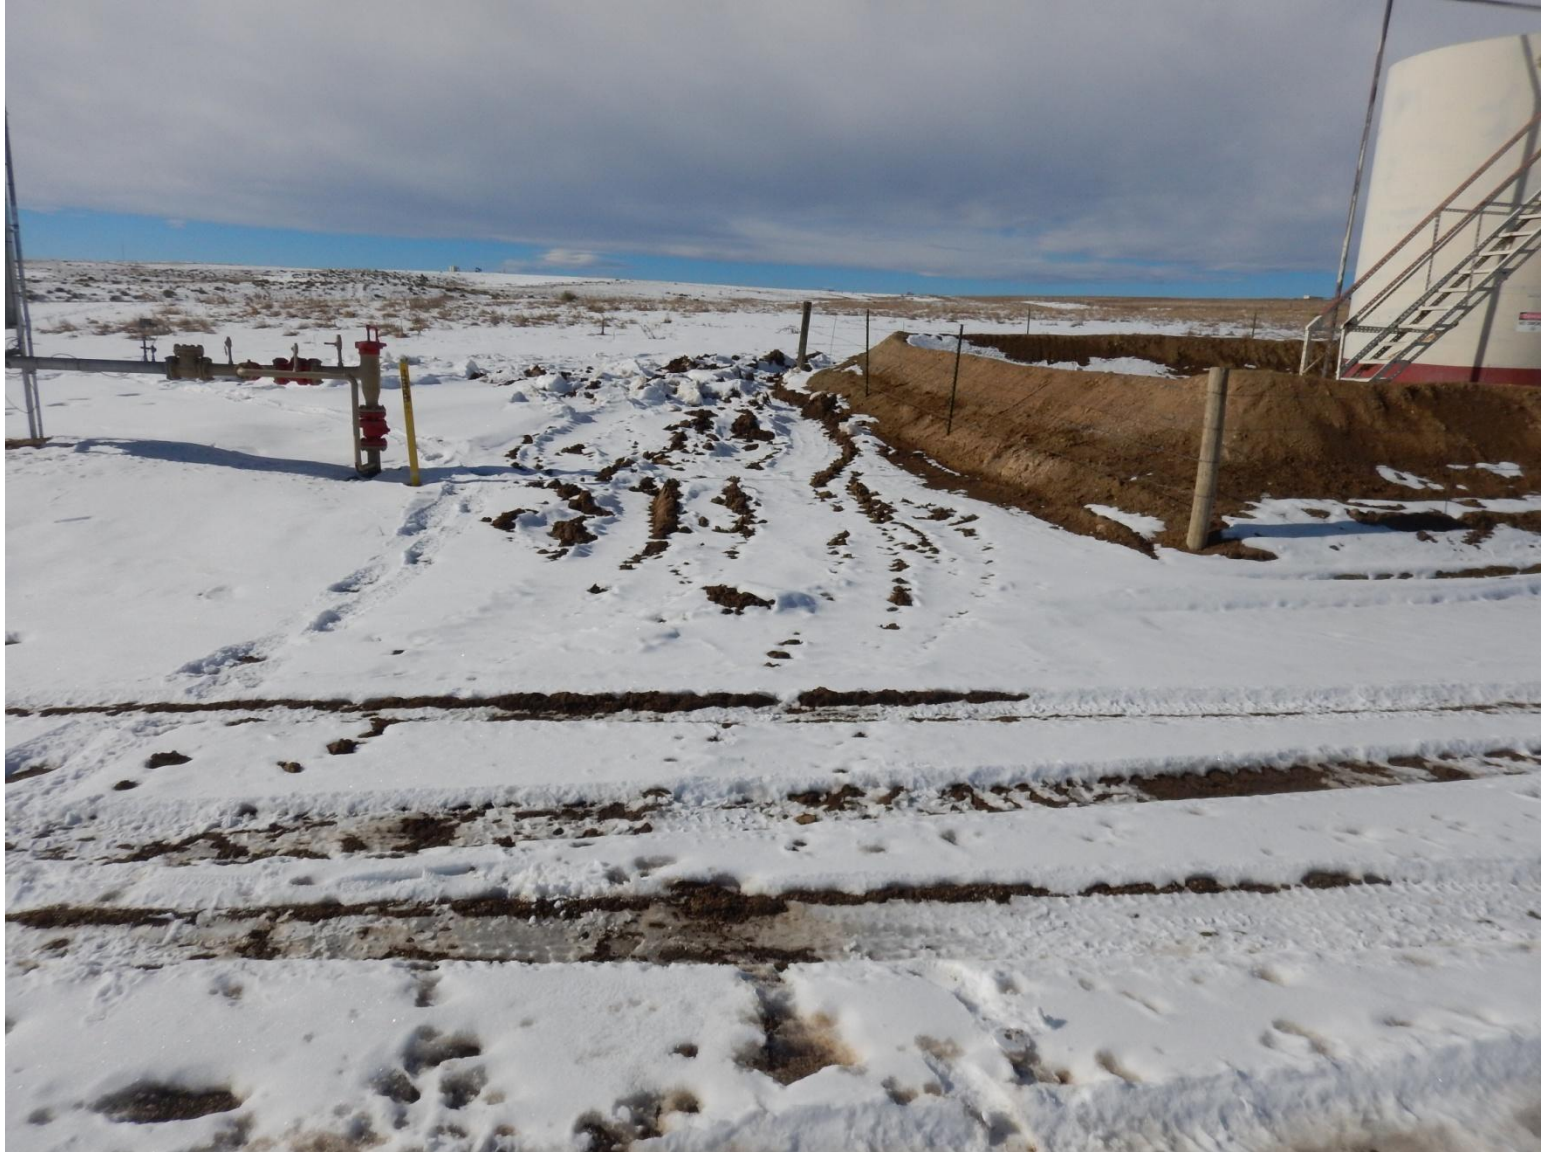
Photo 12: Photo taken from east end of tank battery location, facing west.
Photo of stormwater ditch.

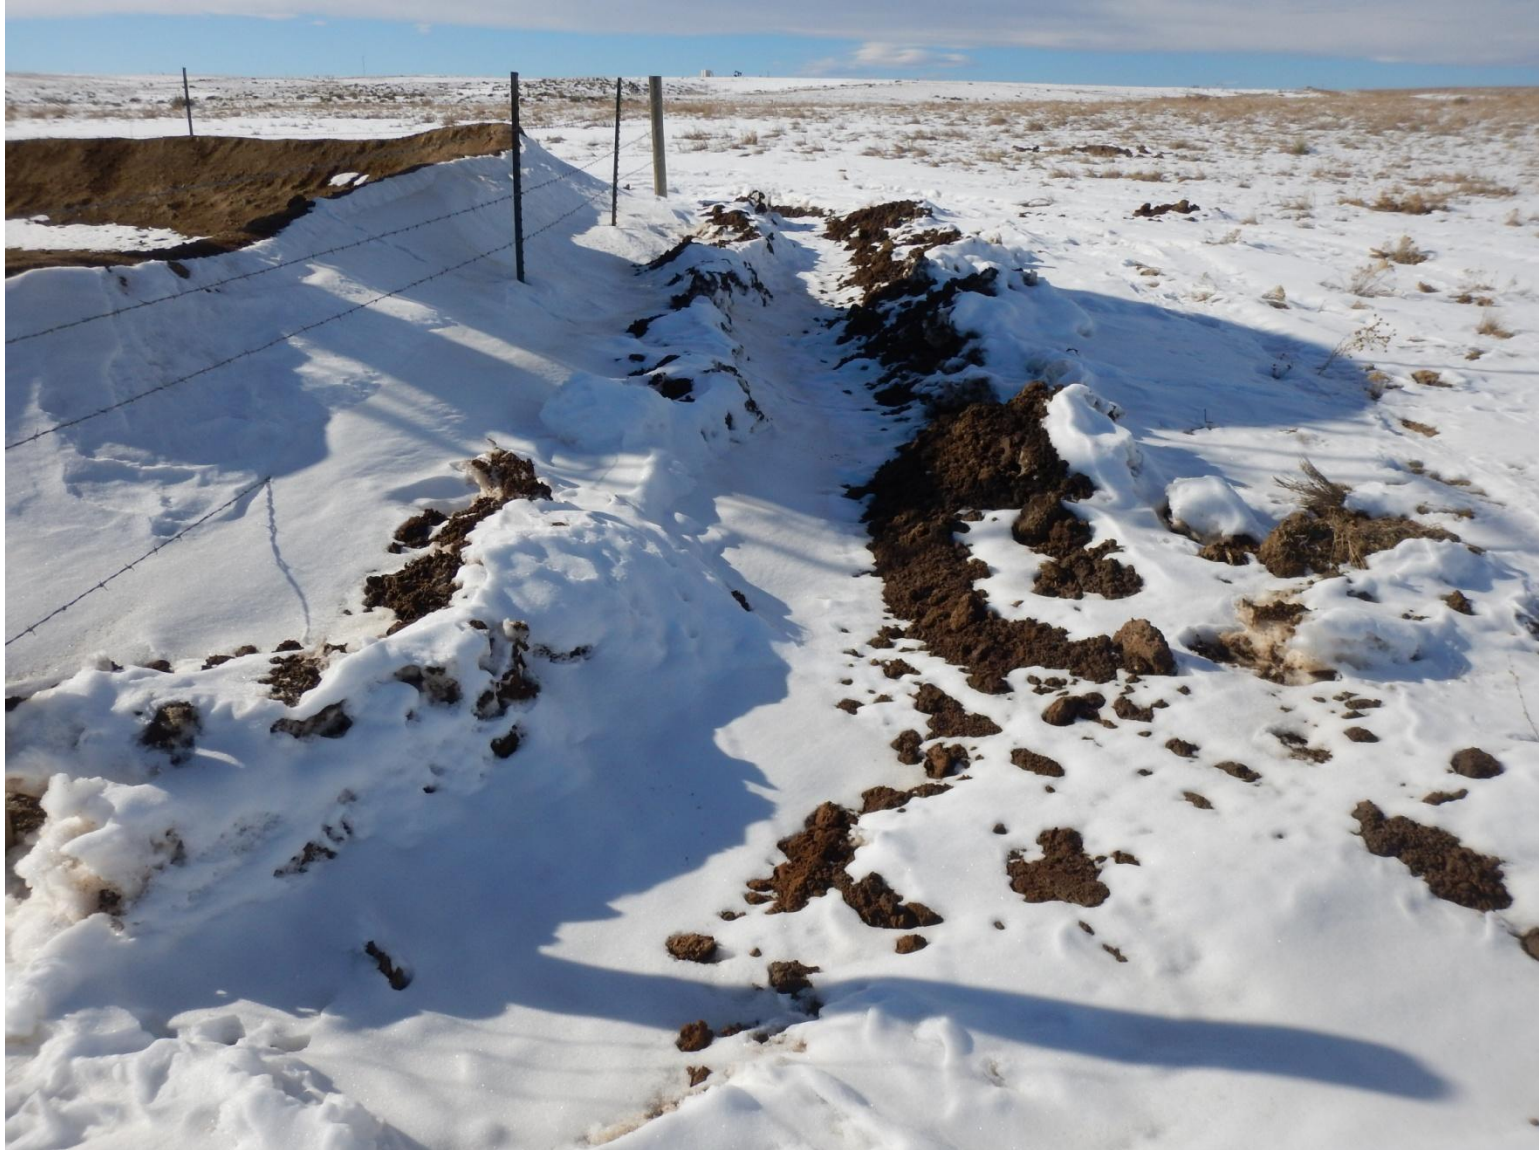
Photo 13: Photo taken from north end of tank battery location, facing west. Photo of stormwater ditch.
