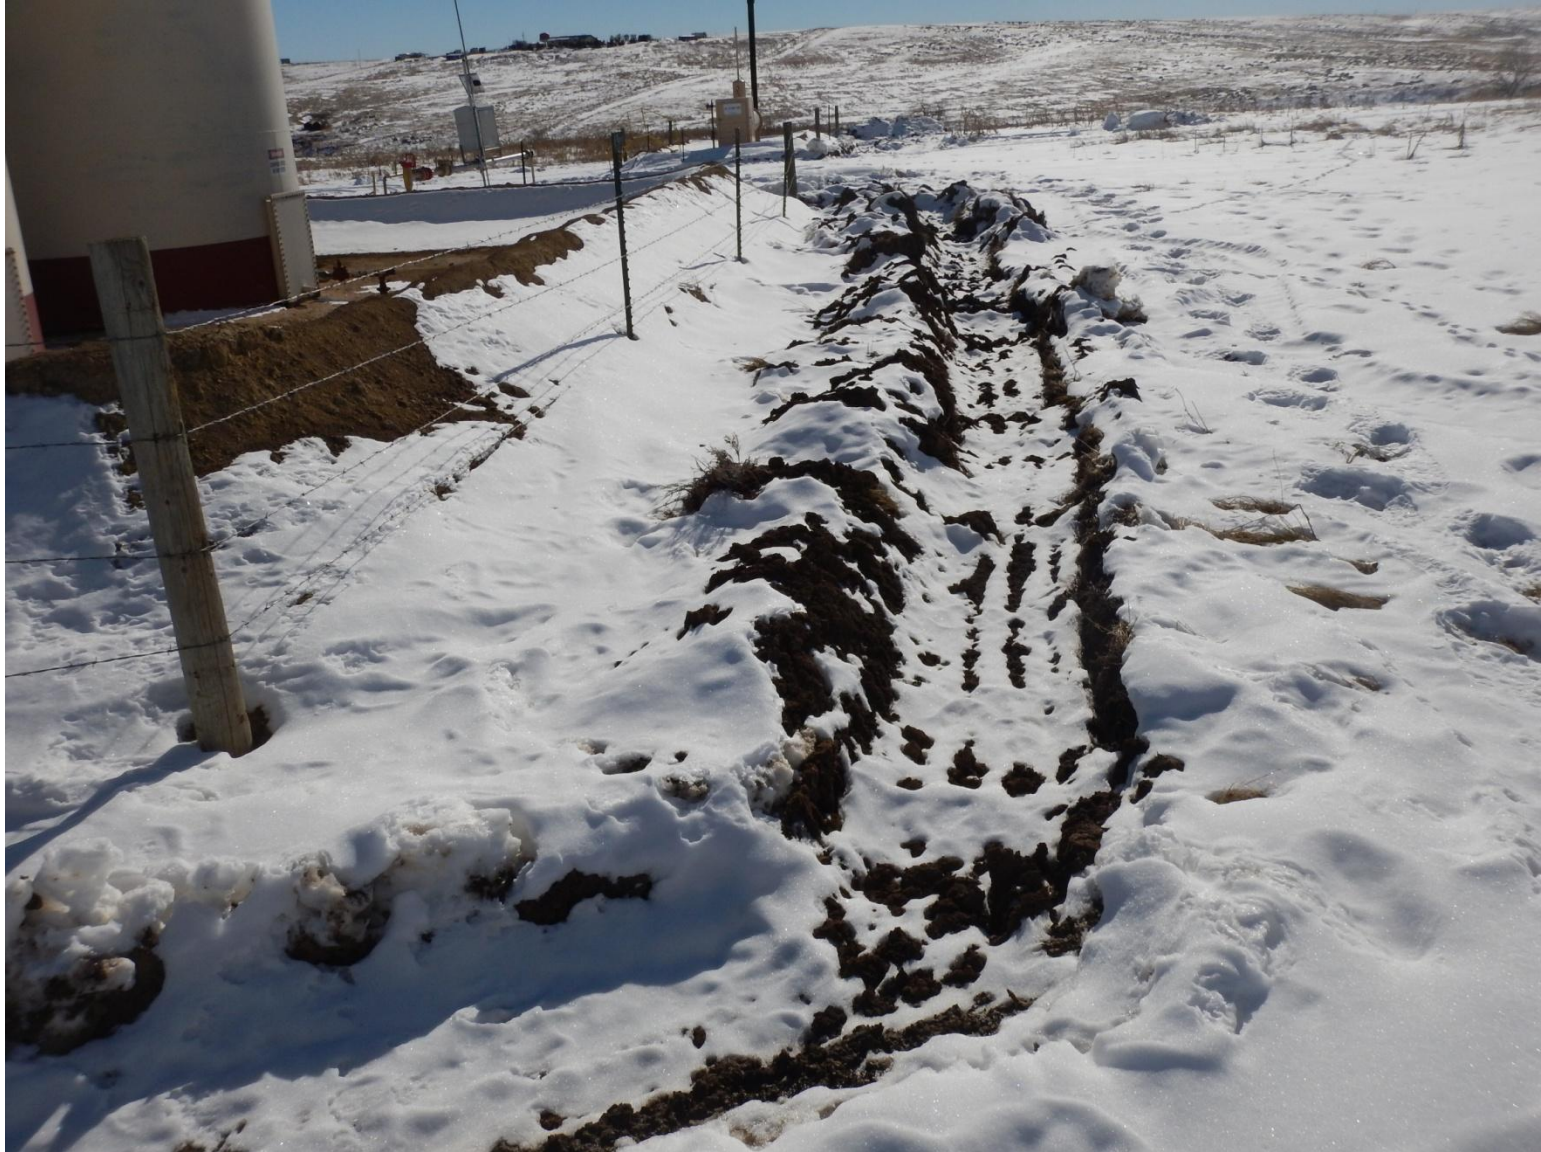
Photo 11: Photo taken from northwest end of tank battery location, facing south. Photo of stormwater ditch.
