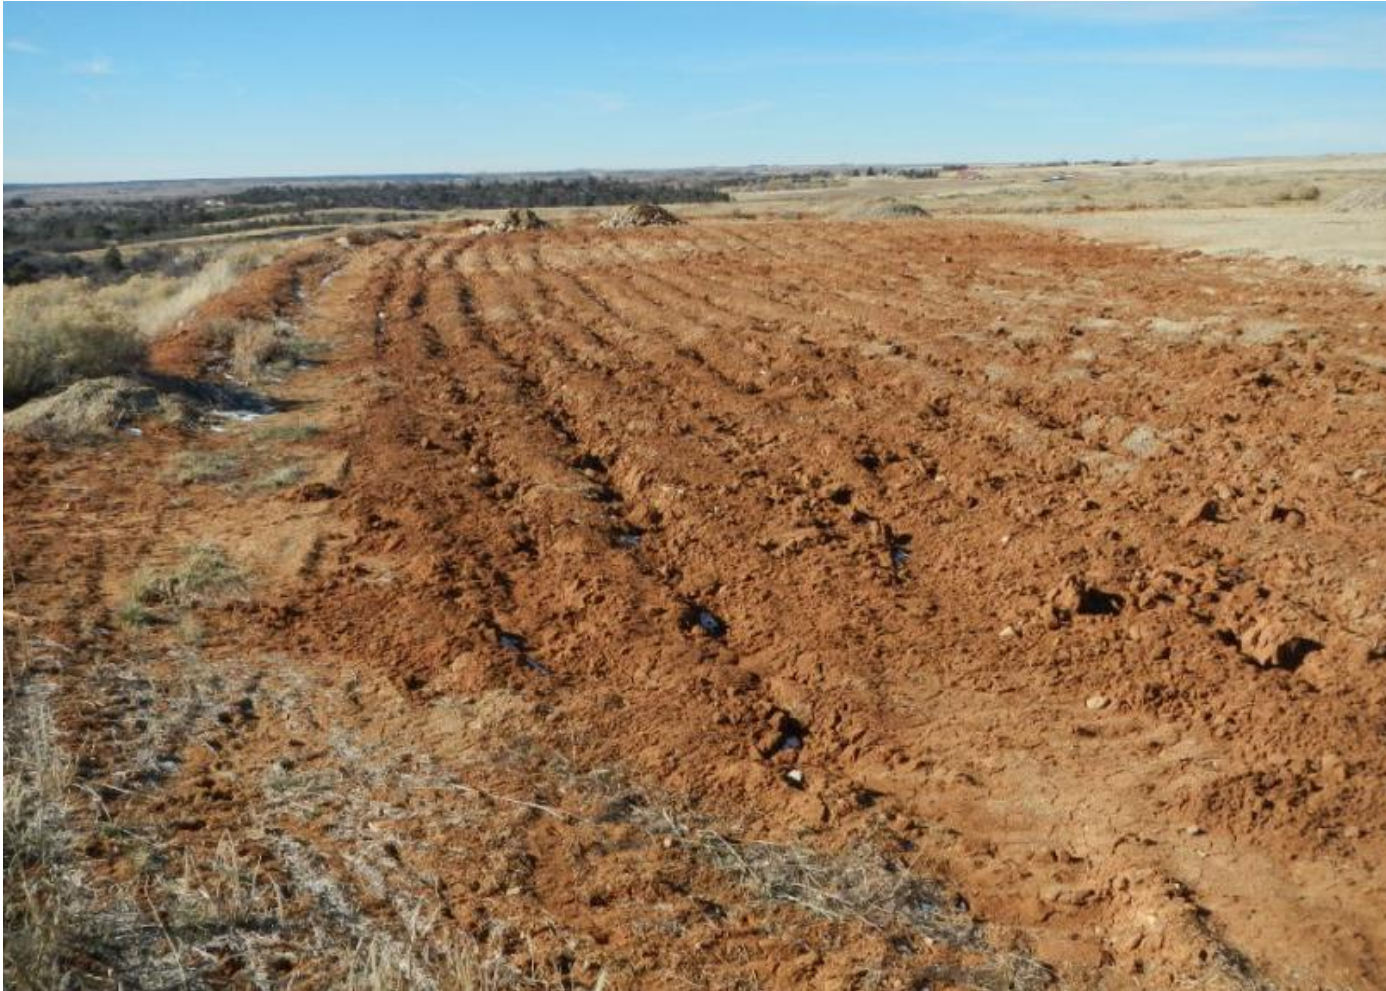
Photo 1. View of the southern portion of the well pad from the southeastern corner facing westward. This portion of the well pad appears to have been recently prepared for interim reclamation. Fill slopes are still present and recontouring needs to be completed.

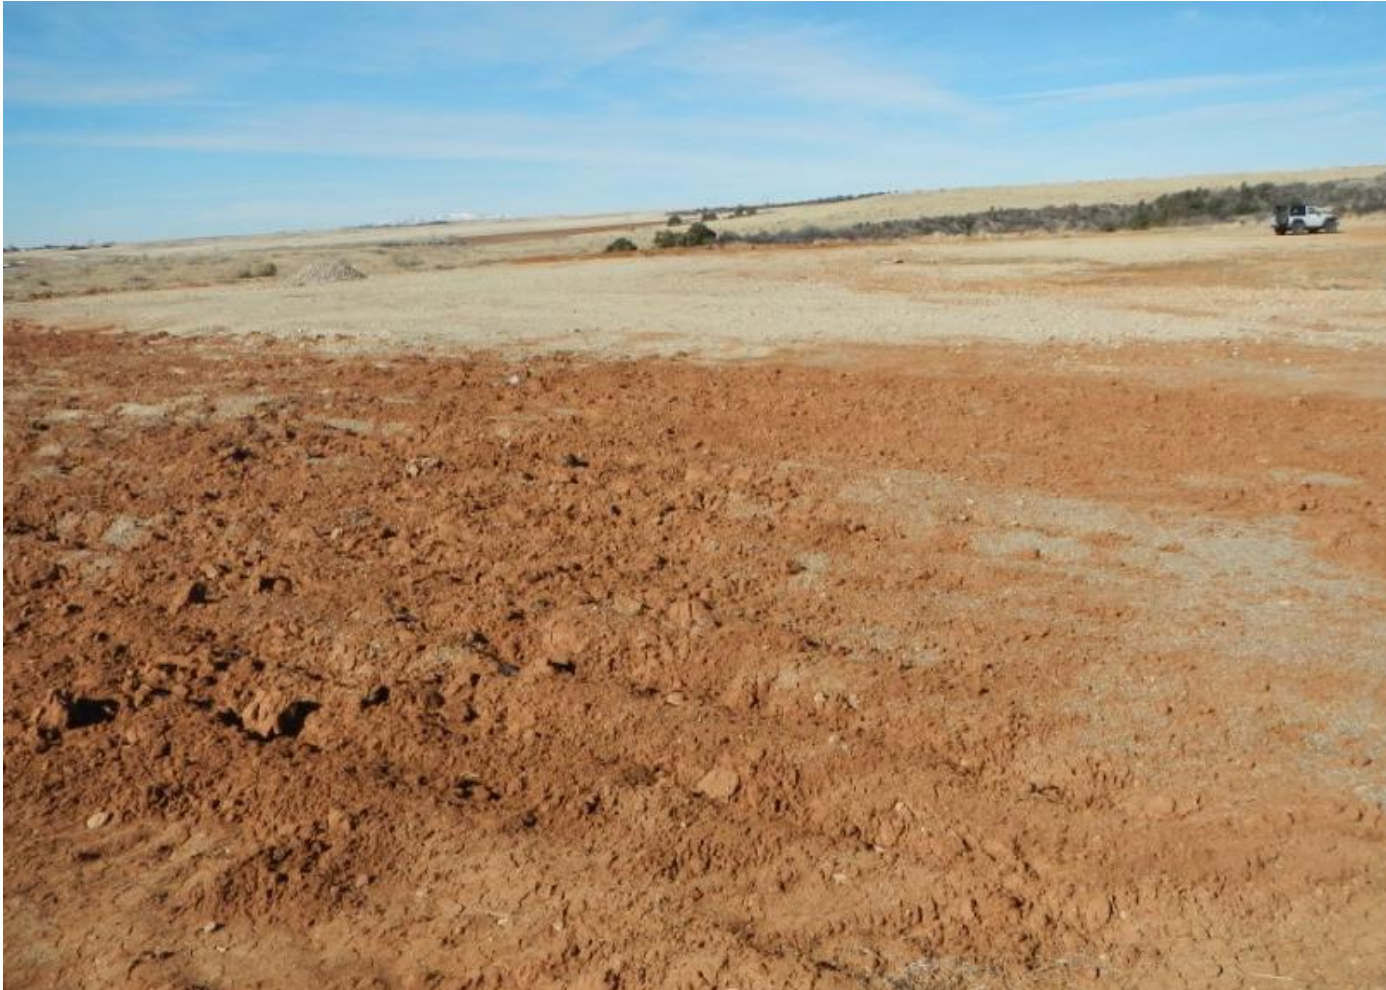
Photo 2. View of project area from the southeastern corner of the project area facing center.

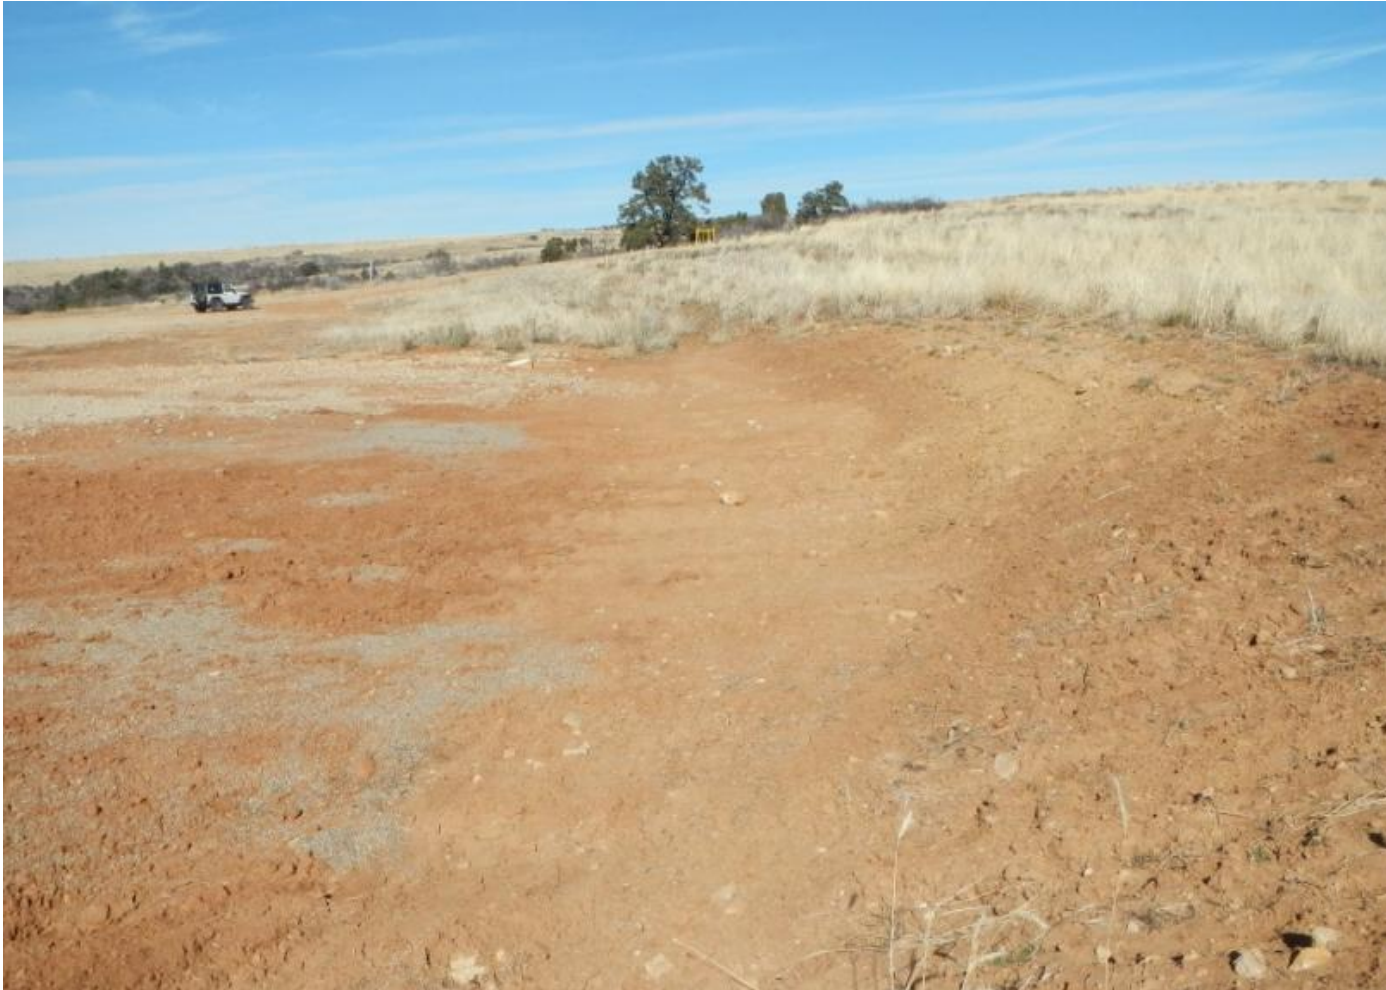
Photo 3. View of the eastern portion of the project area from the southeastern corner of the project area facing northward. Vegetation on the right is from the interim reclamation area.

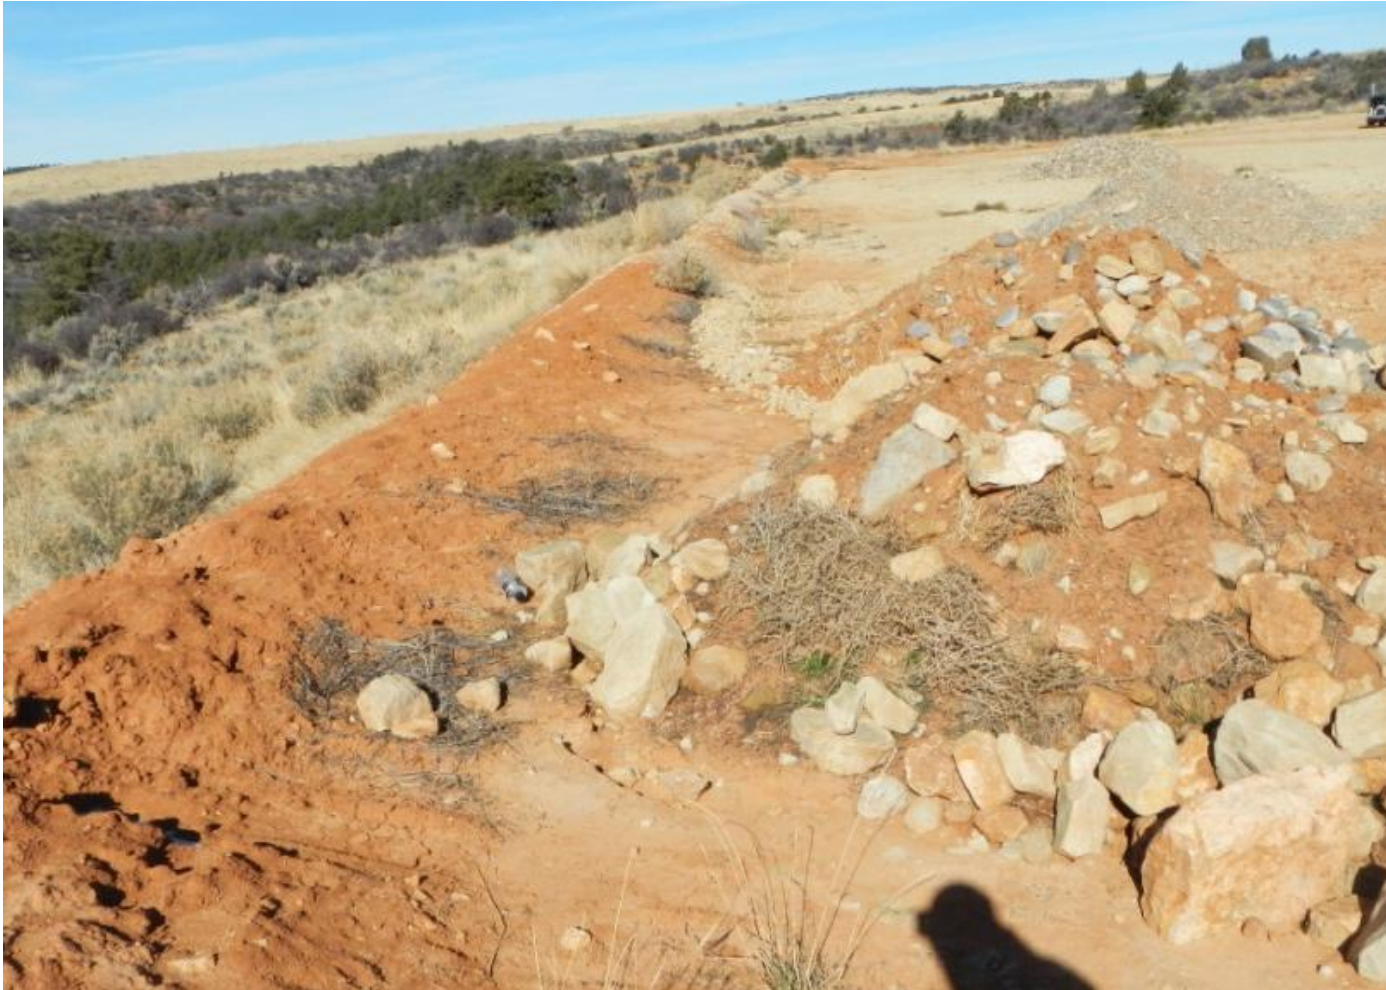
Photo 4. View of the western portion of the project area from the southwestern portion of the project area facing northward. Piles of rock and gravel are present and location has not been recontoured.
